HOME
INSPECTION

Inspection Report

Property Address:
964 Hunter Drive - Nacmine
Drumheller Alberta T0J 0Y0

| Date: 16/12/2021 | Time: 11:00 AM | Report ID: 964 Hunter Drive - Nacmine |

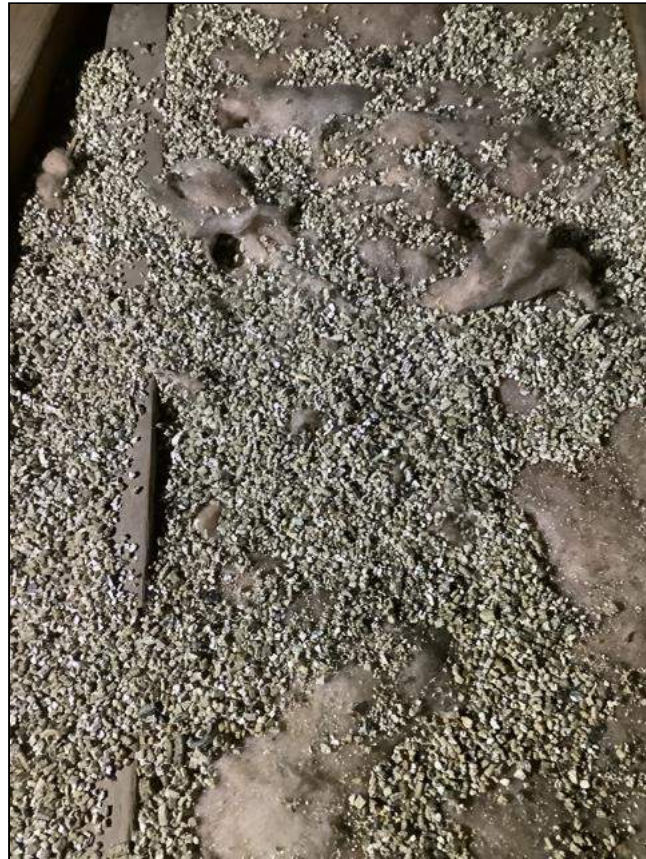
Good amount of insulation in the attic during the inspection but vermiculite was found in the attic space, samples can be taken to the lab for further analysis to confirm if it contains asbestos or not.

2.4 Item 1(Picture) Attic Insulation - vermiculite

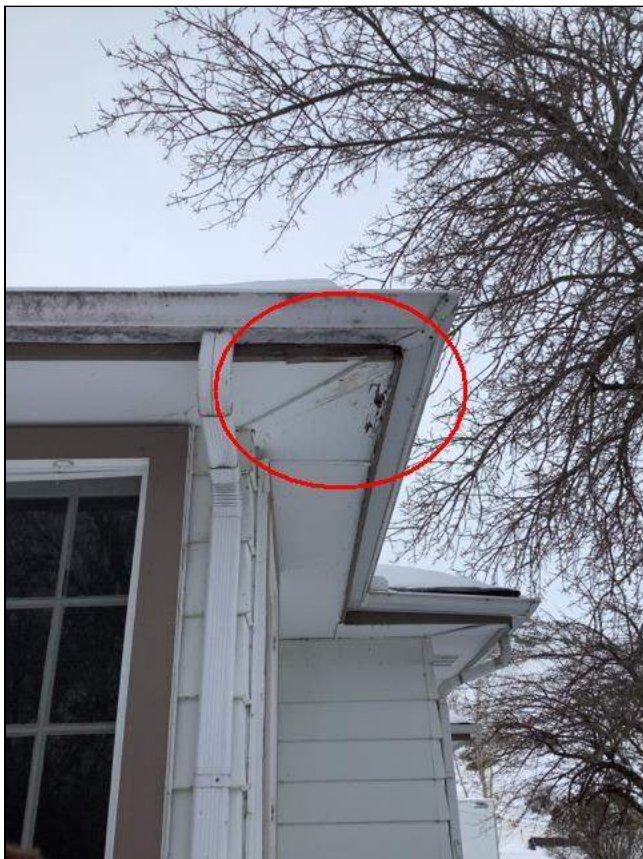
Higher levels of wall clad around the home are only visually inspected from the ground level. There was an area on the back of the house that has signs of moisture damage, recommend further review and repair as required.

3.1 Item 1(Picture) Exterior - signs of moisture damage

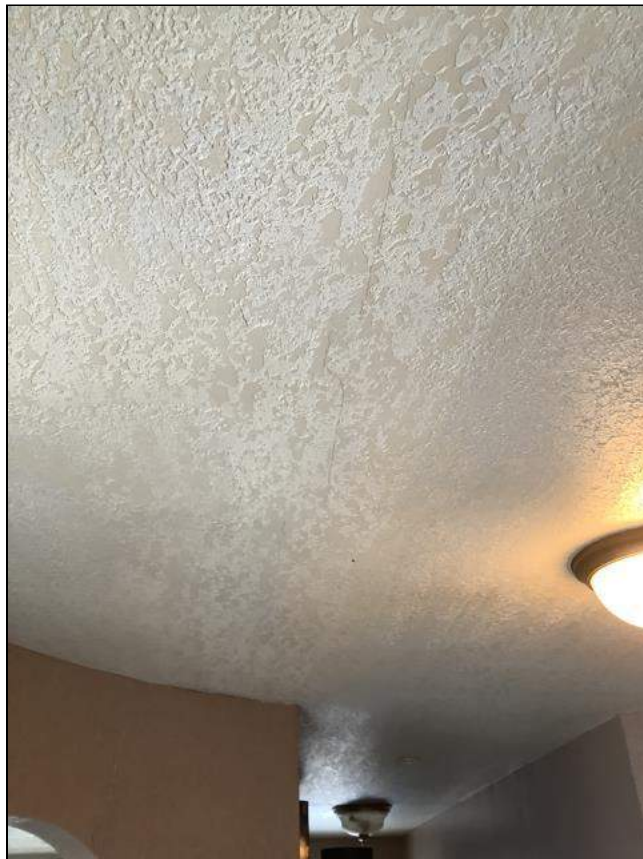
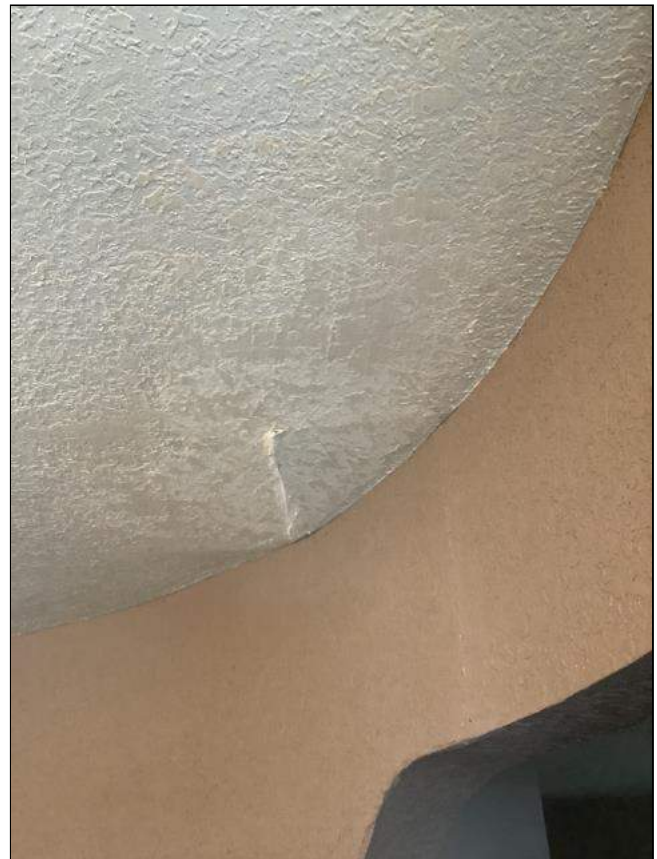
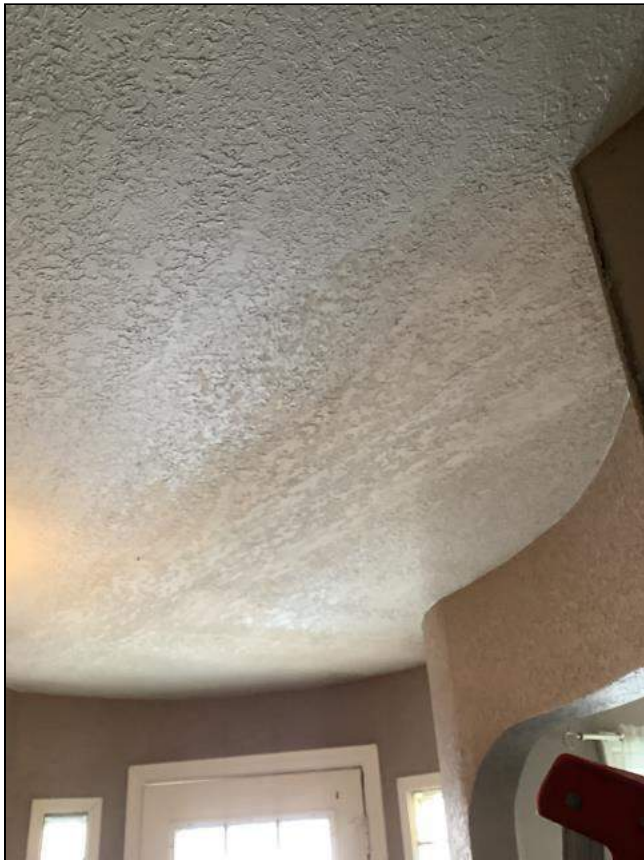
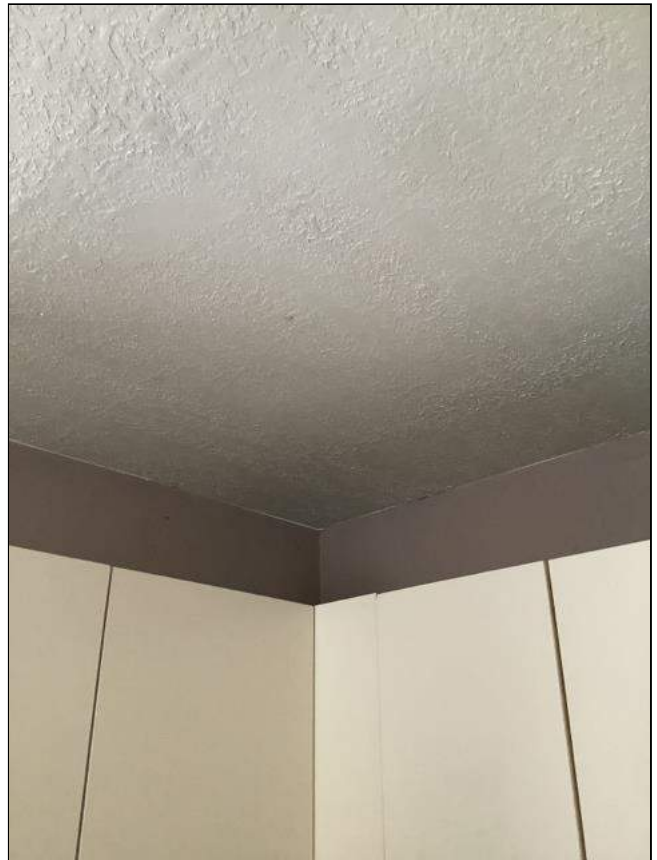
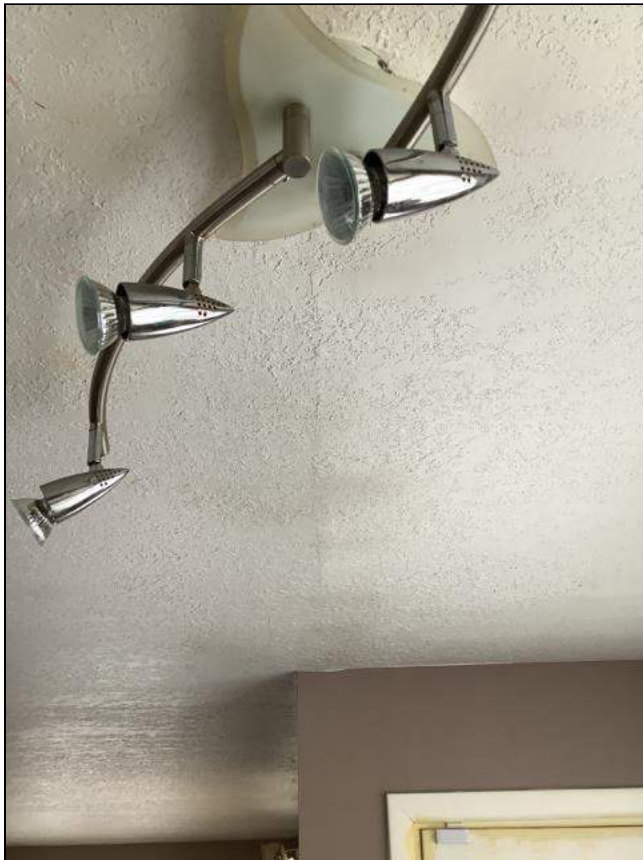
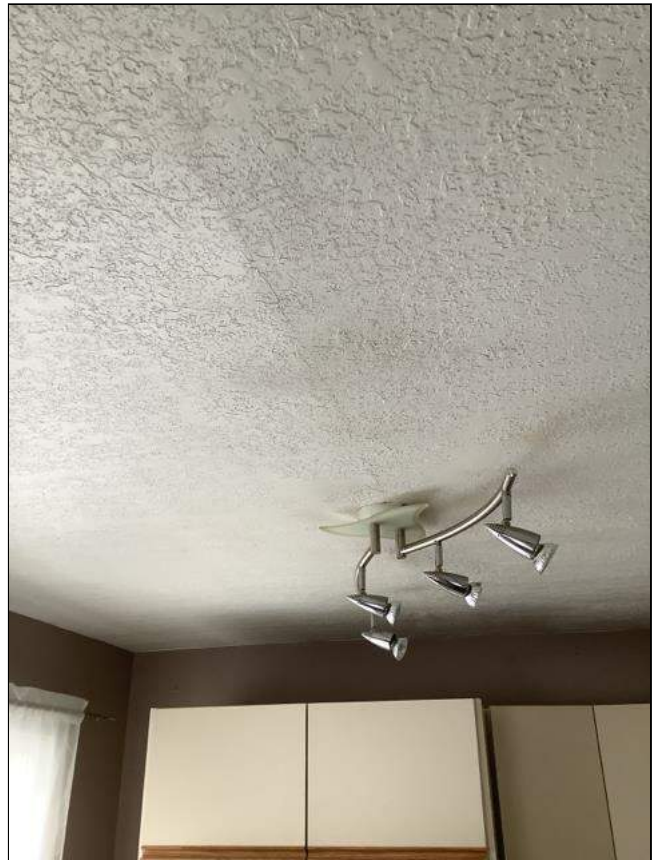
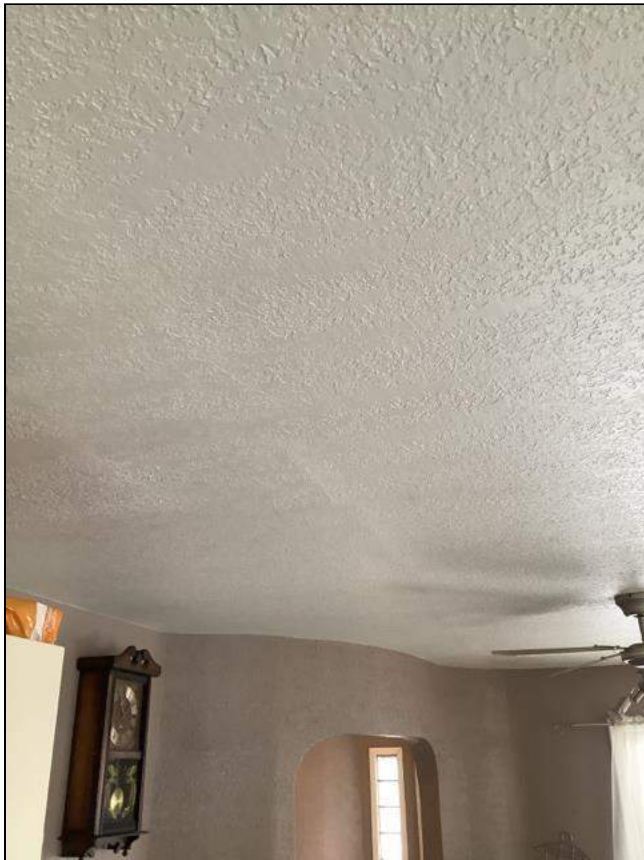
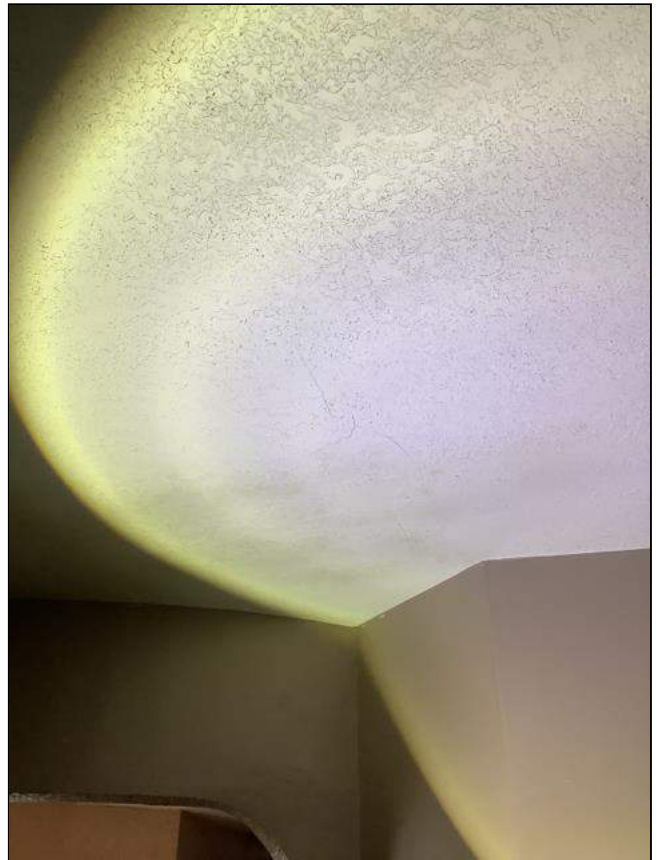
There were areas on the ceiling where there was signs of moisture damage, patching and stressed seams from shifting. Some of these are probably caused by the crooked, slanted joists and beams in the basement.

5.0 Item 1(Picture) Ceiling - signs of moisture damage, patching, stressed seams

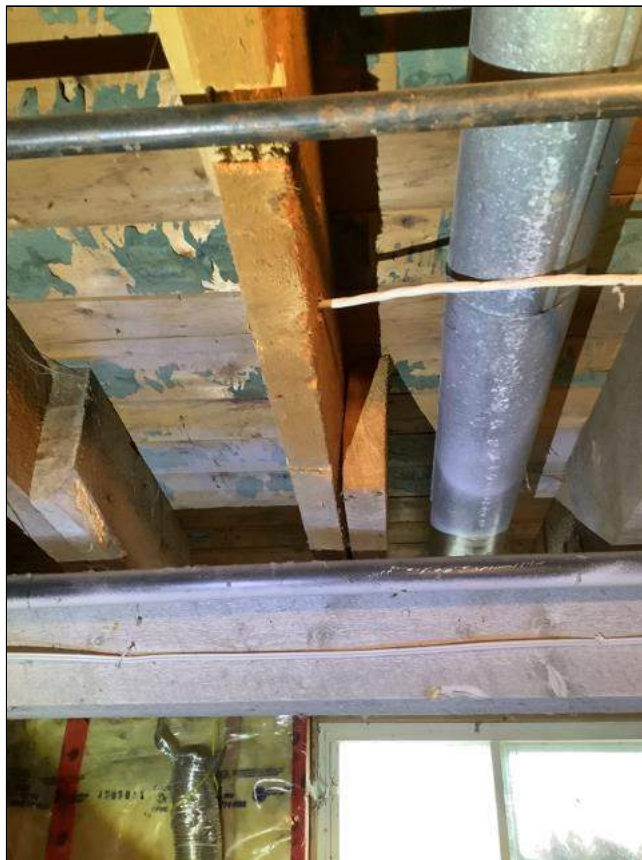
7.9 Item 28(Picture) Joists and Beams - slanted, crooked, notched out, bowed, split

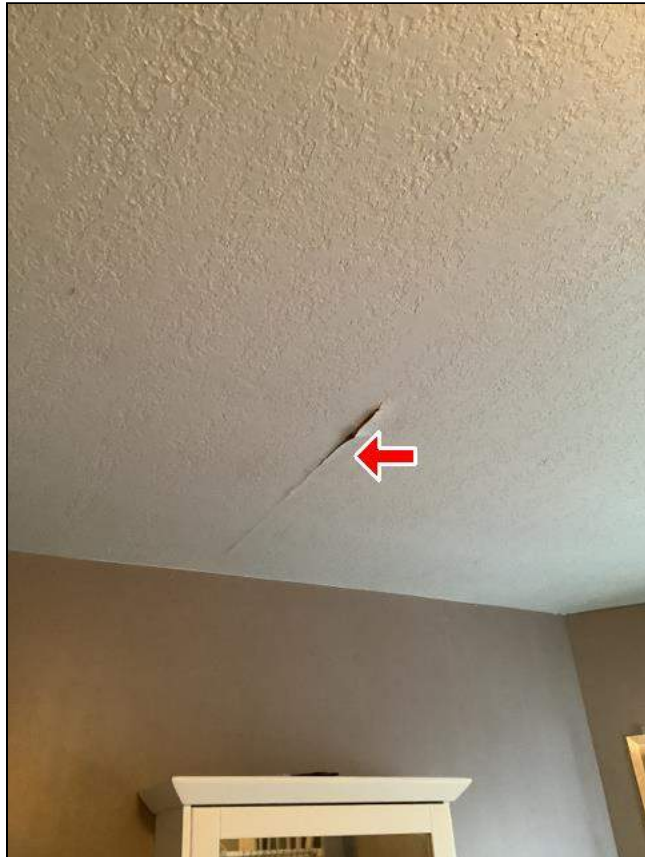
All bathroom walls and ceiling were dry at time of inspection. There was an area in the bathroom ceiling where the seam is splitting but most likely from humidity as there is no fan.

9.0 Item 1(Picture) Bathroom Ceiling - seam splitting

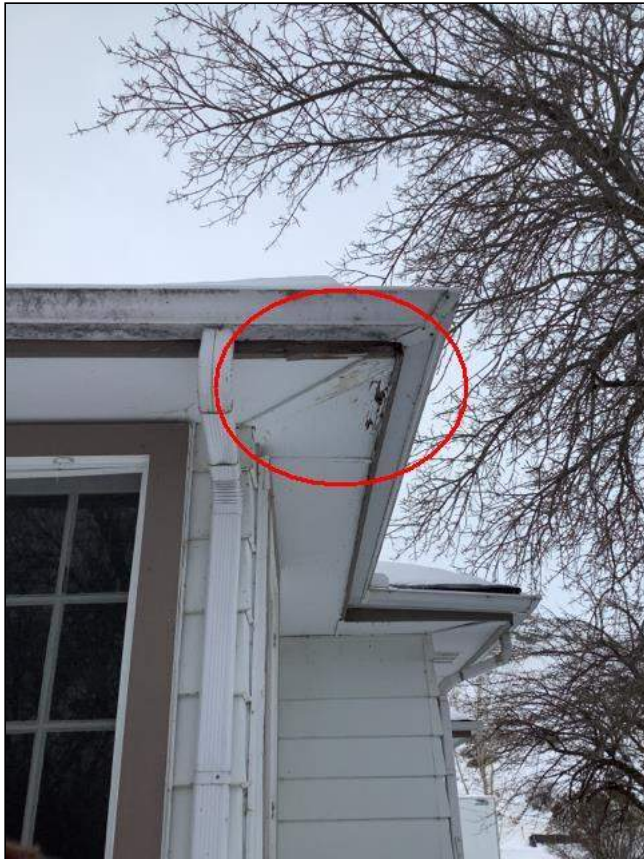
Higher levels of wall clad around the home are only visually inspected from the ground level. There was an area on the back of the house that has signs of moisture damage, recommend further review and repair as required.

3.1 Item 1(Picture) Exterior - signs of moisture damage

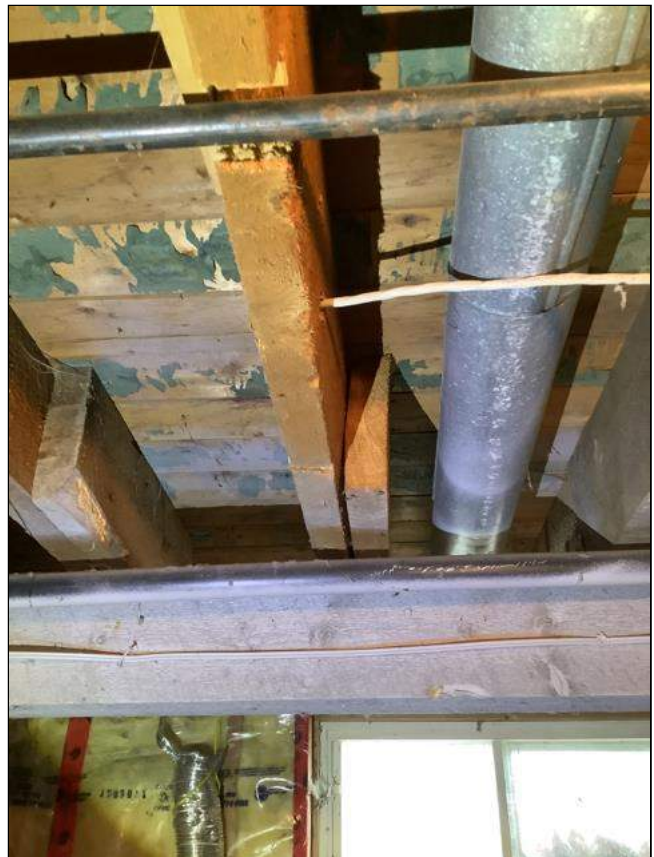
7.9 Item 28(Picture) Joists and Beams - slanted, crooked, notched out, bowed, split

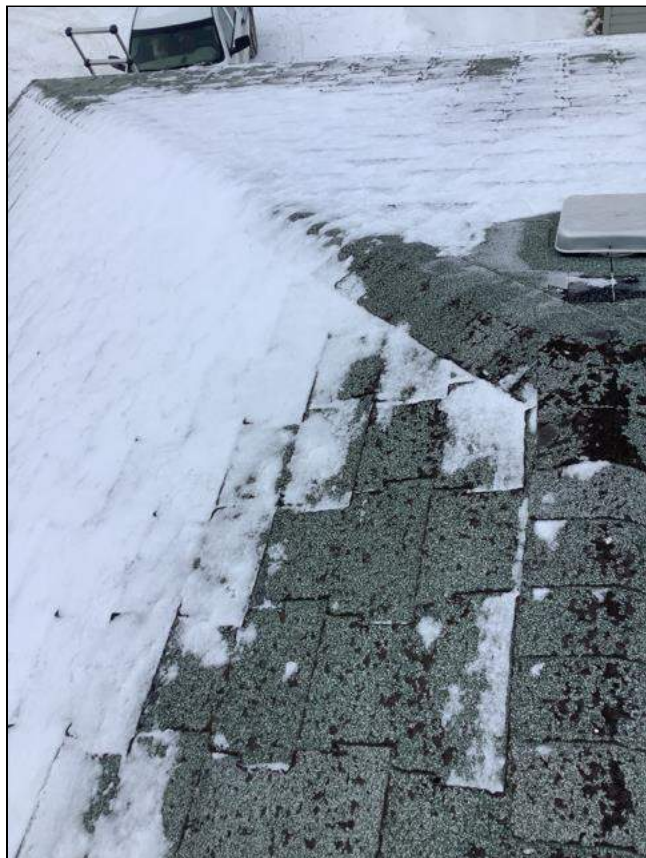
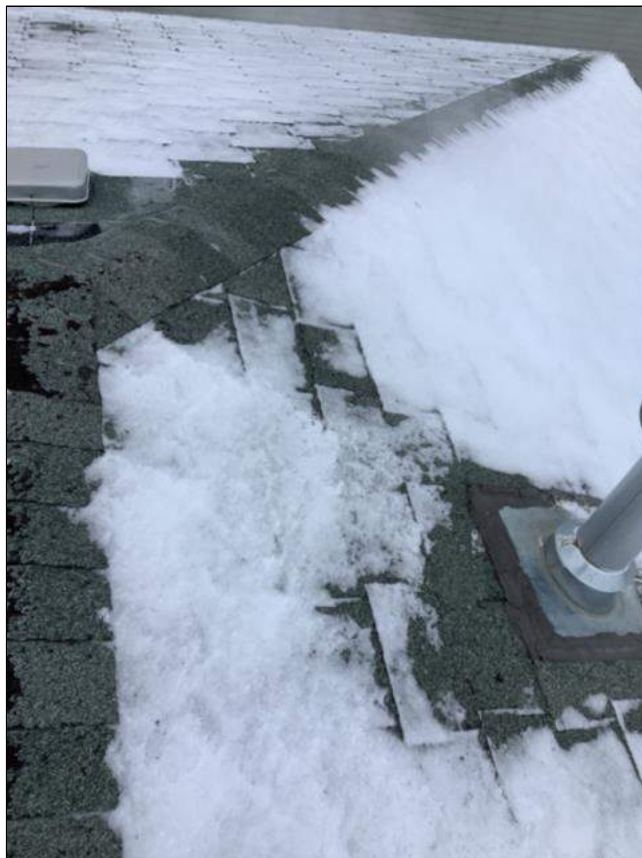
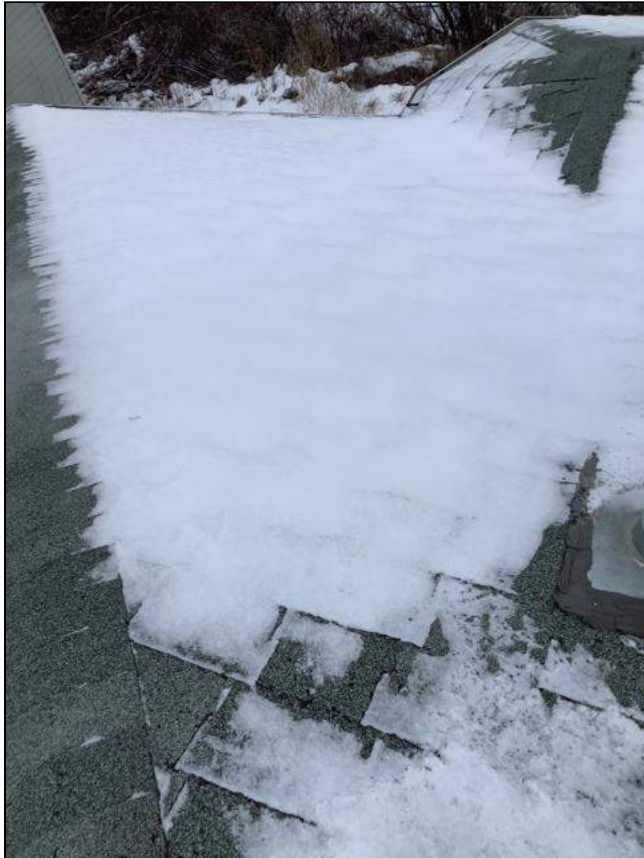
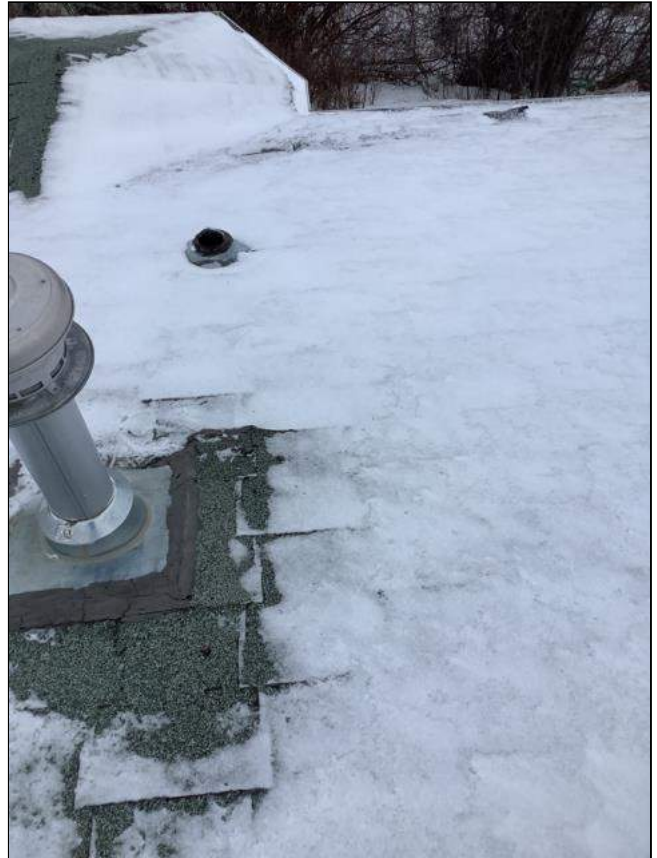
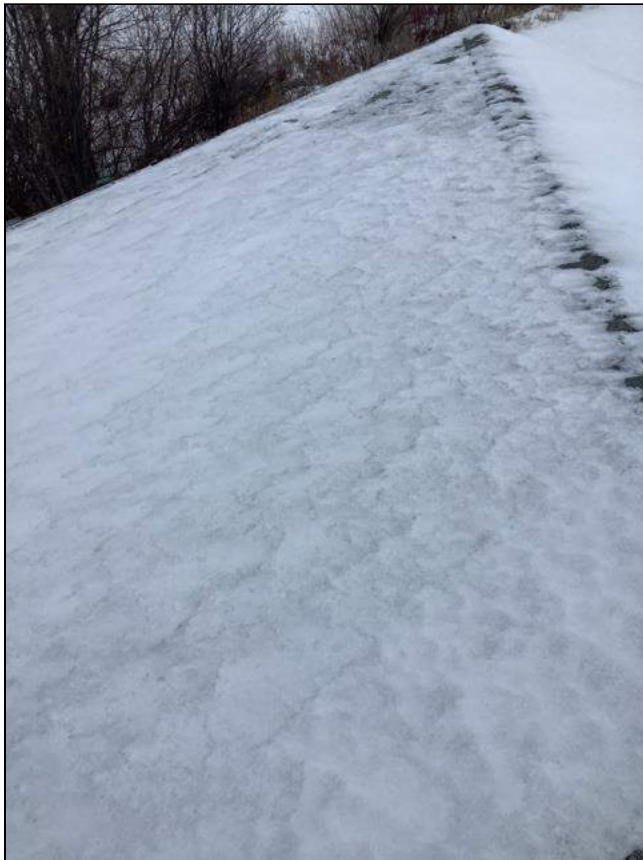
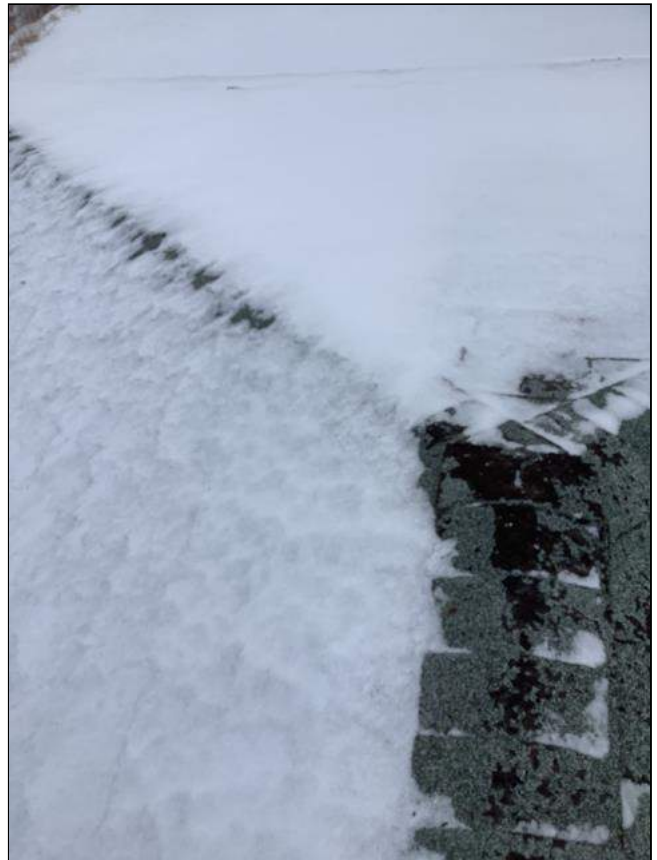
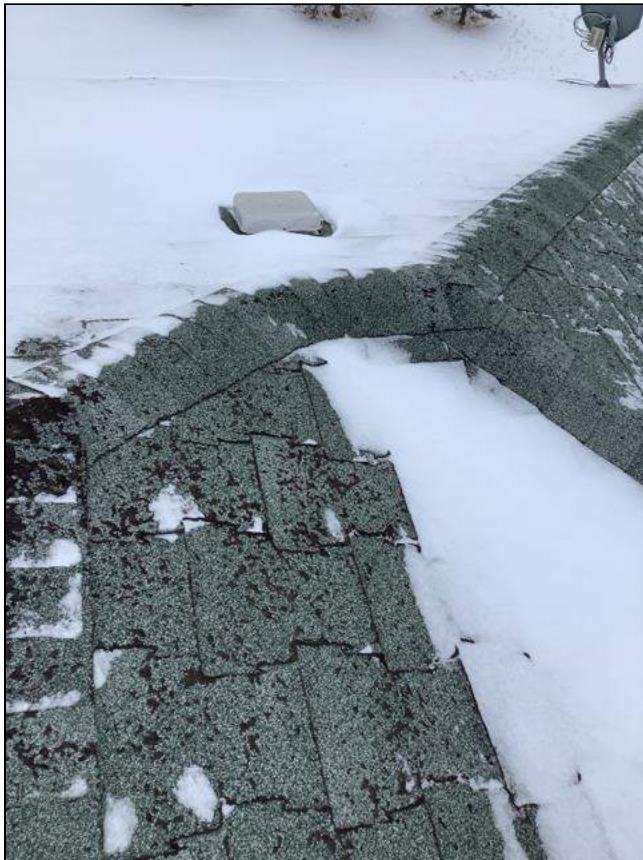
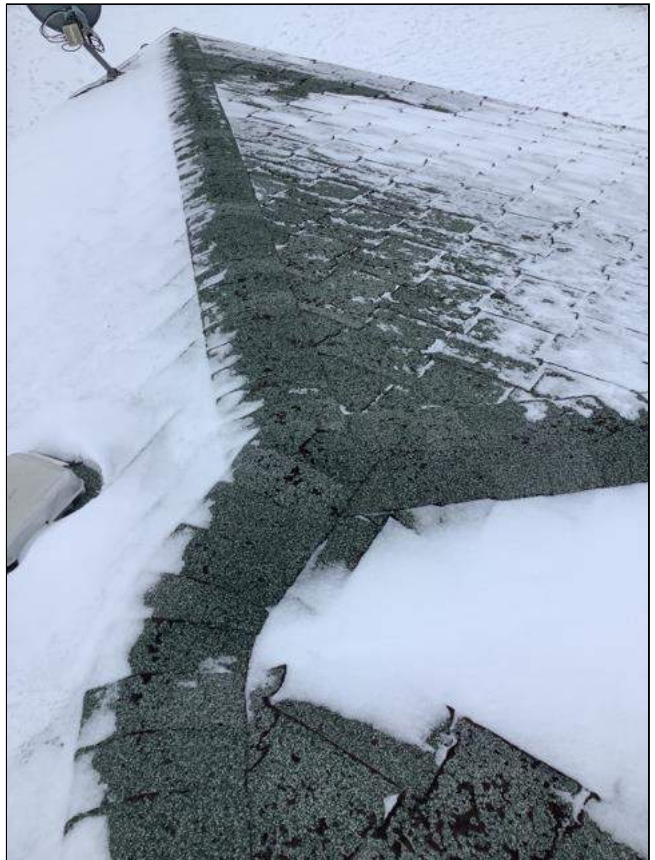
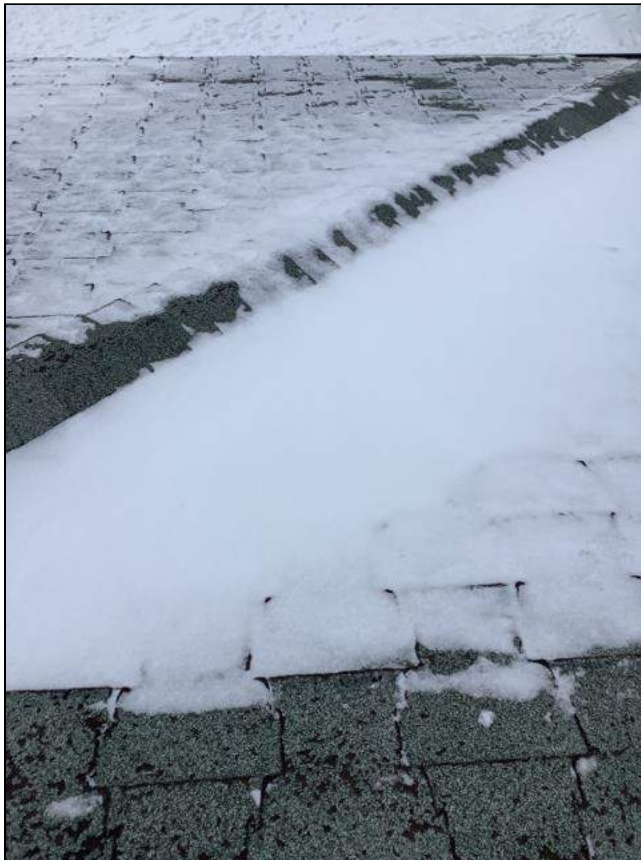
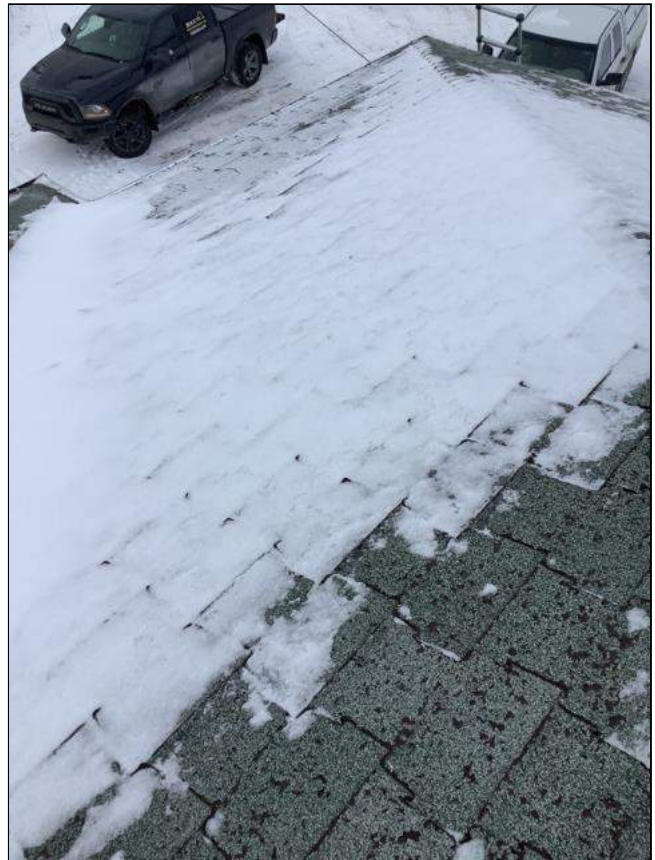
The roof was walked for assessment, could only inspect some of the roof as it was covered in snow. No visual sign of structural concern but shingles are aged and will require replacement.

1.0 Item 1(Picture) Roof - shingles are aged and will require replacement

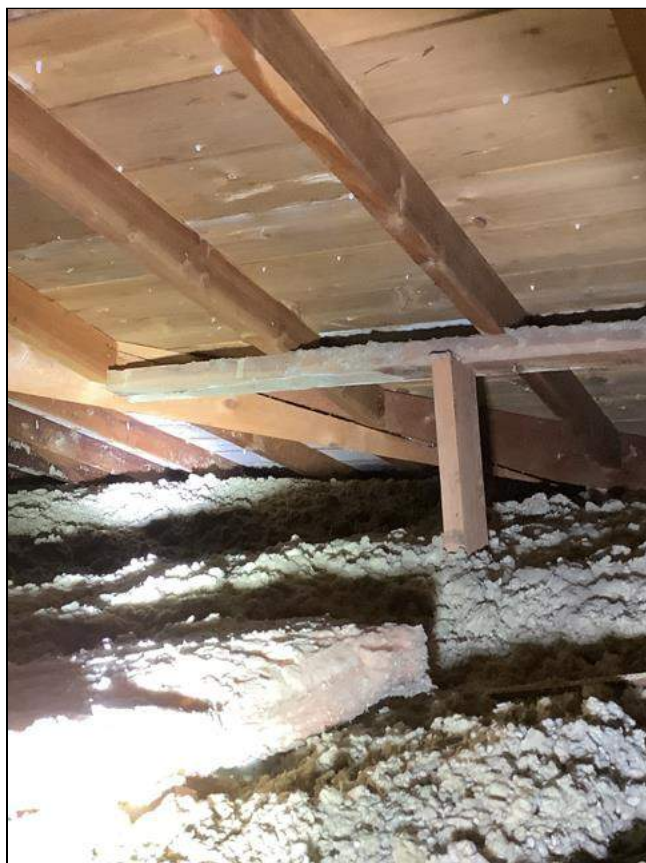
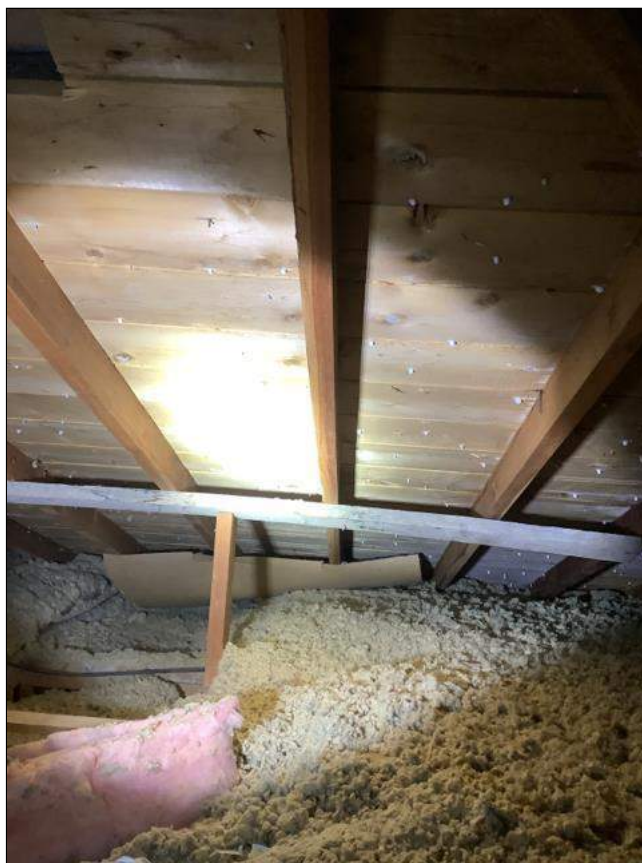
One of the rafters has split where the two are nailed together and the cross support is bowed, both are signs of movement/settling and should be further reviewed and repaired as required.

2.3 Item 1(Picture) Rafter - split, cross support bowed

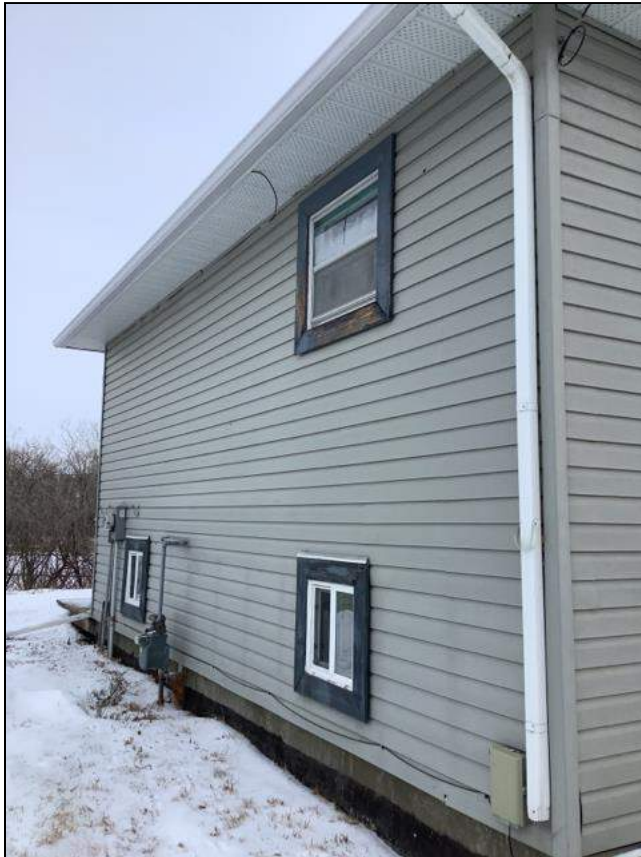
3.1 Item 1(Picture) Exterior

Higher levels of wall clad around the home are only visually inspected from the ground level. At the back of the house the top row of siding is bowed over the sliding patio door, recommend that it be further reviewed and repaired as required.

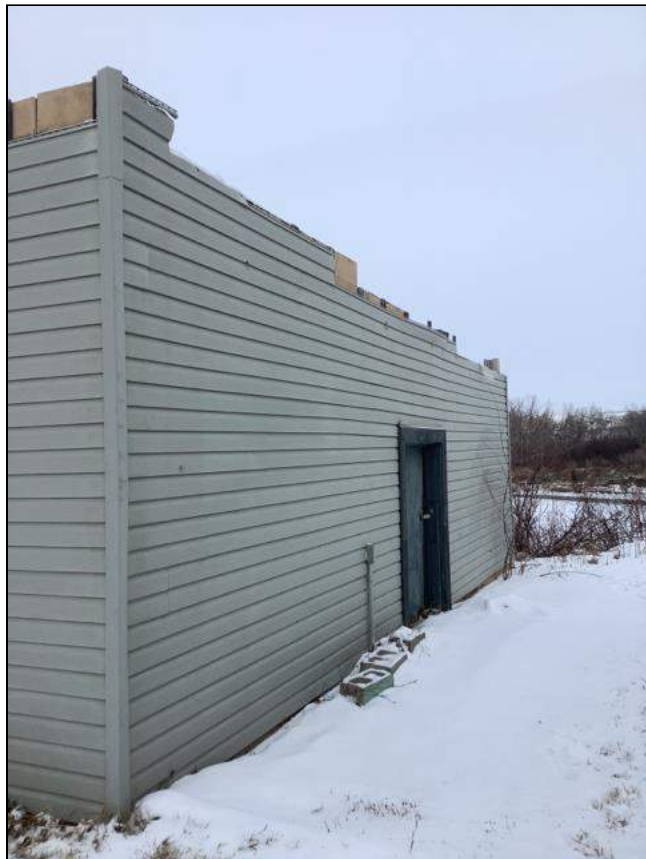
The back of the garage is heavily bowed, replacement of the garage is recommended.

4.4 Item 1(Picture) Back of Garage - heavily bowed

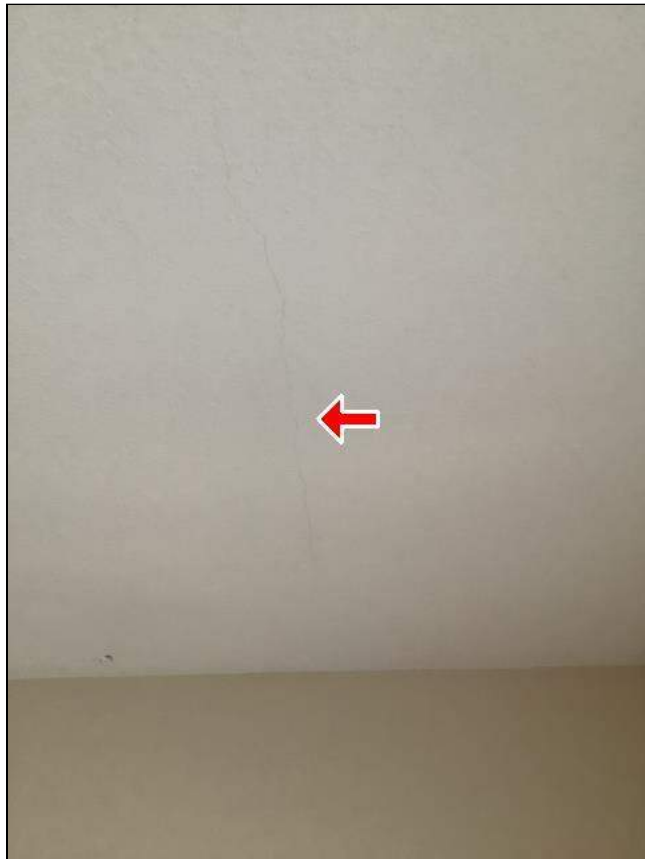
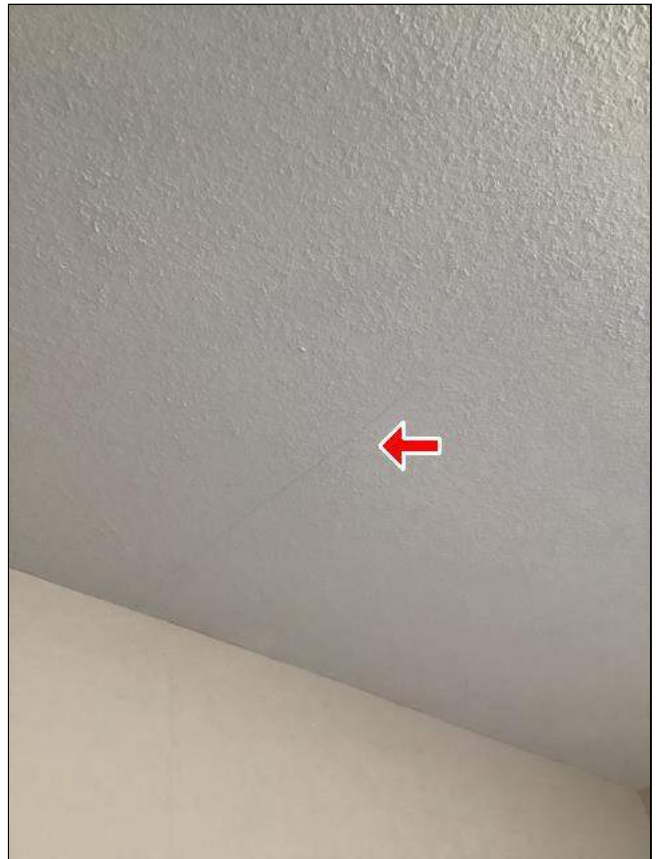
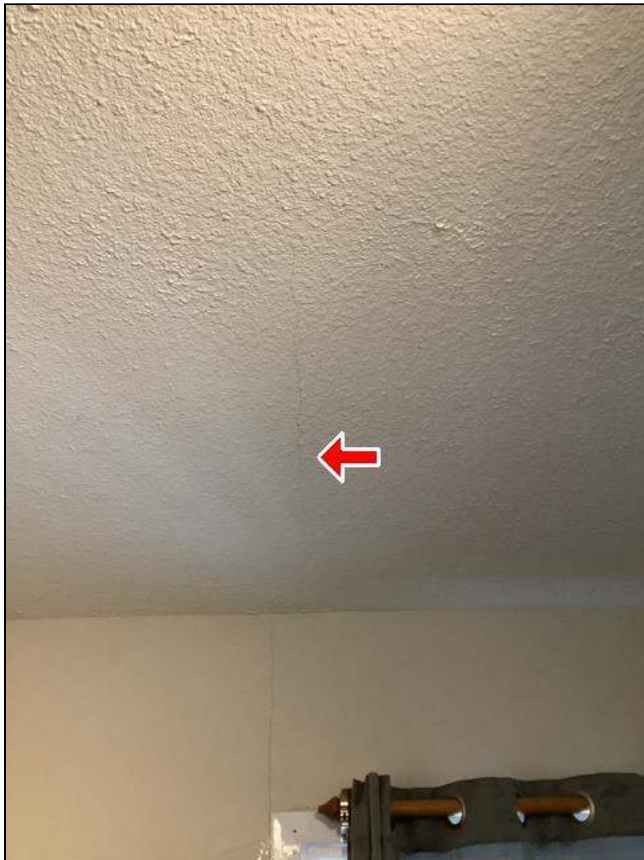
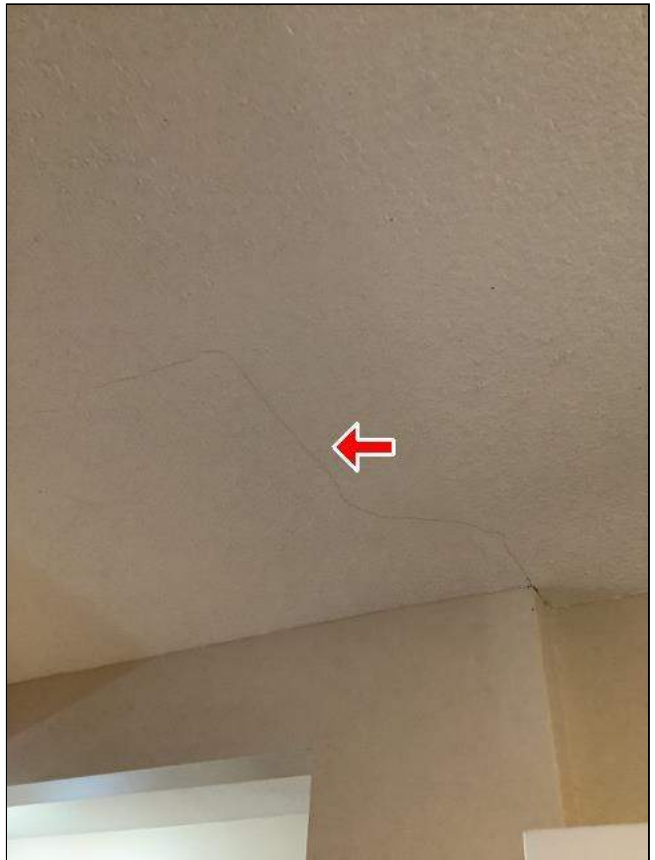
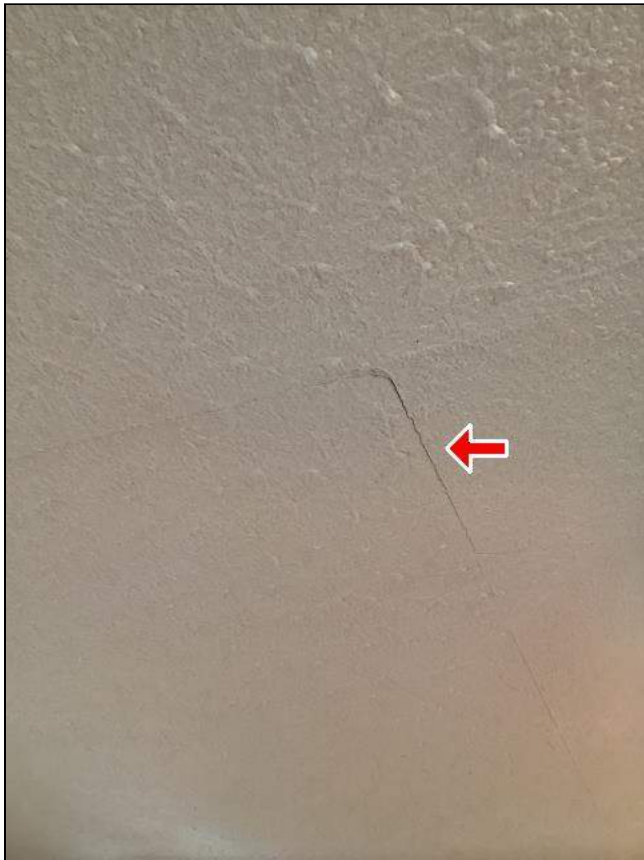
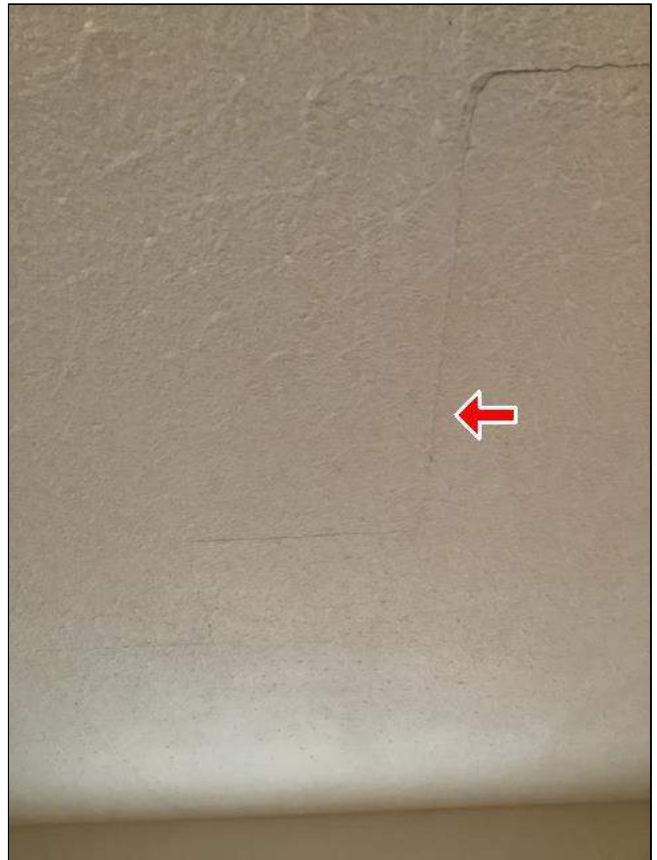
All ceilings were dry at time of inspection but had multiple cracks throughout the house some common from settling and some from shifting.

5.0 Item 1(Picture) Ceiling - common cracks from settling and shifting
