HOME
INSPECTION

Inspection Report

Property Address:
964 Hunter Drive - Nacmine
Drumheller Alberta T0J 0Y0

| Date: 16/12/2021 | Time: 11:00 AM | Report ID: 964 Hunter Drive - Nacmine |

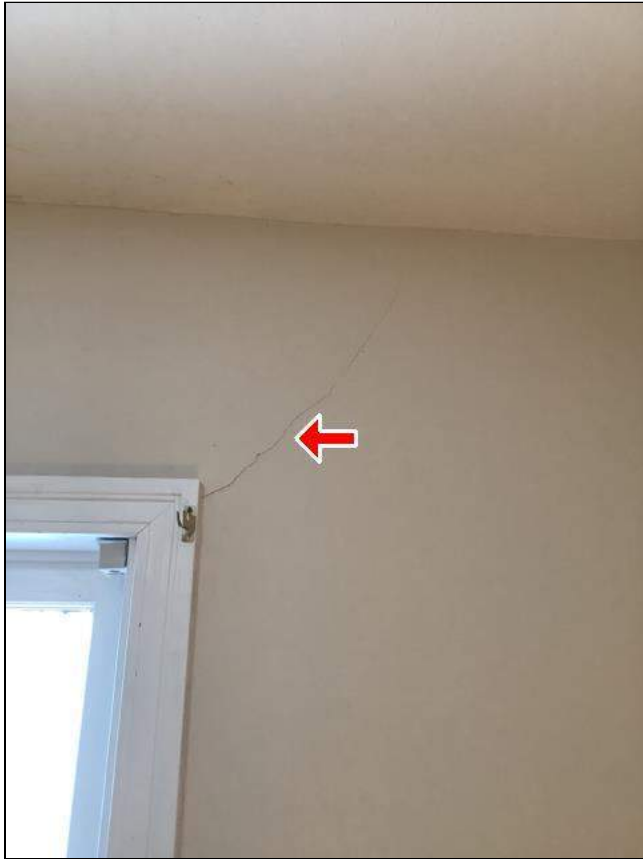
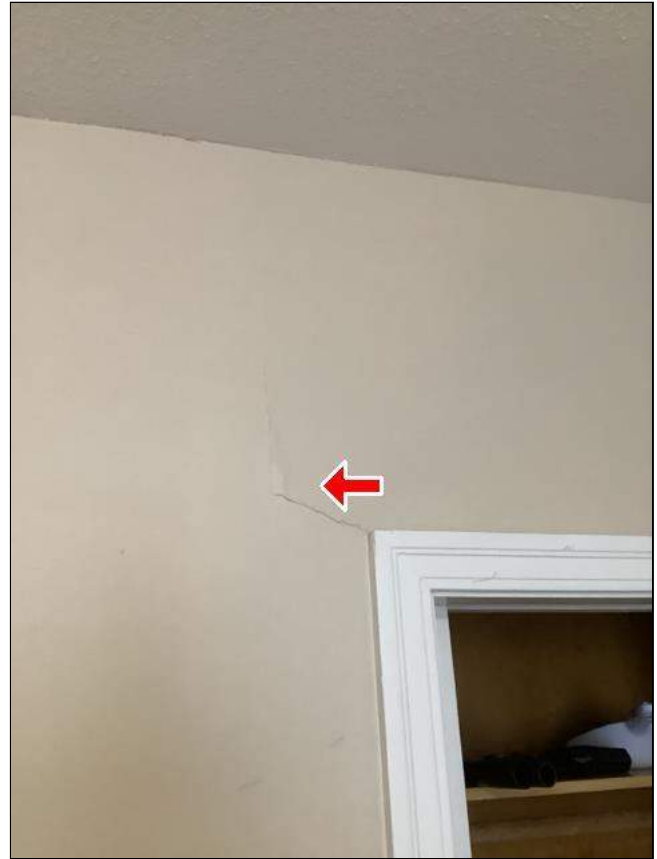
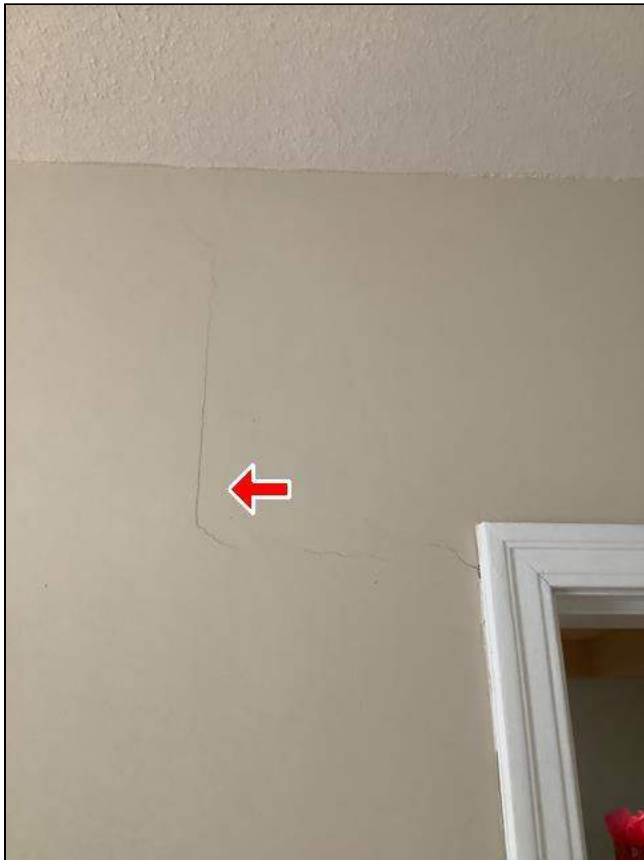
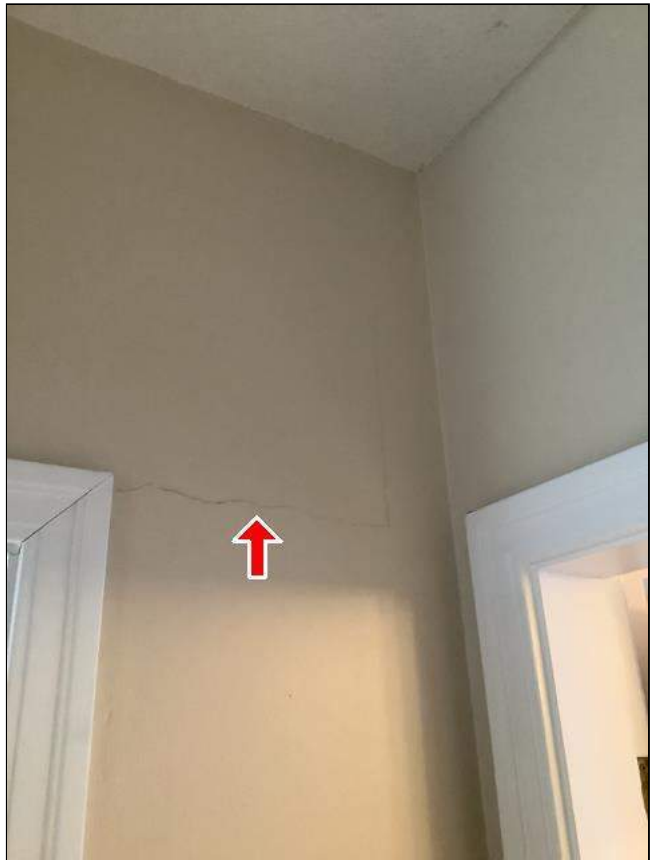
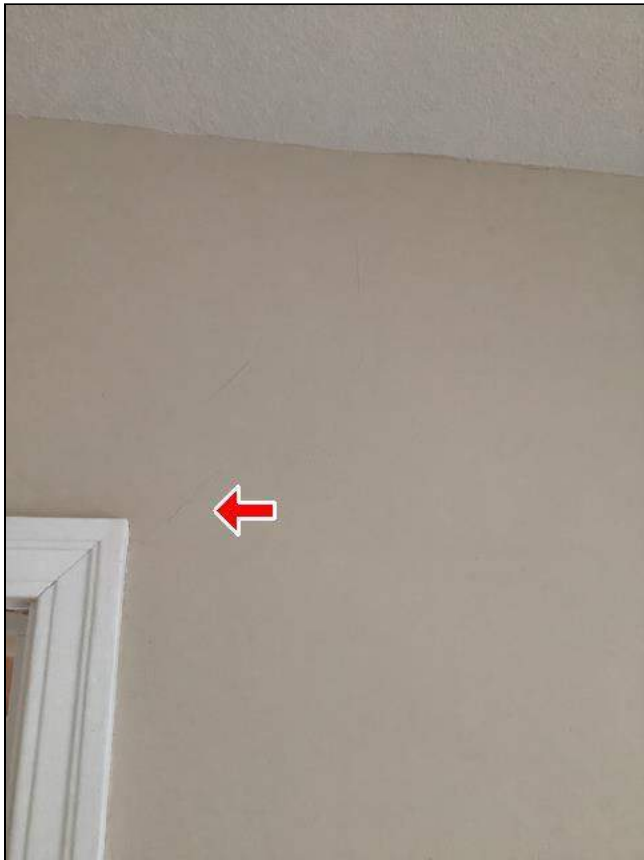
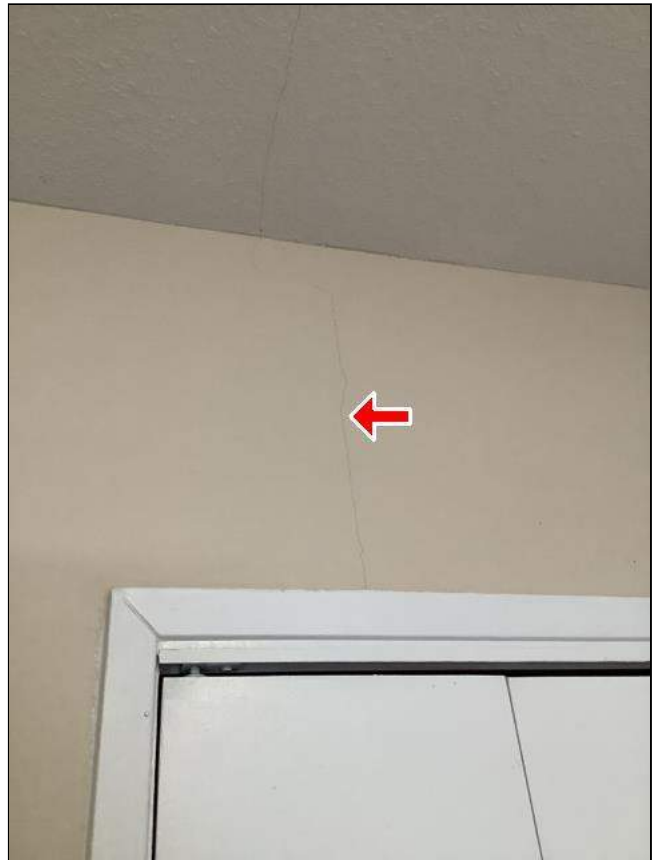
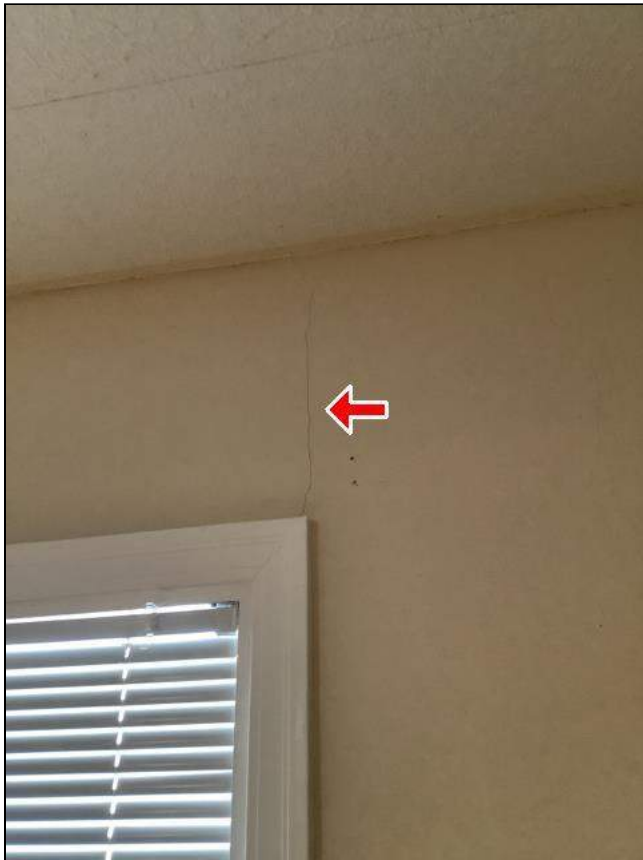
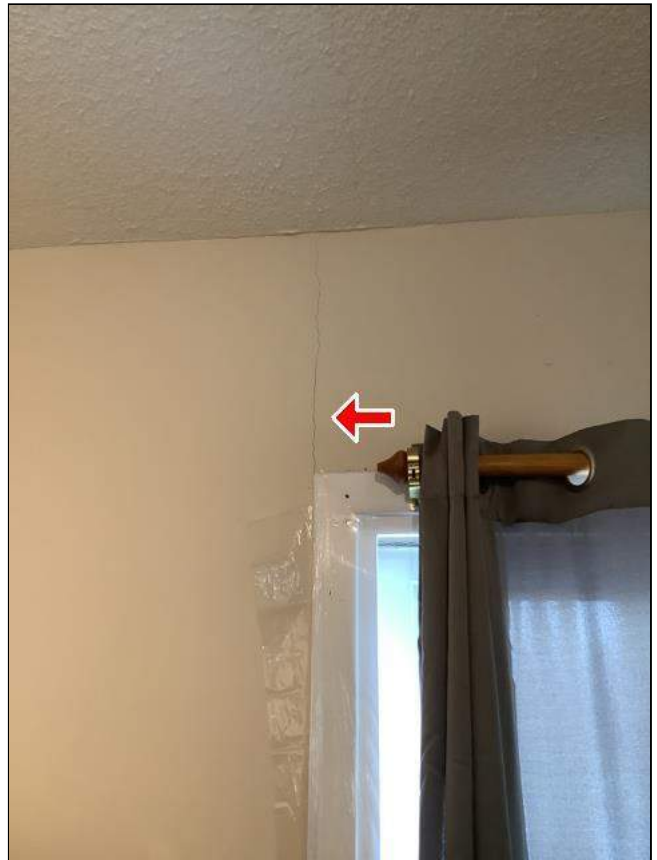
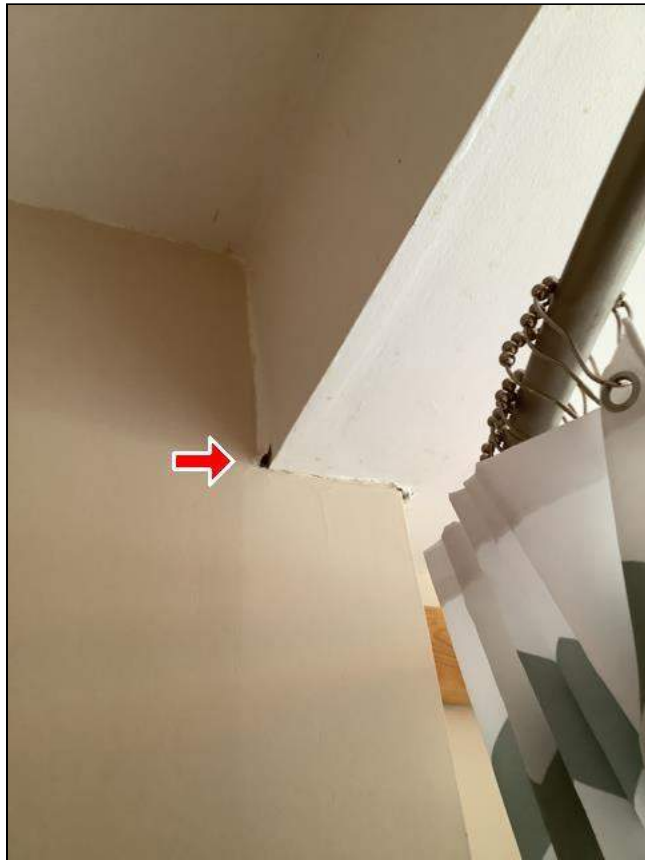
All walls were dry at time of inspection but had multiple cracks throughout the house some common from settling and some from shifting.

5.1 Item 1(Picture) Interior Walls - cracks from settling and shifting

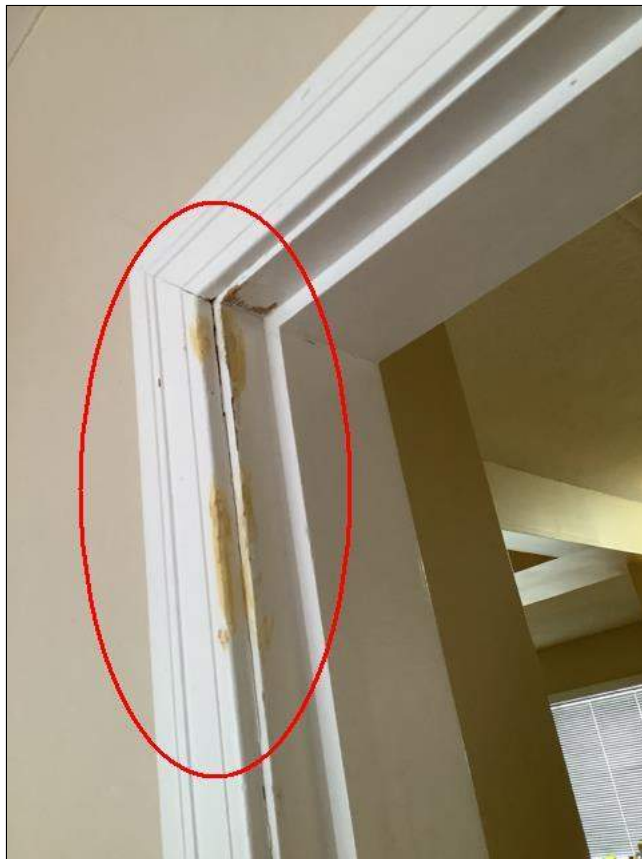
5.4 Item 2(Picture) Door - signs of rubbing

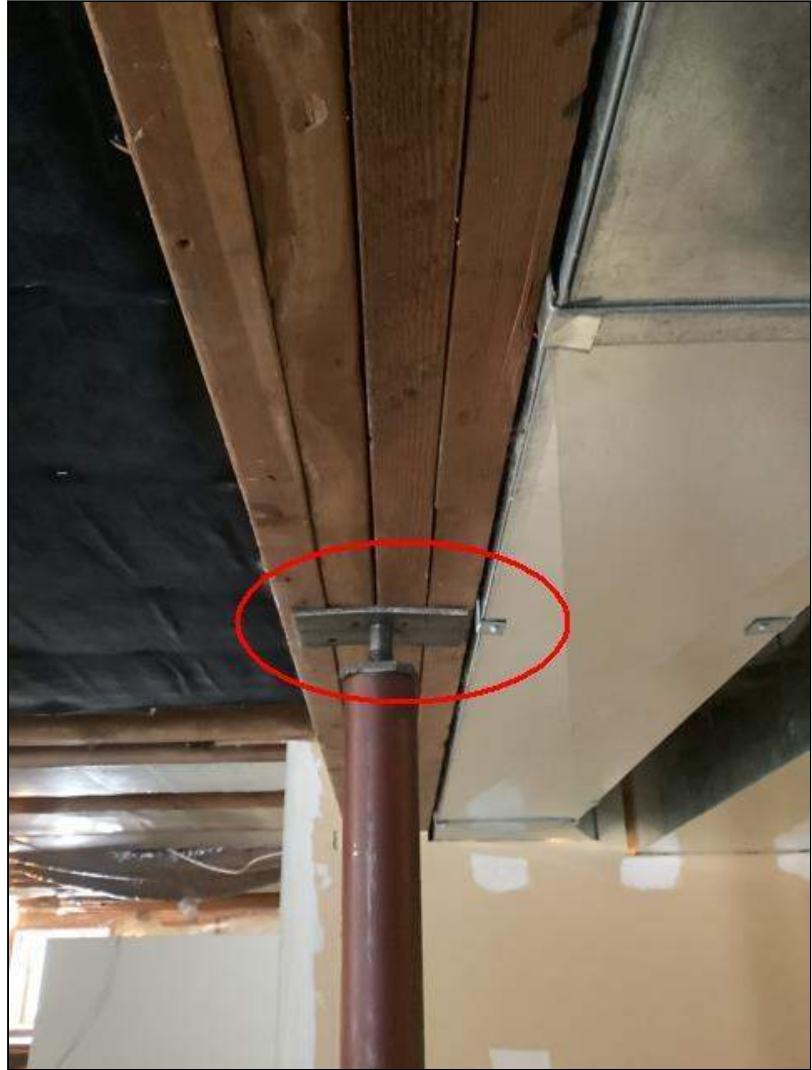
The plate on the steel screw jack was bowed, recommend that it be further reviewed. Never remove support posts without seeking advice from structural engineer.

7.6 Item 1(Picture) Plate - bowed

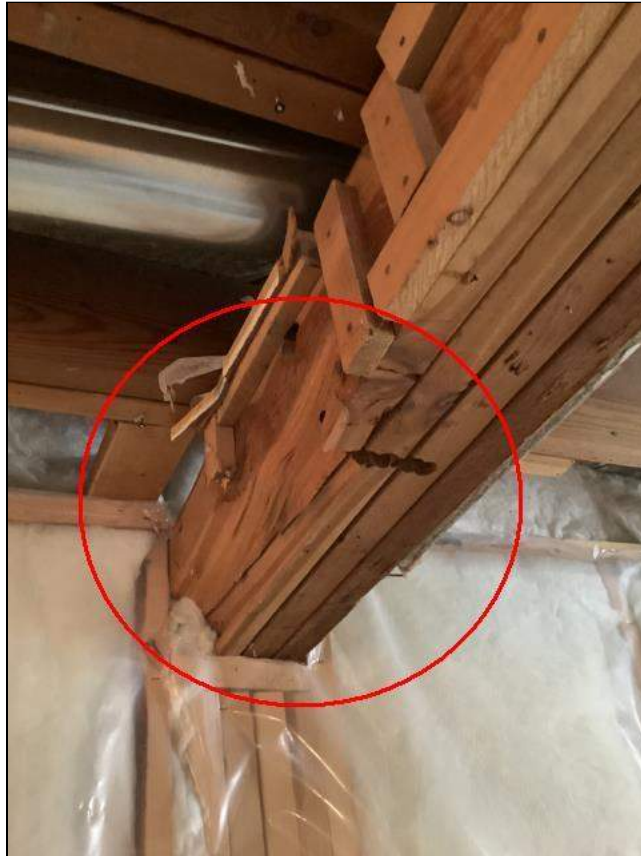
7.9 Item 1(Picture) Beam - end is broken

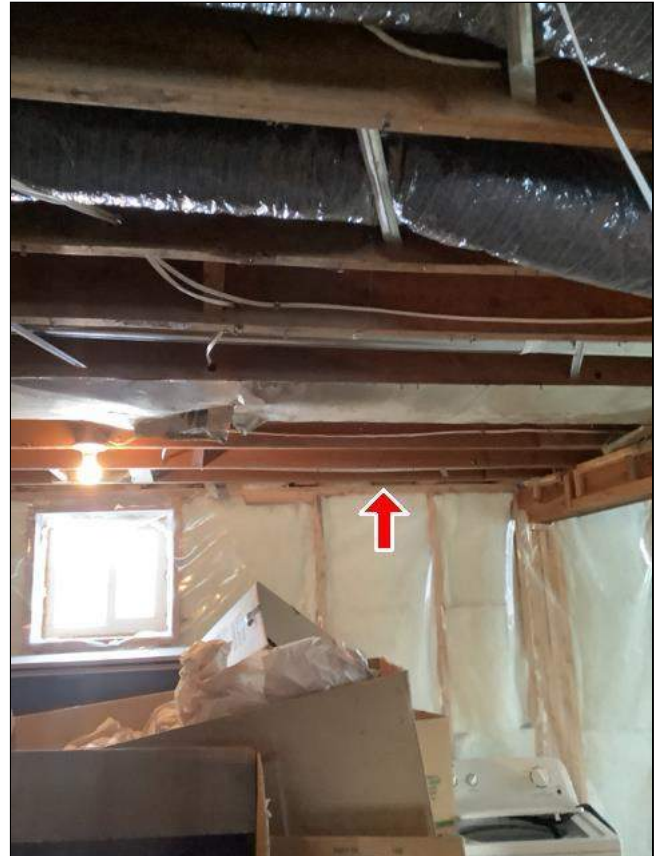
7.9 Item 2(Picture) Joist - sagging

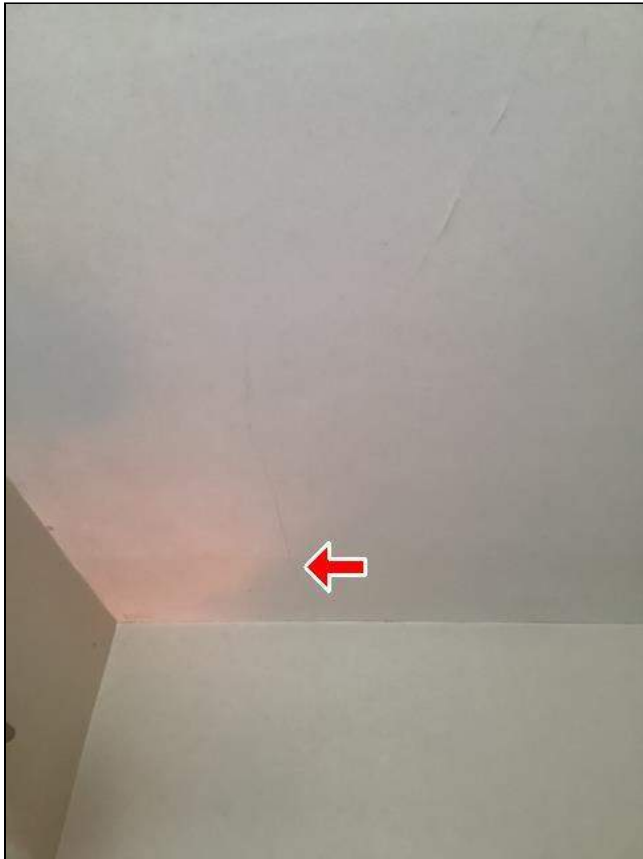
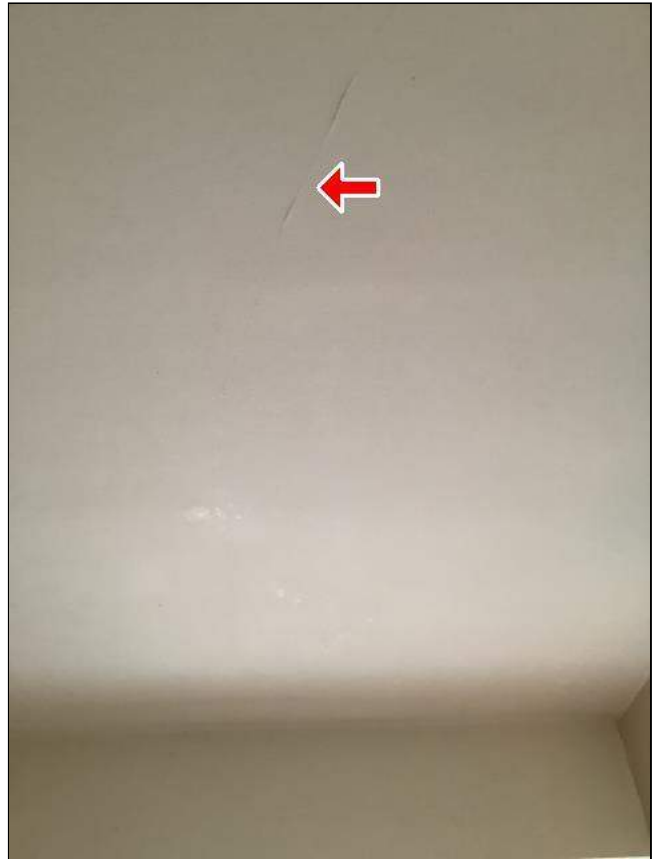
All ceilings were dry at time of inspection but had cracks, some common from settling and some from shifting.

9.0 Item 1(Picture) Bathroom Ceiling - cracks from settling

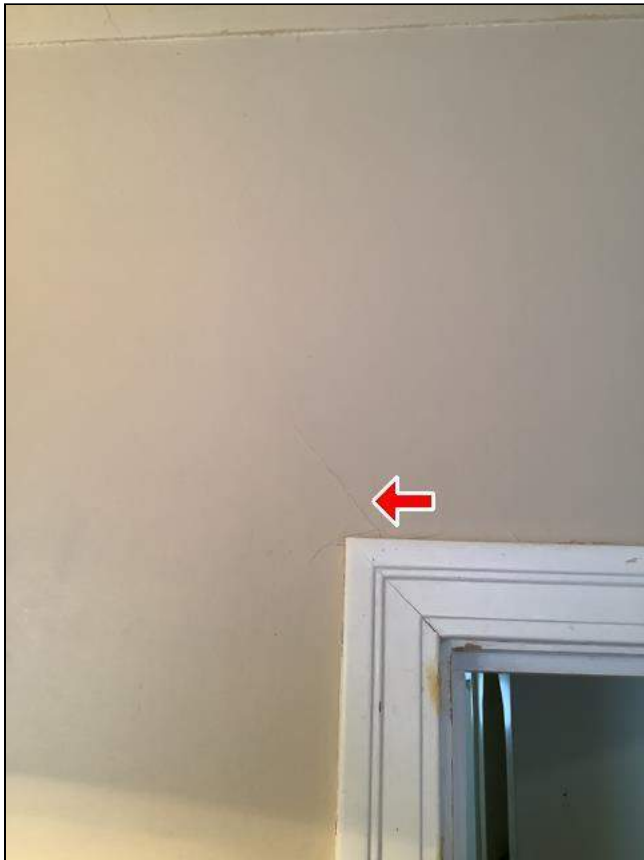
9.0 Item 3(Picture) Bathroom Wall - cracks from settling

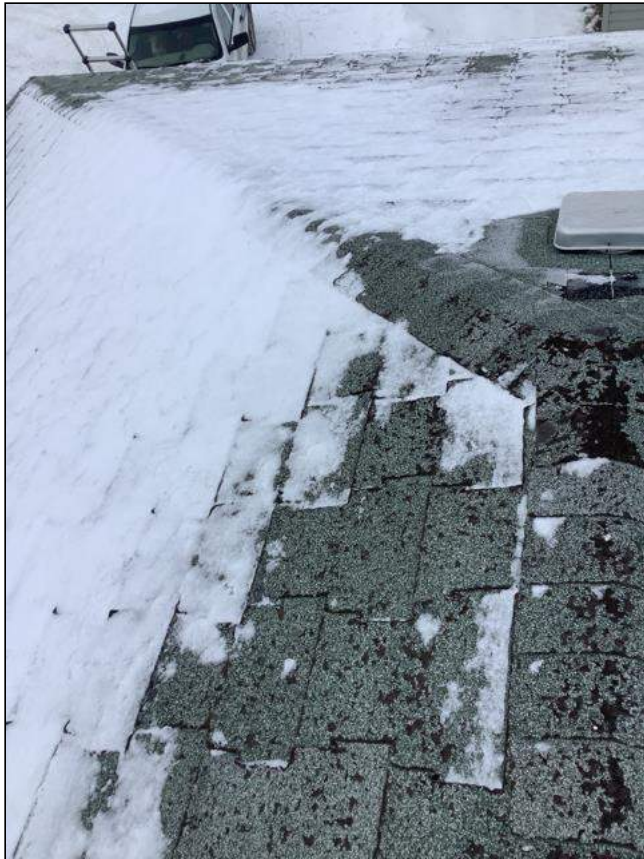
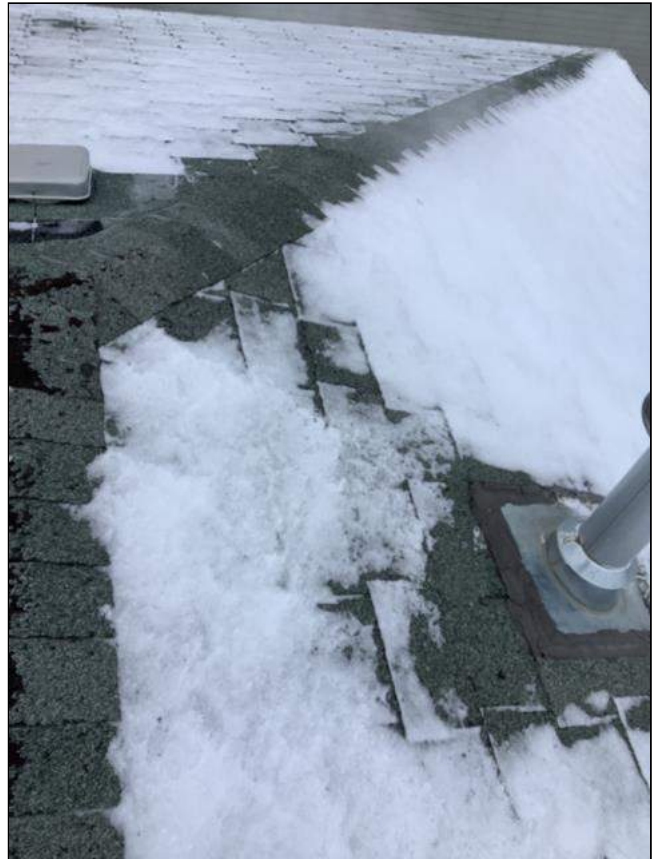
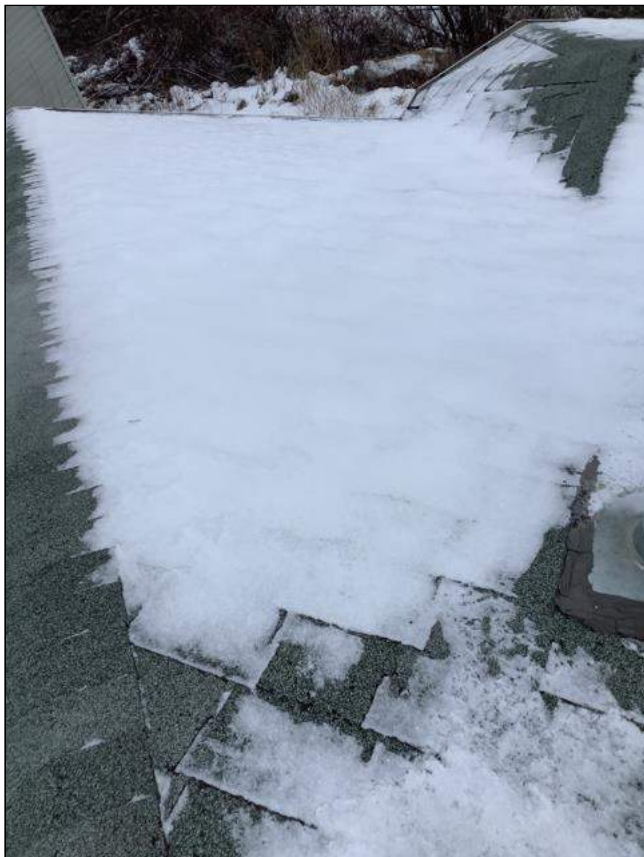
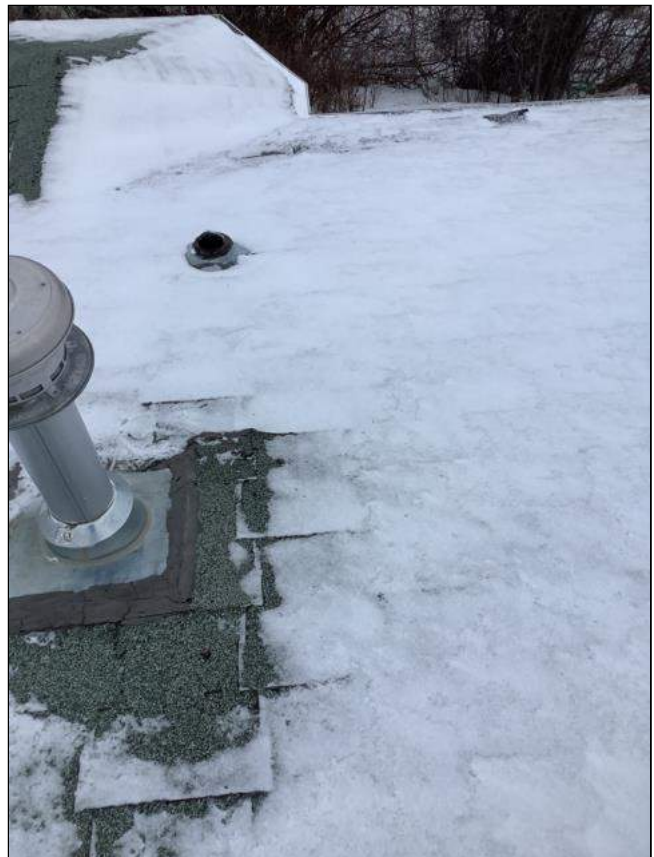
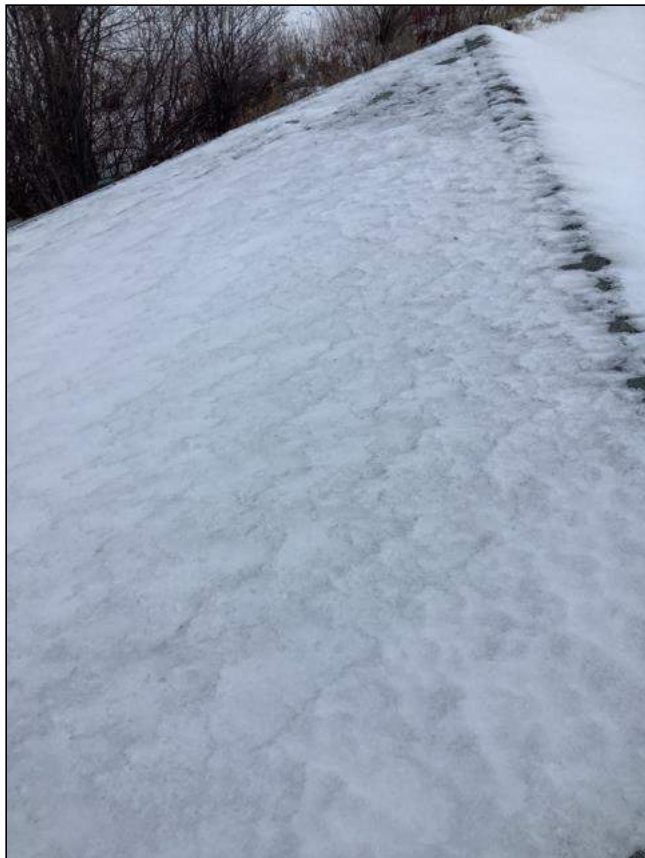
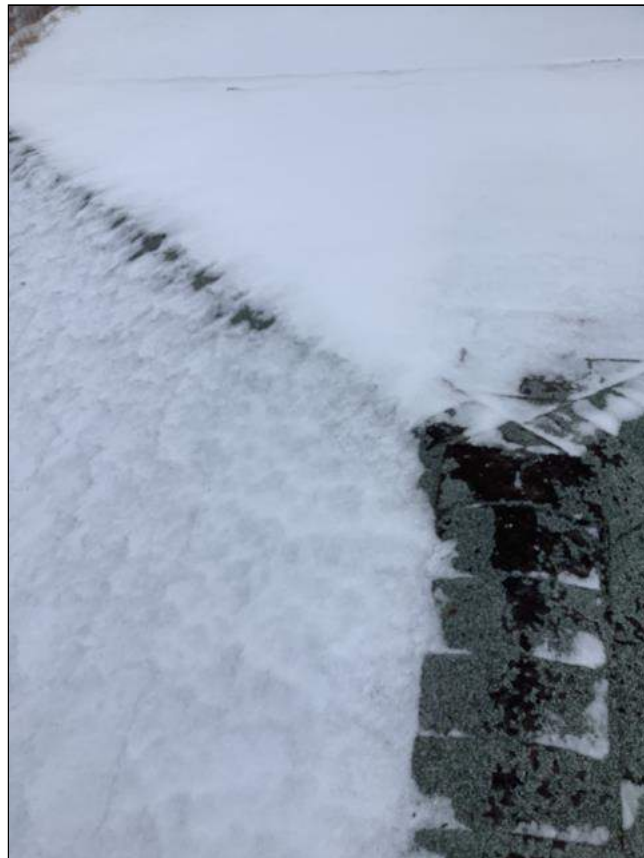
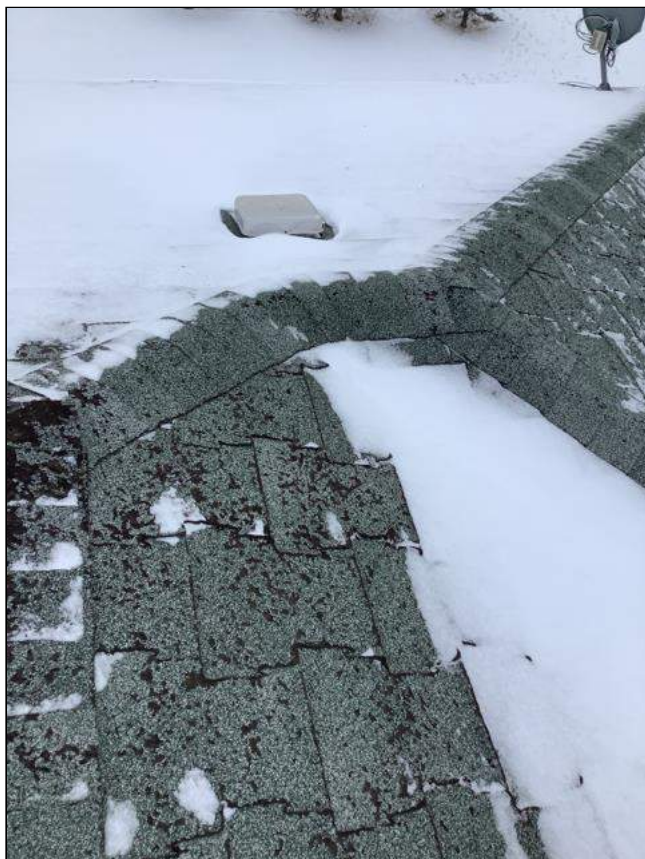
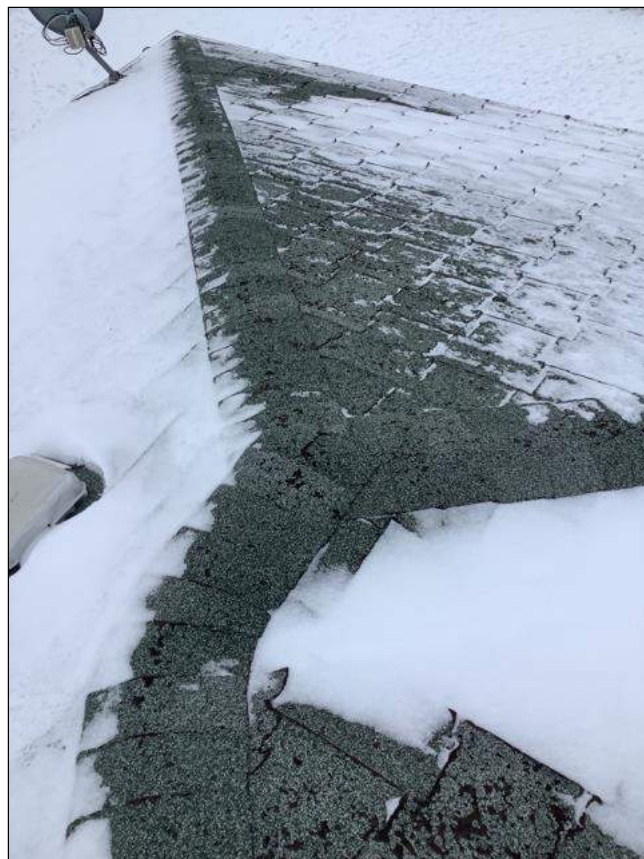
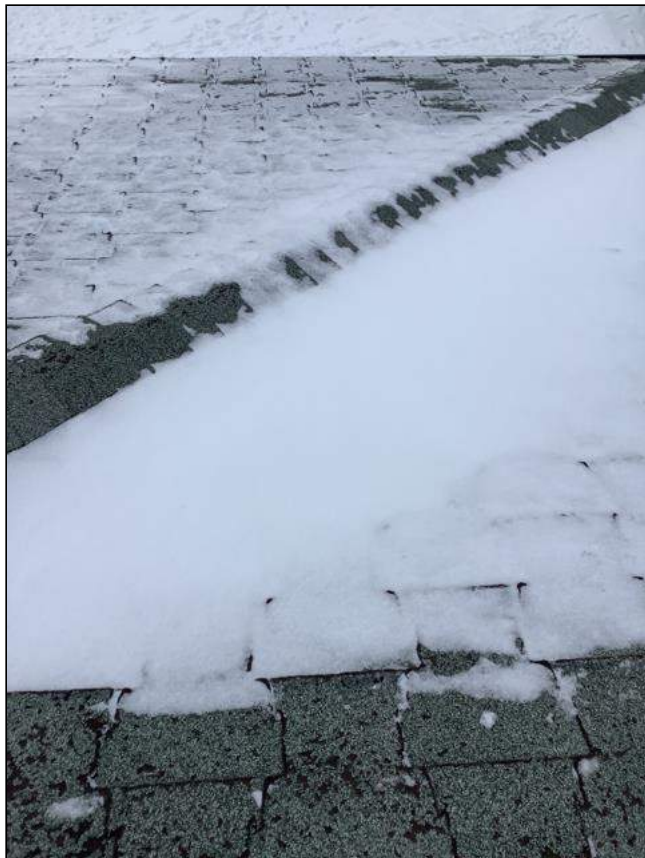
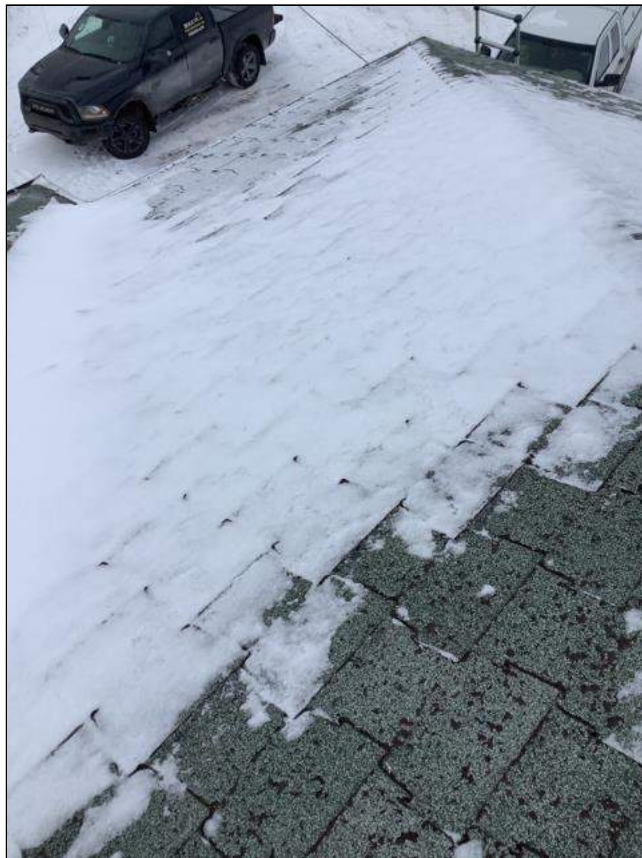
The roof was walked for assessment, could only inspect some of the roof as it was covered in snow. No visual sign of structural concern but shingles are aged and will require replacement.

1.0 Item 1(Picture) Roof - shingles are aged and will require replacement

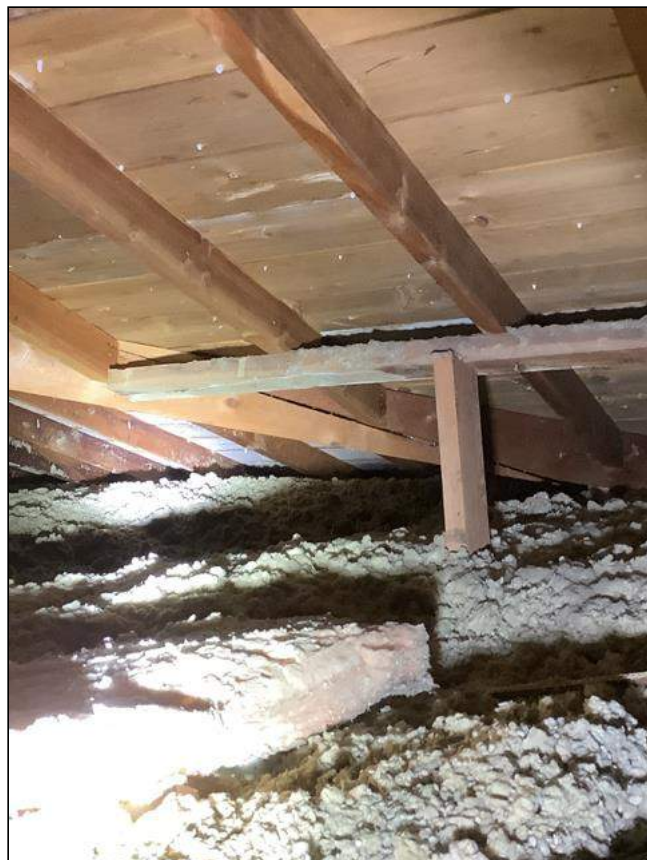
One of the rafters has split where the two are nailed together and the cross support is bowed, both are signs of movement/settling and should be further reviewed and repaired as required.

2.3 Item 1(Picture) Rafter - split, cross support bowed

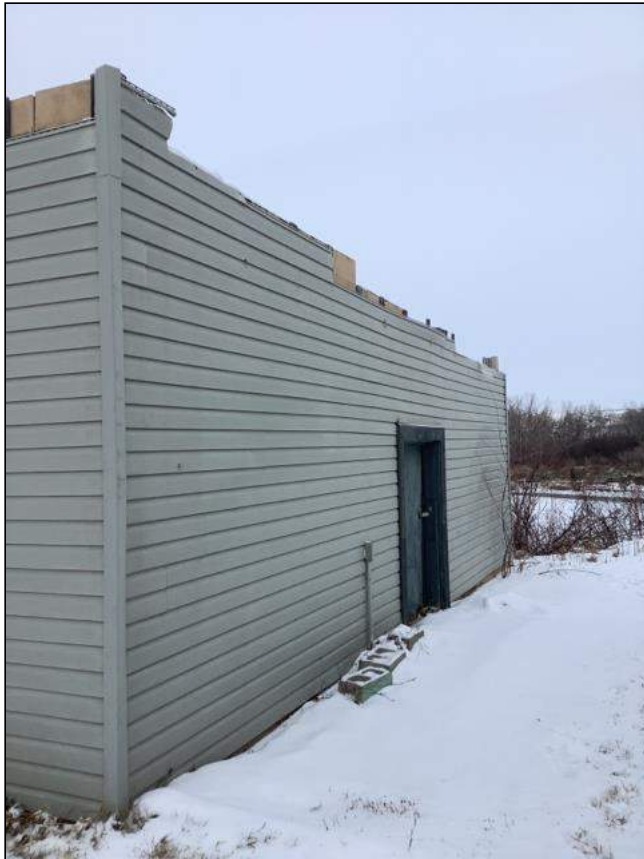
The back of the garage is heavily bowed, replacement of the garage is recommended.

4.4 Item 1(Picture) Back of Garage - heavily bowed

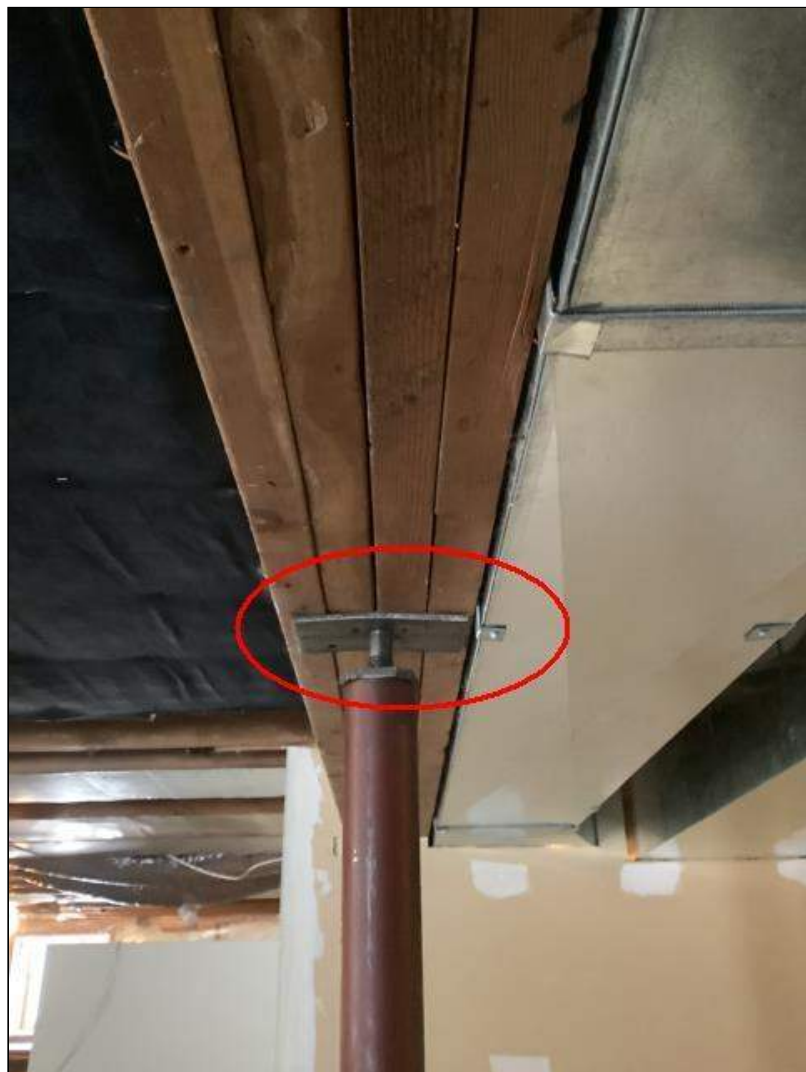
The plate on the steel screw jack was bowed, recommend that it be further reviewed. Never remove support posts without seeking advice from structural engineer.

7.6 Item 1(Picture) Plate - bowed

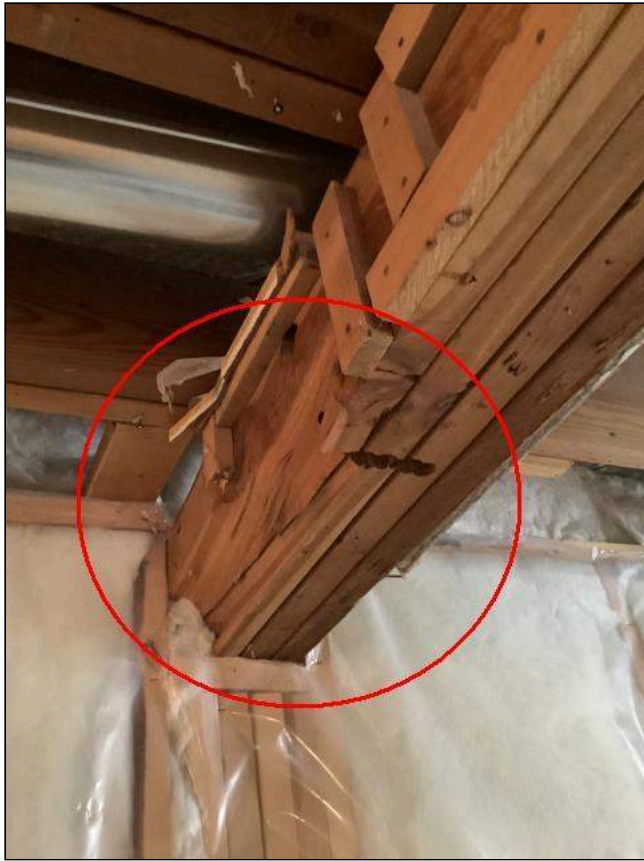
7.9 Item 1(Picture) Beam - end is broken

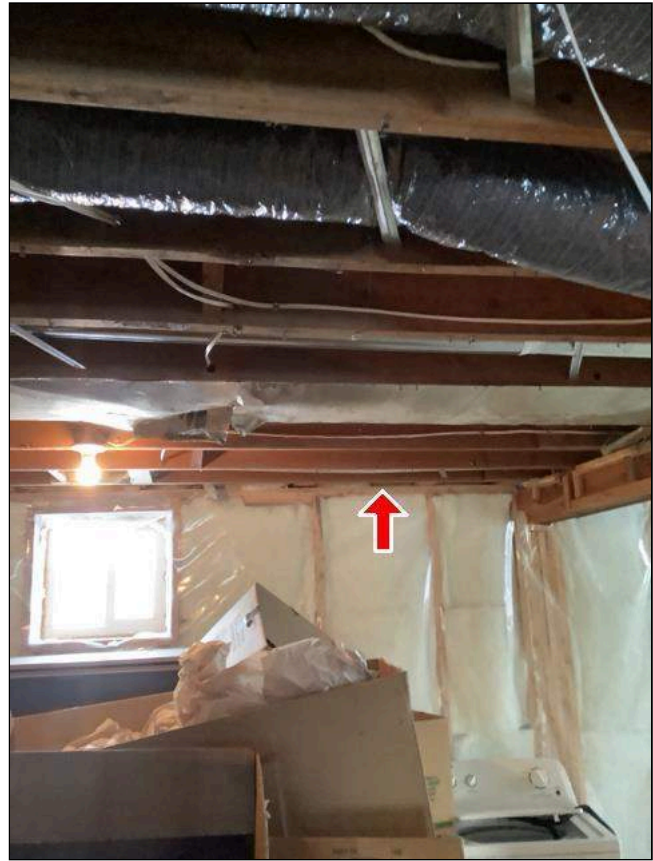
7.9 Item 2(Picture) Joist - sagging

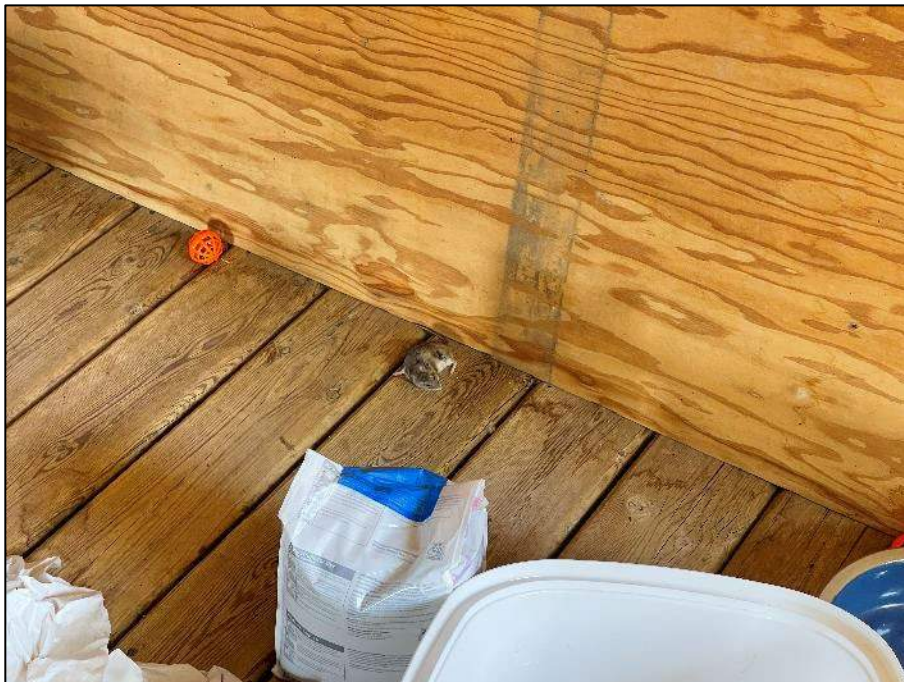
PHOTOGRAPH #24: Animal Carcass on Front Porch (Biological Hazard)
