Demolition and Remediation Services

**Residential Demolition Project
for
The Town of Drumheller**

Tender issued September 2, 2022
Tender closing September 22, 2022 – 2:00:00 P.M.

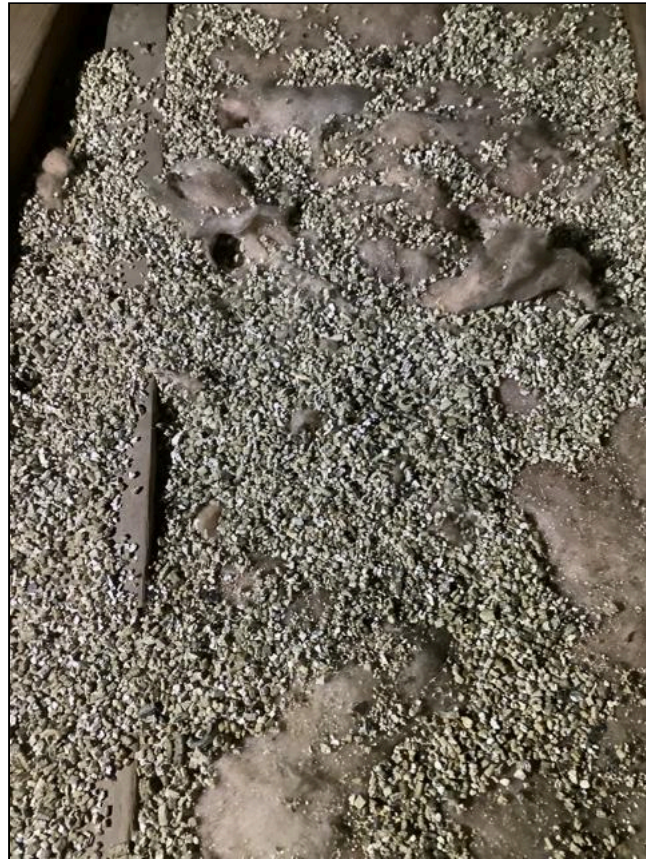
Good amount of insulation in the attic during the inspection but vermiculite was found in the attic space, samples can be taken to the lab for further analysis to confirm if it contains asbestos or not.

2.4 Item 1(Picture) Attic Insulation - vermiculite

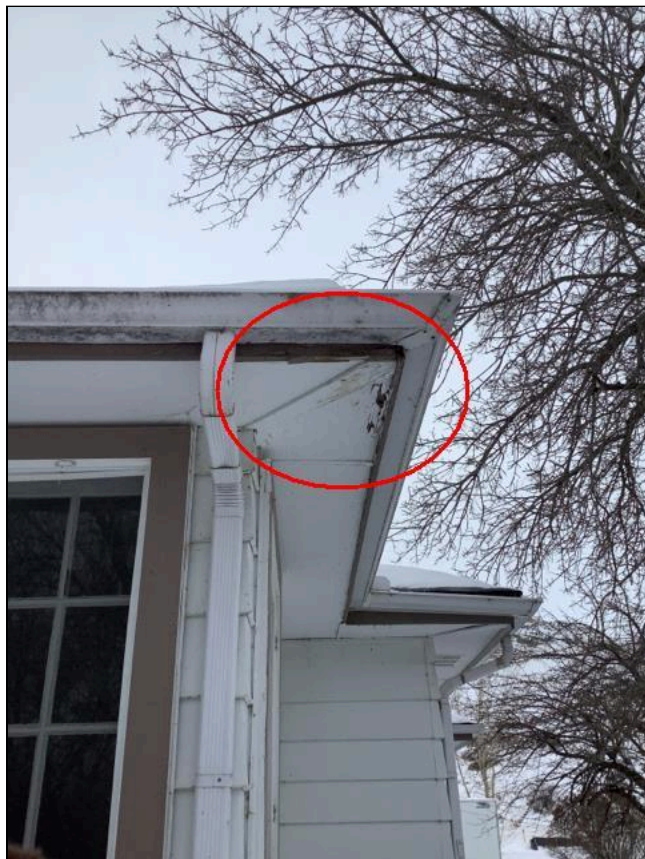
Higher levels of wall clad around the home are only visually inspected from the ground level. There was an area on the back of the house that has signs of moisture damage, recommend further review and repair as required.

3.1 Item 1(Picture) Exterior - signs of moisture damage

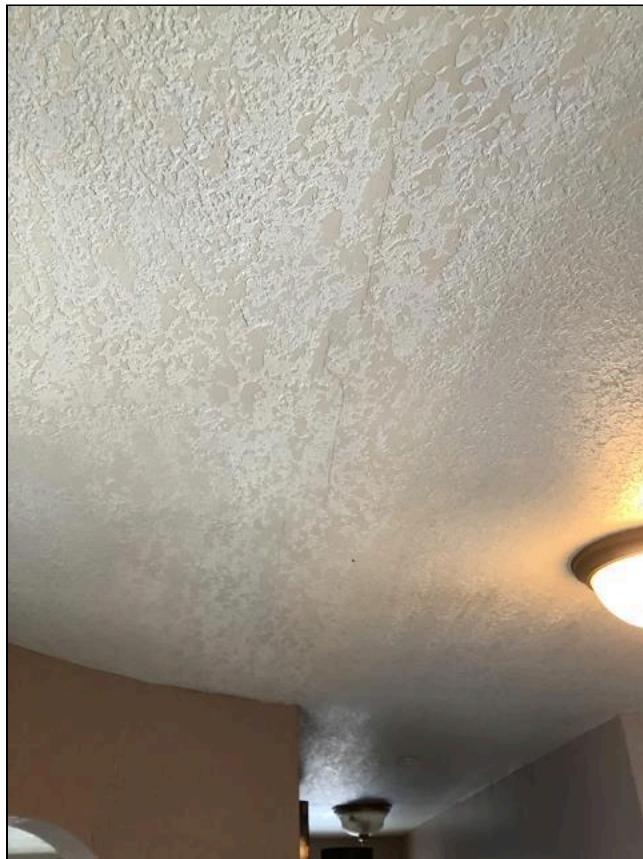
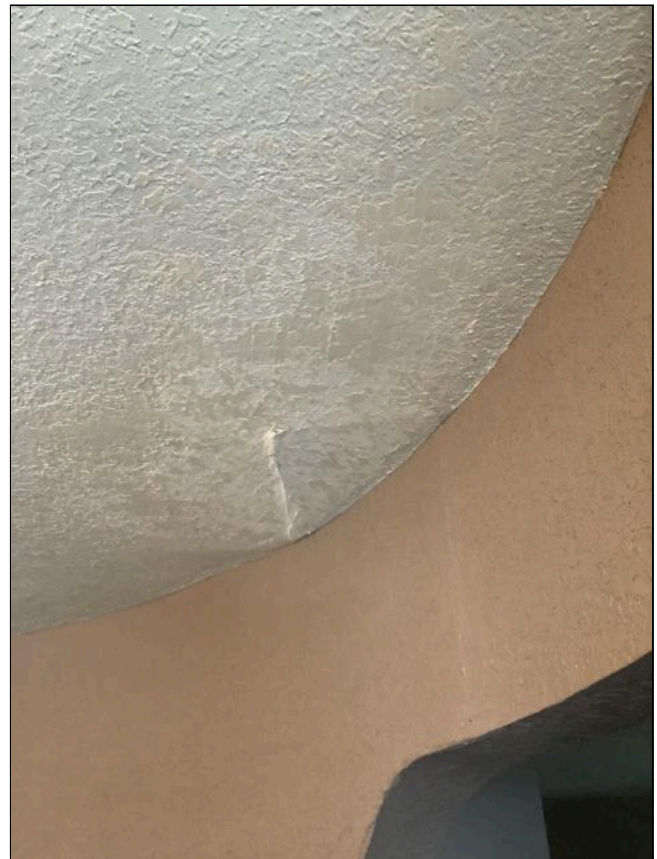
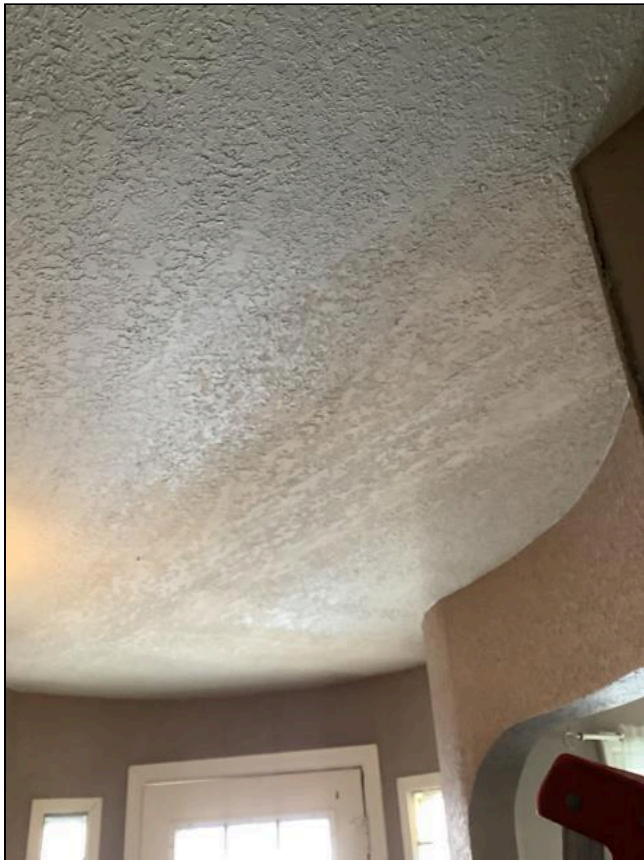
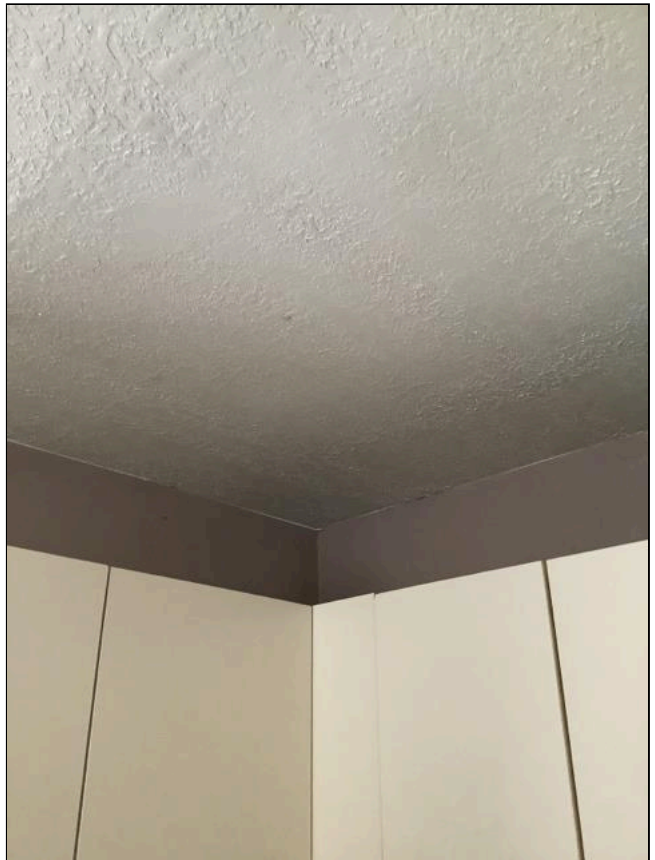
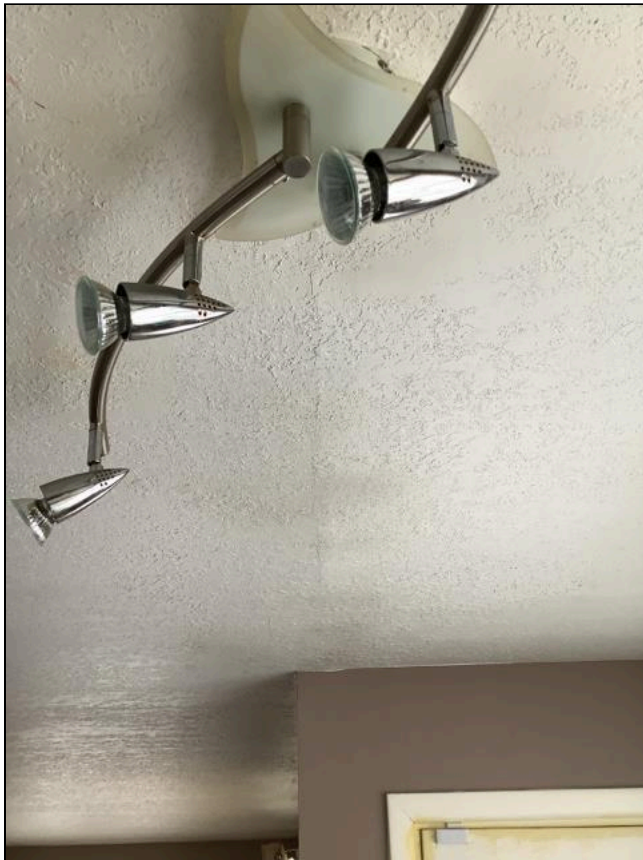
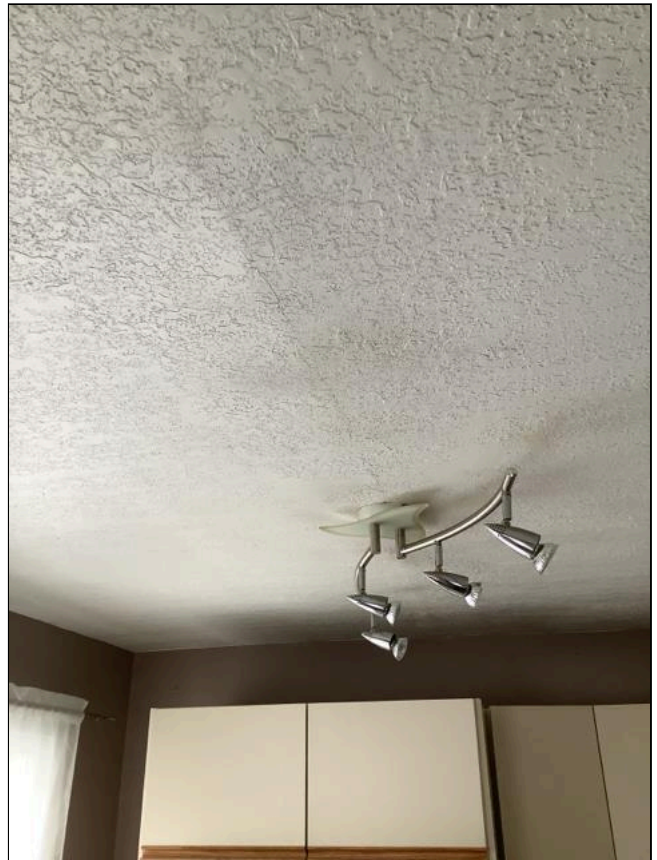
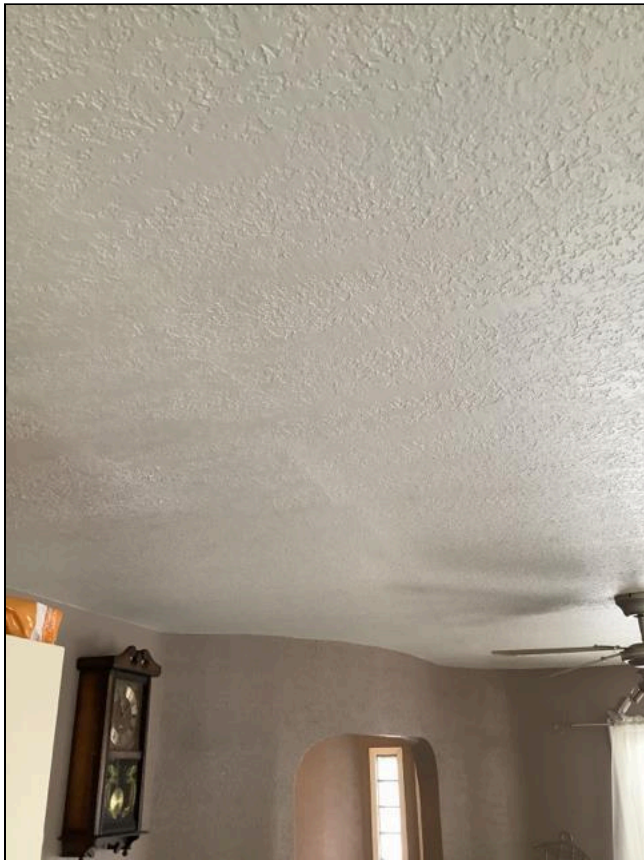
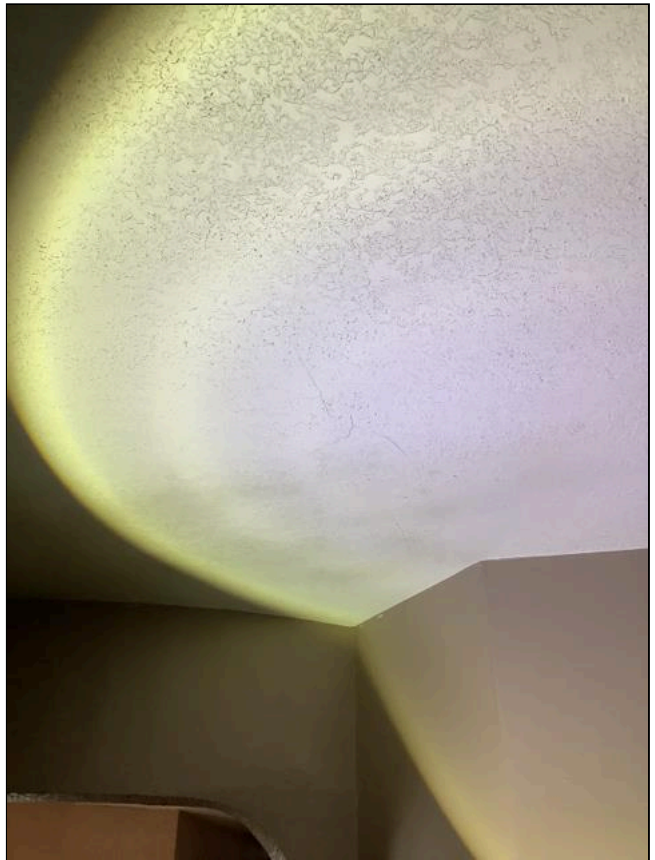
There were areas on the ceiling where there was signs of moisture damage, patching and stressed seams from shifting. Some of these are probably caused by the crooked, slanted joists and beams in the basement.

5.0 Item 1(Picture) Ceiling - signs of moisture damage, patching, stressed seams

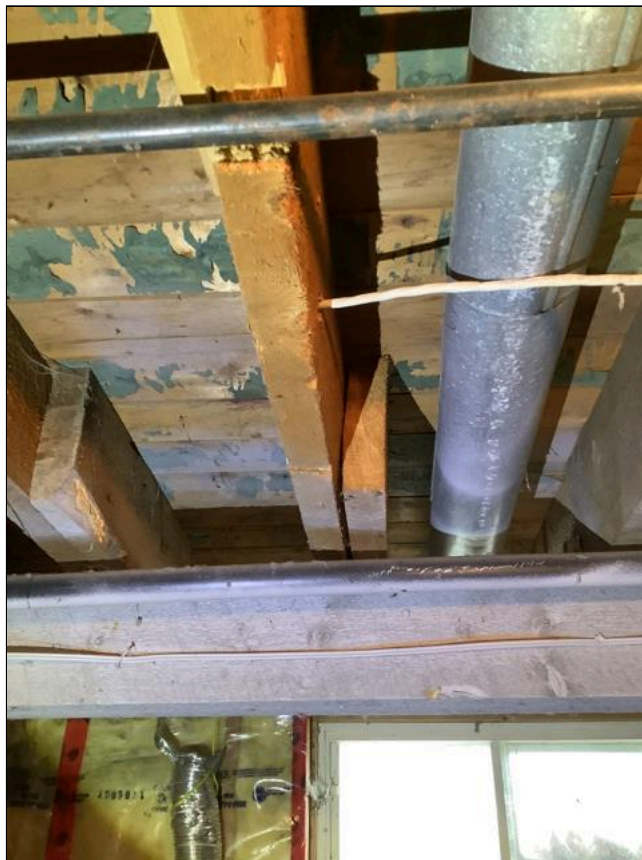
7.9 Item 28(Picture) Joists and Beams - slanted, crooked, notched out, bowed, split

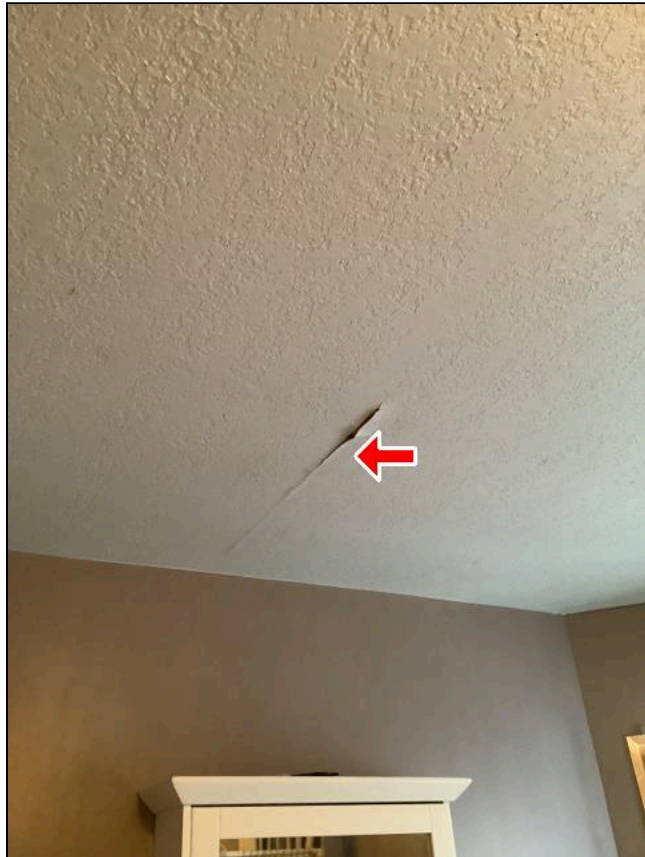
All bathroom walls and ceiling were dry at time of inspection. There was an area in the bathroom ceiling where the seam is splitting but most likely from humidity as there is no fan.

9.0 Item 1(Picture) Bathroom Ceiling - seam splitting

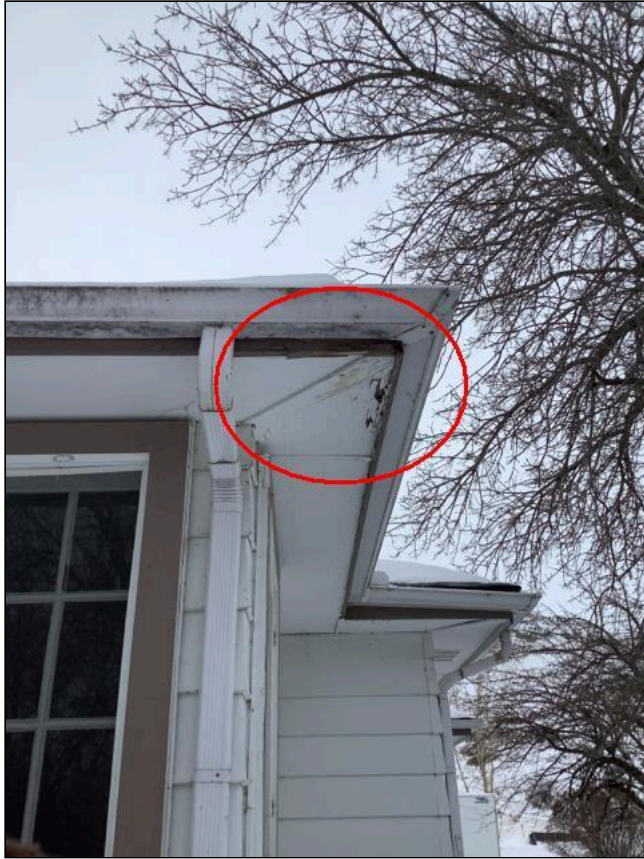
Higher levels of wall clad around the home are only visually inspected from the ground level. There was an area on the back of the house that has signs of moisture damage, recommend further review and repair as required.

3.1 Item 1(Picture) Exterior - signs of moisture damage

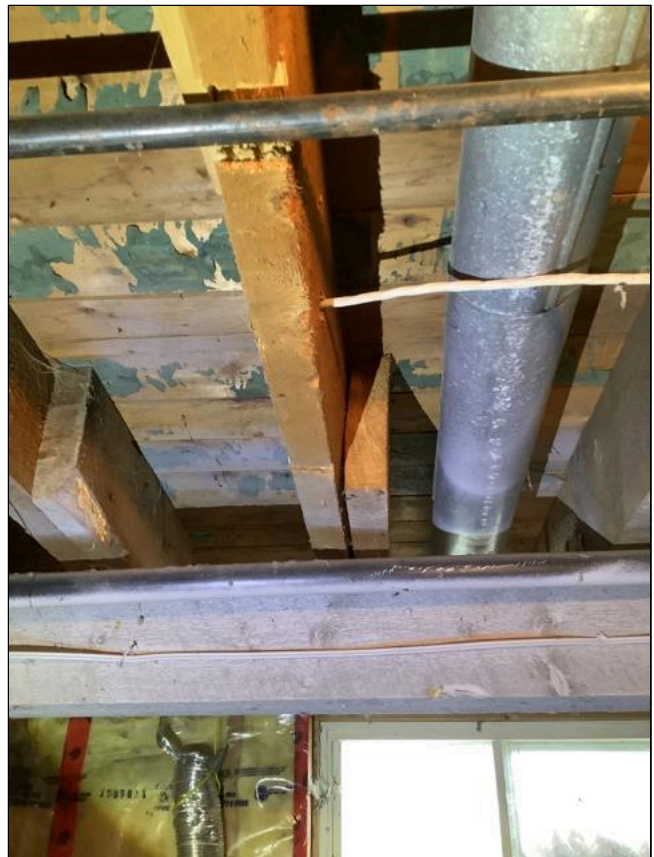
7.9 Item 28(Picture) Joists and Beams - slanted, crooked, notched out, bowed, split

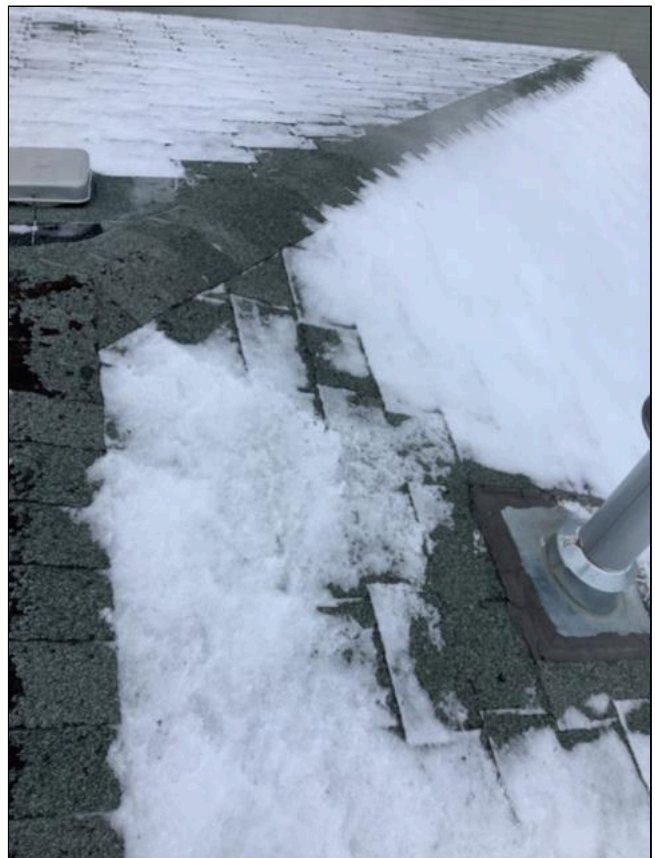
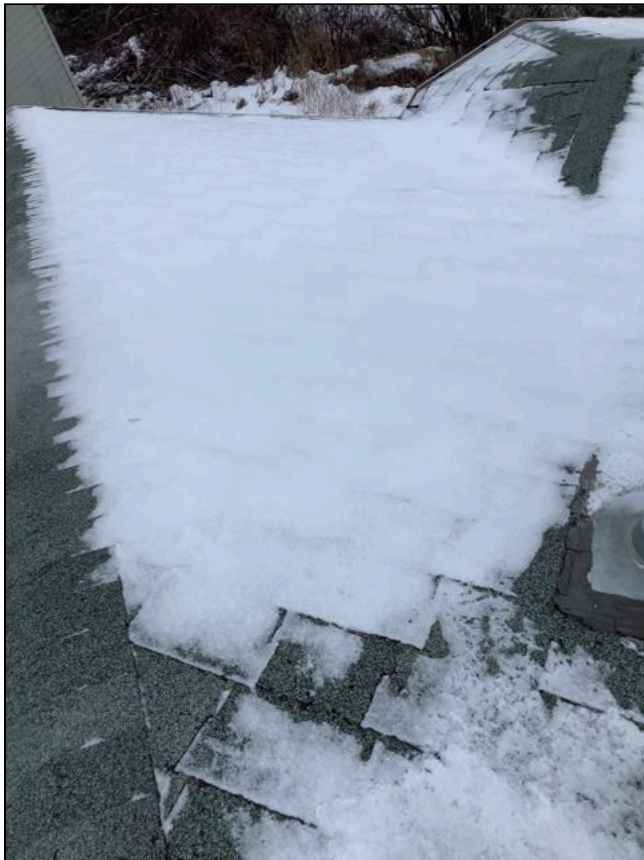
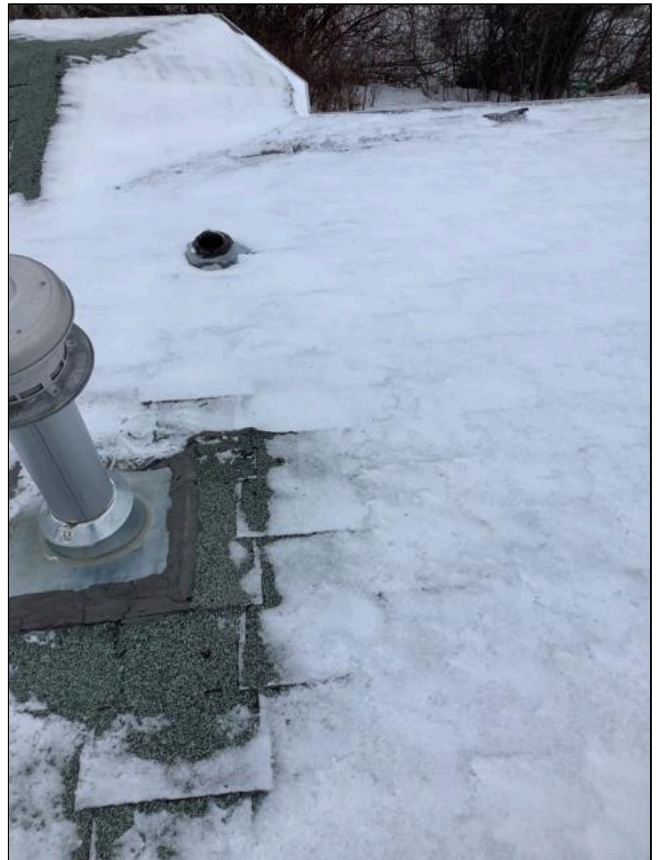
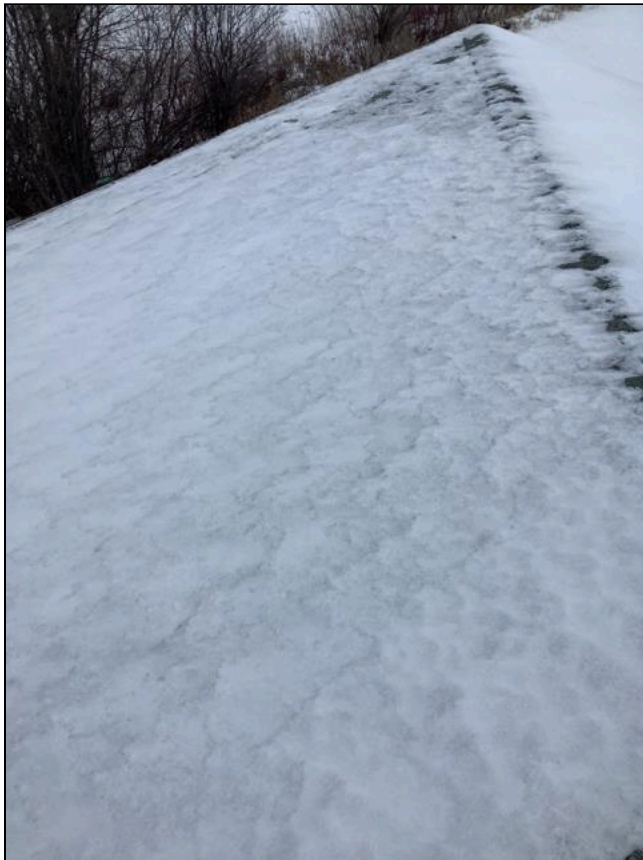
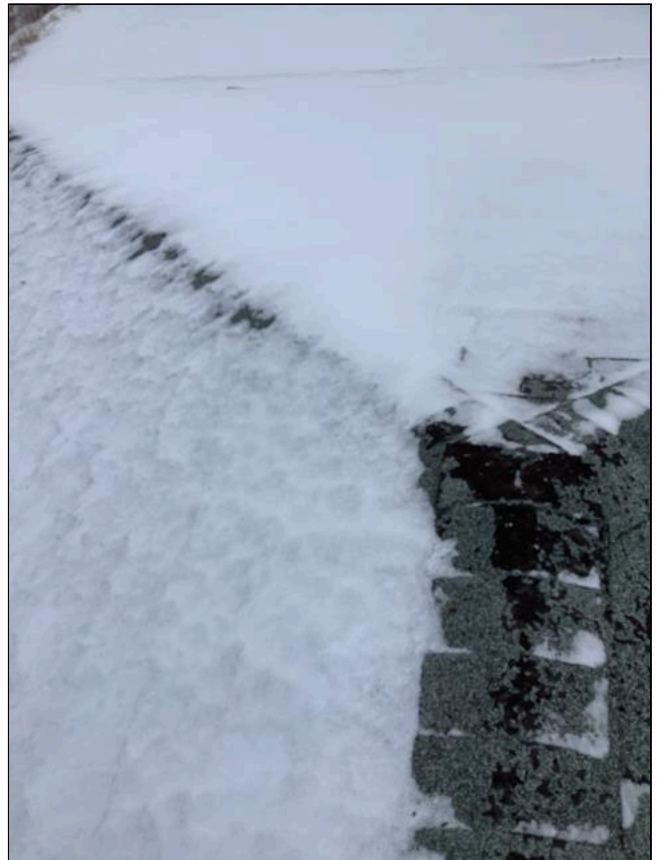
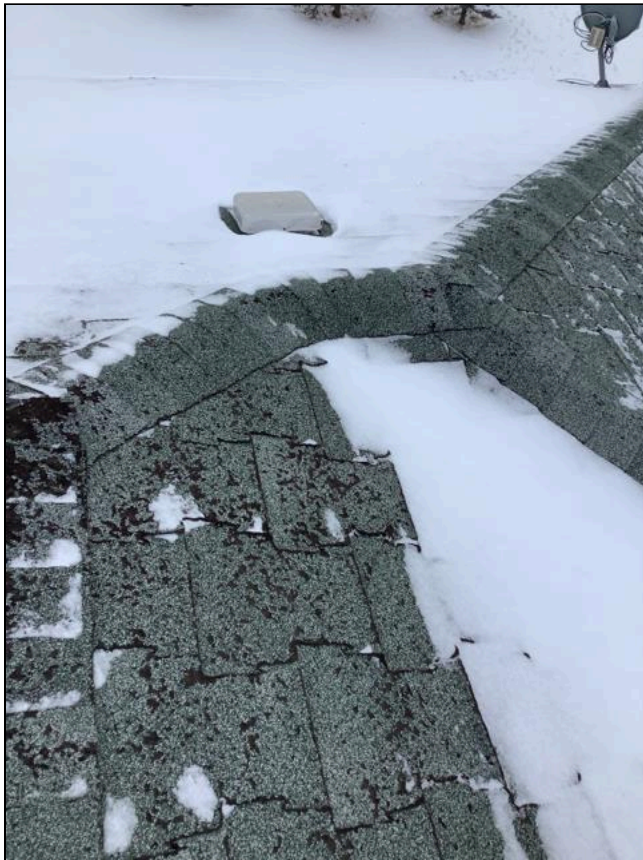
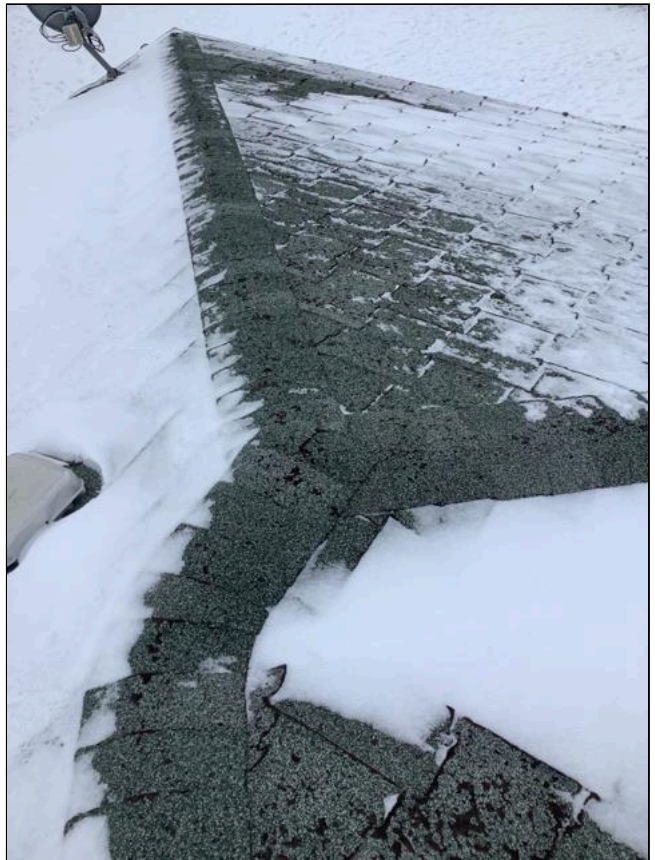
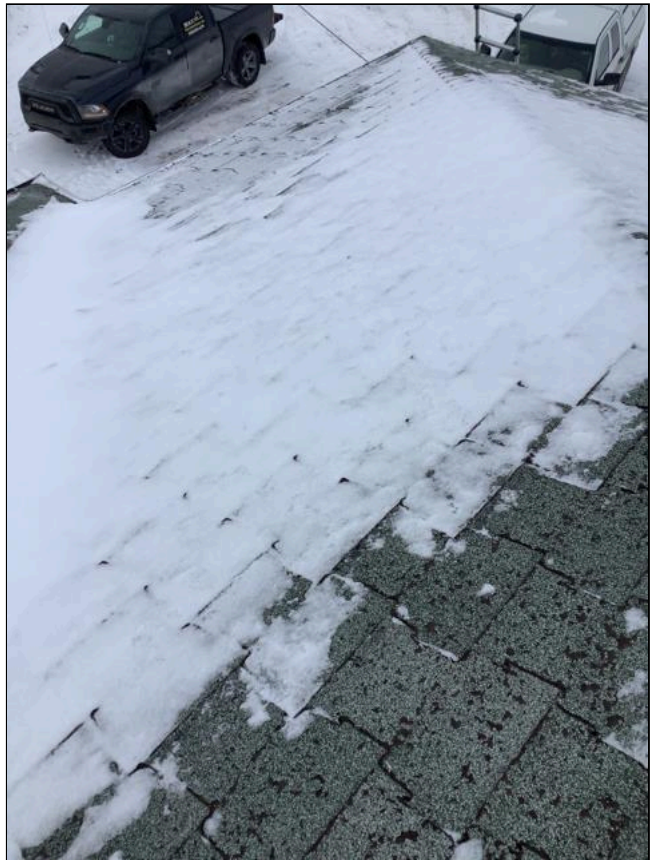
1.0 Item 2(Picture) Roof - shingles are aged and will require replacement

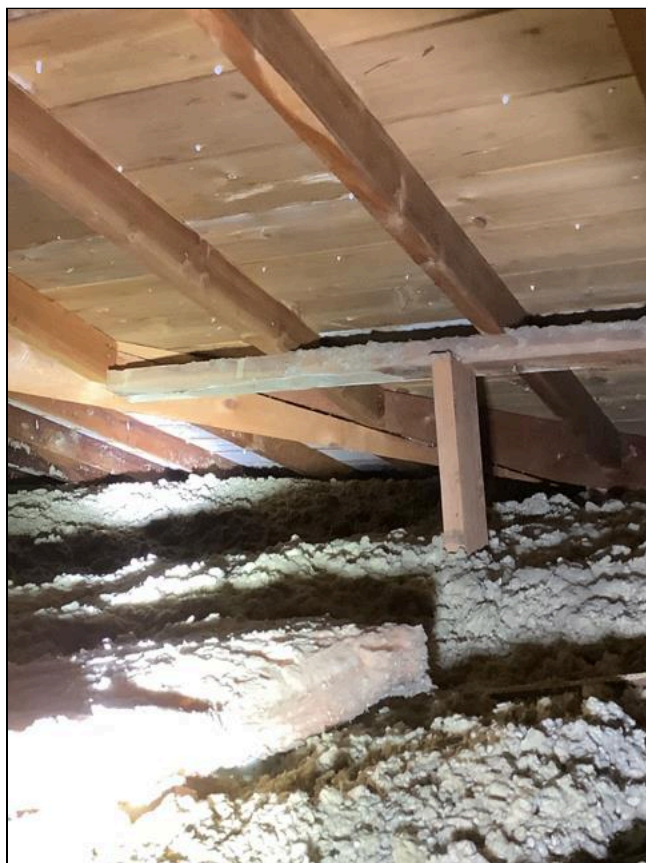
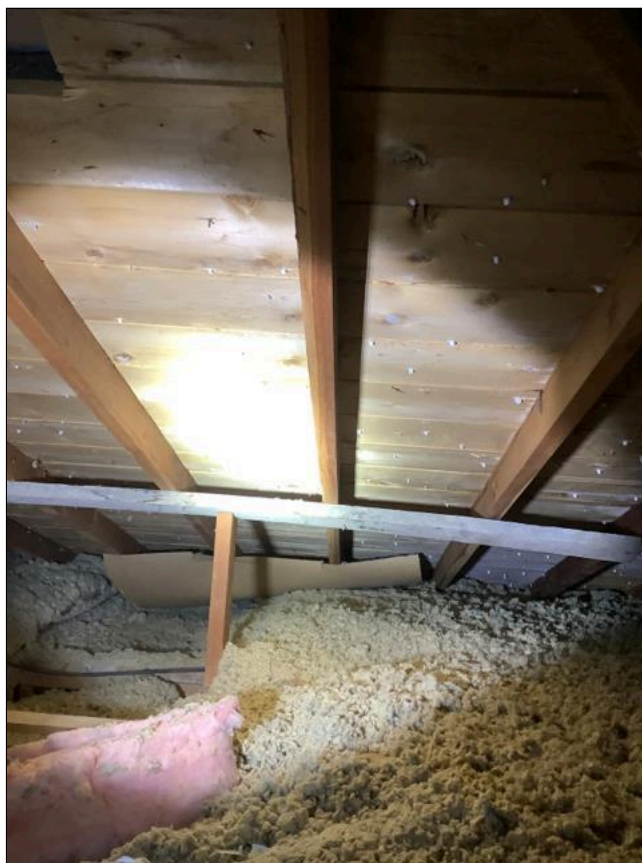
One of the rafters has split where the two are nailed together and the cross support is bowed, both are signs of movement/settling and should be further reviewed and repaired as required.

2.3 Item 1(Picture) Rafter - split, cross support bowed

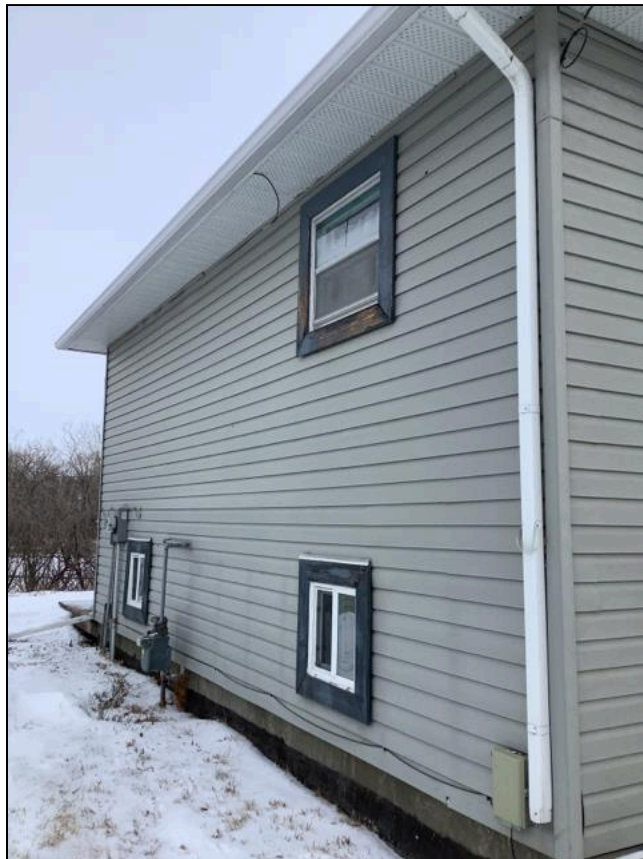
3.1 Item 1(Picture) Exterior

Higher levels of wall clad around the home are only visually inspected from the ground level. At the back of the house the top row of siding is bowed over the sliding patio door, recommend that it be further reviewed and repaired as required.

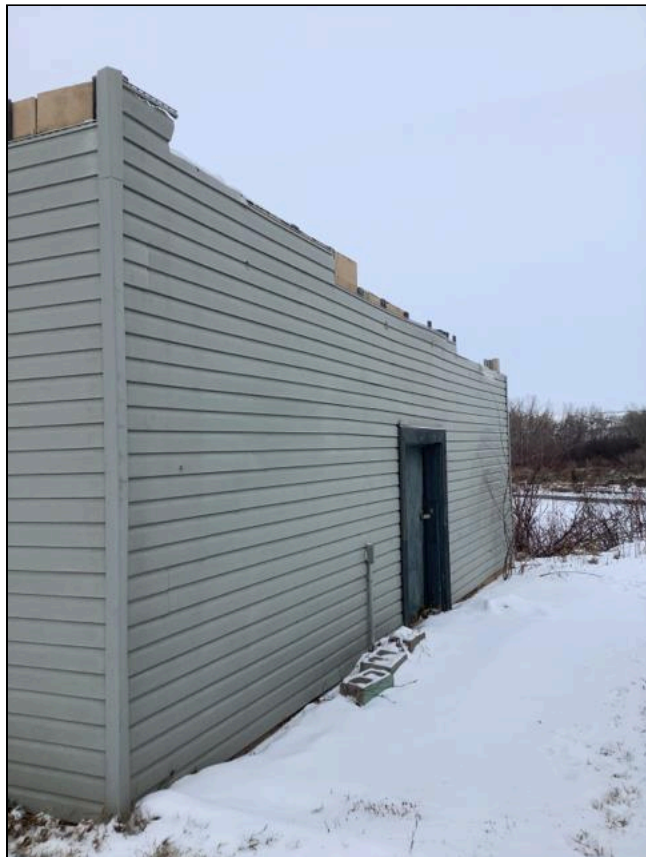
The back of the garage is heavily bowed, replacement of the garage is recommended.

4.4 Item 1(Picture) Back of Garage - heavily bowed

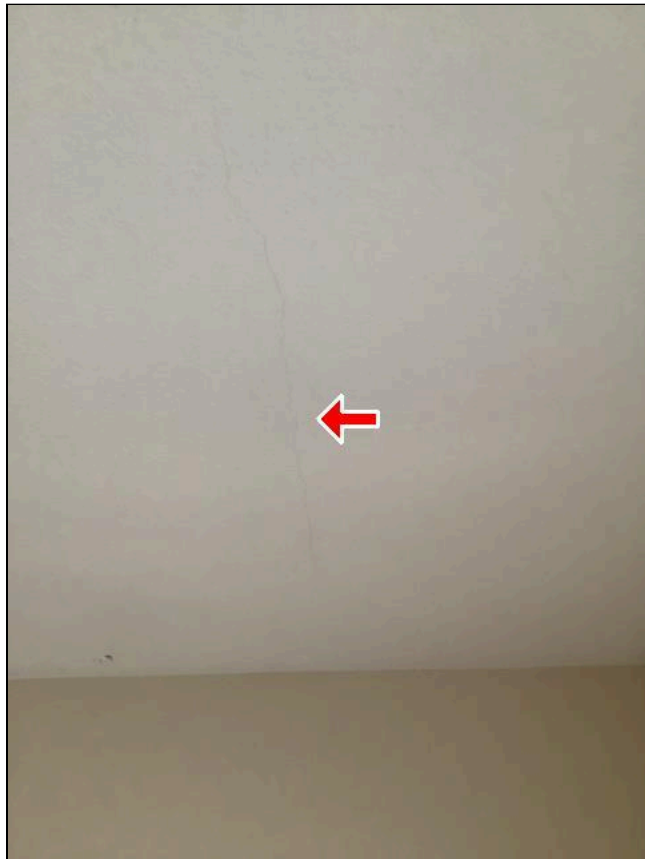
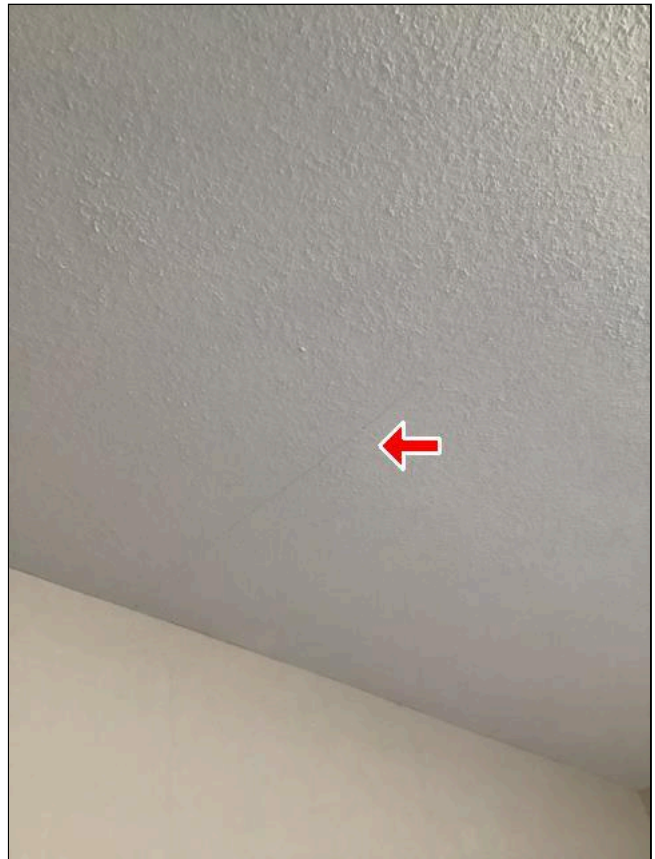
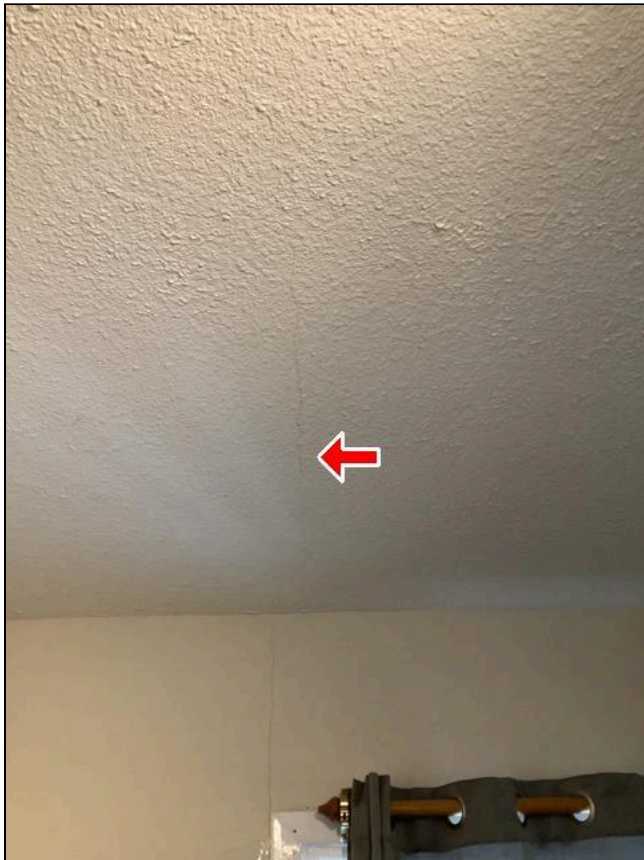
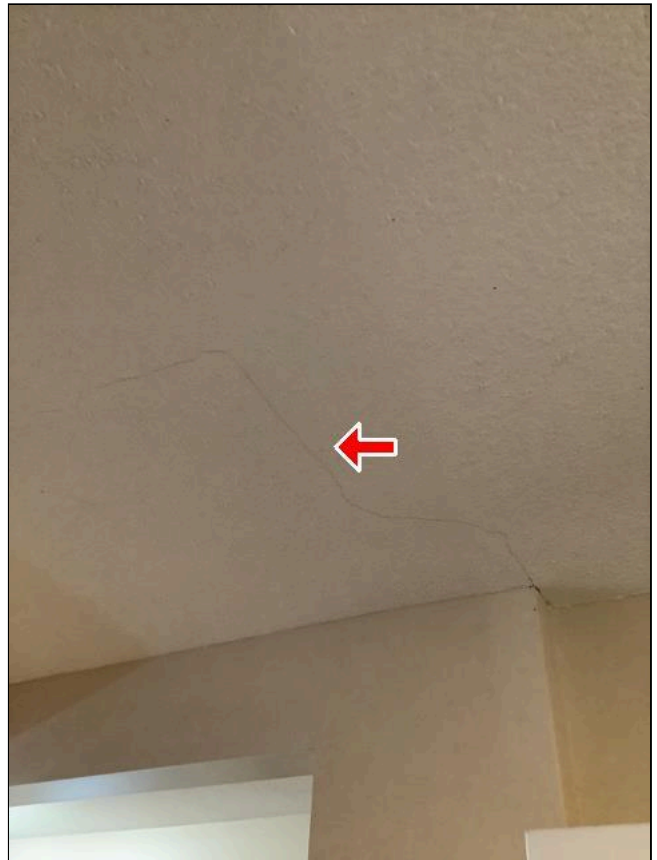
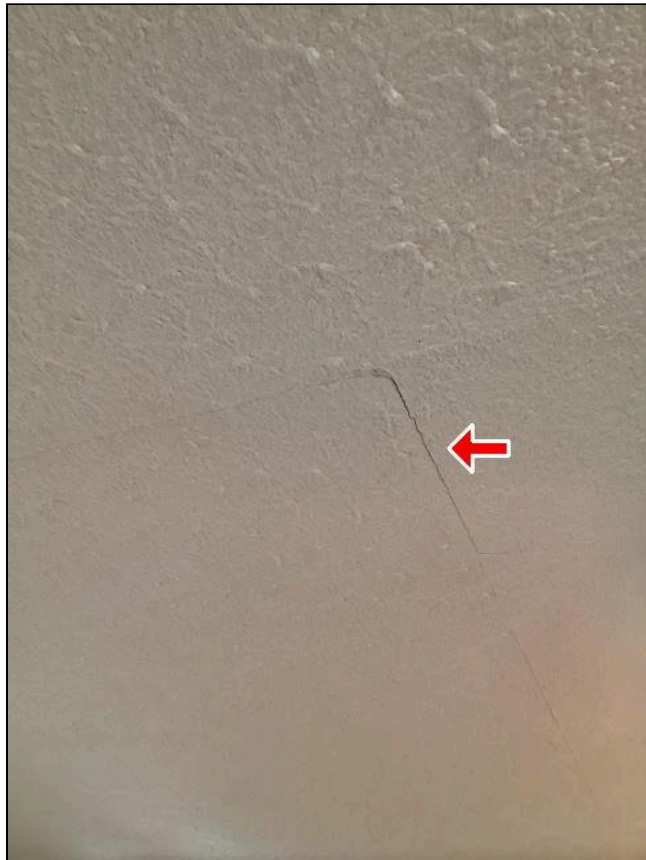
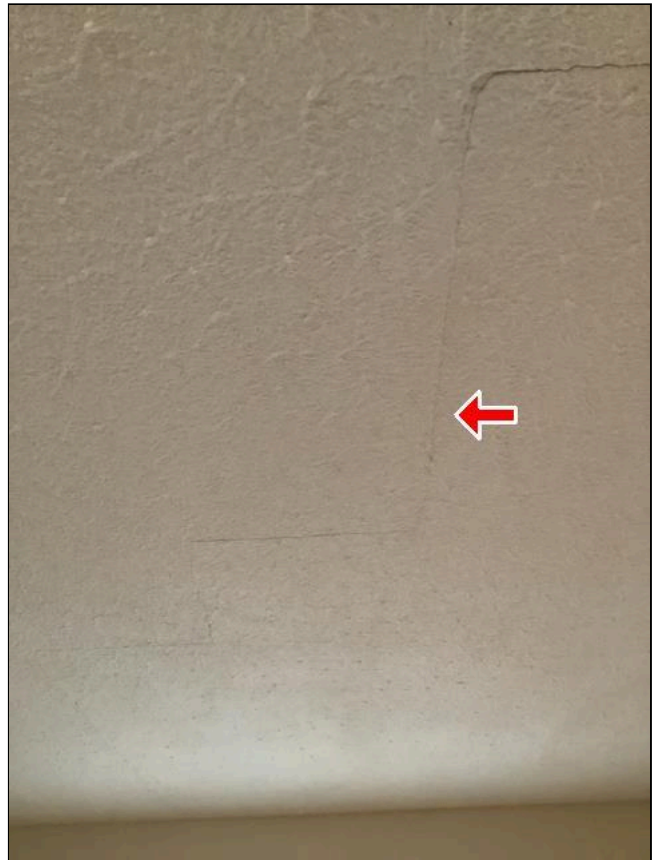
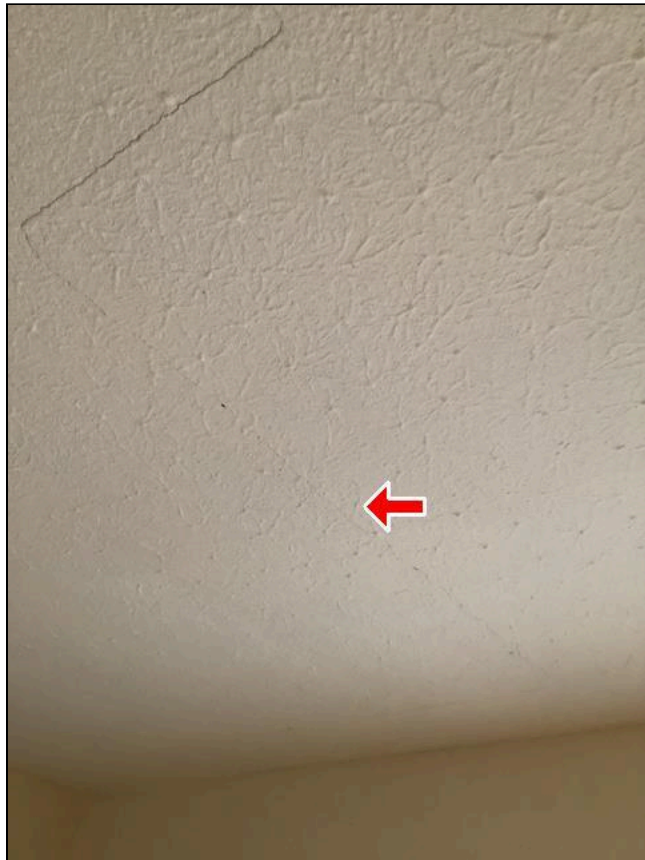
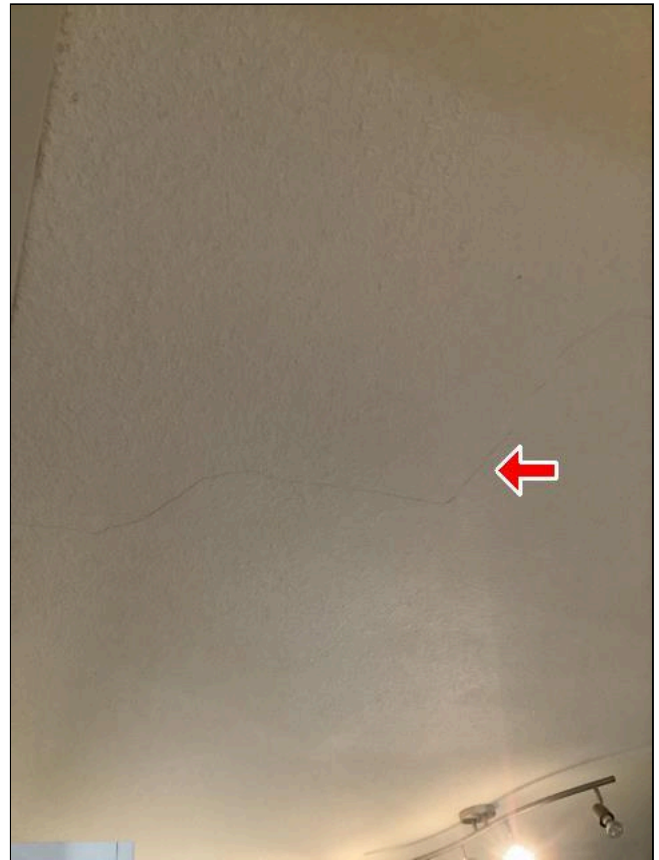
All ceilings were dry at time of inspection but had multiple cracks throughout the house some common from settling and some from shifting.

5.0 Item 1(Picture) Ceiling - common cracks from settling and shifting
