Demolition and Remediation Services

**Residential Demolition Project
for
The Town of Drumheller**

Tender issued September 2, 2022
Tender closing September 22, 2022 – 2:00:00 P.M.

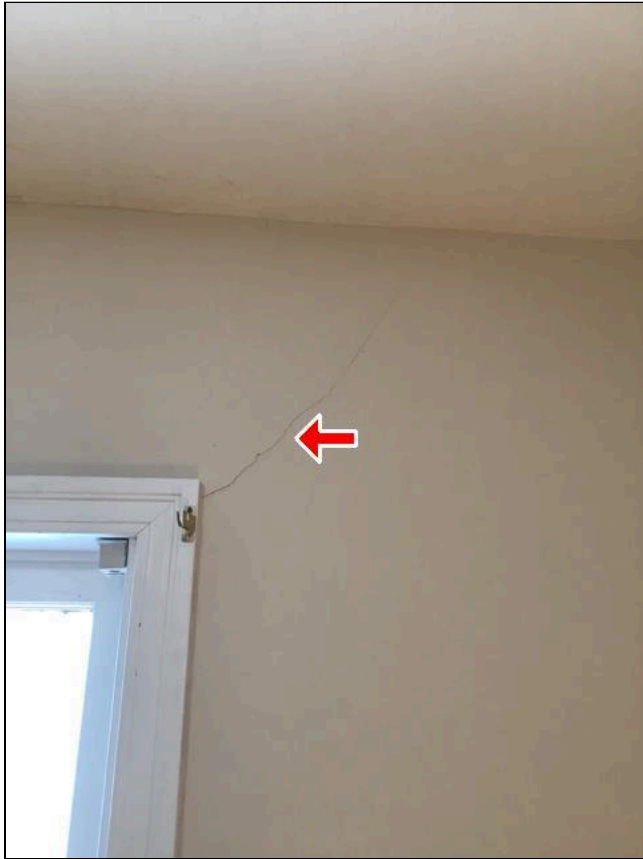
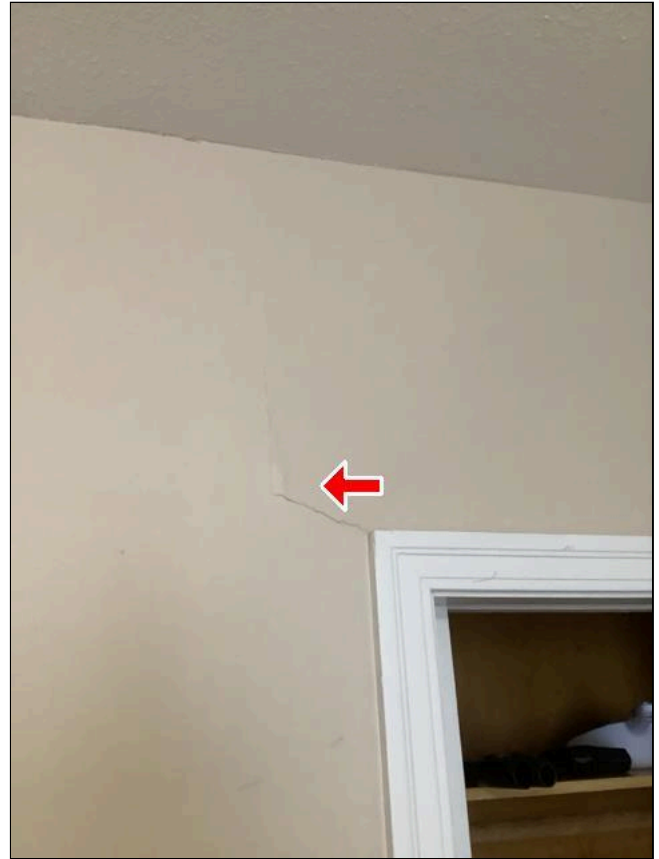
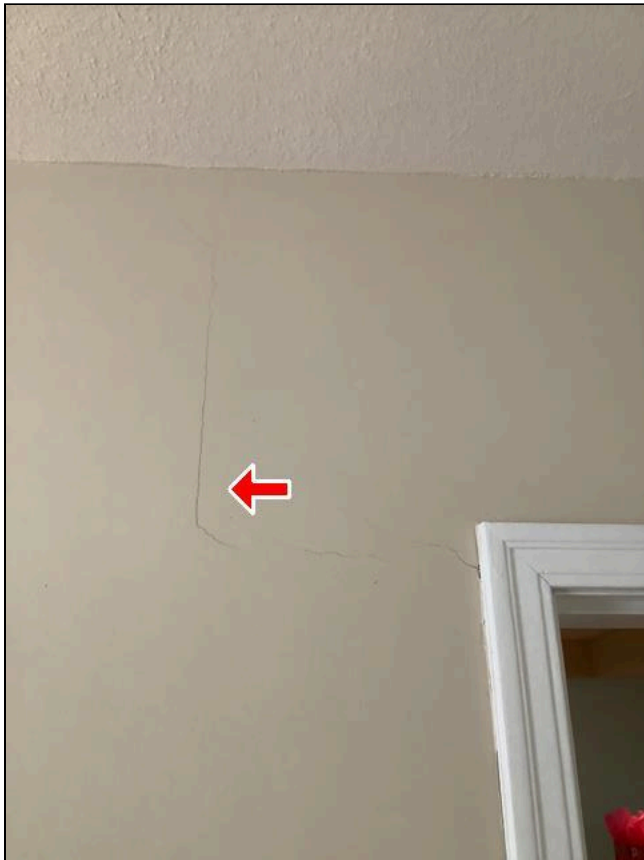
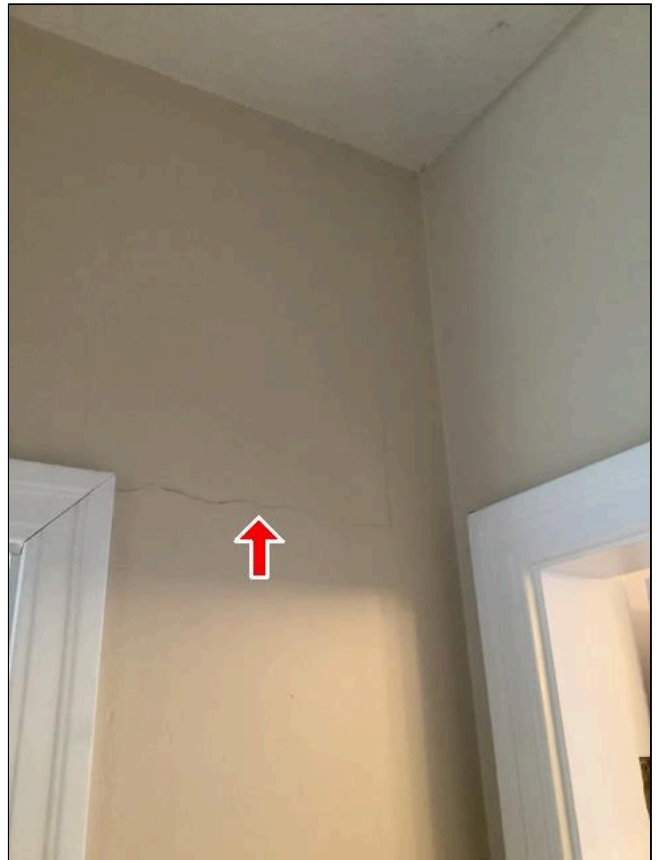
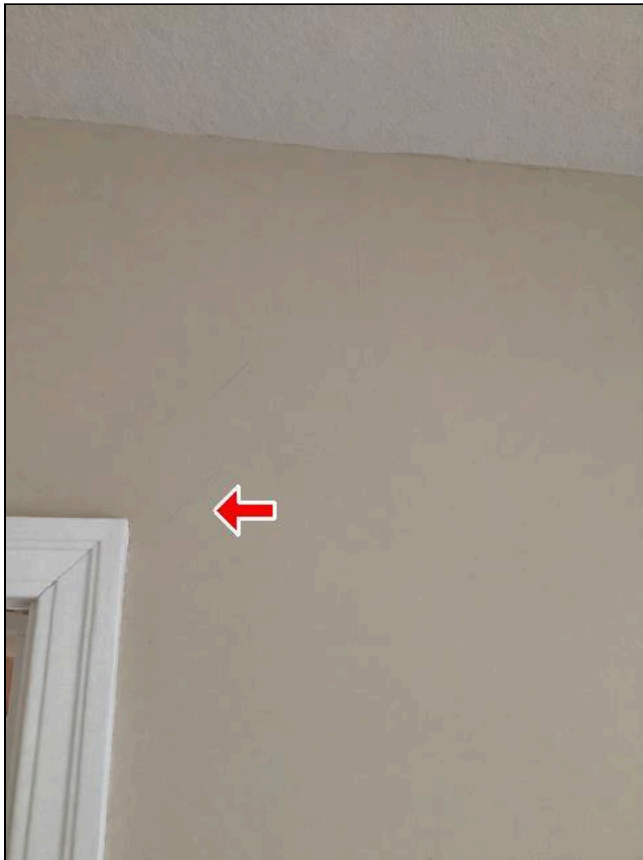
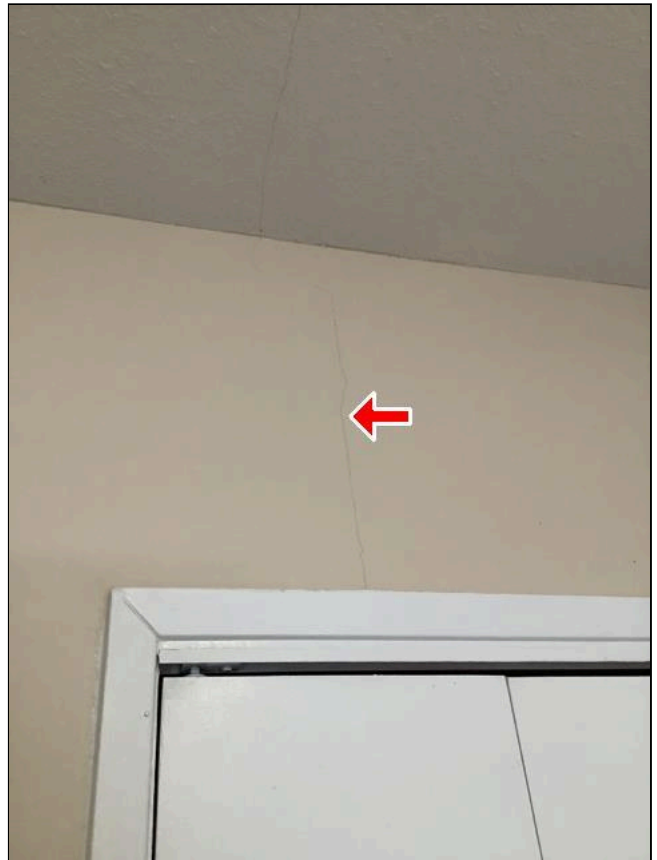
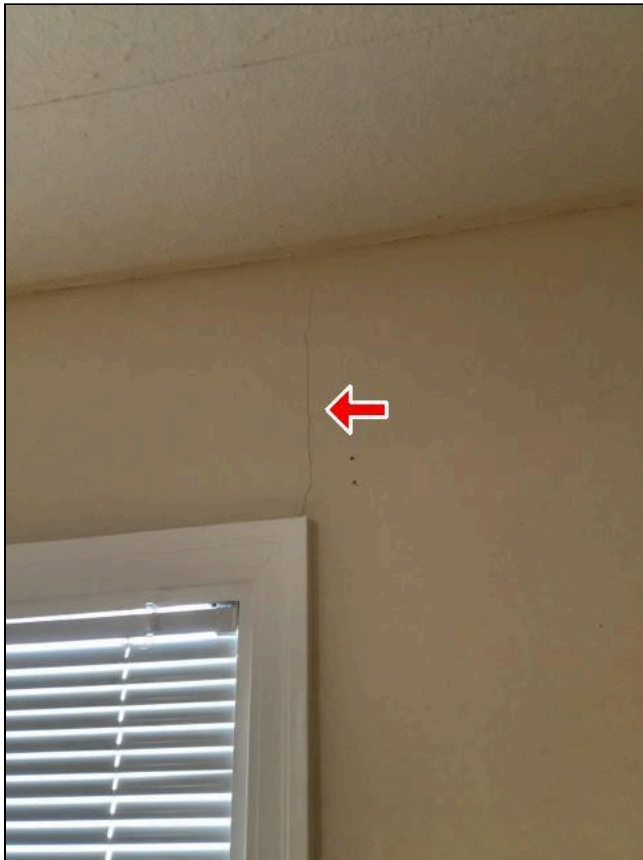
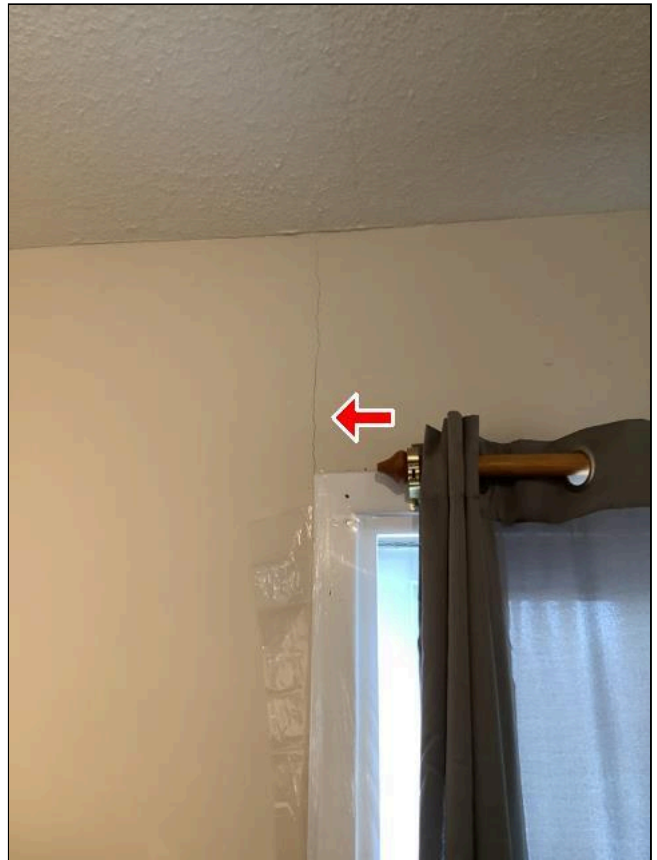
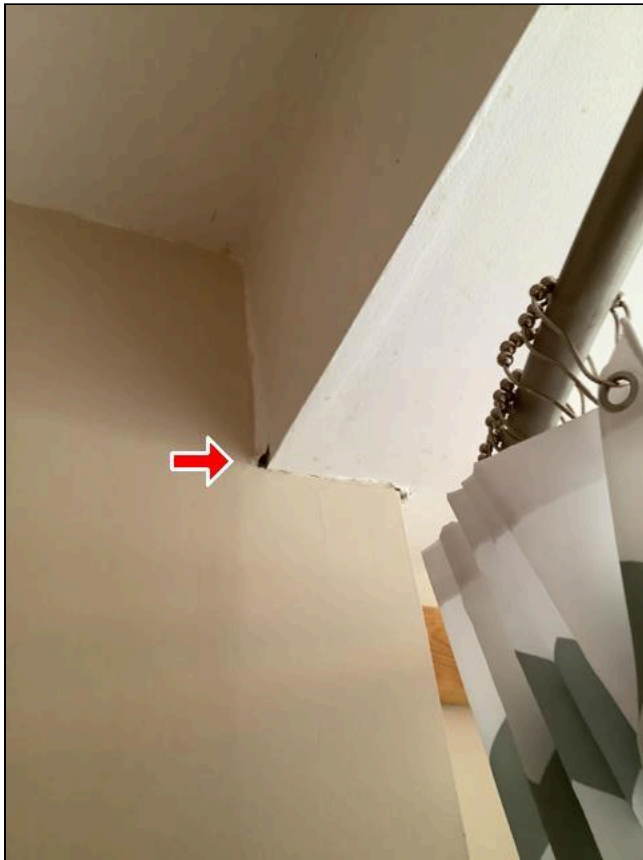
All walls were dry at time of inspection but had multiple cracks throughout the house some common from settling and some from shifting.

5.1 Item 1(Picture) Interior Walls - cracks from settling and shifting

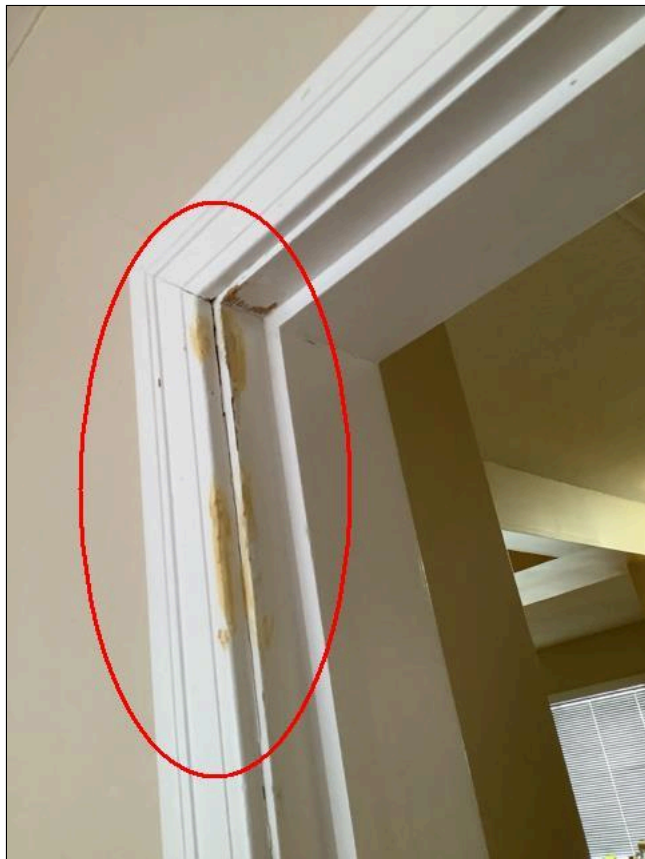
5.4 Item 2(Picture) Door - signs of rubbing

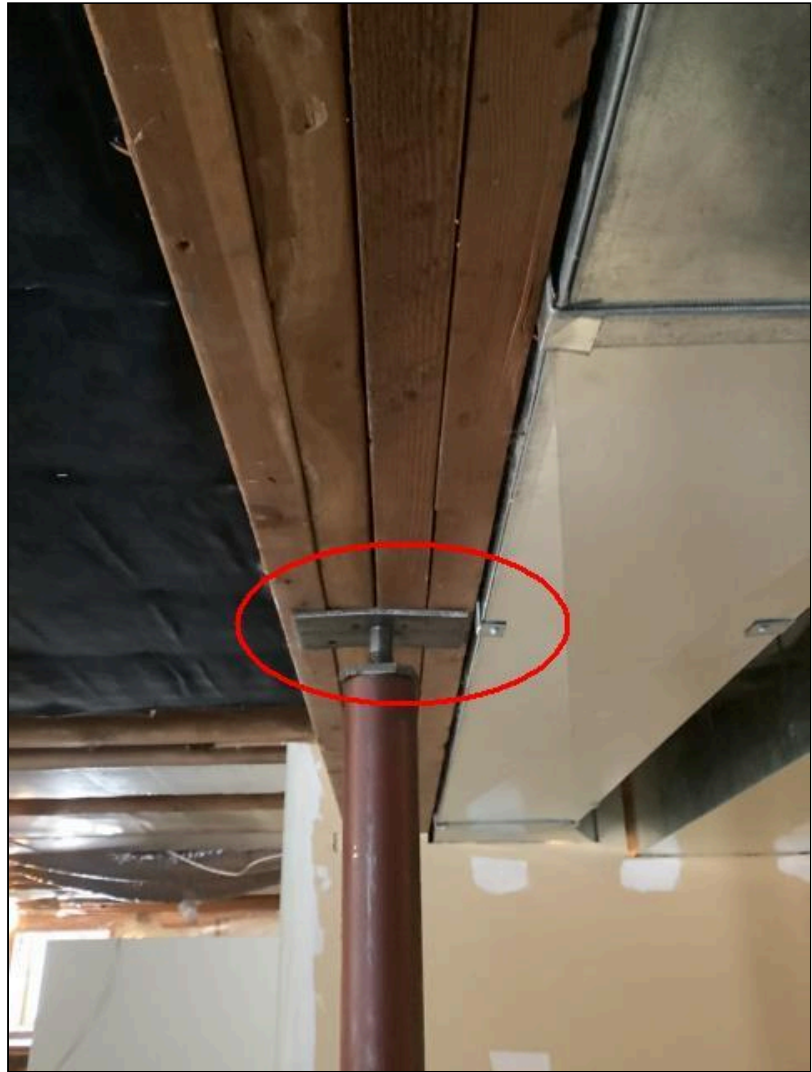
The plate on the steel screw jack was bowed, recommend that it be further reviewed. Never remove support posts without seeking advice from structural engineer.

7.6 Item 1(Picture) Plate - bowed

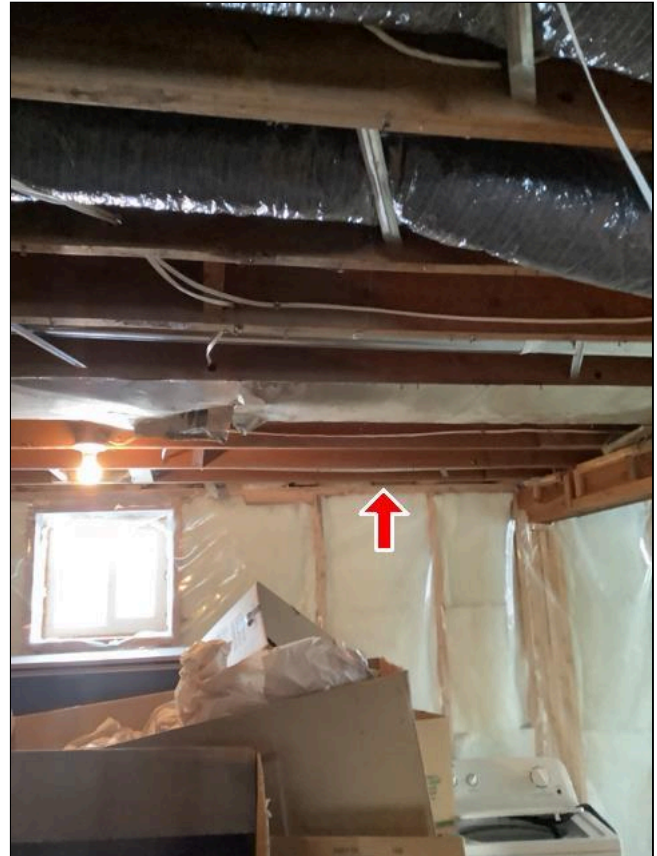
7.9 Item 2(Picture) Joist - sagging

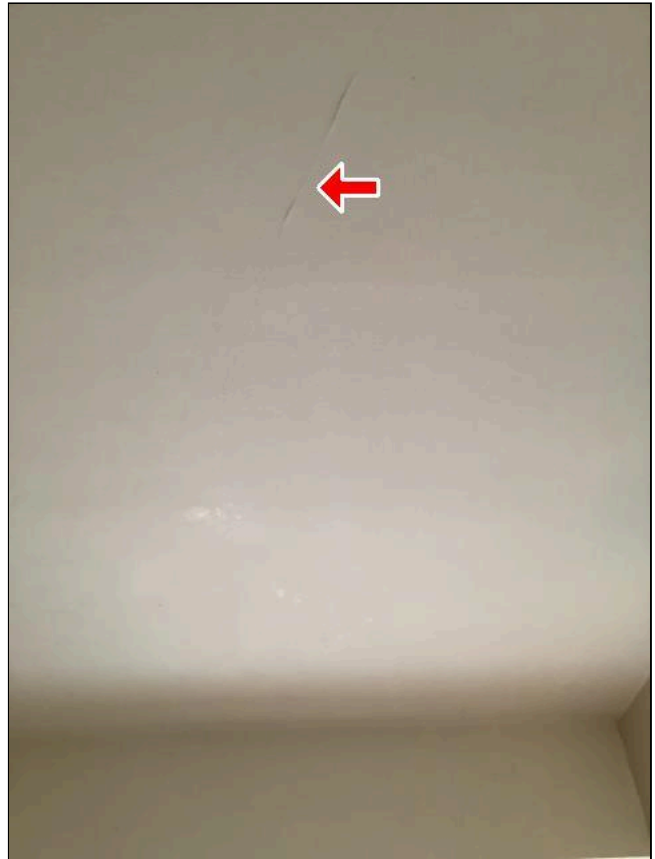
9.0 Item 2(Picture) Bathroom Ceiling - cracks from settling

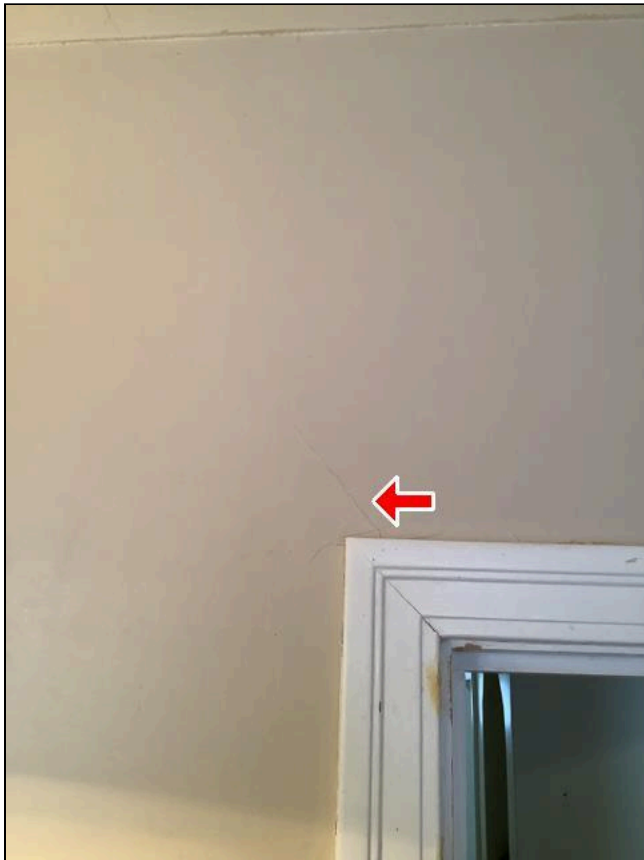
9.0 Item 3(Picture) Bathroom Wall - cracks from settling

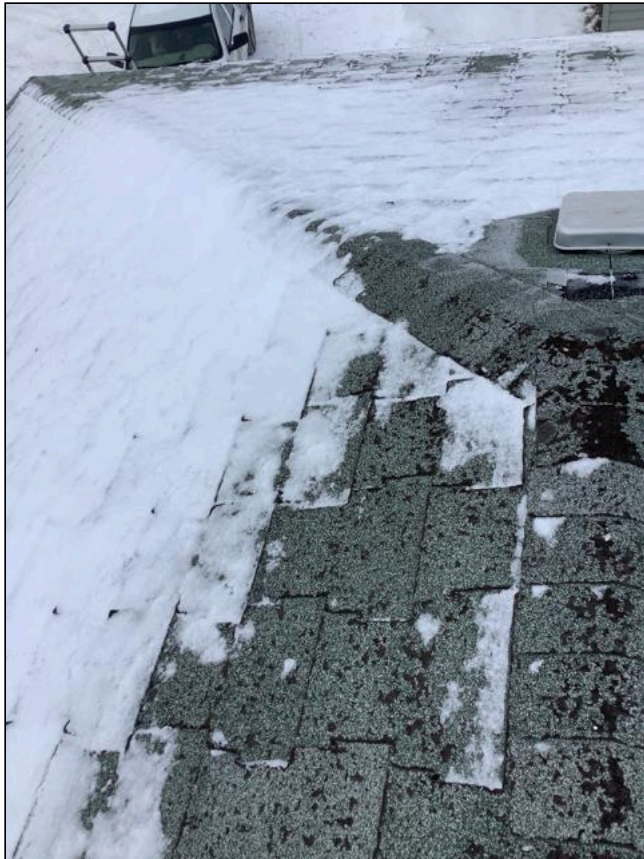
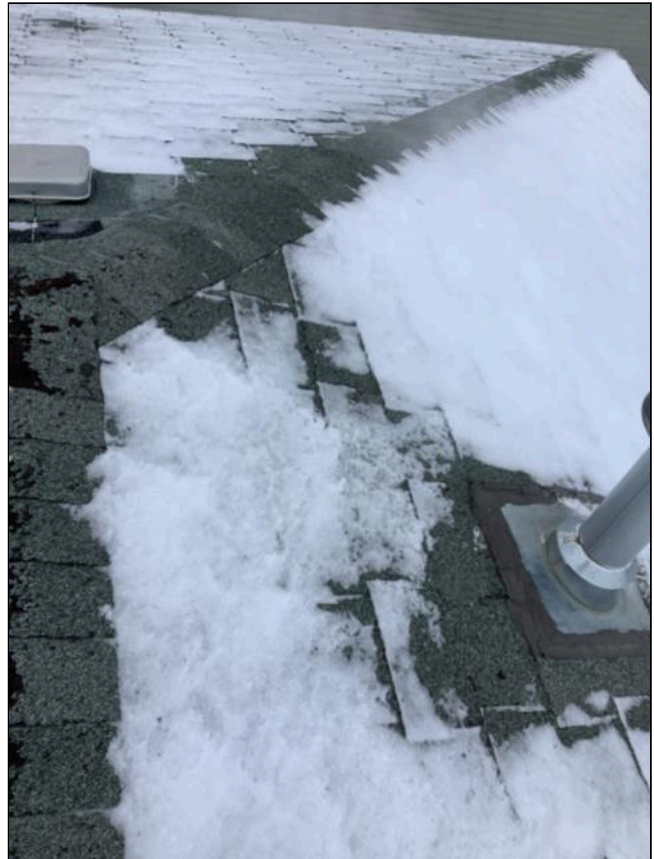
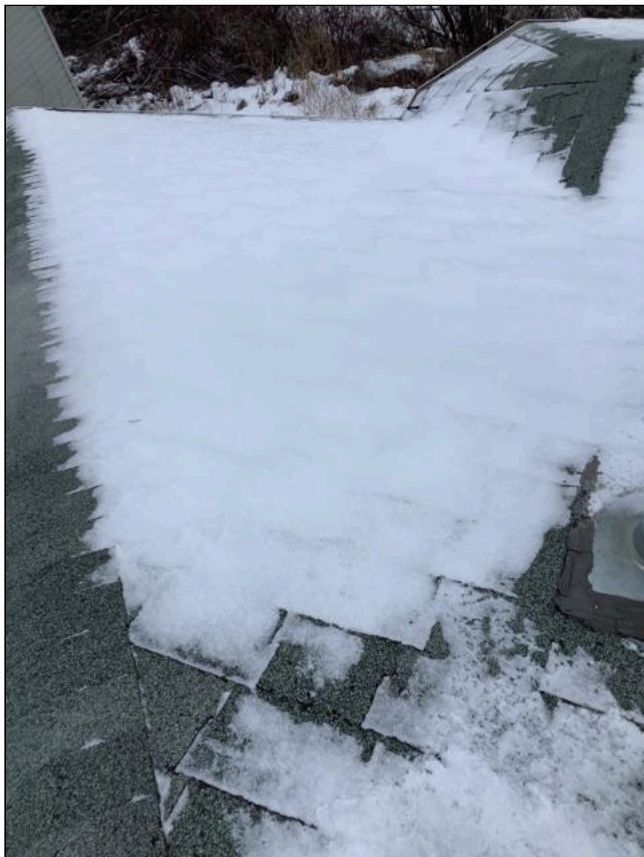
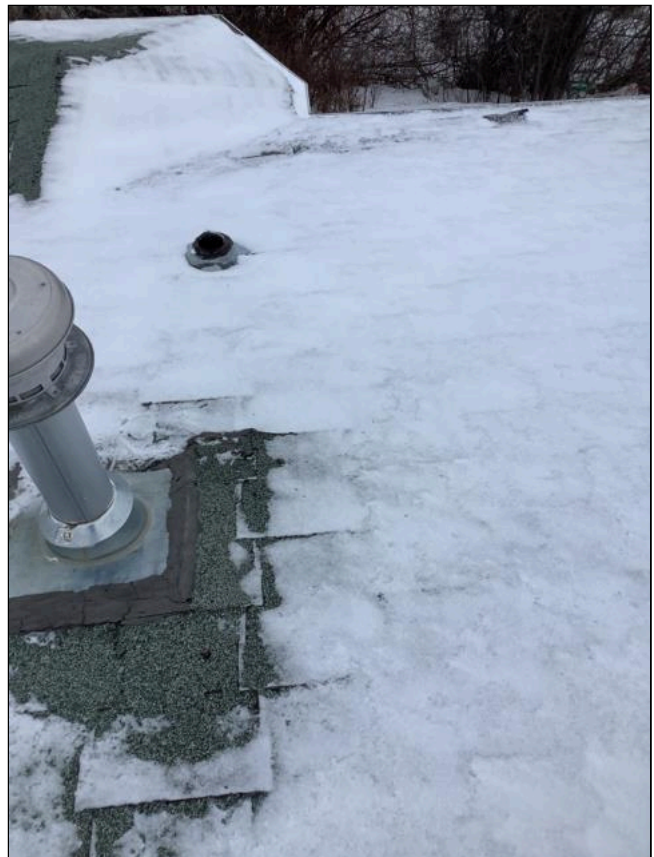
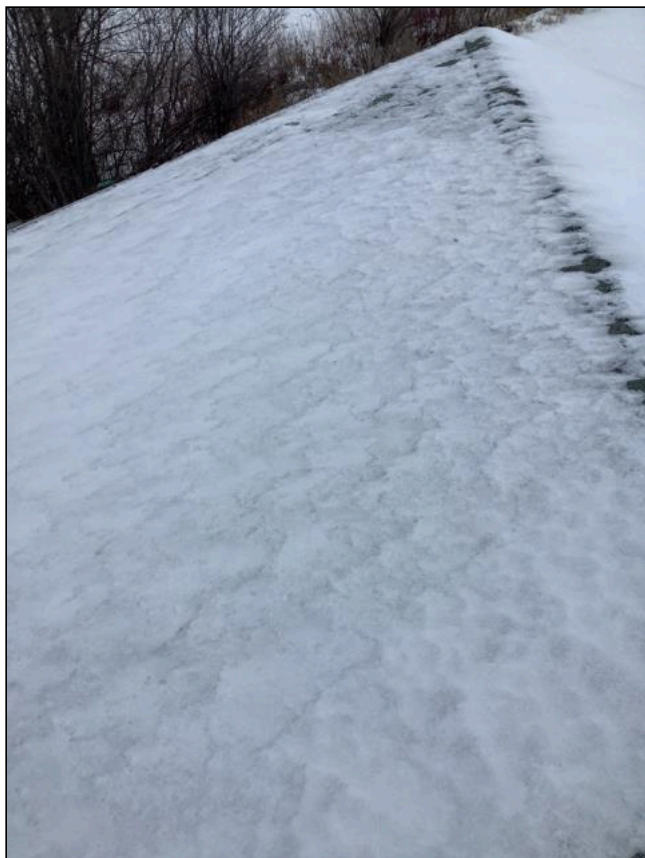
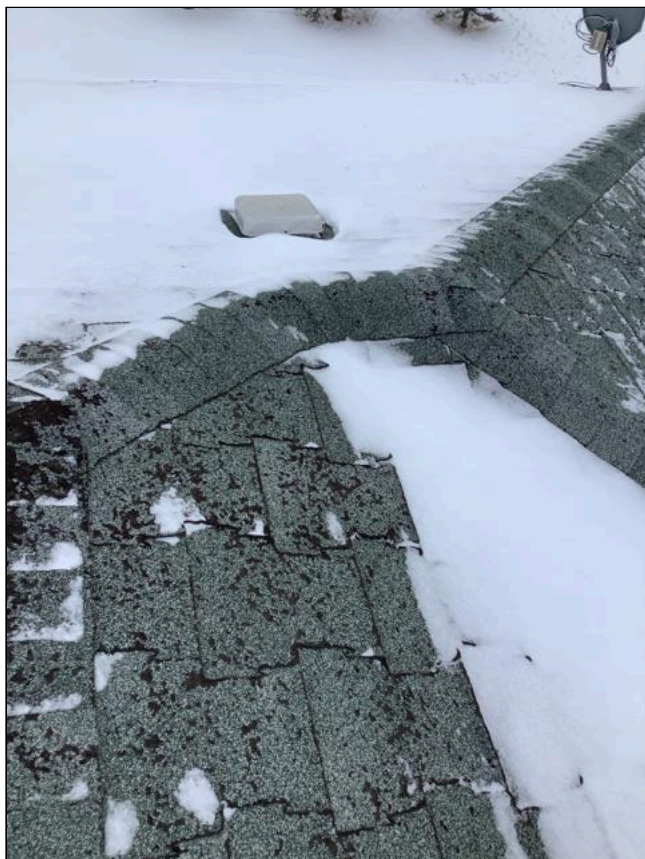
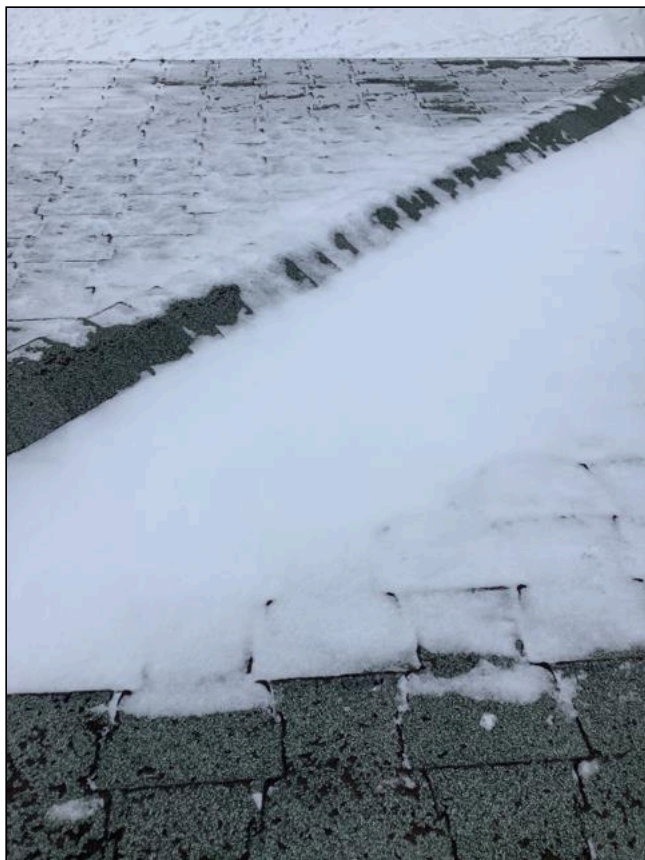
The roof was walked for assessment, could only inspect some of the roof as it was covered in snow. No visual sign of structural concern but shingles are aged and will require replacement.

1.0 Item 1(Picture) Roof - shingles are aged and will require replacement

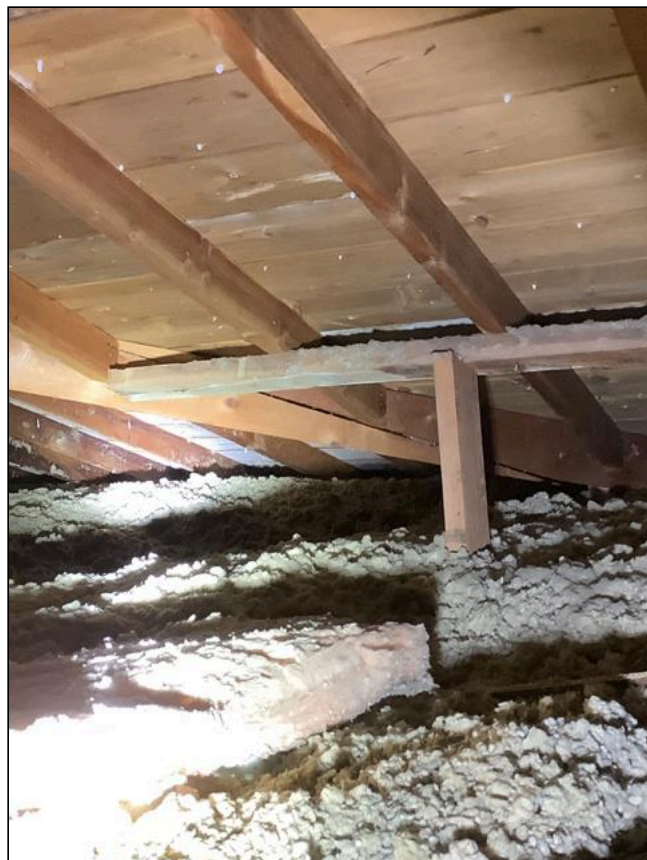
One of the rafters has split where the two are nailed together and the cross support is bowed, both are signs of movement/settling and should be further reviewed and repaired as required.

2.3 Item 1(Picture) Rafter - split, cross support bowed

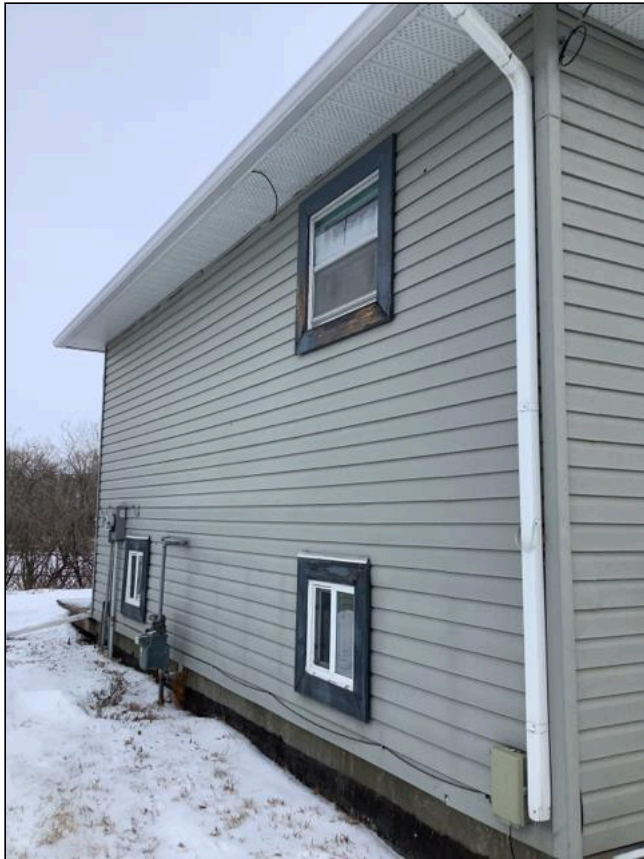
3.1 Item 1(Picture) Exterior

Higher levels of wall clad around the home are only visually inspected from the ground level. At the back of the house the top row of siding is bowed over the sliding patio door, recommend that it be further reviewed and repaired as required.

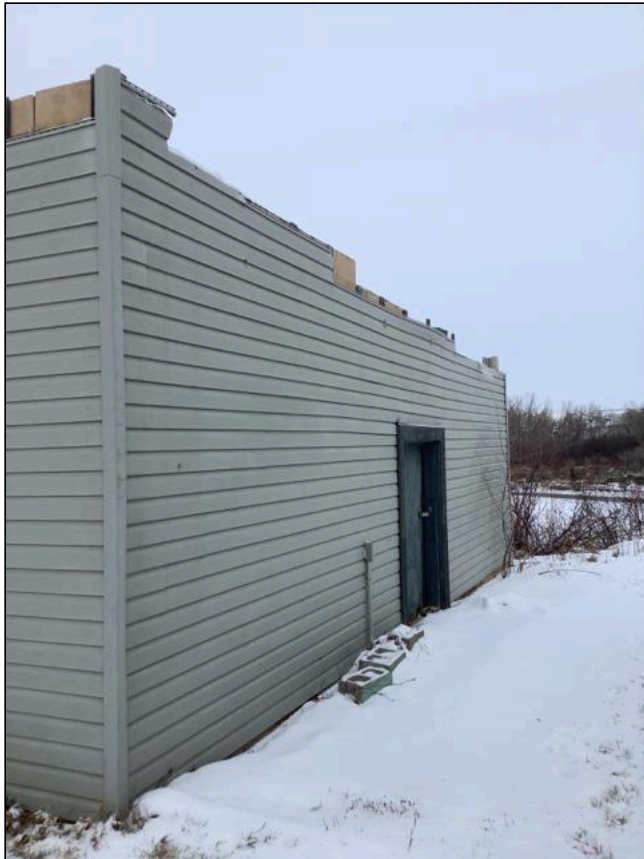
The back of the garage is heavily bowed, replacement of the garage is recommended.

4.4 Item 1(Picture) Back of Garage - heavily bowed

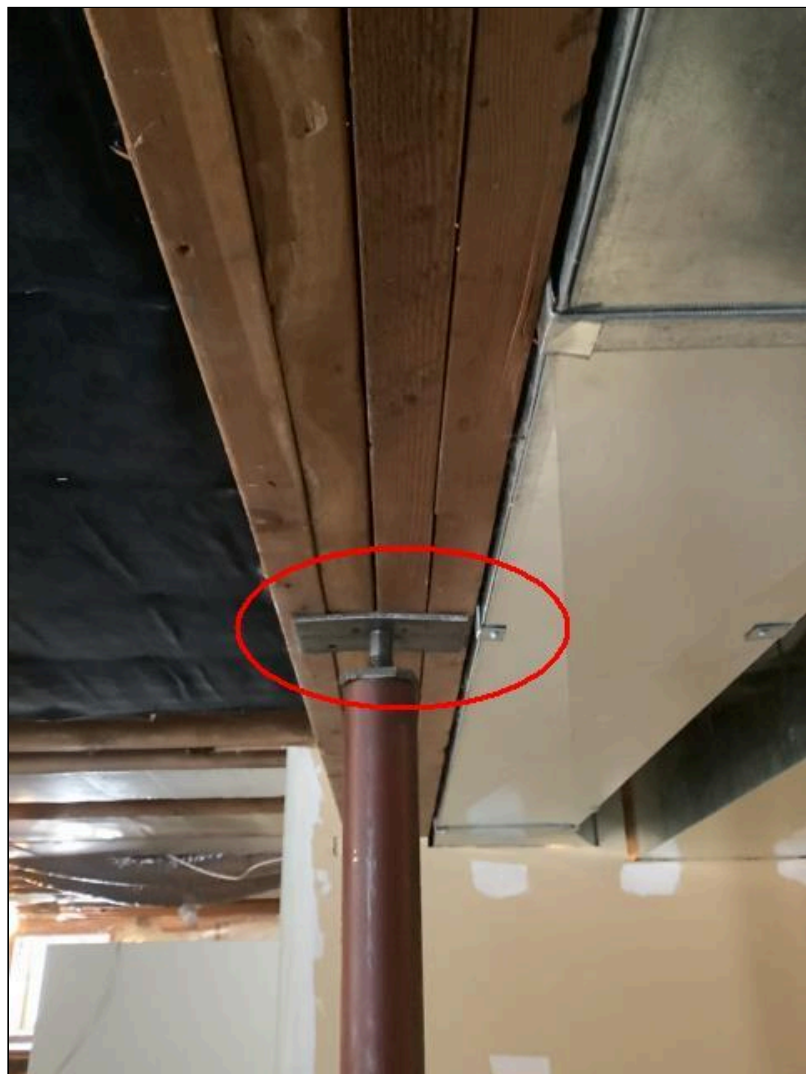
The plate on the steel screw jack was bowed, recommend that it be further reviewed. Never remove support posts without seeking advice from structural engineer.

7.6 Item 1(Picture) Plate - bowed

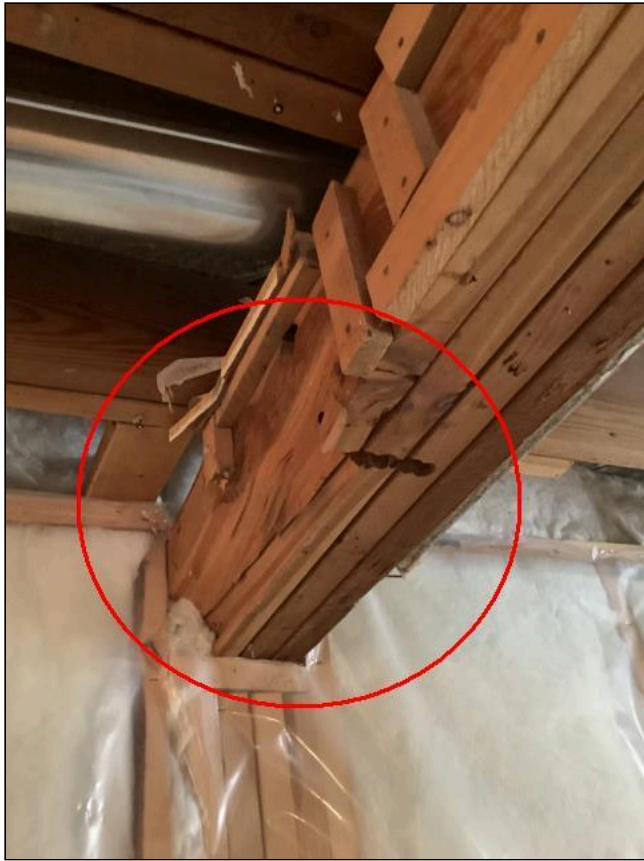
7.9 Item 1(Picture) Beam - end is broken

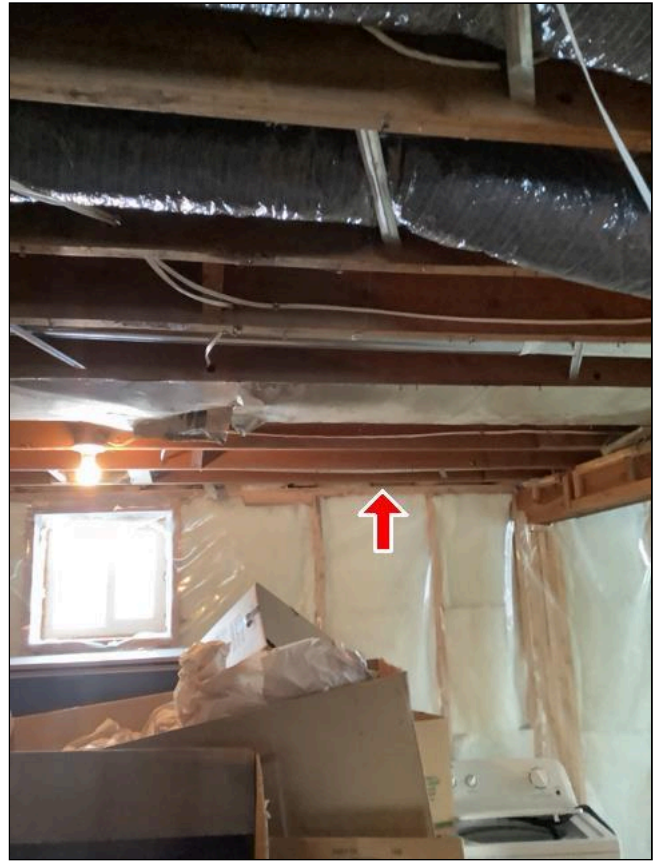
7.9 Item 2(Picture) Joist - sagging

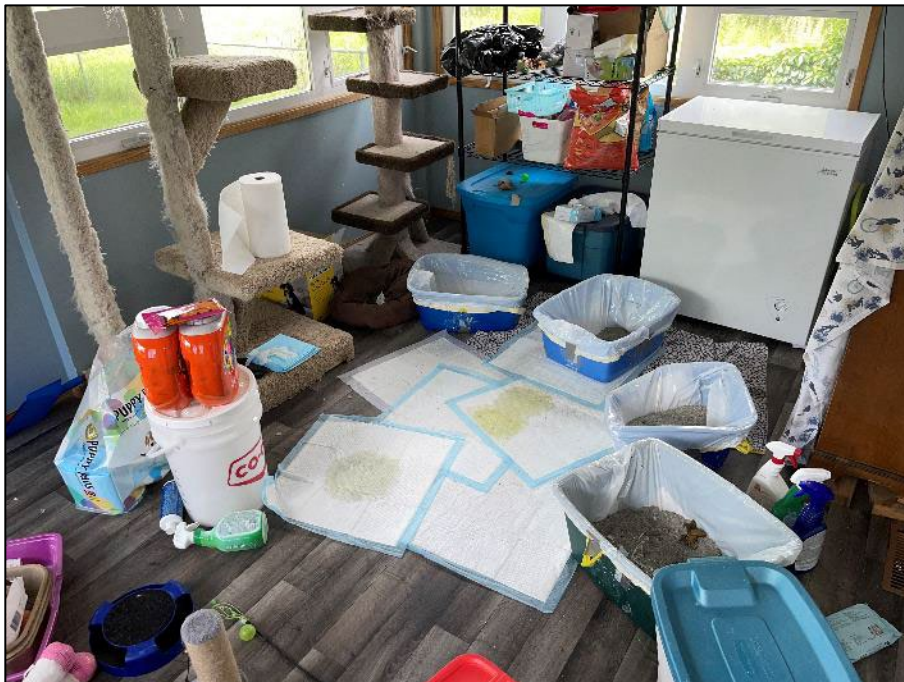
PHOTOGRAPH #22: Cat Urine and Fecal Matter Present in Large Quantities (Biological Hazard)

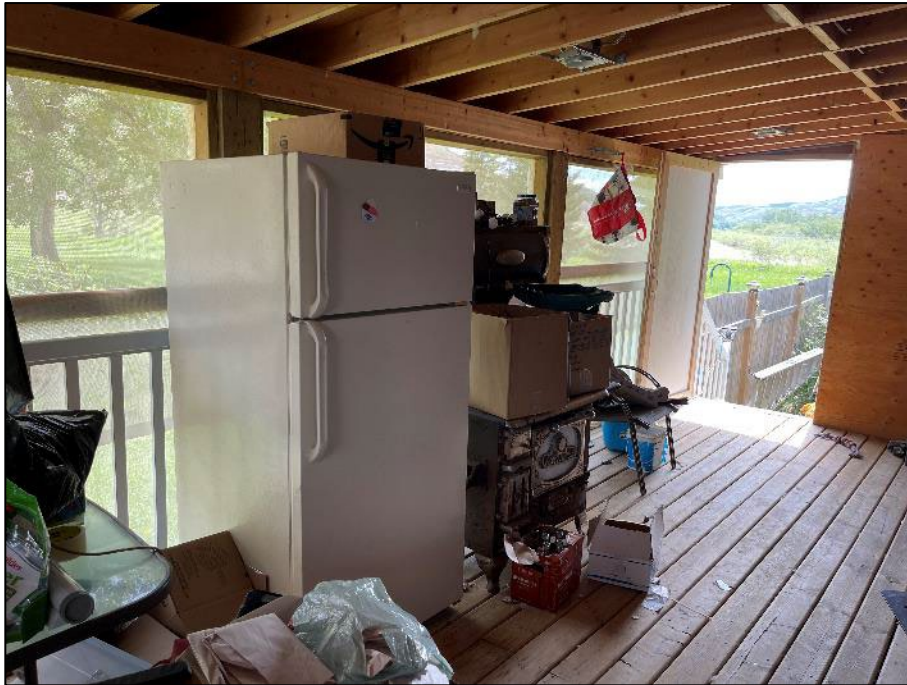
PHOTOGRAPH #23: Fridge on Porch (Ozone Depleting Substances)

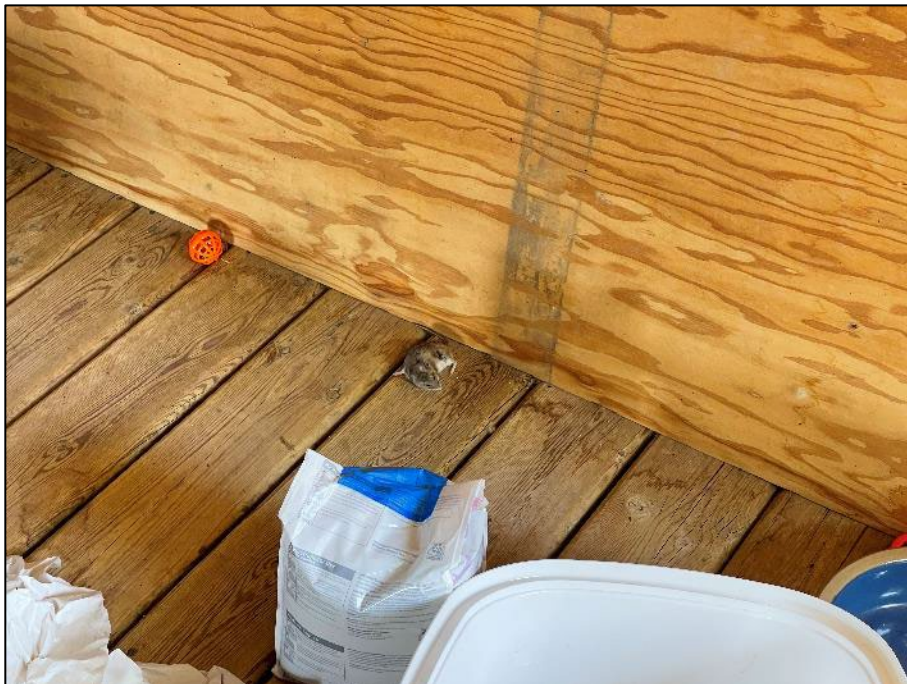
PHOTOGRAPH #24: Animal Carcass on Front Porch (Biological Hazard)

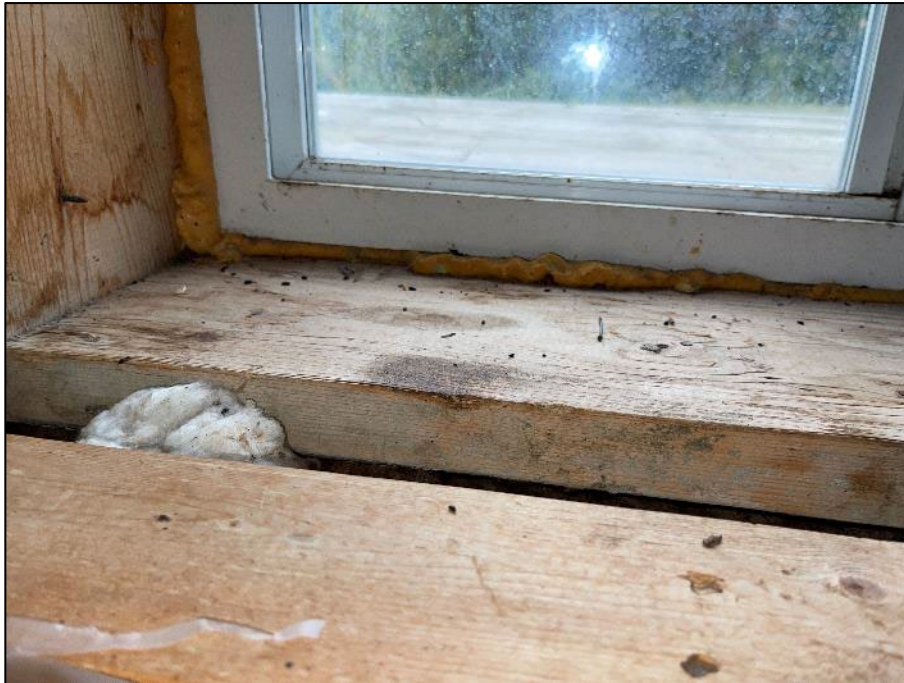
PHOTOGRAPH #25: Mouse Droppings Present in Basement Laundry Room (Biological Hazard)

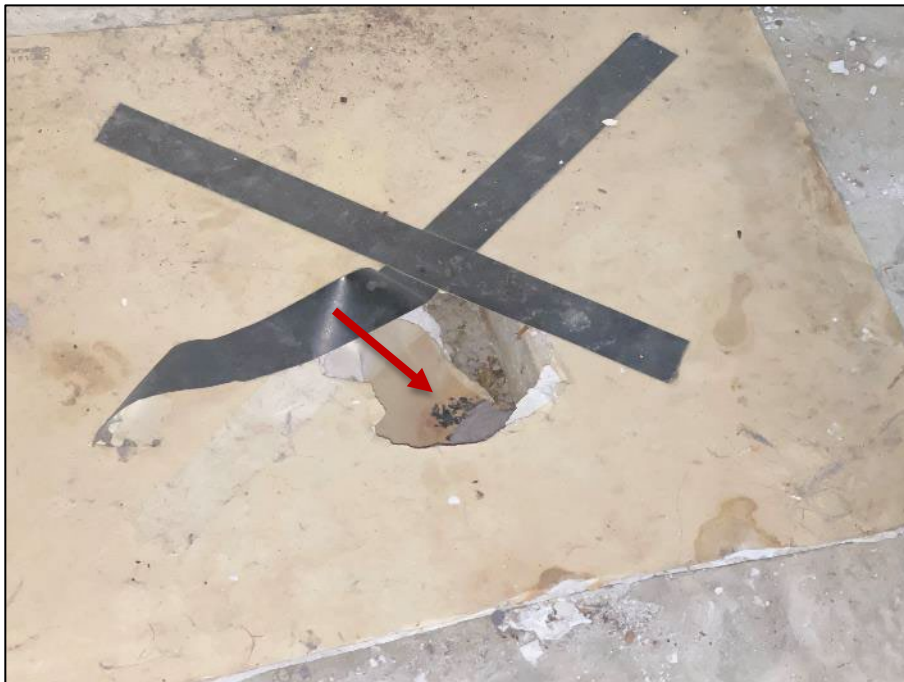
PHOTOGRAPH #26: Visible Mould Contamination - Basement Laundry Room (Biological Hazard)

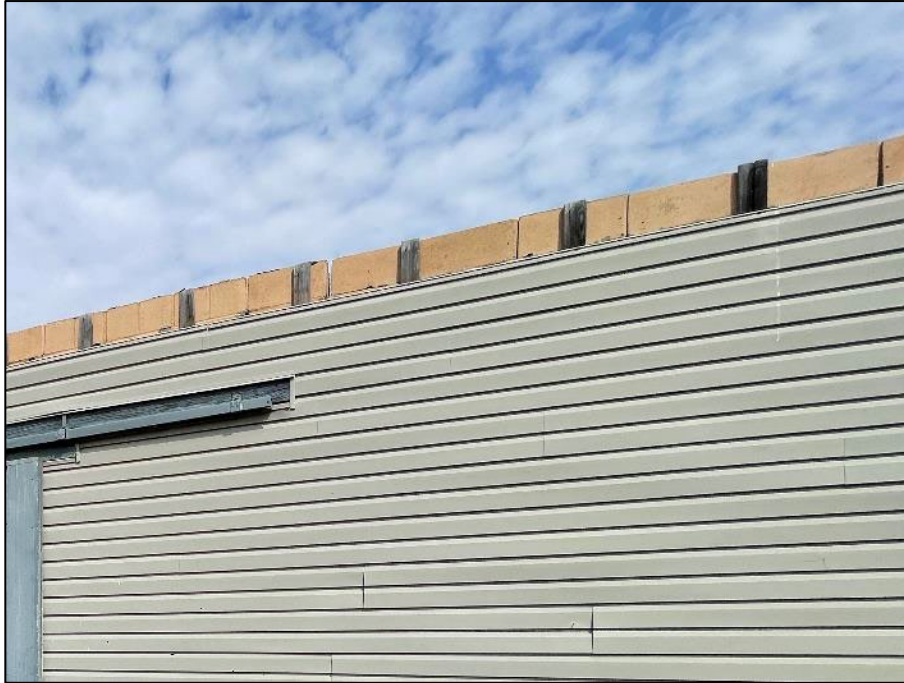
PHOTOGRAPH #27: Block Wall Used for Garage Construction – No Visible Vermiculite Identified
