## EXPRESSION OF INTEREST DRFM #2023-02-16

PROPOSAL: [Flood Mitigation– House Salvage]

DATE: [February 16, 2023]

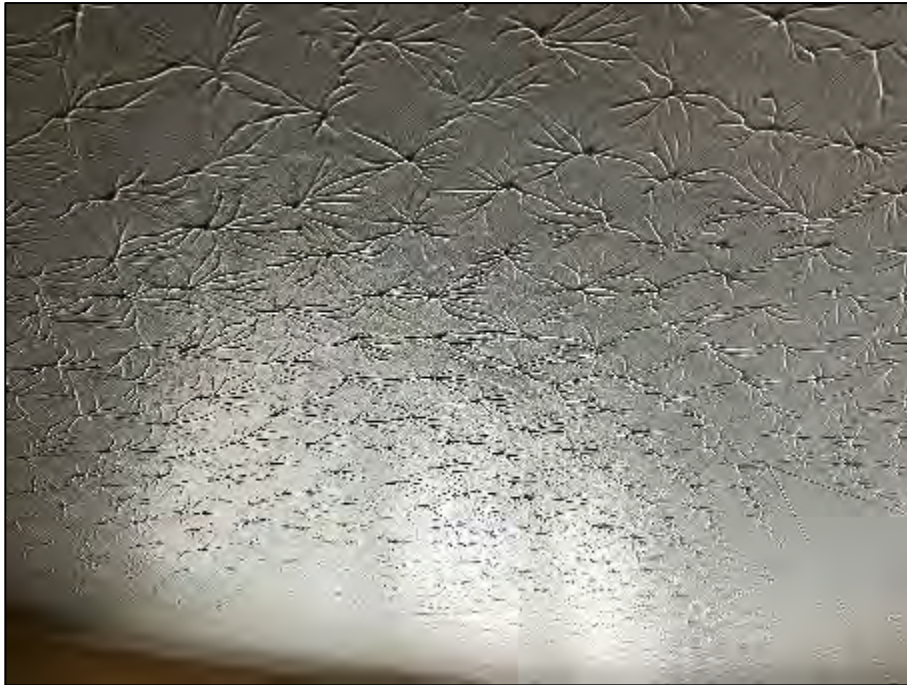
**PHOTOGRAPH #5:** Ceiling Texture - Level 1 Living Room Lace (None Detected)

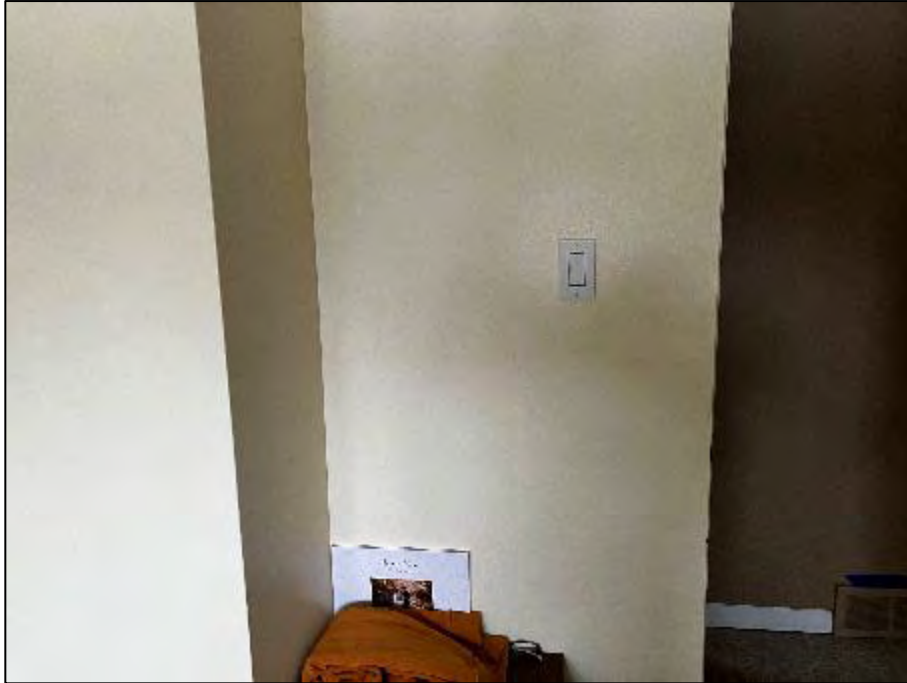
**PHOTOGRAPH #12:** Plaster - Level 1 Primary Bedroom Interior (None Detected)

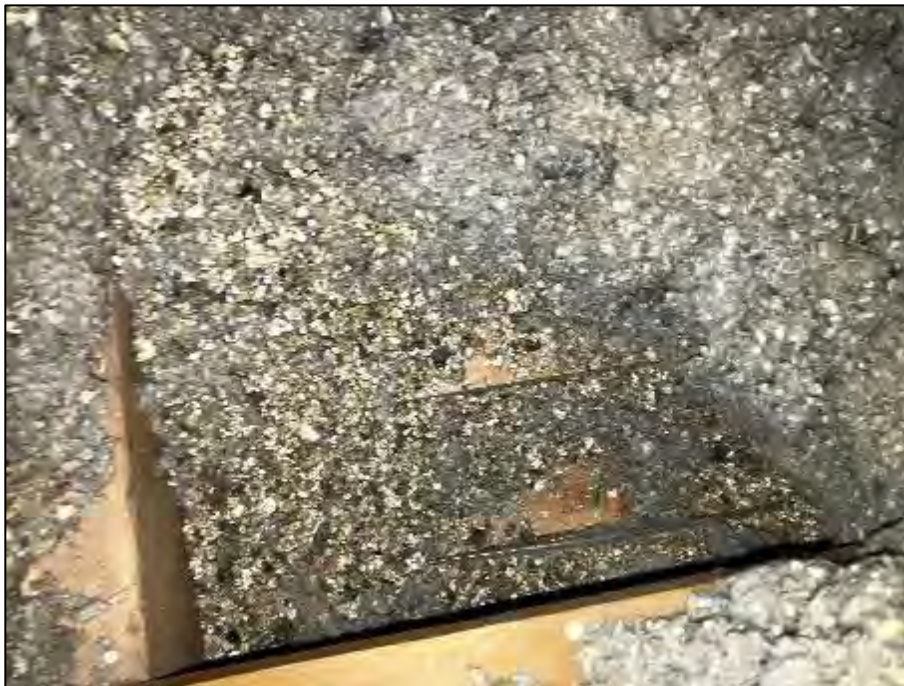
**PHOTOGRAPH #27:** Vermiculite - Attic (<1% Actinolite)

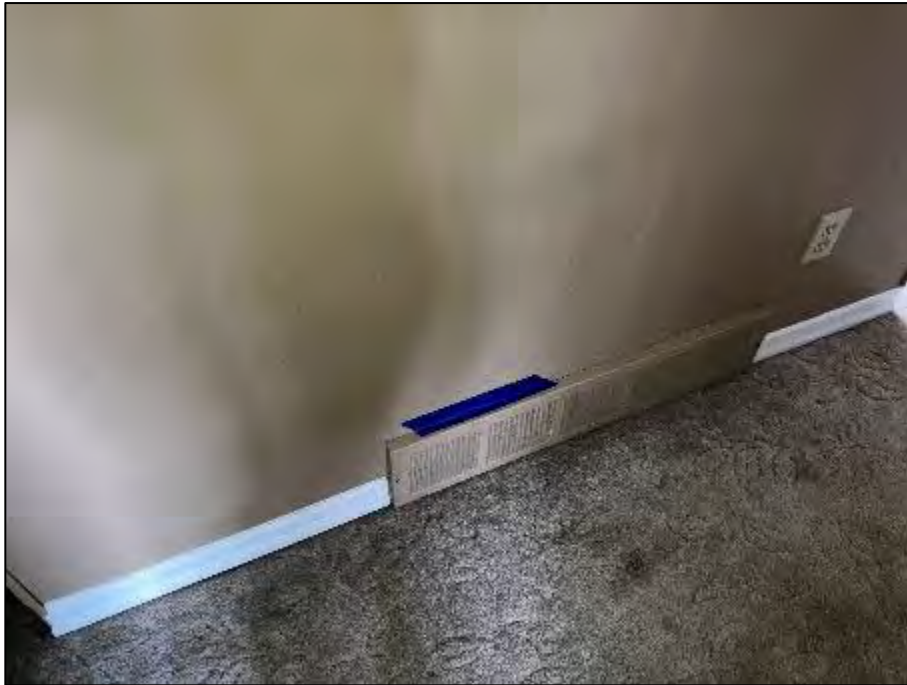
**PHOTOGRAPH #28:** Paint - Level 1 Hallway Brown (160 ppm Lead)

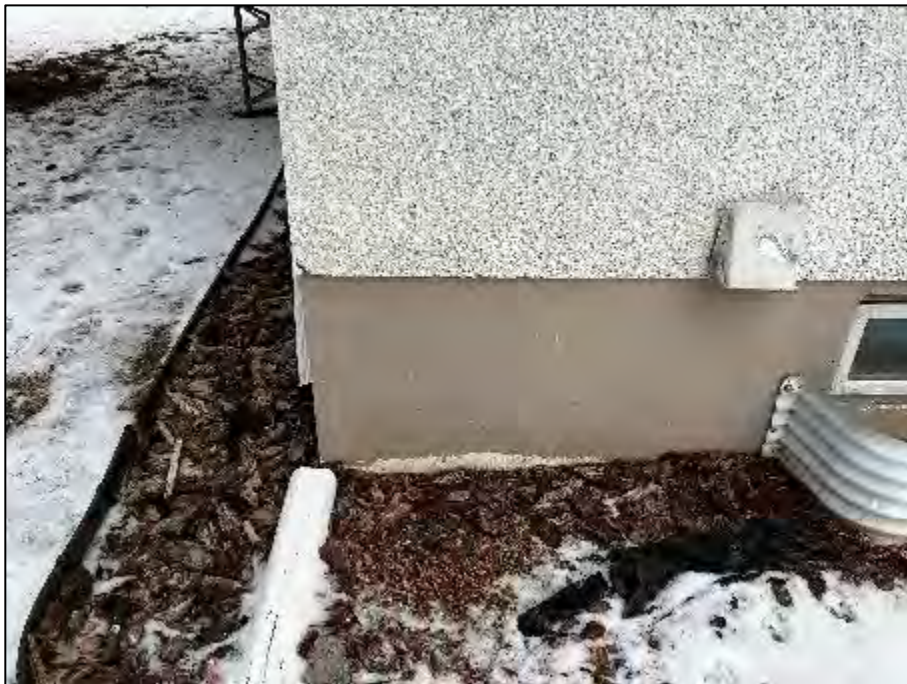
**PHOTOGRAPH #29:** Paint - Exterior House Brown (670 ppm Lead)

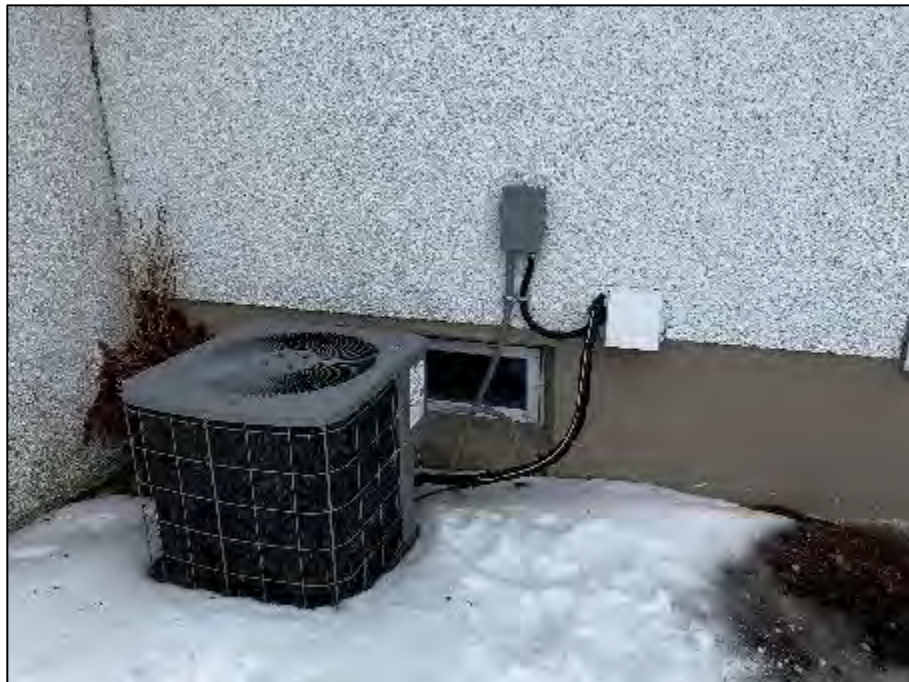
**PHOTOGRAPH #35:** Air Conditioning Unit on Property

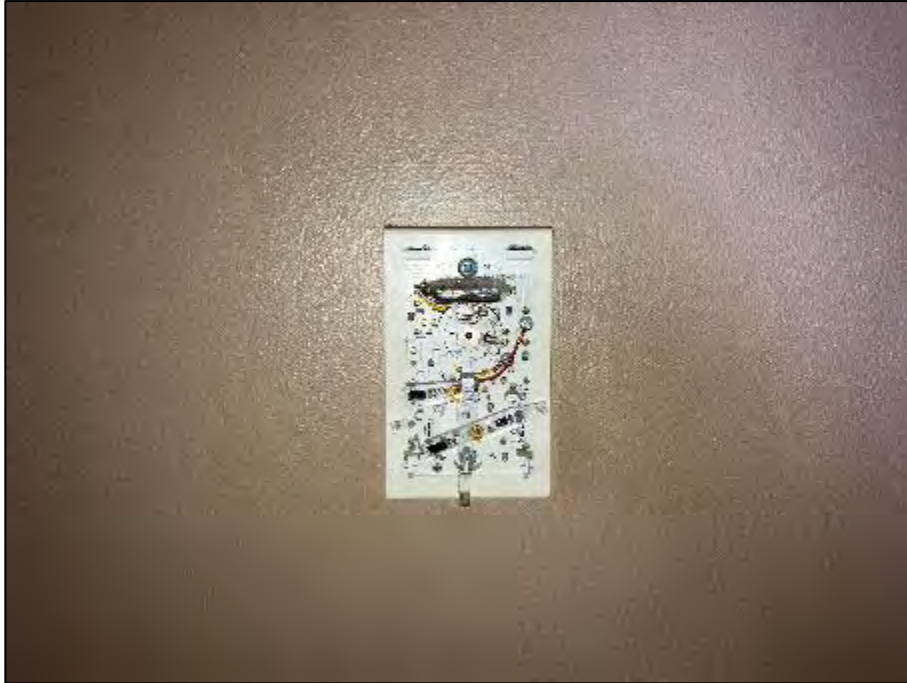
**PHOTOGRAPH #36:** Thermostat (Mercury)

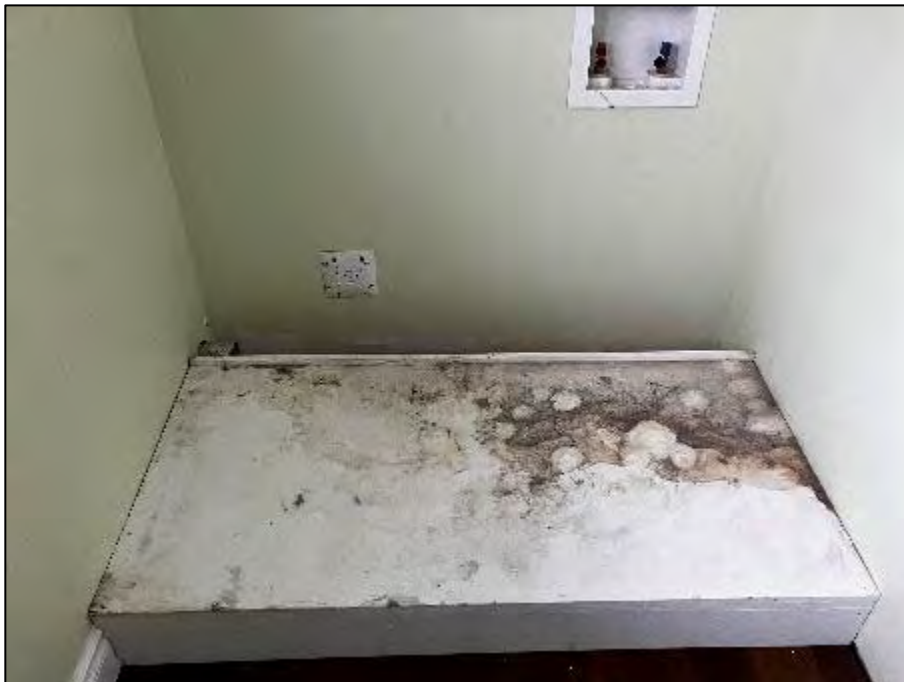
**PHOTOGRAPH #28:** Organic Growth Observed in Laundry Room

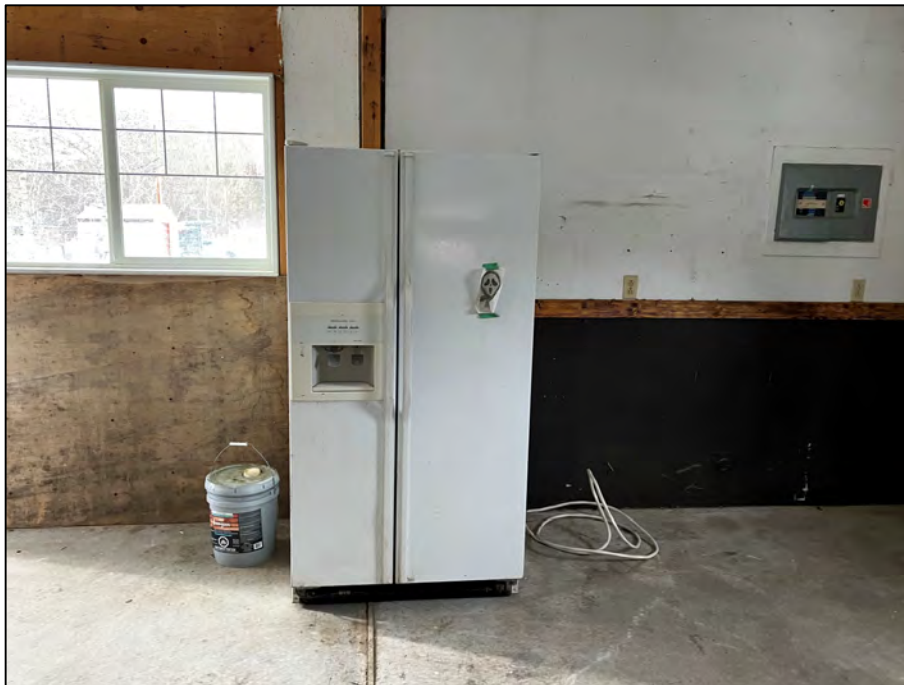
PHOTOGRAPH #11: Ozone Depleting Substances in Fridge

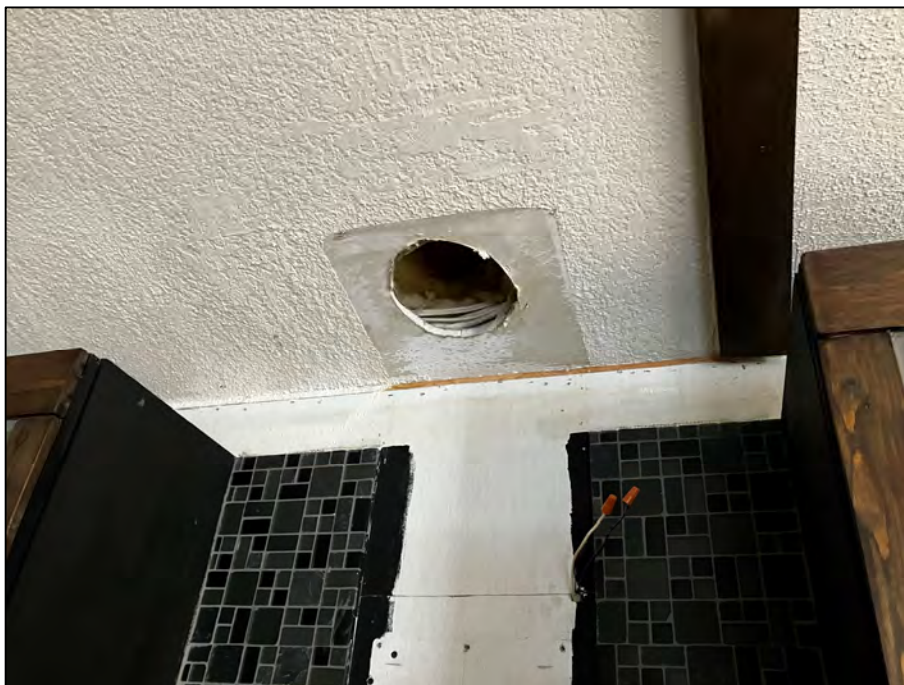
**PHOTOGRAPH #17:** Kitchen Ceiling Penetration into Attic Space

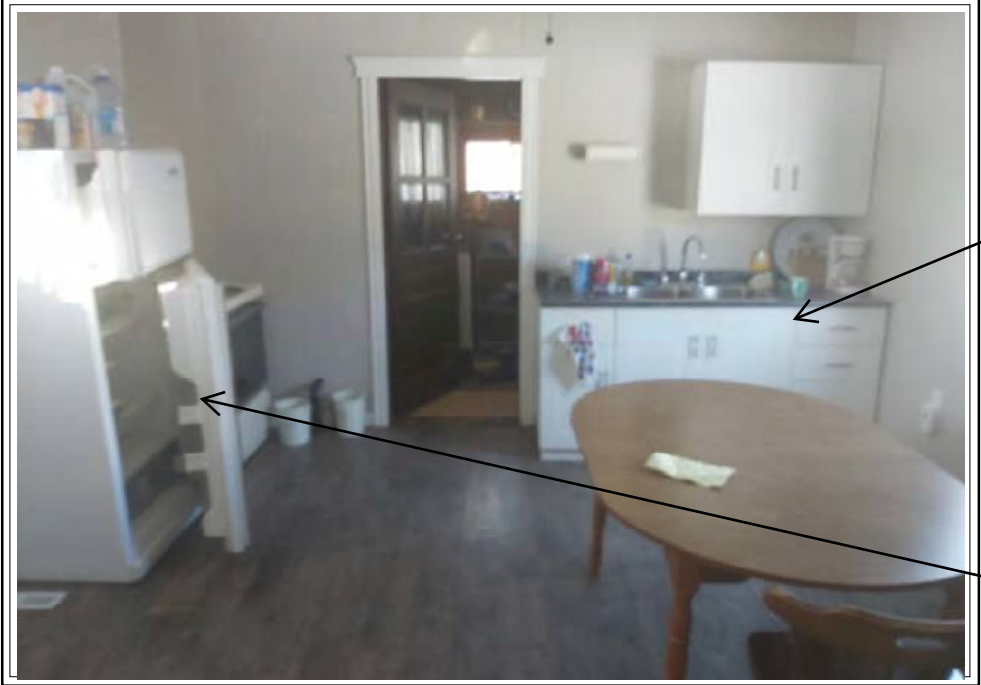
**Kitchen**

Counters not Included

Fridge not Included

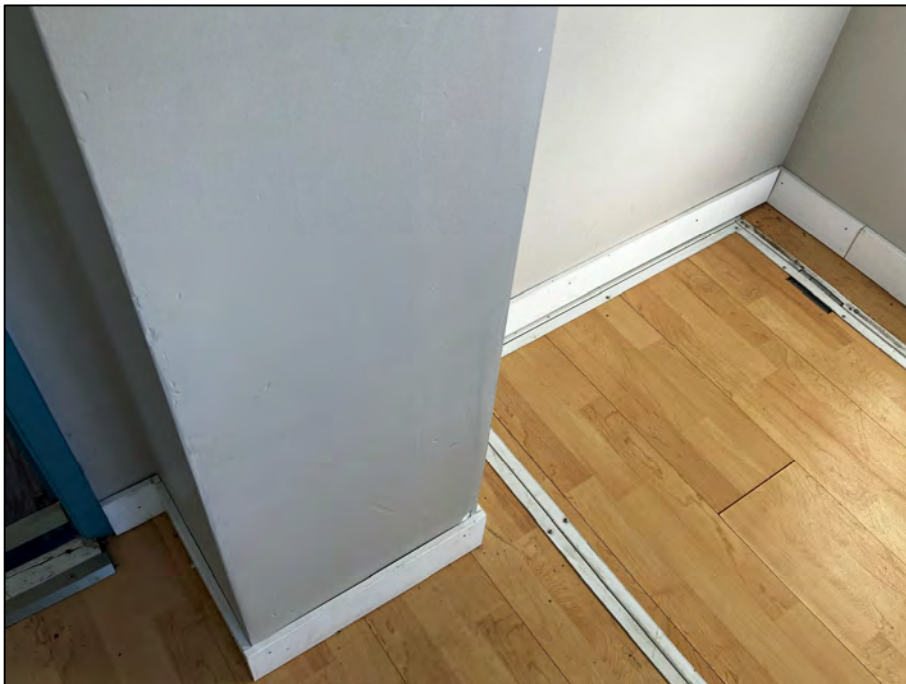
**PHOTOGRAPH #4:** Drywall Joint Compound - Level 1 Storage Room Interior (Assume Positive)

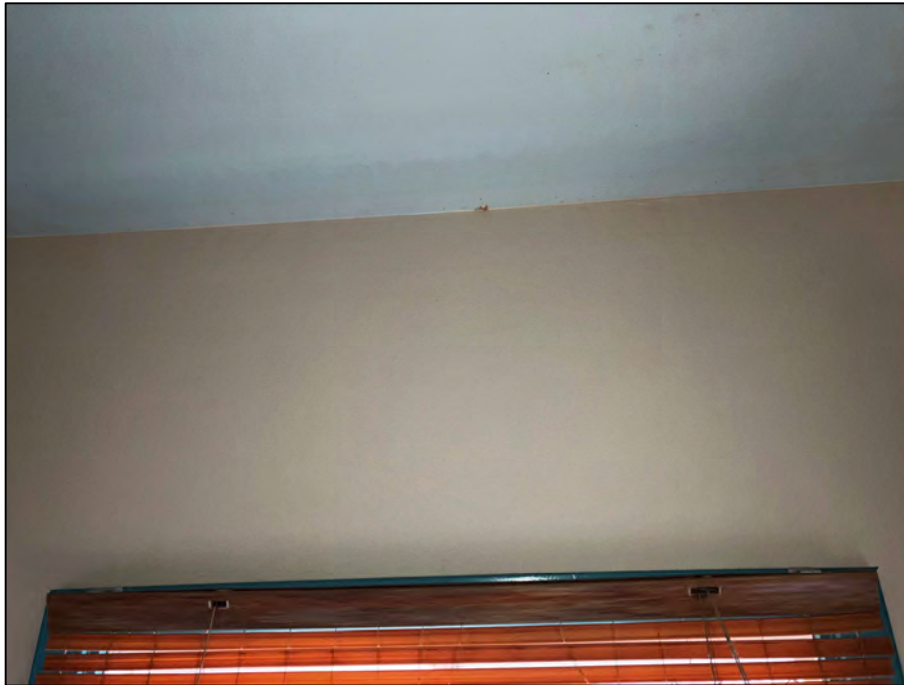
**PHOTOGRAPH #7:** Drywall Joint Compound - Level 1 Bathroom Ceiling (2% Chrysotile)

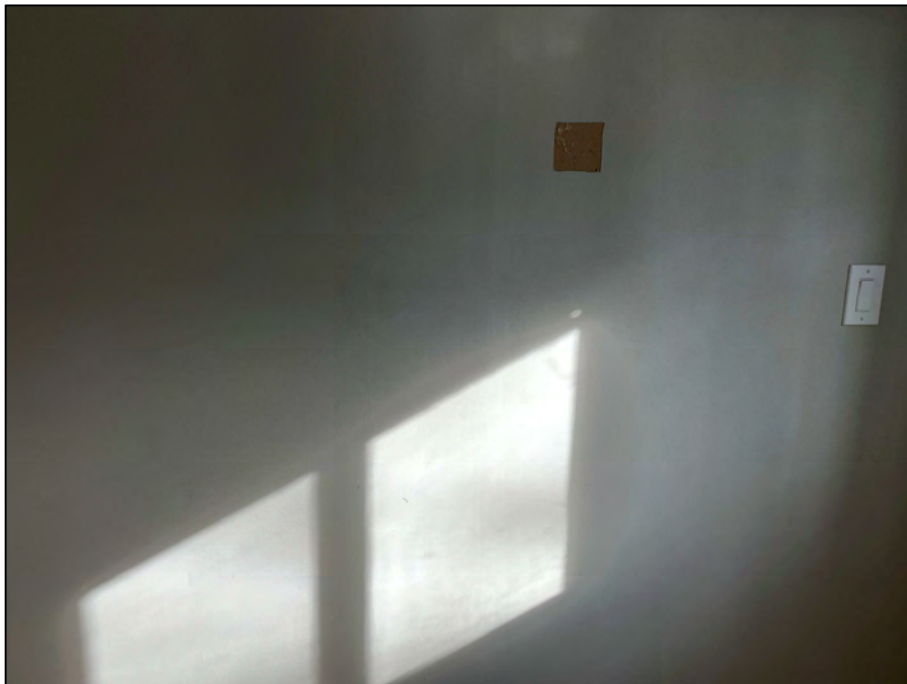
**PHOTOGRAPH #18:** Paint - Storage Room Beige (570 ppm Lead)

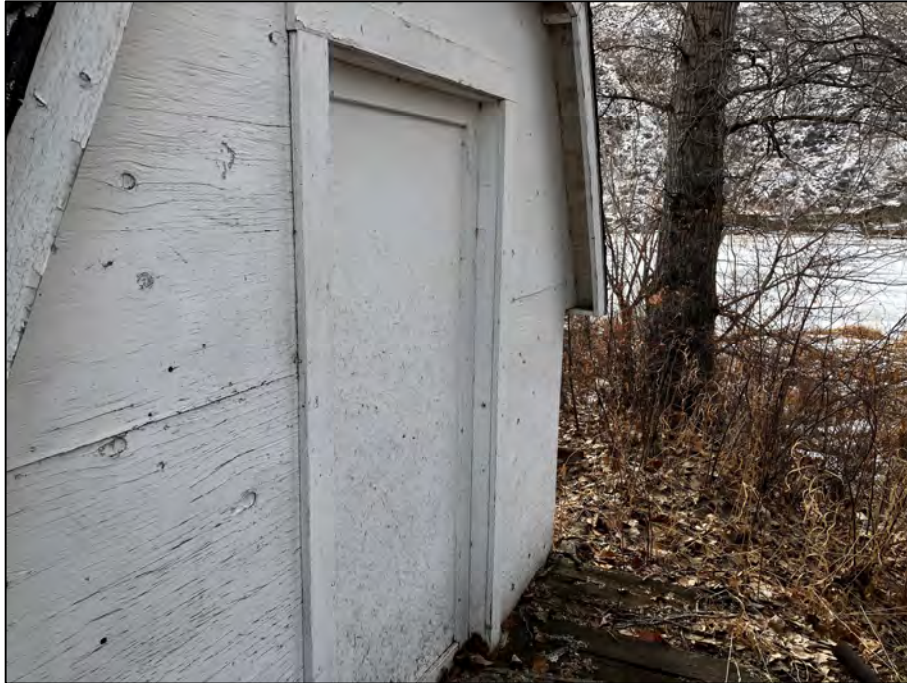
**PHOTOGRAPH #21:** Paint - Shed White (3400 ppm Lead)

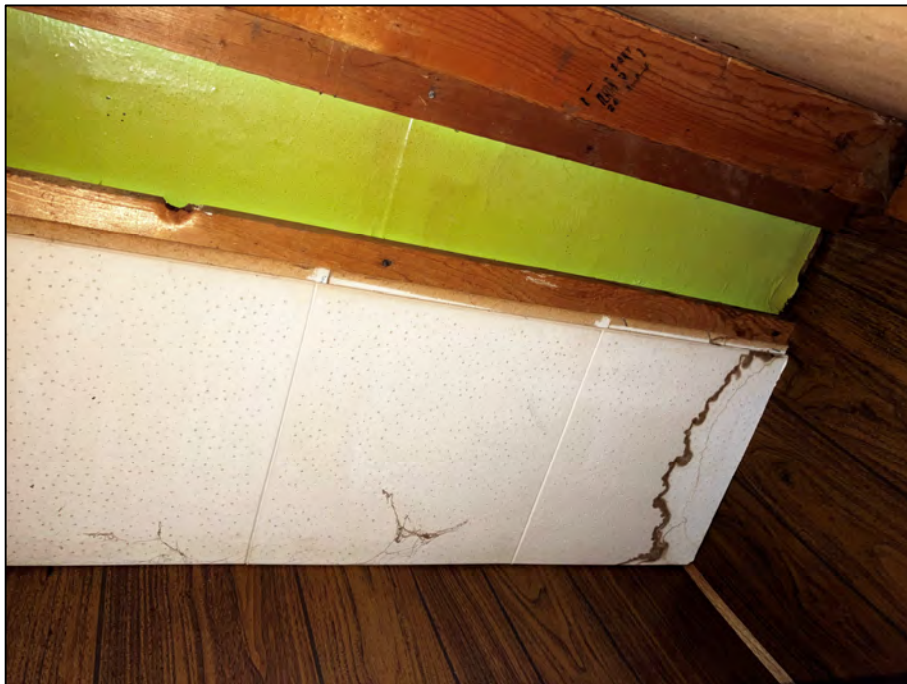
**PHOTOGRAPH #22:** Paint - Foyer Green (980 ppm Lead )

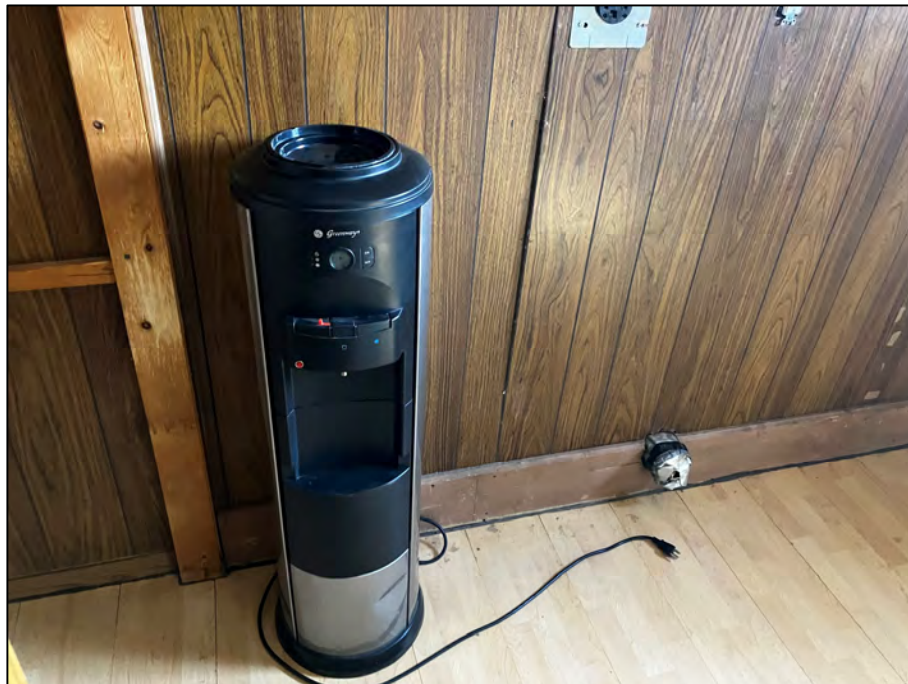
PHOTOGRAPH #27: Water Cooler with Ozone Deleting Substances

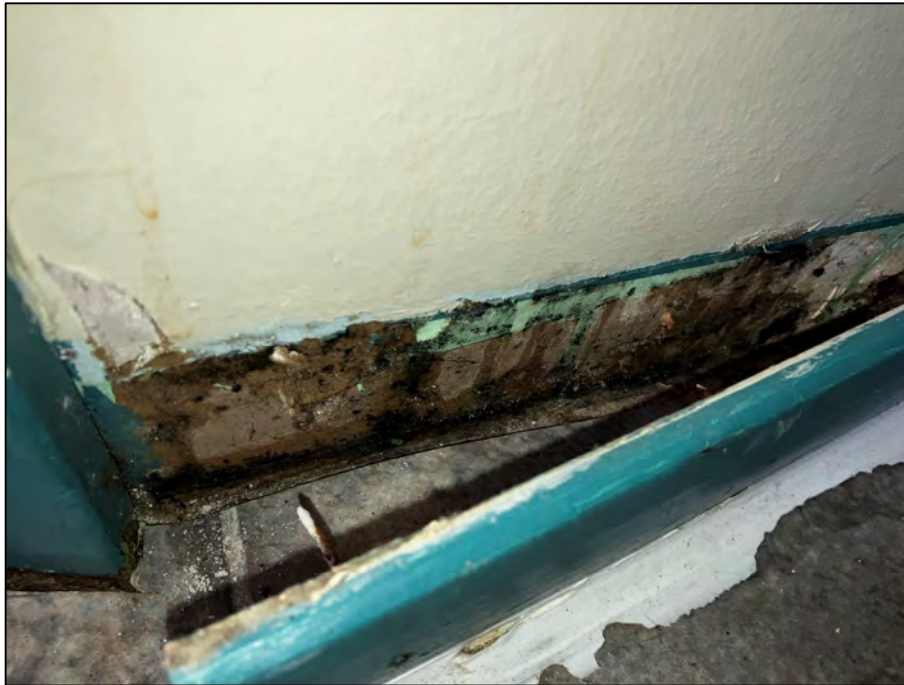
**PHOTOGRAPH #28:** Organic Growth Behind Bathroom Baseboard

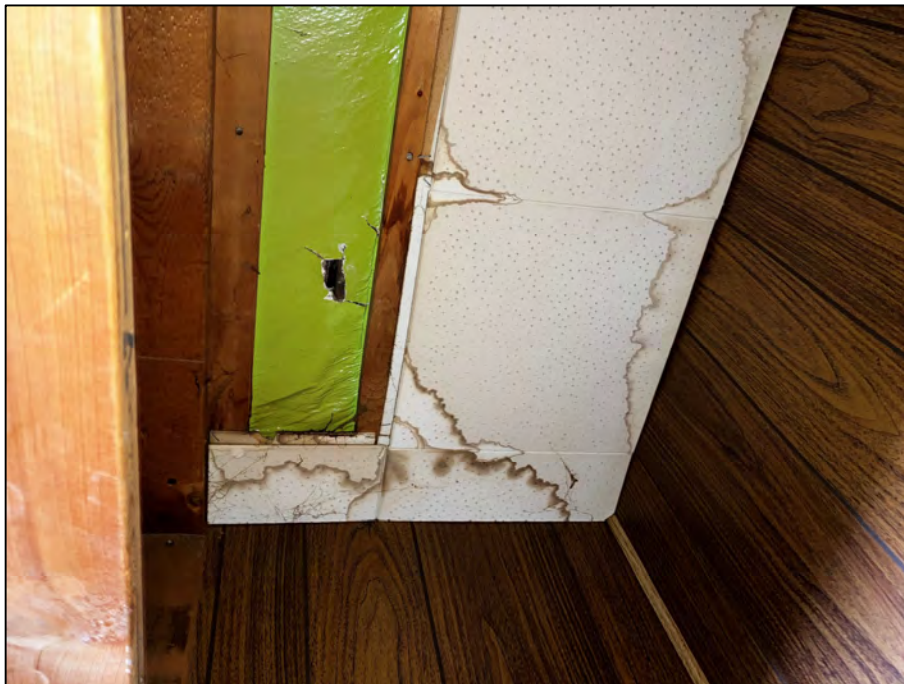
**PHOTOGRAPH #29:** Water Damaged Ceiling Tile in Foyer

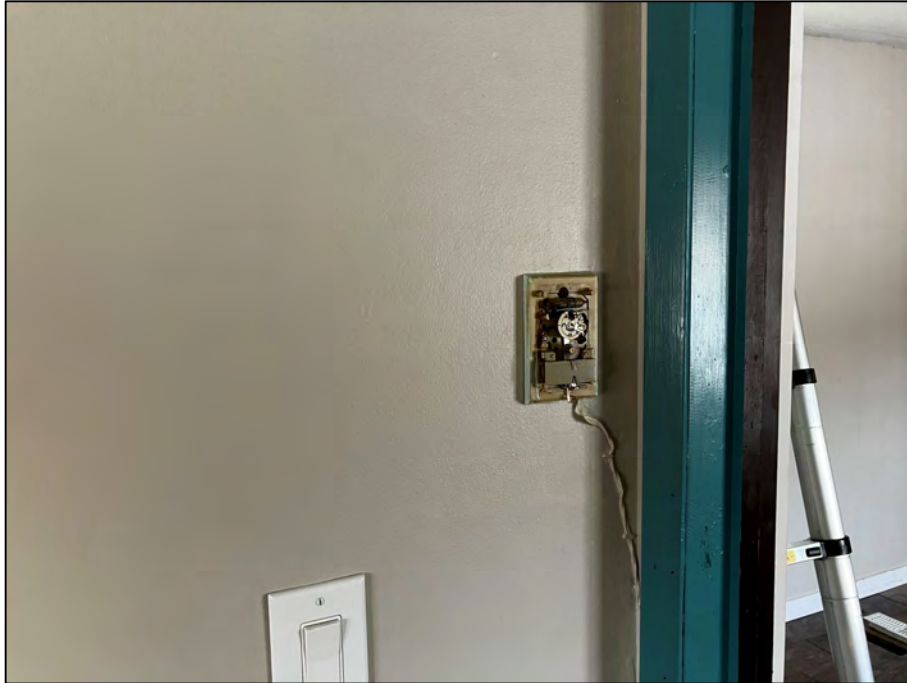
**PHOTOGRAPH #30:** Mercury Thermostat
