RE: **Hazardous Material Assessment Report**
330 2nd Ave W Lehigh, AB
Project #: E3030-E

EXECUTIVE SUMMARY:

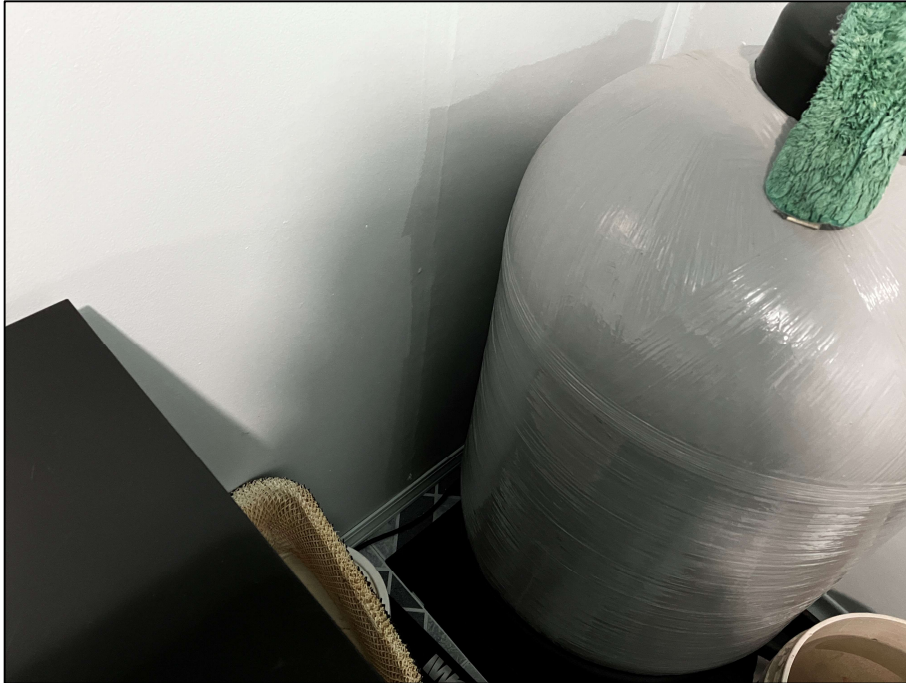
PHOTOGRAPH #1: Drywall Joint Compound - Level 1 Mud Room Interior (None Detected)

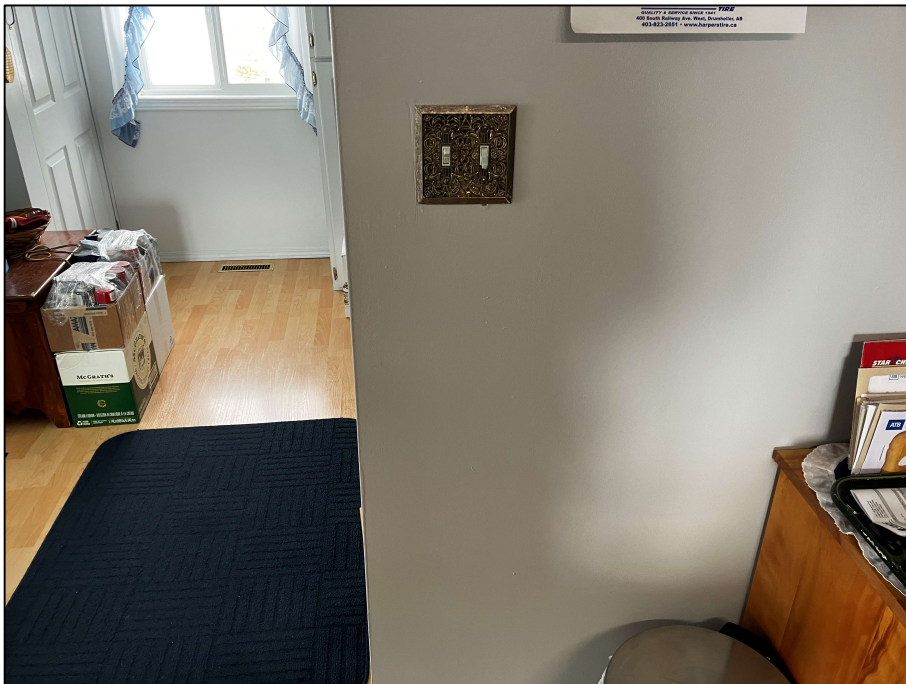
PHOTOGRAPH #2: Drywall Joint Compound - Level 1 Kitchen Interior (None Detected)

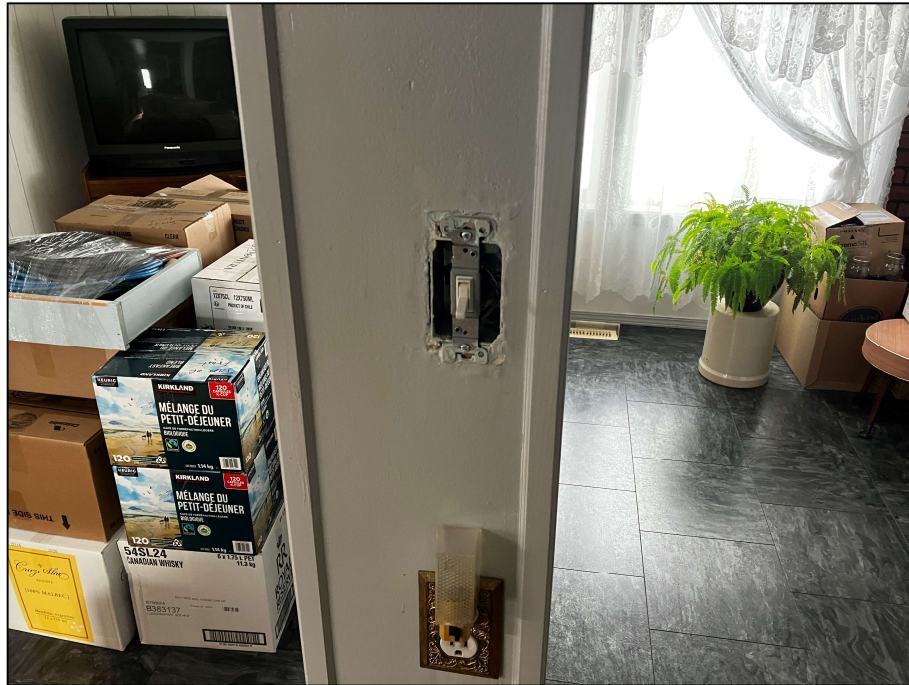
PHOTOGRAPH #3: Drywall Joint Compound - Level 1 Kitchen Pillar Interior (None Detected)

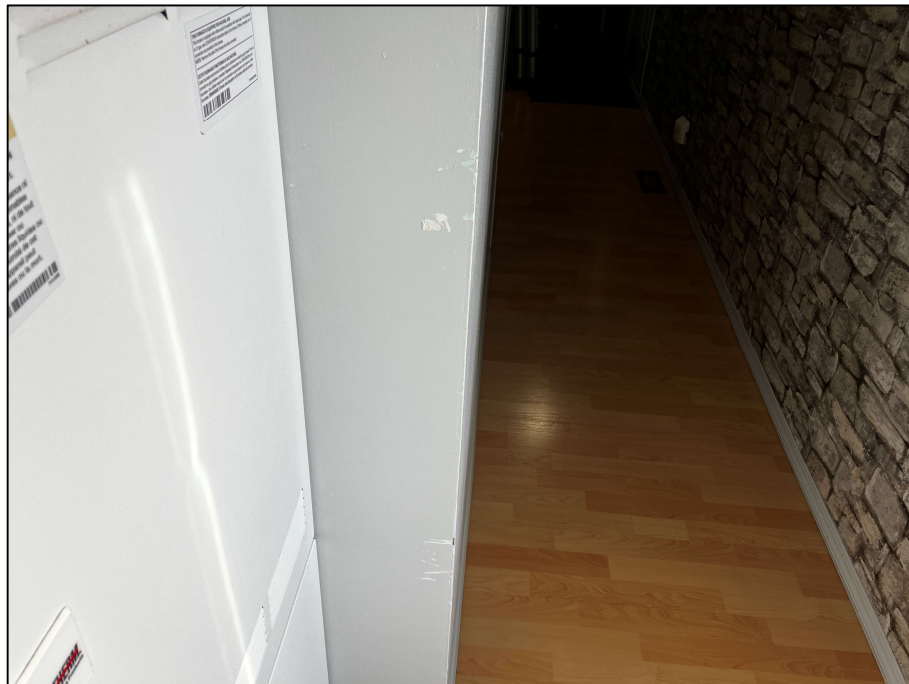
PHOTOGRAPH #4: Drywall Joint Compound - Level 1 Hallway Interior (None Detected)

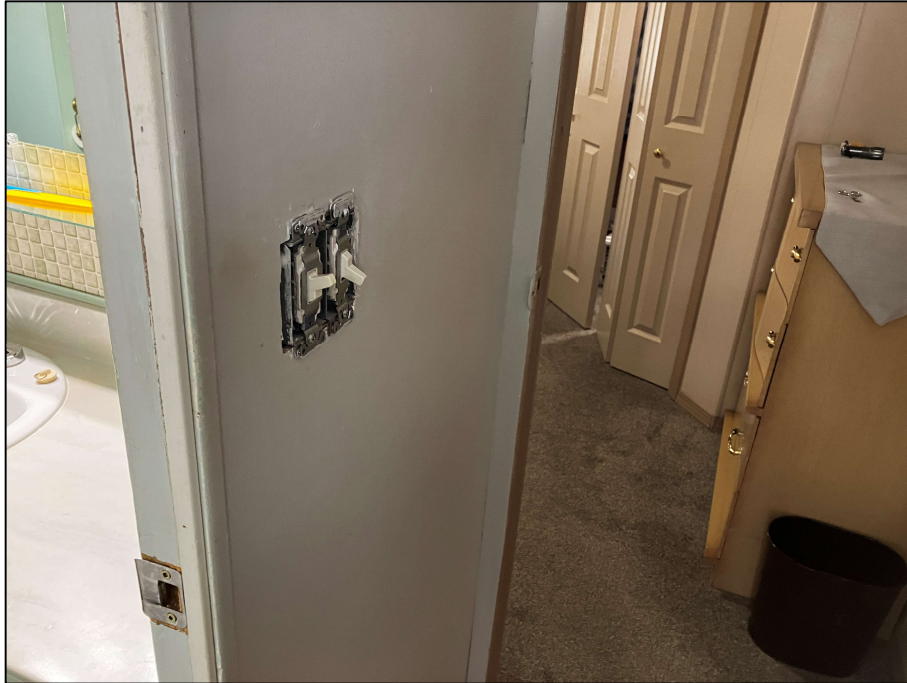
PHOTOGRAPH #5: Drywall Joint Compound - Level 1 Bathroom Hallway Interior (None Detected)

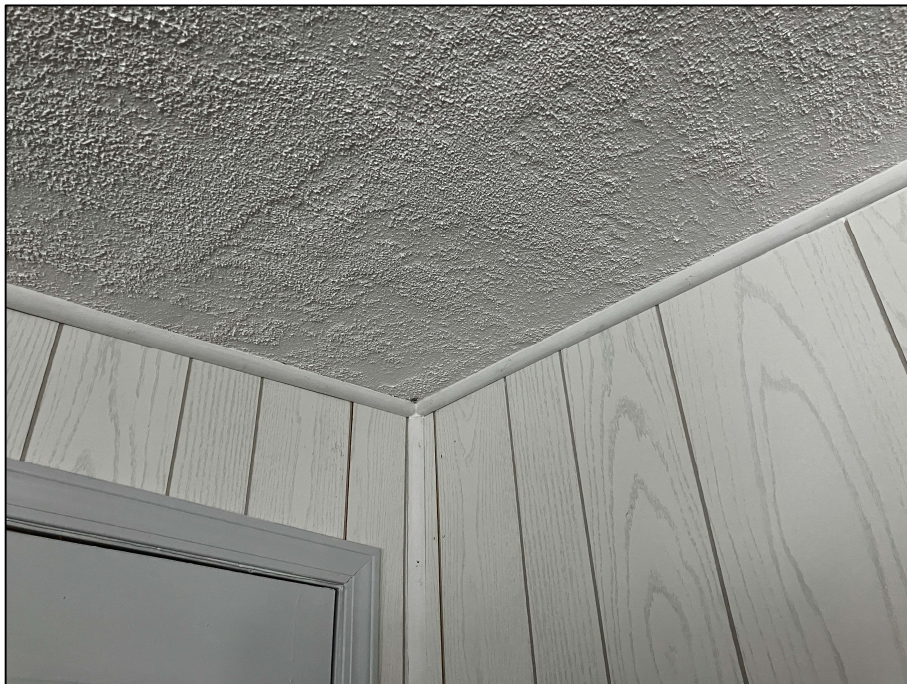
PHOTOGRAPH #6: Drywall Joint Compound - Level 1 Living Room Ceiling (None Detected)

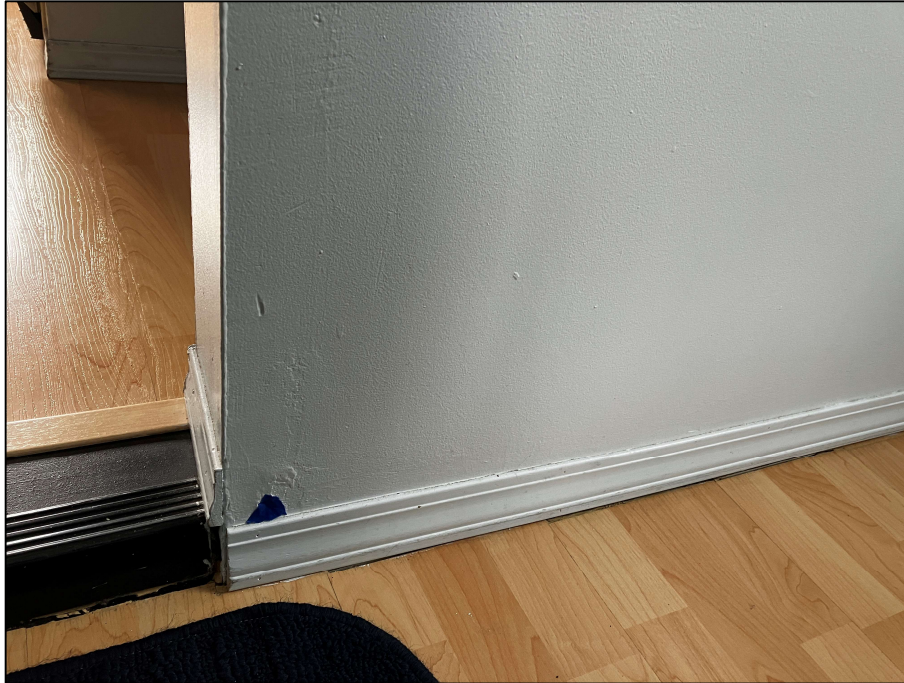
PHOTOGRAPH #7: Drywall Joint Compound - Level 1 Back Door Interior (None Detected)

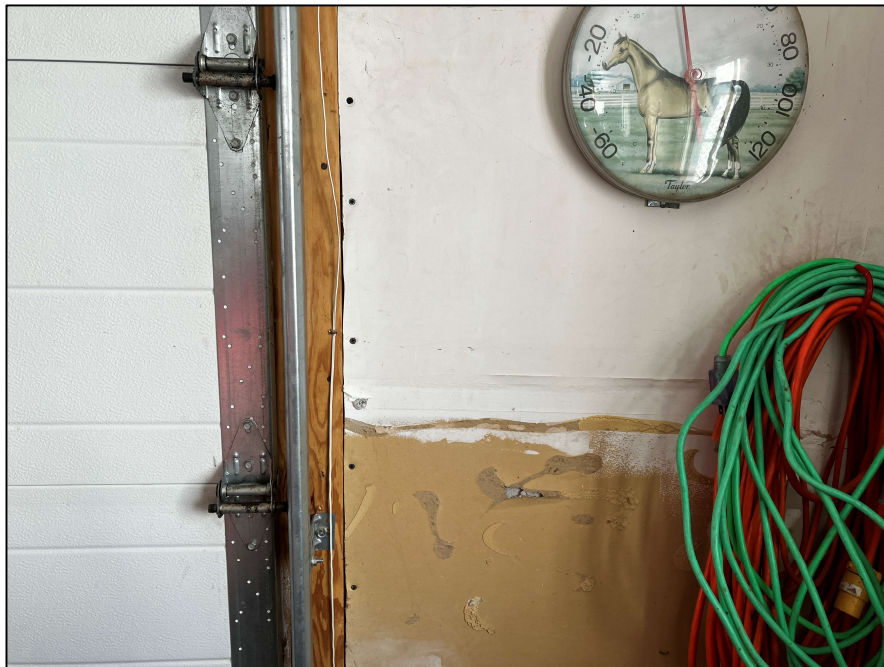
PHOTOGRAPH #8: Drywall Joint Compound - Level 1 Garage Exterior (None Detected)

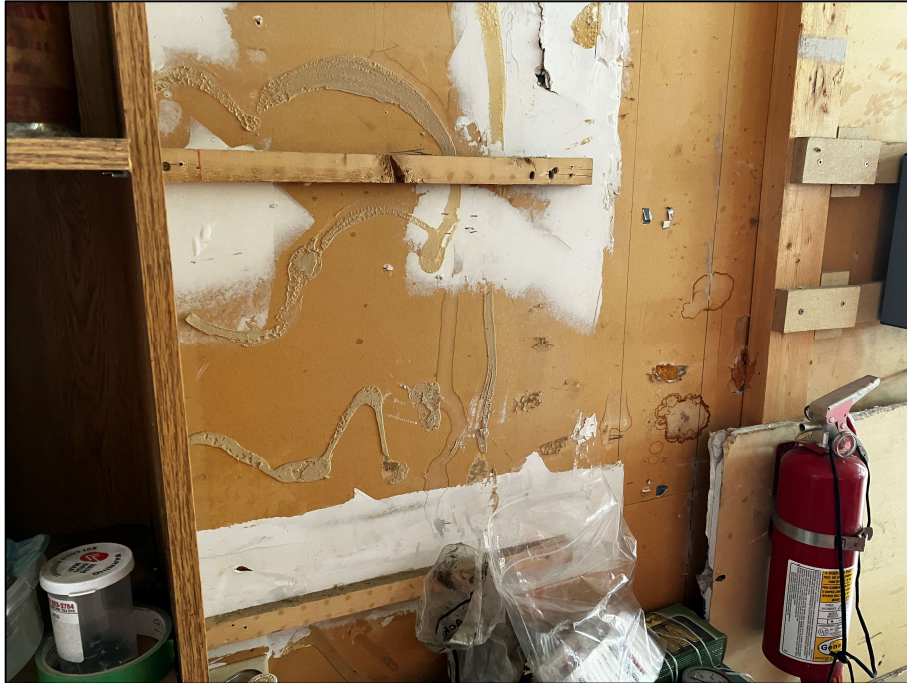
PHOTOGRAPH #9: Drywall Joint Compound - Level 1 Garage Interior (None Detected)

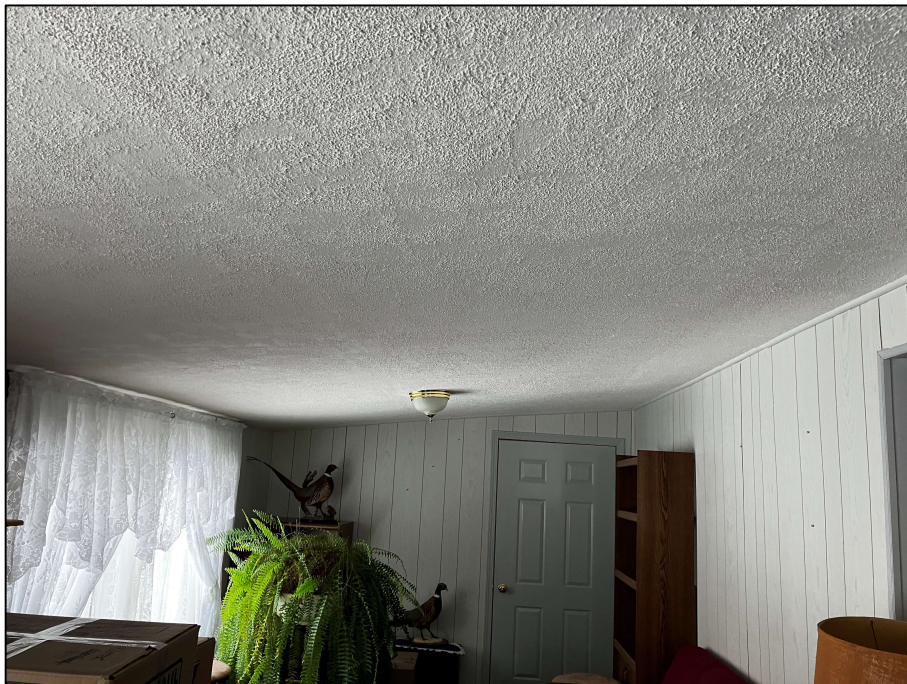
PHOTOGRAPH #10: Ceiling Texture - Level 1 Living Room (None Detected)

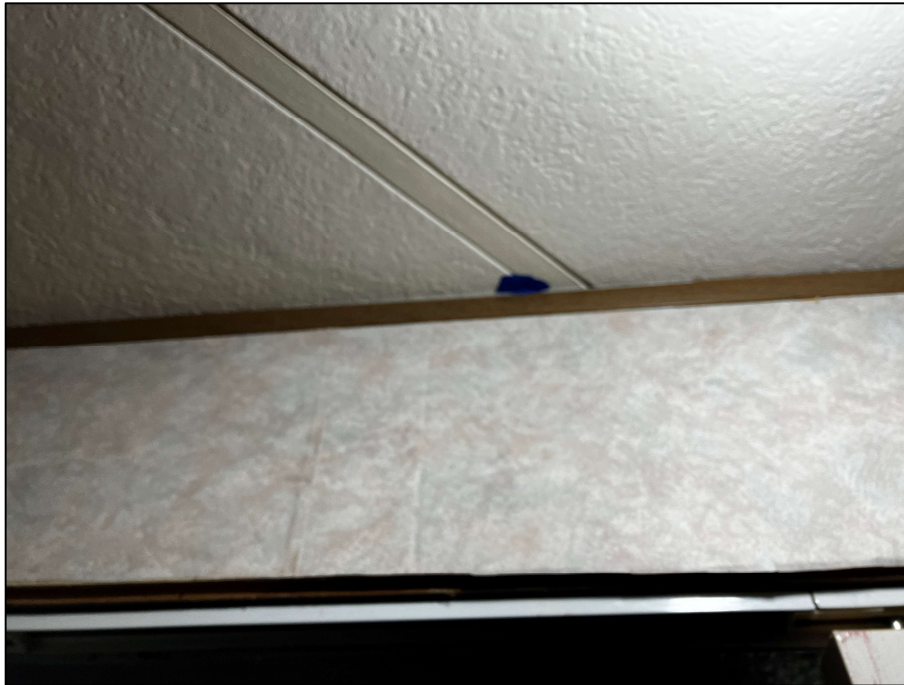
PHOTOGRAPH #11: Ceiling Tile - Level 1 Primary Bedroom Closet (None Detected)

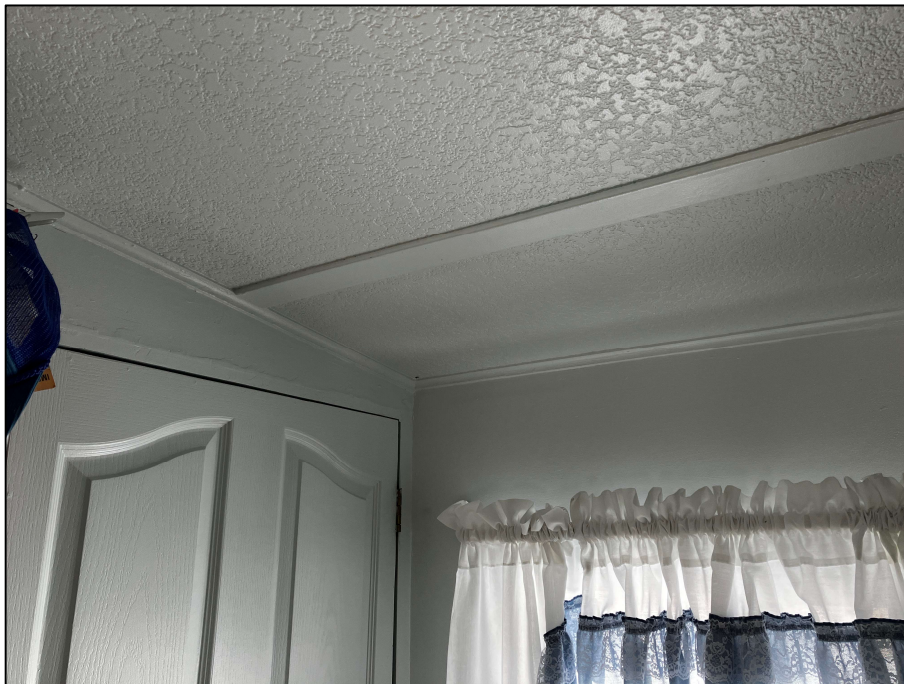
PHOTOGRAPH #12: Ceiling Tile - Level 1 Back Door (None Detected)

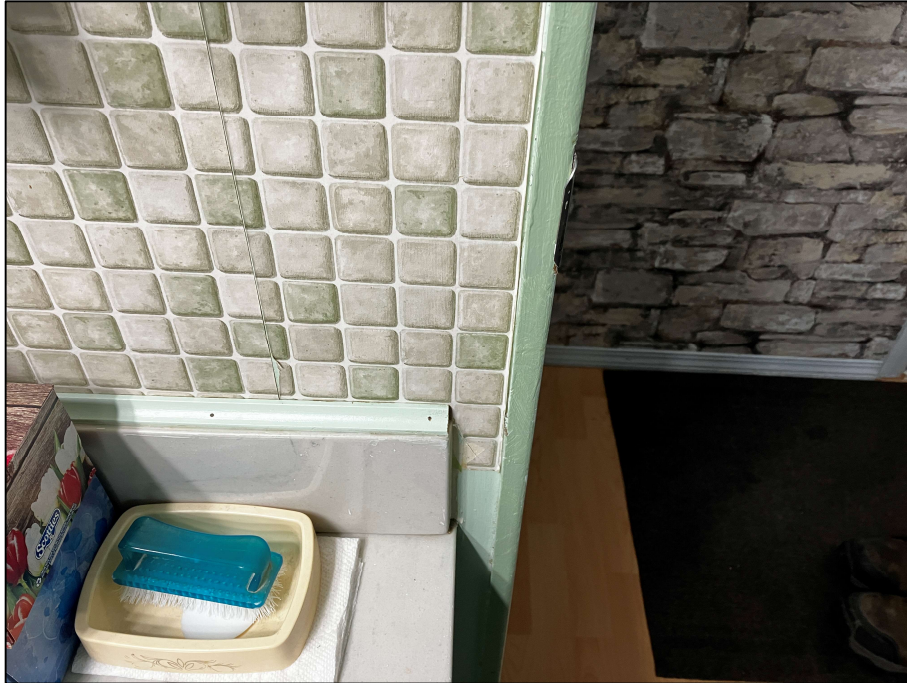
PHOTOGRAPH #13: Wallpaper - Level 1 Bathroom (None Detected)

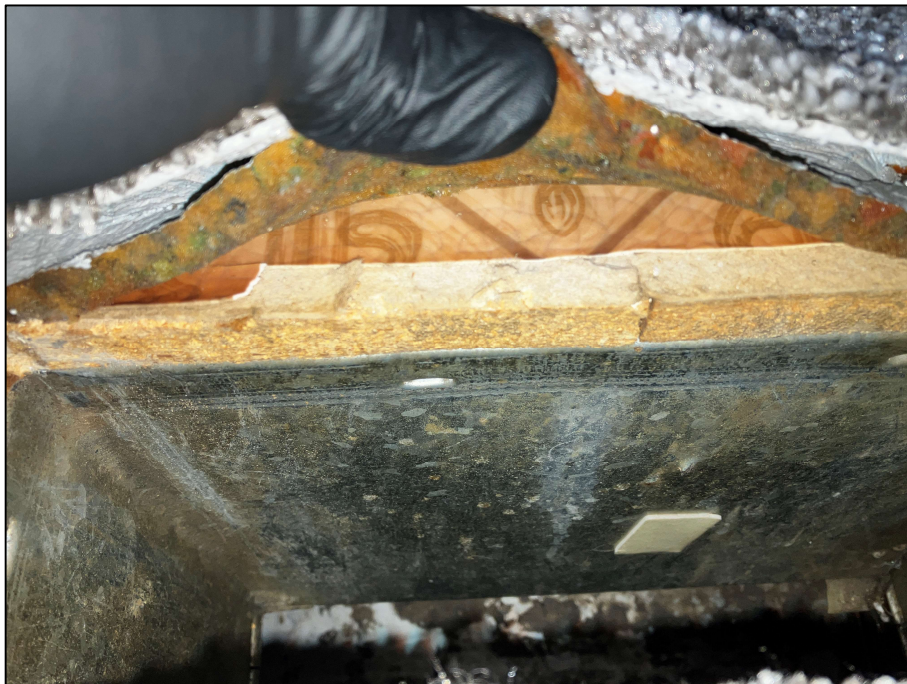
PHOTOGRAPH #14: Sheet Flooring - Level 1 Primary Bedroom (None Detected)

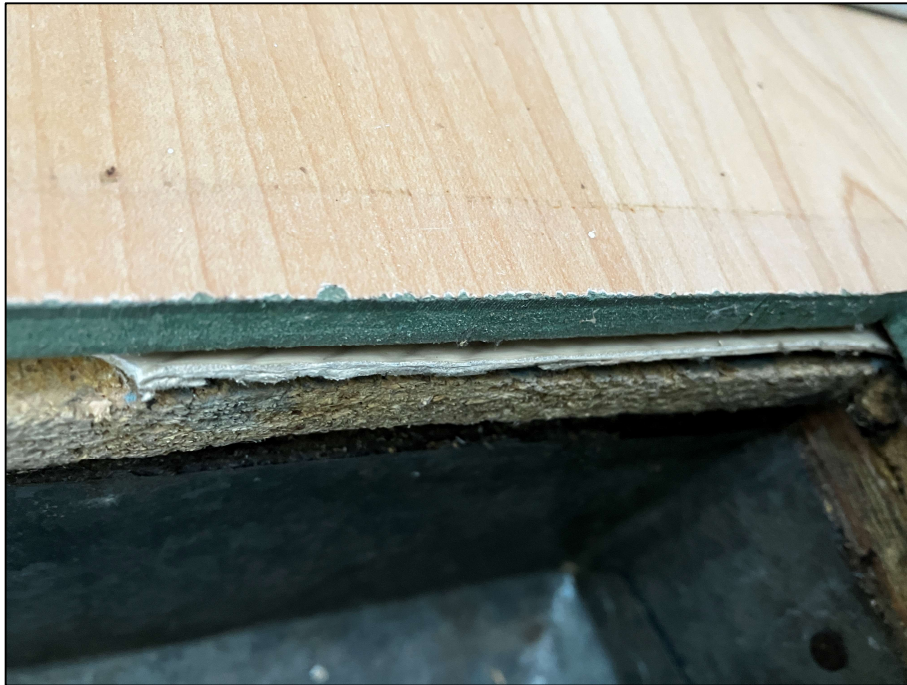
PHOTOGRAPH #15: Sheet Flooring - Level 1 Storage Room (None Detected)

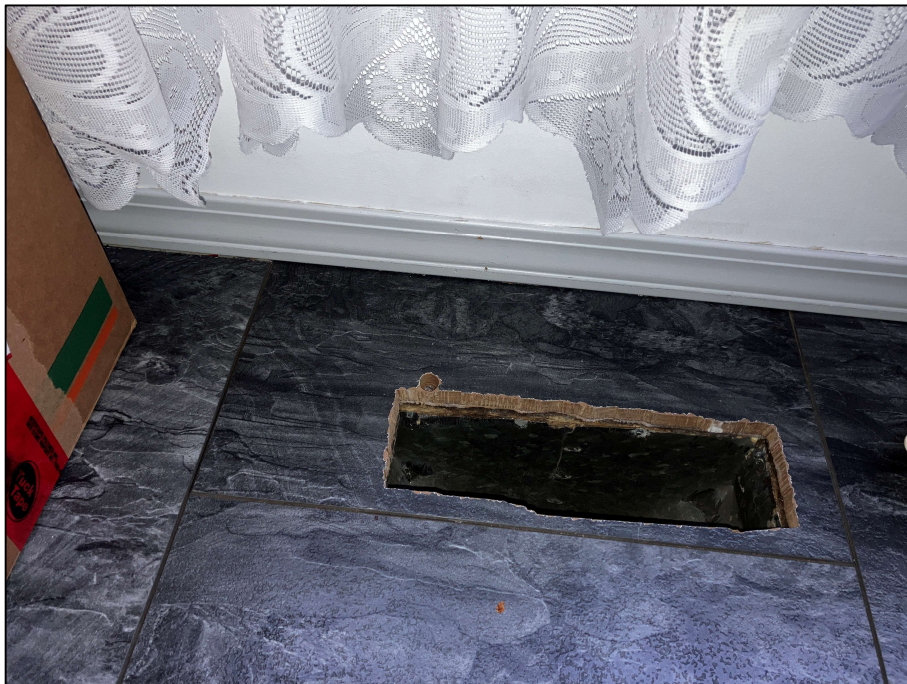
PHOTOGRAPH #16: Sheet Flooring - Level 1 Living Room (None Detected)

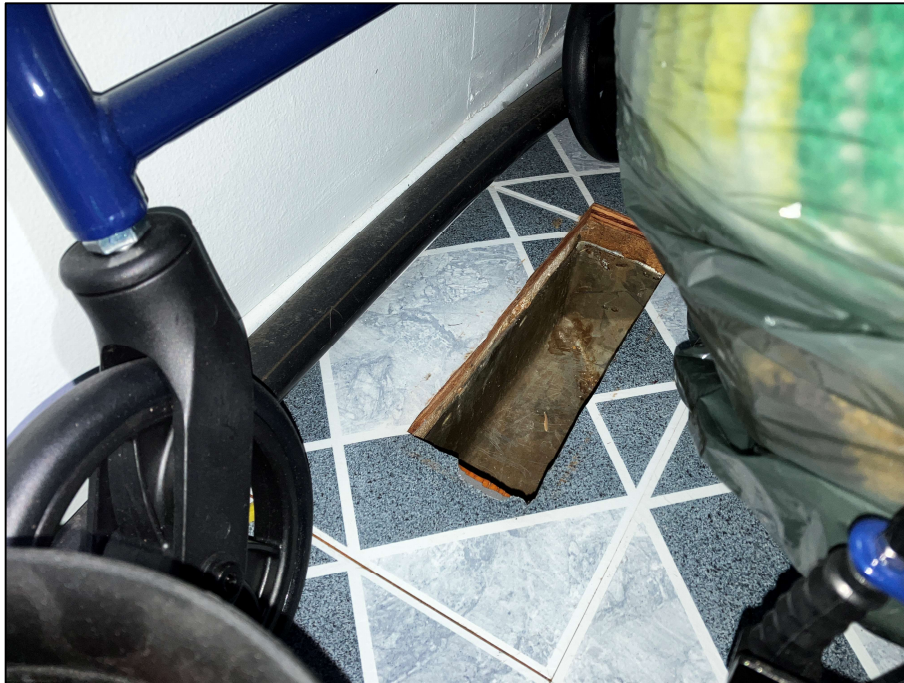
PHOTOGRAPH #17: Flooring - Level 1 Mud Room (None Detected)

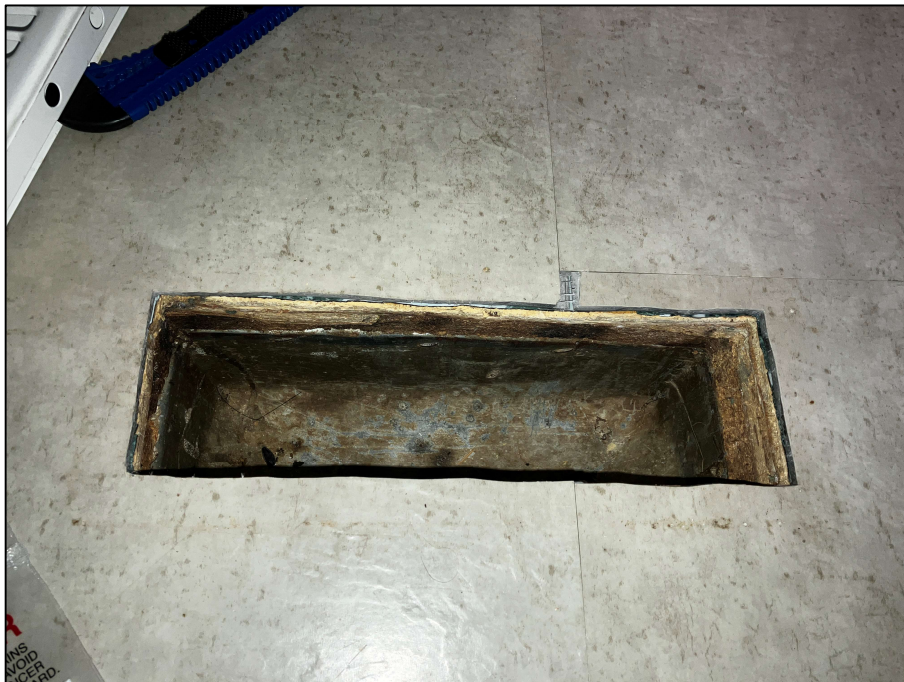
PHOTOGRAPH #18: Flooring - Level 1 Bathroom Layer 1 (None Detected)

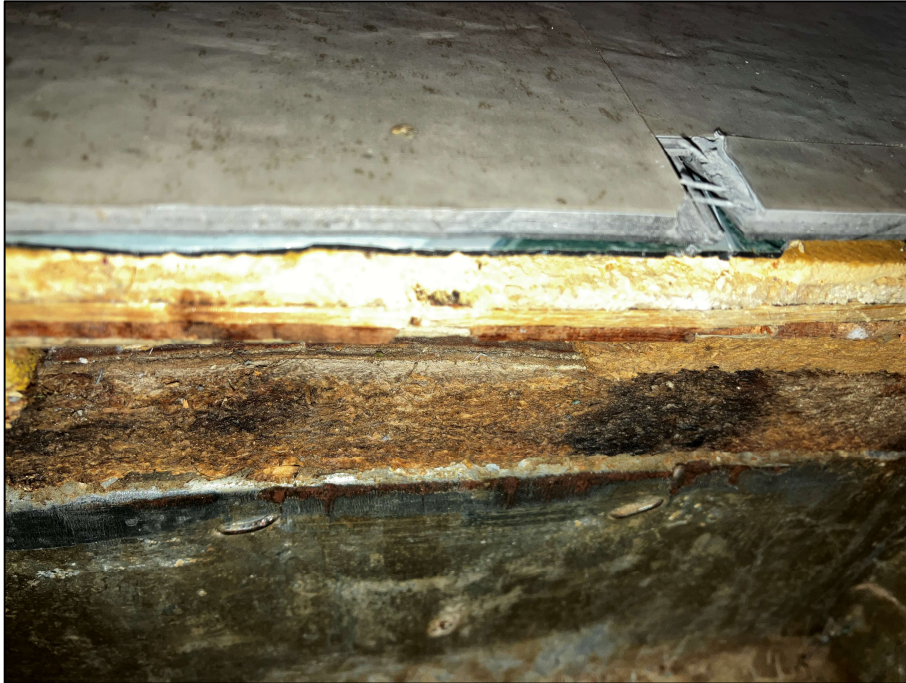
PHOTOGRAPH #19: Flooring - Level 1 Bathroom Layer 2 (None Detected)

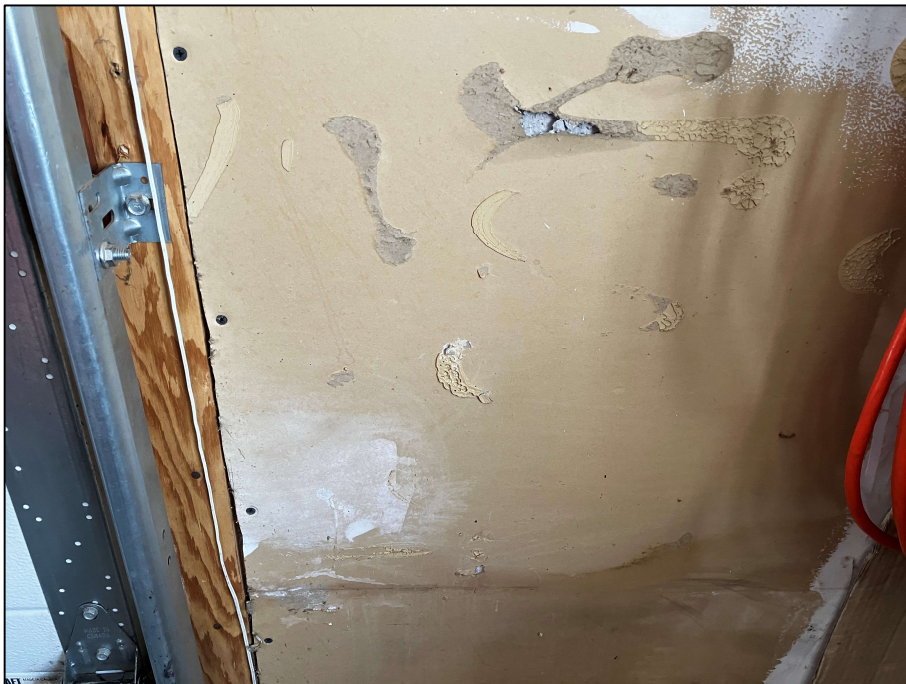
PHOTOGRAPH #20: Mastic - Level 1 Garage (None Detected)

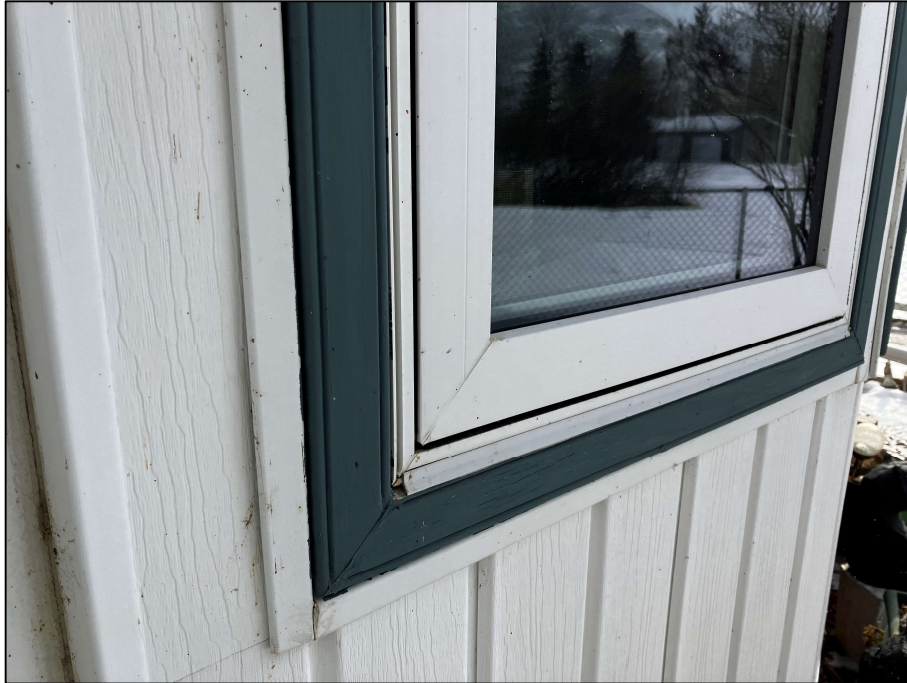
PHOTOGRAPH #21: Caulking - Exterior of Home (None Detected)

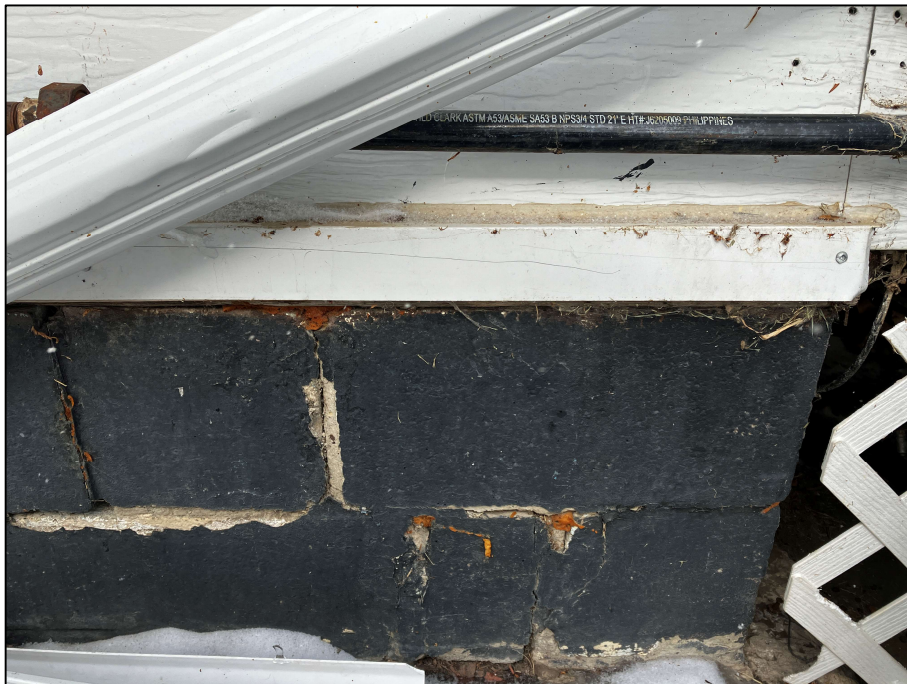
PHOTOGRAPH #22: Parging - Exterior of Home (None Detected)

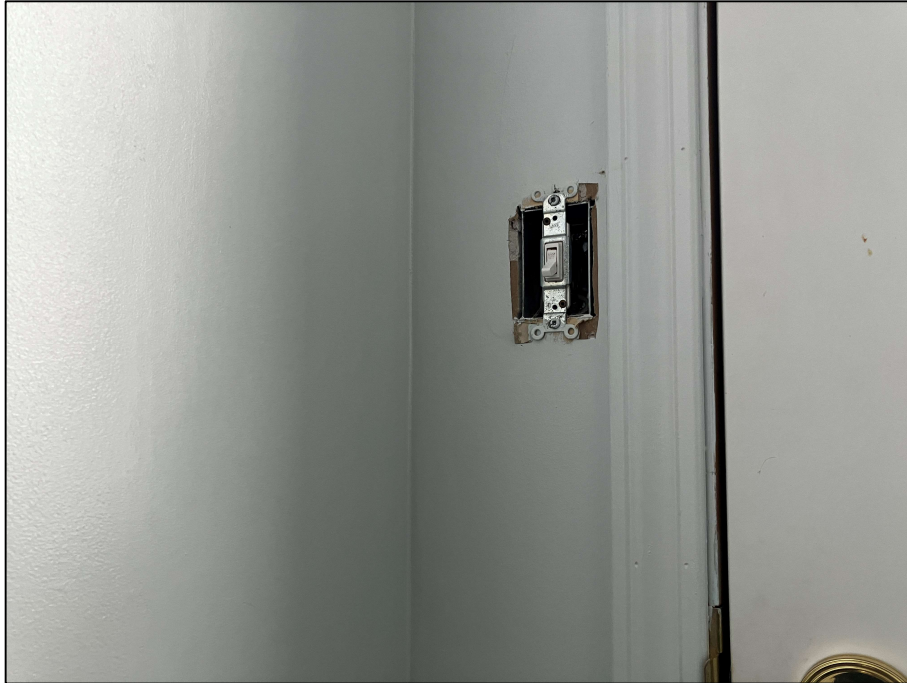
PHOTOGRAPH #23: Paint - Back Door Blue (<80 ppm Lead)

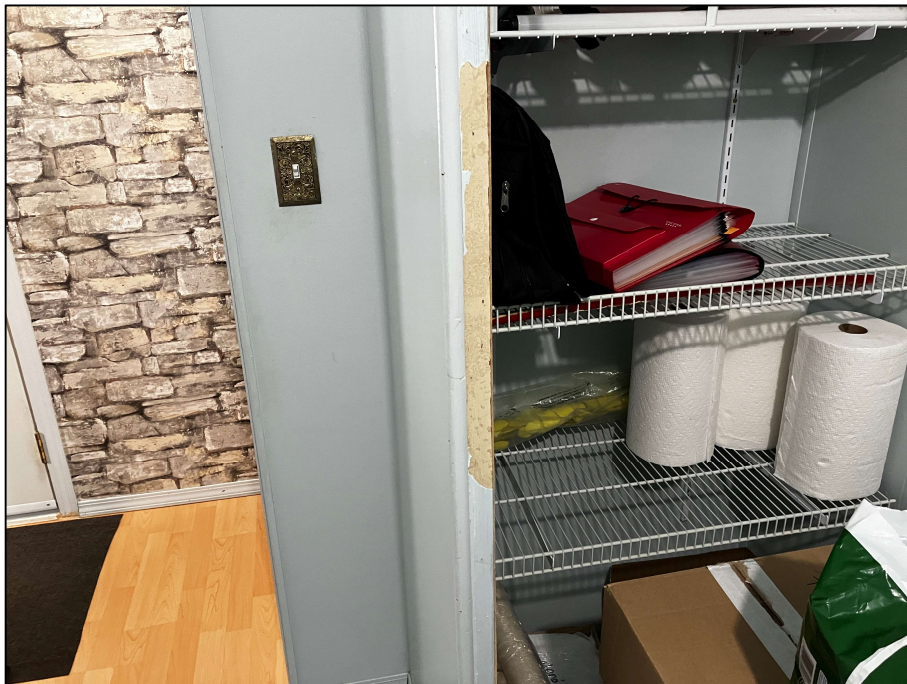
PHOTOGRAPH #24: Paint - Mud Room Light Blue (<80 ppm Lead)

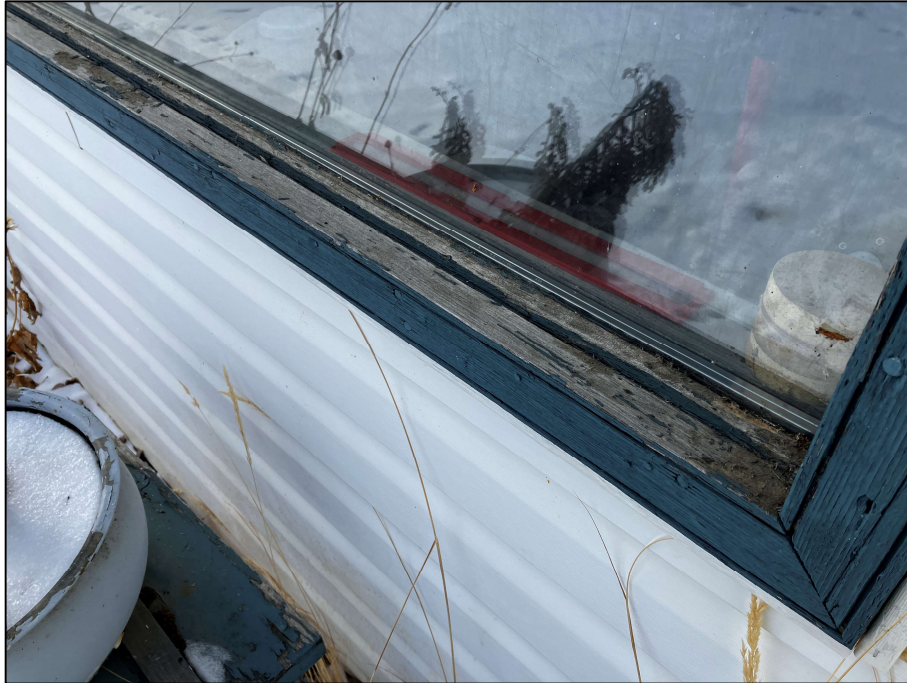
PHOTOGRAPH #25: Paint - Exterior Window Turquoise (<80 ppm Lead)

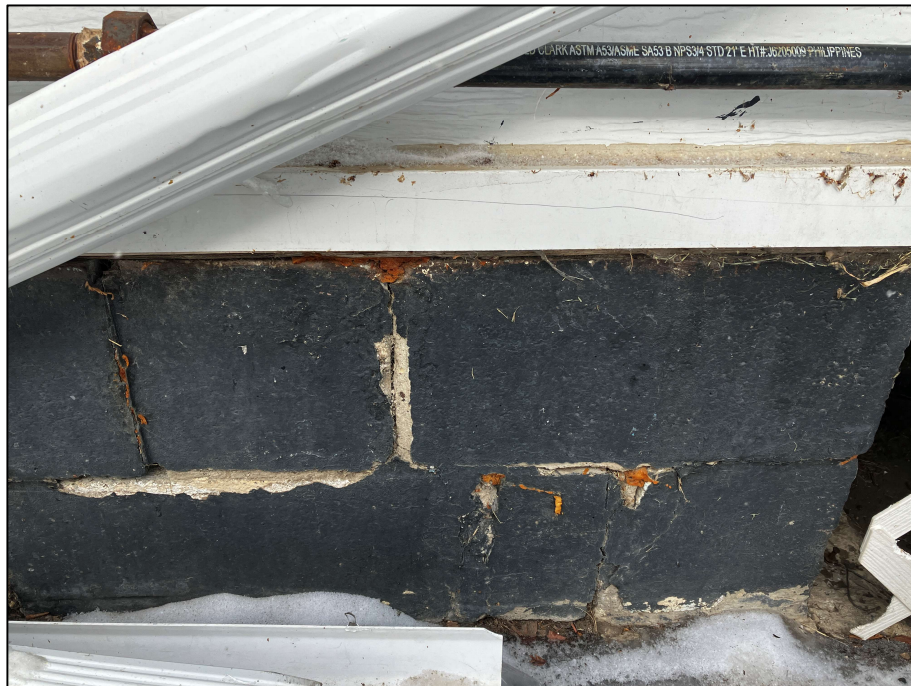
ID#	LOCATION	COLOR	CONC. (ppm)	INTERPRETATION
A	Back Door Wall	Blue	<80	Non-Lead
B	Mud Room	Light Blue	<80	Non-Lead
C	Exterior Window	Turquoise	<80	Non-Lead
D	Exterior Parging	Black	510	Lead Based

PHOTOGRAPH #26: Paint - Exterior of Home Black (510 ppm Lead)

1. Lead-containing paints (*See Appendix II*) were identified on the property. Disturbance of lead-containing surface coatings should be performed following using exposure prevention controls found in WorkSafeBC's Lead Containing Paints and Coatings: Preventing Exposure in the Construction Industry (2011) document and described in the Alberta Governments Lead at the Work Site (2013) bulletin.

PLEASE NOTE: All waste which includes the paint must be disposed of as hazardous waste unless toxicity characteristic leachate procedure (TCLP) testing can confirm the levels below the hazardous waste definition in the Government of Alberta's document Alberta User Guide for Waste Managers (1996)¹.

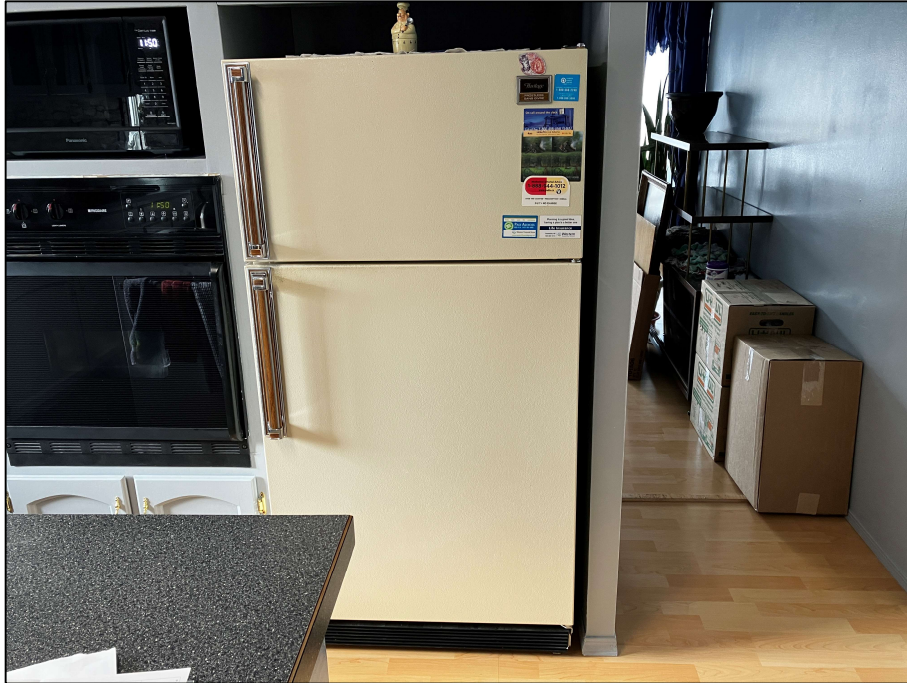
PHOTOGRAPH #28: Refrigerator in Kitchen

2. Hazardous components were identified on site and will require appropriate disposal prior to demolition, including: mercury thermostat, ozone depleting substances, fire extinguishers, and miscellaneous chemicals.
3. Should any new materials be identified throughout the process, work should stop until the materials can be assessed by a qualified health and safety professional.

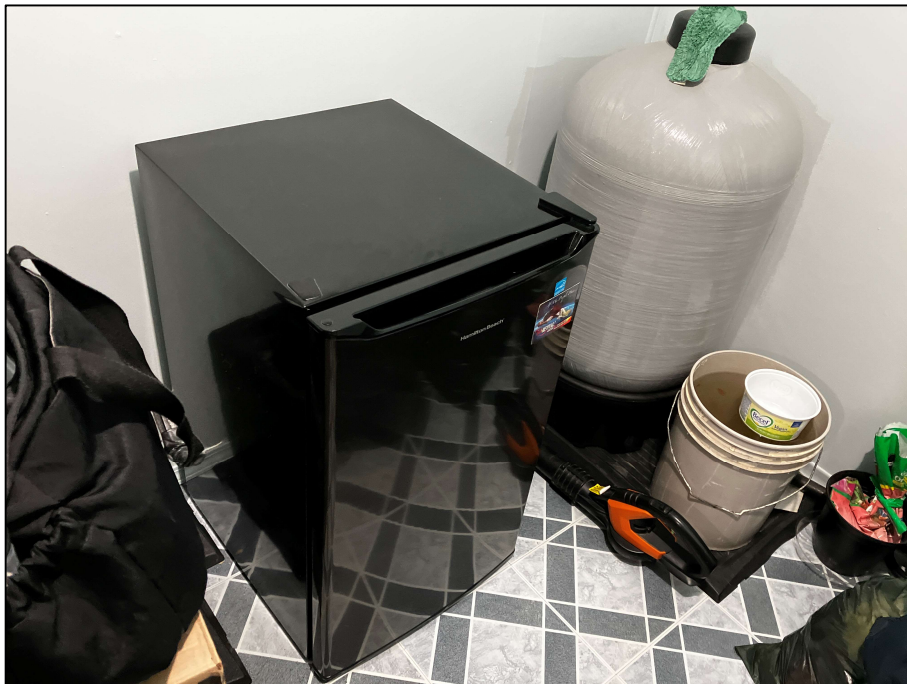
PHOTOGRAPH #29: Refrigerator in Mudroom

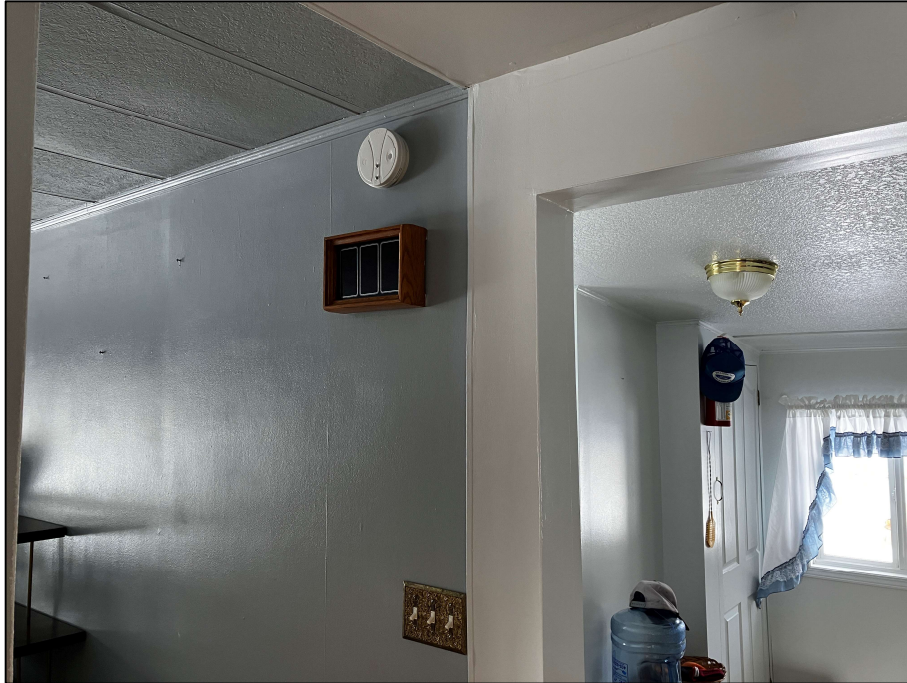
PHOTOGRAPH #30: Smoke Detector in Hallway Near Kitchen

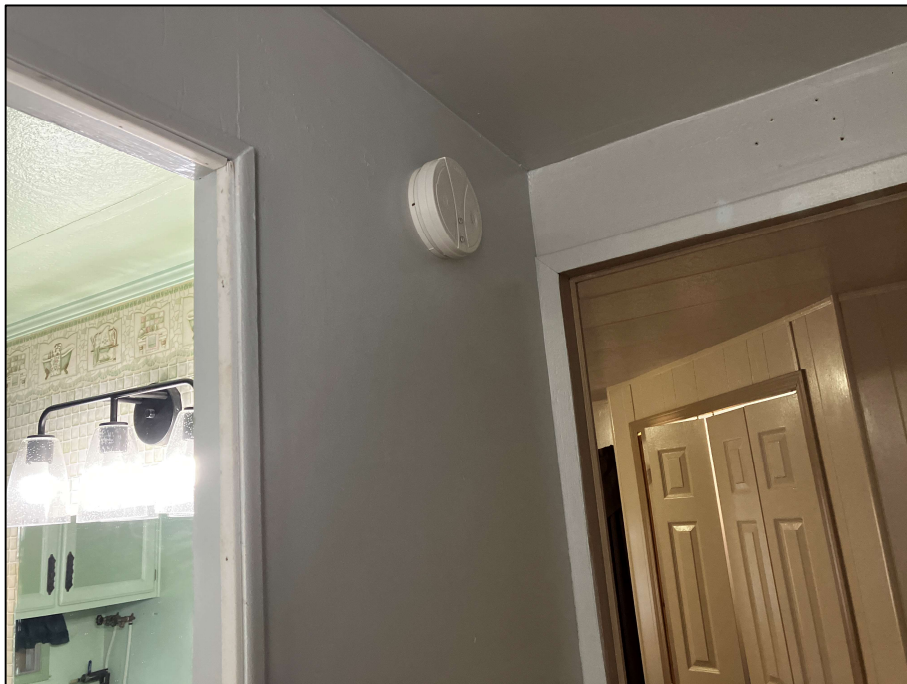
PHOTOGRAPH #31: Smoke Detector in Hallway Near Bedroom

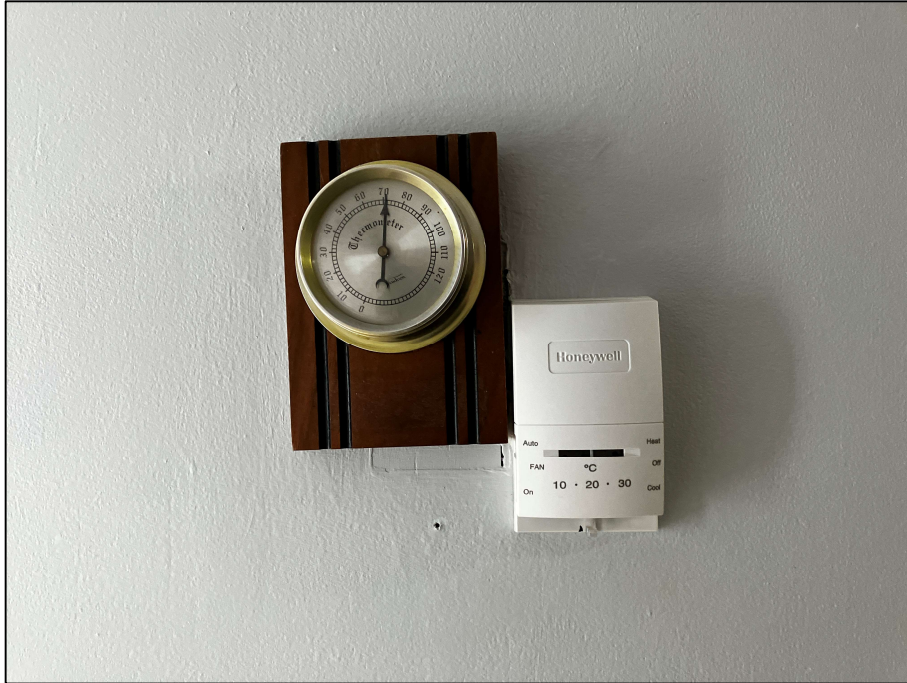
PHOTOGRAPH #32: Suspected Mercury Thermostat

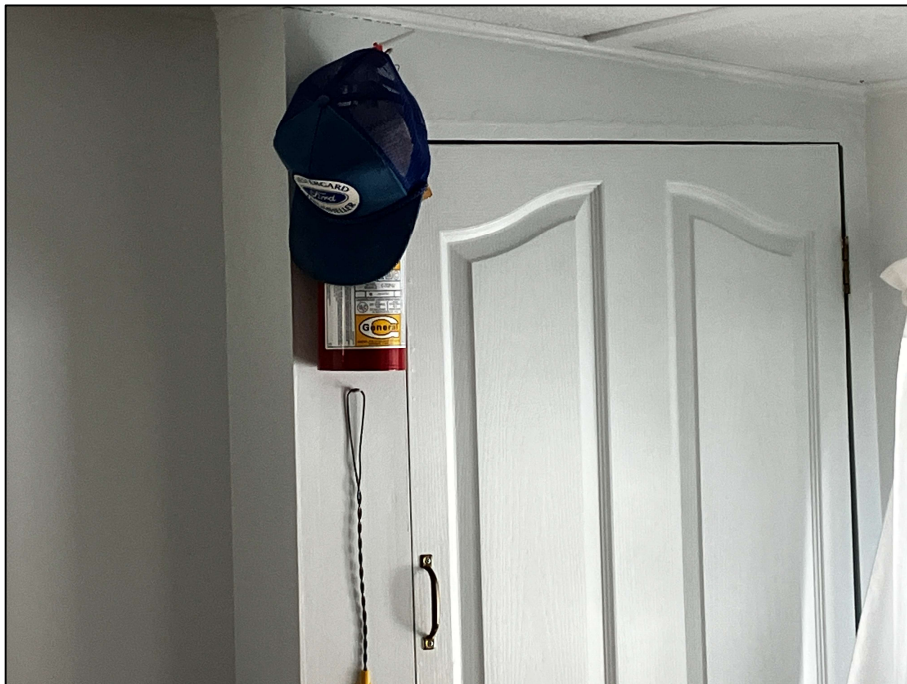
PHOTOGRAPH #33: Fire Extinguisher in Back Room

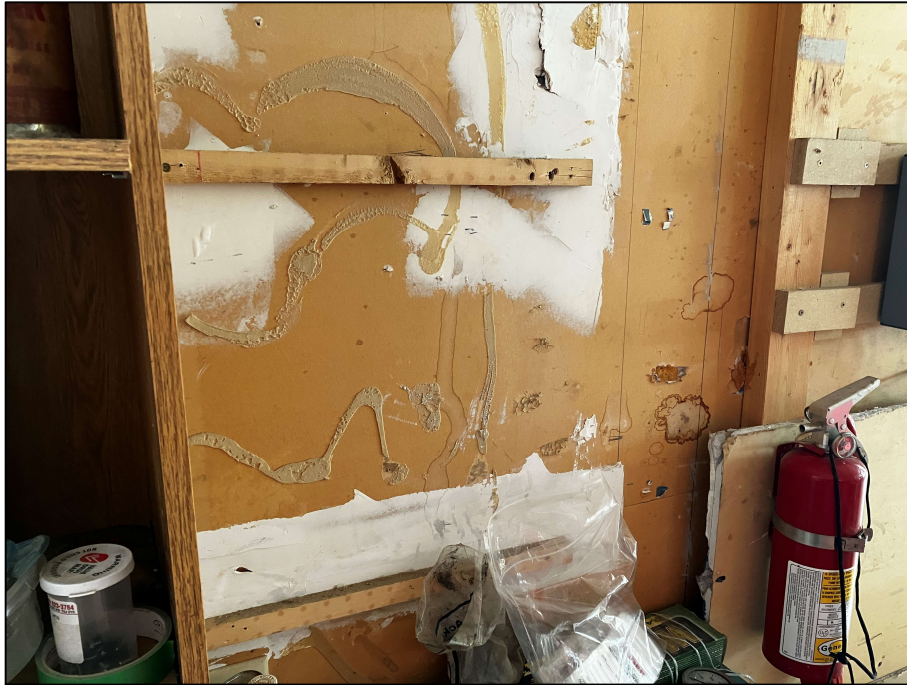
PHOTOGRAPH #34: Fire Extinguisher in Garage

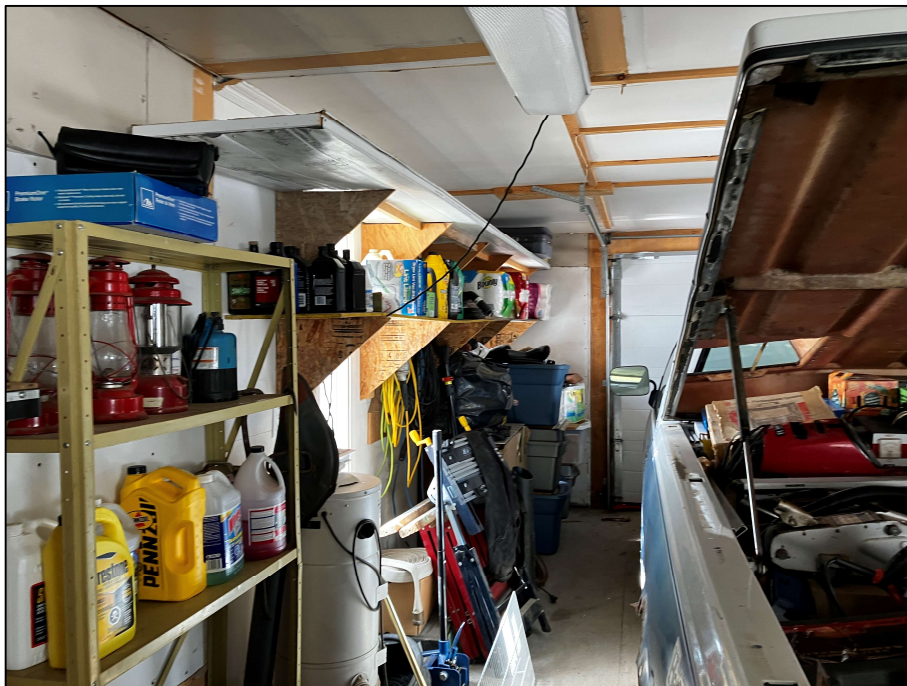
Various chemicals were identified in the garage.

PHOTOGRAPH #35: Miscellaneous Chemical in Garage
