SENT: March 7, 2023

**Town of Drumheller**  
Premier Way  
Drumheller, Alberta  
T0J 0Y4

**RE:** **Hazardous Material Assessment Report**  
112 4th St Lehigh in Lehigh, AB  
**Project #: E3030-F**

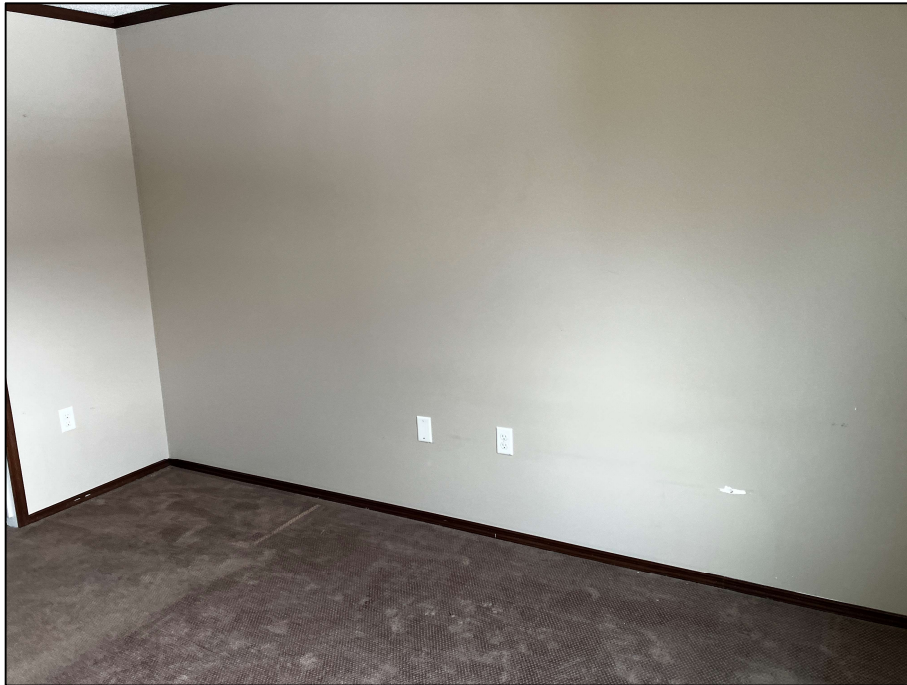
**PHOTOGRAPH #1:** Drywall Joint Compound - Level 1 Primary Bedroom Exterior (None Detected)

ID	Sample Description / Location	Results
1	Drywall Joint Compound - Level 1 Primary Bedroom (EXT)	None Detected
2	Drywall Joint Compound - Level 1 Kitchen (INT)	None Detected
3	Drywall Joint Compound - Level 1 Dining Room (EXT)	None Detected
4	Drywall Joint Compound - Level 1 NW Bedroom (INT)	None Detected
5	Ceiling Texture - Level 1 Hallway	None Detected

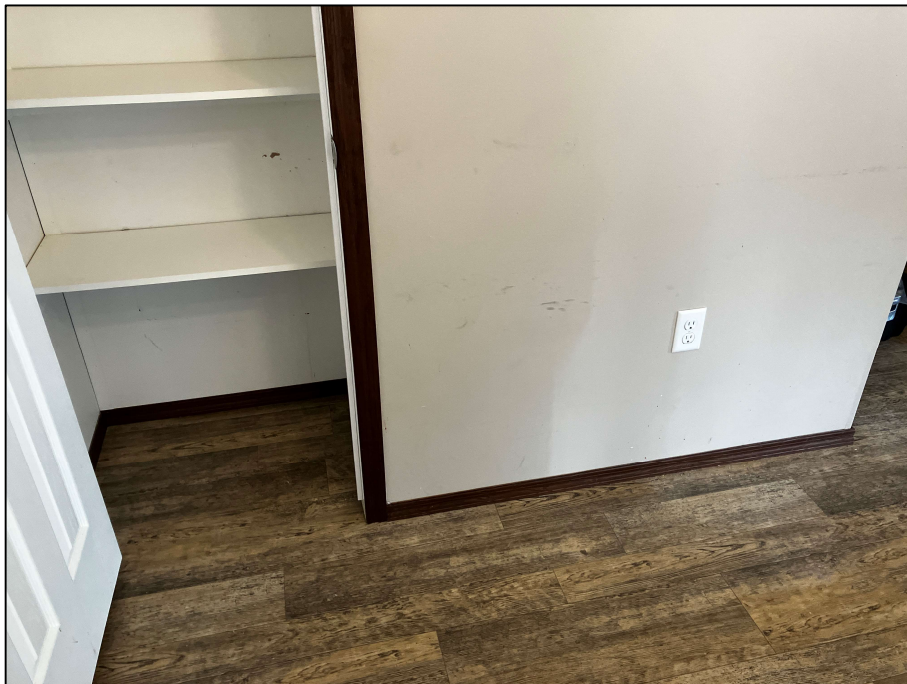
**PHOTOGRAPH #2:** Drywall Joint Compound - Level 1 Kitchen Interior (None Detected)

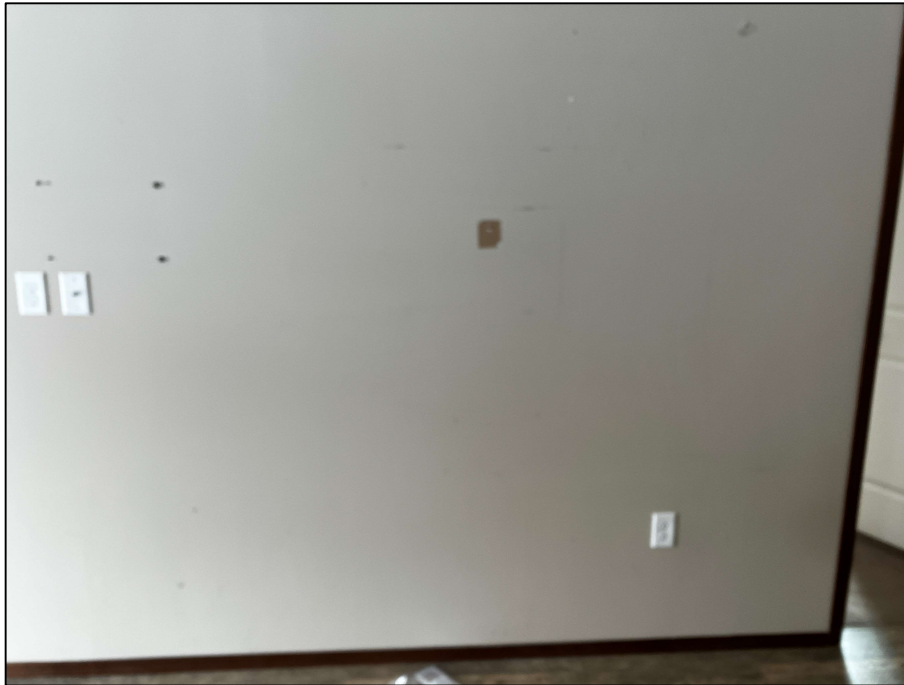
**PHOTOGRAPH #3:** Drywall Joint Compound - Level 1 Dining Room Exterior (None Detected)

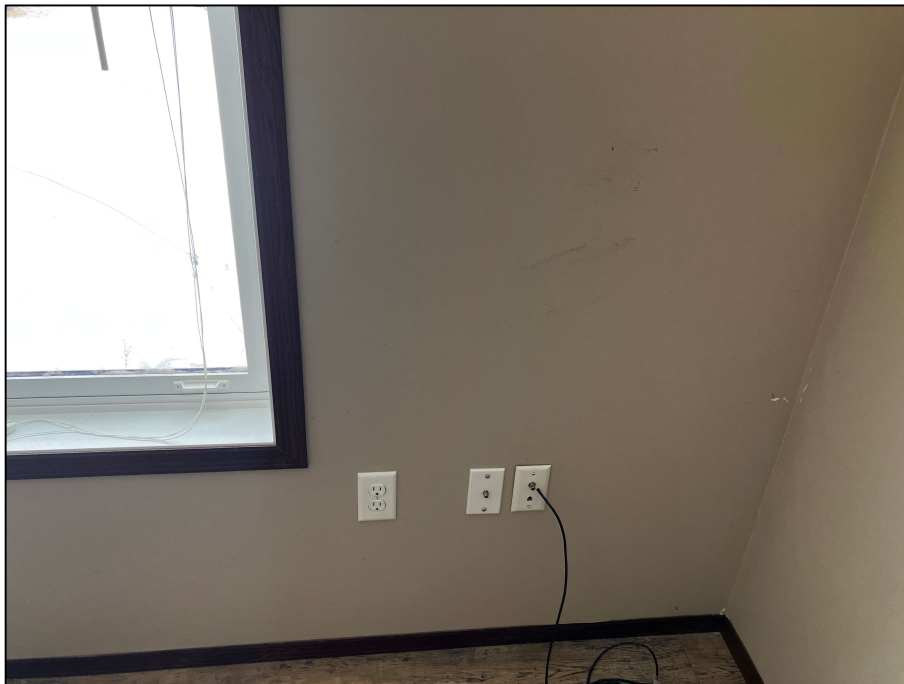
**PHOTOGRAPH #4:** Drywall Joint Compound - Level 1 NW Bedroom Interior (None Detected)

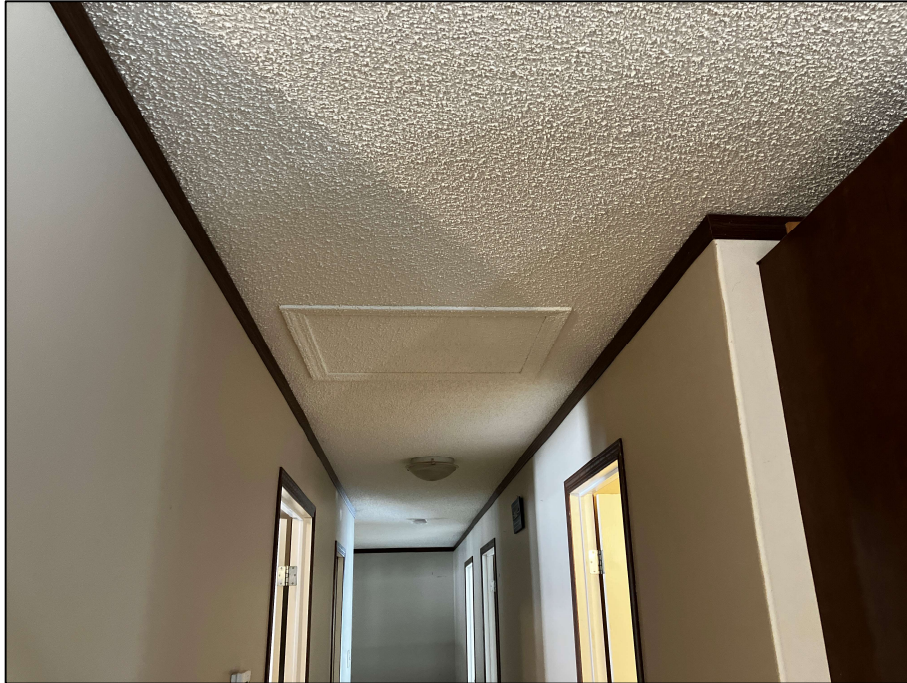
**PHOTOGRAPH #5:** Ceiling Texture - Level 1 Hallway (None Detected)

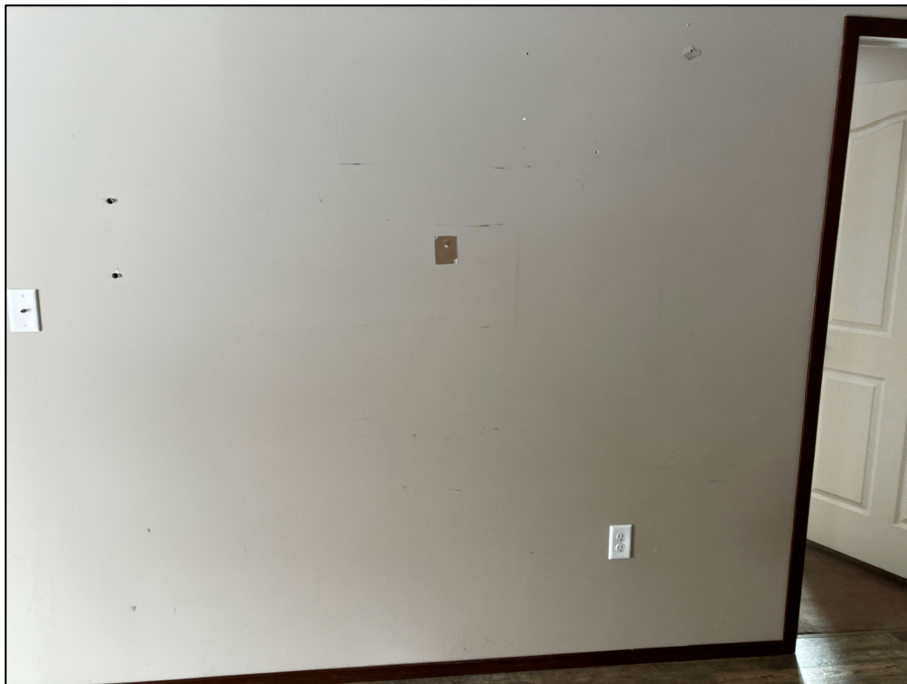
ID#	LOCATION	COLOR	CONC. (ppm)	INTERPRETATION
A	Dining Room	Beige	<80	Non-Lead

**PHOTOGRAPH #6:** Paint - Level 1 Dining Room Beige (<80 ppm Lead)

ID	Sample Description / Location	Results
A	Paint - Dining Room (Beige)	<80 ppm

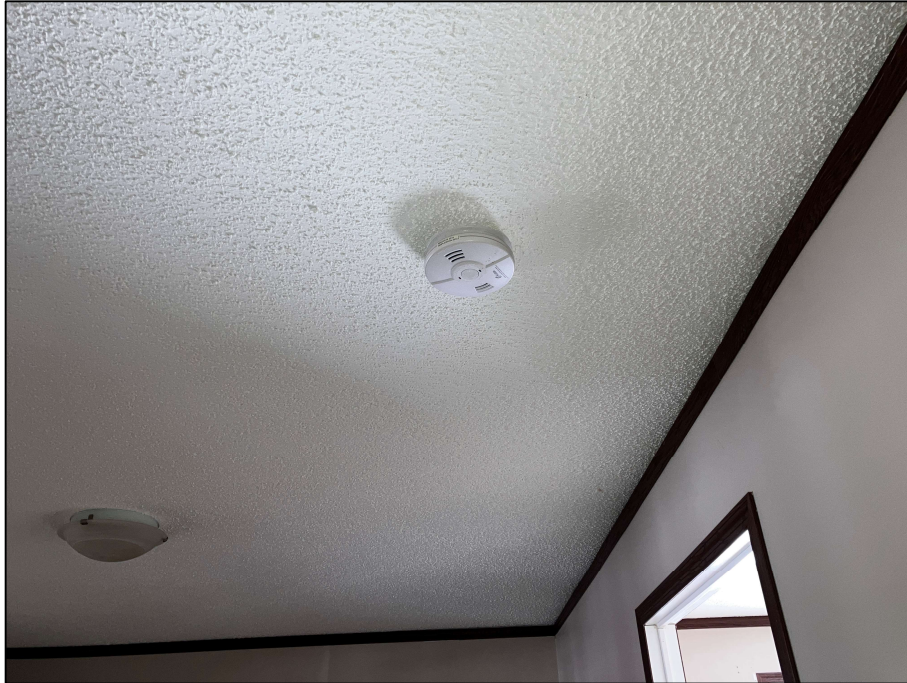
**PHOTOGRAPH #7:** Smoke Detector in Bedroom

1. Hazardous components were identified on site and will require appropriate disposal prior to demolition, including: radioactive materials in smoke detectors and ozone depleting substances in air conditioning unit.
2. Should any new materials be identified throughout the process, work should stop until the materials can be assessed by a qualified health and safety professional.

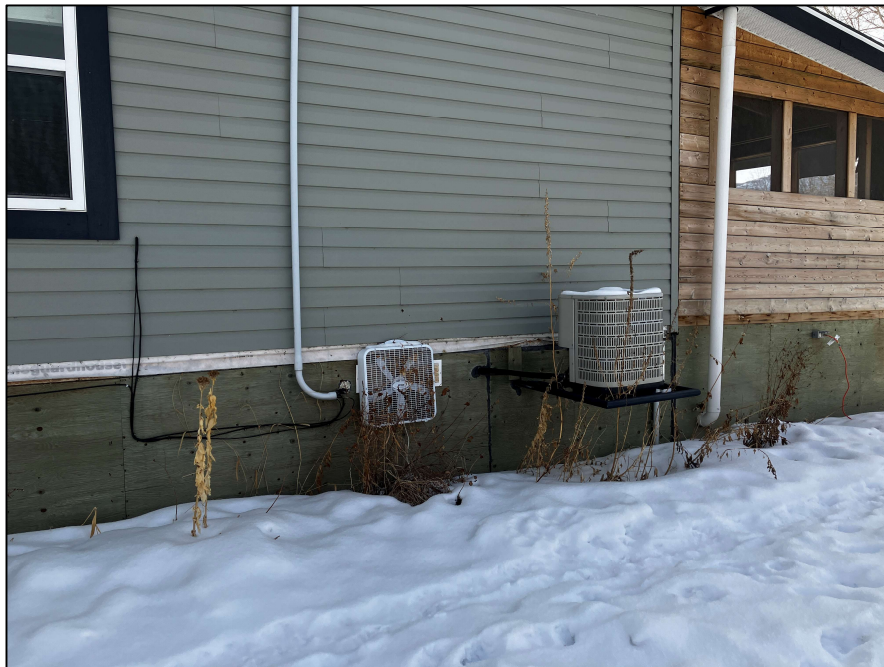
**PHOTOGRAPH #8:** Air Conditioning Unit on the Exterior of the Home

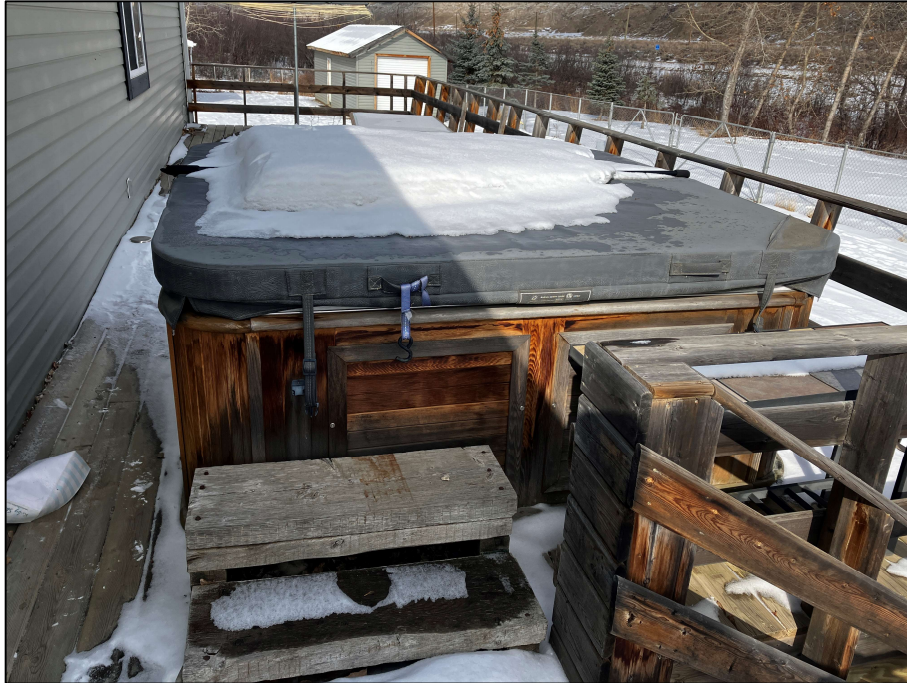
**PHOTOGRAPH #9:** Hot Tub on the Back Deck

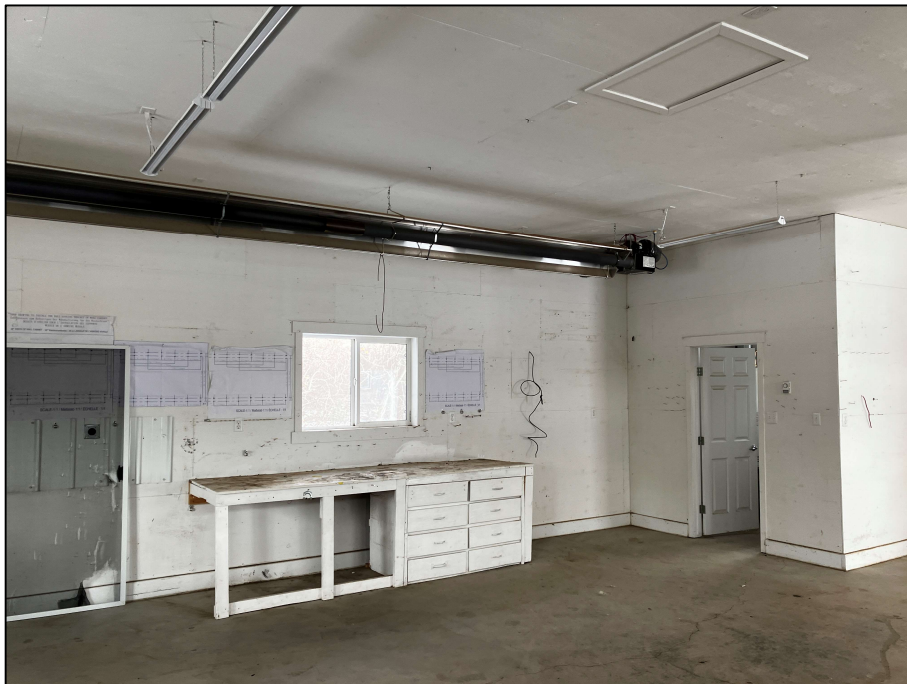
**PHOTOGRAPH #10:** Garage with Large Heater
