NOTICE TO POTENTIAL PROPONENTS ADDENDUM 4

Project Name: Expression of Interest House Salvage DRFM#2023-02-16	
Date: March 27, 2023	
Item	Detail
A1.1	Clarification on Scope Revised Schedule C – 199 River Drive, East Coulee Please see the attached revised Schedule C for 199 River Drive, East Coulee.
Attachments: 1. Revised Schedule C – 199 River Drive, East Coulee

RE: **Hazardous Material Assessment Report**
199 River Dr in Rosedale, AB
Project #: E3030-D

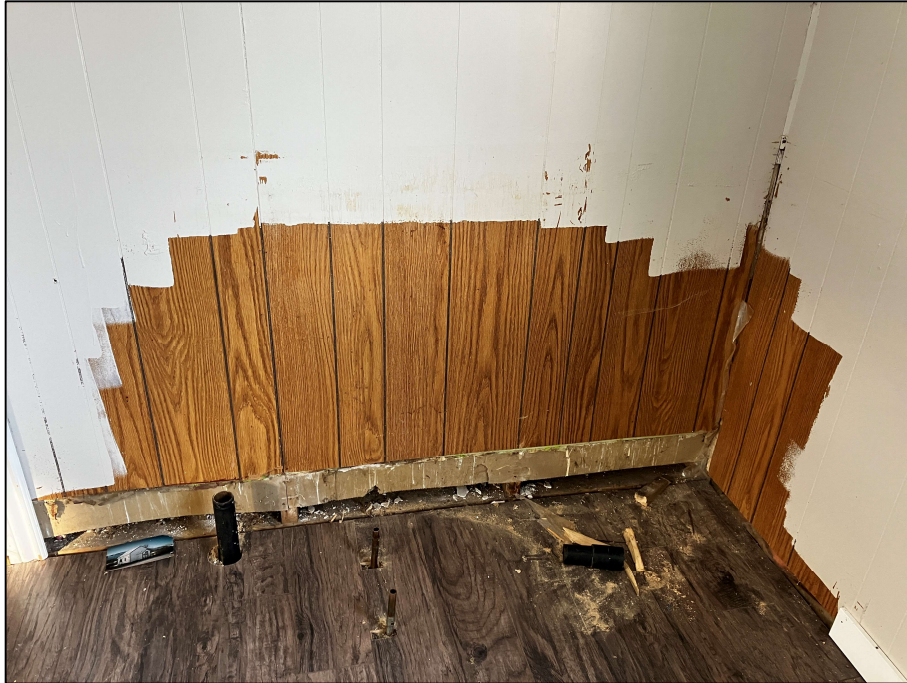
PHOTOGRAPH #1: Drywall Joint Compound - Level 1 Main Room Interior (Assume Positive)

1. The drywall on the property was identified as asbestos-containing. Any renovation, demolition, or removal of the material must be performed by a qualified abatement contractor using moderate-risk asbestos abatement procedures found in Section 5.3 of the Alberta Asbestos Abatement Manual (2019) (See *Photographs #18-20*).

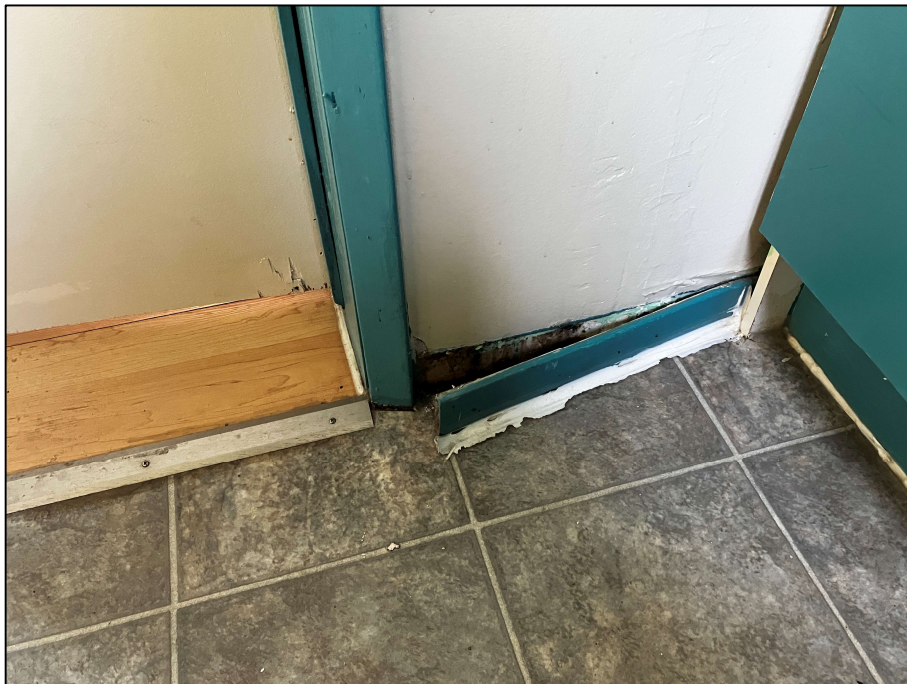
PHOTOGRAPH #2: Drywall Joint Compound - Level 1 Bathroom Interior (2% Chrysotile)

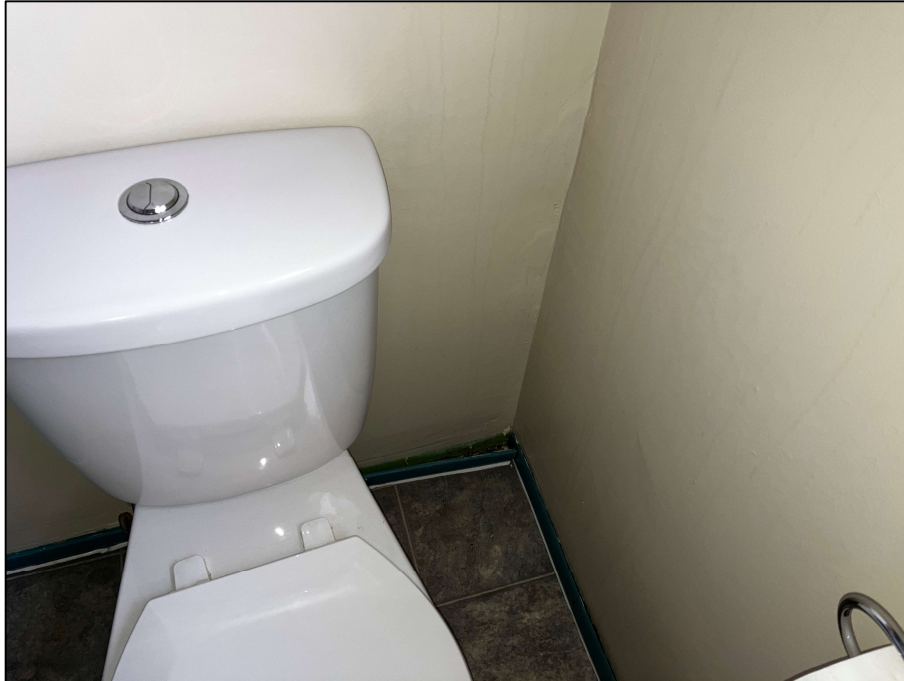
PHOTOGRAPH #3: Drywall Joint Compound - Level 1 Bathroom Exterior (2% Chrysotile)

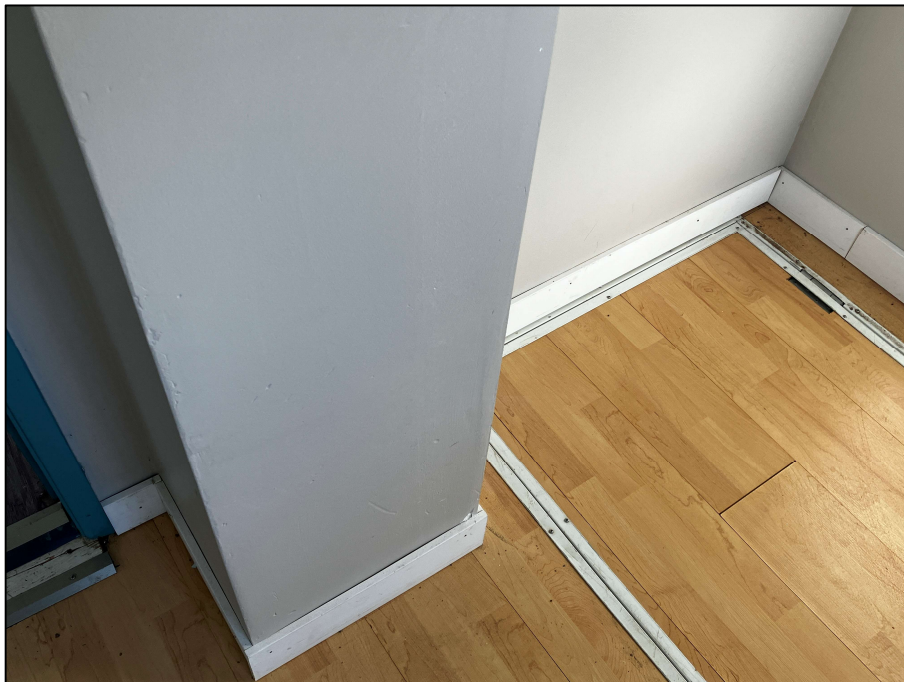
PHOTOGRAPH #4: Drywall Joint Compound - Level 1 Storage Room Interior (Assume Positive)

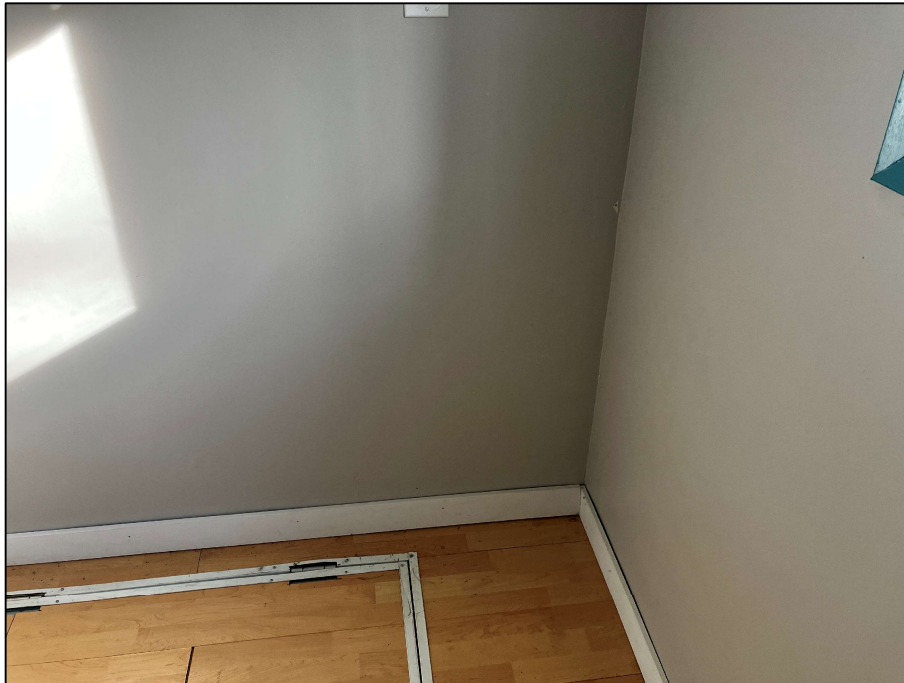
PHOTOGRAPH #5: Drywall Joint Compound - Level 1 Storage Room Exterior (2% Chrysotile)

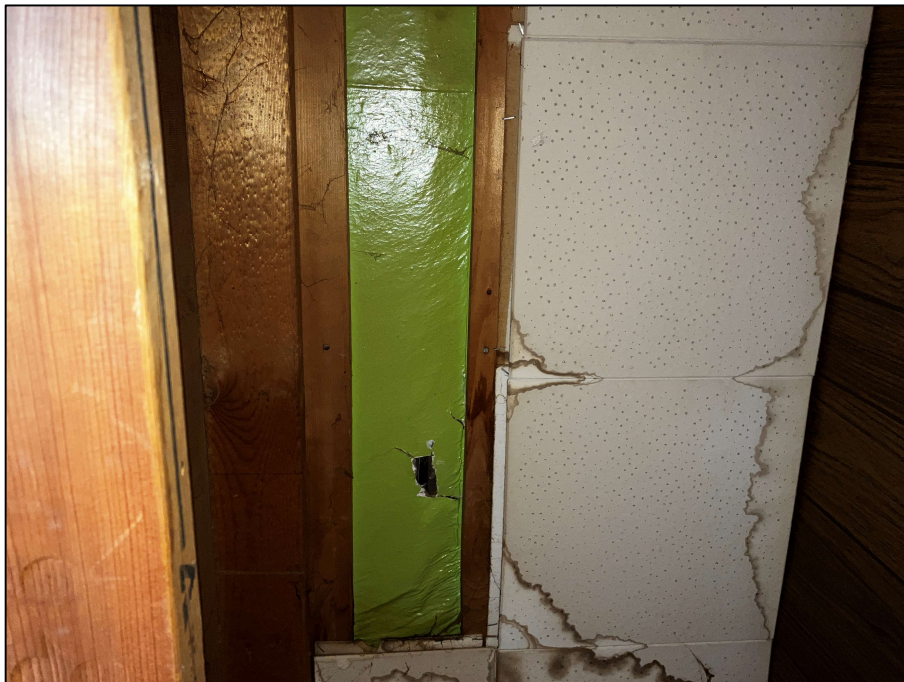
PHOTOGRAPH #6: Drywall Joint Compound - Level 1 Foyer Ceiling (Assume Positive)

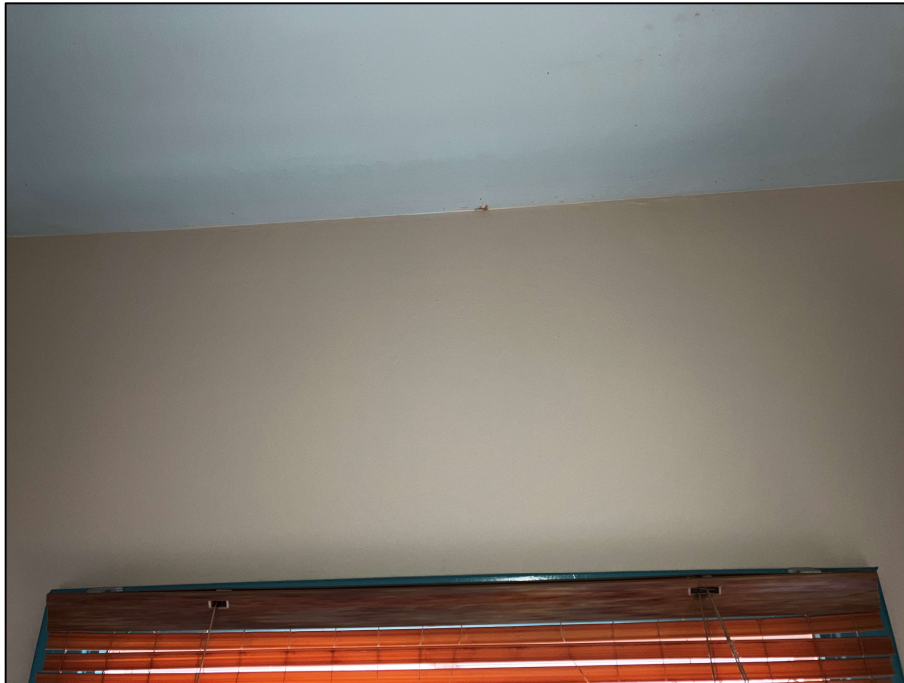
PHOTOGRAPH #7: Drywall Joint Compound - Level 1 Bathroom Ceiling (2% Chrysotile)

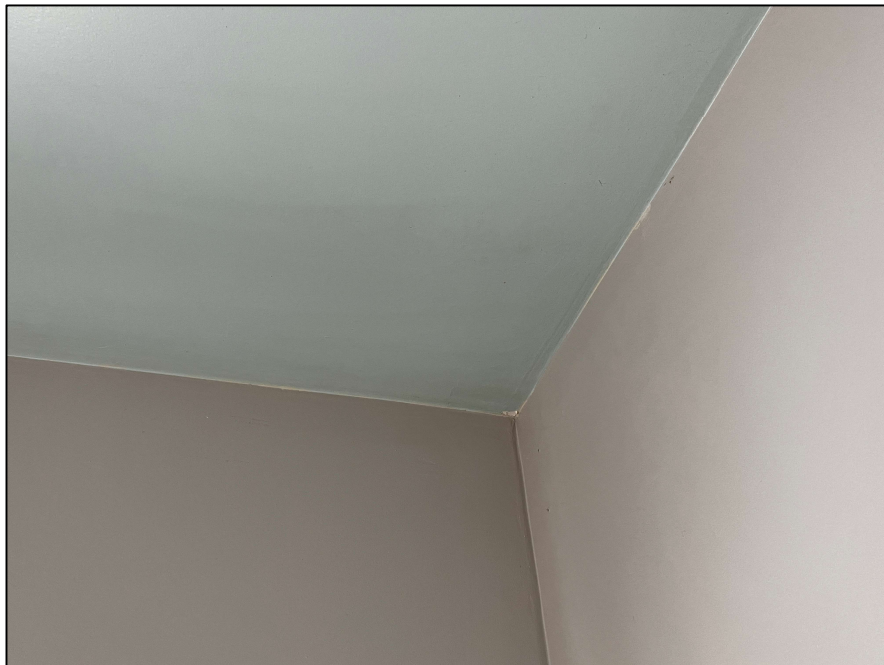
PHOTOGRAPH #8: Drywall Joint Compound - Level 1 Storage Room Ceiling (2% Chrysotile)

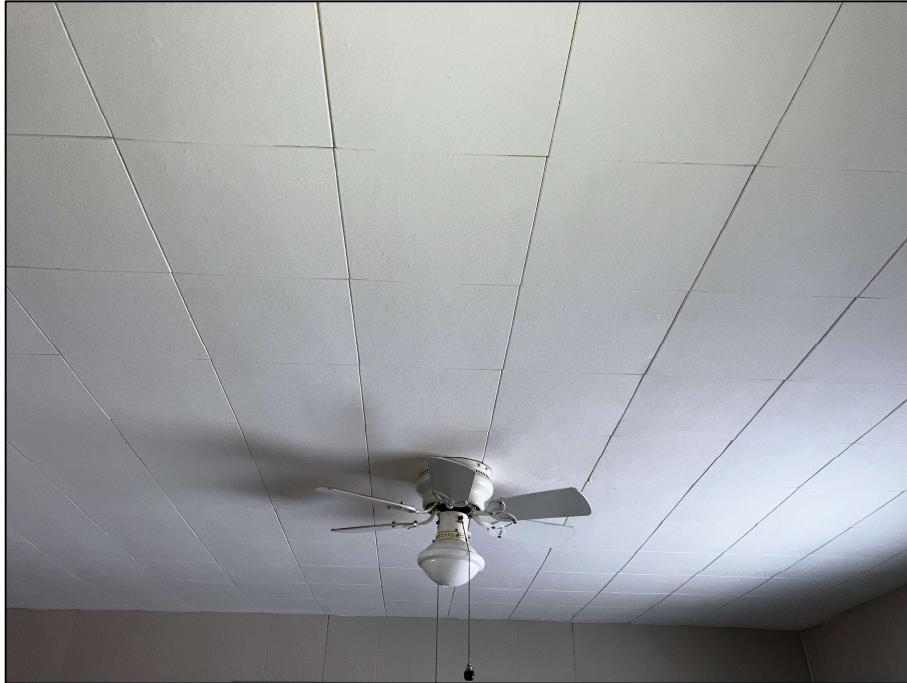
PHOTOGRAPH #9: Ceiling Tile - Level 1 Main Room (None Detected)

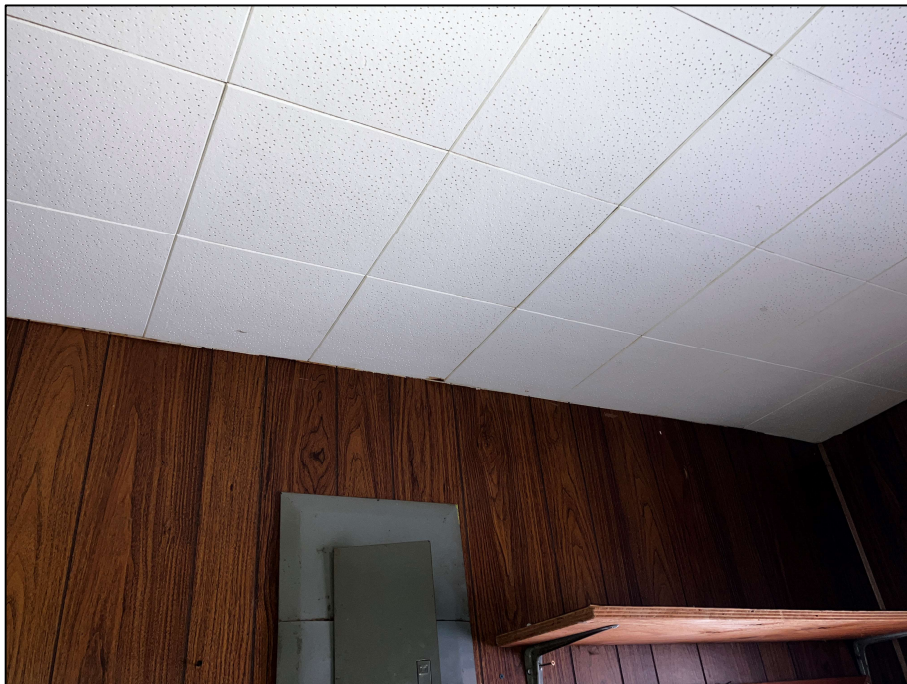
PHOTOGRAPH #10: Ceiling Tile - Level 1 Foyer (None Detected)

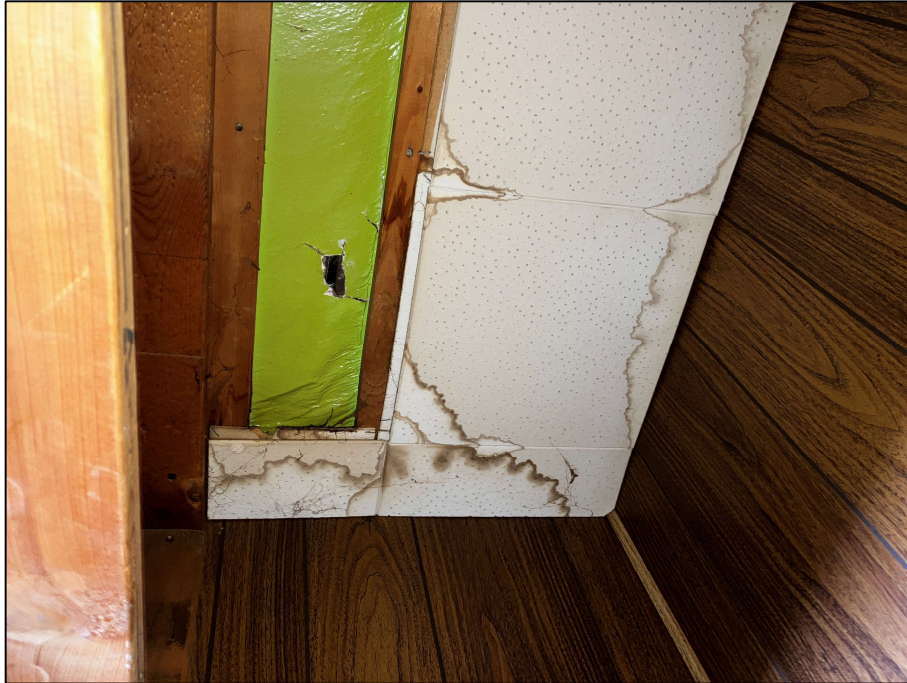
PHOTOGRAPH #11: Ceiling Tile - Level 1 Foyer (None Detected)

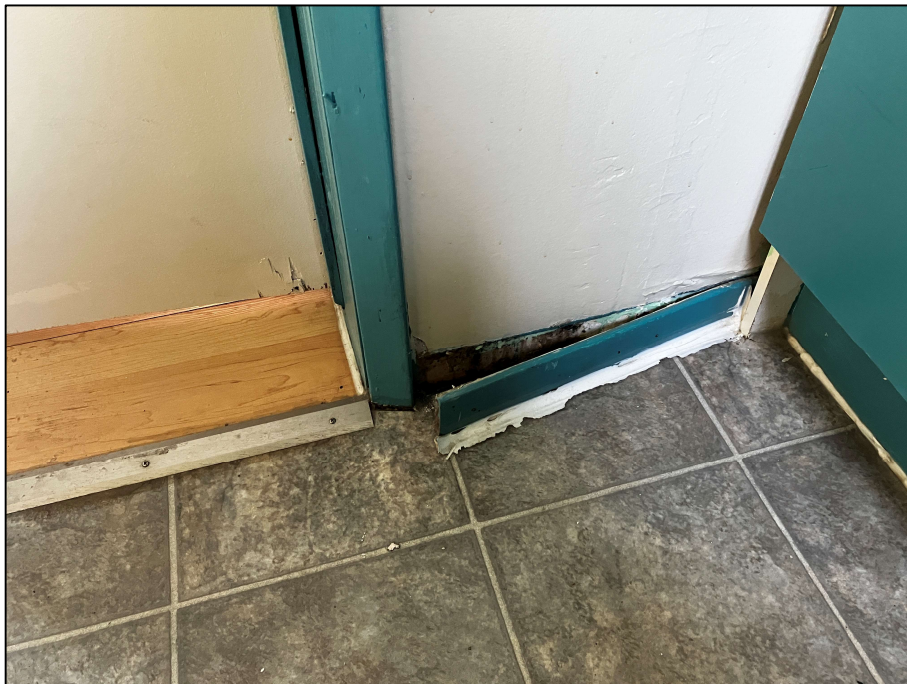
PHOTOGRAPH #12: Sheet Flooring - Level 1 Bathroom (None Detected)

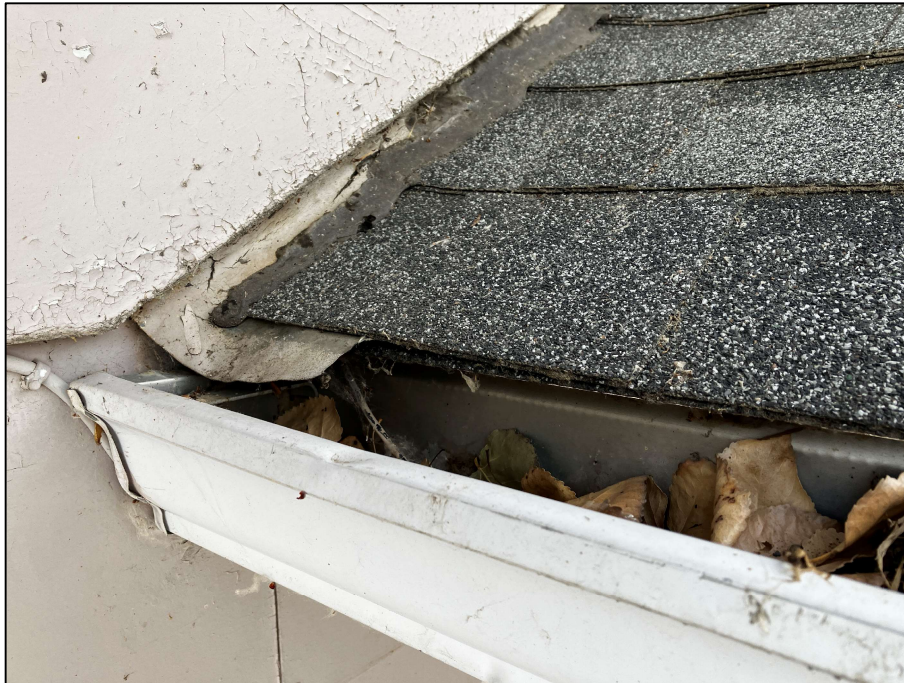
PHOTOGRAPH #13: Roof Shingle - Exterior Home (None Detected)

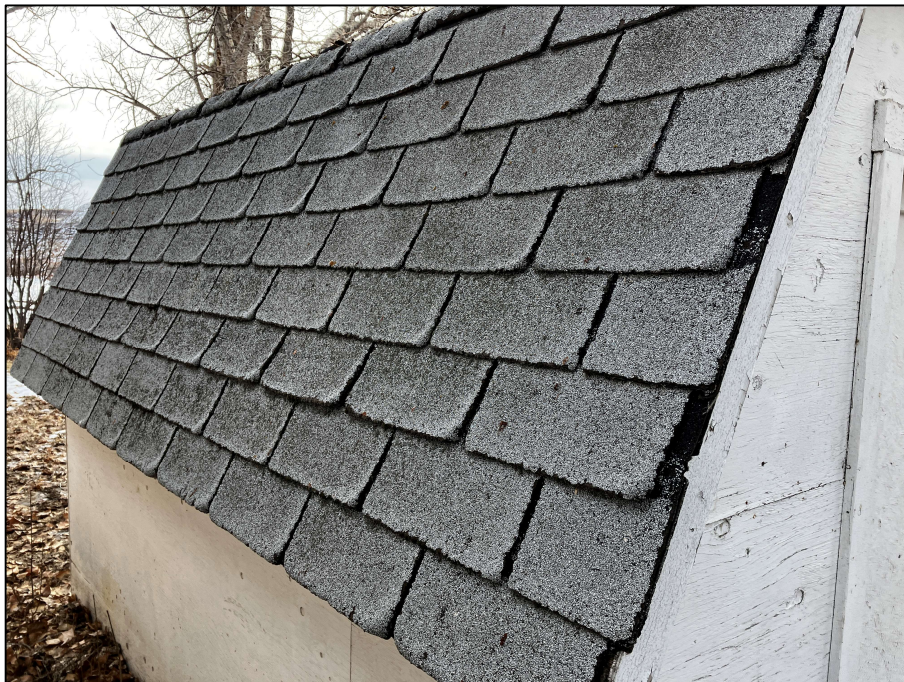
PHOTOGRAPH #14: Roof Shingle - Exterior Shed (None Detected)

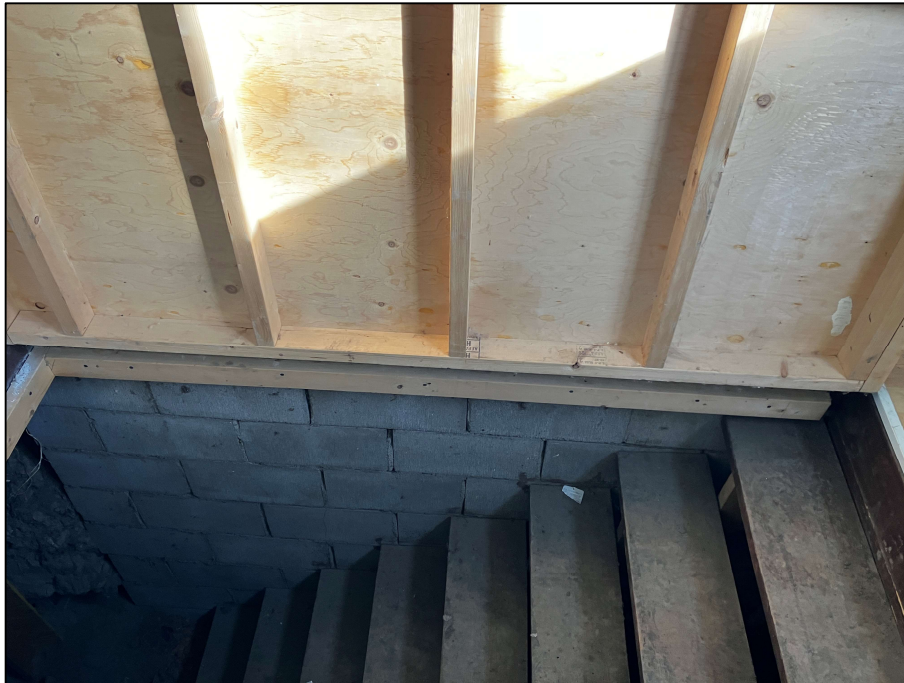
PHOTOGRAPH #15: Brick Mortar - Stairs (None Detected)

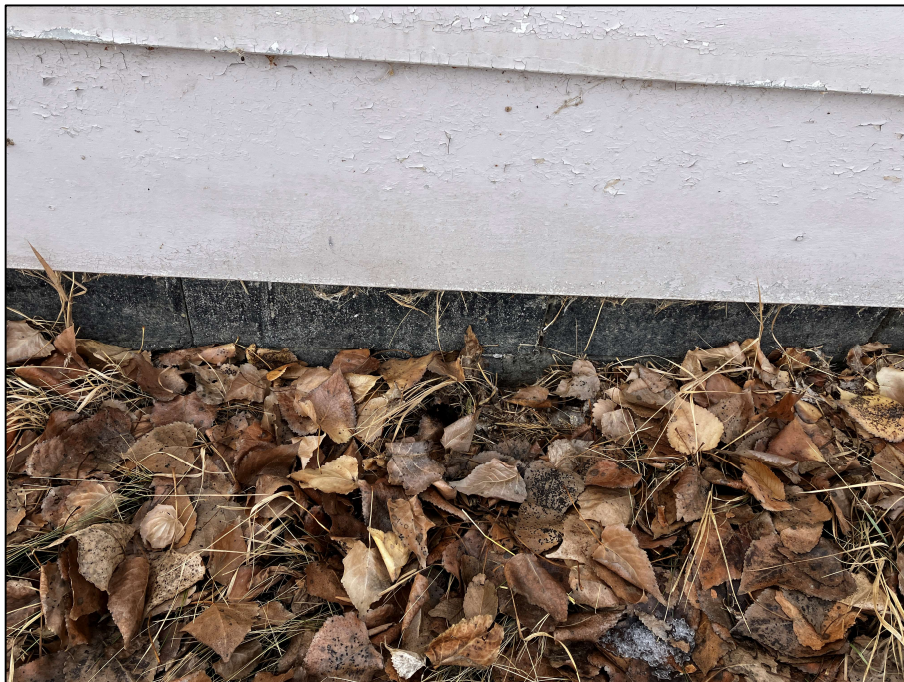
PHOTOGRAPH #16: Parging - Exterior (None Detected)

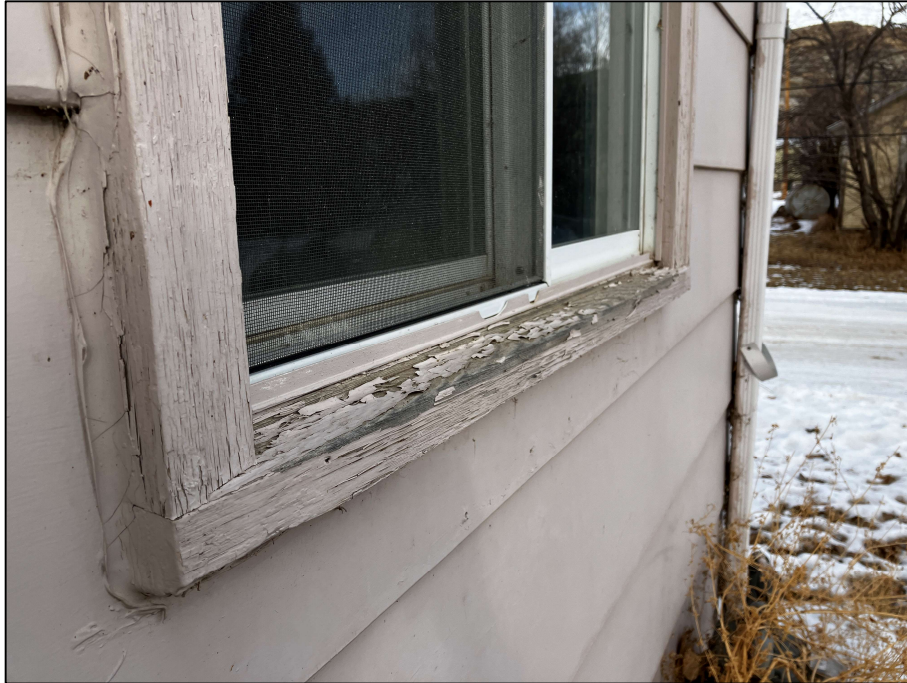
PHOTOGRAPH #17: Window Caulking - Exterior (None Detected)

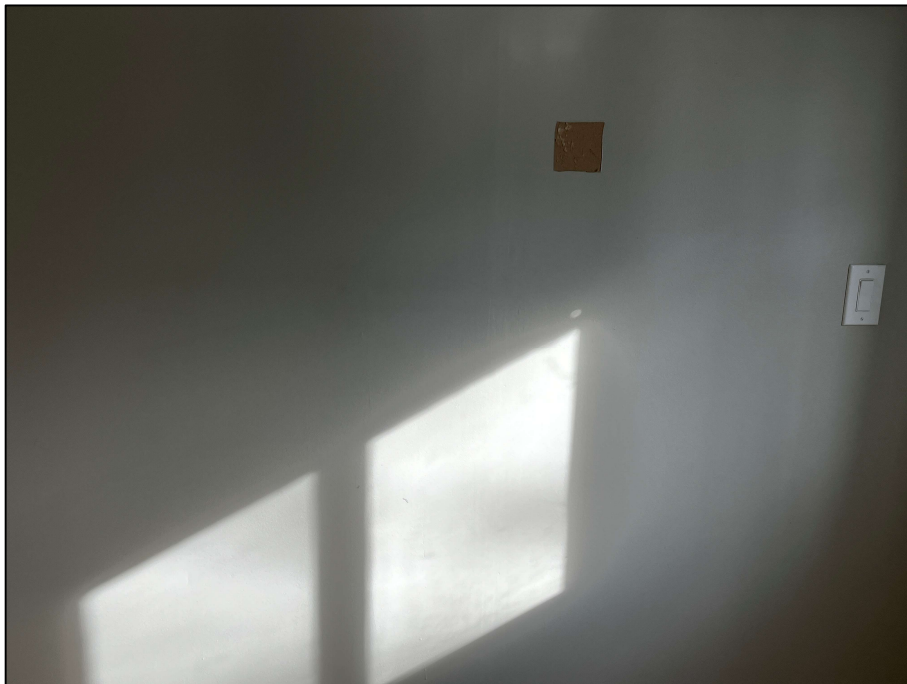
PHOTOGRAPH #18: Paint - Storage Room Beige (570 ppm Lead)

2. Lead-containing paints (See *Appendix II*) were identified on the property. Disturbance of lead-containing surface coatings should be performed following using exposure prevention controls found in WorkSafeBC's Lead Containing Paints and Coatings: Preventing Exposure in the Construction Industry (2011) document and described in the Alberta Governments Lead at the Work Site (2013) bulletin.

PLEASE NOTE: All waste which includes the paint must be disposed of as hazardous waste unless toxicity characteristic leachate procedure (TCLP) testing can confirm the levels below the hazardous waste definition in the Government of Alberta's document Alberta User Guide for Waste Managers (1996)¹.

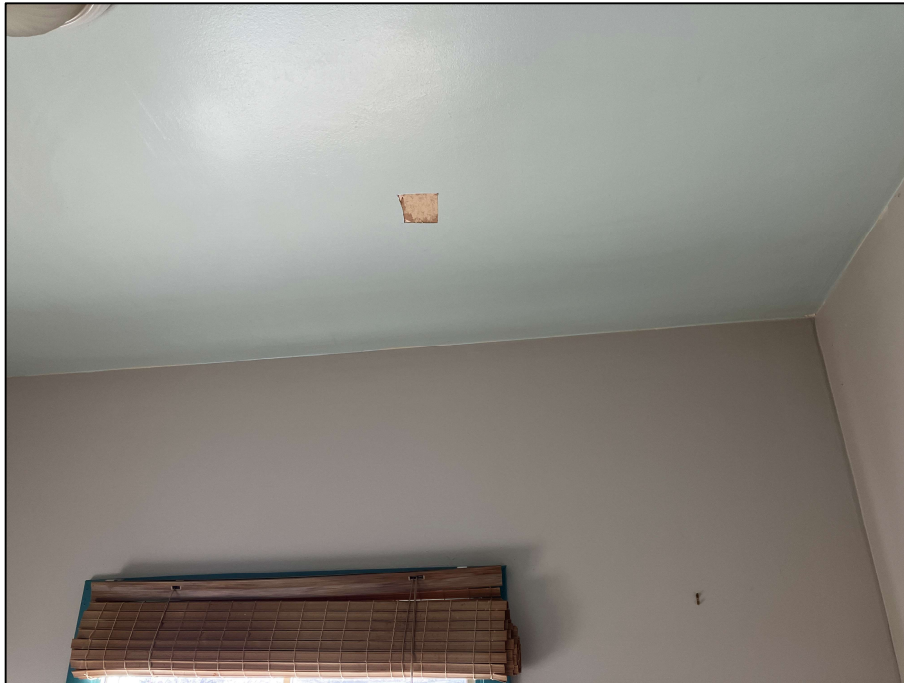
PHOTOGRAPH #19: Paint - Storage Room Green (640 ppm Lead)

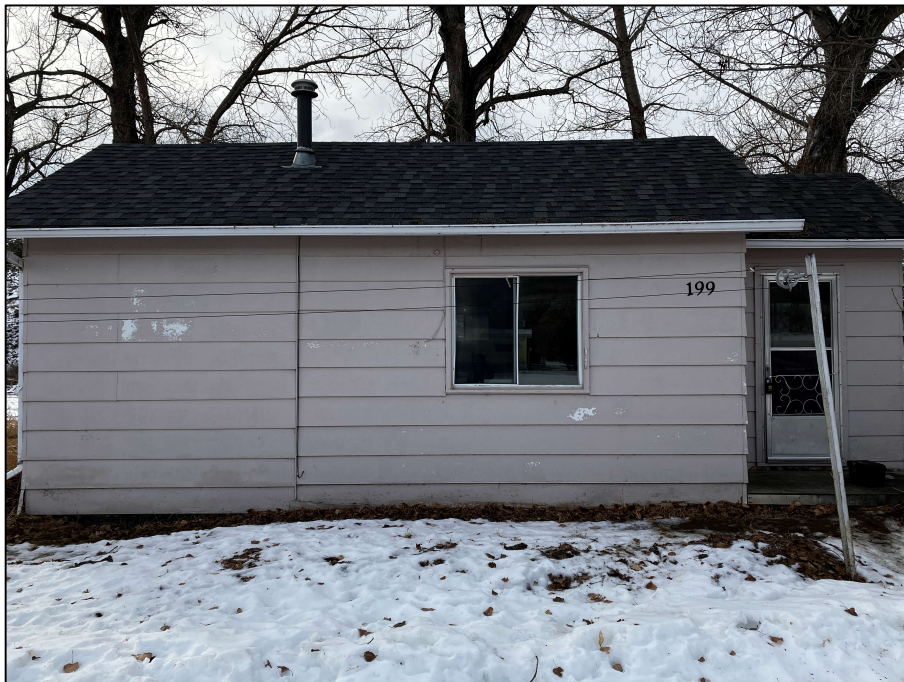
PHOTOGRAPH #20: Paint - Exterior Beige (<80 ppm Lead)

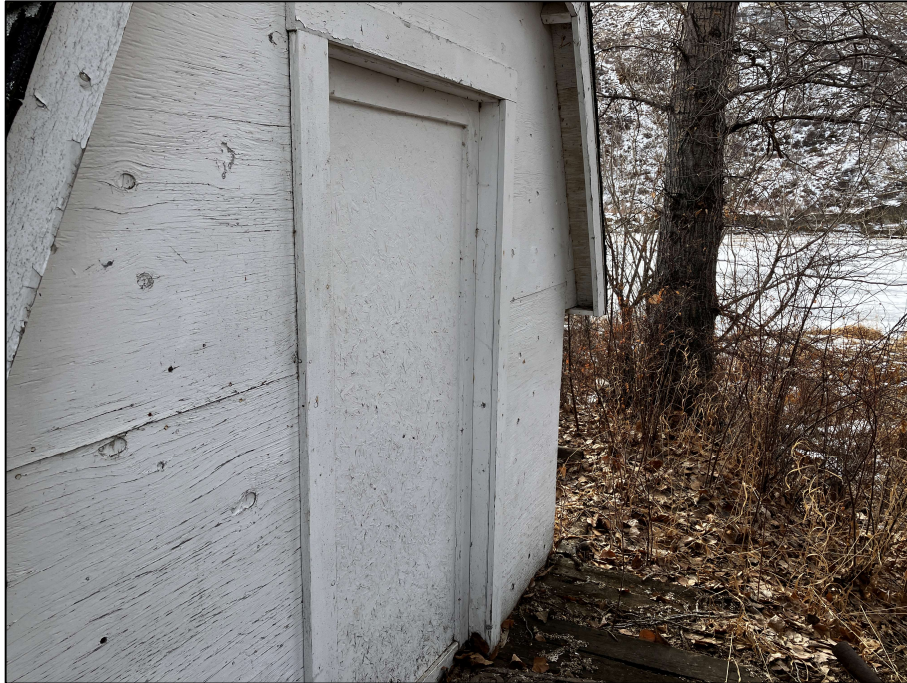
PHOTOGRAPH #21: Paint - Shed White (3400 ppm Lead)

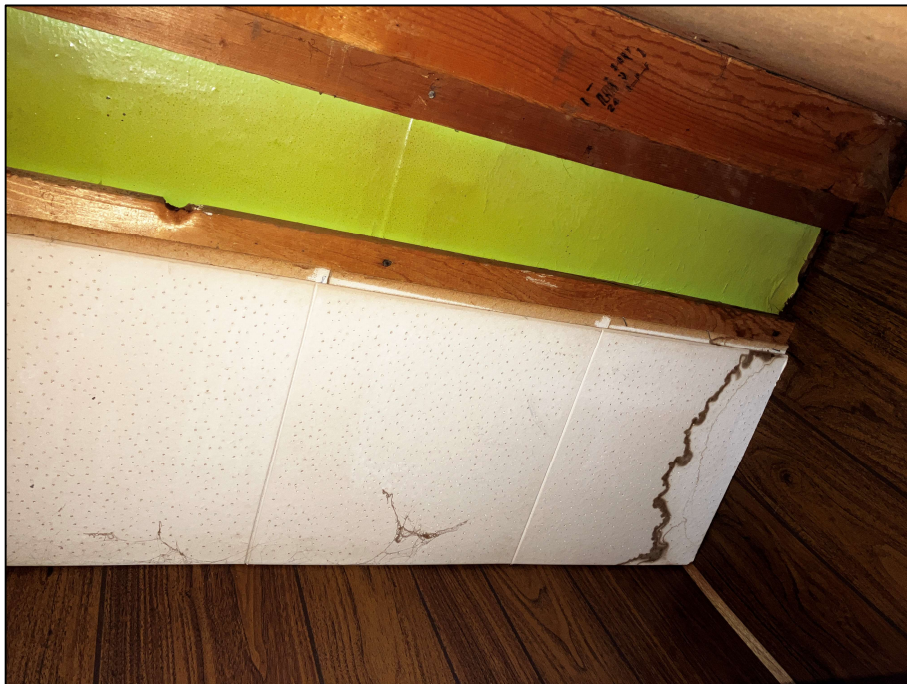
PHOTOGRAPH #22: Paint - Foyer Green (980 ppm Lead)

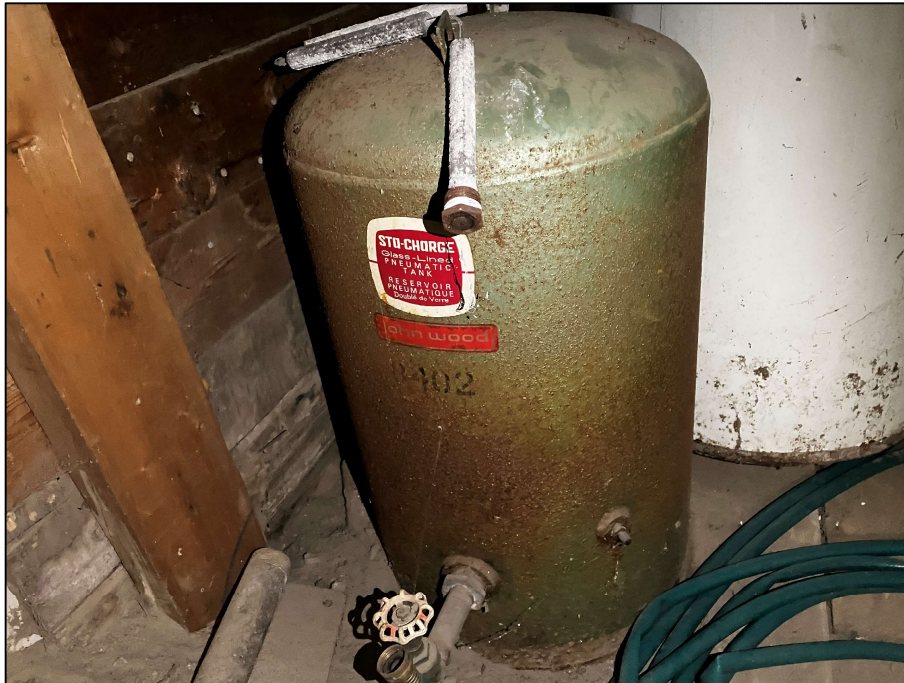
PHOTOGRAPH #24: Pneumatics Storage Tank in Basement

3. Hazardous components were identified on site and will require appropriate disposal prior to demolition, including: mercury thermostats, ozone depleting substances, pneumatic storage tank and miscellaneous chemicals.
4. Should any new materials be identified throughout the process, work should stop until the materials can be assessed by a qualified health and safety professional.

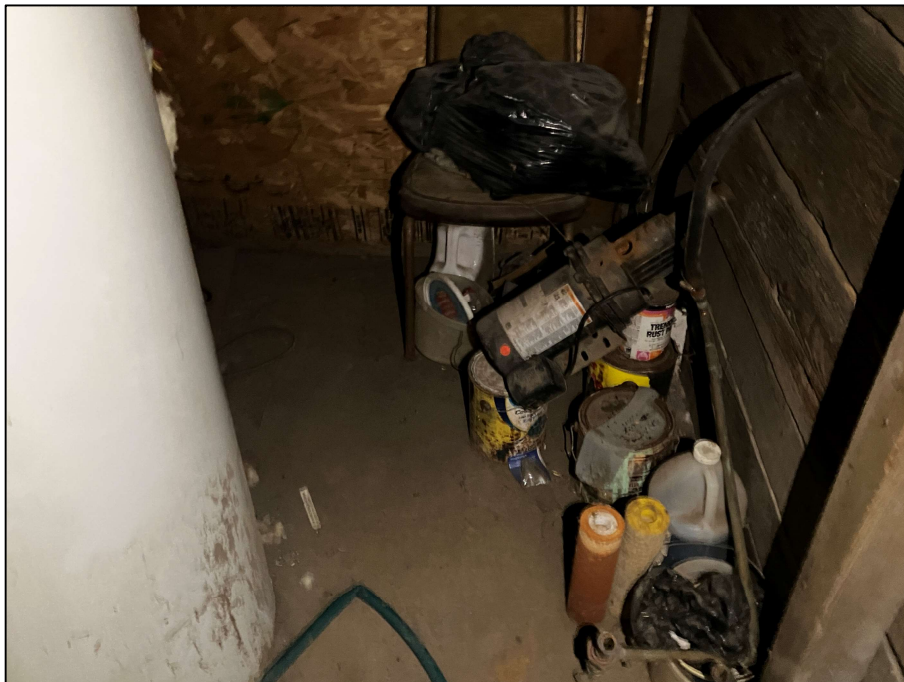
PHOTOGRAPH #25: Miscellaneous Chemicals in Basement

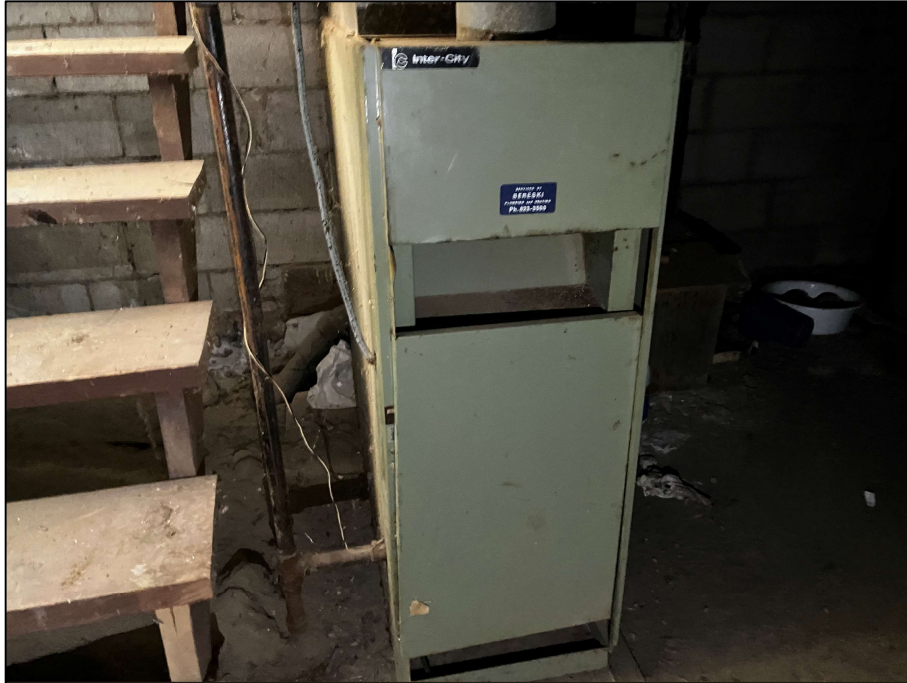
PHOTOGRAPH #26: Furnace Unit Within Basement

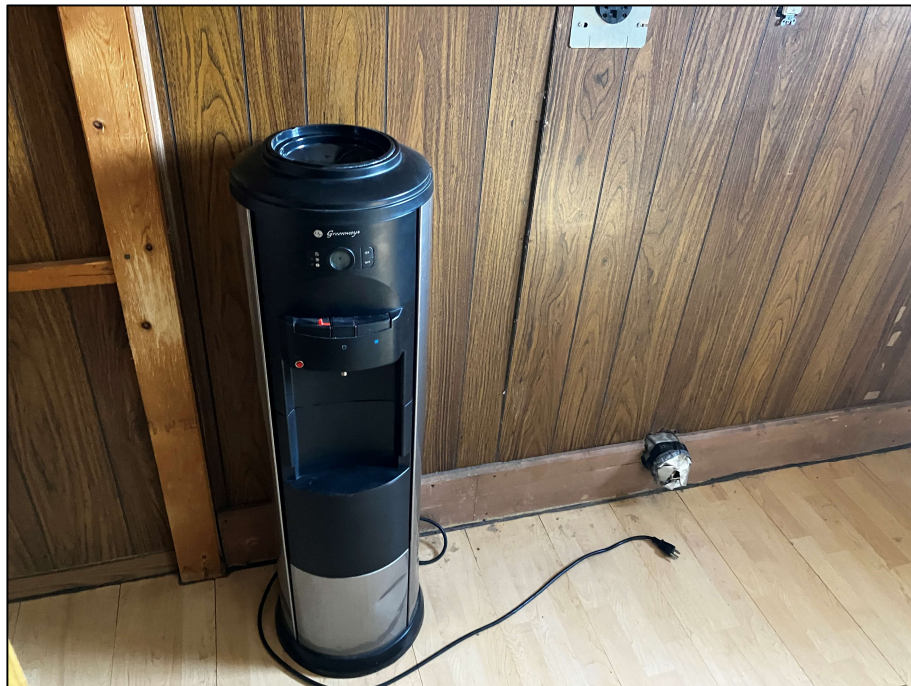
PHOTOGRAPH #27: Water Cooler with Ozone Deleting Substances

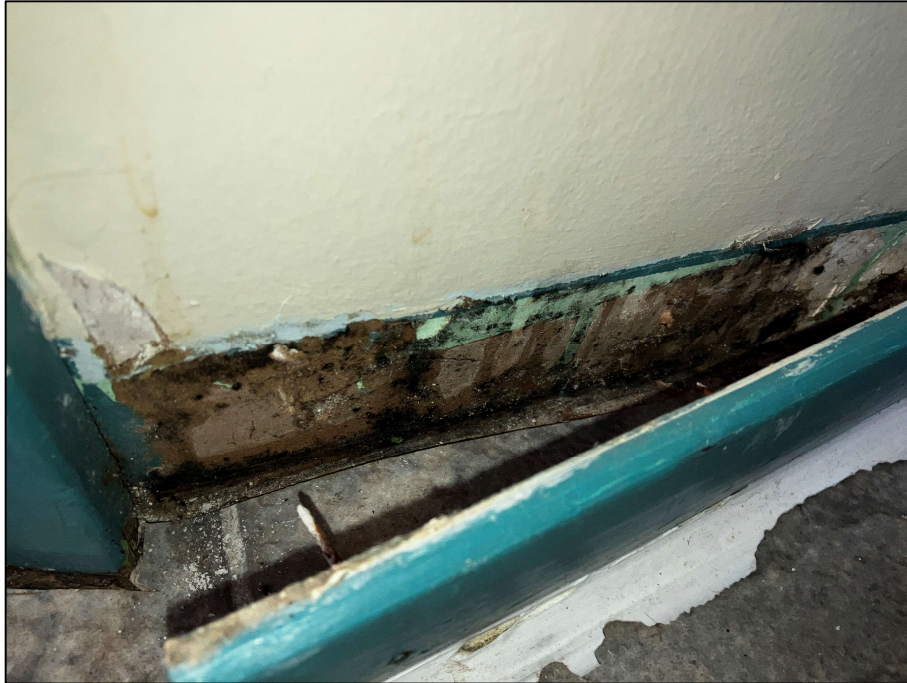
PHOTOGRAPH #28: Organic Growth Behind Bathroom Baseboard

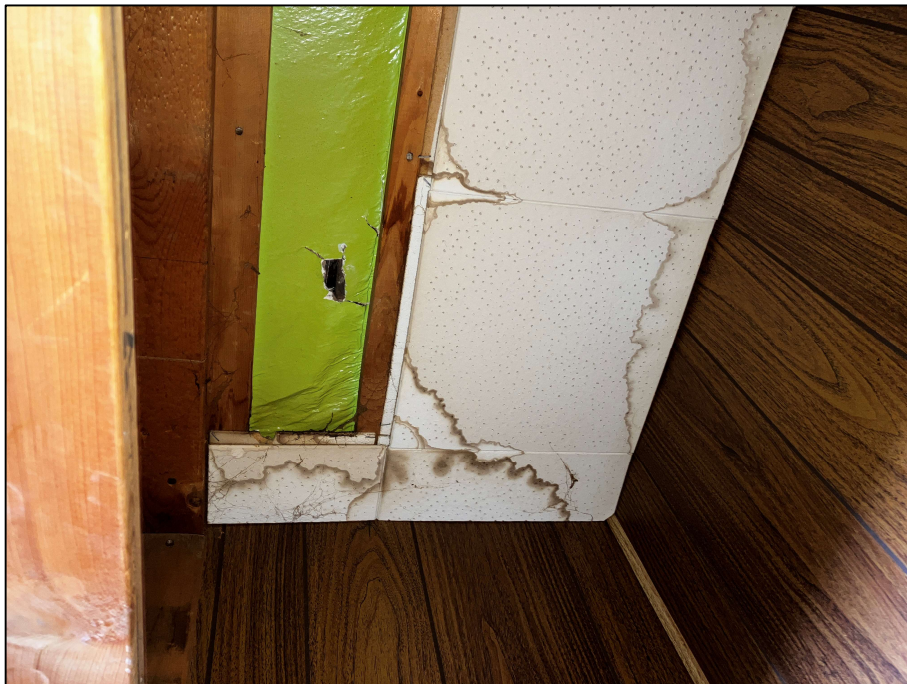
Water damage ceiling tiles in foyer.

PHOTOGRAPH #29: Water Damaged Ceiling Tile in Foyer

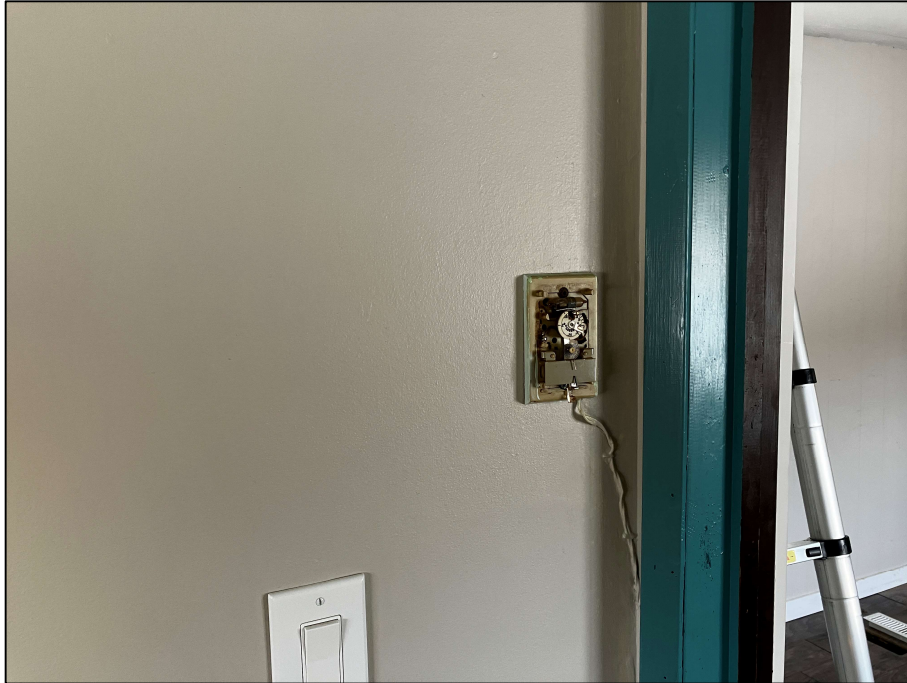
PHOTOGRAPH #30: Mercury Thermostat

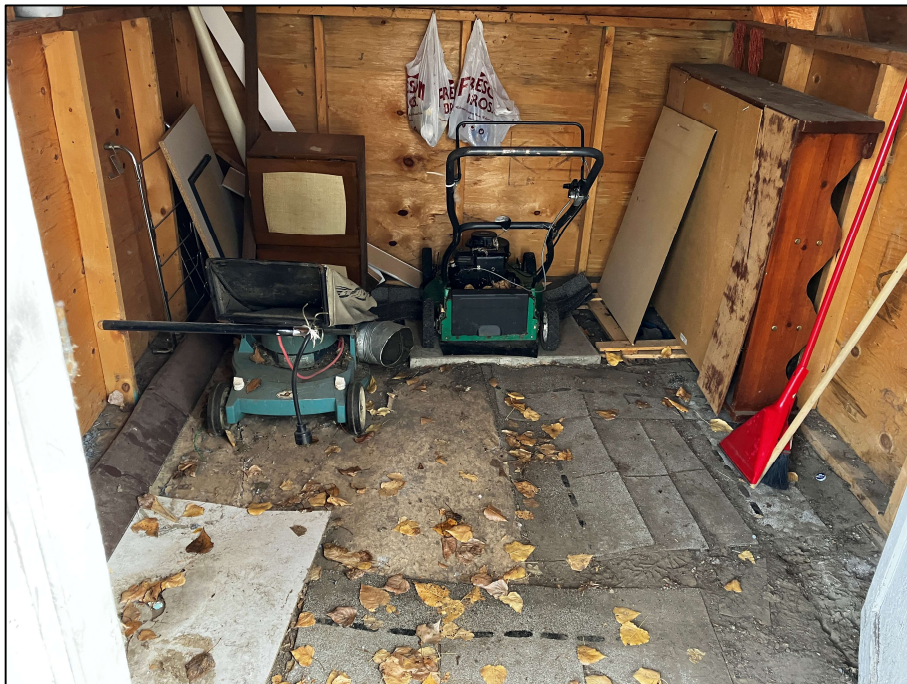
PHOTOGRAPH #31: Small Shed with Lawn Mower Units
