# **APPRAISAL OF REAL PROPERTY**

106 2nd Street W  
Lehigh, AB T0J 1B0  
PLAN 8810626 BLOCK 1 LOT 3

**RE:** **Hazardous Material Assessment Report**  
106 2 St Lehigh  
**Project #: E3030-C**

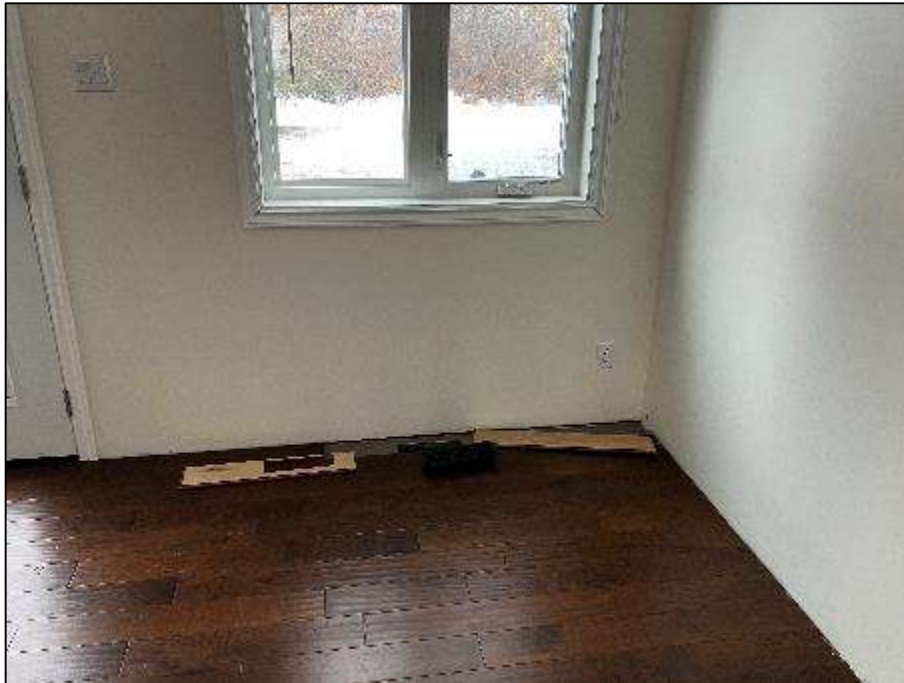
**PHOTOGRAPH #1:** Drywall Joint Compound - Level 1 SW Bedroom Exterior (None Detected)

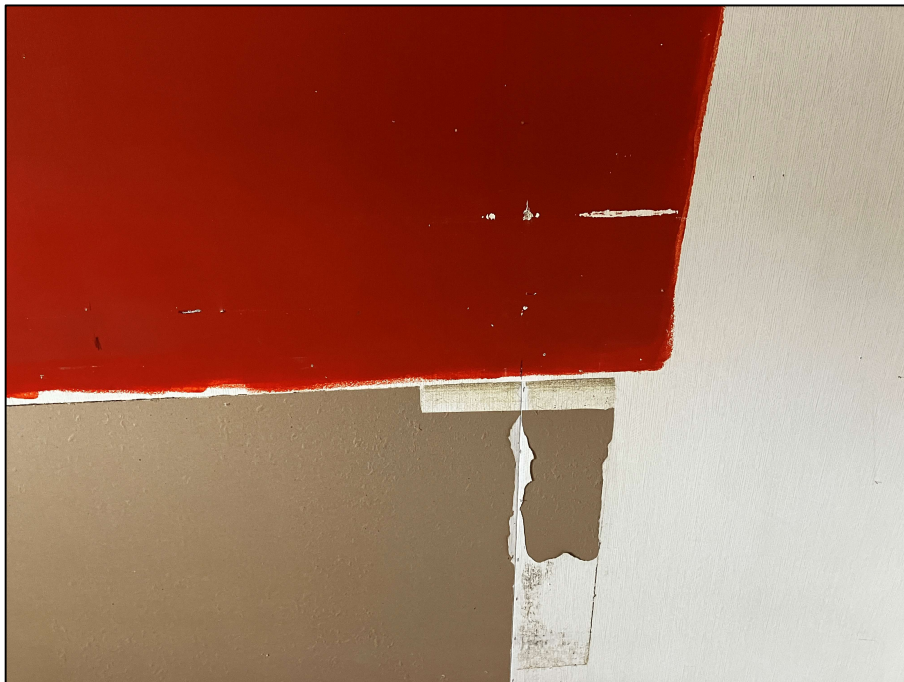
**PHOTOGRAPH #2:** Drywall Joint Compound - Level 1 S Bedroom Exterior (None Detected)

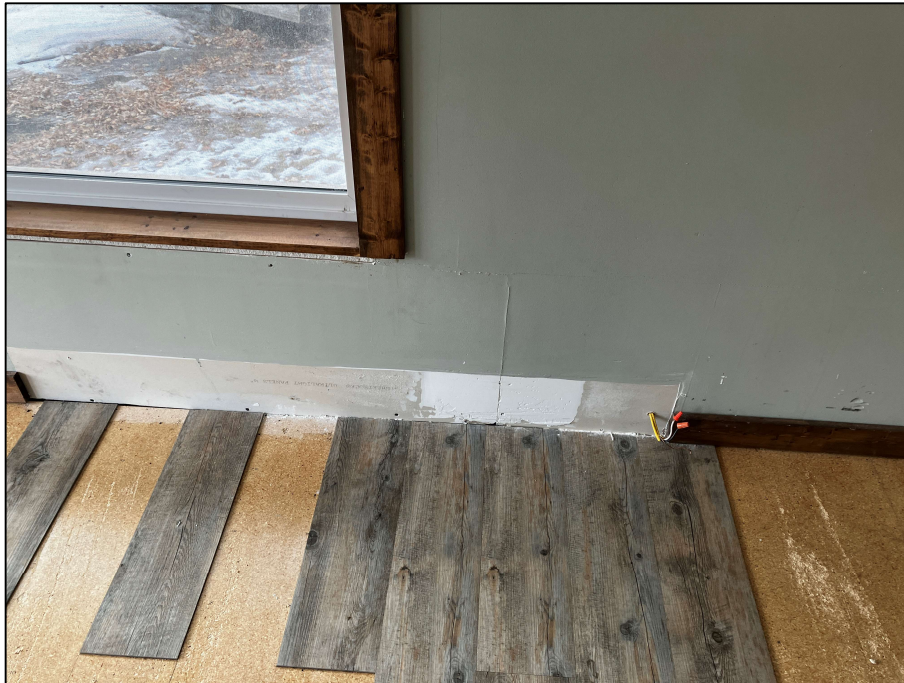
**PHOTOGRAPH #3:** Drywall Joint Compound - Level 1 Kitchen Exterior (None Detected)

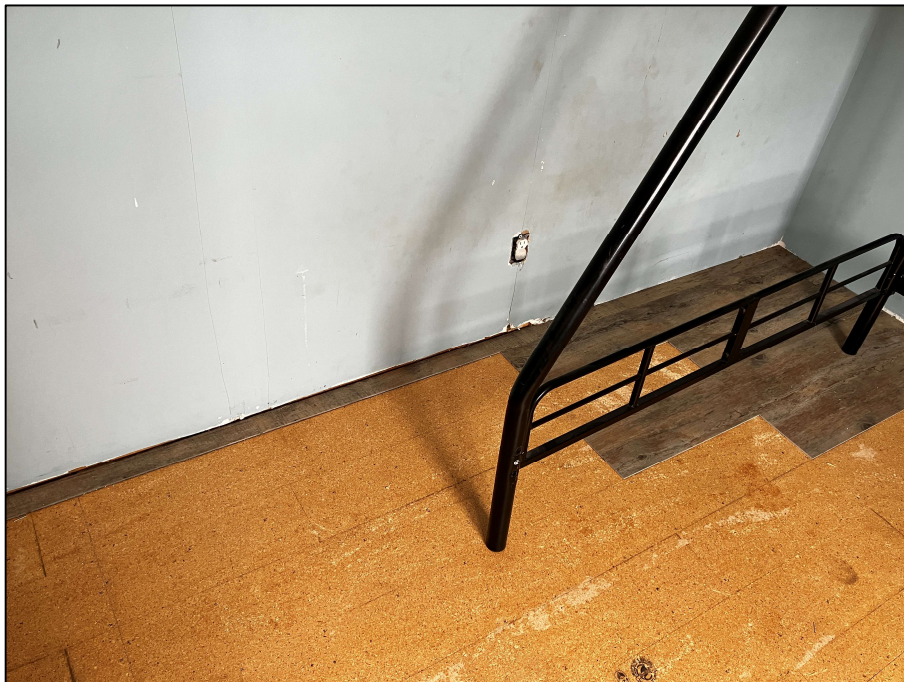
**PHOTOGRAPH #4:** Drywall Joint Compound - Level 1 N Bedroom Interior (None Detected)

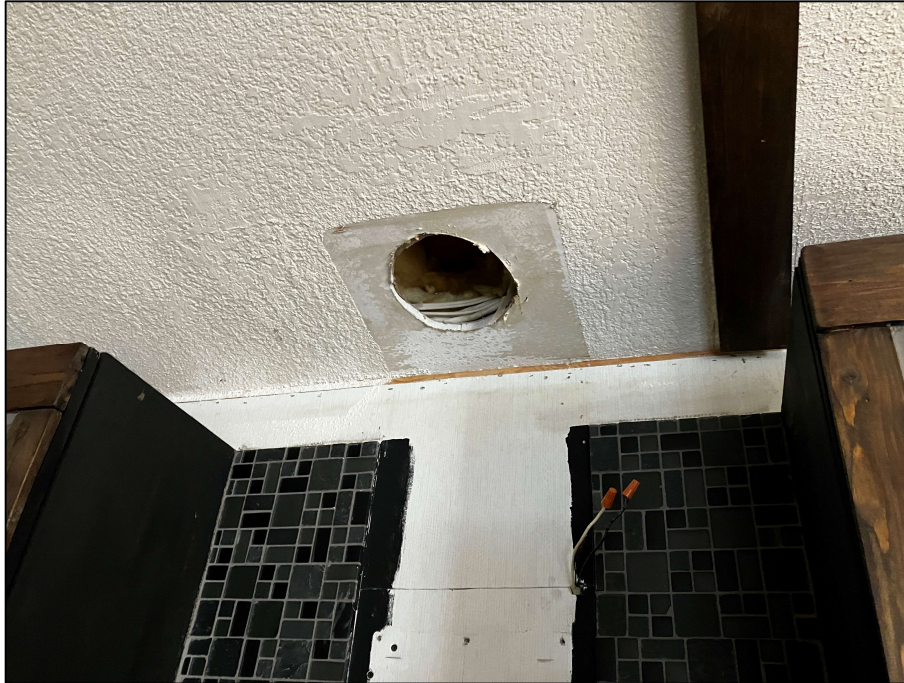
**PHOTOGRAPH #5:** Ceiling Texture - Level 1 Kitchen (None Detected)

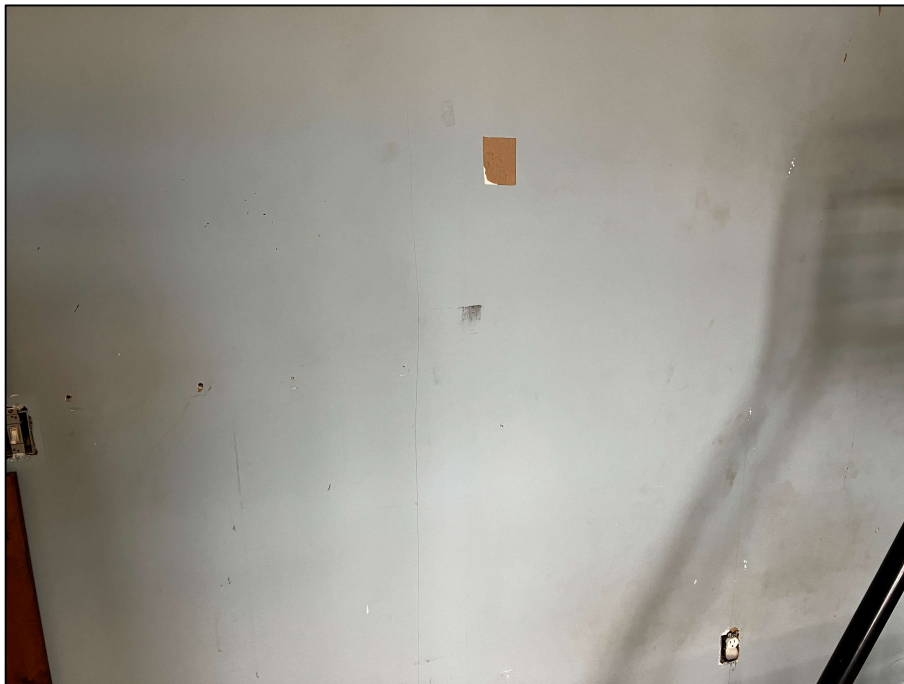
**PHOTOGRAPH #6:** Paint - N Bedroom Pale Blue (<80 ppm Lead)

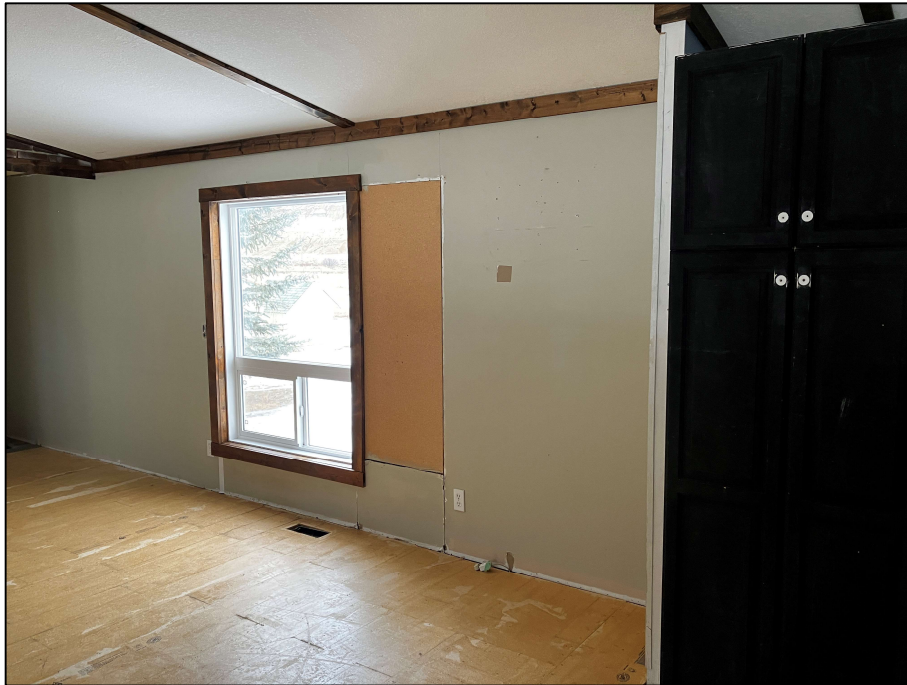
**PHOTOGRAPH #7:** Paint - Kitchen Green (<80 ppm Lead)

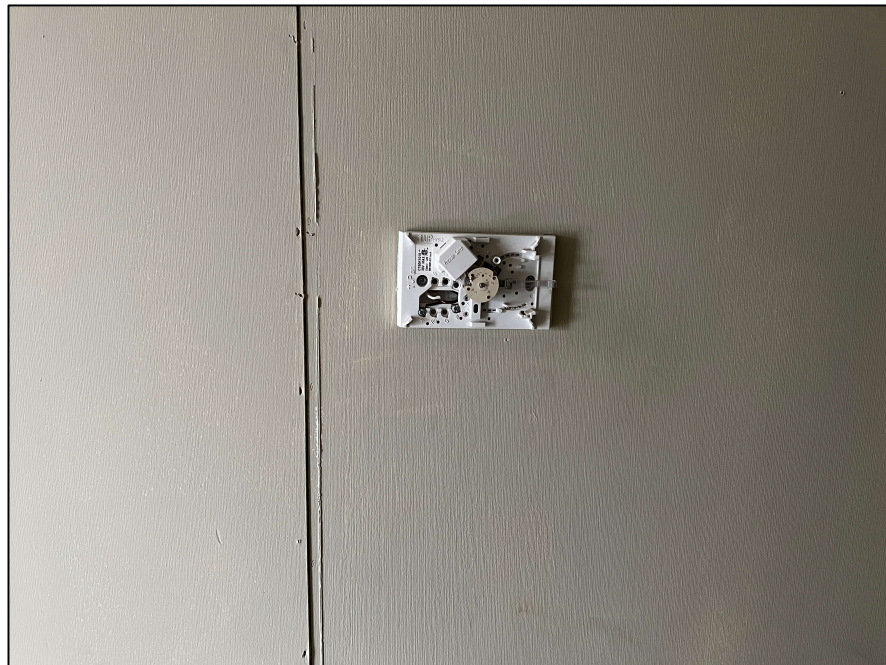
**PHOTOGRAPH #8:** Non-Mercury Containing Thermostat

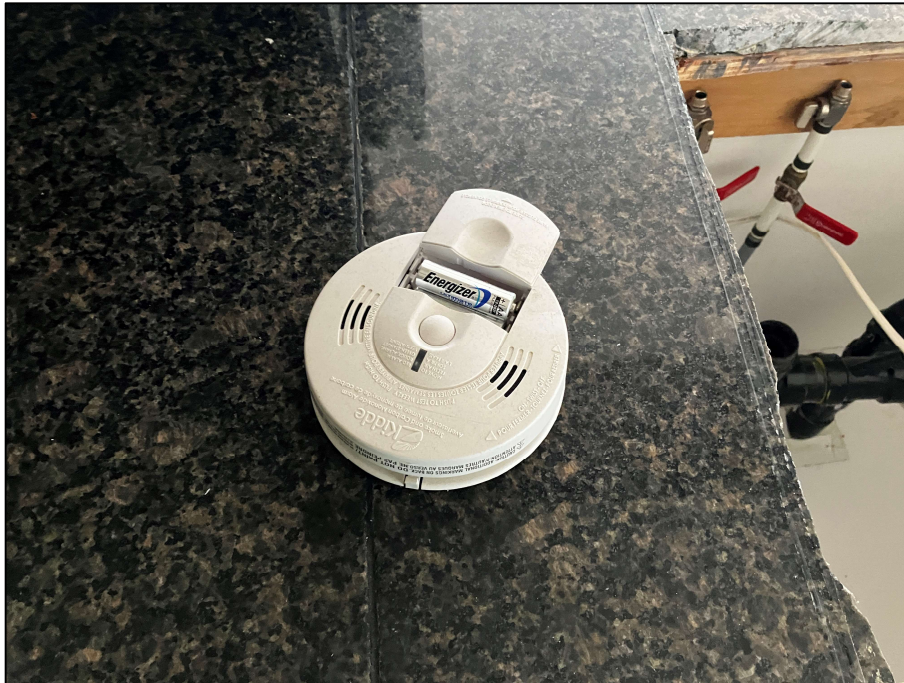
**PHOTOGRAPH #9:** Smoke Detector in Kitchen

1. Hazardous components were identified on site and will require appropriate disposal prior to demolition, including: radioactive materials in smoke detectors, ozone depleting substances in refrigerator units, and miscellaneous chemicals .
2. Should any new materials be identified throughout the process, work should stop until the materials can be assessed by a qualified health and safety professional.

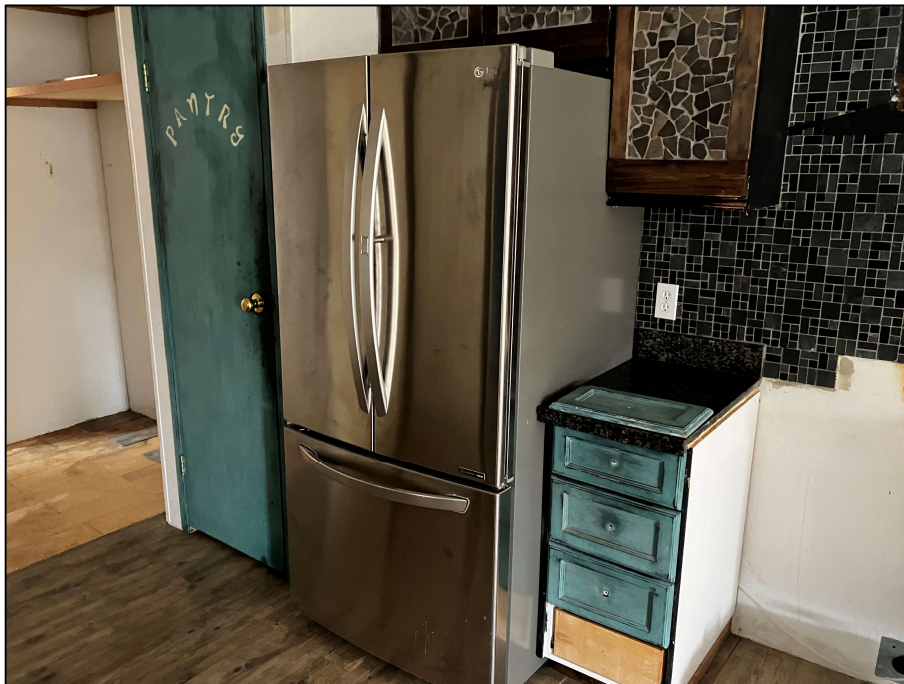
**PHOTOGRAPH #10:** Ozone Depleting Substances in Fridge

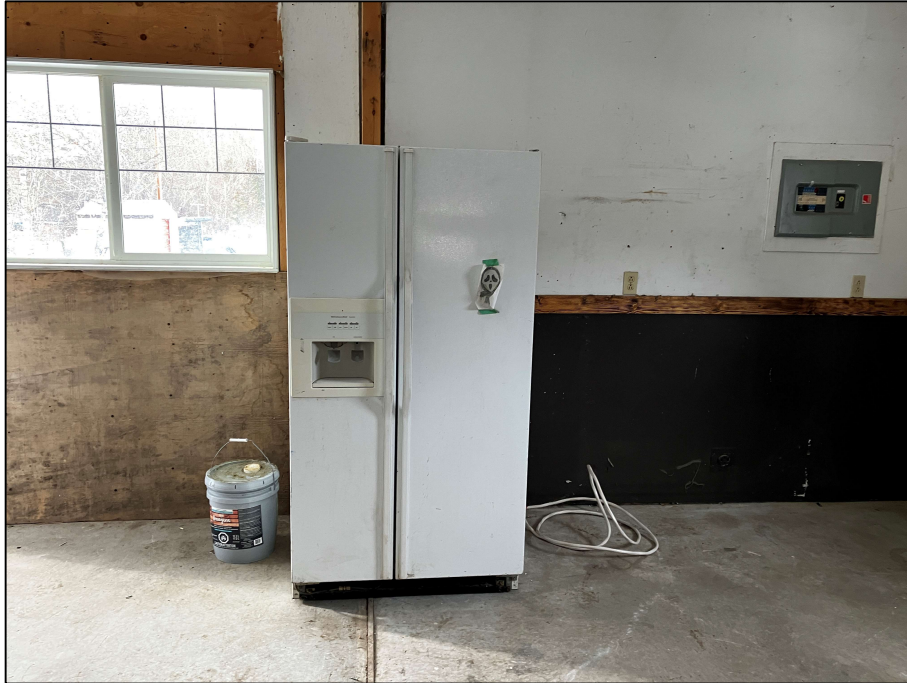
PHOTOGRAPH #11: Ozone Depleting Substances in Fridge

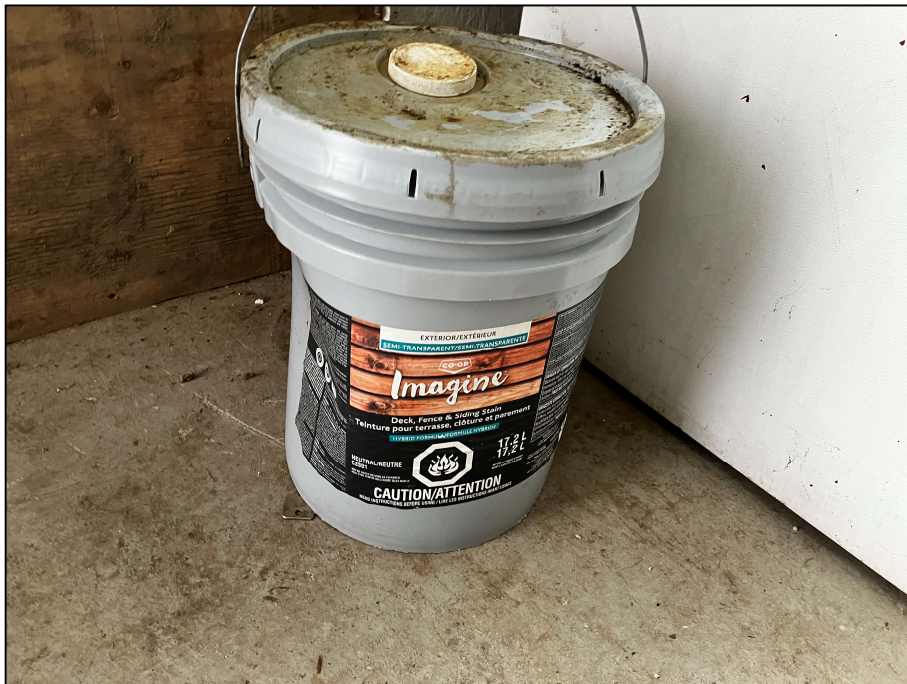
PHOTOGRAPH #12: Miscellaneous Chemicals in Garage

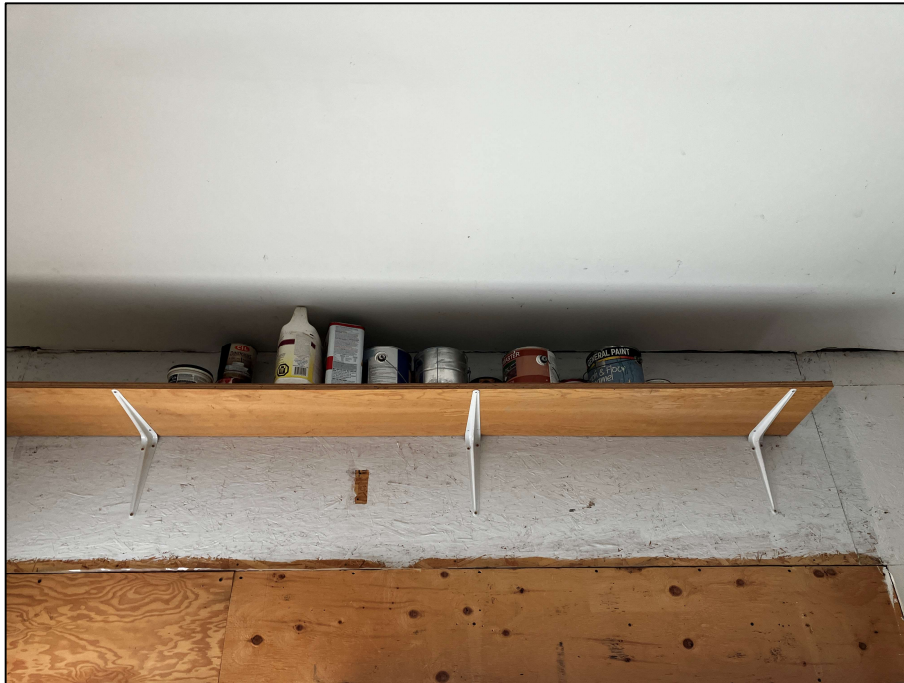
PHOTOGRAPH #13: Miscellaneous Chemicals in Garage

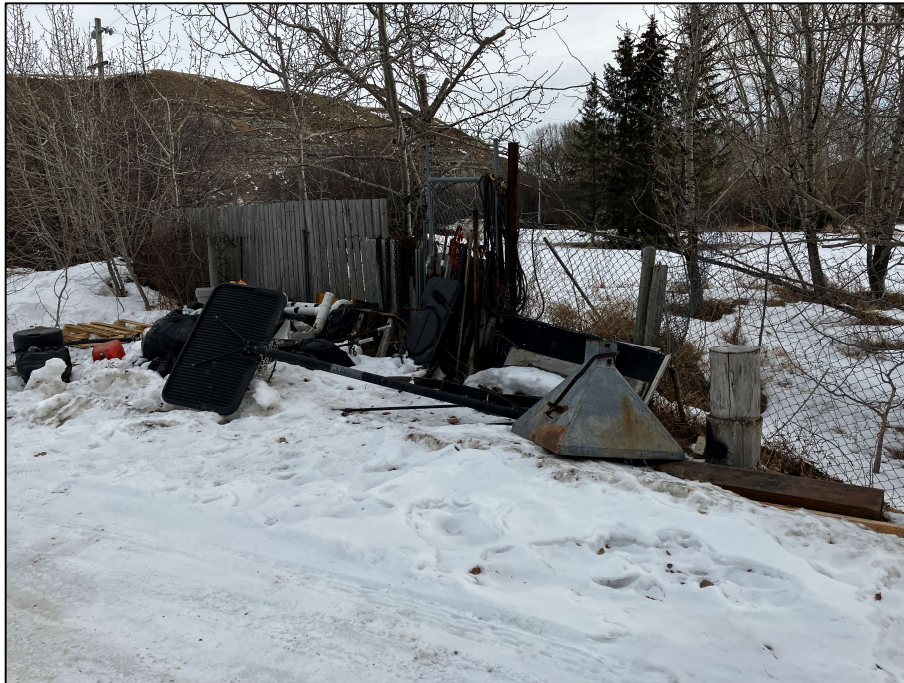
**PHOTOGRAPH #17:** Miscellaneous Chemicals and Debris

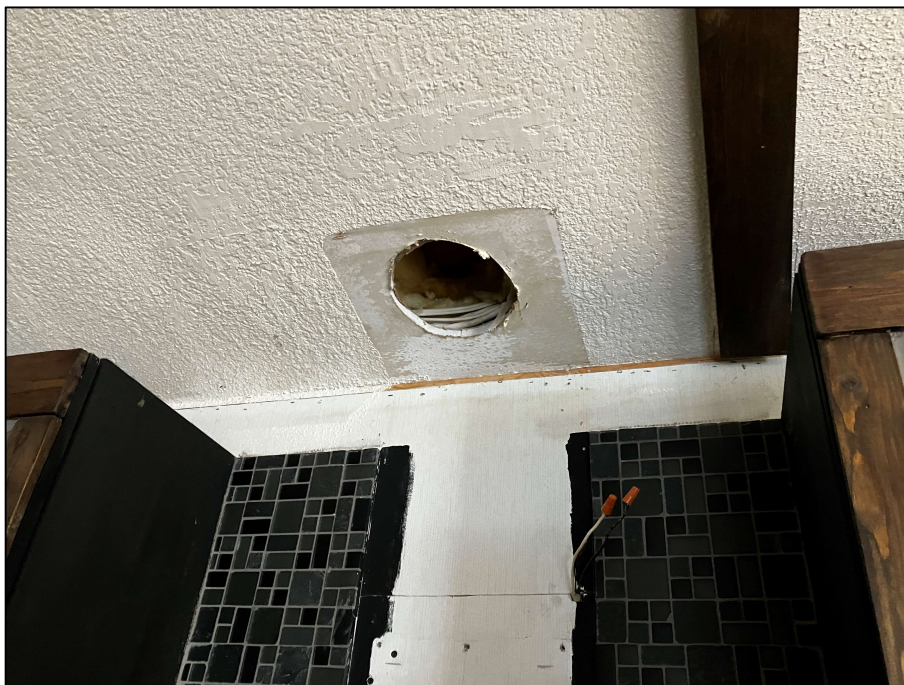
**PHOTOGRAPH #17:** Kitchen Ceiling Penetration into Attic Space
