DRFM Dike D - Geotechnical Investigation Report

FINAL - REVISION NO. 0

Issue Date: September 17, 2021

Project No.: 21.2311.002 Doc No.: D-RPT-GEO-20210917-01

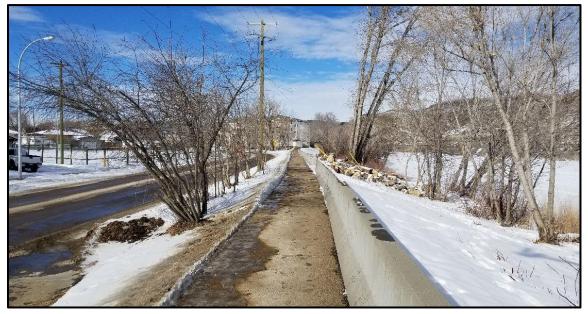
Image 1 - Riverside Drive Conflict Area

the river. The flood barrier along Riverside Drive is currently constructed of concrete jersey barriers with a narrow (<2 m wide) walking path beside it. The portion of the dike alignment with jersey barriers is located between dike station D 0+806 to station D 1+100. If the typical dike detail (trapezoidal 3H:1V side slopes) is utilized in this area and instream river work is to be avoided, the entire width of Riverside Drive falls within the proposed dike footprint. As such, preliminary options for the Aquaplex and Riverview Terrace Condominiums involves the construction of a retention system on the landside of the dike to reduce the proposed footprint. Along Riverside Drive preliminary options include the construction of retaining walls, a combination of retaining walls and reconfiguring Riverside Drive and complete removal of a portion of Riverside Drive to allow for the typical dike section to be constructed. The specific layout, design details and materials for these areas have yet to be selected and further design and decision making from IBI Group and the DRFM is required prior to proceeding with the detailed design for these specific areas.

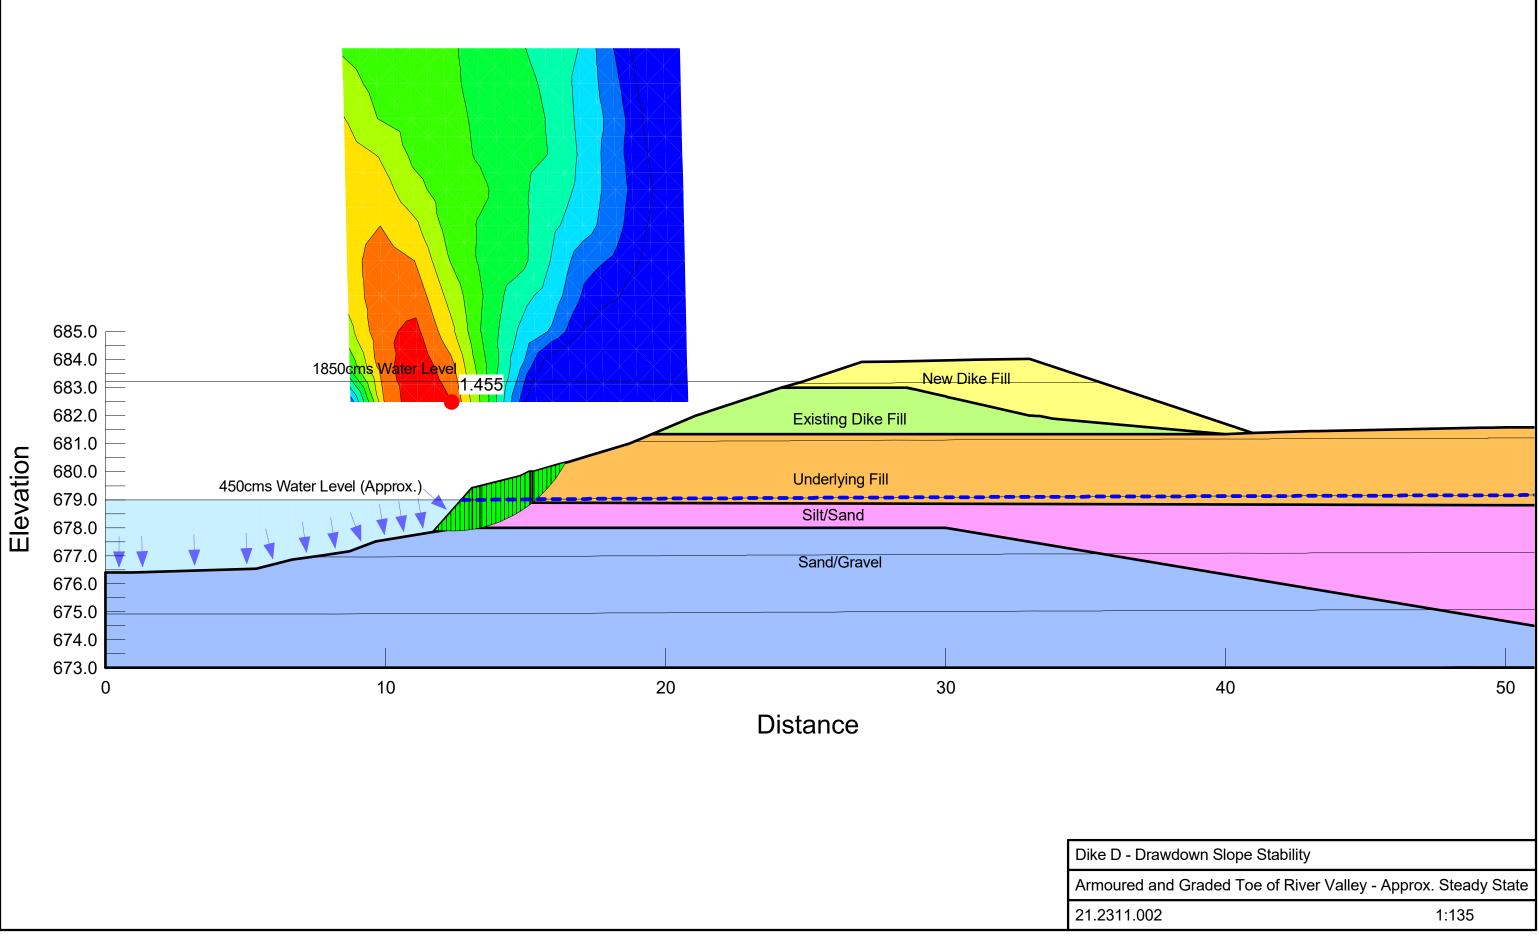
Dike D - Dra
Armoured a
21.2311.00

To avoid these lower safety factors, undercutting of the proposed dike and to avoid further over steepening along the toe of the river valley wall, it is generally recommended to grade and protect the toe of the riverbank utilizing a competent rip-rap material. Where the dike is built within 3 m of the crest of the riverbank, the over steepened bank is to be graded to a 2H:1V and is to be protected with a 1 to 2 m thick layer of keyed-in rip-rap along the toe of the riverbank. This was found to increase the drawdown safety factor to approximately 1.2. This rip-rap placement will allow for the safety factor to increase to above 1.1 under rapid drawdown, as per the "Minimum Design Factors of Safety for DRFM Dikes" found within the Geotechnical Design Basis Memo for the DRFM System. Where the typical dike section is constructed above the riverbank and within 3 m of the crest, The Town of Drumheller could accept the risks of a drawdown induced instability along the toe of the dike and perform critical repairs after a flood event. As the typical dike is not likely with this wider dike section as long as failures are addressed rapidly. Where the typical section is not achieved and is built within 3 m of the crest, keyed-in rip-rap will be required to attain the "Minimum Design Factors of Safety for DRFM Dikes".
