TOWN OF DRUMHELLER DIKE C – NORTH DRUMHELLER GROVE PLAZA DIKE PROJECT

Volume 2 of 3: Contract Information Documents

March 31, 2022
Project No. RD6950-03

Re: Berm Material Borrow Summary
Drumheller, AB

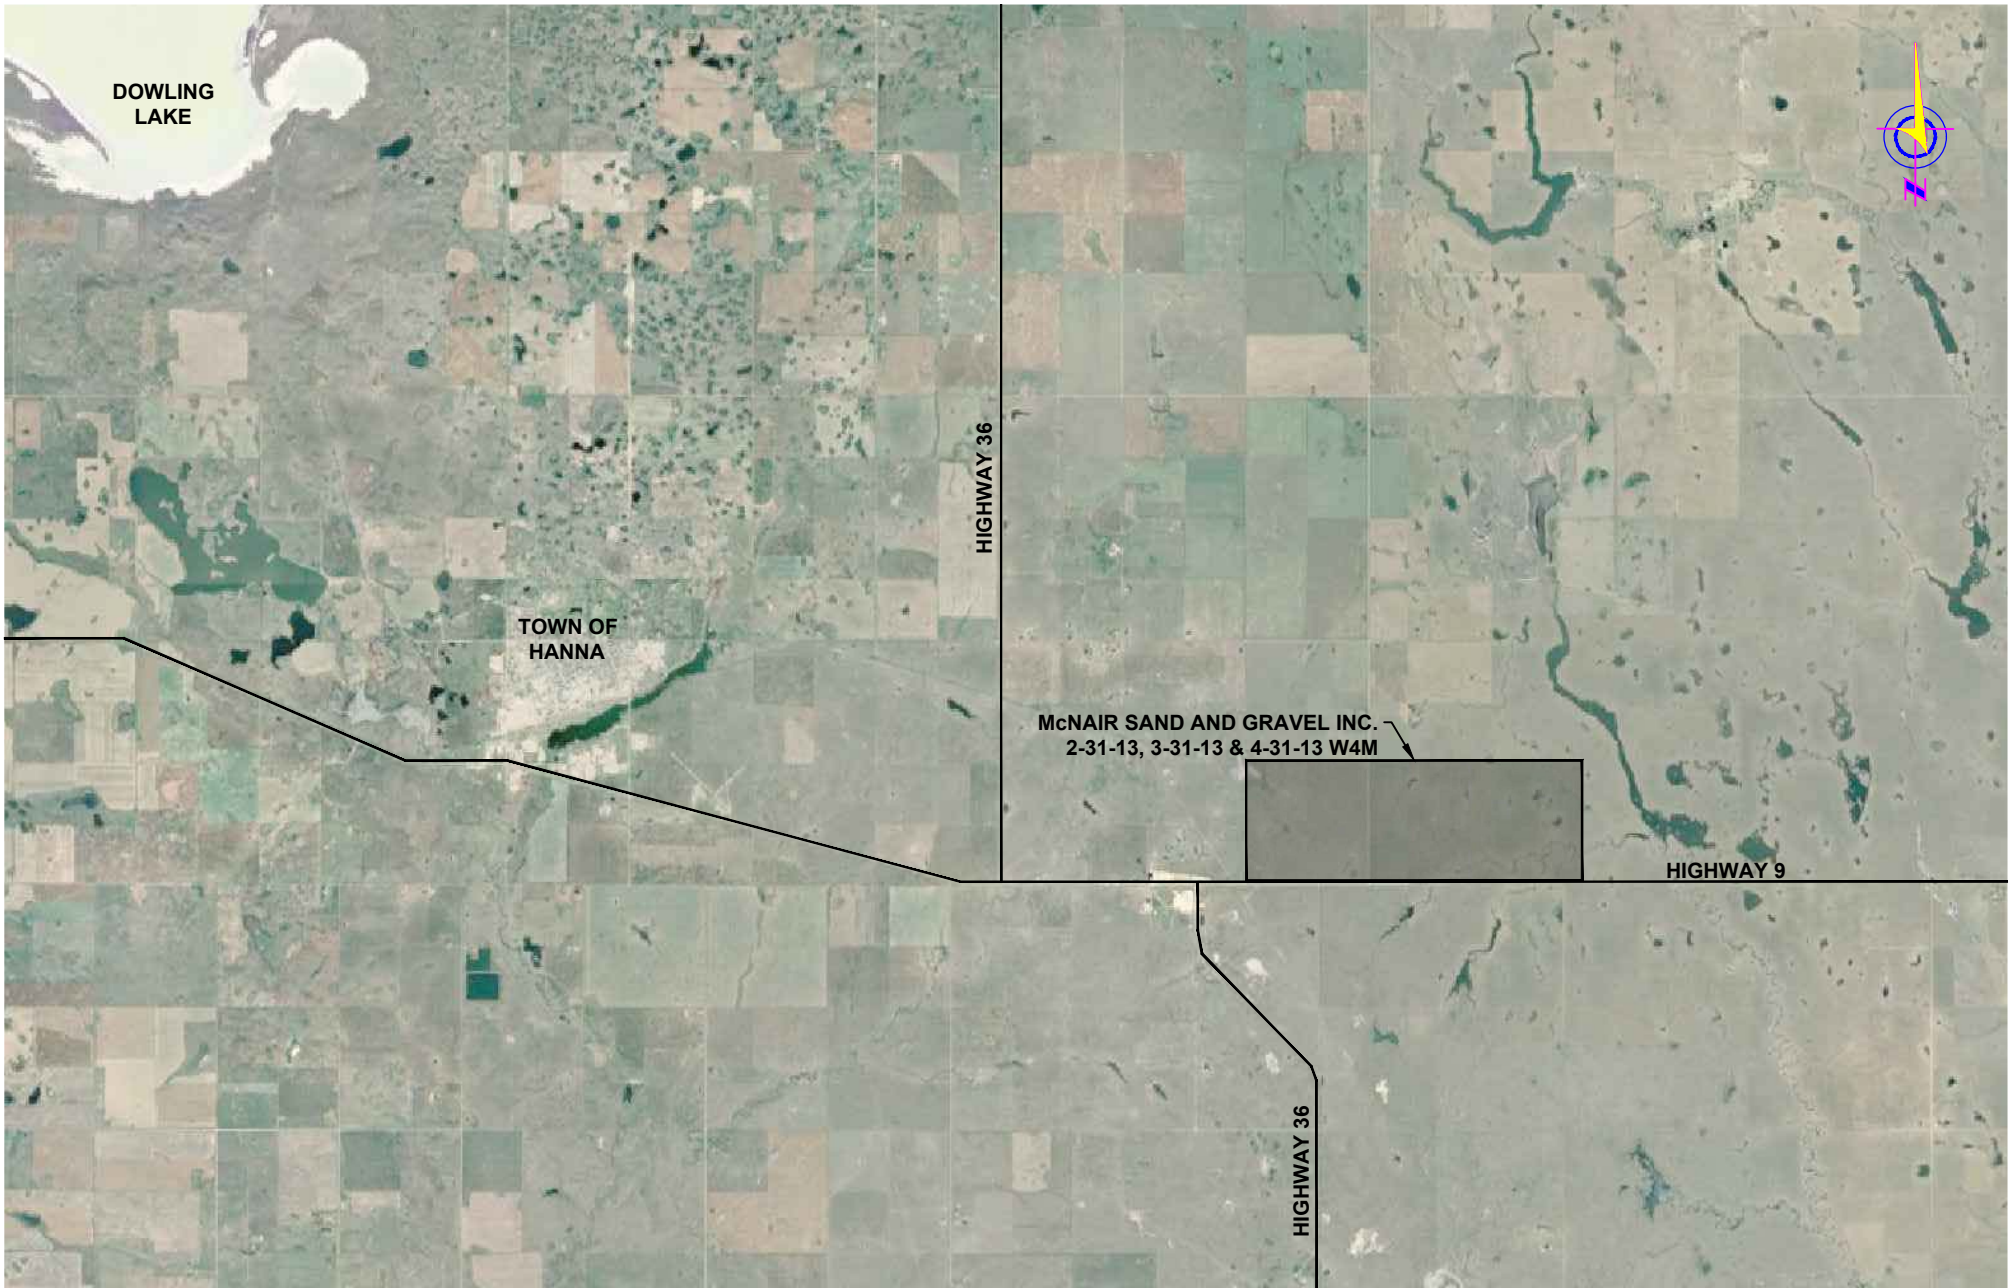
DRAWN: NC	CHK'D.: BK	REV #: 0	DATE: MARCH 2022
SCALE: 1:100,000	JOB NO. RD6950-03	DRAWING NO. FIGURE 3

AERIAL PLAN - HANNA

BORROW SOURCE SITES
2-31-13 W4M, 3-31-13 W4M & 4-31-13 W4M, ALBERTA

McNair Sand and Gravel Inc.	Miles McNair	403-850-5956	Miles@mcnairmsg.ca	TBD*	No information on soil	4-31-13-W4M & 3-31-13-W4M & 2-31-13-W4M	4
D+K Christensen Farms Ltd.	Duane Christensen	403-334-3644	dewakat@aisnet.co	TBD*	No information on soil	S 36-27-19-W4M	4

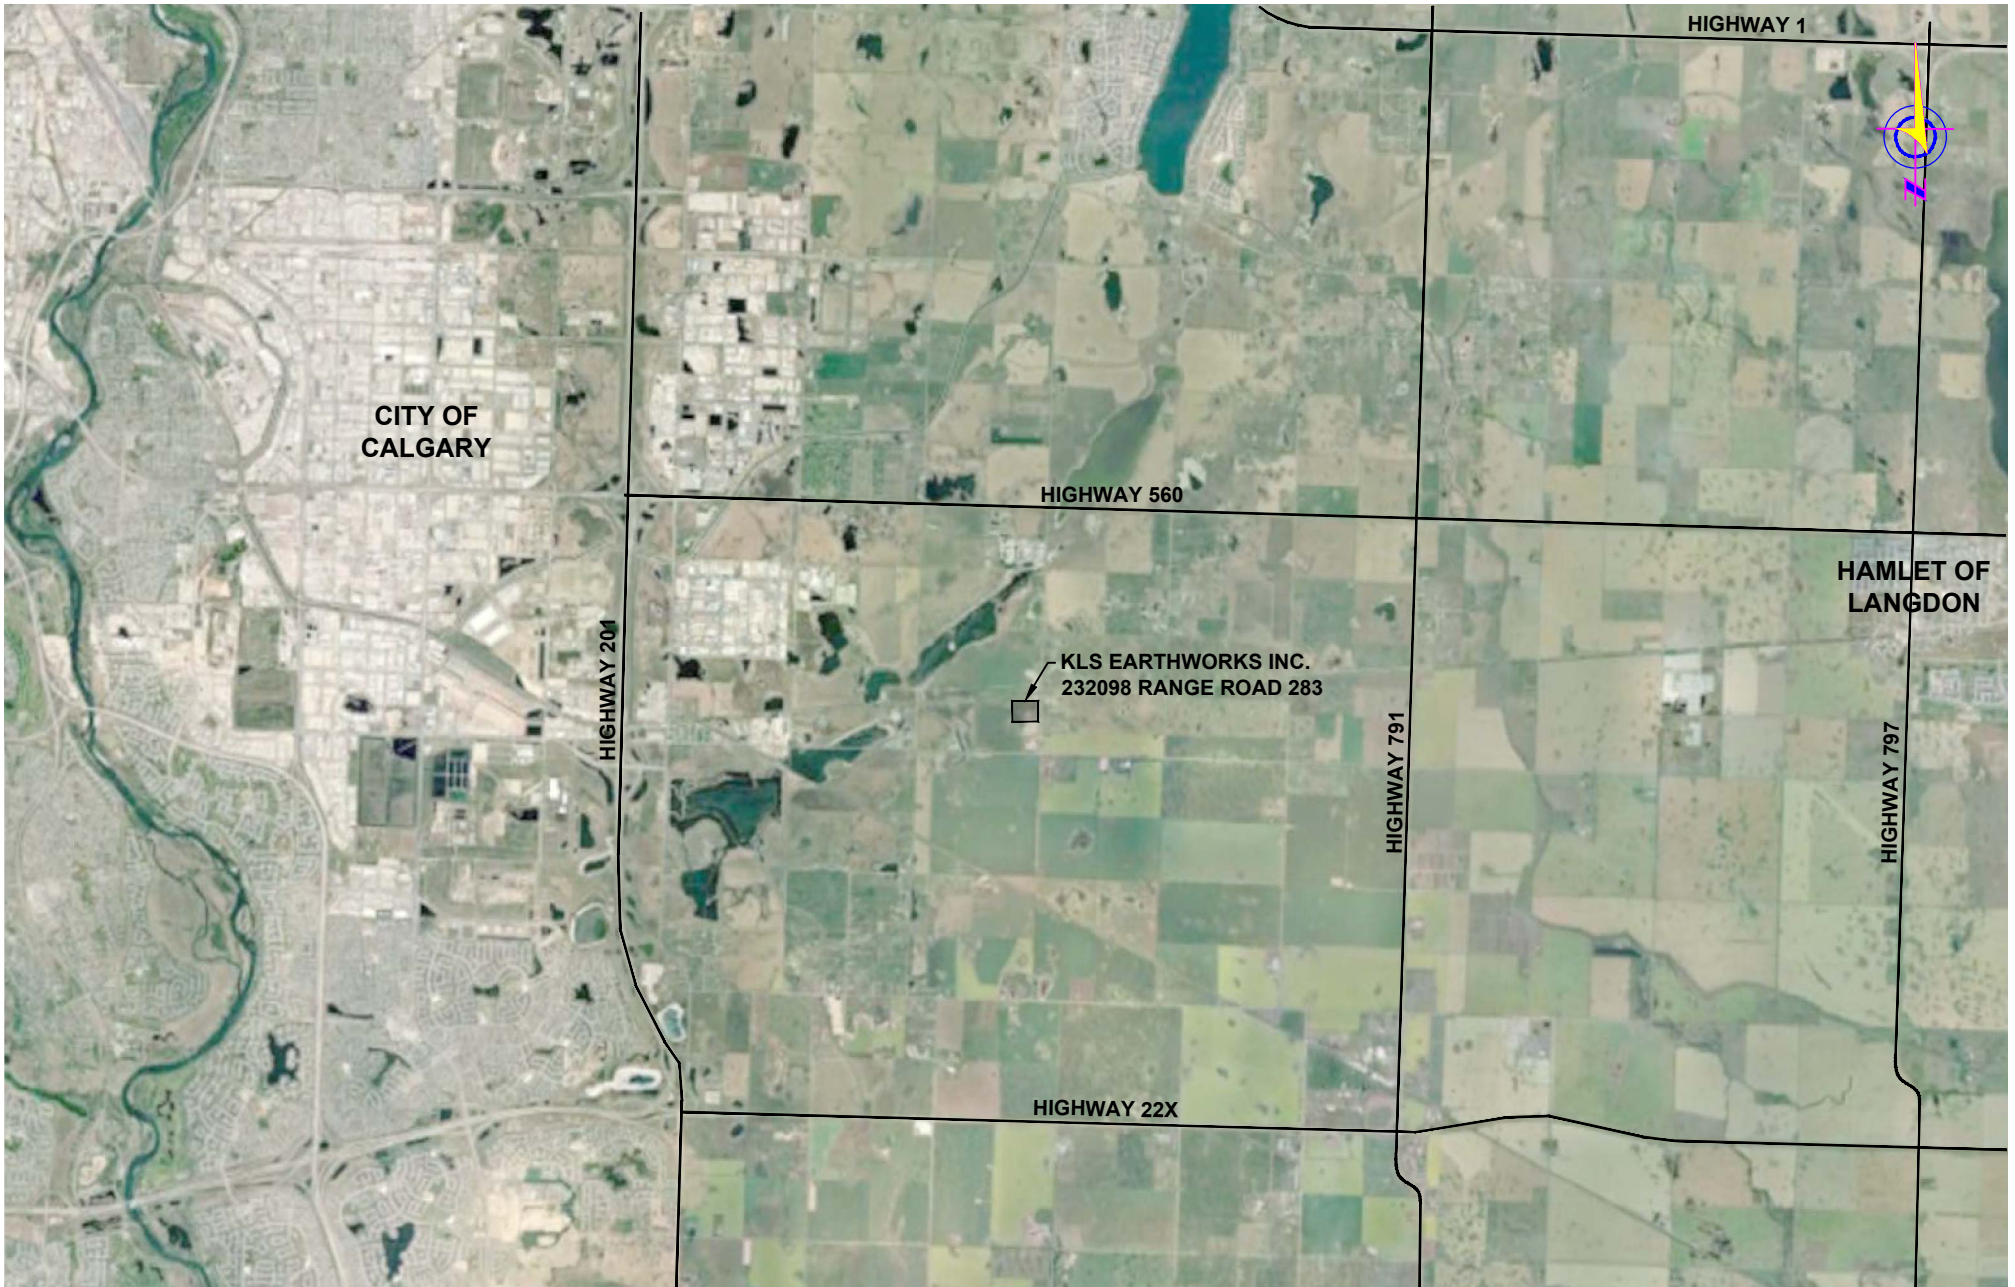
DRAWN: NC	CHK'D.: BK	REV #: 0	DATE: MARCH 2022
SCALE: 1:100,000		JOB NO. RD6950-03	DRAWING NO. FIGURE 5

AERIAL PLAN - CALGARY

BORROW SOURCE SITES
232098 RANGE ROAD 283, ALBERTA

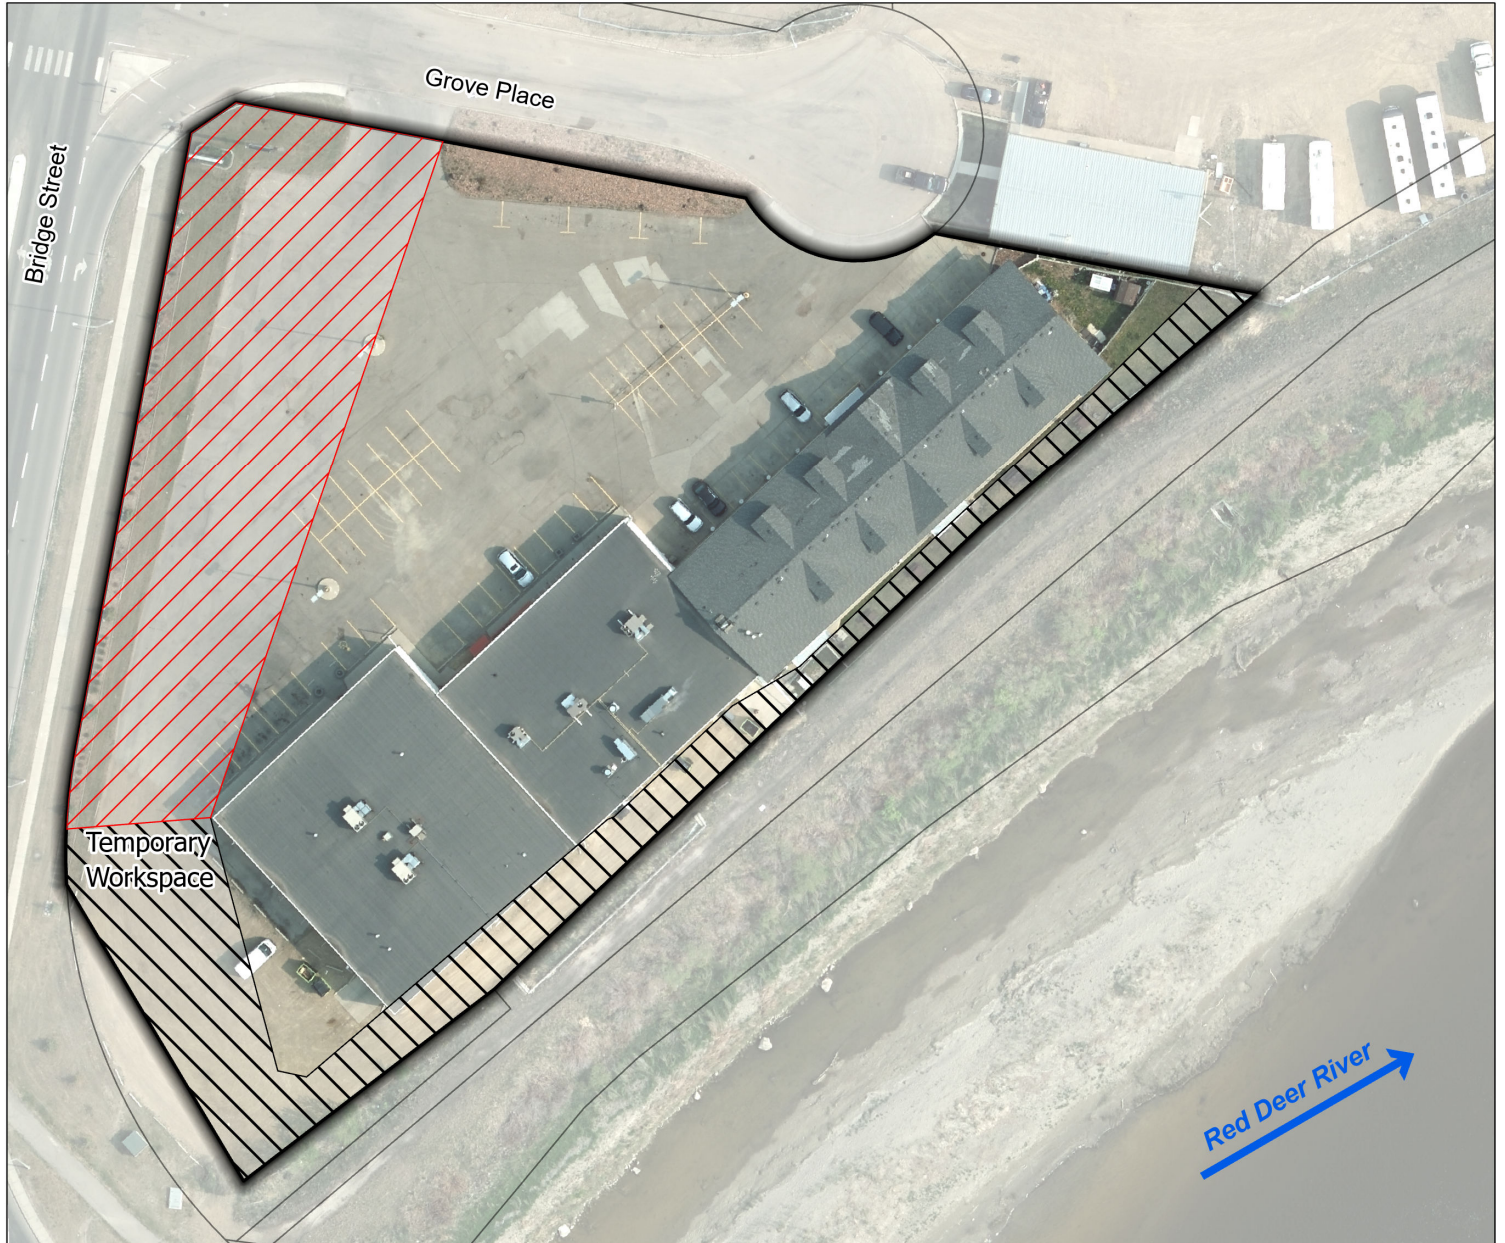
SCHEDULE - A PLAN SHOWING AREA REQUIRED FOR TEMPORARY WORKSPACE

AFFECTING A PORTION OF CONDOMINIUM PLAN NO. 7911235
N.E. 1/4 SEC. 11, TWP. 29, RGE. 20, W.4TH. MER.

LINC	0016892994
C. of T #	7911235CS3 .
Area Required	TWS: 13,580 Sq Ft (approximate) Access: 21,582 Sq Ft (approximate)
Registered Owner(s)	1363657 Alberta Ltd.
Phone	403-820-2337
Dike Version Date	2022-03-17
