HOME
INSPECTION

Inspection Report

Property Address:
964 Hunter Drive - Nacmine
Drumheller Alberta T0J 0Y0

| Date: 16/12/2021 | Time: 11:00 AM | Report ID: 964 Hunter Drive - Nacmine |

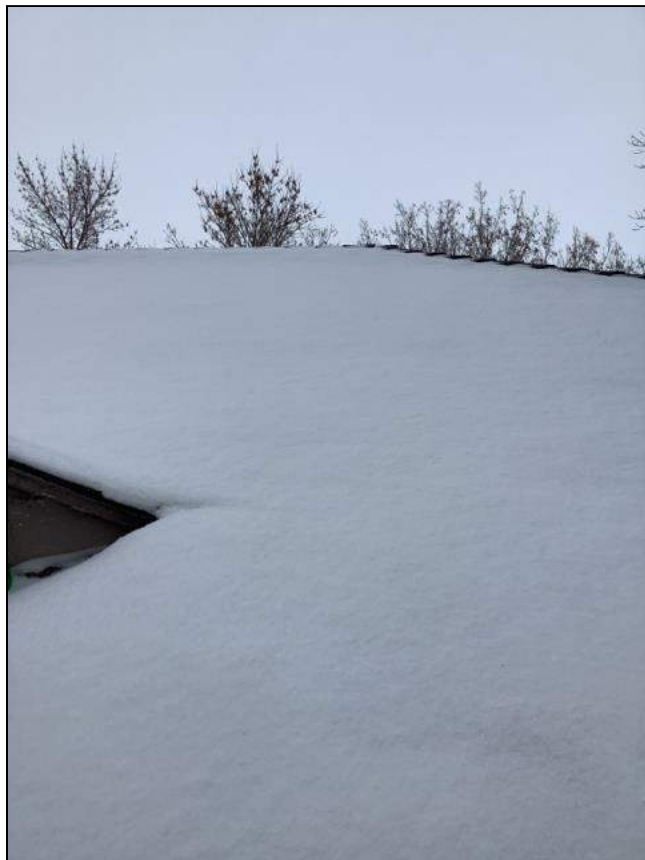
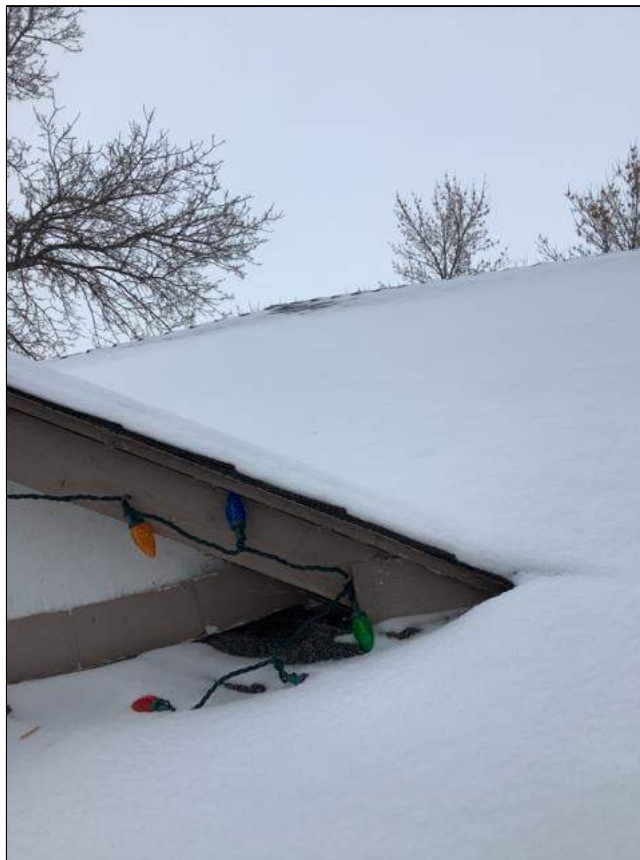
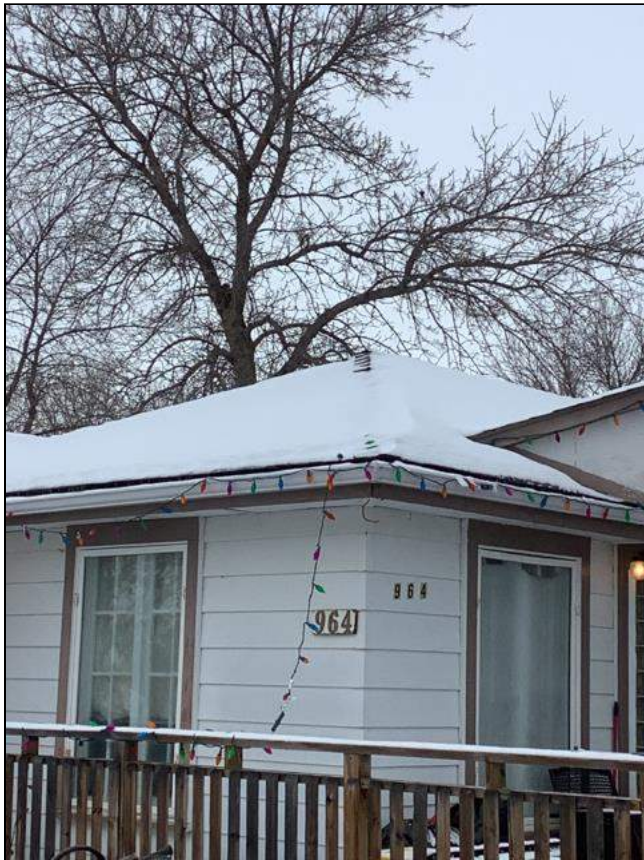
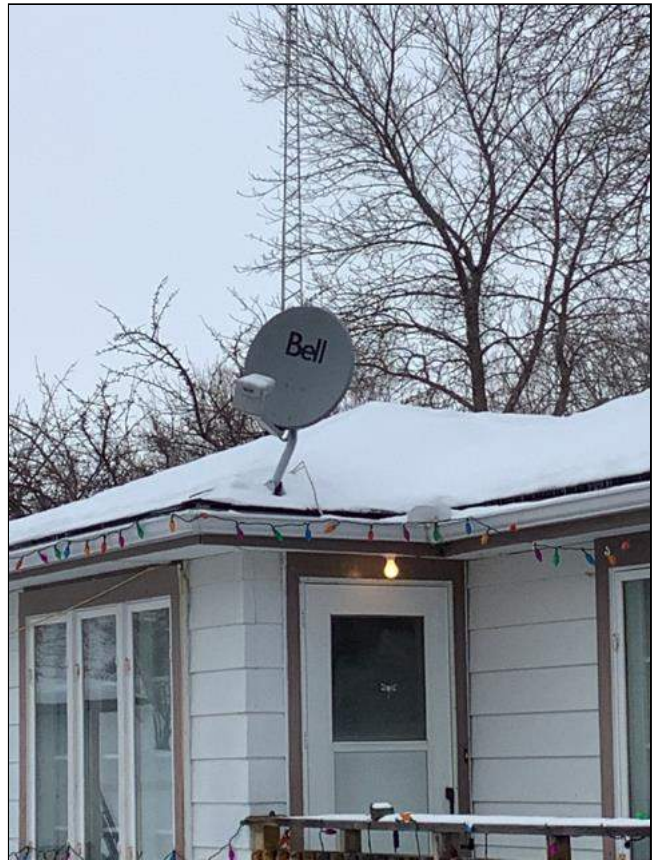
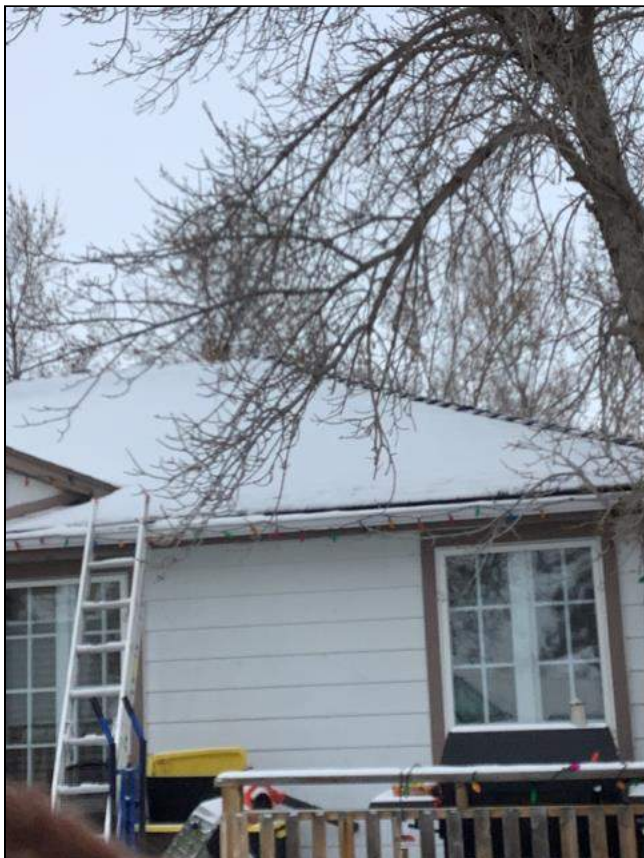
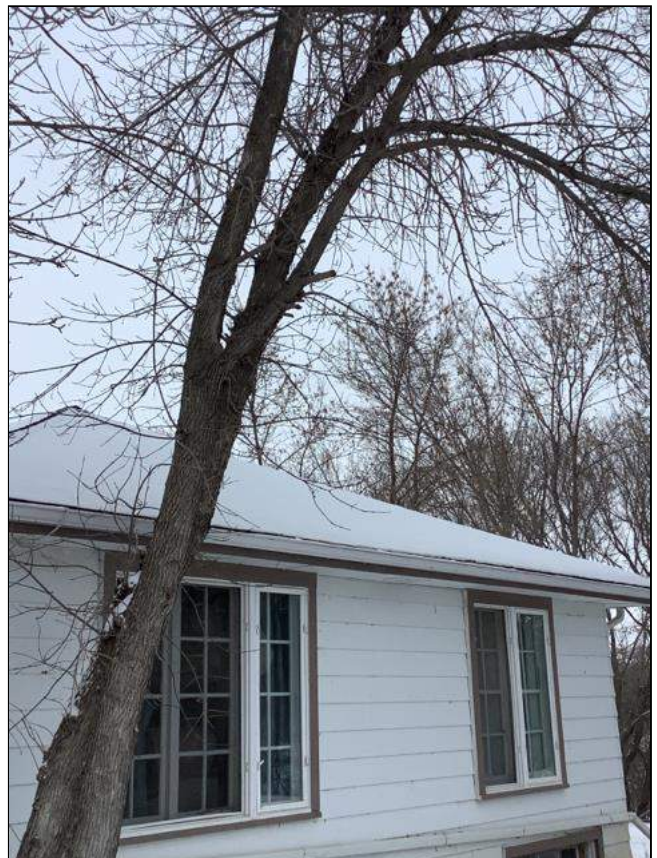
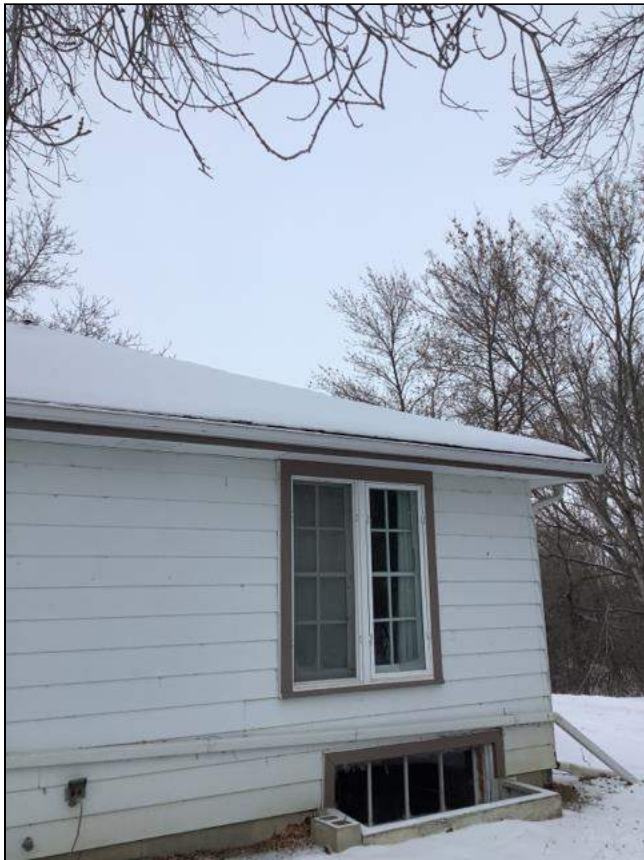
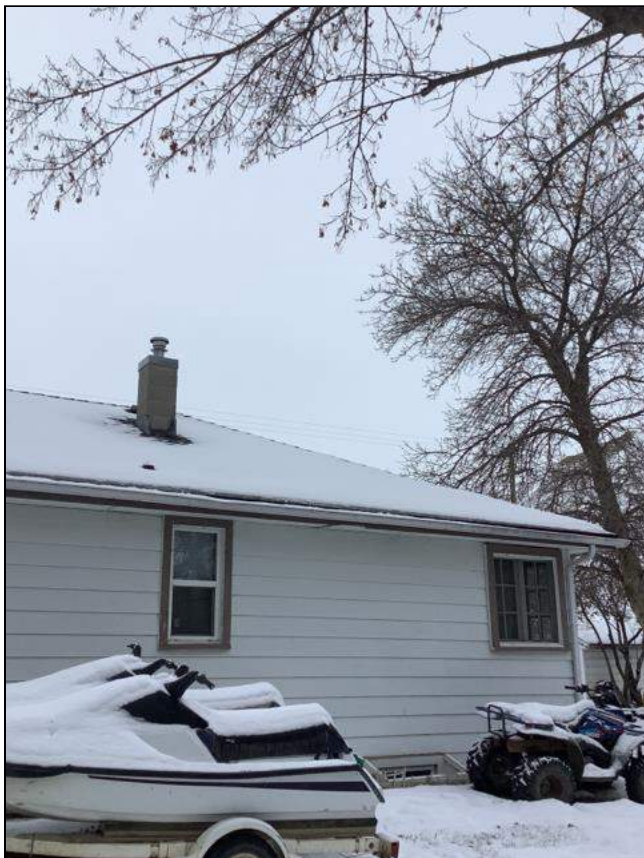
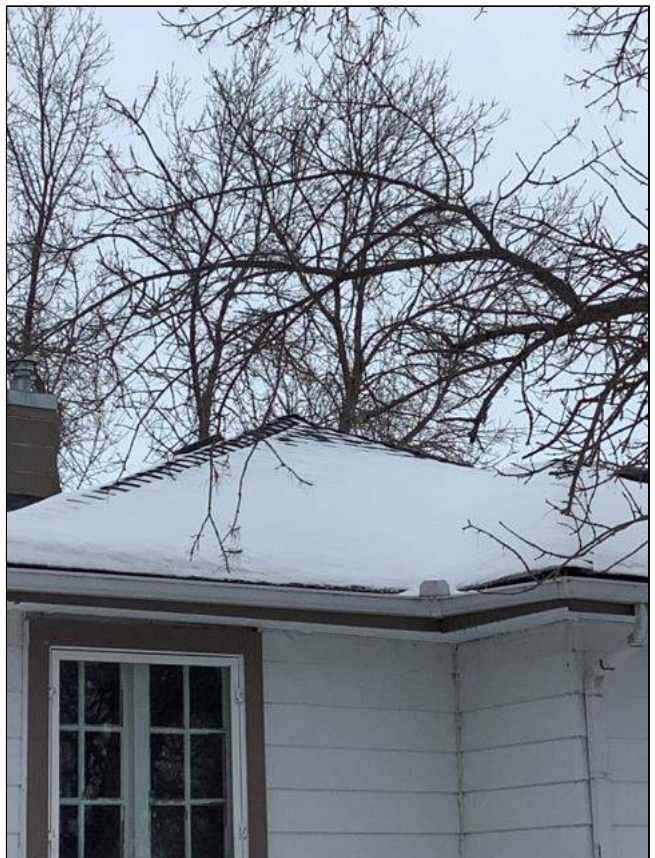
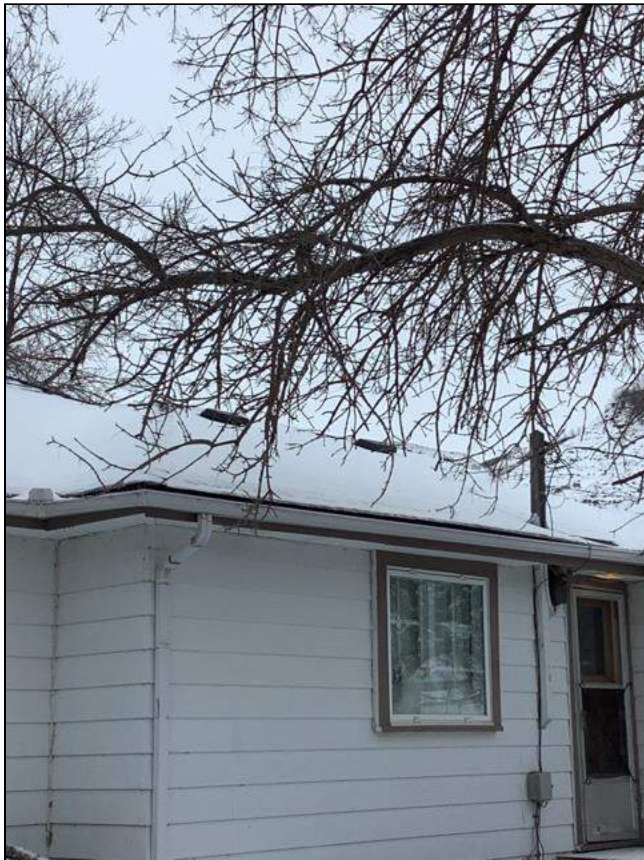
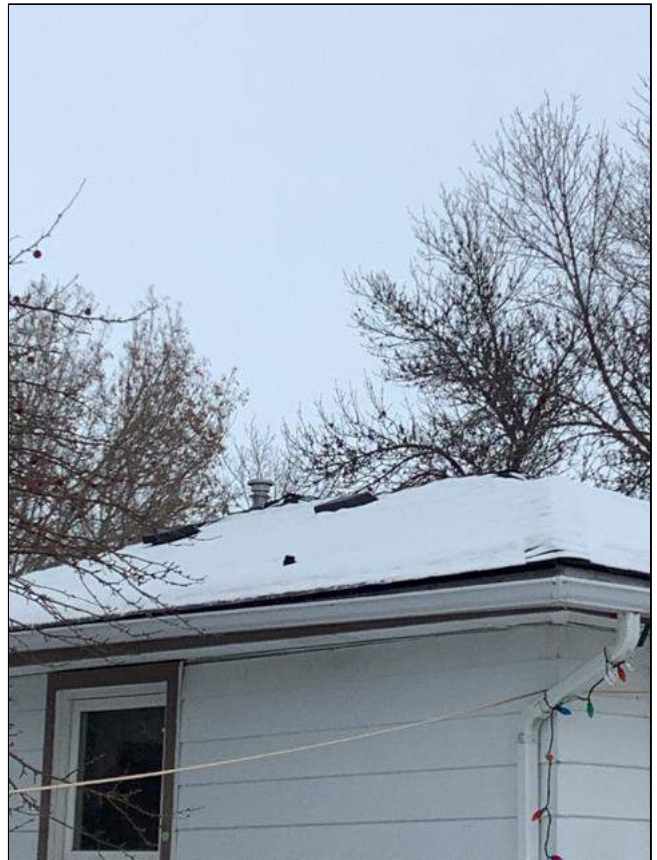
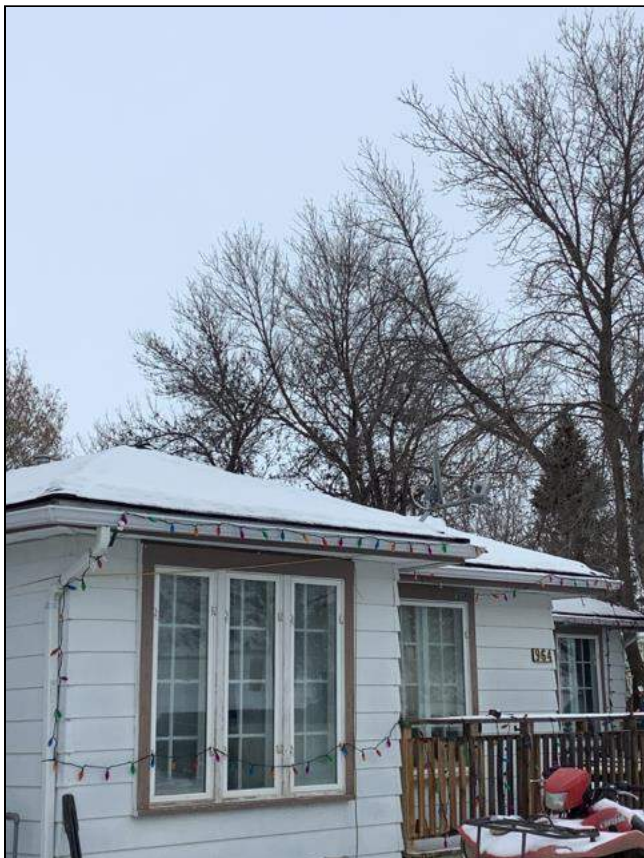
Roof was limited to a visual inspection with the use of binoculars and from a ladders edge as it was covered in snow, no issues to report from what was seen.

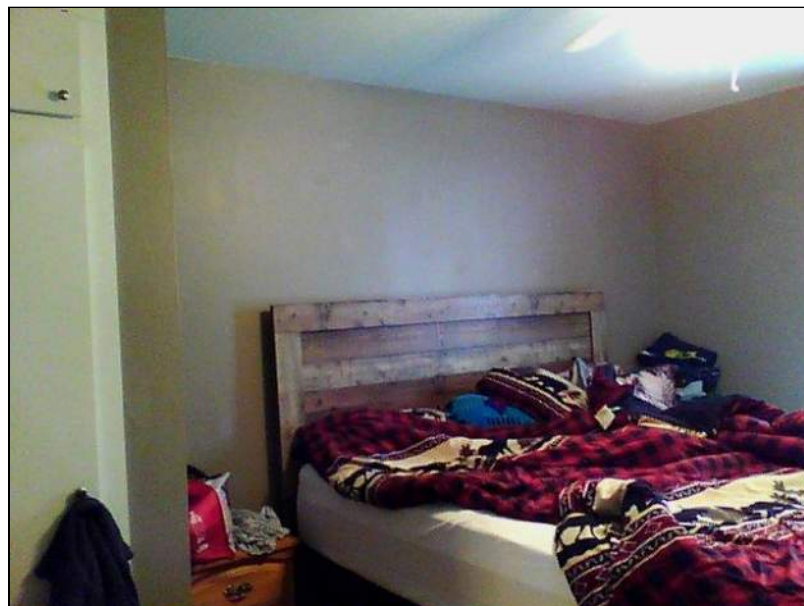
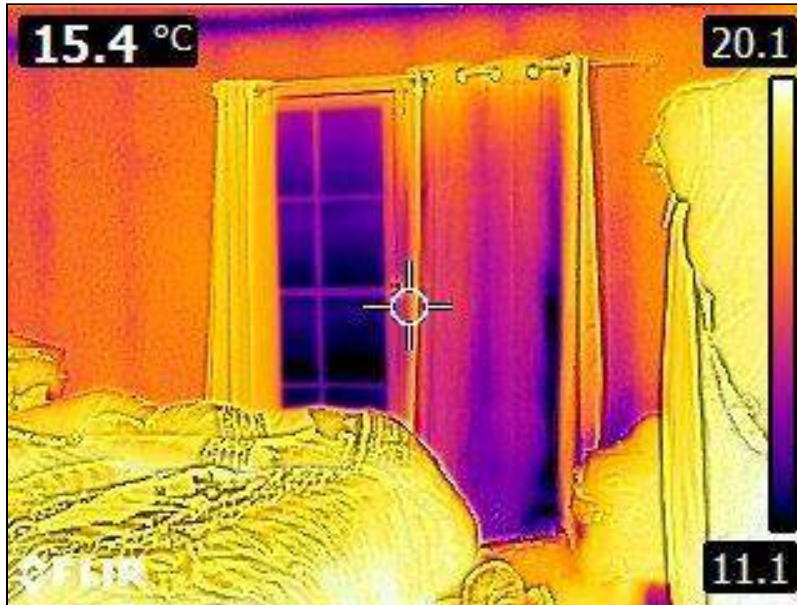
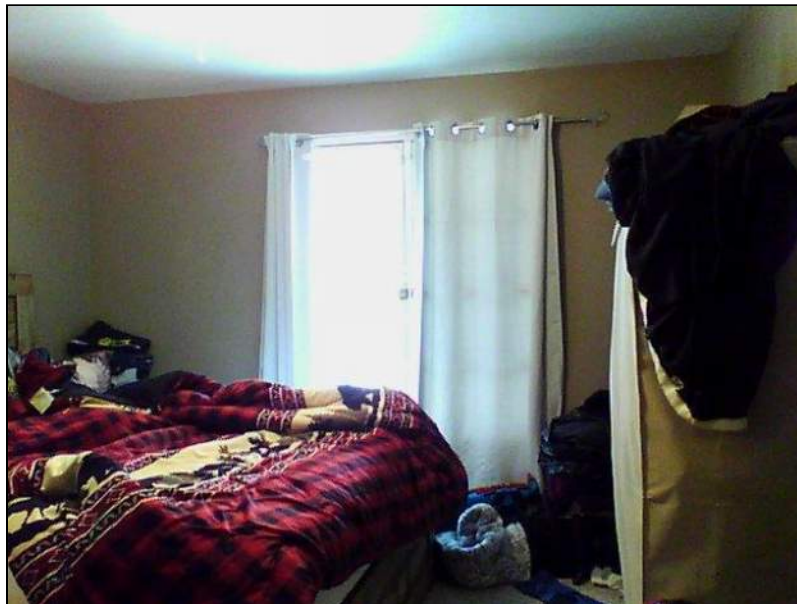
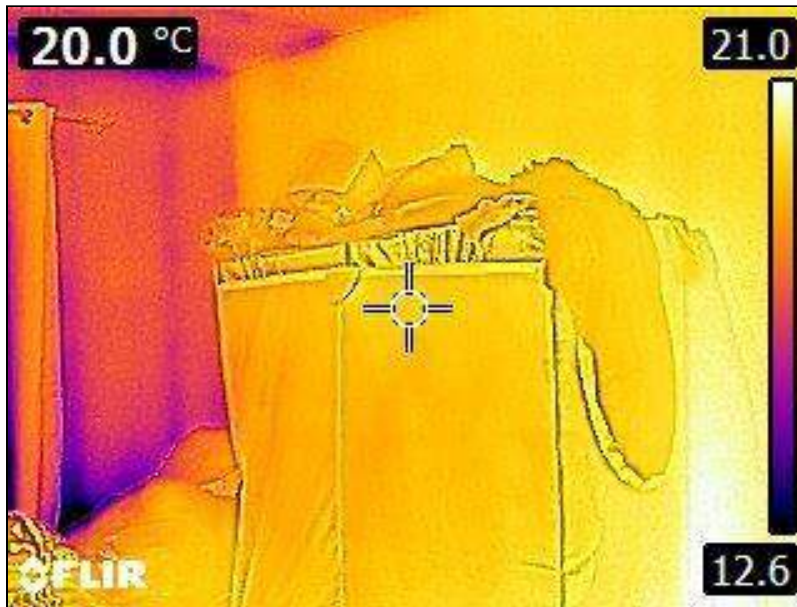
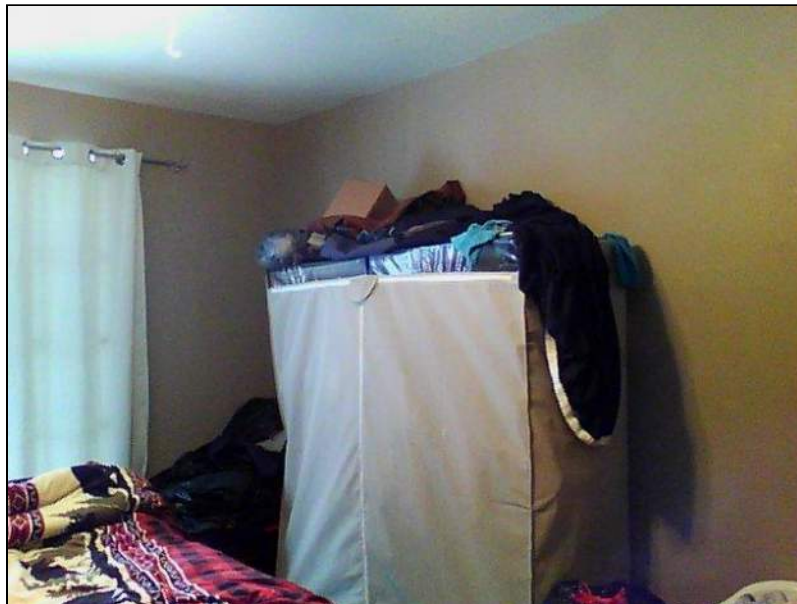
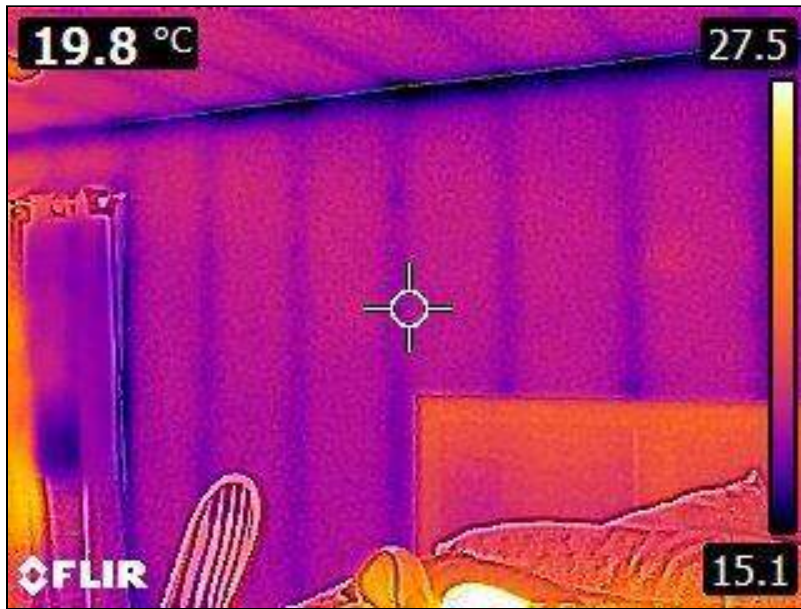
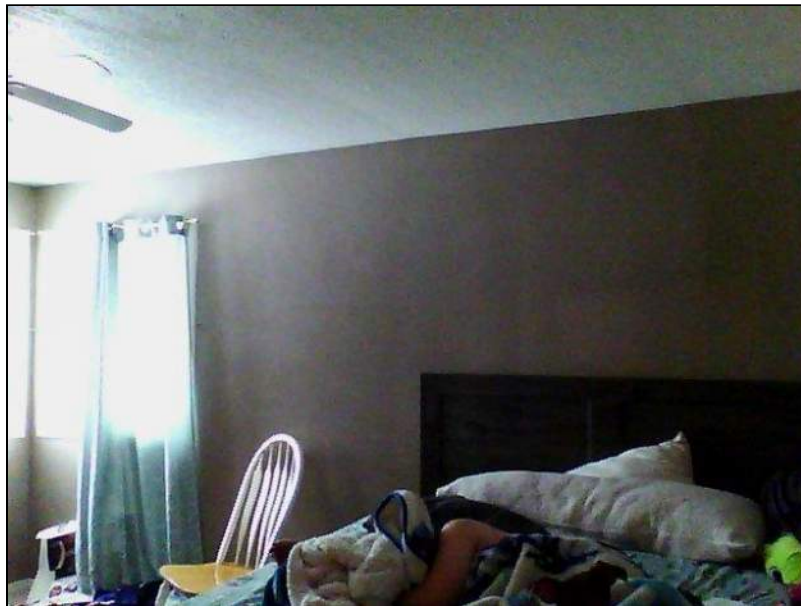
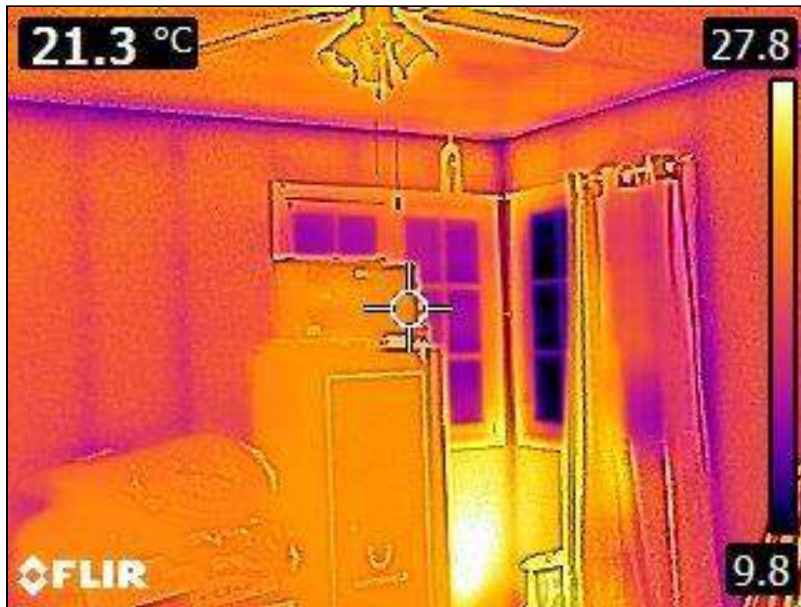
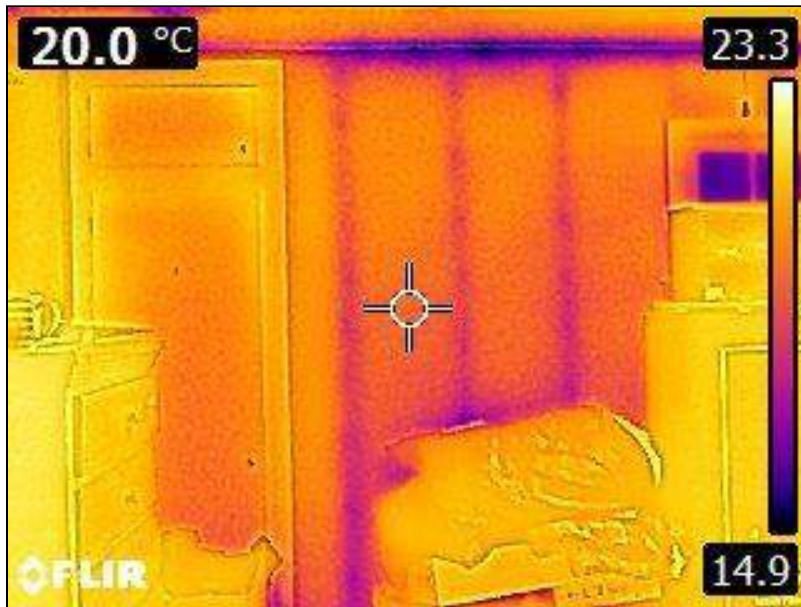
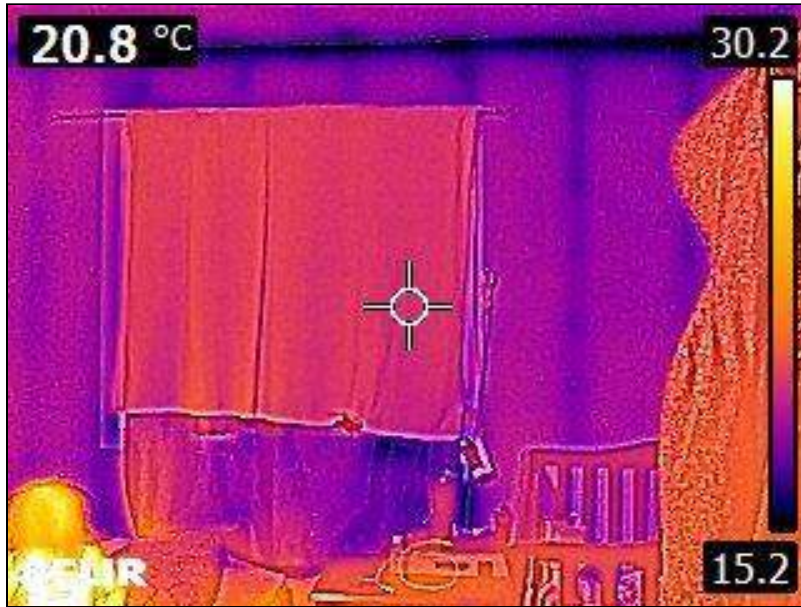
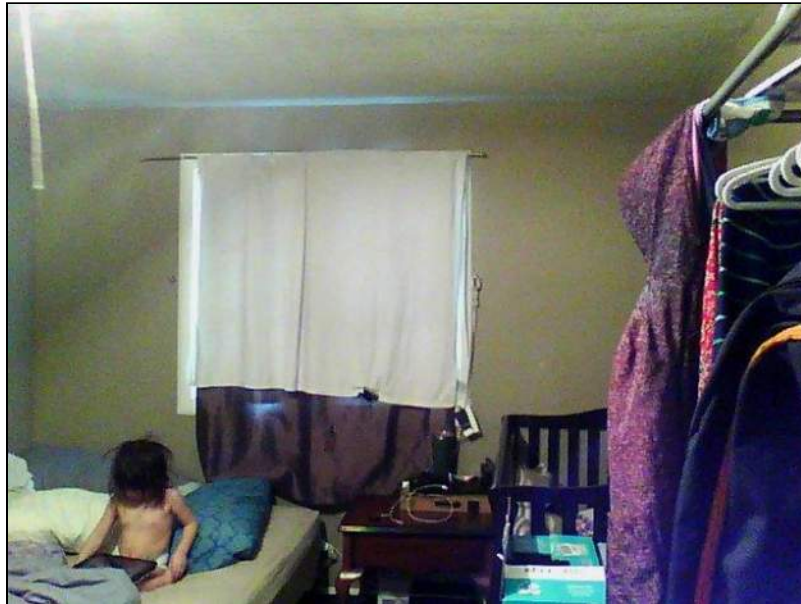
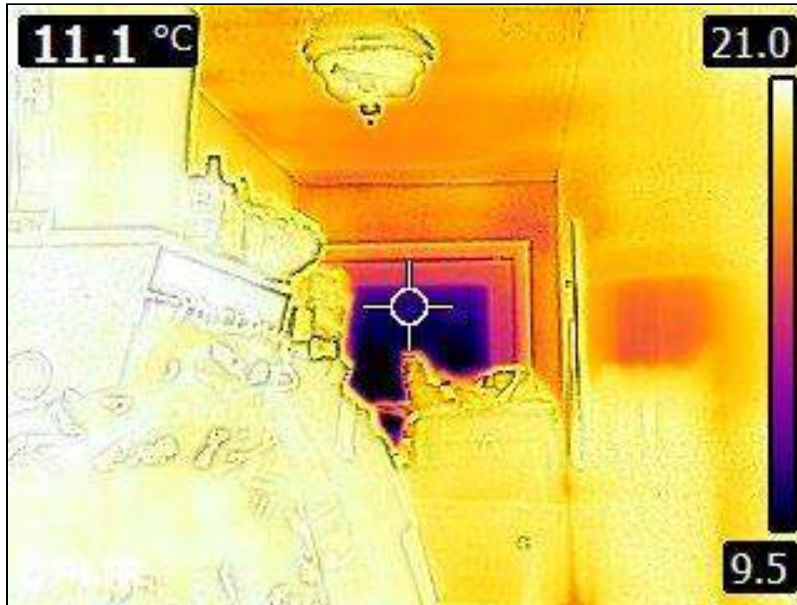
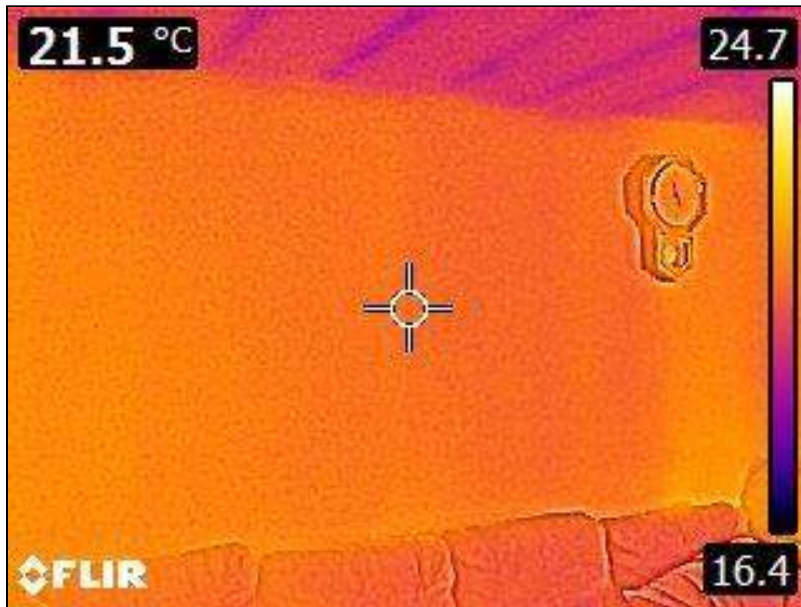
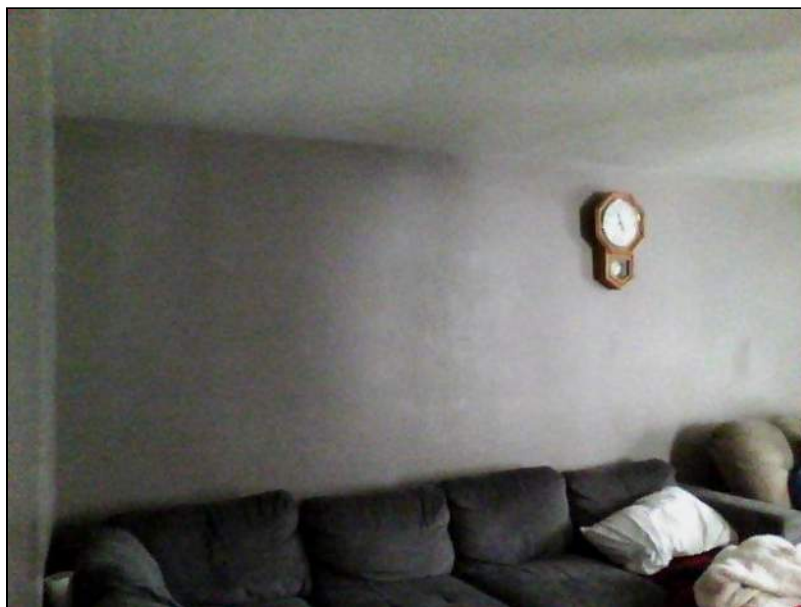
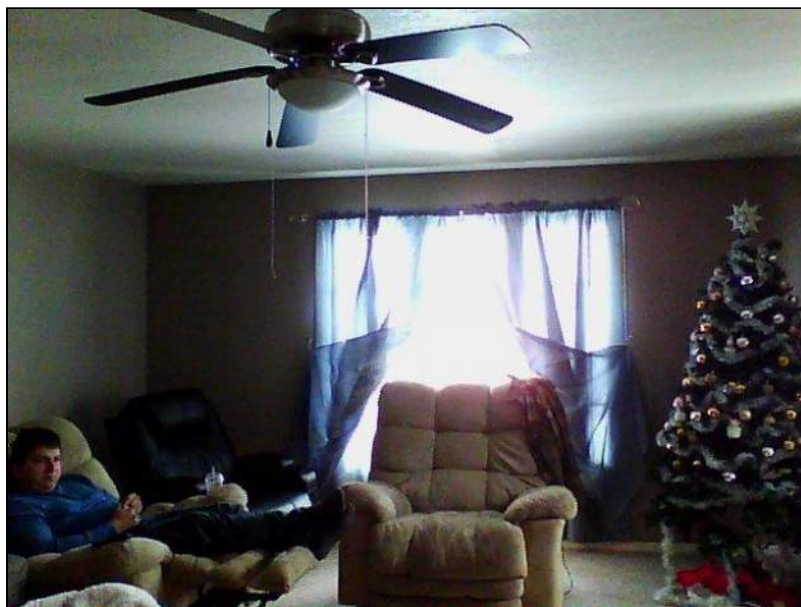
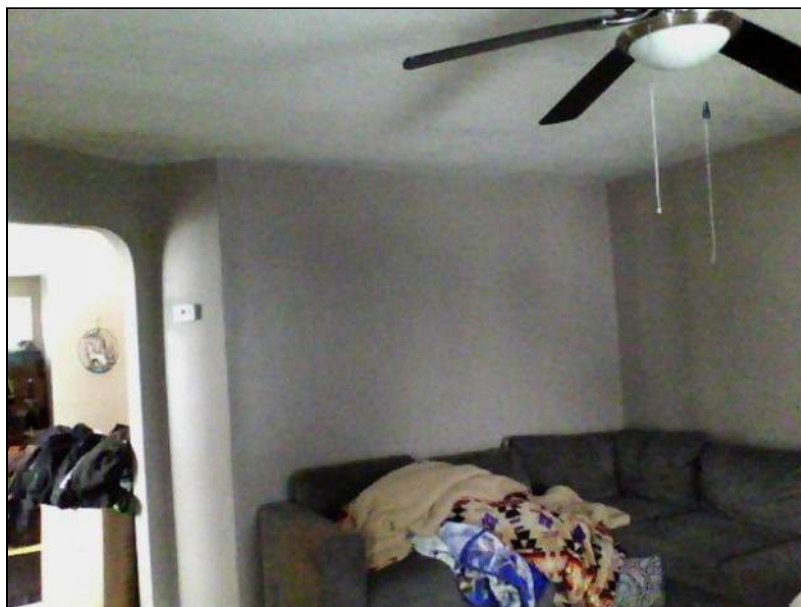
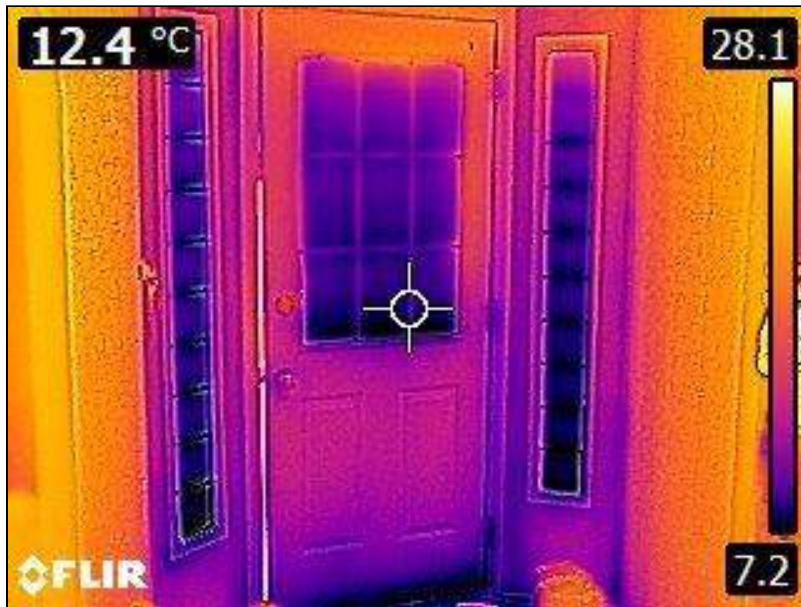
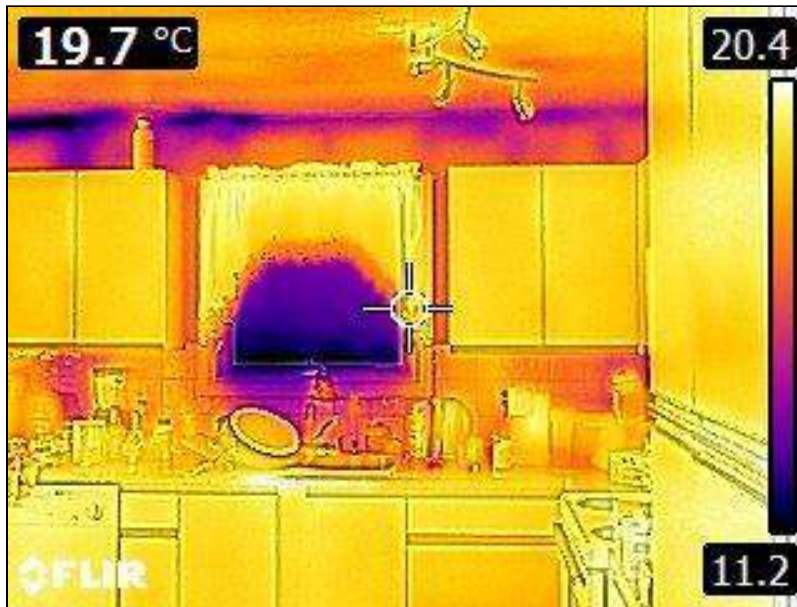
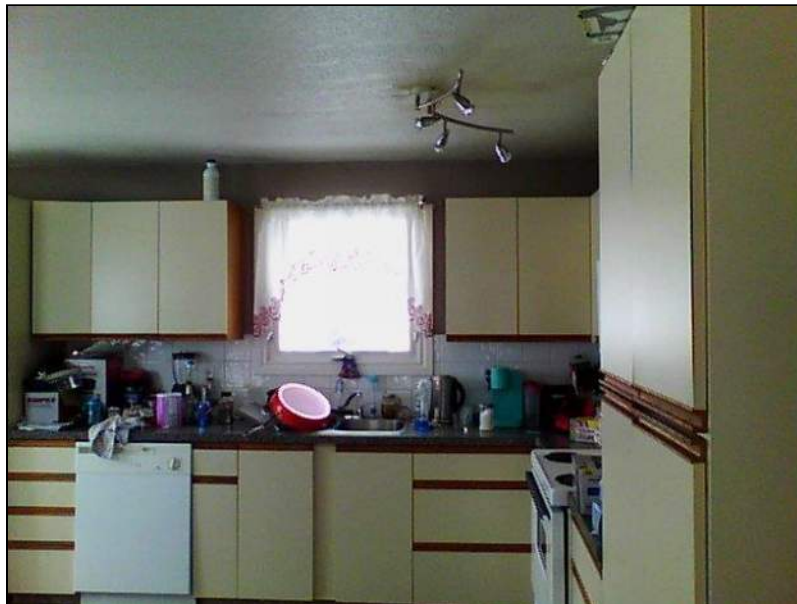
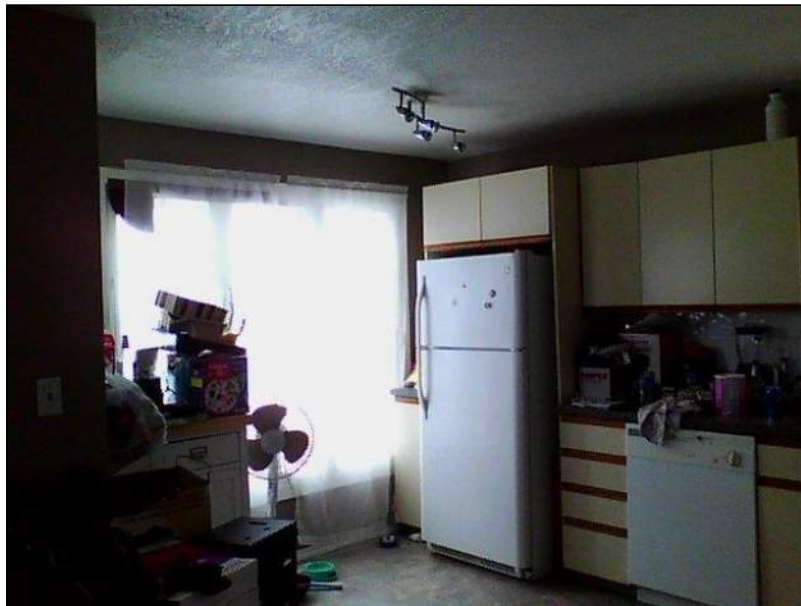
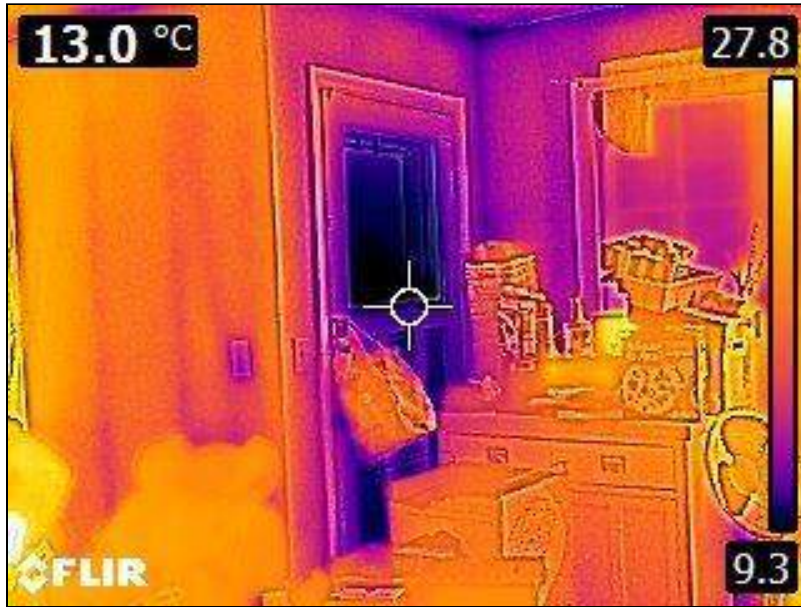
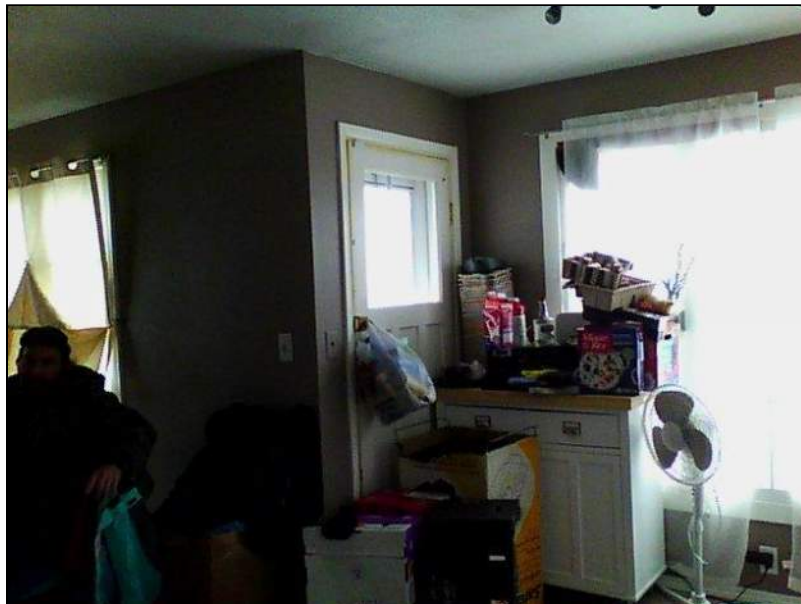
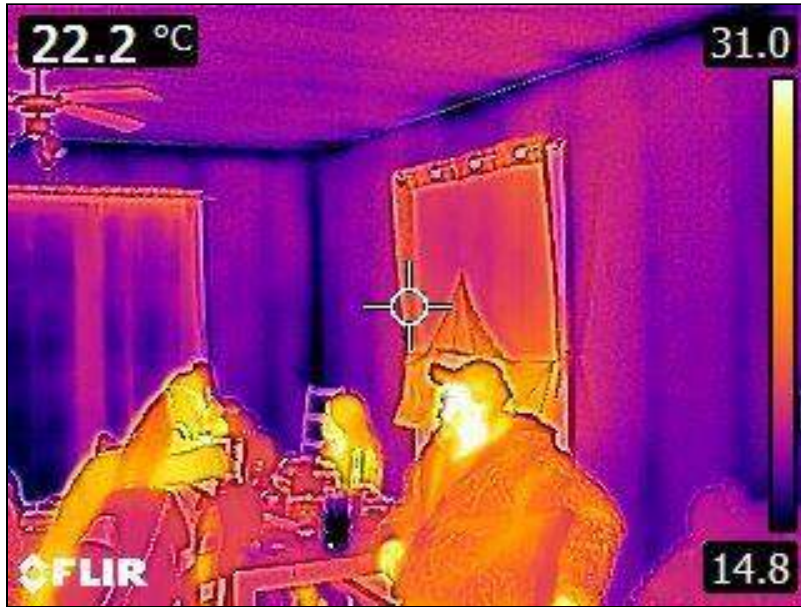
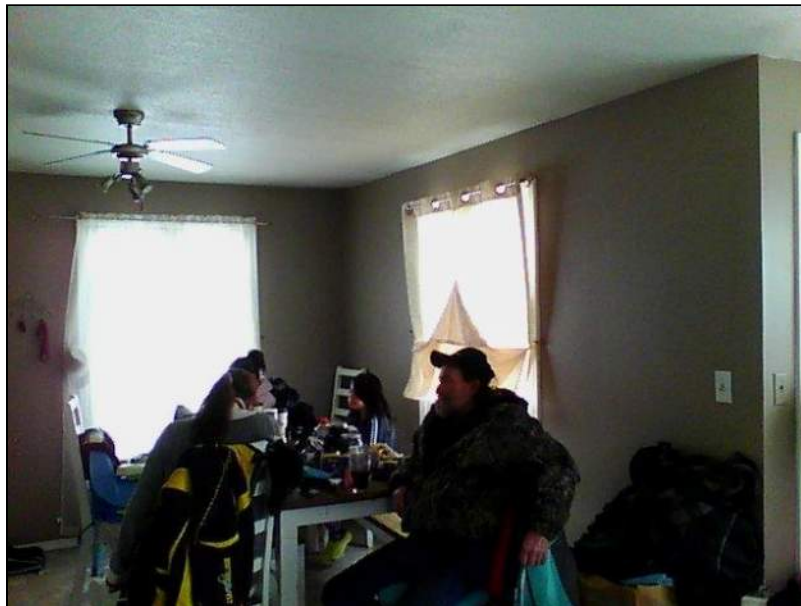
All walls were in good condition and dry at the time of inspection. (Cosmetic issues are not part of the inspection.)

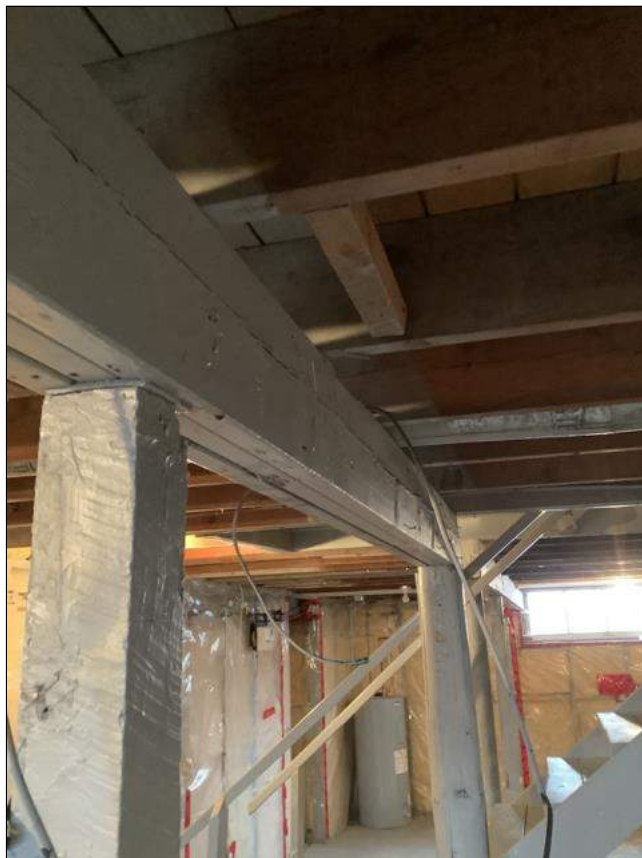
7.9 Item 2(Picture) Joists and Beams - slanted, crooked, notched out, bowed, split

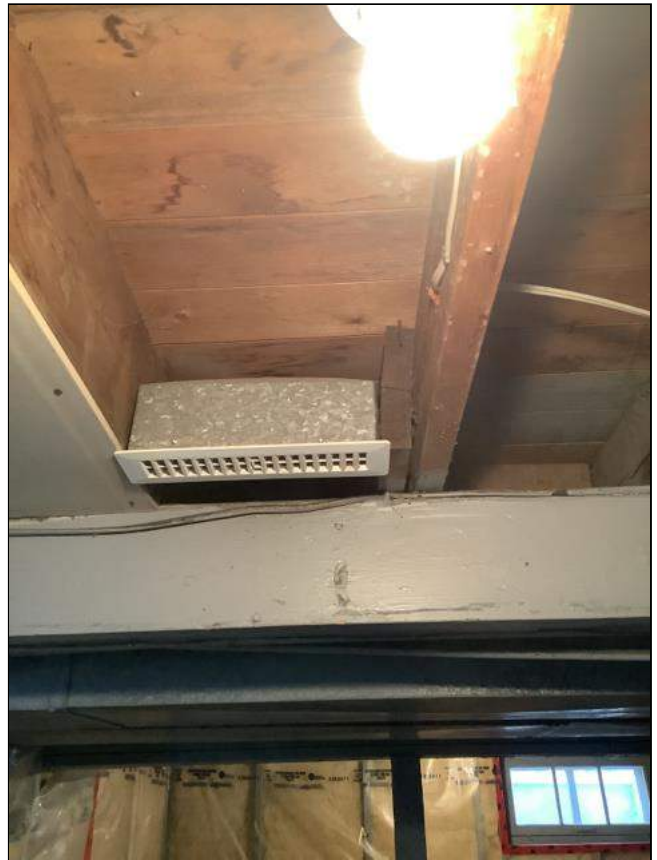
7.9 Item 6(Picture) Joists and Beams - slanted, crooked, notched out, bowed, split

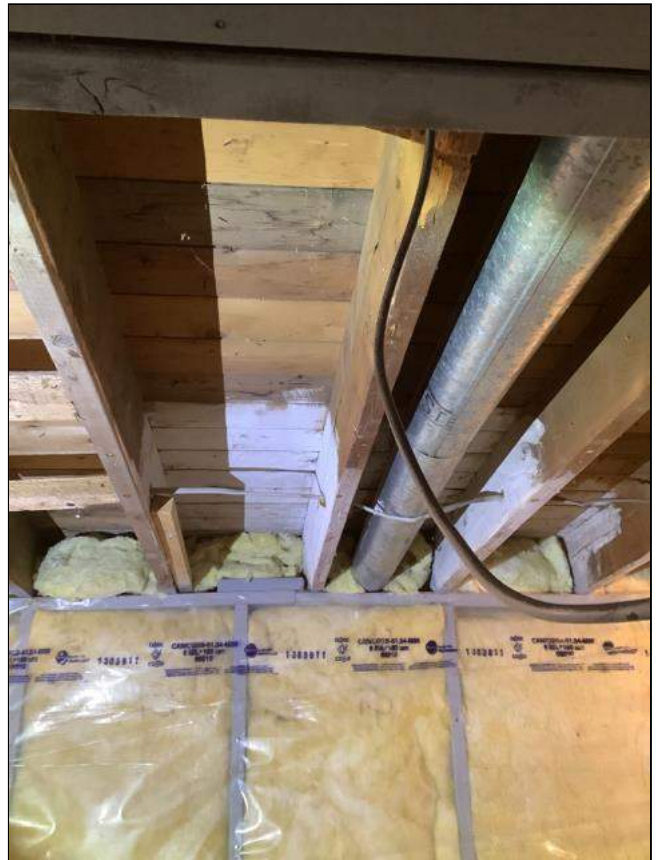
7.9 Item 10(Picture) Joists and Beams - slanted, crooked, notched out, bowed, split

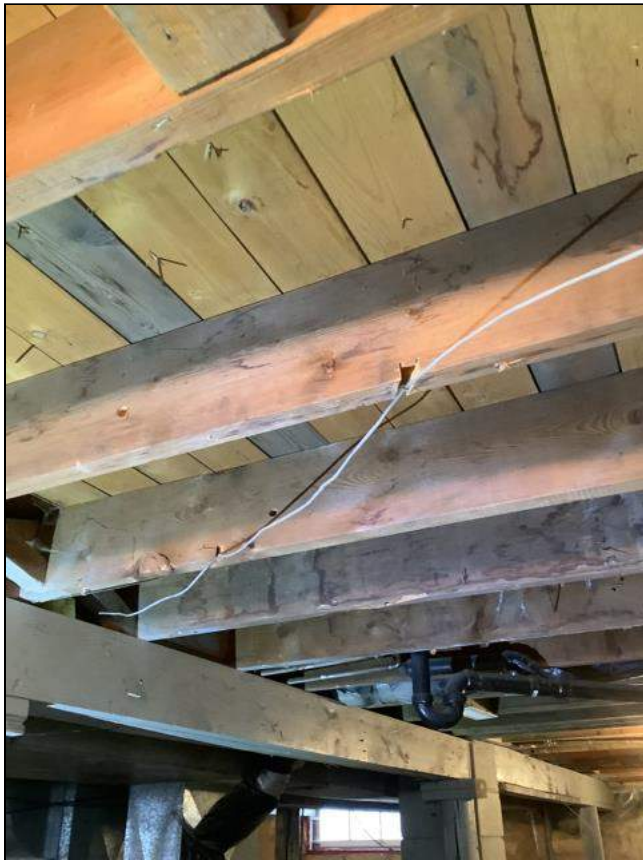
7.9 Item 17(Picture) Joists and Beams - slanted, crooked, notched out, bowed, split

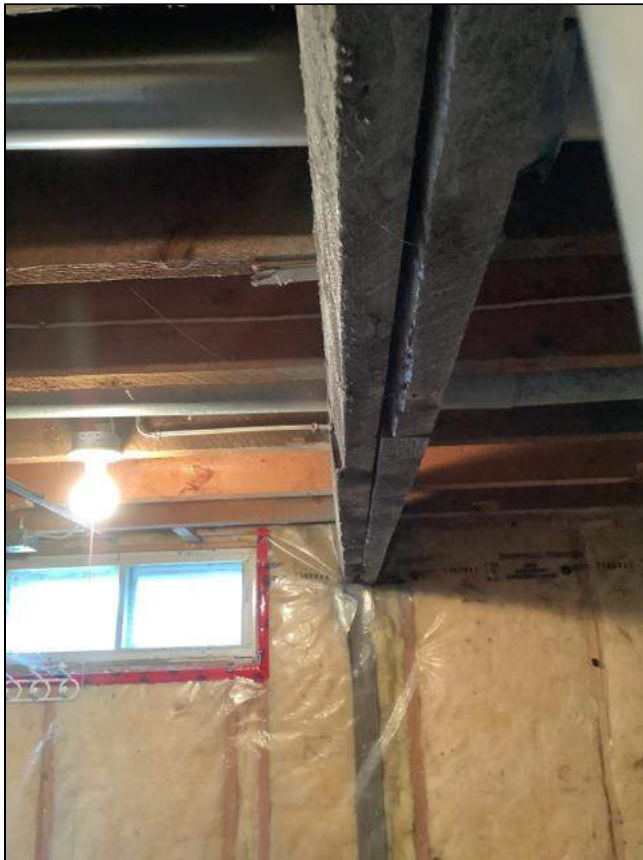
7.9 Item 21(Picture) Joists and Beams - slanted, crooked, notched out, bowed, split

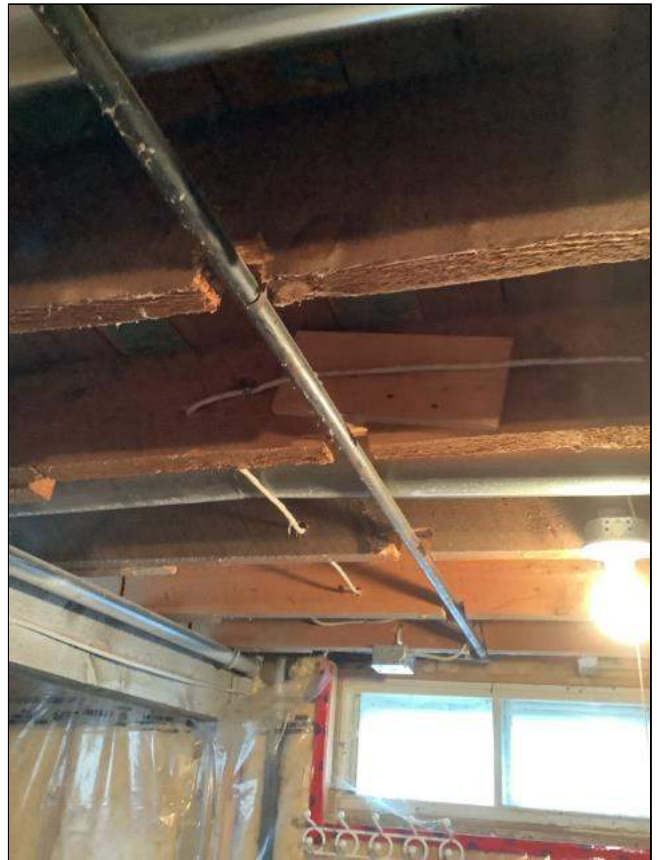
7.9 Item 22(Picture) Joists and Beams - slanted, crooked, notched out, bowed, split

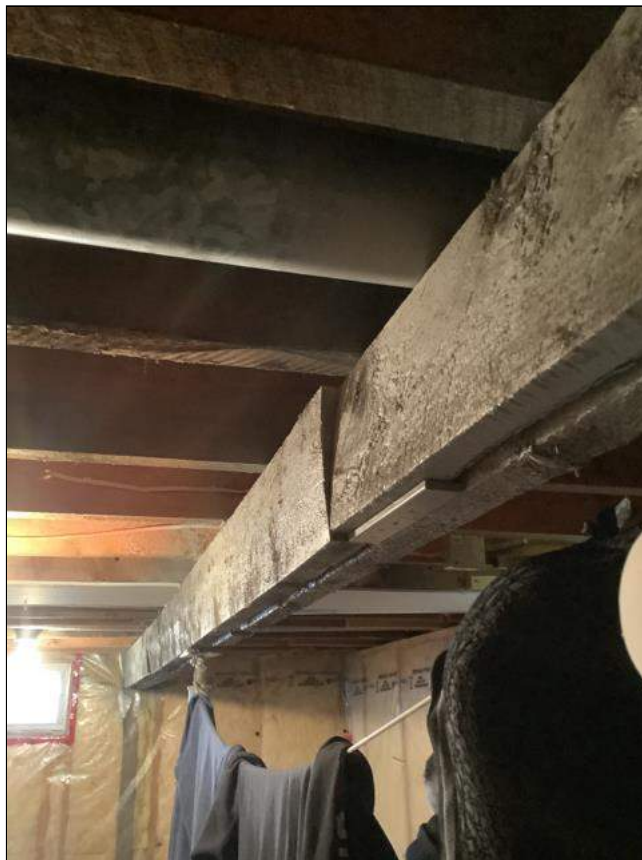
7.9 Item 24(Picture) Joists and Beams - slanted, crooked, notched out, bowed, split

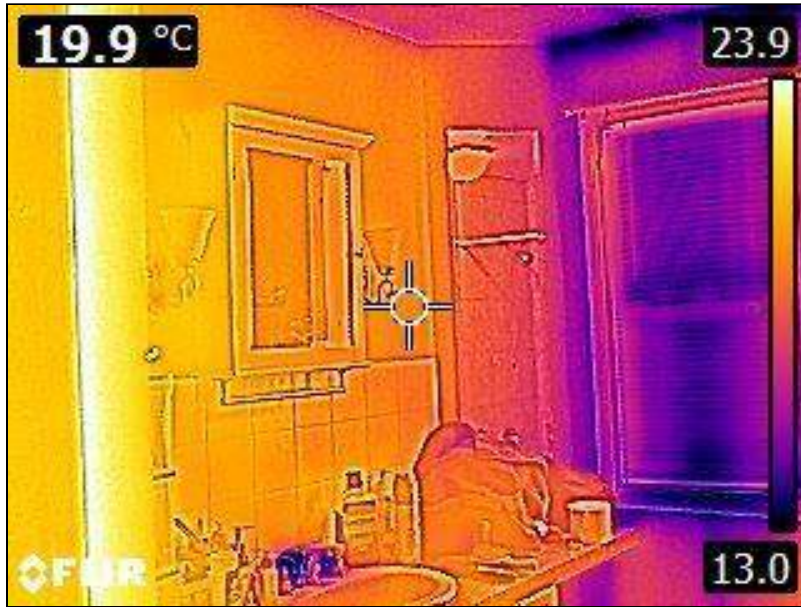
All bathroom walls and ceiling were dry at time of inspection. There was an area in the bathroom ceiling where the seam is splitting but most likely from humidity as there is no fan.

9.0 Item 1(Picture) Bathroom Ceiling - seam splitting
