HOME
INSPECTION

Inspection Report

Property Address:
964 Hunter Drive - Nacmine
Drumheller Alberta T0J 0Y0

| Date: 16/12/2021 | Time: 11:00 AM | Report ID: 964 Hunter Drive - Nacmine |

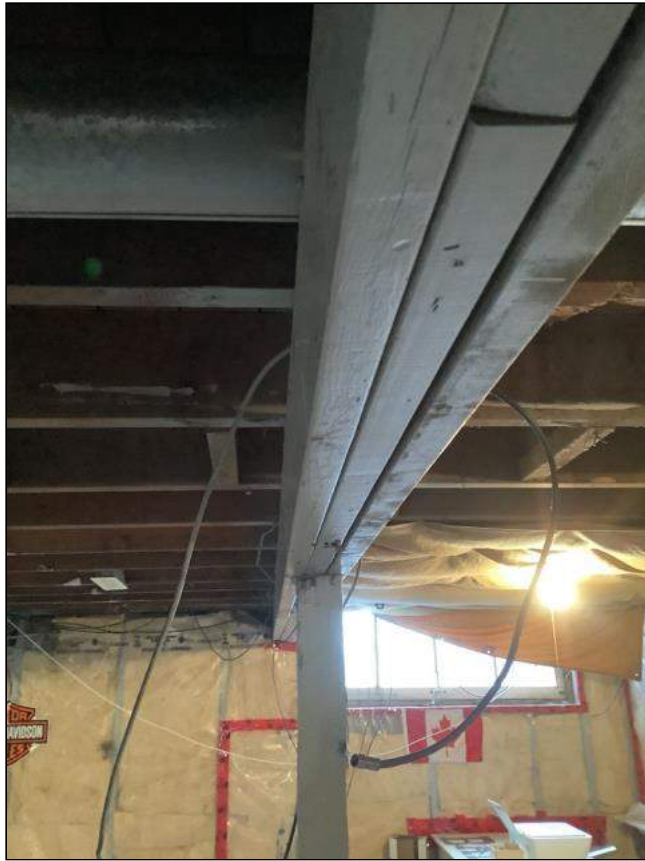
7.9 Item 1(Picture) Joists and Beams - slanted, crooked, notched out, bowed, split

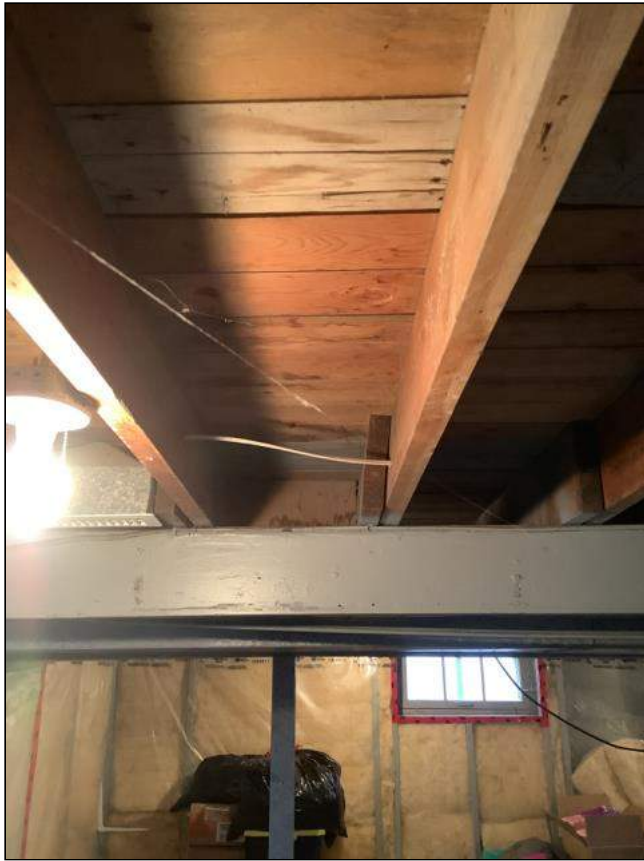
7.9 Item 4(Picture) Joists and Beams - slanted, crooked, notched out, bowed, split

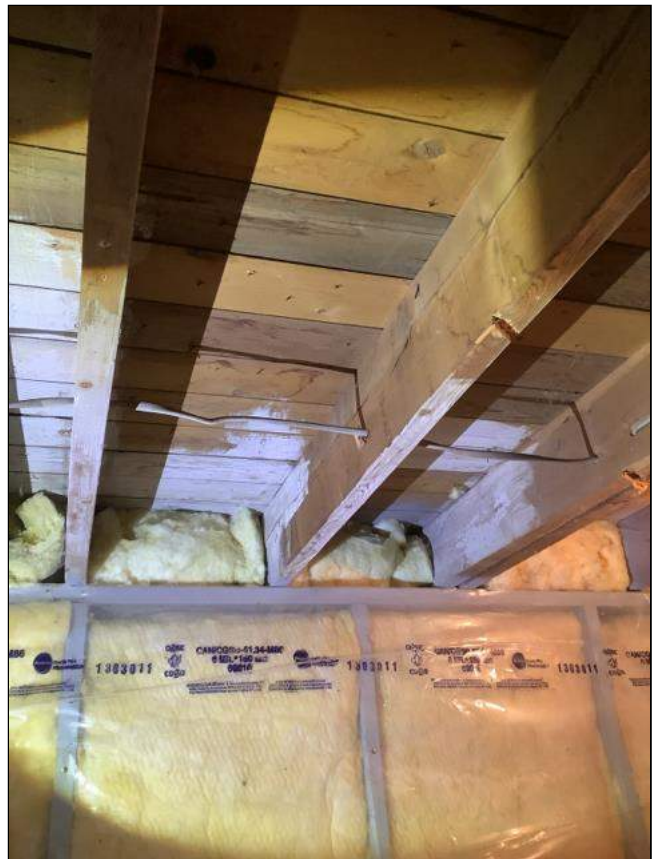
7.9 Item 7(Picture) Joists and Beams - slanted, crooked, notched out, bowed, split

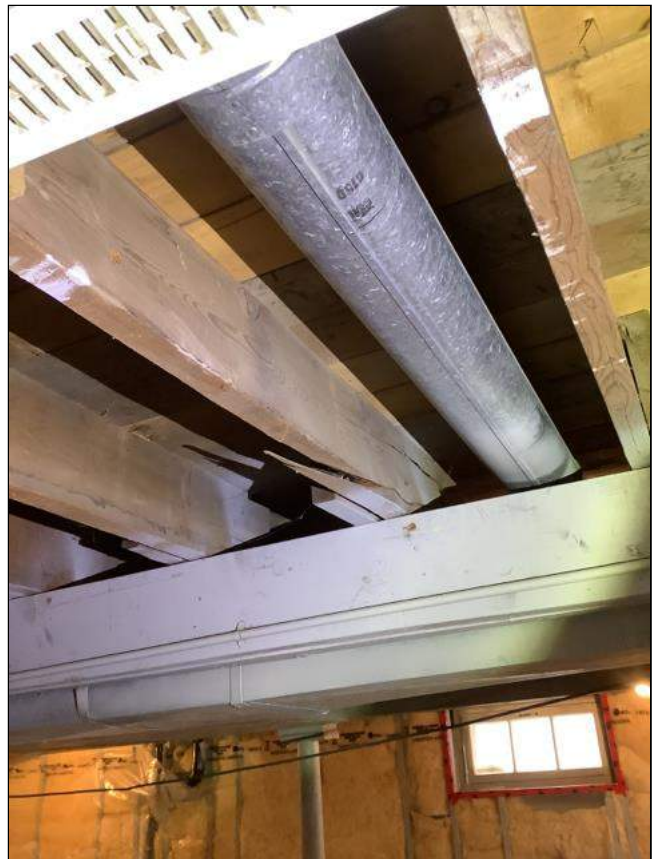
7.9 Item 11(Picture) Joists and Beams - slanted, crooked, notched out, bowed, split

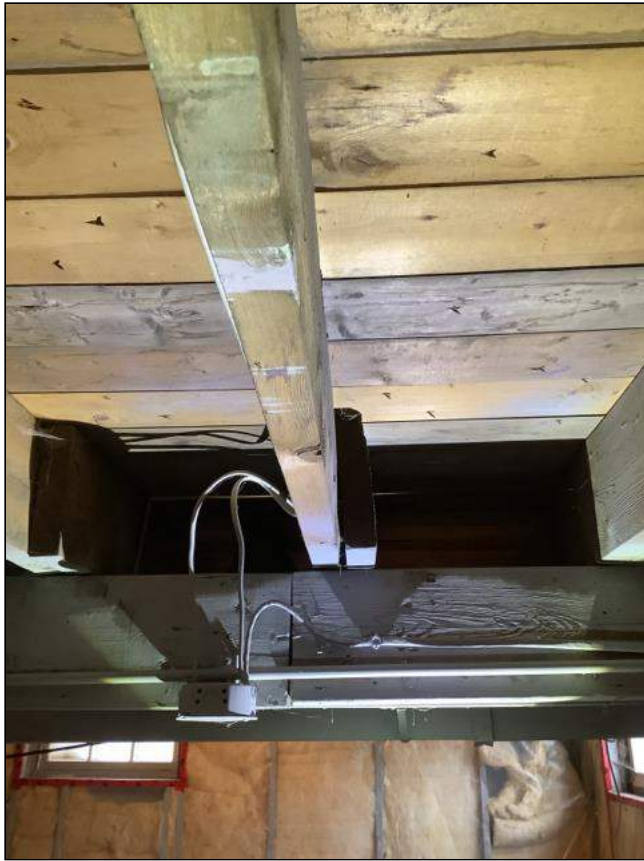
7.9 Item 12(Picture) Joists and Beams - slanted, crooked, notched out, bowed, split

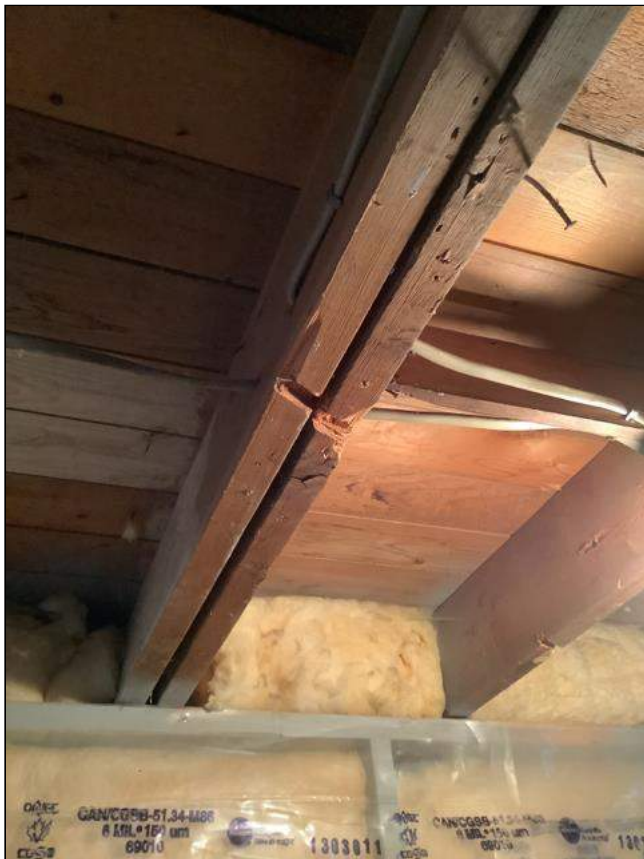
7.9 Item 14(Picture) Joists and Beams - slanted, crooked, notched out, bowed, split

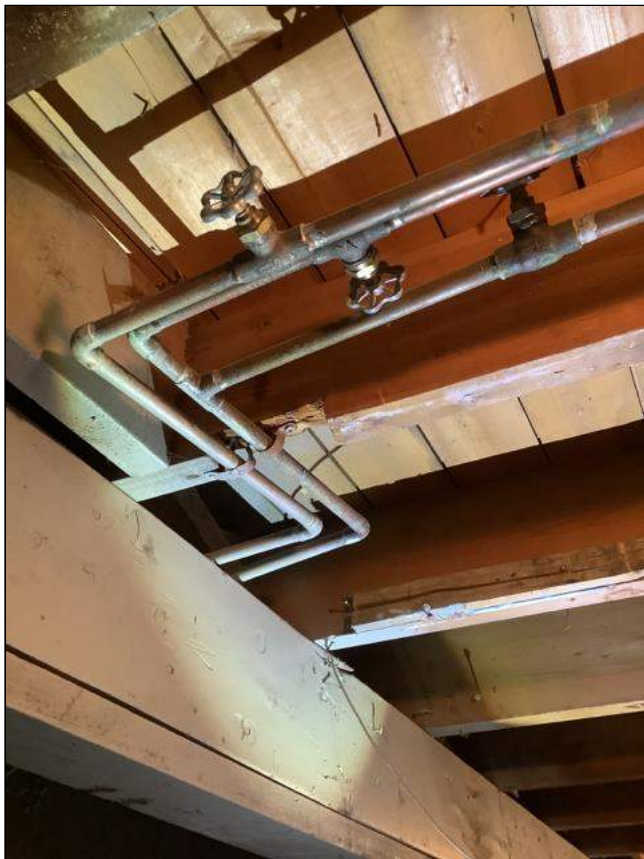
7.9 Item 18(Picture) Joists and Beams - slanted, crooked, notched out, bowed, split

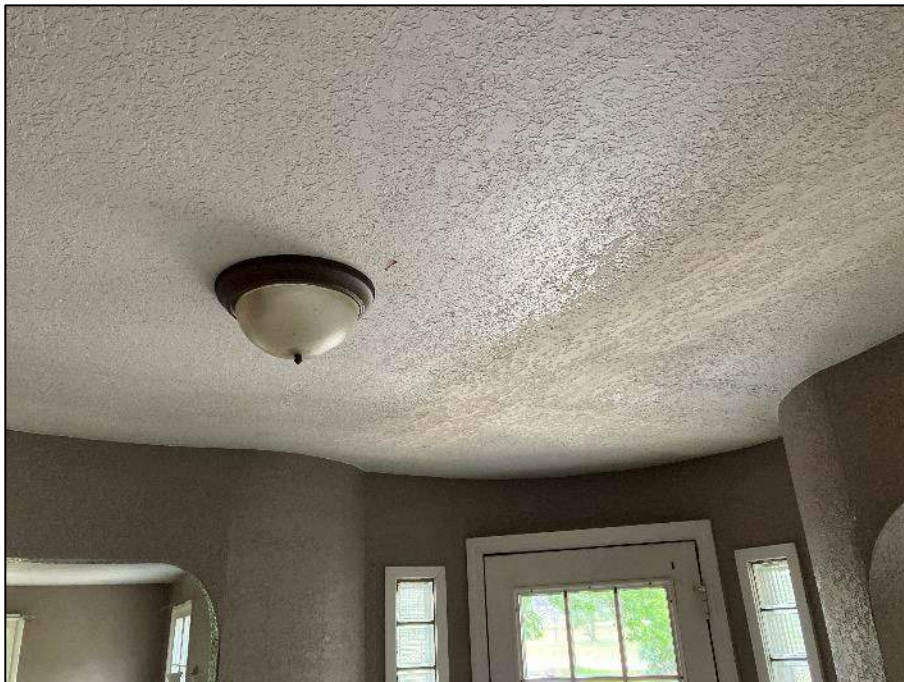
PHOTOGRAPH #10: Ceiling Texture - Floor 1 Foyer (Non-Asbestos)

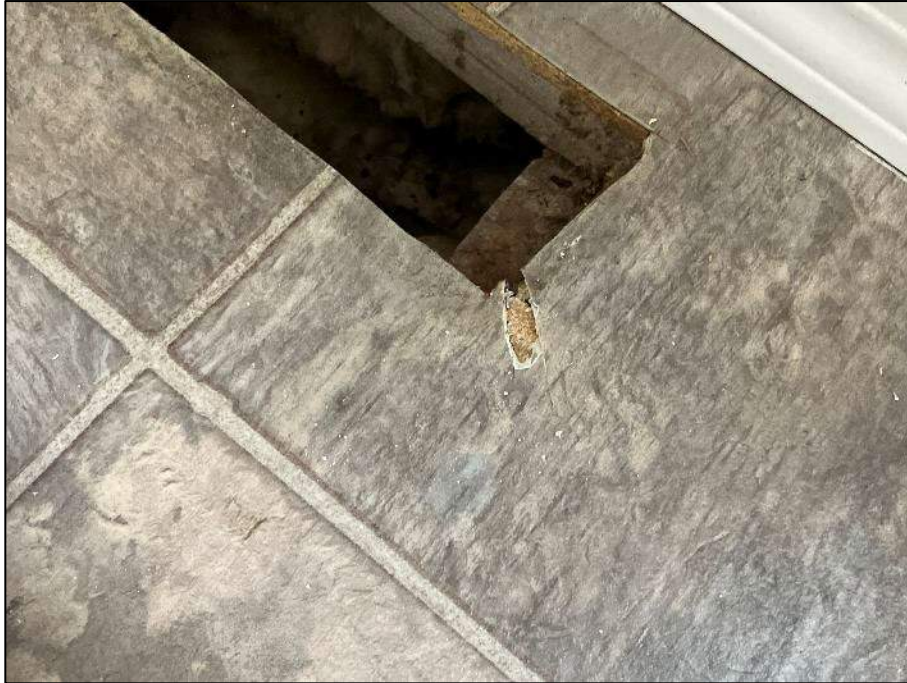
PHOTOGRAPH #11: Sheet Flooring – Floor 1 Kitchen (Non-Asbestos)

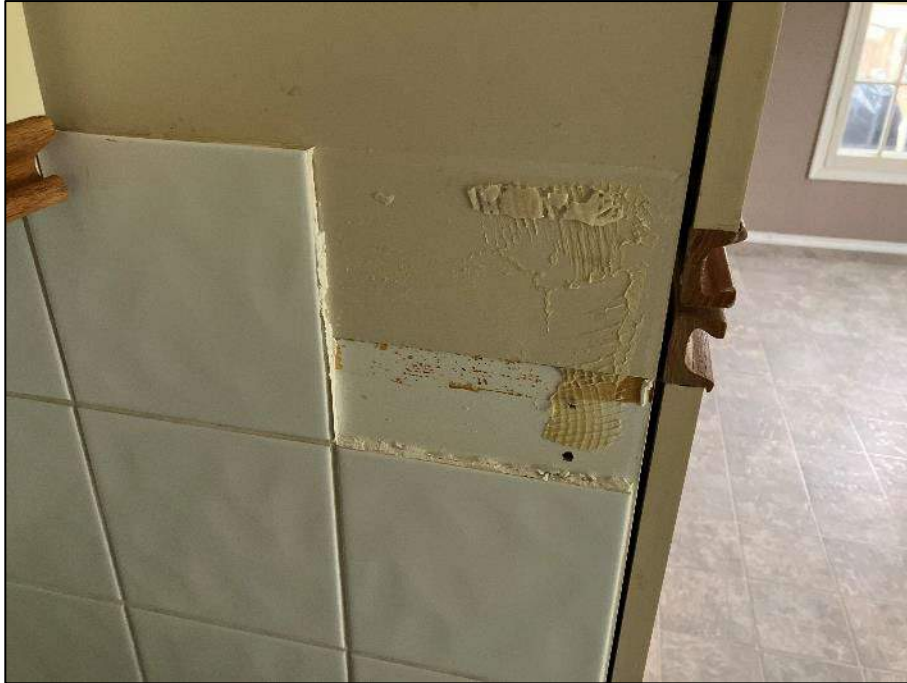
PHOTOGRAPH #13: Thinset – Kitchen (Non-Asbestos)

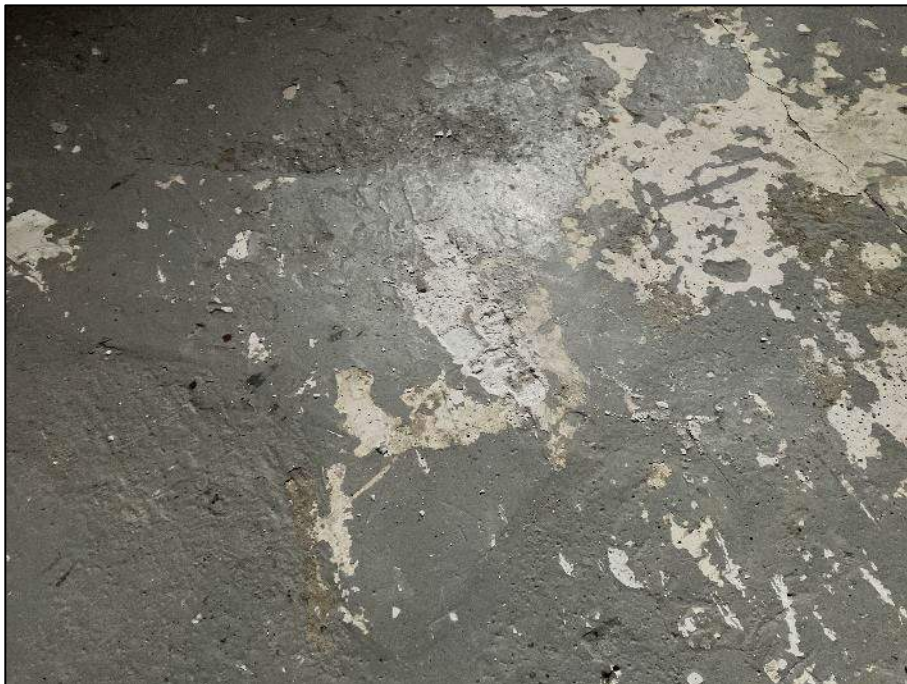
PHOTOGRAPH #14: Leveling Compound – Basement (Non-Asbestos)

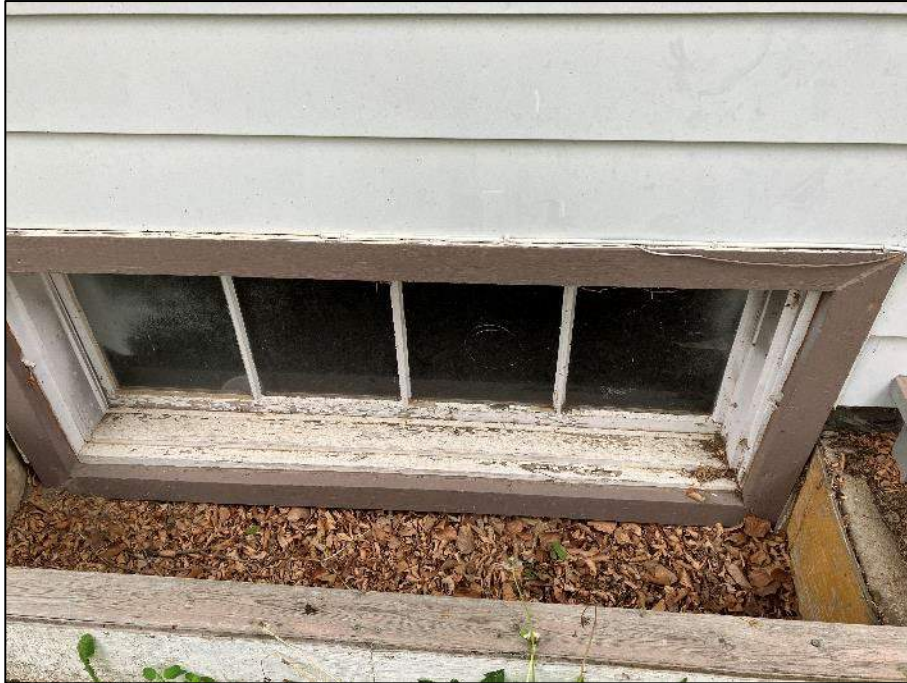
PHOTOGRAPH #15: Window Caulking – Exterior (Non-Asbestos)

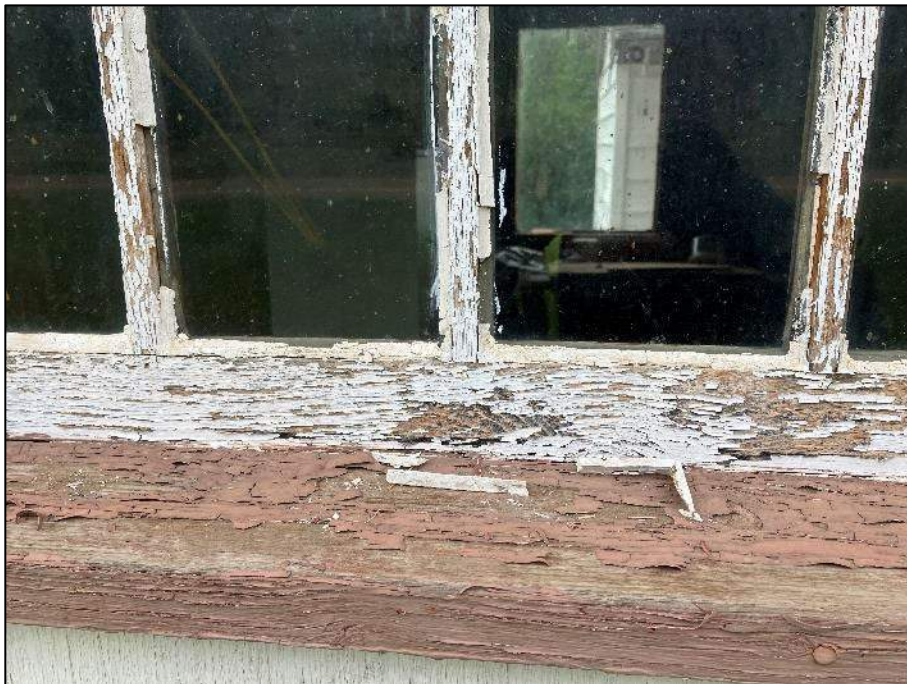
PHOTOGRAPH #16: Window Caulking – Shed (Non-Asbestos)

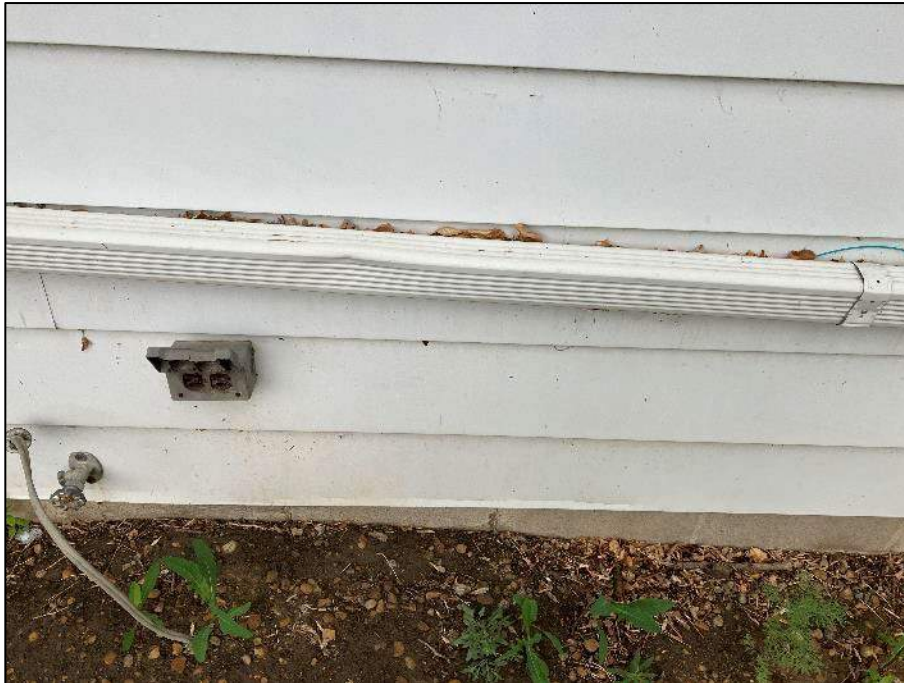
PHOTOGRAPH #17: Parging 1 – Exterior (Non-Asbestos)

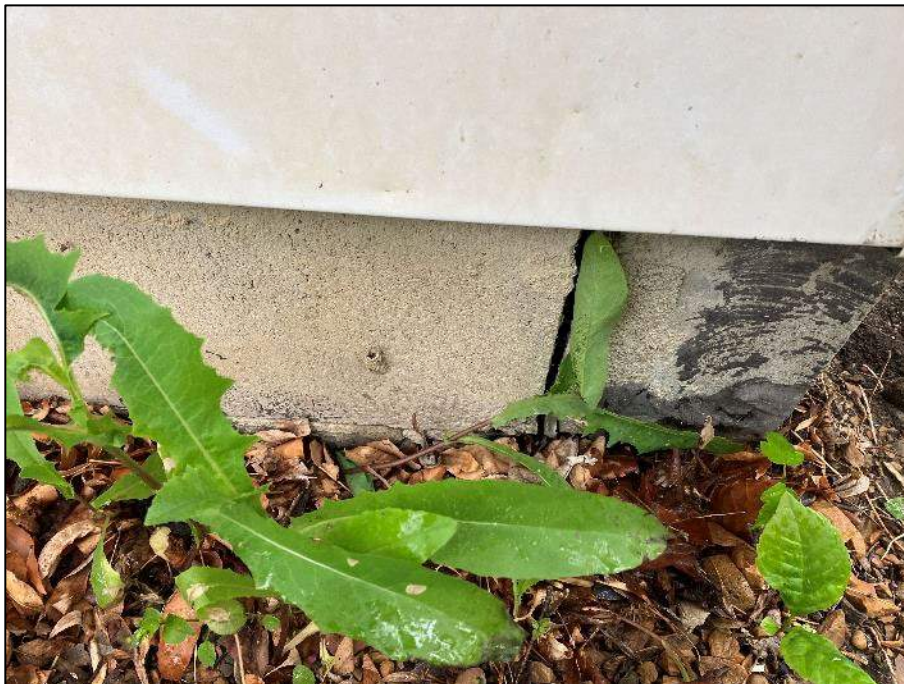
PHOTOGRAPH #18: Parging 2 – Exterior (Non-Asbestos)

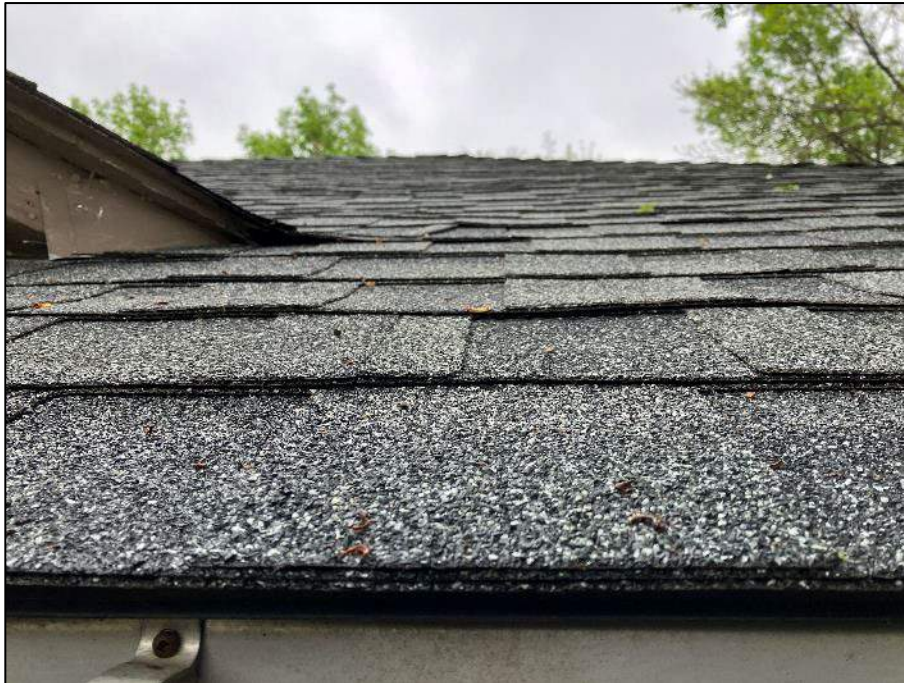
PHOTOGRAPH #19: Roof Shingle – Exterior (Non-Asbestos)

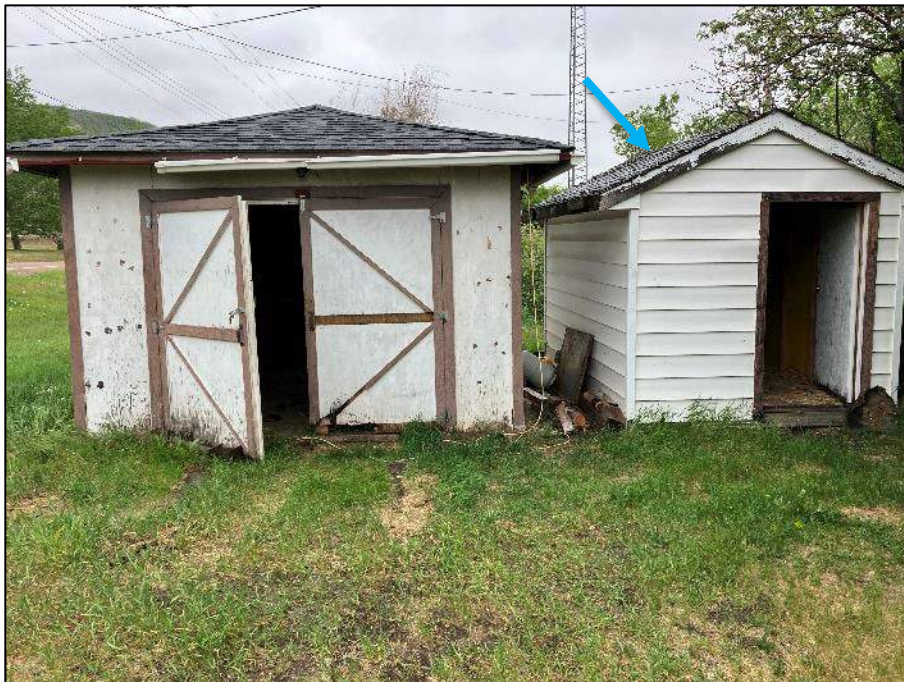
PHOTOGRAPH #20: Roof Shingle – Shed (Non-Asbestos)

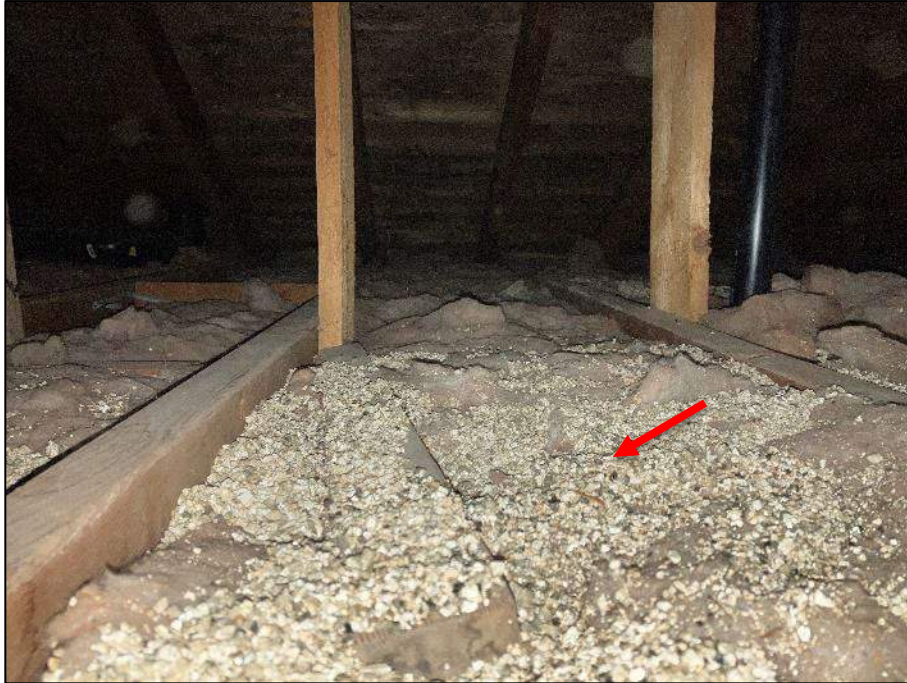
1. The following materials were identified as asbestos-containing and will require abatement prior to demolition of the structure:
 - a. Drywall Joint Compound (*See Photographs #1 to 8*).
 - b. Vermiculite – Attic (*See Photographs #21 and 22*).

PHOTOGRAPH #21: Vermiculite in the Attic Space (<1% Tremolite)

2. Vermiculite material was confirmed in the attic space and confirmed asbestos-containing (*See Photographs #21 and 22*). Removal of the material must be performed prior to demolition by a qualified abatement contractor using high-risk asbestos abatement procedures found in Section 5.4 of the AAAM (2019).
3. Lead-containing paints (*See Appendix II*) were identified on all surfaces present on the home. Disturbance of lead-containing surface coatings should be performed following using exposure prevention controls found in WorkSafeBC's Lead Containing Paints and Coatings: Preventing Exposure in the Construction Industry (2011) document and described in the Alberta Governments Lead at the Work Site (2013) bulletin.

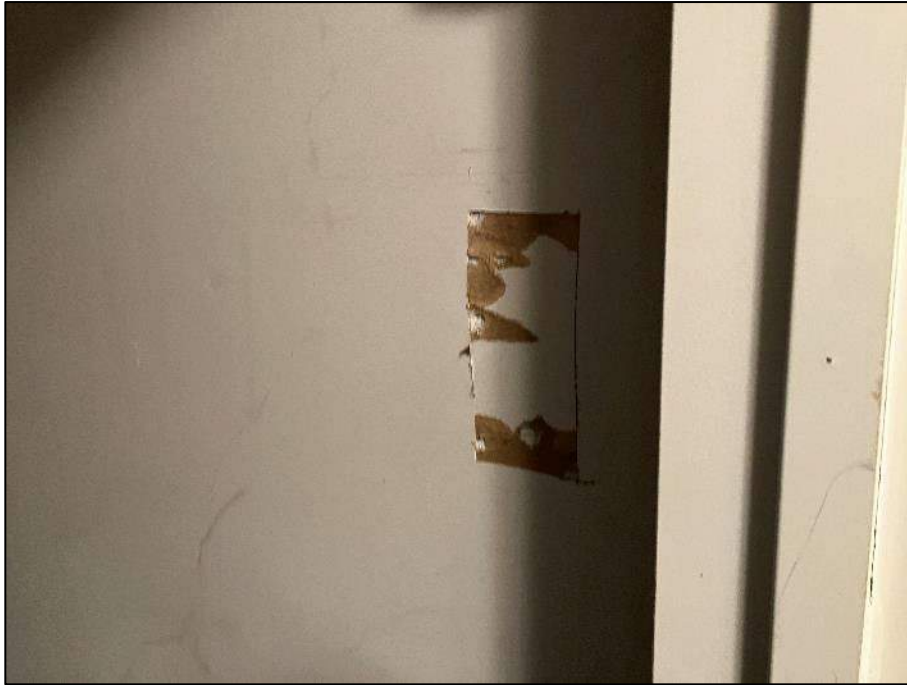
PHOTOGRAPH #23: Paint – White Stairs (Non-Lead Based)

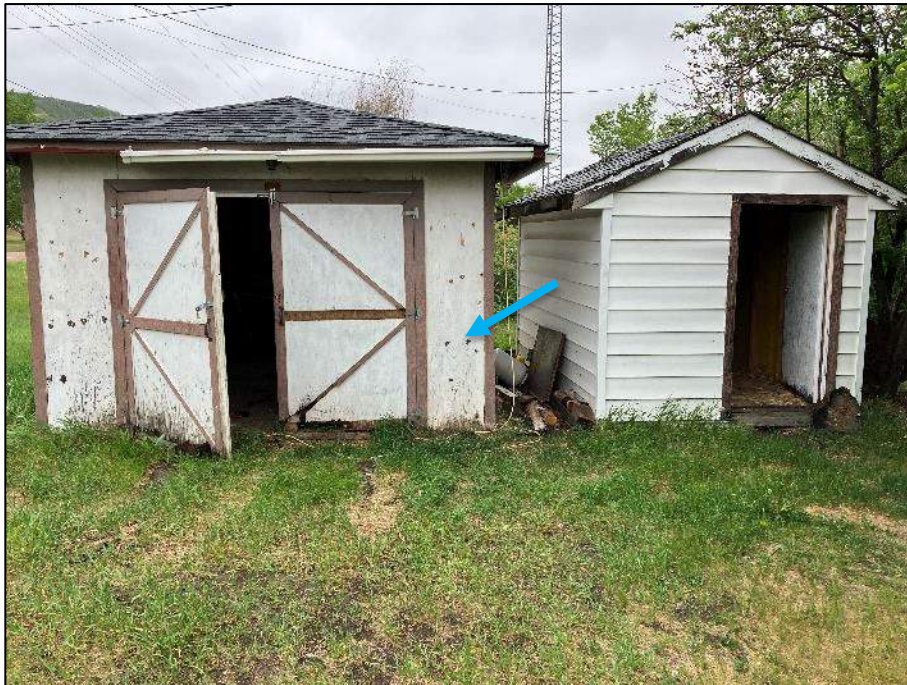
PHOTOGRAPH #27: Paint – White Shed (Non-Lead Based)

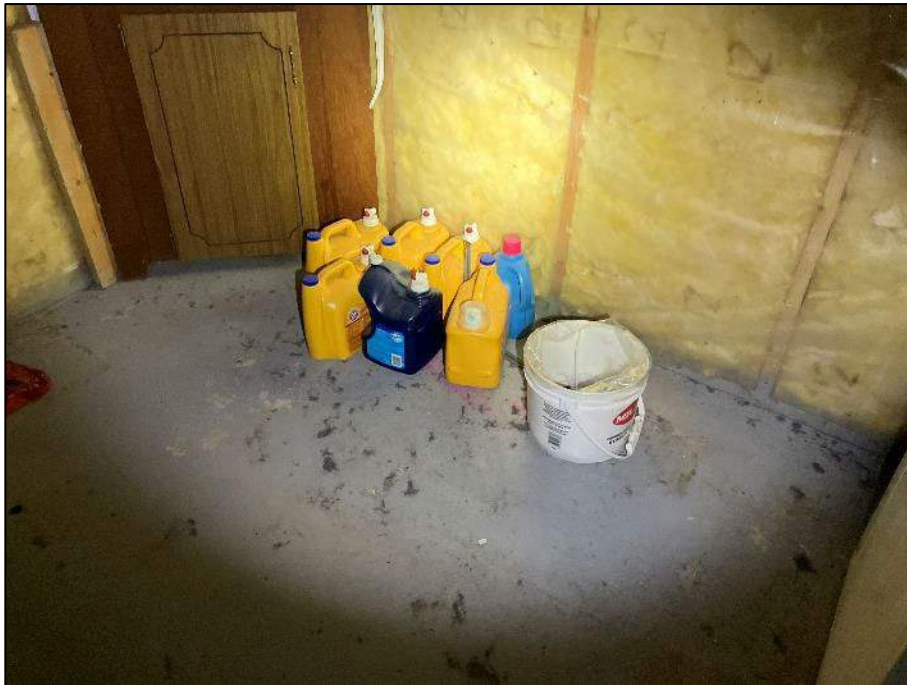
PHOTOGRAPH #29: Miscellaneous Chemicals - Basement

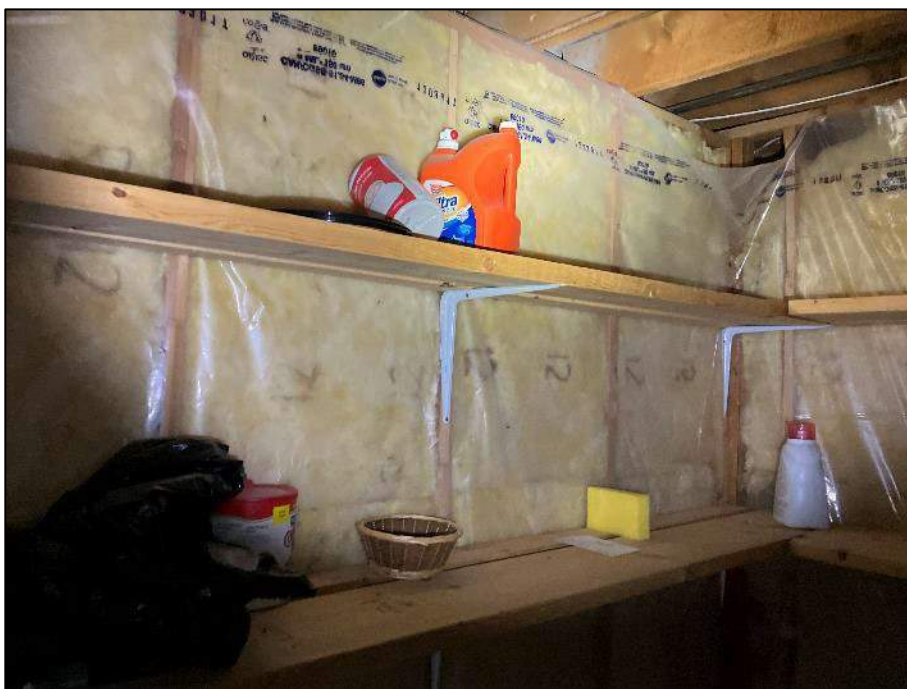
PHOTOGRAPH #30: Miscellaneous Chemicals - Basement

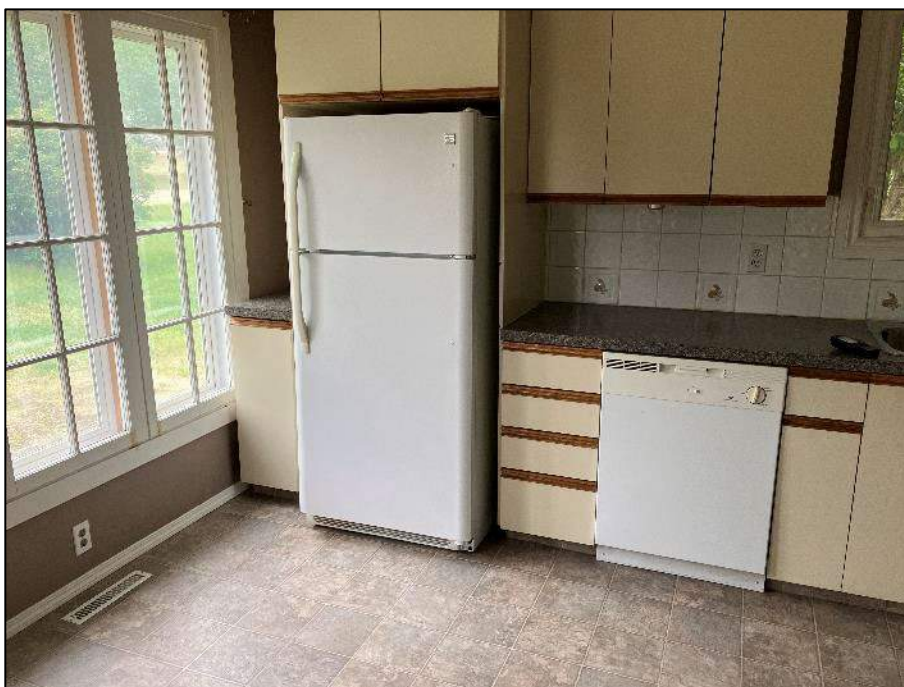
PHOTOGRAPH #32: Ozone Depleting Unit - Fridge

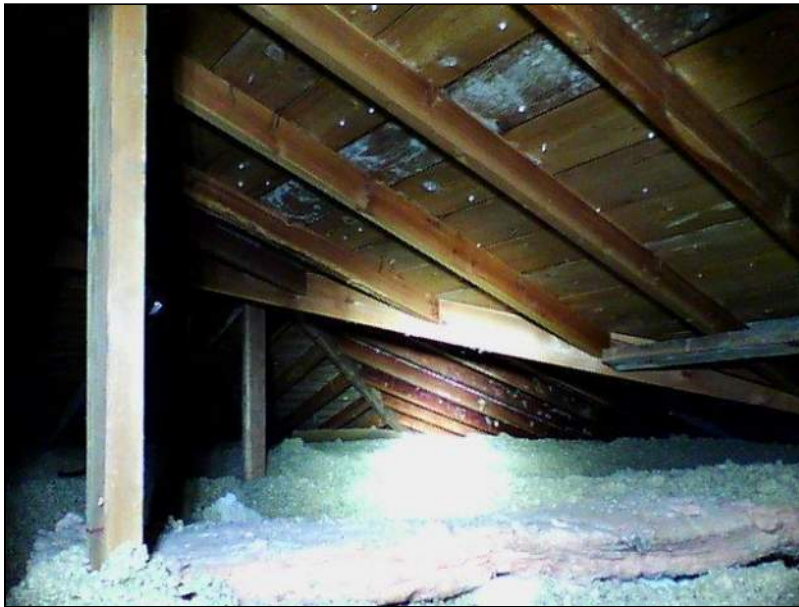
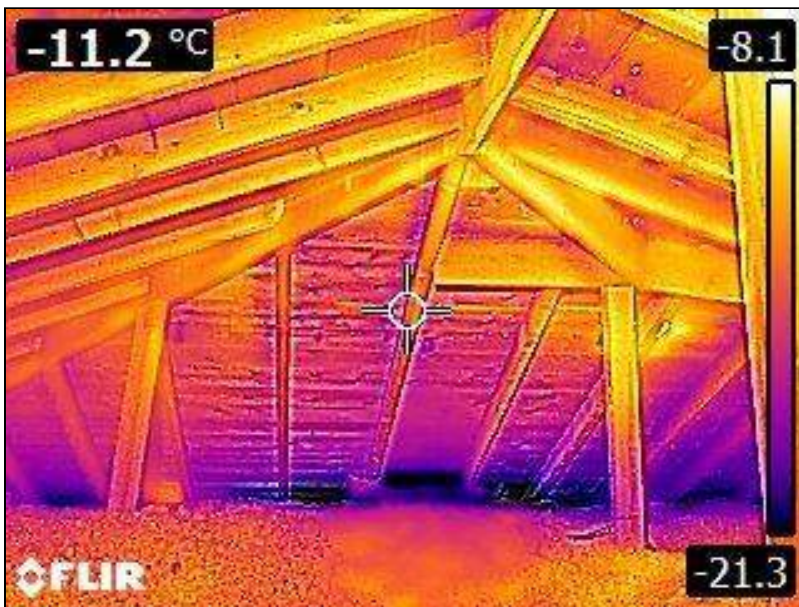
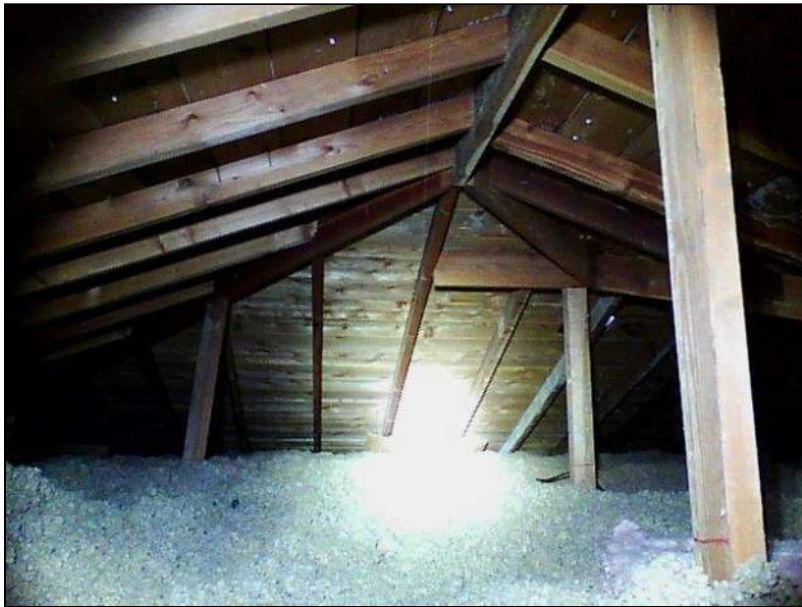
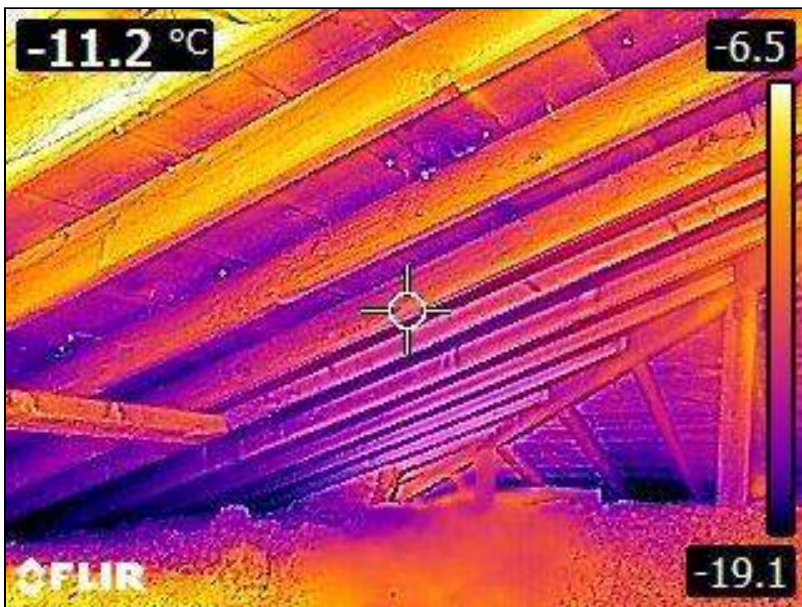
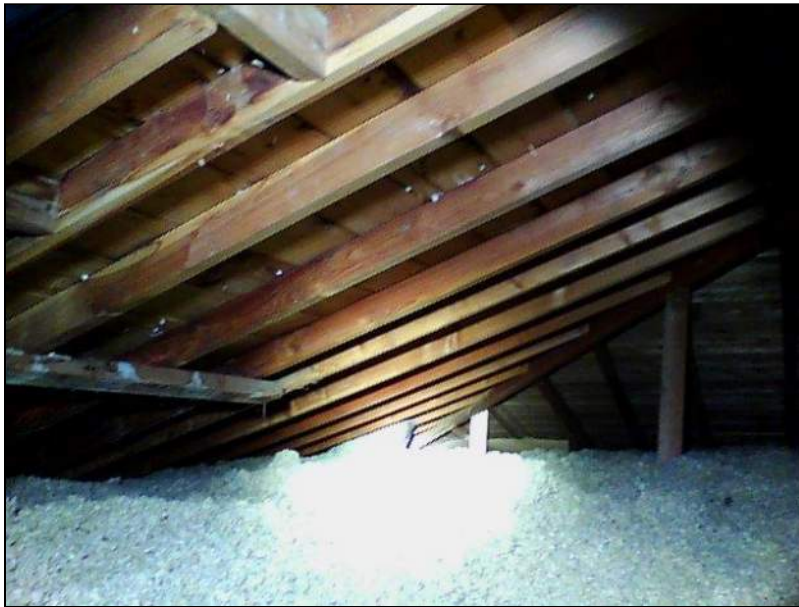
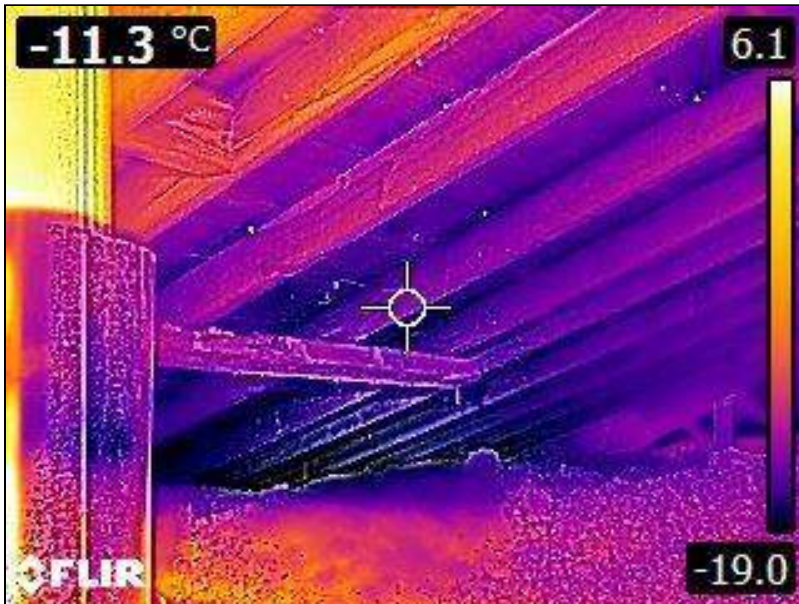
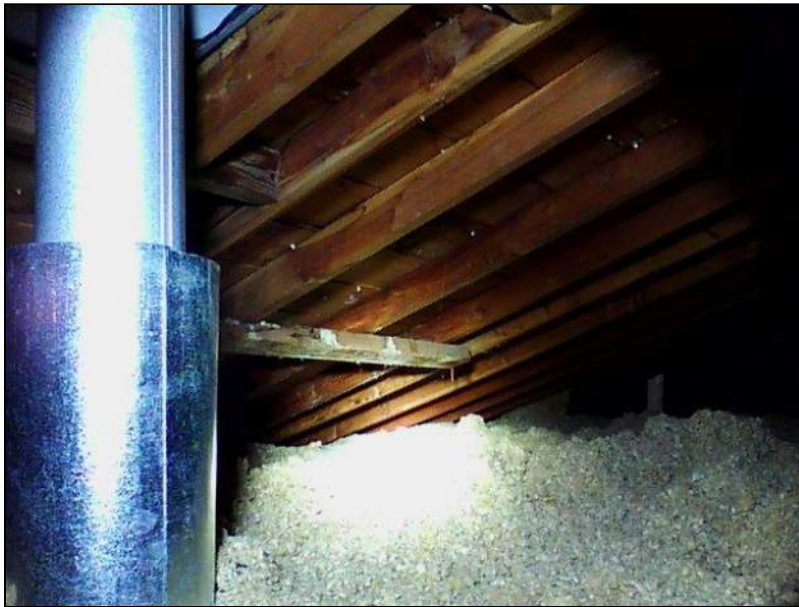
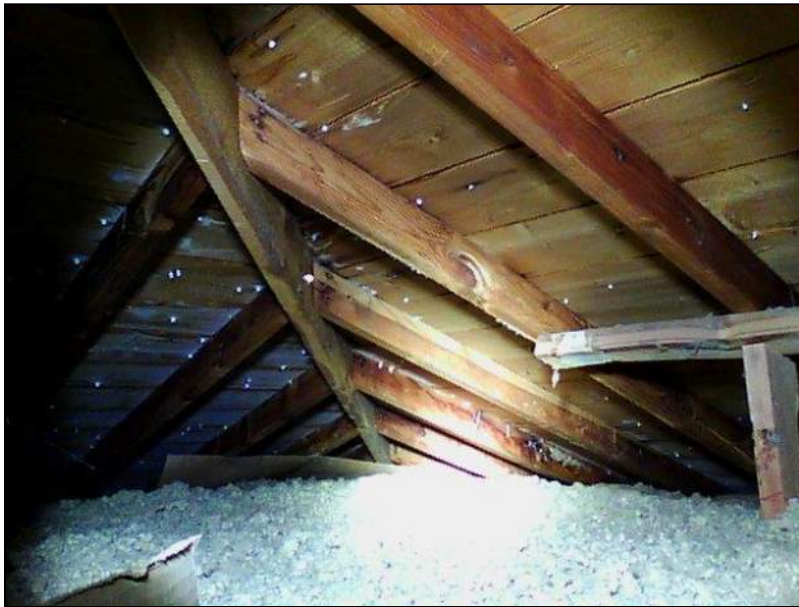
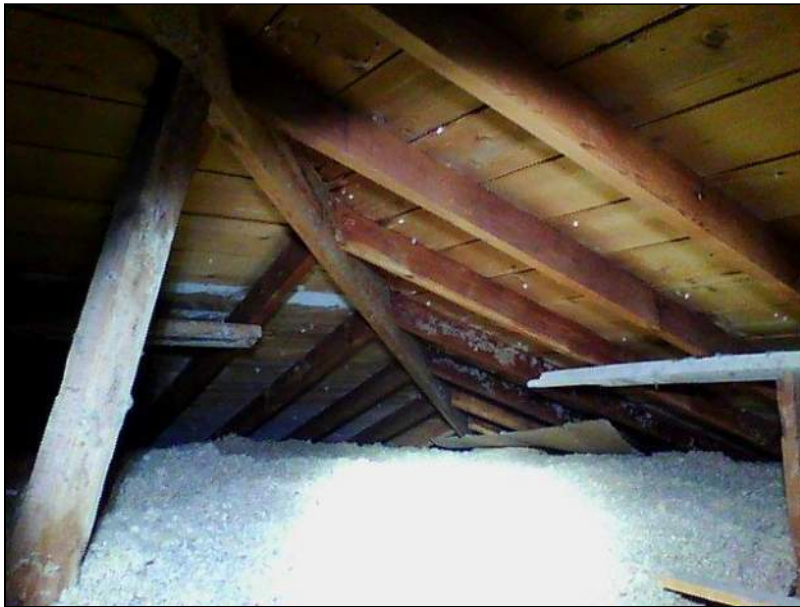
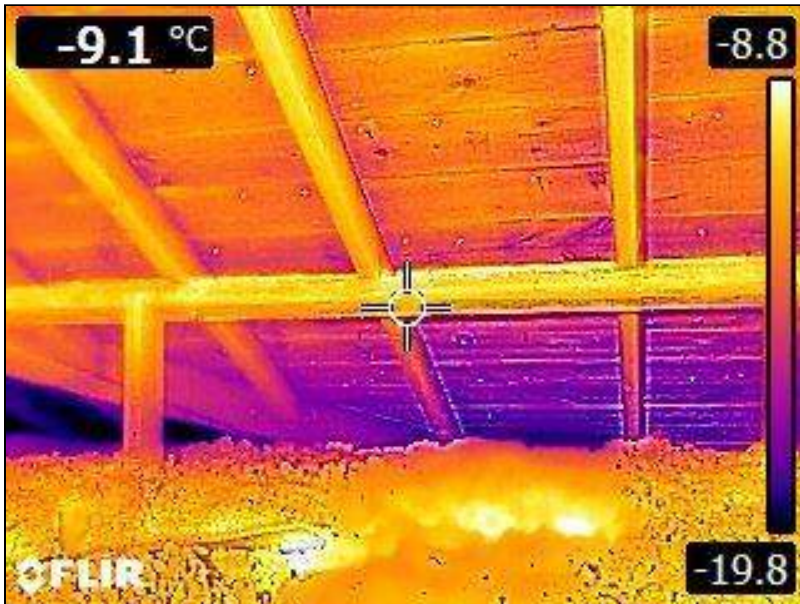
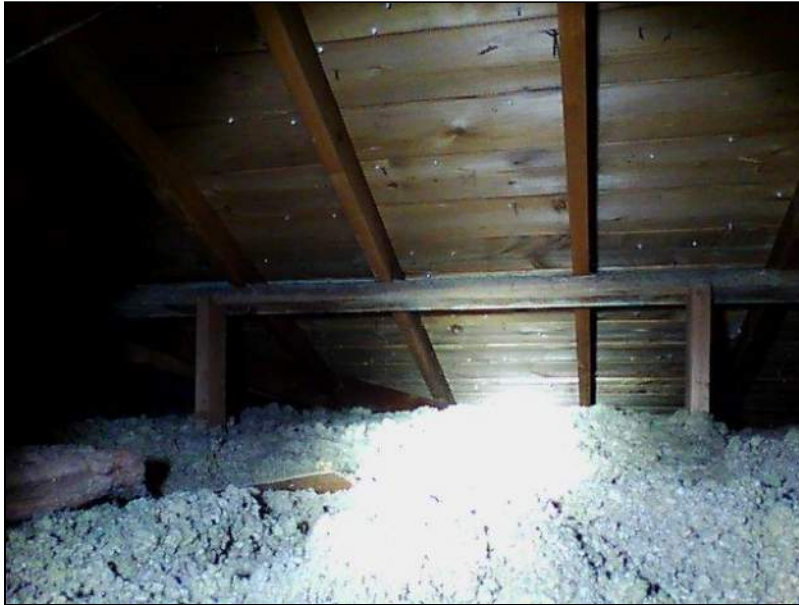
One of the rafters has split where the two are nailed together and the cross support is bowed, both are signs of movement/settling and should be further reviewed and repaired as required.

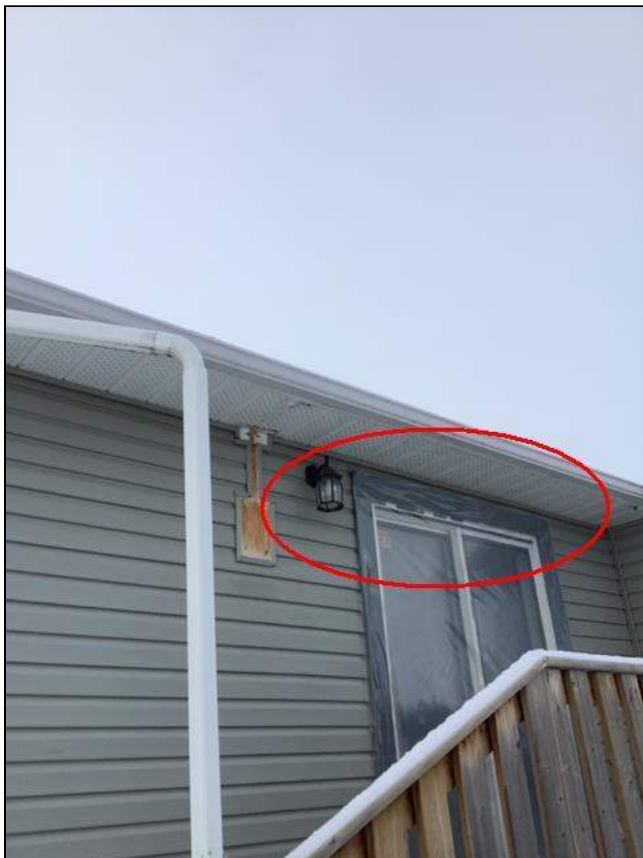
Higher levels of wall clad around the home are only visually inspected from the ground level. At the back of the house the top row of siding is bowed over the sliding patio door, recommend that it be further reviewed and repaired as required.

3.1 Item 9(Picture) Exterior Siding - bowed

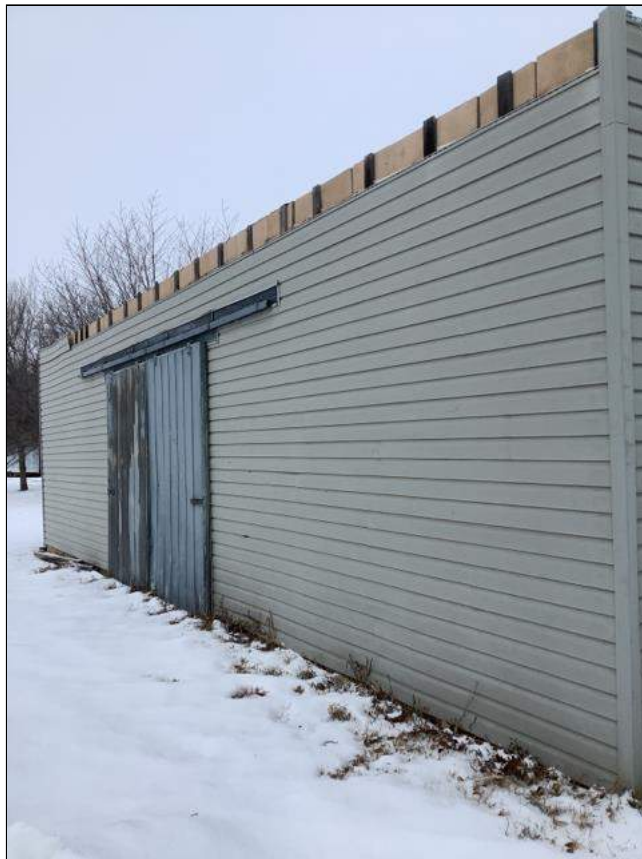
4.4 Item 2(Picture) Garage Exterior

The back of the garage is heavily bowed, replacement of the garage is recommended.

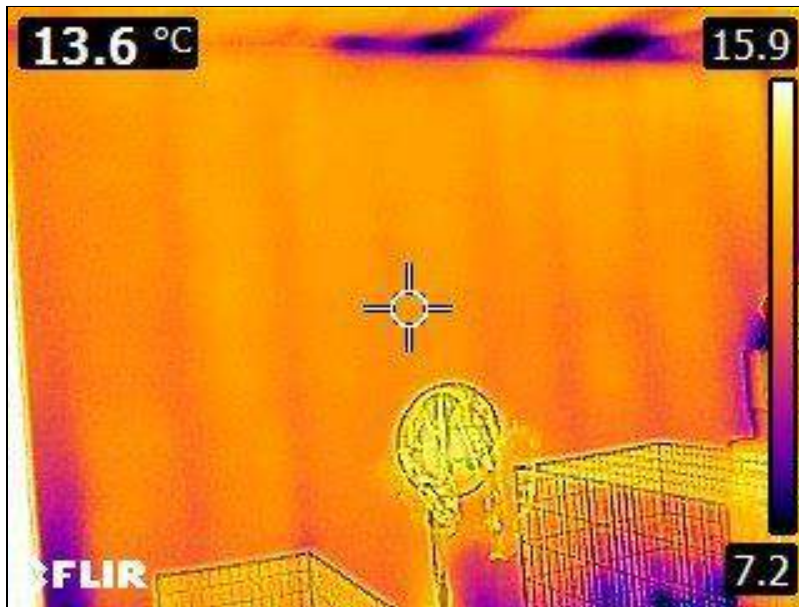
5.1 Item 10(Picture) Interior Walls

All walls were dry at time of inspection but had multiple cracks throughout the house some common from settling and some from shifting.

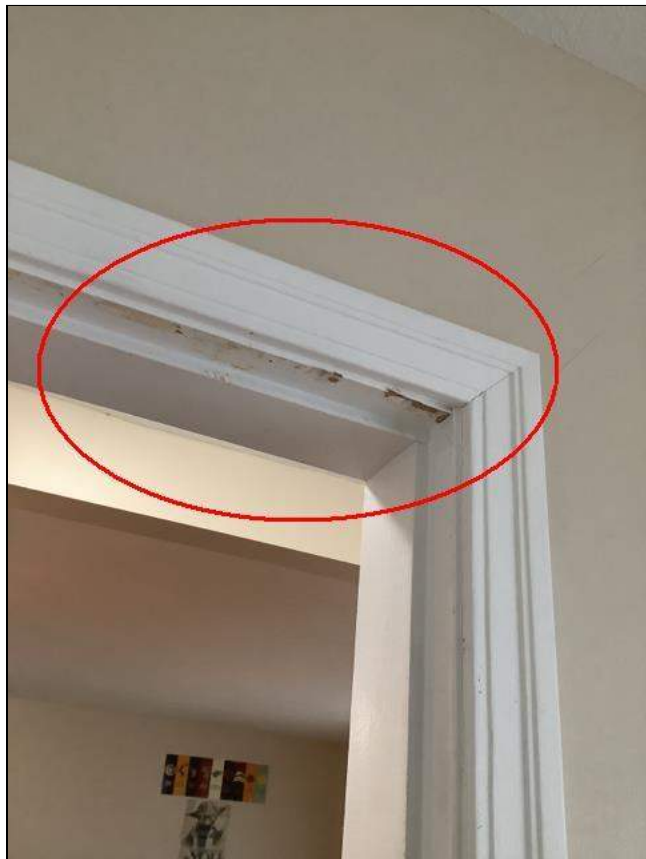
Doors were all inspected and two had signs of rubbing which aligns with the settlement the house experienced.

5.4 Item 1(Picture) Door - signs of rubbing
