HOME
INSPECTION

Inspection Report

Property Address:
964 Hunter Drive - Nacmine
Drumheller Alberta T0J 0Y0

| Date: 16/12/2021 | Time: 11:00 AM | Report ID: 964 Hunter Drive - Nacmine |

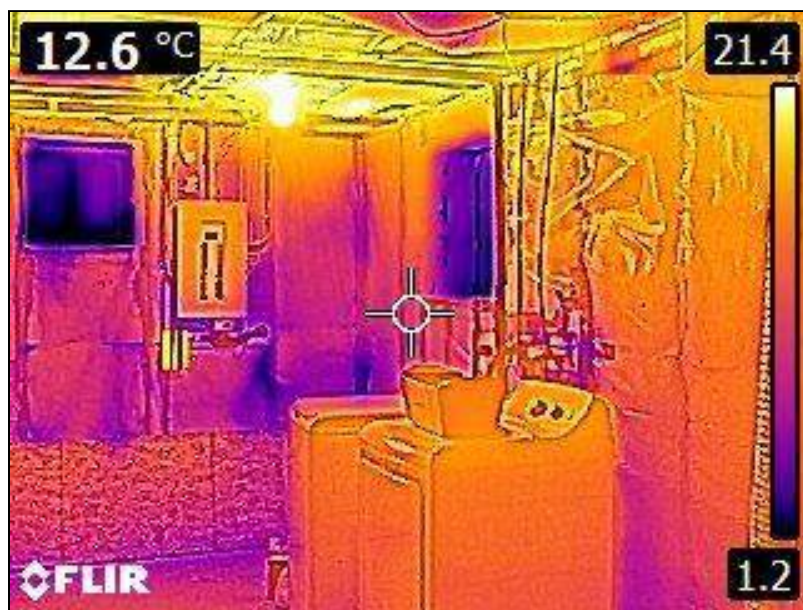
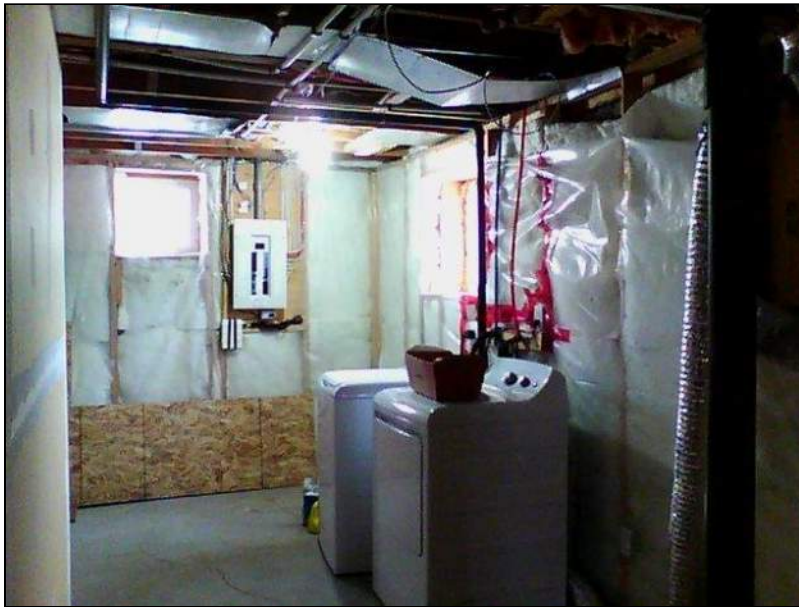
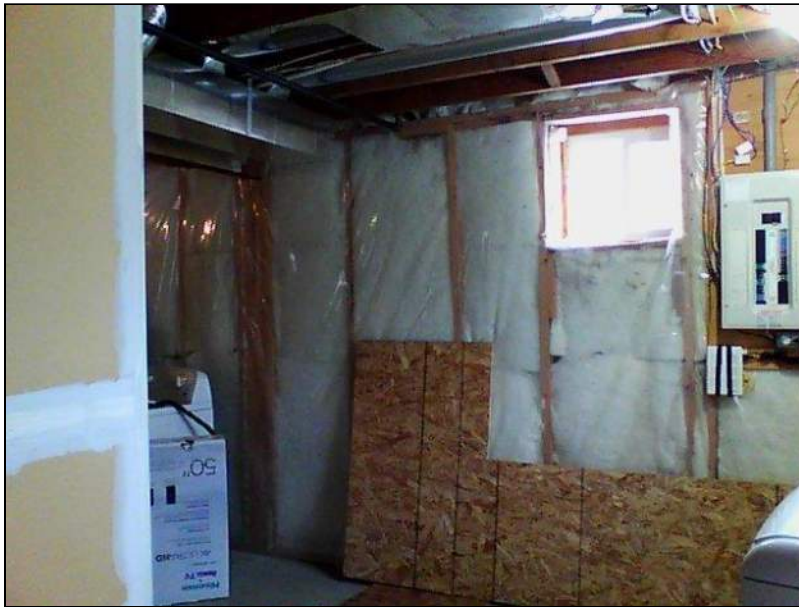
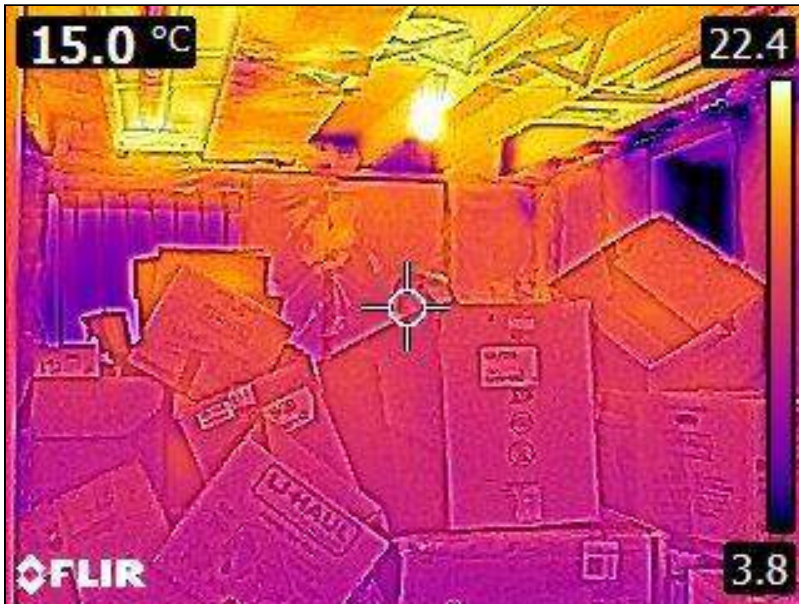
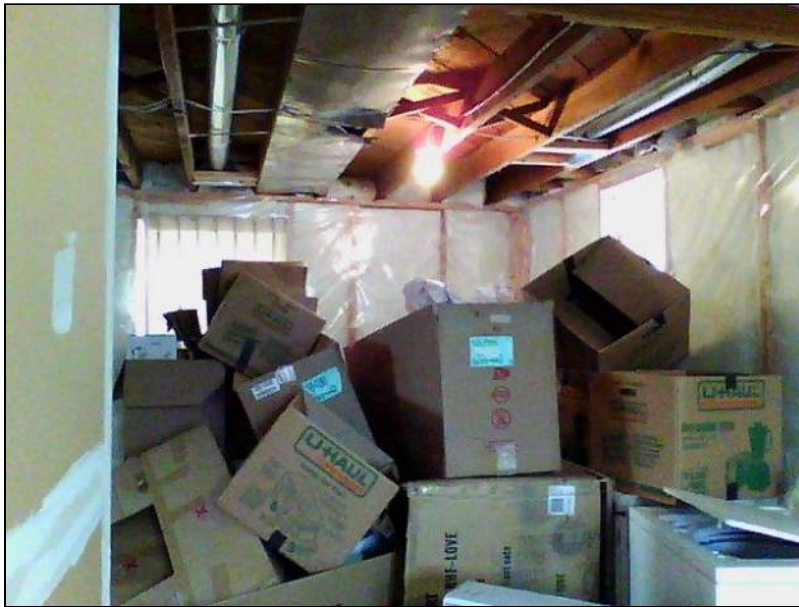
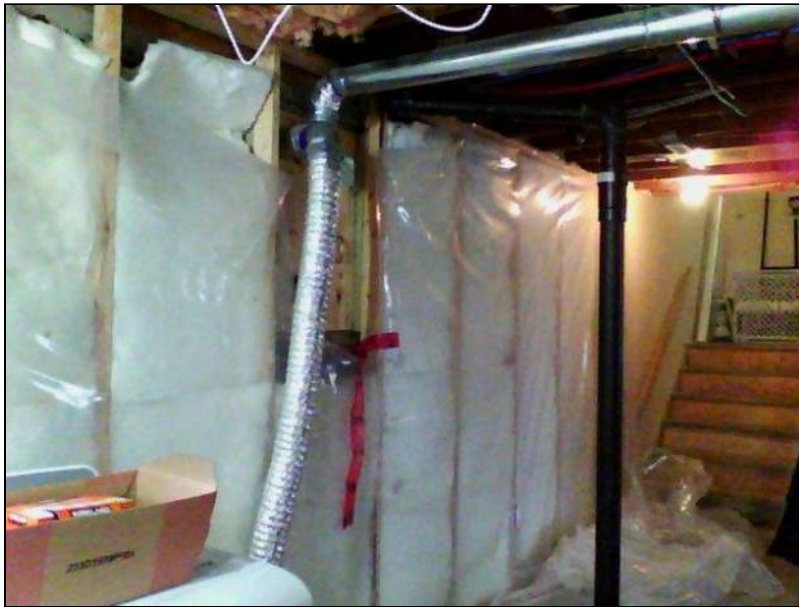
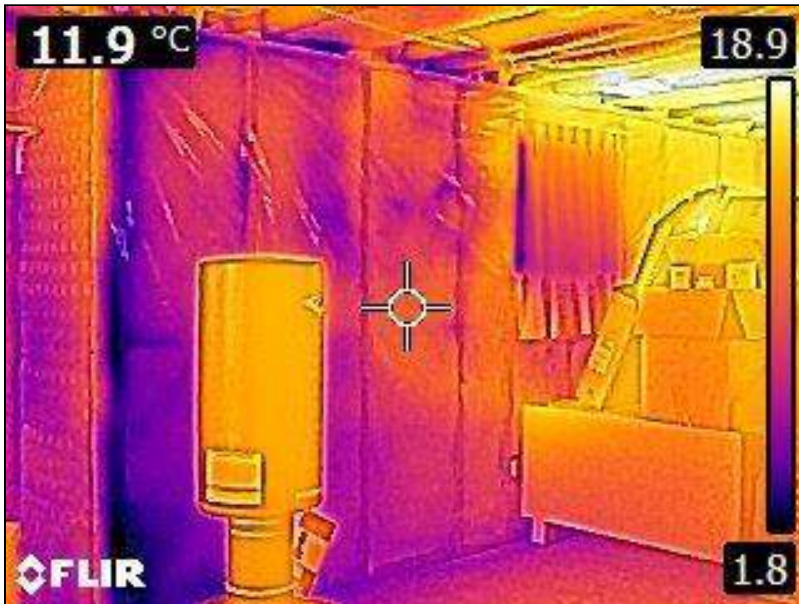
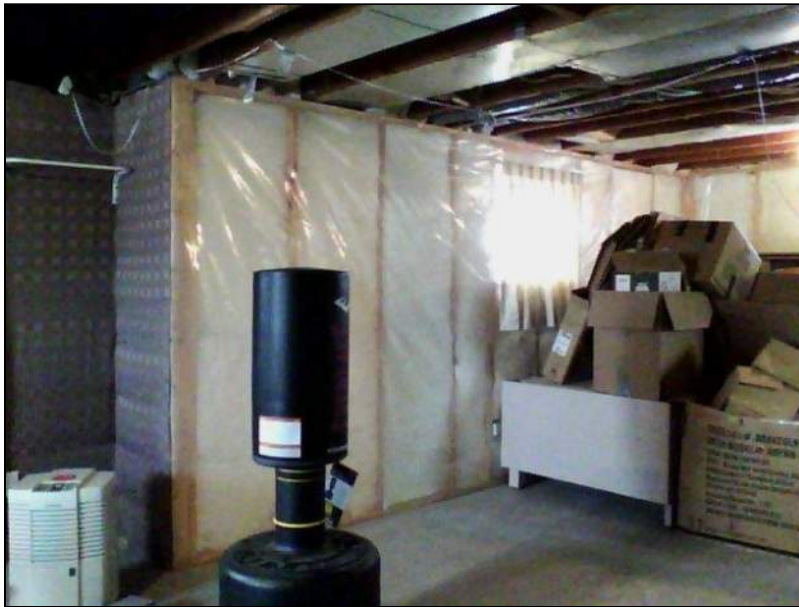
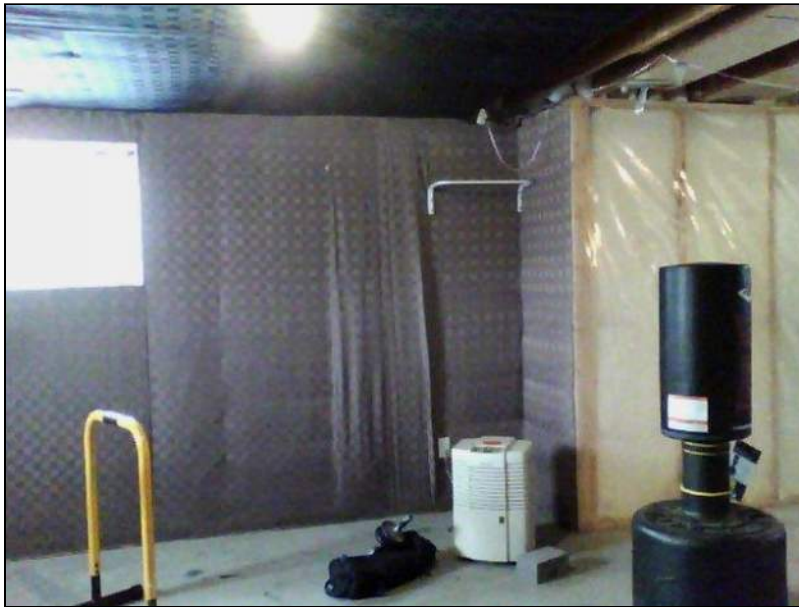
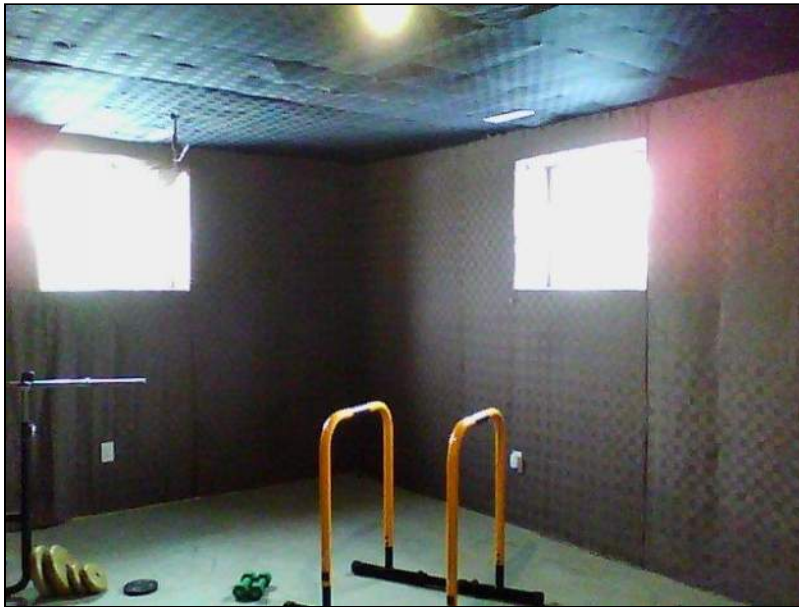
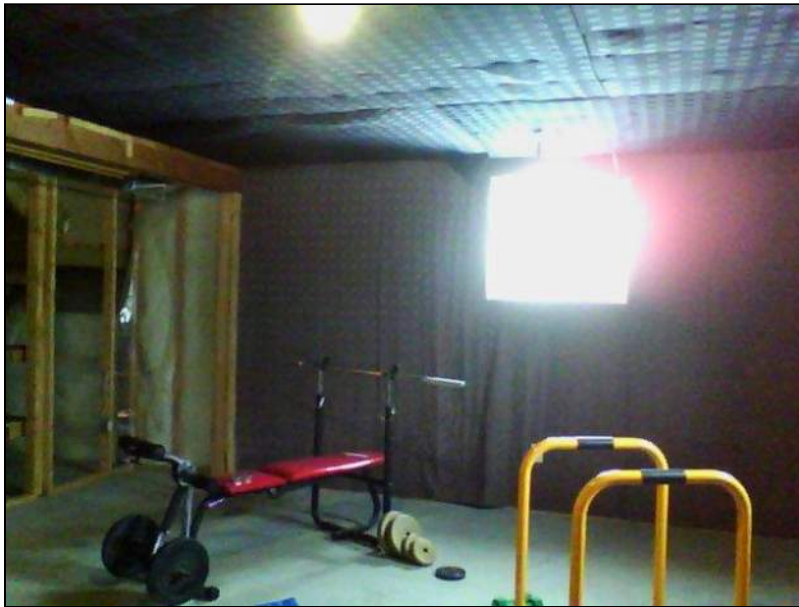
The basement area was dry on day of the inspection. Future conditions cannot be determined as these are changeable with the weather conditions. Recommend obtaining information from seller on any past water/moisture penetration.

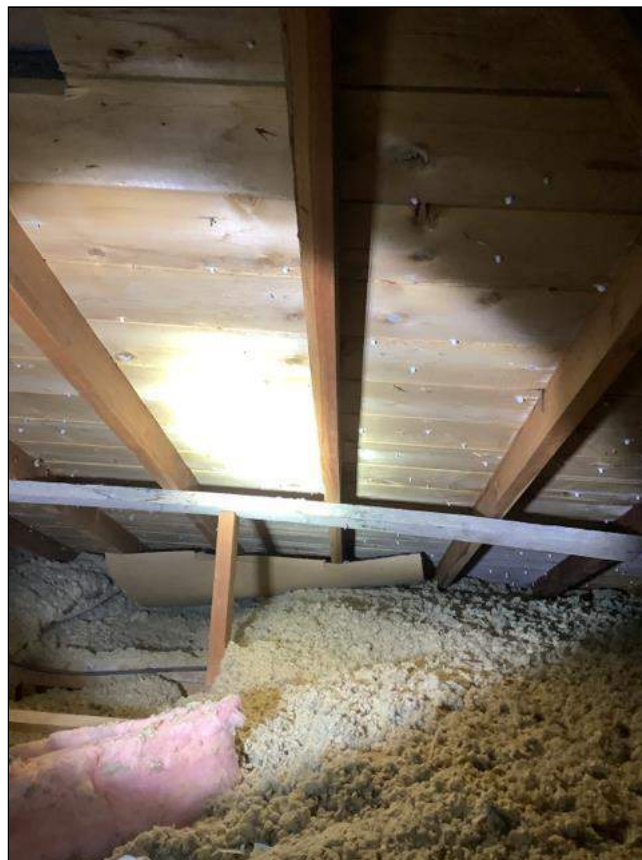
2.3 Item 2(Picture) Rafter - split, cross support bowed

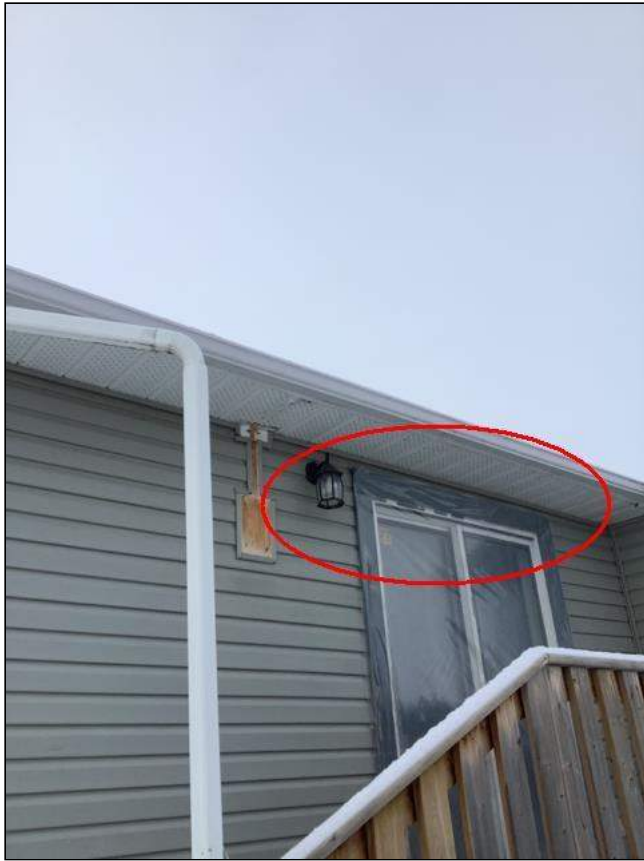
3.1 Item 9(Picture) Exterior Siding - bowed

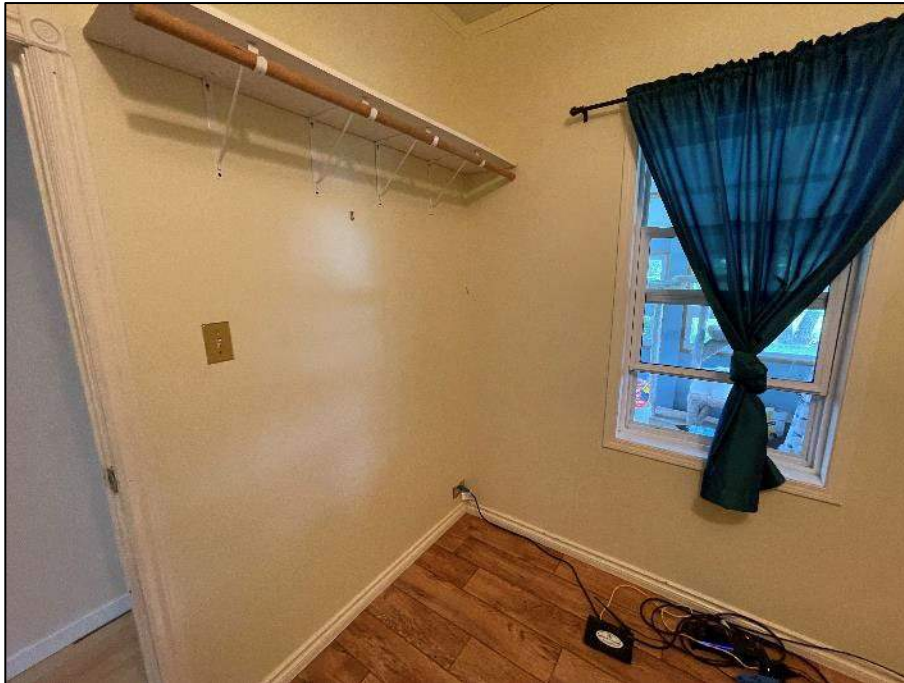
PHOTOGRAPH #1: Drywall Joint Compound - Level 1 SW Bedroom (Non-Asbestos)

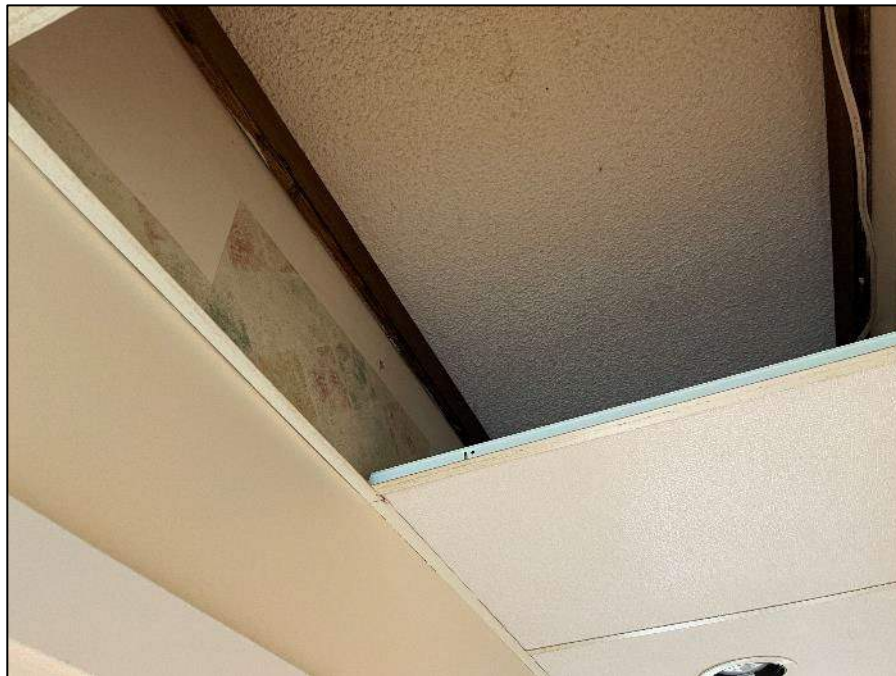
PHOTOGRAPH #4: Drywall Joint Compound - Level 1 SW Hallway (Non-Asbestos)

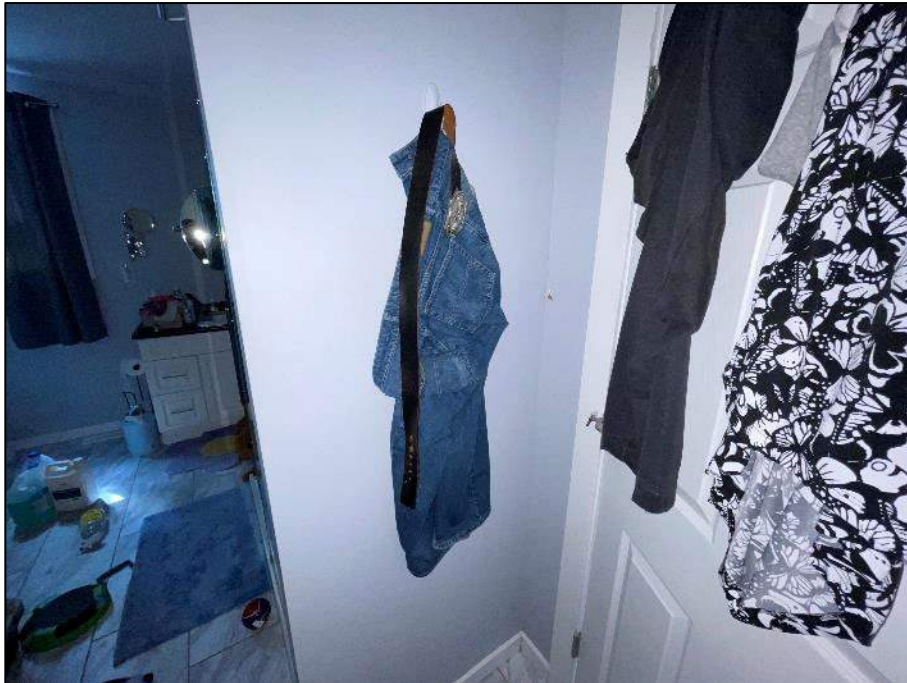
PHOTOGRAPH #5: Drywall Joint Compound - Level 1 Laundry Area (Non-Asbestos)

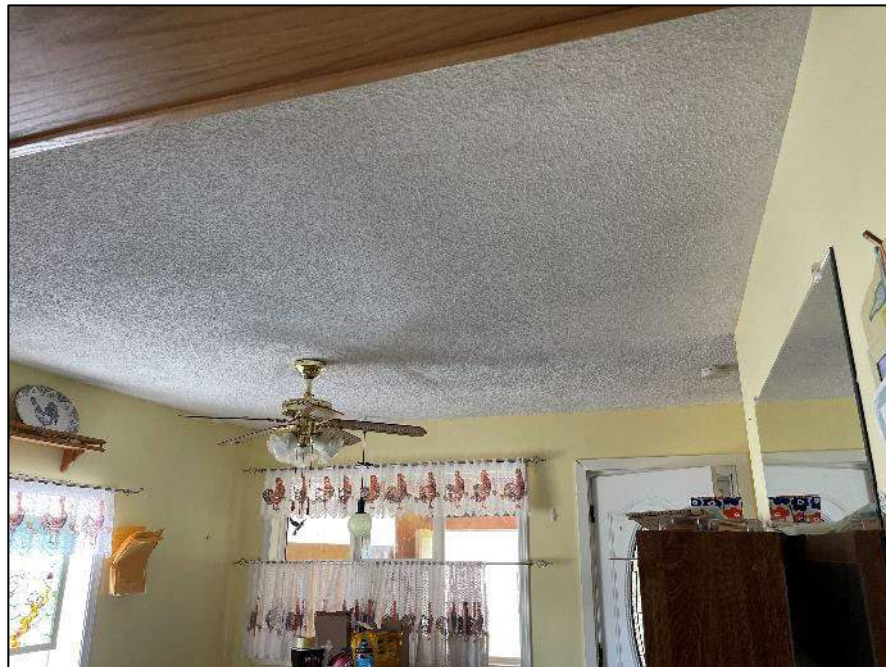
PHOTOGRAPH #8: Ceiling Texture - Level 1 Kitchen (Non-Asbestos)

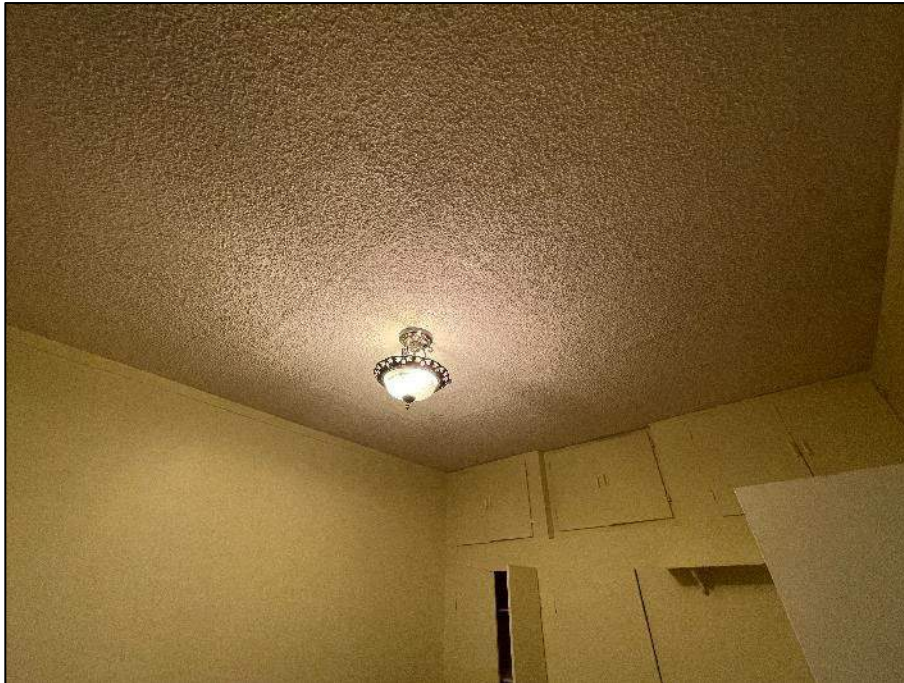
PHOTOGRAPH #9: Ceiling Texture - Level 1 SW Bedroom (Non-Asbestos)

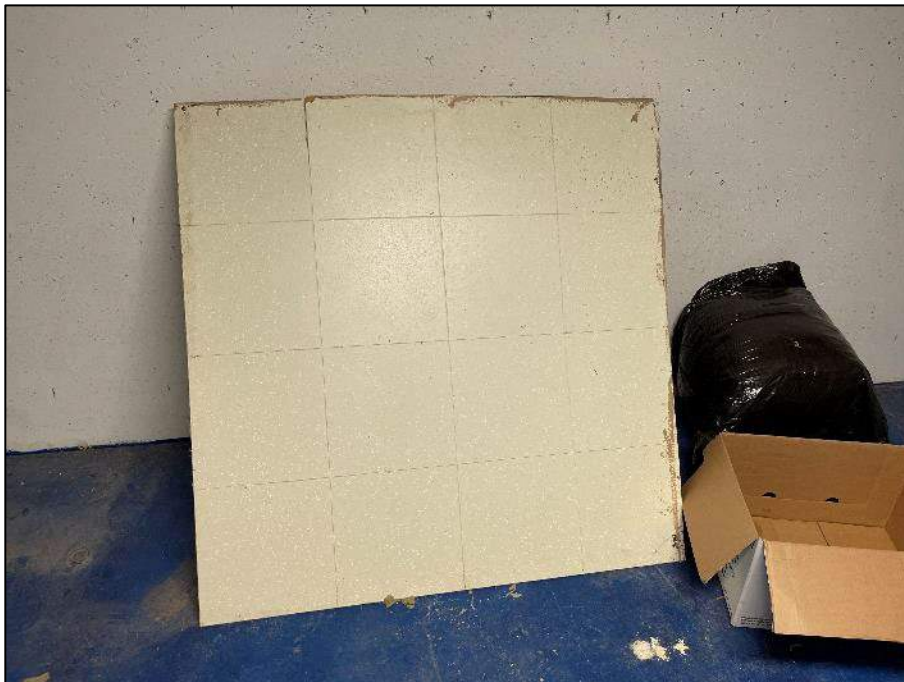
PHOTOGRAPH #10: Ceiling Tile - Basement (Non-Asbestos)

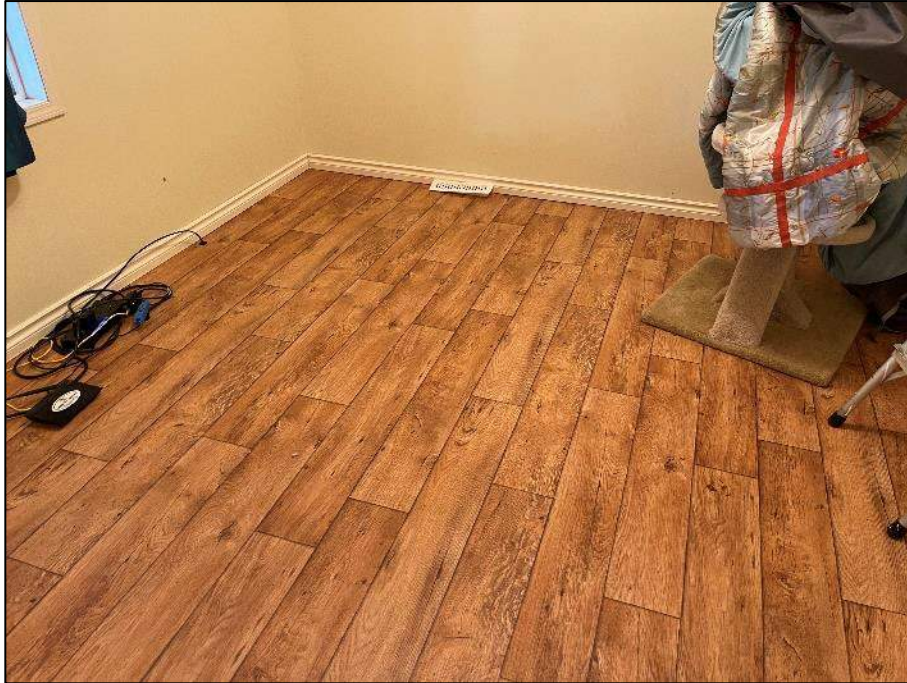
PHOTOGRAPH #11: Flooring - Level 1 SW Bedroom (Non-Asbestos)

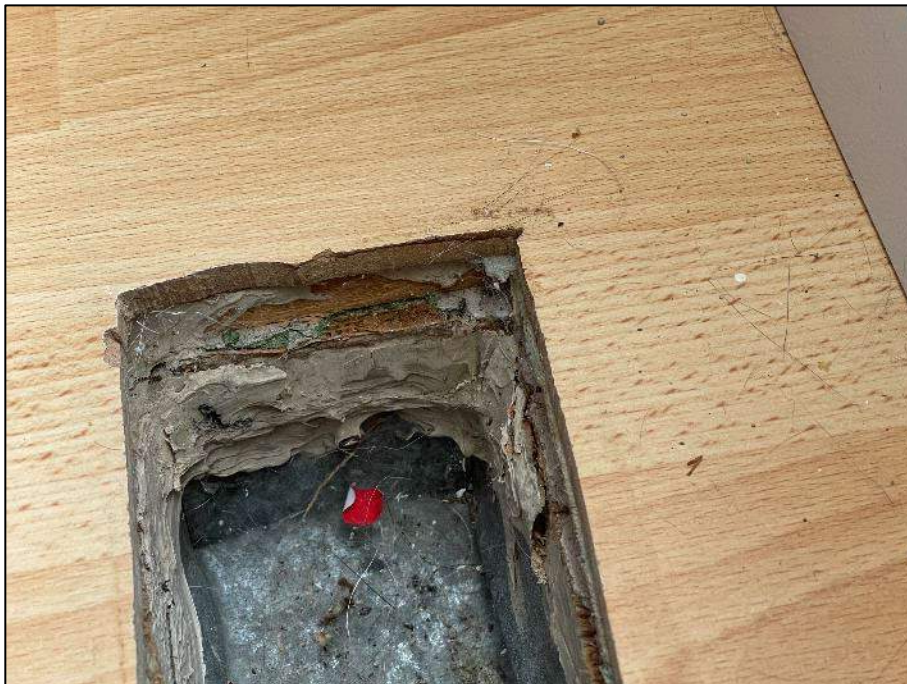
PHOTOGRAPH #12: Flooring - Level 1 Living Room (Non-Asbestos)

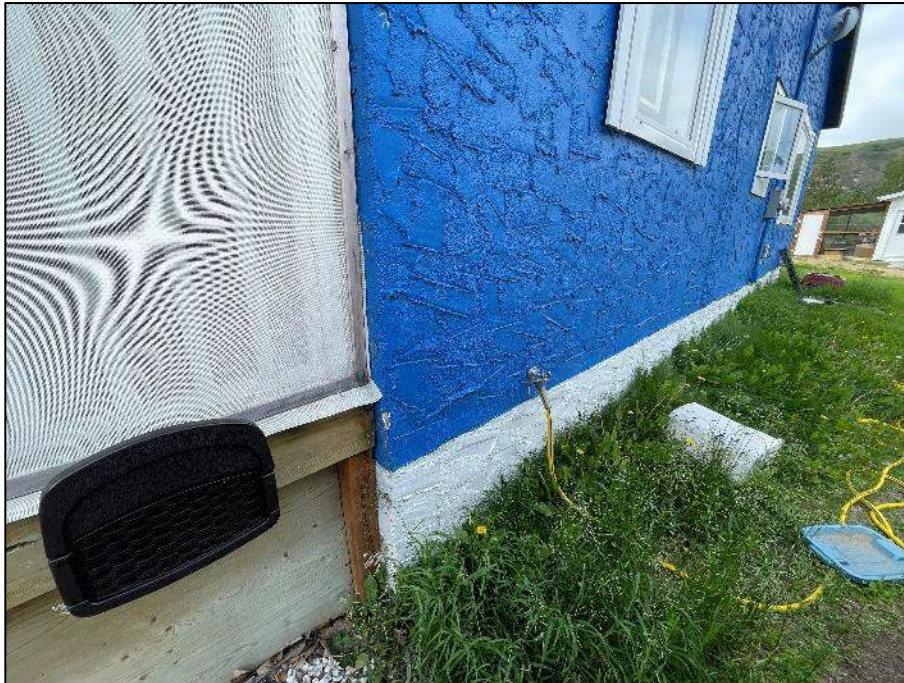
PHOTOGRAPH #13: Stucco - Exterior NE Corner (Assume Positive)

1. The stucco on the property was identified as asbestos-containing (*See Photographs #13 to 17*). Removal of the material must be performed prior to demolition by a qualified abatement contractor using moderate-risk asbestos abatement procedures found in Section 5.3 of the AAAM (2019).

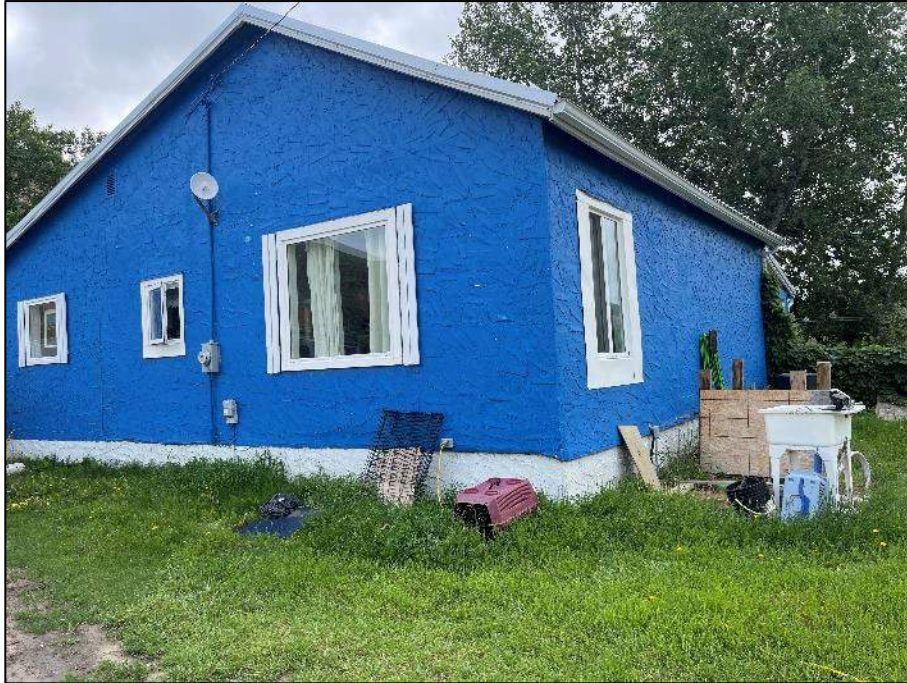
PHOTOGRAPH #15: Stucco - Exterior NW Corner (2% Chrysotile)

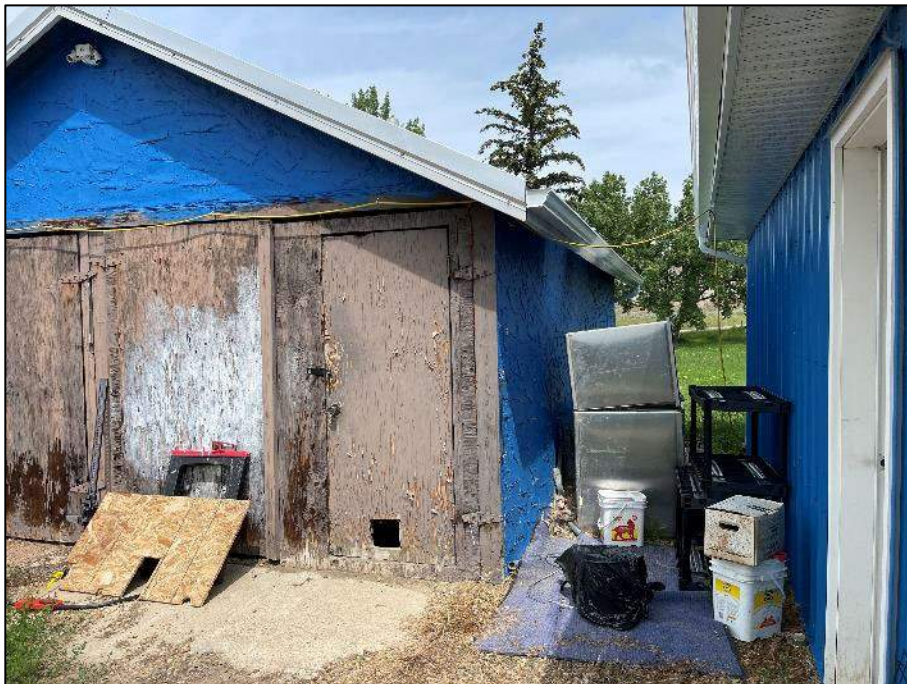
PHOTOGRAPH #16: Stucco - Shed SE Corner (2% Chrysotile)

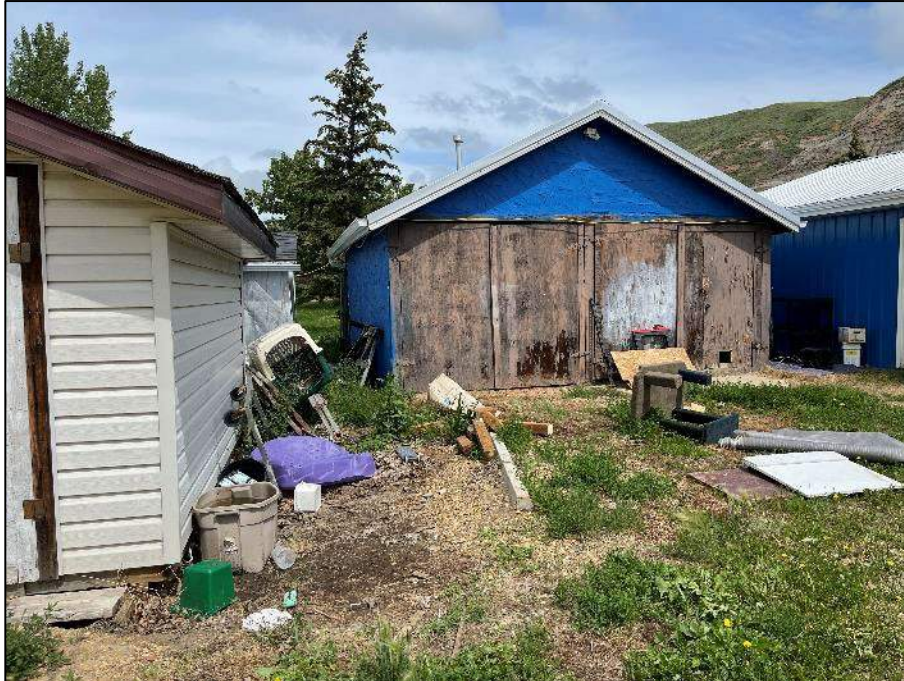
PHOTOGRAPH #17: Stucco - Shed SW Corner (2% Chrysotile)

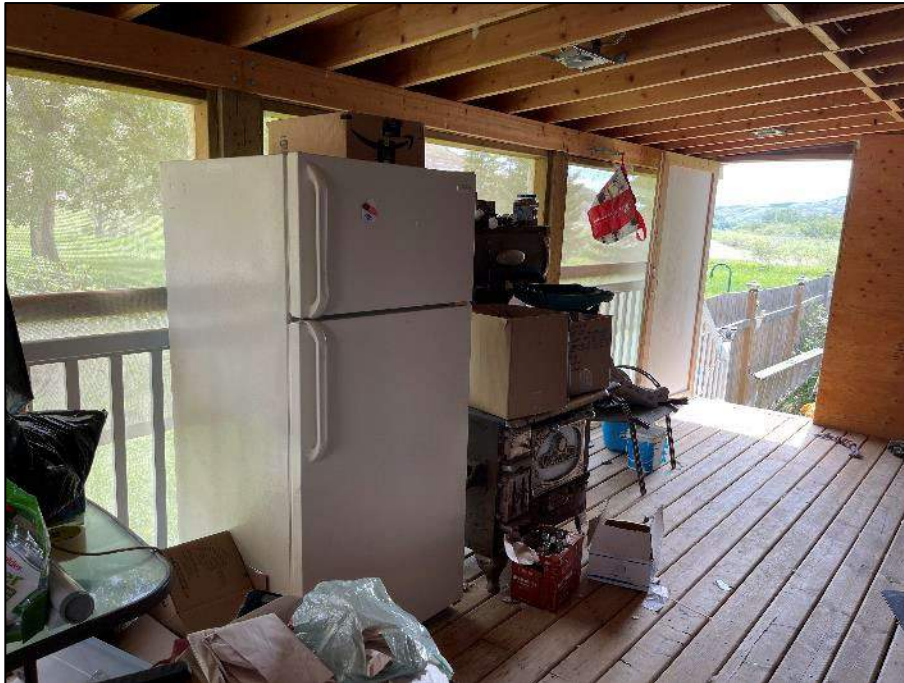
PHOTOGRAPH #23: Fridge on Porch (Ozone Depleting Substances)
