Demolition and Remediation Services

**Residential Demolition Project
for
The Town of Drumheller**

Tender issued September 2, 2022
Tender closing September 22, 2022 – 2:00:00 P.M.

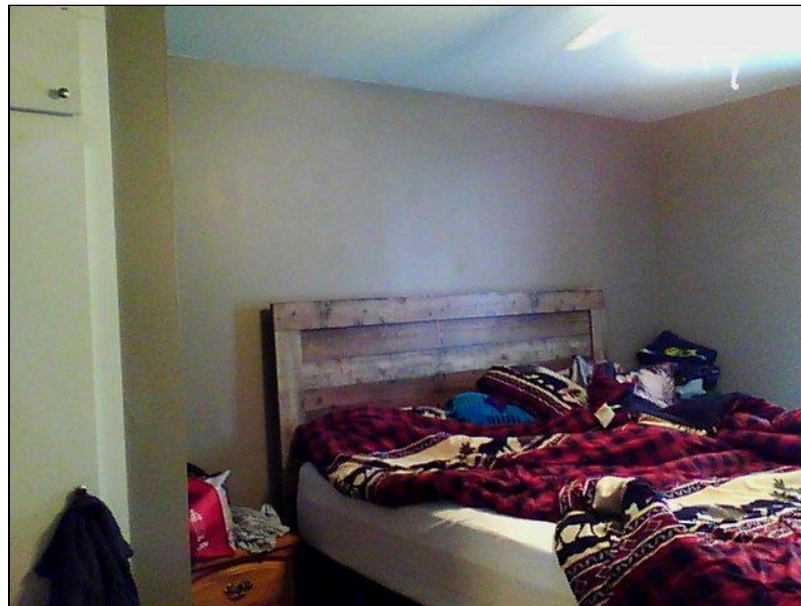
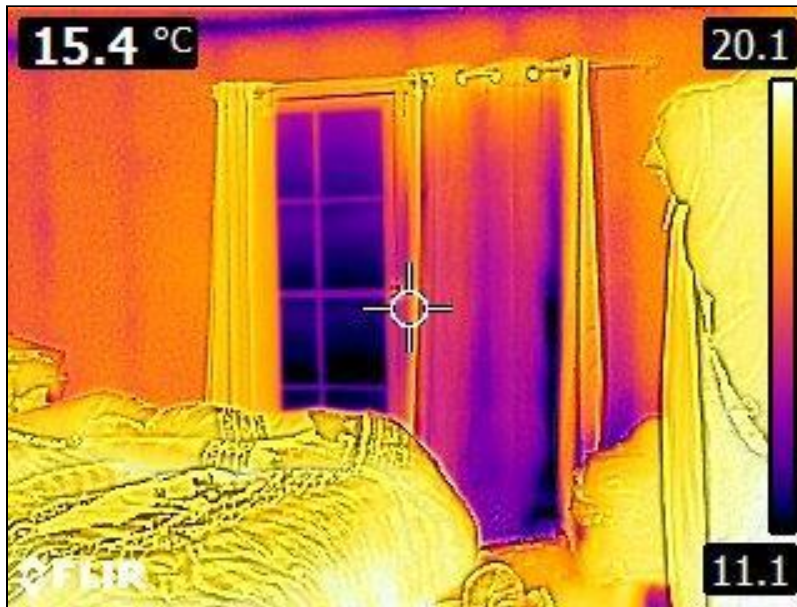
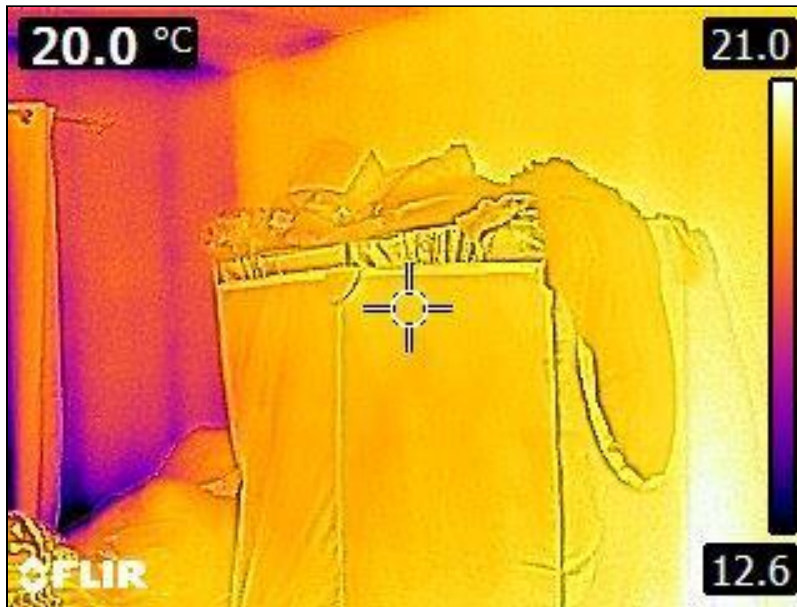
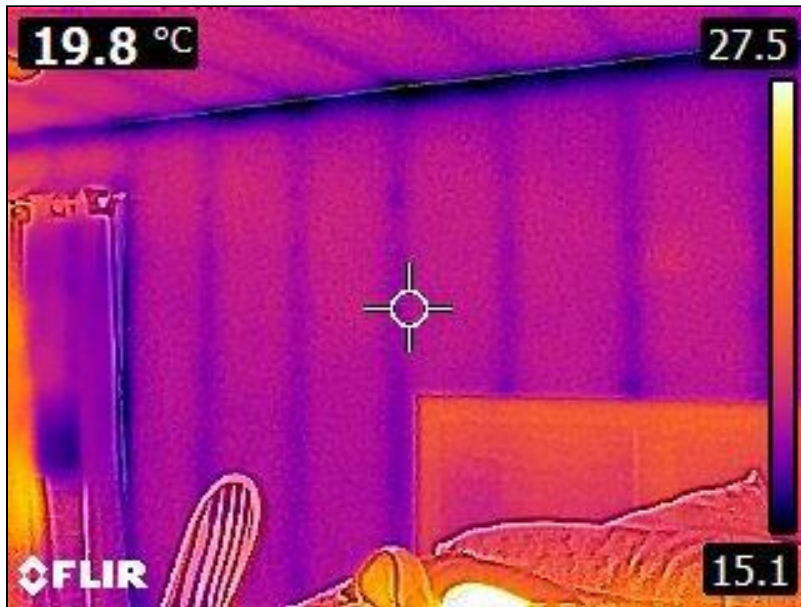
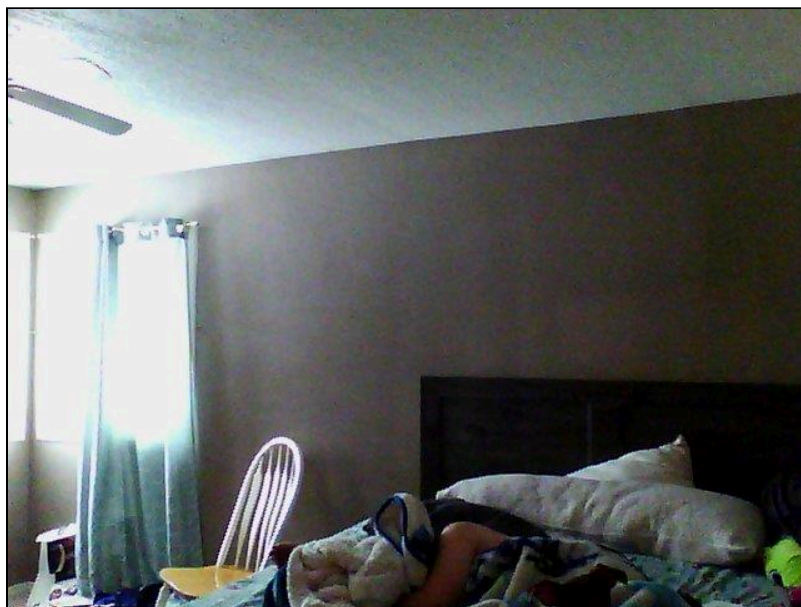
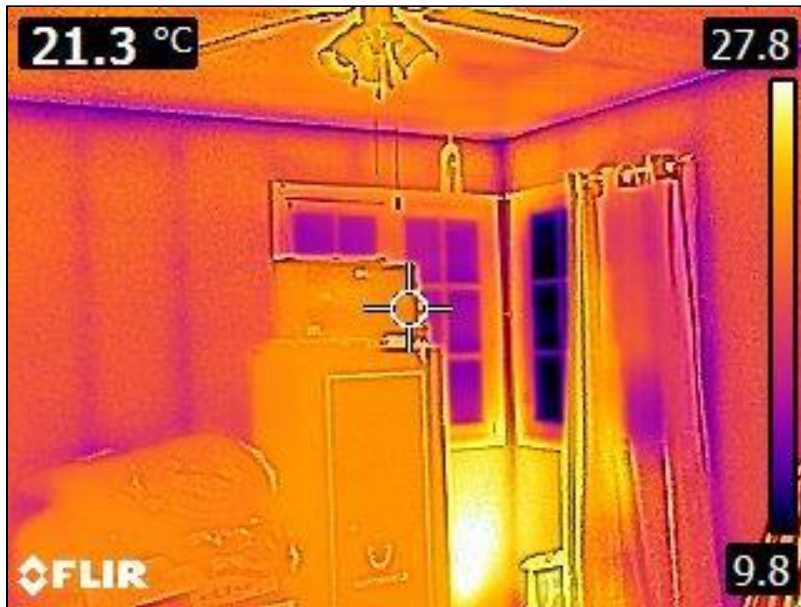
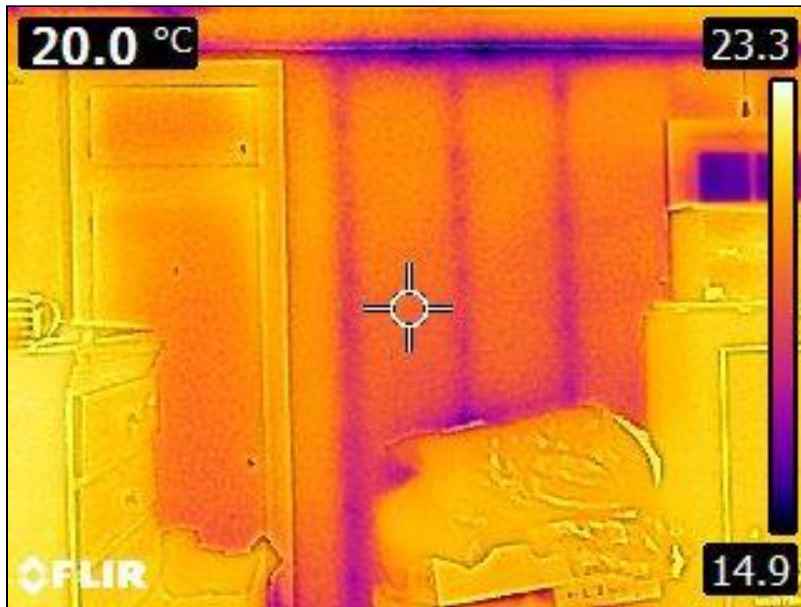
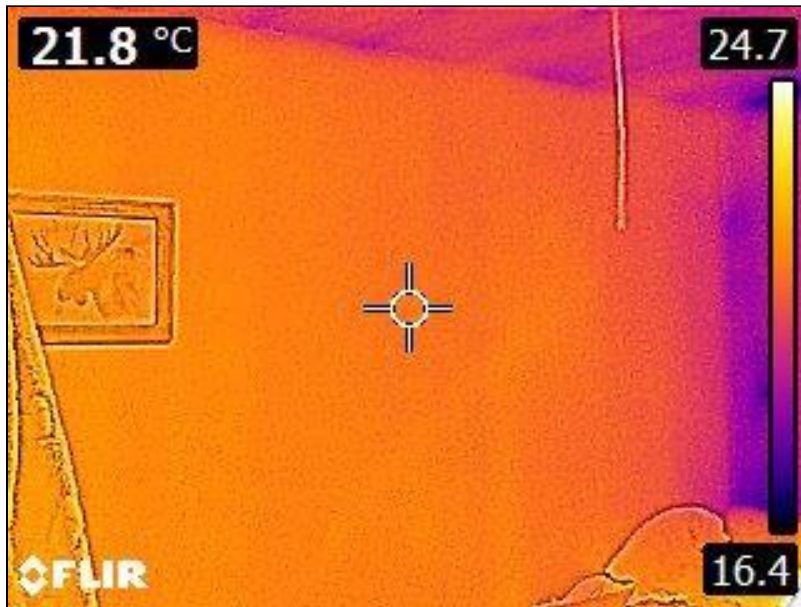
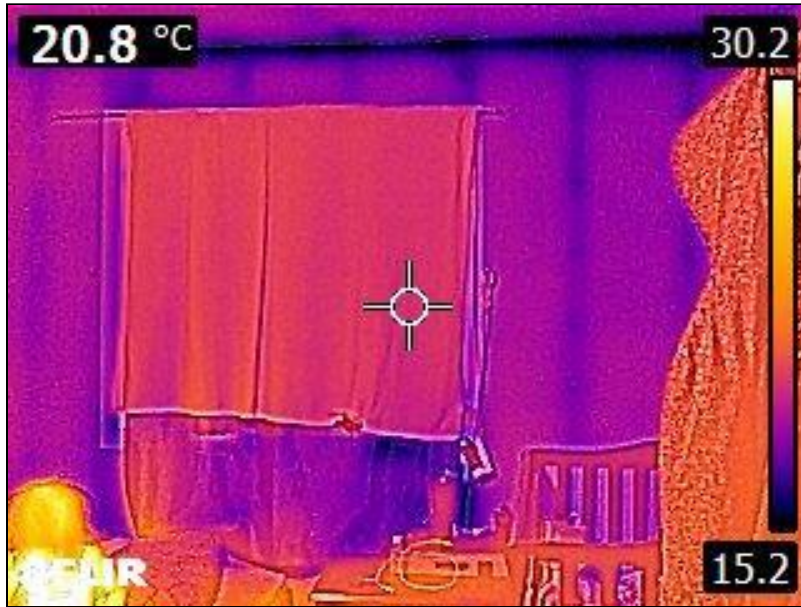
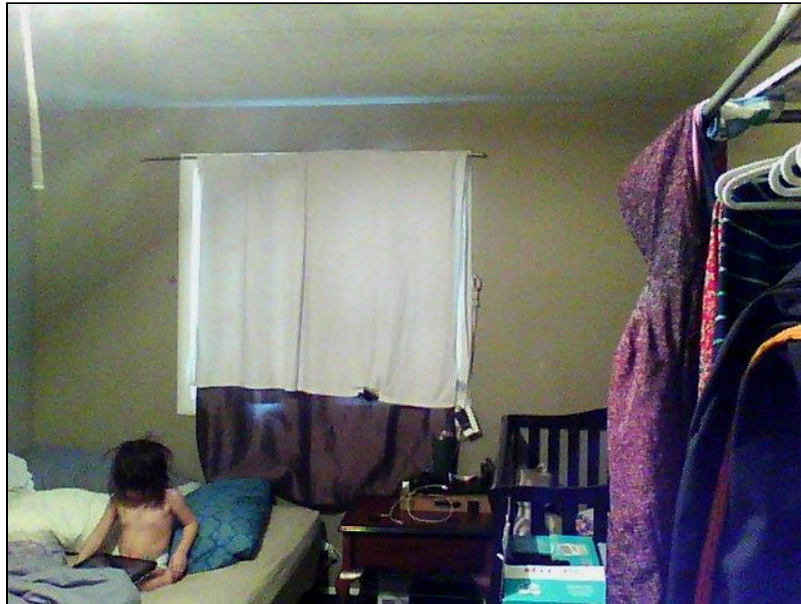
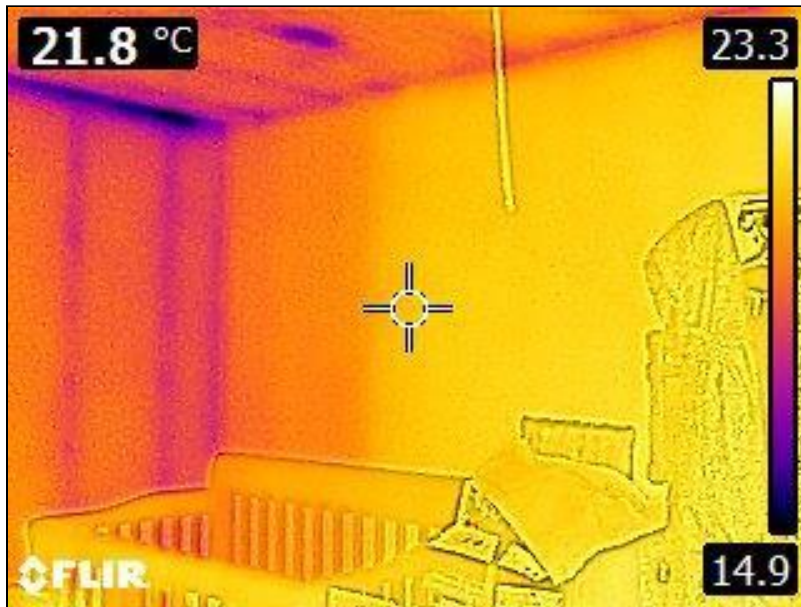
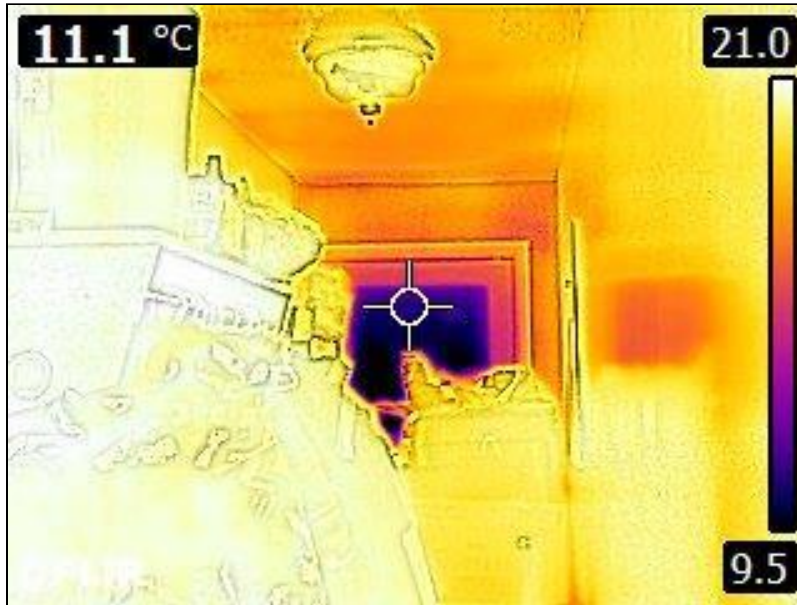
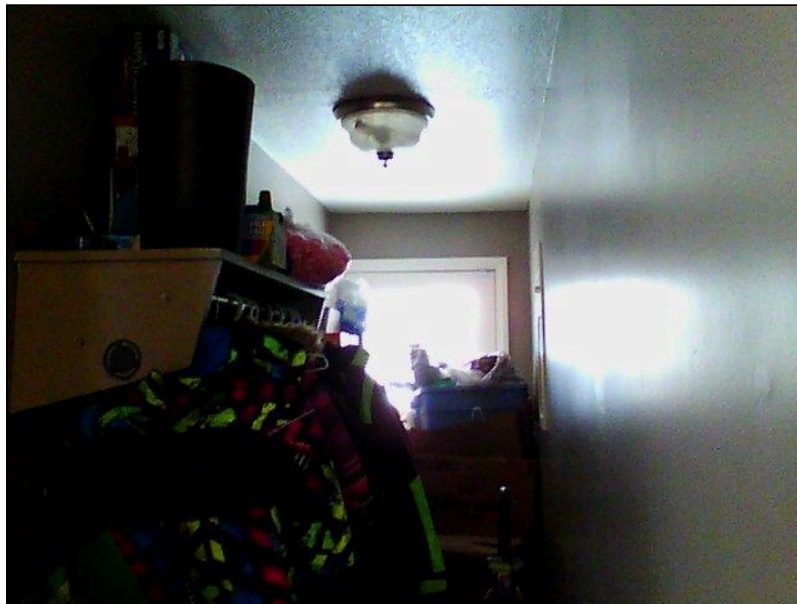
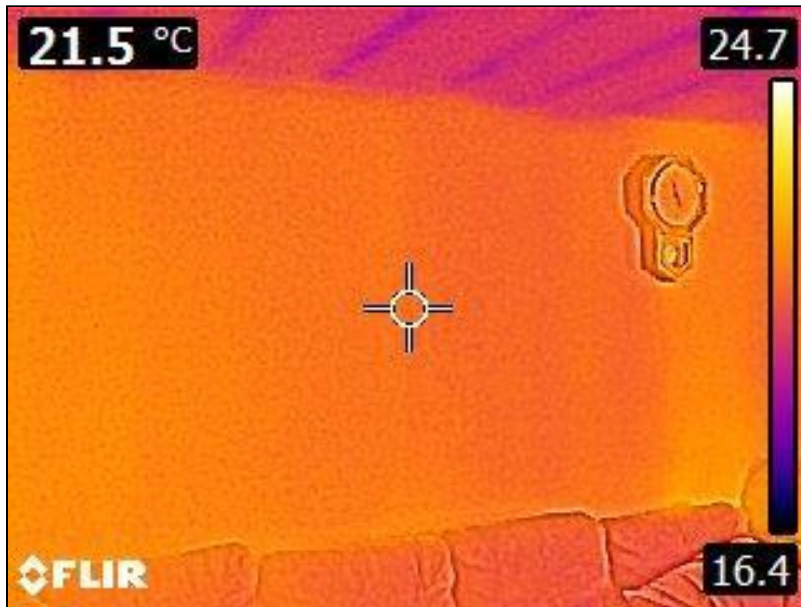
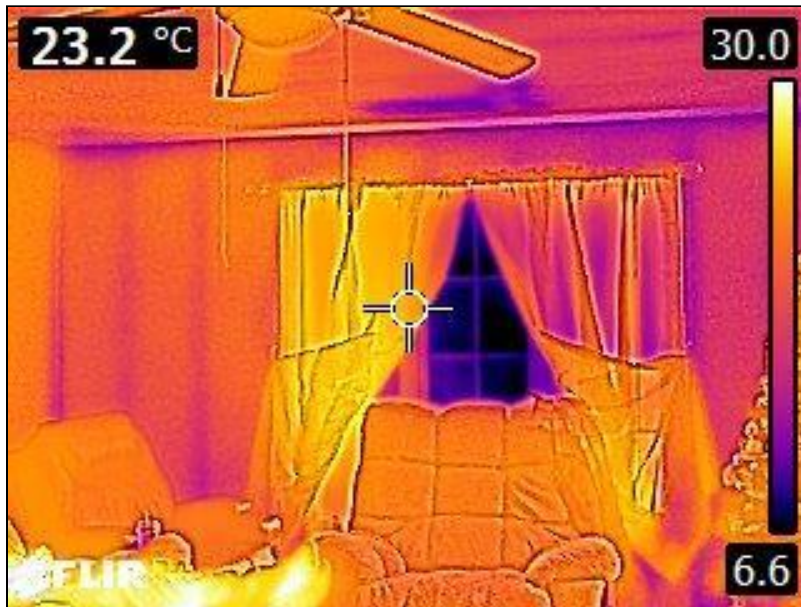
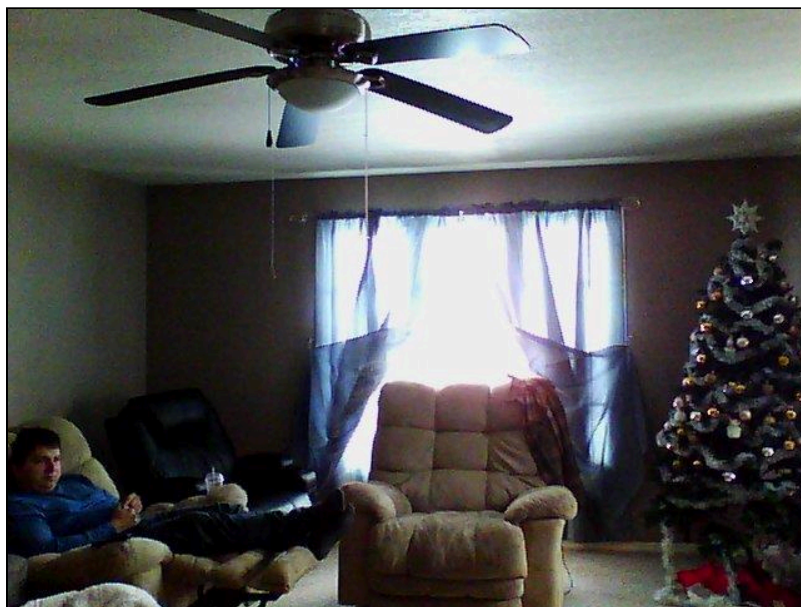
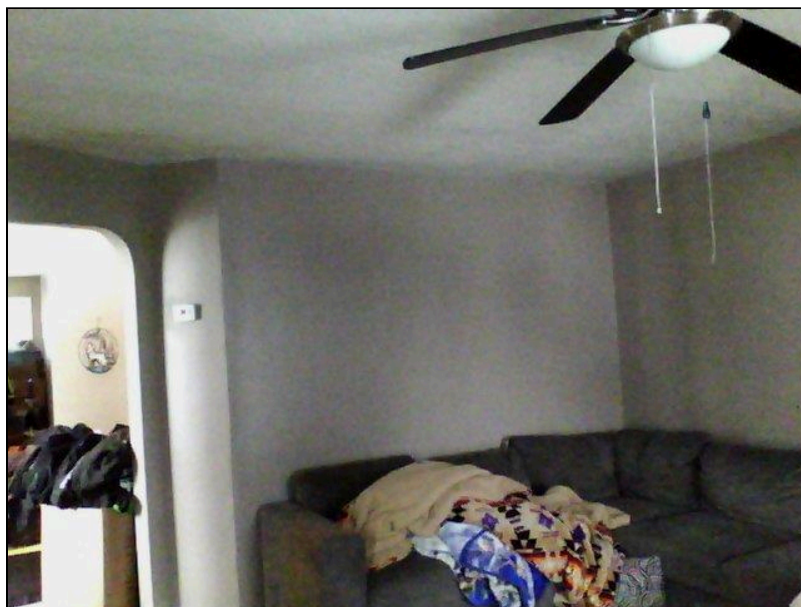
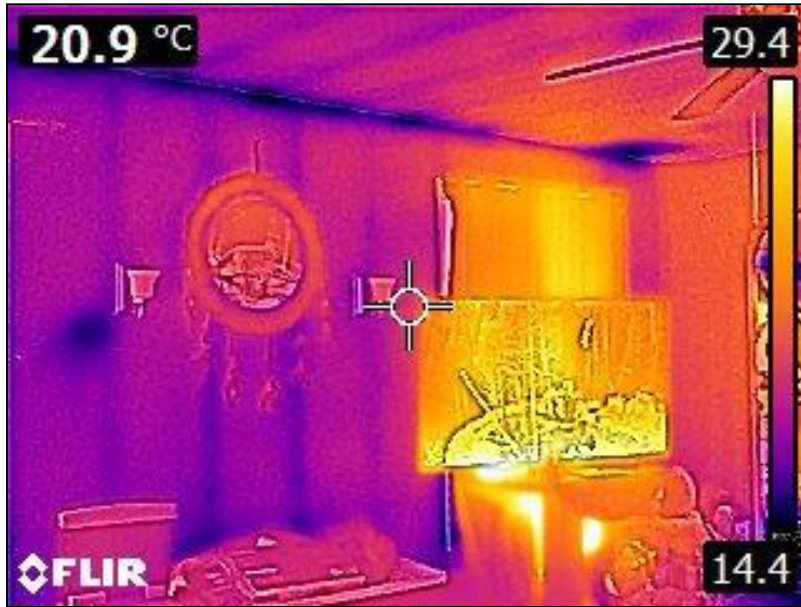
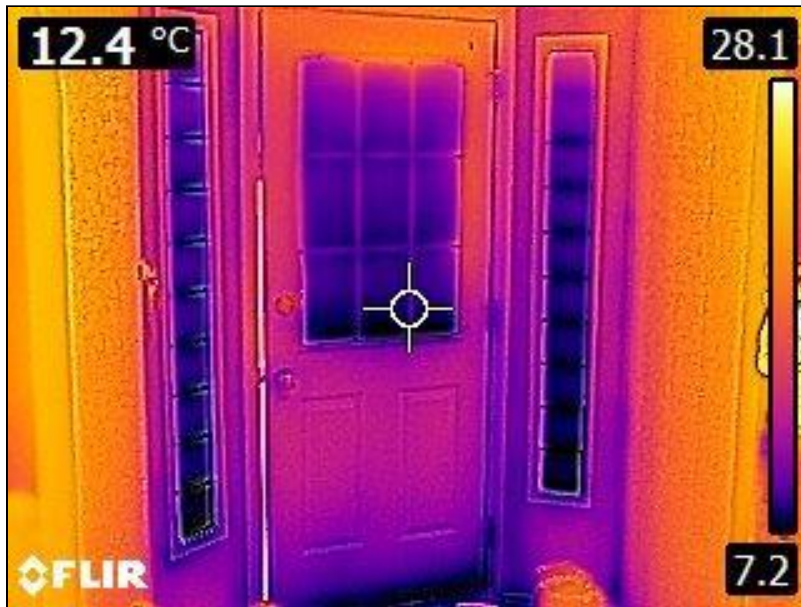
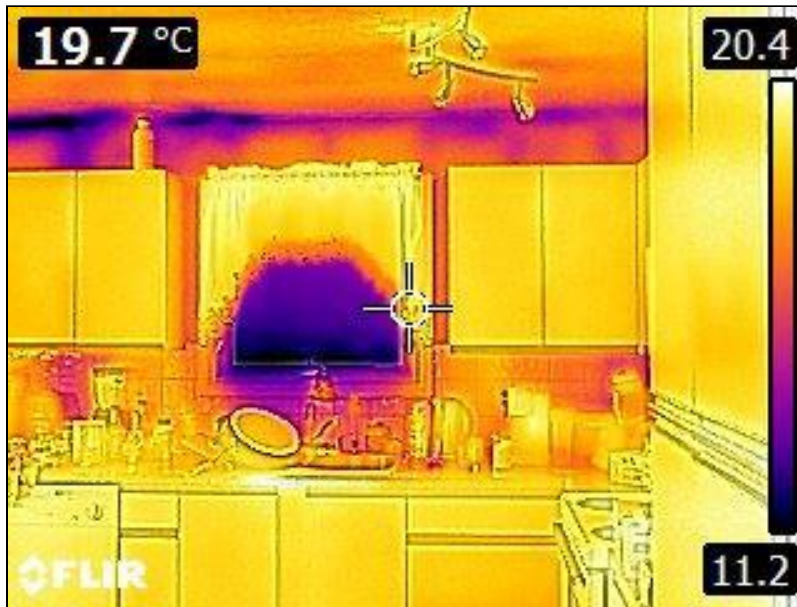
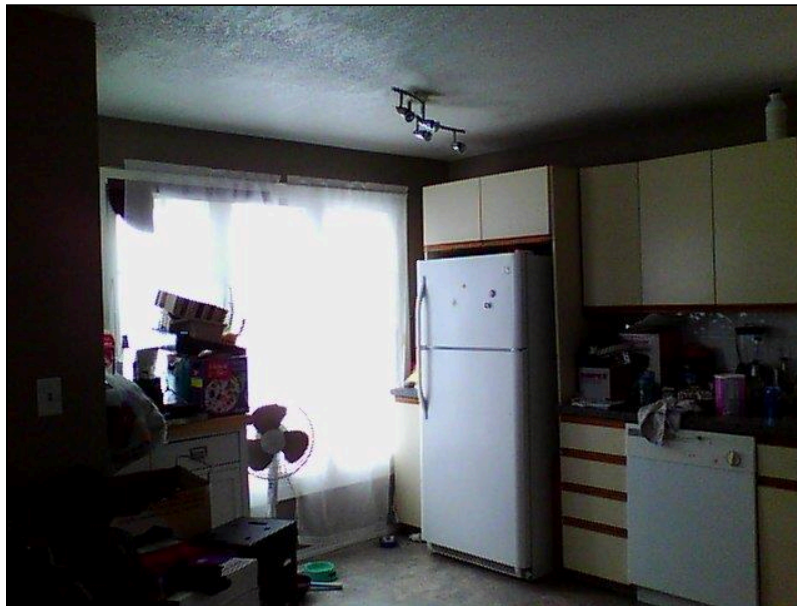
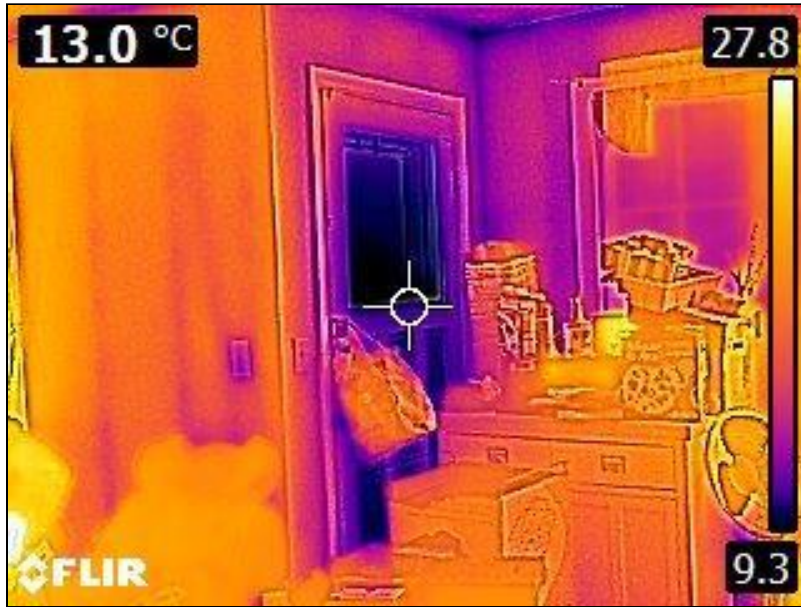
All walls were in good condition and dry at the time of inspection. (Cosmetic issues are not part of the inspection.)

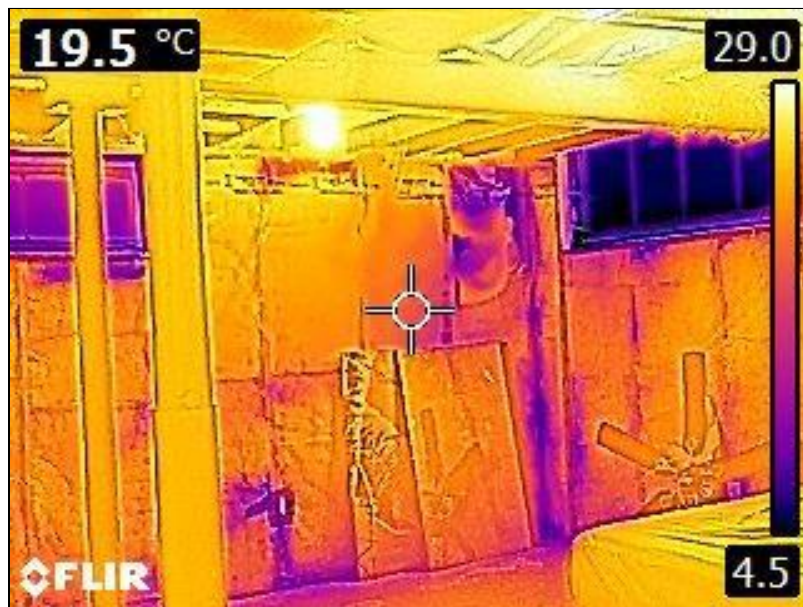
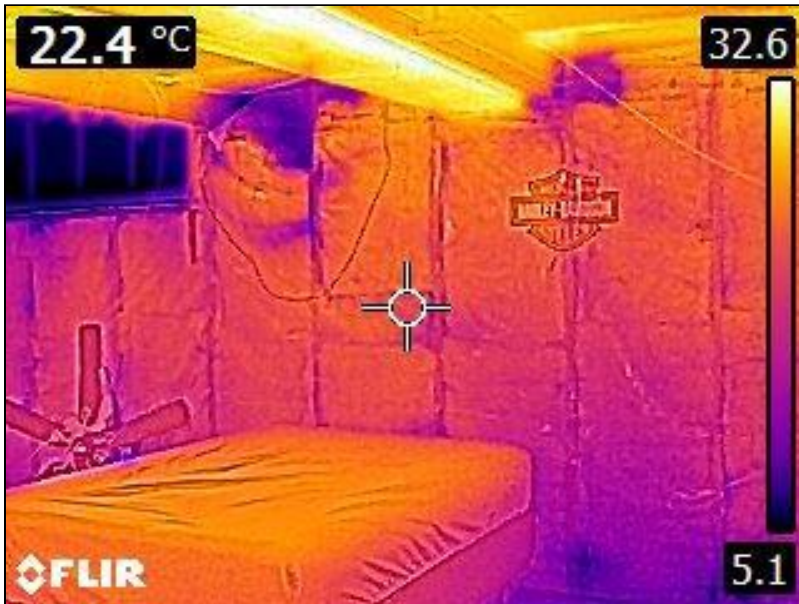
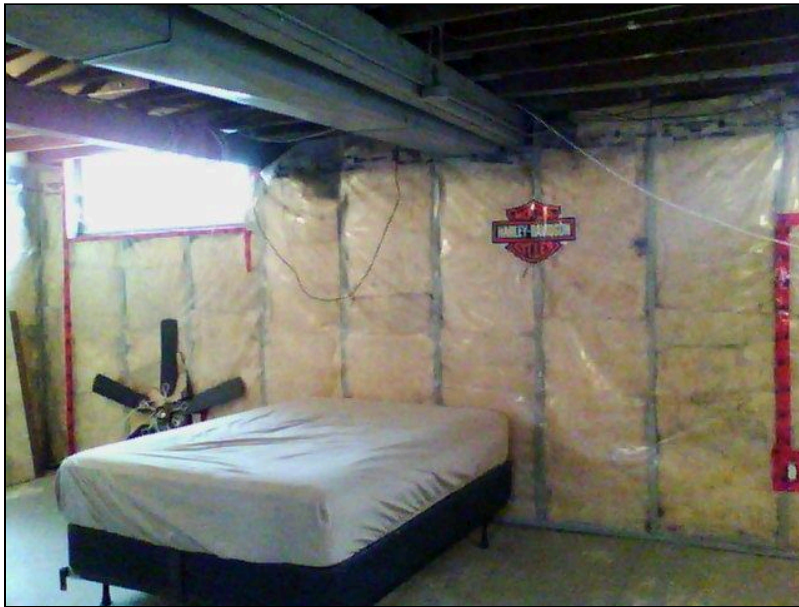
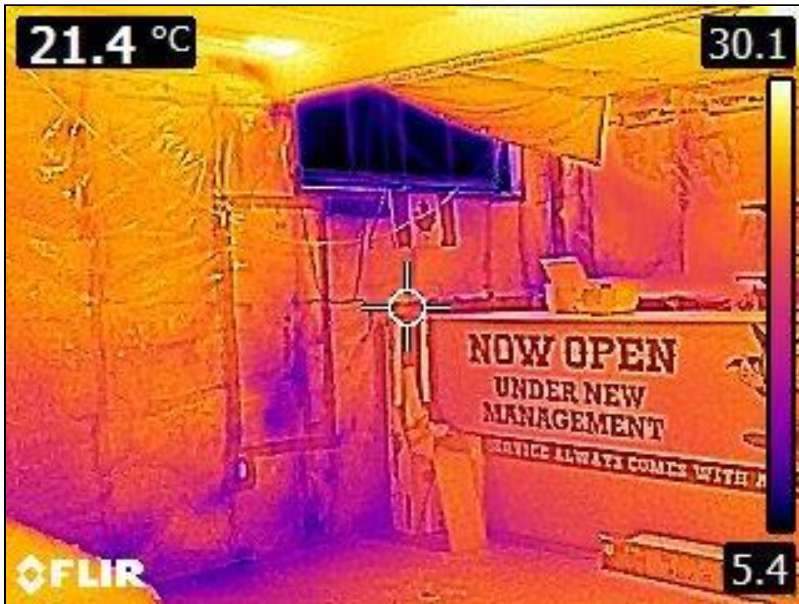
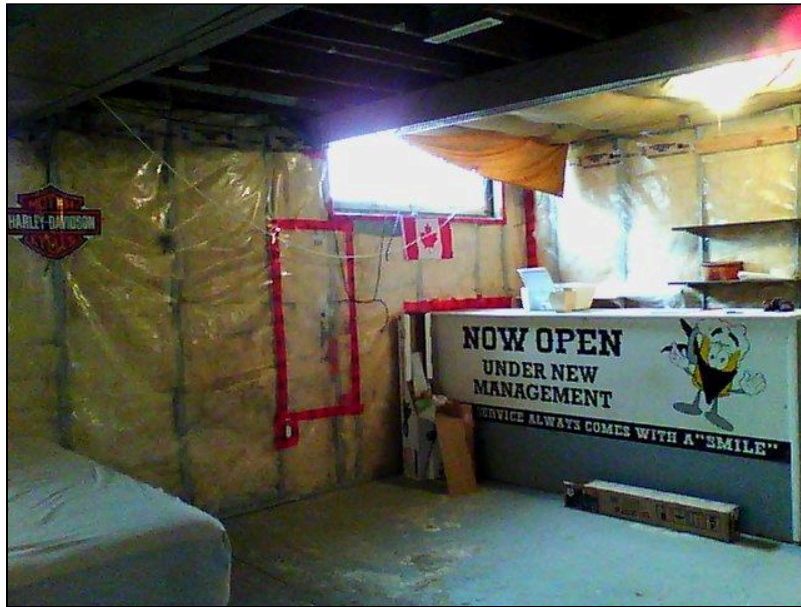
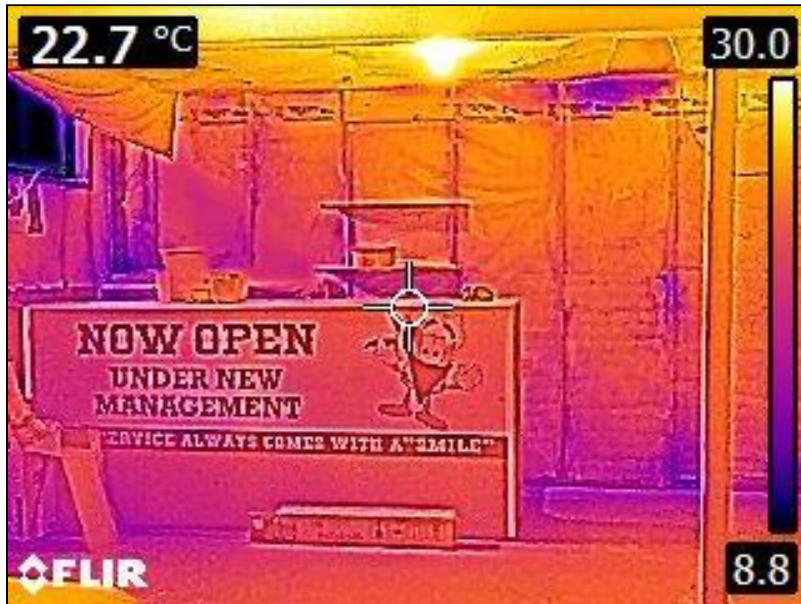
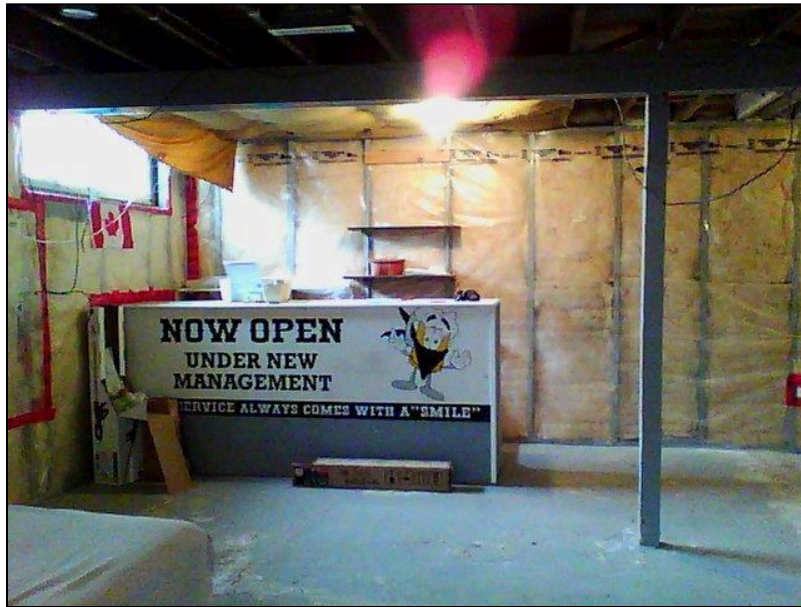
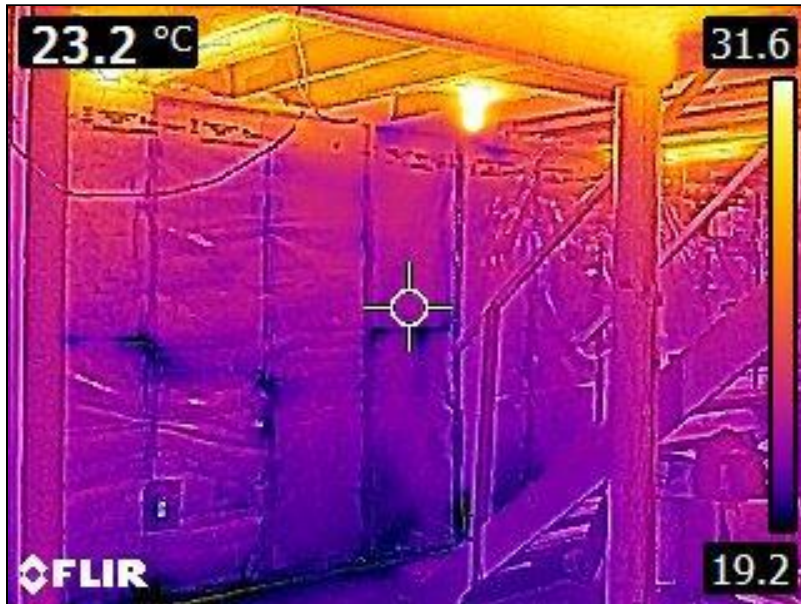
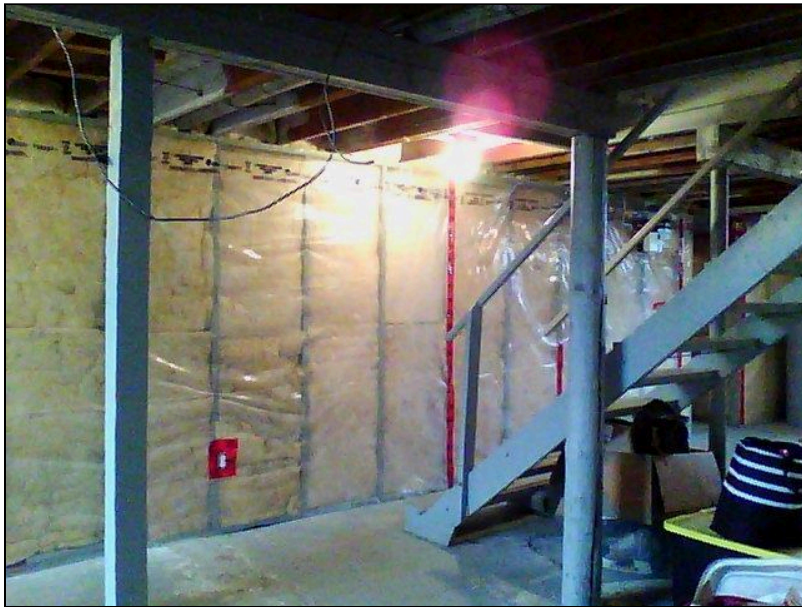
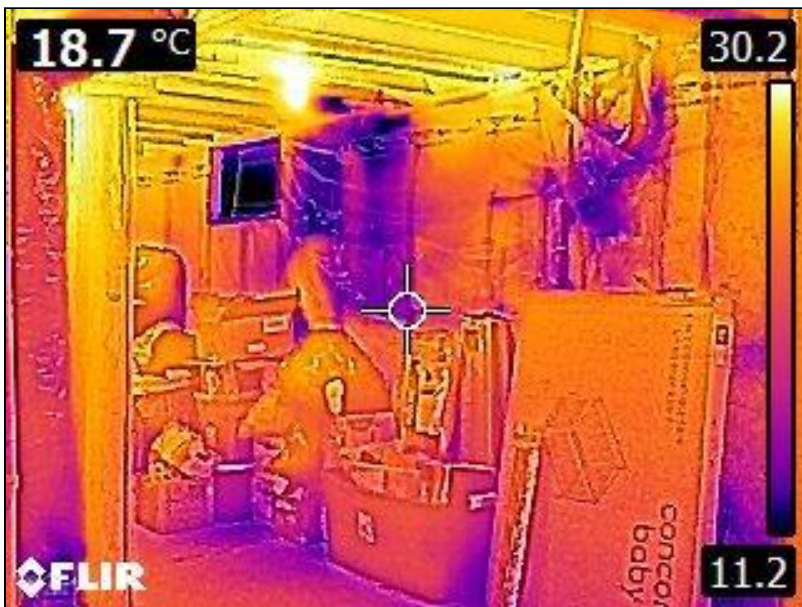
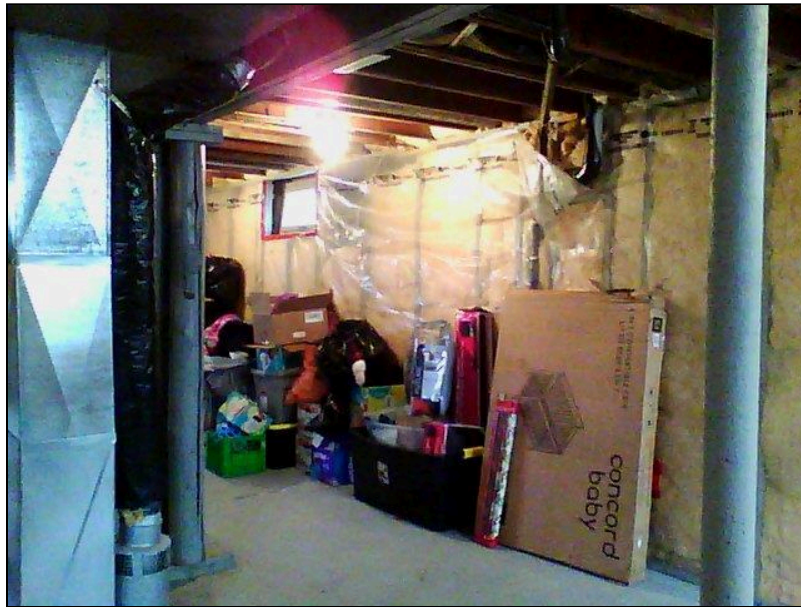
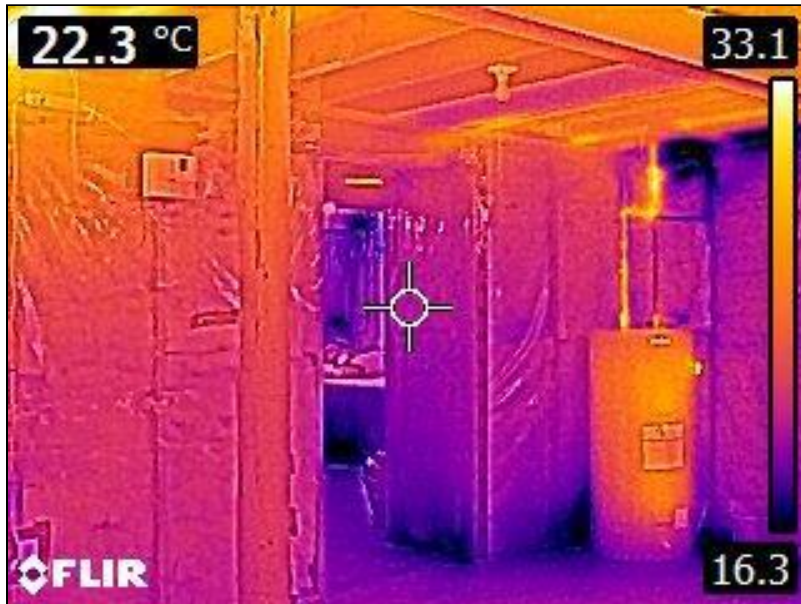
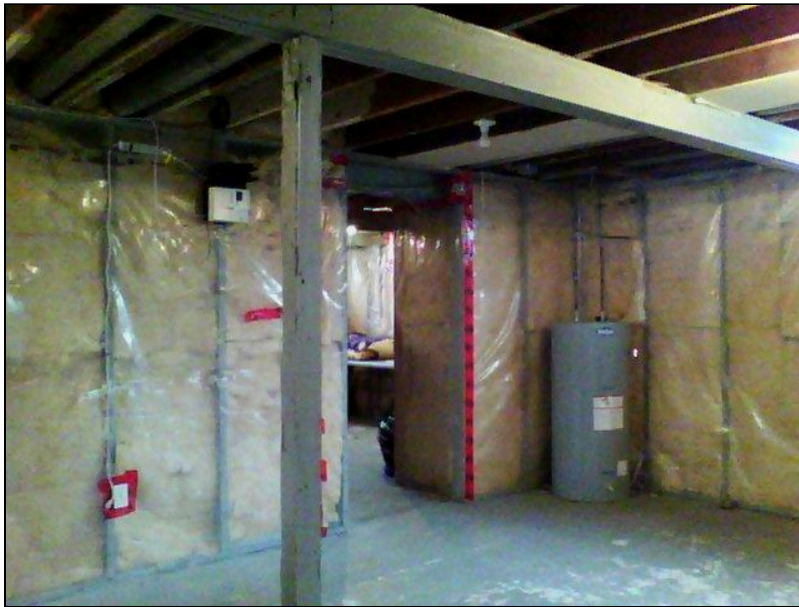
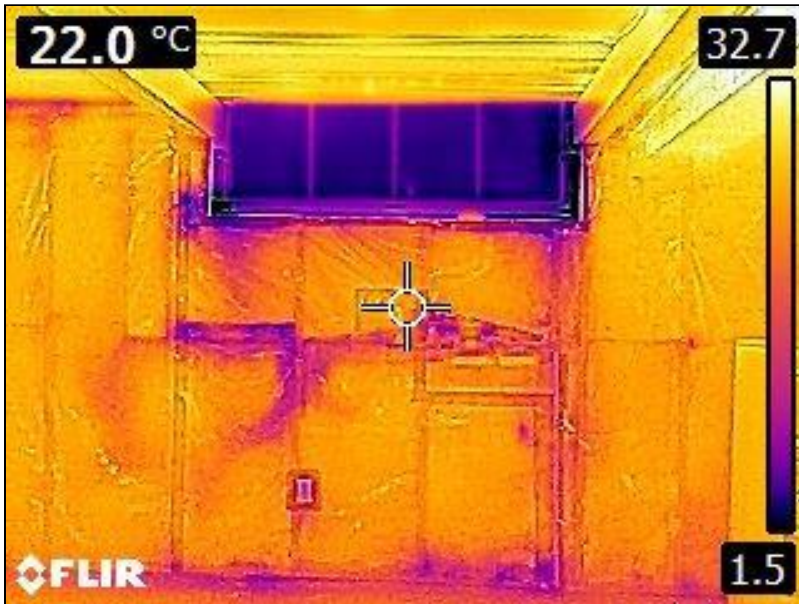
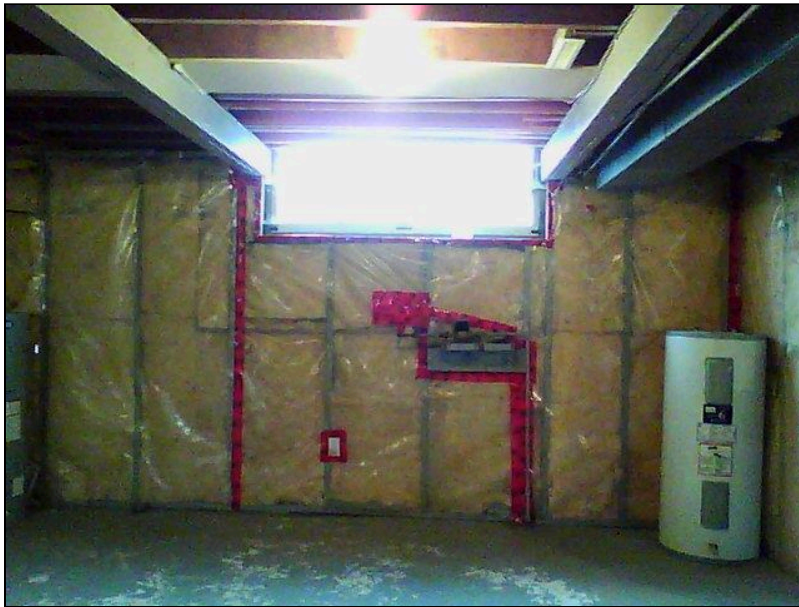
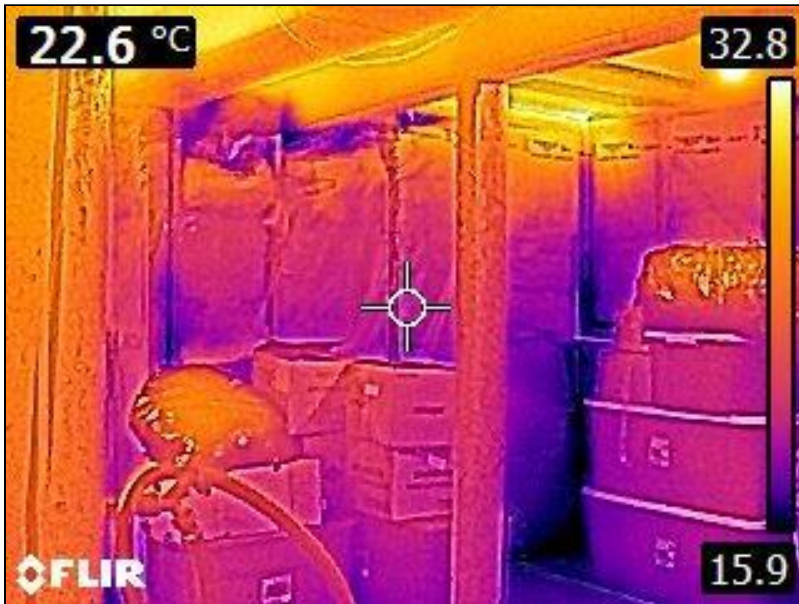
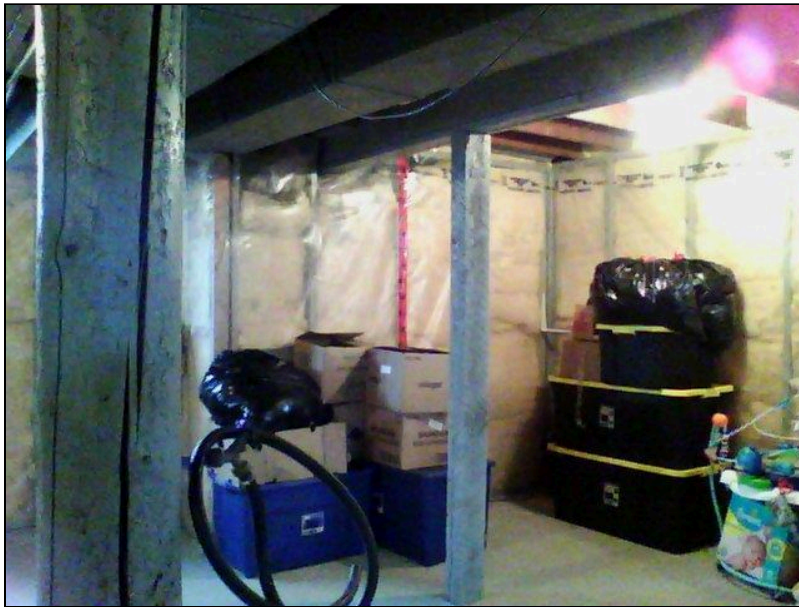
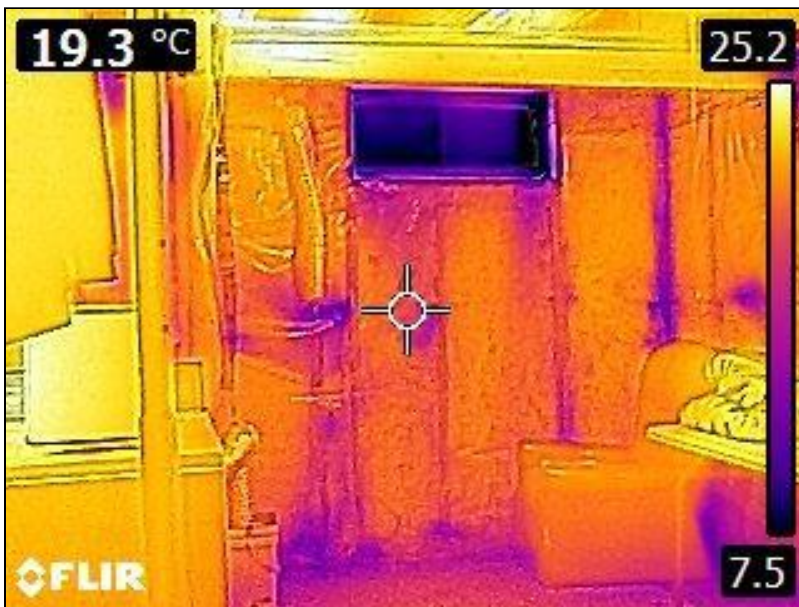
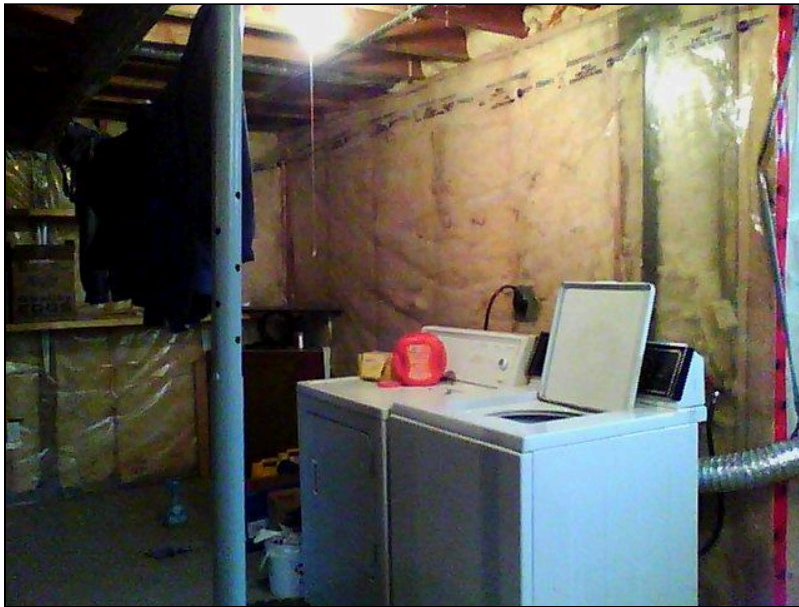
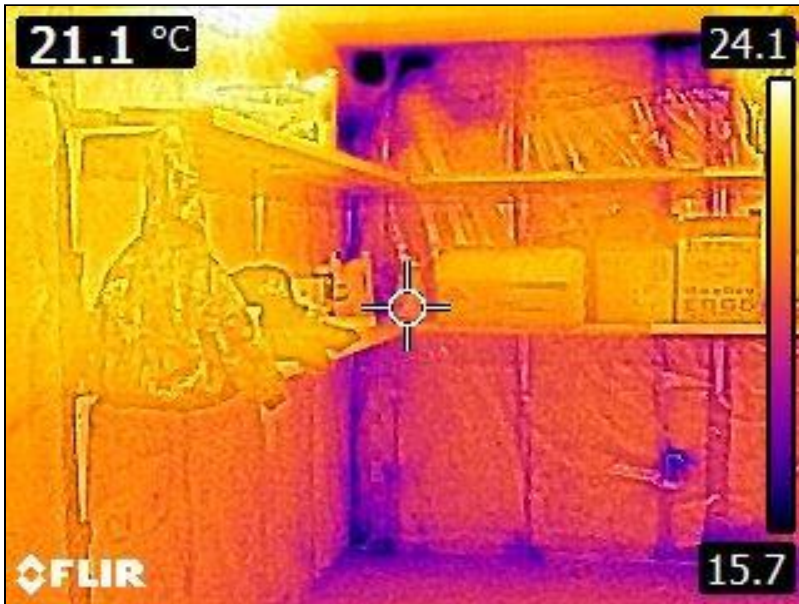
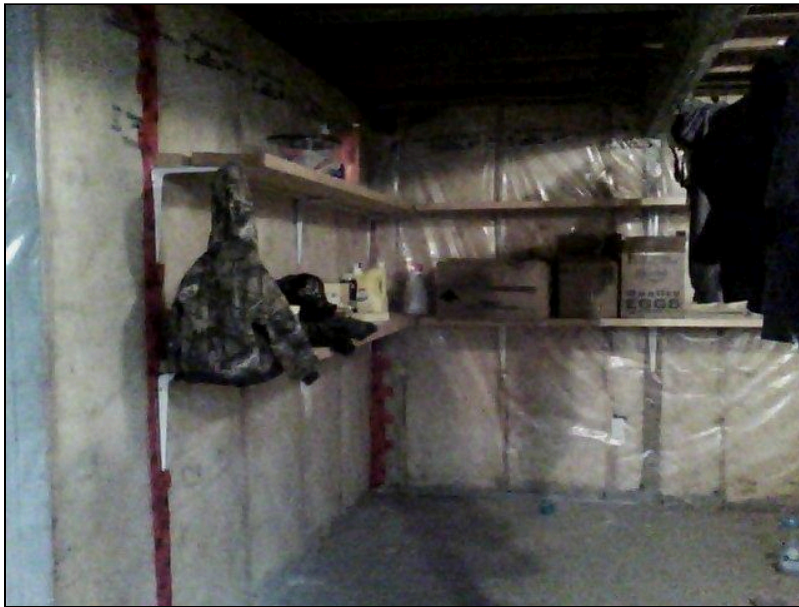
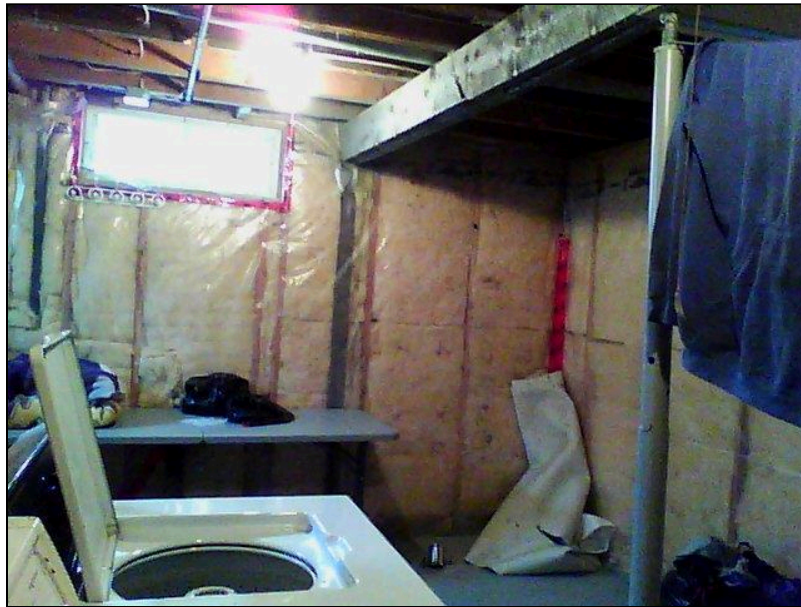
The basement area was dry on day of the inspection. Future conditions cannot be determined as these are changeable with the weather conditions. Recommend obtaining information from seller on any past water/moisture penetration.

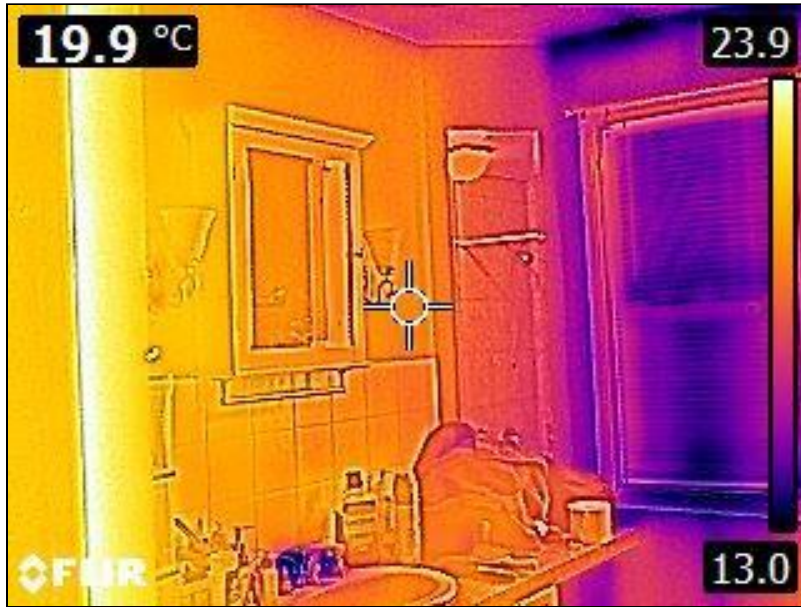
All bathroom walls and ceiling were dry at time of inspection. There was an area in the bathroom ceiling where the seam is splitting but most likely from humidity as there is no fan.

9.0 Item 1(Picture) Bathroom Ceiling - seam splitting

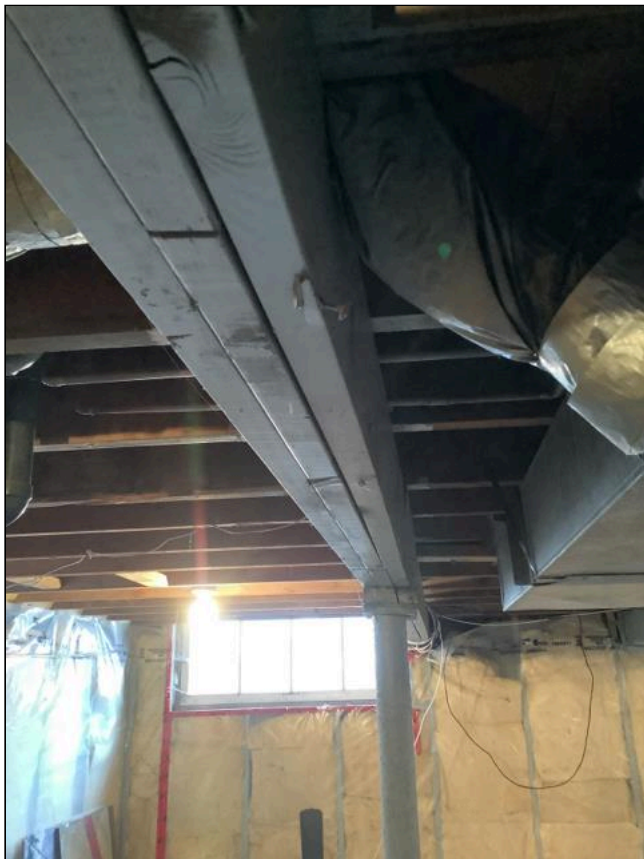
7.9 Item 2(Picture) Joists and Beams - slanted, crooked, notched out, bowed, split

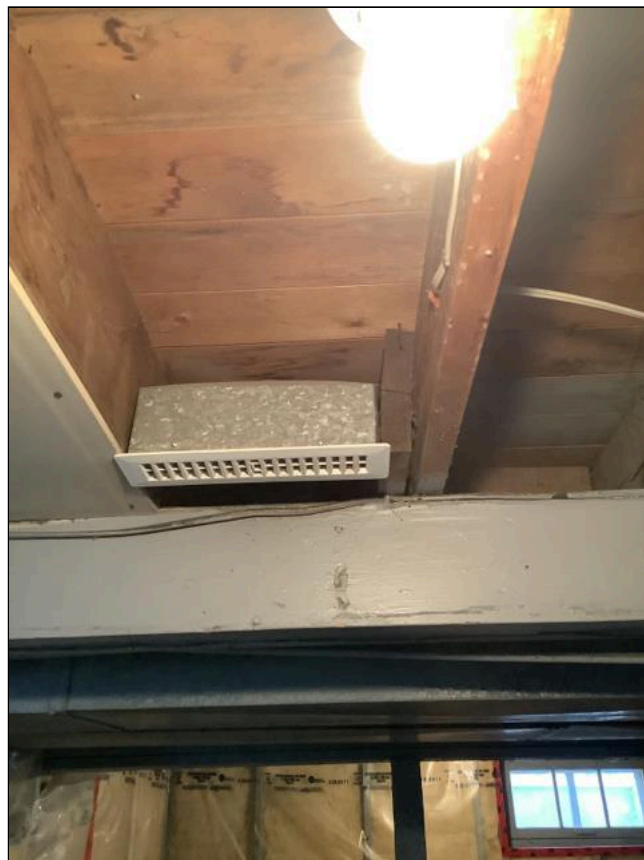
7.9 Item 5(Picture) Joists and Beams - slanted, crooked, notched out, bowed, split
