Demolition and Remediation Services

**Residential Demolition Project
for
The Town of Drumheller**

Tender issued September 2, 2022
Tender closing September 22, 2022 – 2:00:00 P.M.

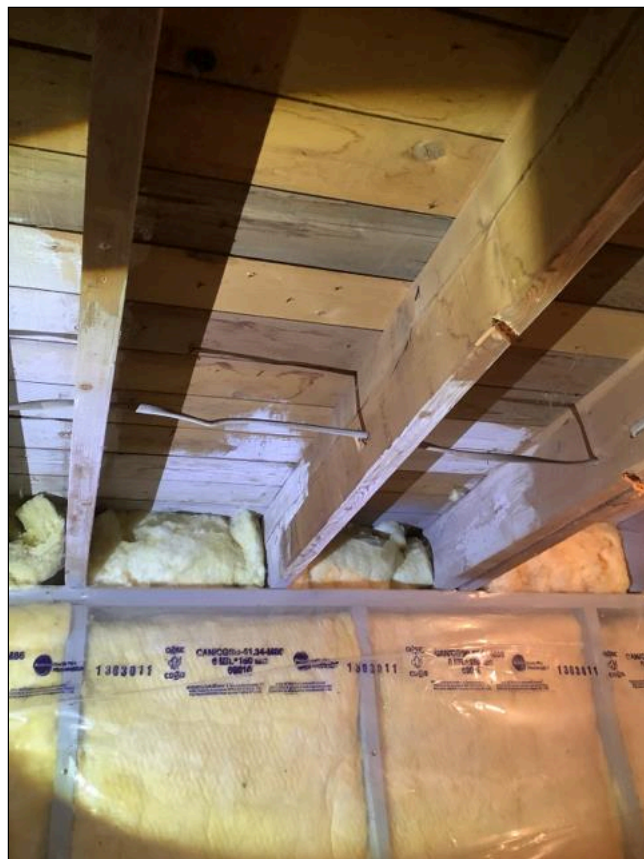
7.9 Item 7(Picture) Joists and Beams - slanted, crooked, notched out, bowed, split

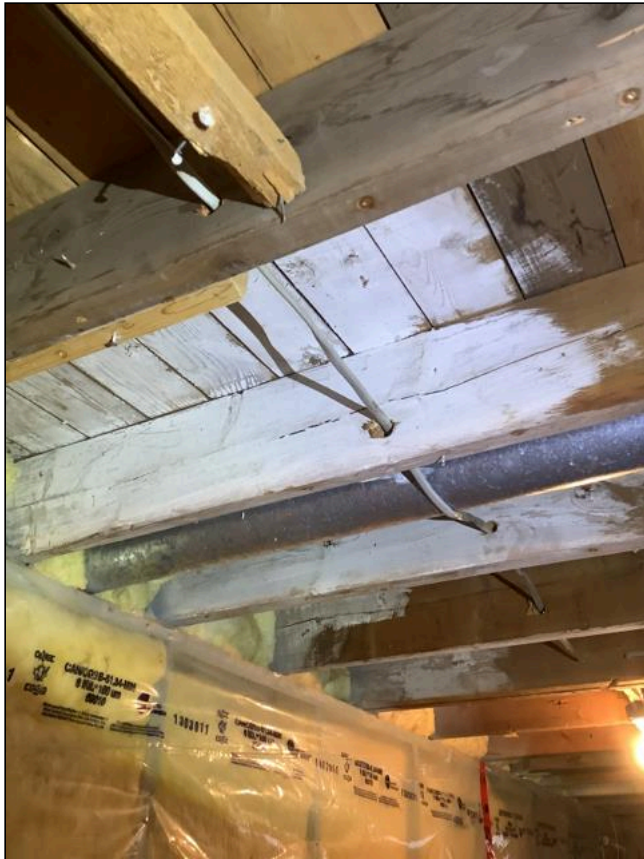
7.9 Item 8(Picture) Joists and Beams - slanted, crooked, notched out, bowed, split

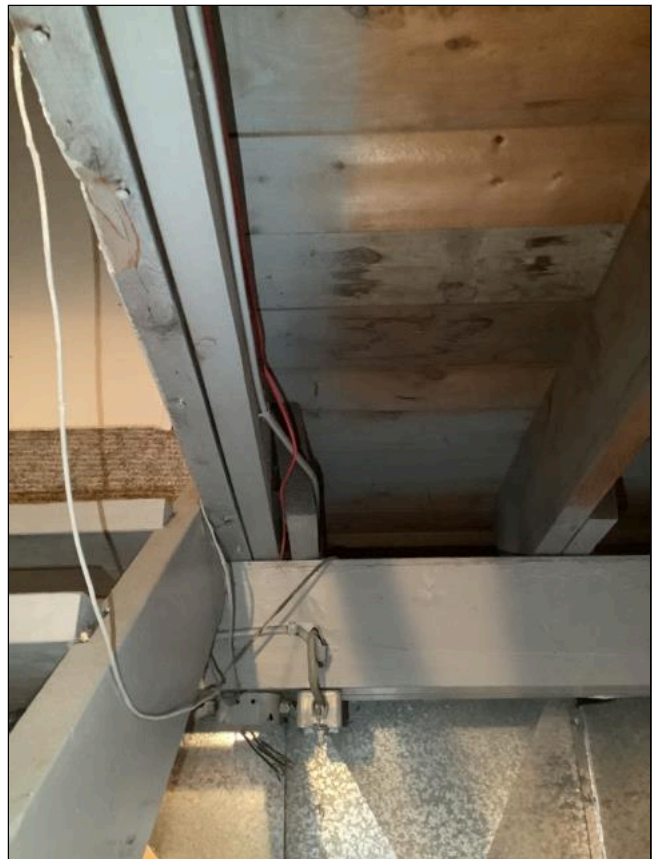
7.9 Item 15(Picture) Joists and Beams - slanted, crooked, notched out, bowed, split

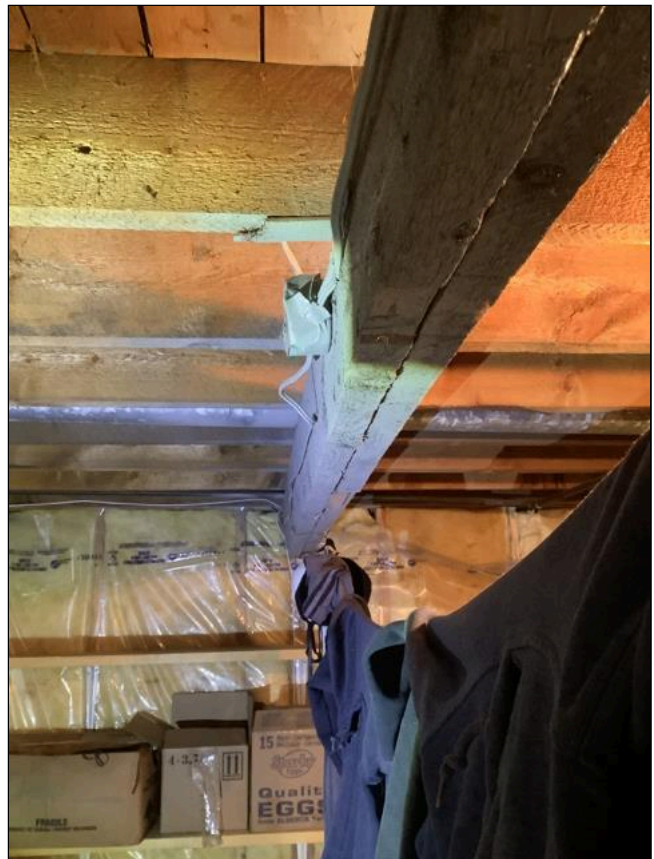
7.9 Item 19(Picture) Joists and Beams - slanted, crooked, notched out, bowed, split

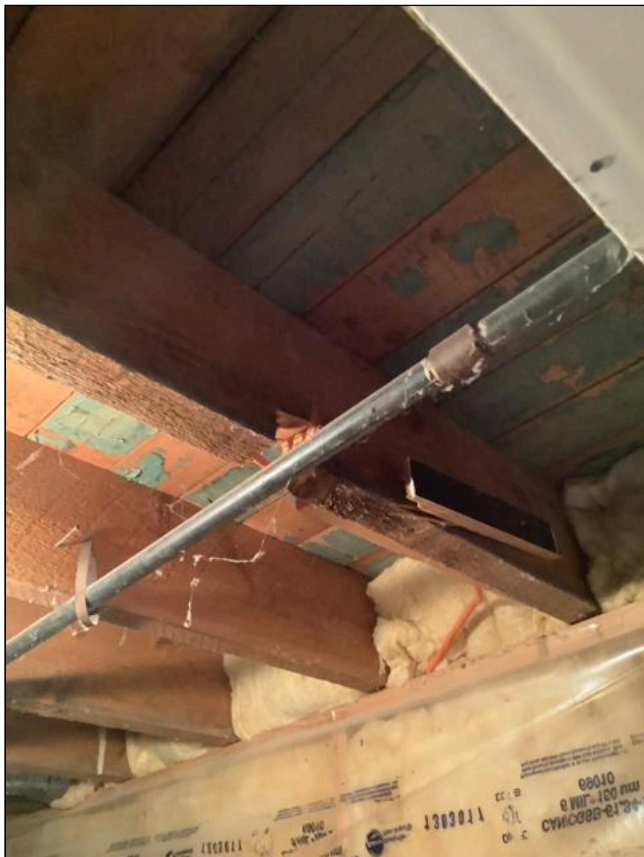
7.9 Item 22(Picture) Joists and Beams - slanted, crooked, notched out, bowed, split

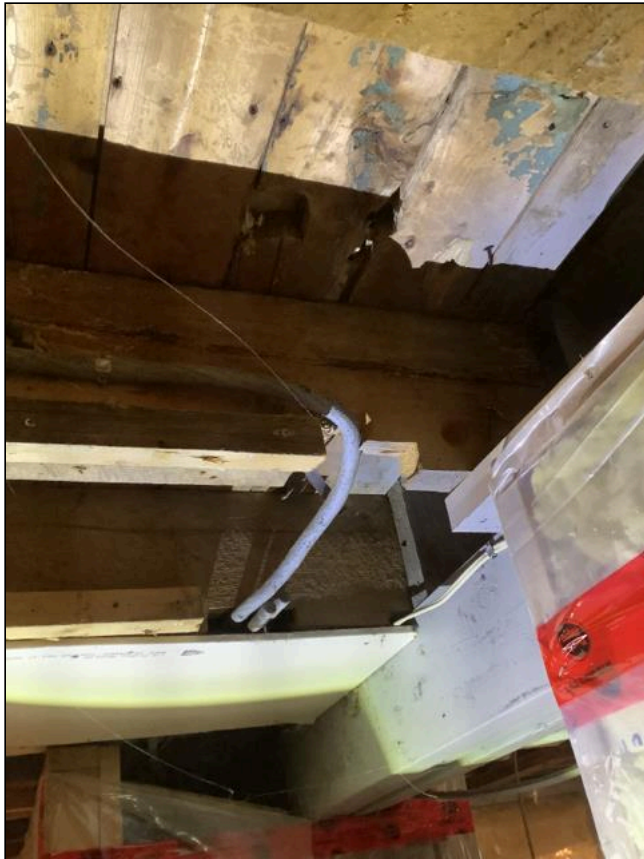
7.9 Item 24(Picture) Joists and Beams - slanted, crooked, notched out, bowed, split

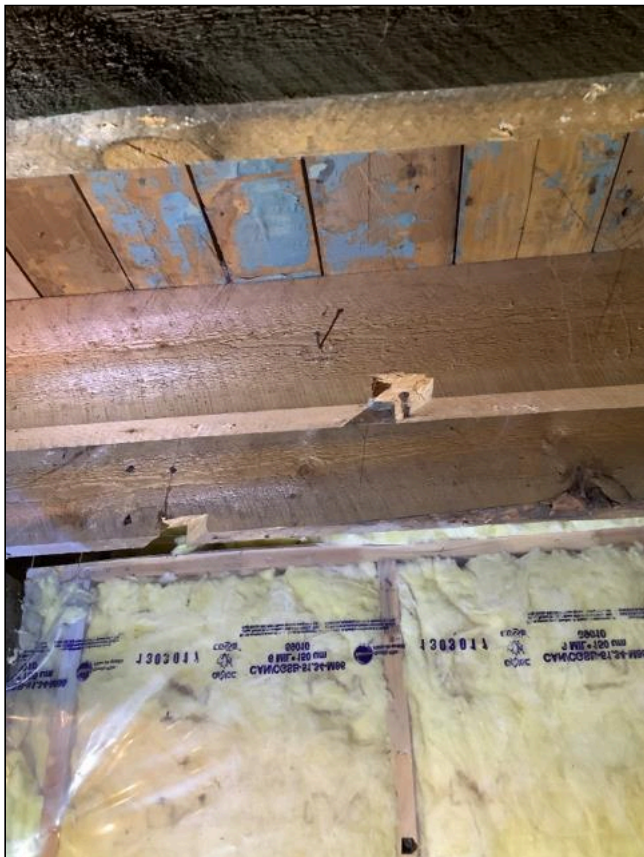
7.9 Item 26(Picture) Joists and Beams - slanted, crooked, notched out, bowed, split

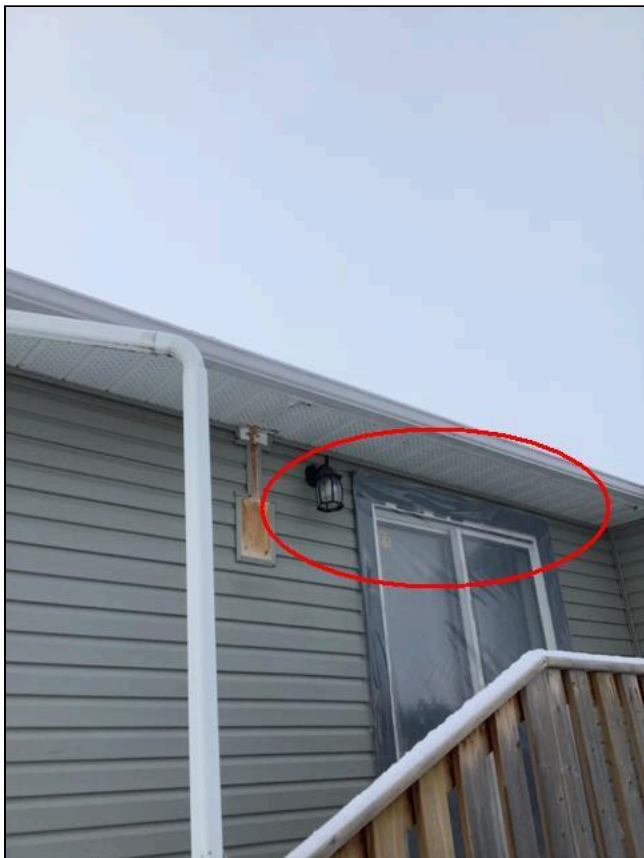
Higher levels of wall clad around the home are only visually inspected from the ground level. At the back of the house the top row of siding is bowed over the sliding patio door, recommend that it be further reviewed and repaired as required.

3.1 Item 9(Picture) Exterior Siding - bowed

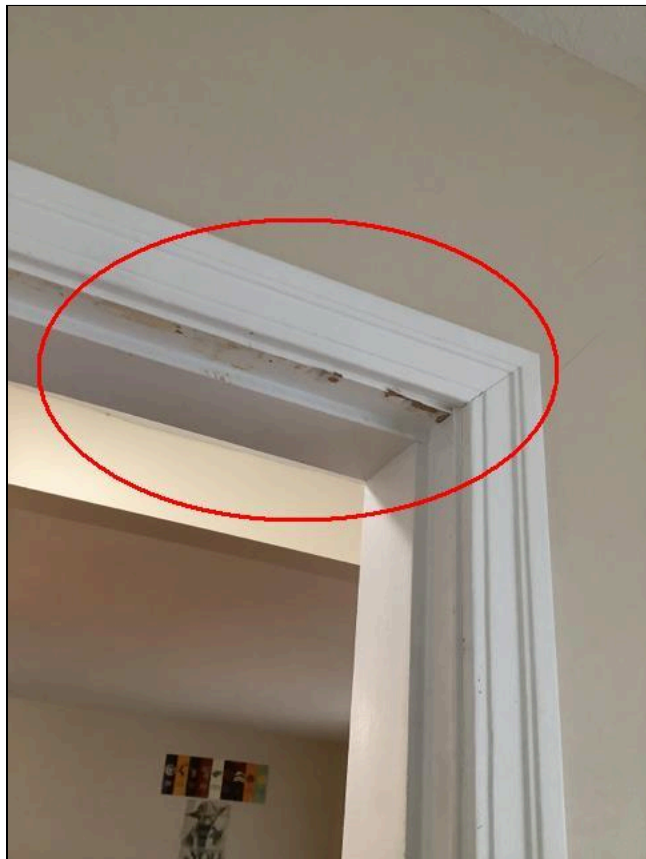
Doors were all inspected and two had signs of rubbing which aligns with the settlement the house experienced.

5.4 Item 1(Picture) Door - signs of rubbing

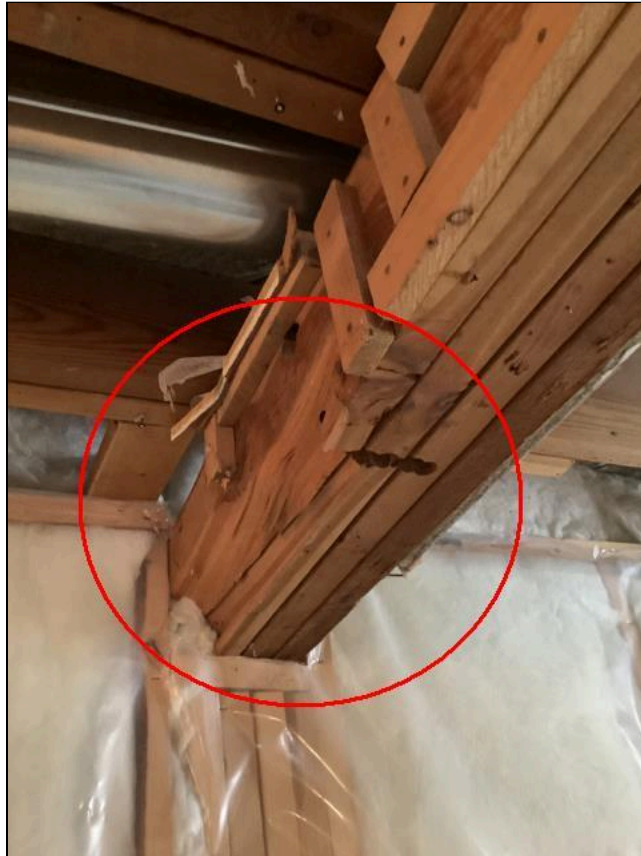
The end of the one beam is broken and there is sagging in the joists by the split beam, recommend that the beam and joists be further reviewed and repaired as required.

7.9 Item 1(Picture) Beam - end is broken

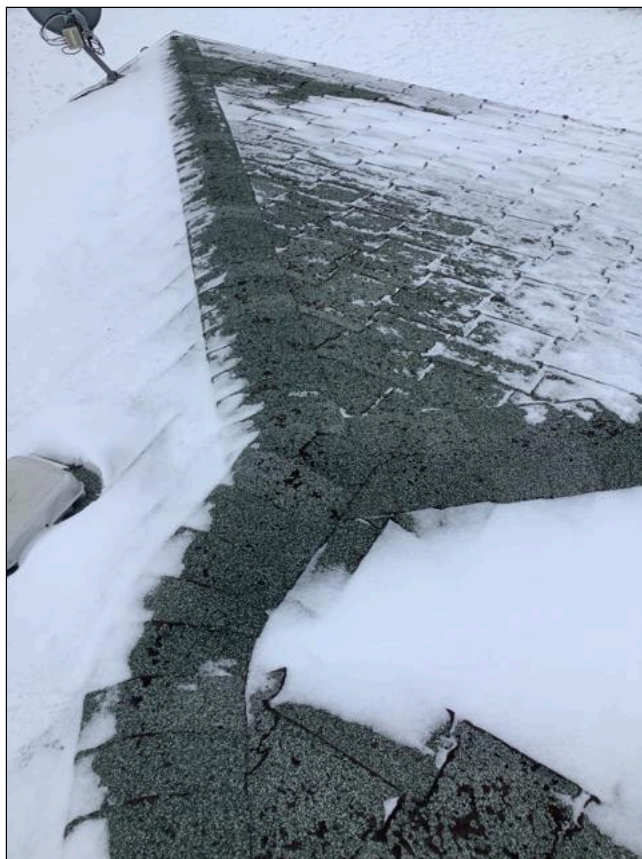
The roof was walked for assessment, could only inspect some of the roof as it was covered in snow. No visual sign of structural concern but shingles are aged and will require replacement.

1.0 Item 8(Picture) Roof - shingles are aged and will require replacement

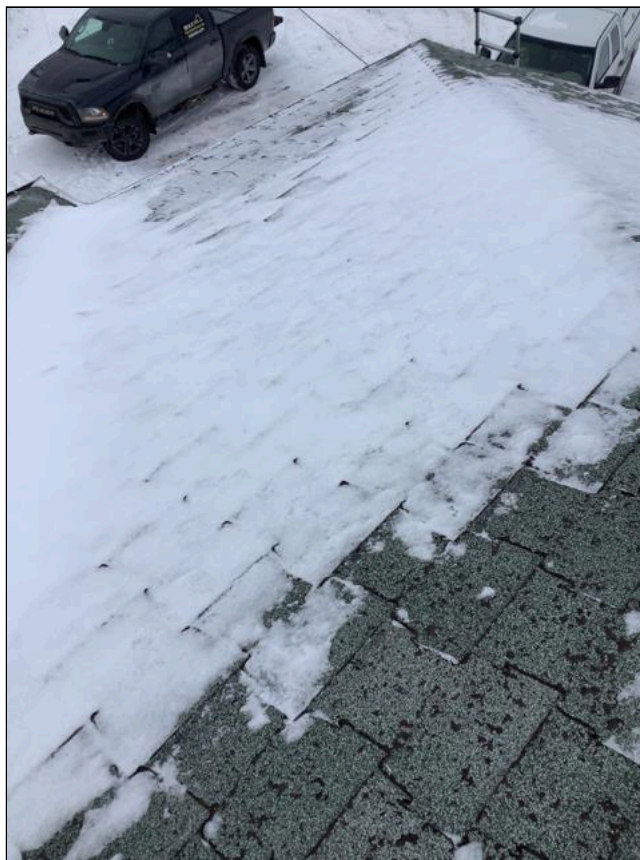
1.0 Item 10(Picture) Roof - shingles are aged and will require replacement

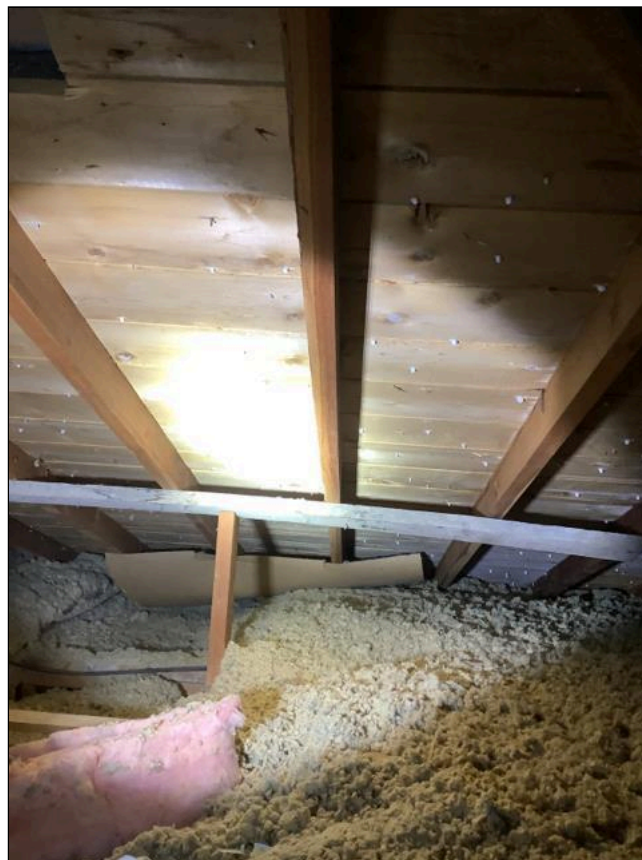
One of the rafters has split where the two are nailed together and the cross support is bowed, both are signs of movement/settling and should be further reviewed and repaired as required.

2.3 Item 2(Picture) Rafter - split, cross support bowed

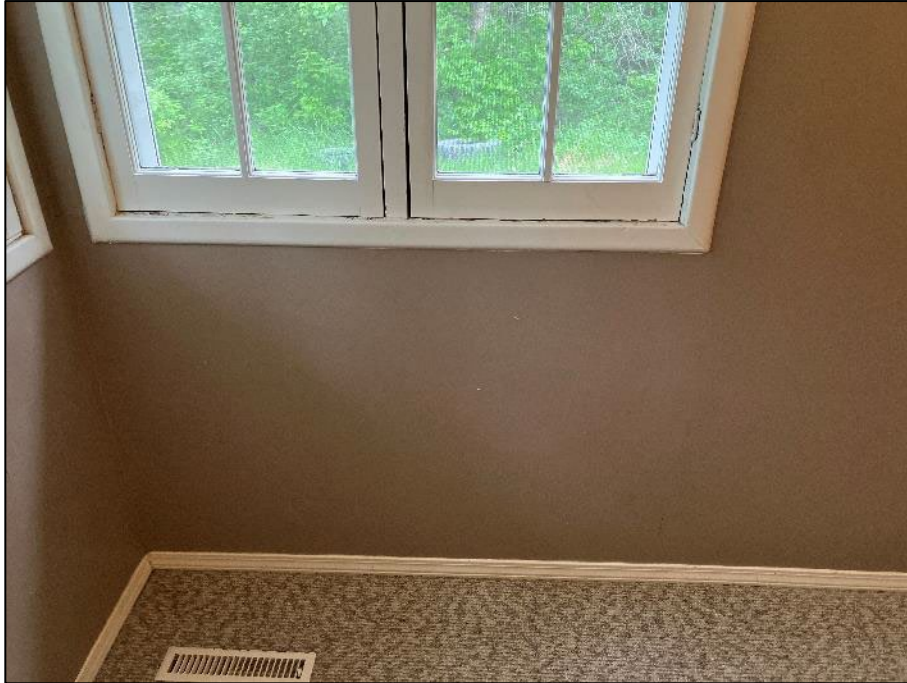
1. The following materials were identified as asbestos-containing and will require abatement prior to demolition of the structure:
 - a. Drywall Joint Compound (*See Photographs #1 to 8*).
 - b. Vermiculite – Attic (*See Photographs #21 and 22*).

PHOTOGRAPH #5: Drywall Joint Compound – Floor 1 Ext NW Bedroom (Assume Positive)

1. Drywall joint compound was identified as asbestos-containing (*See Photographs #1 to 8*). Removal of the material must be performed prior to demolition by a qualified abatement contractor using moderate risk asbestos abatement procedures found in Section 5.3 of the AAAM (2019).

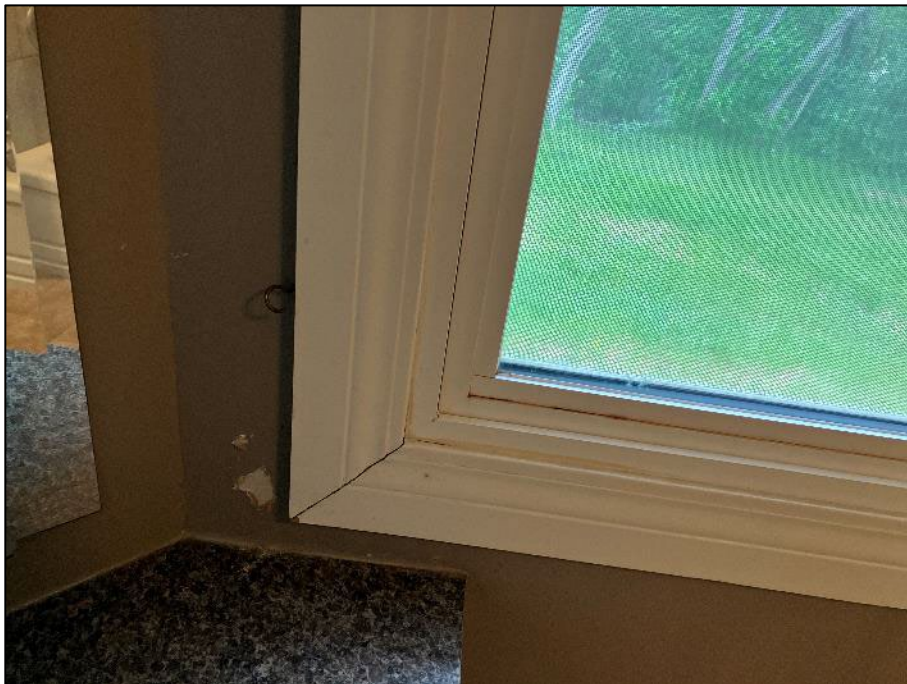
PHOTOGRAPH #6: Drywall Joint Compound – Floor 1 Ext Bathroom (Assume Positive)

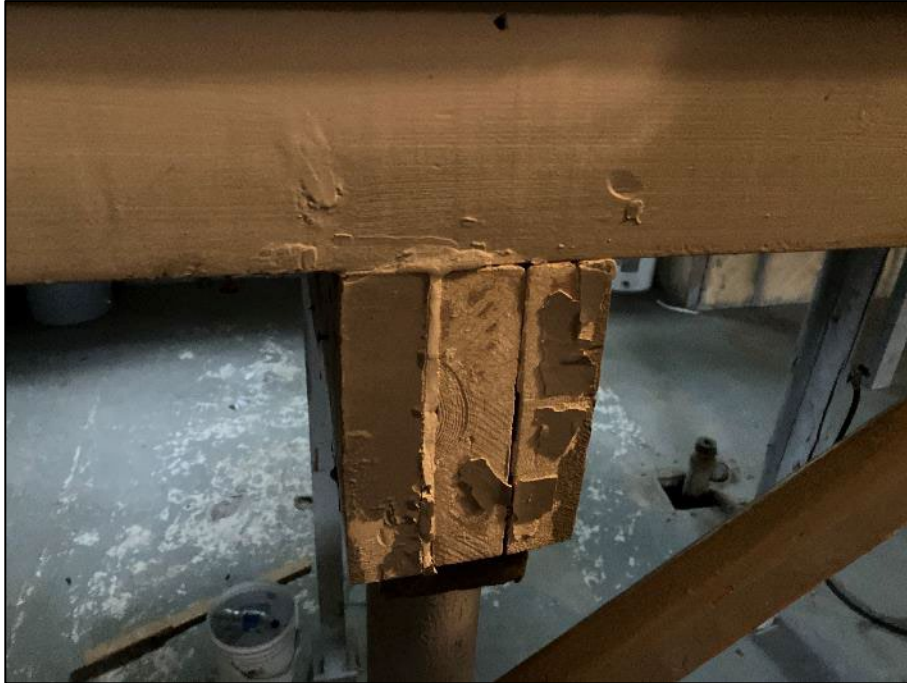
PHOTOGRAPH #7: Drywall Joint Compound – Basement Int Stairs (Assume Positive)

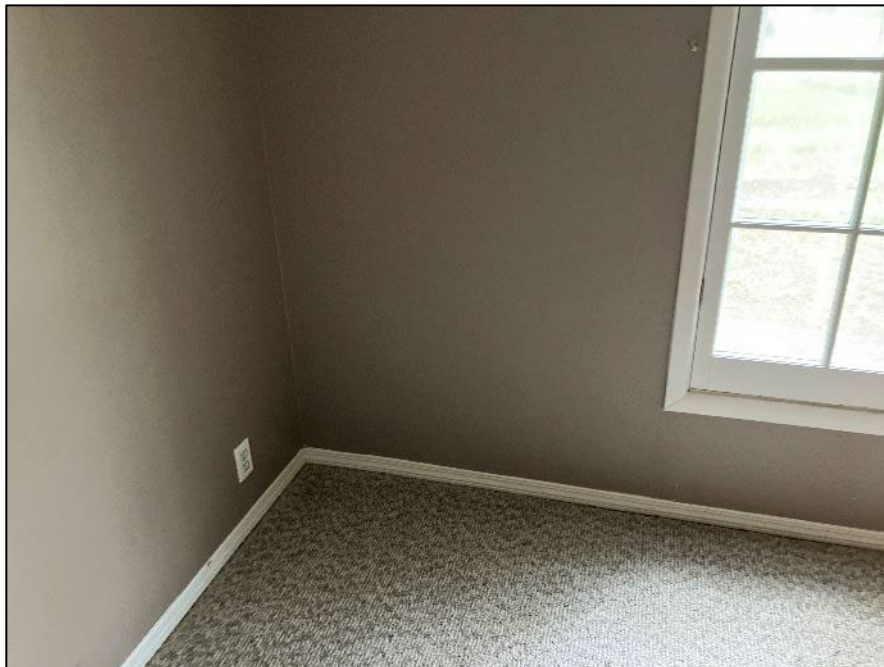
PHOTOGRAPH #8: Drywall Joint Compound – Floor 1 Ext NE Bedroom (2% Chrysotile)

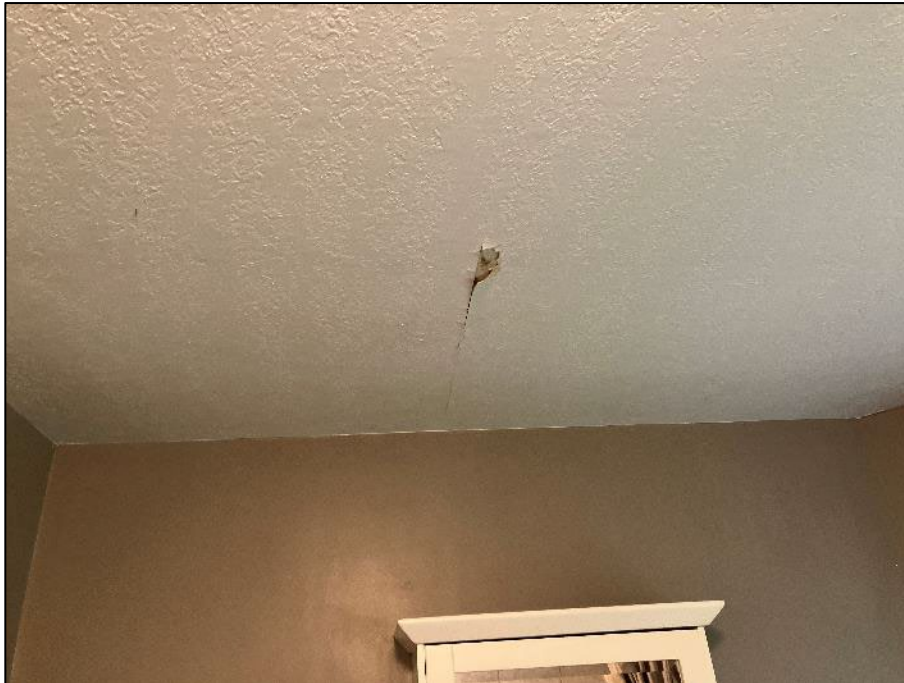
PHOTOGRAPH #9: Ceiling Texture - Floor 1 Bathroom (Non-Asbestos)

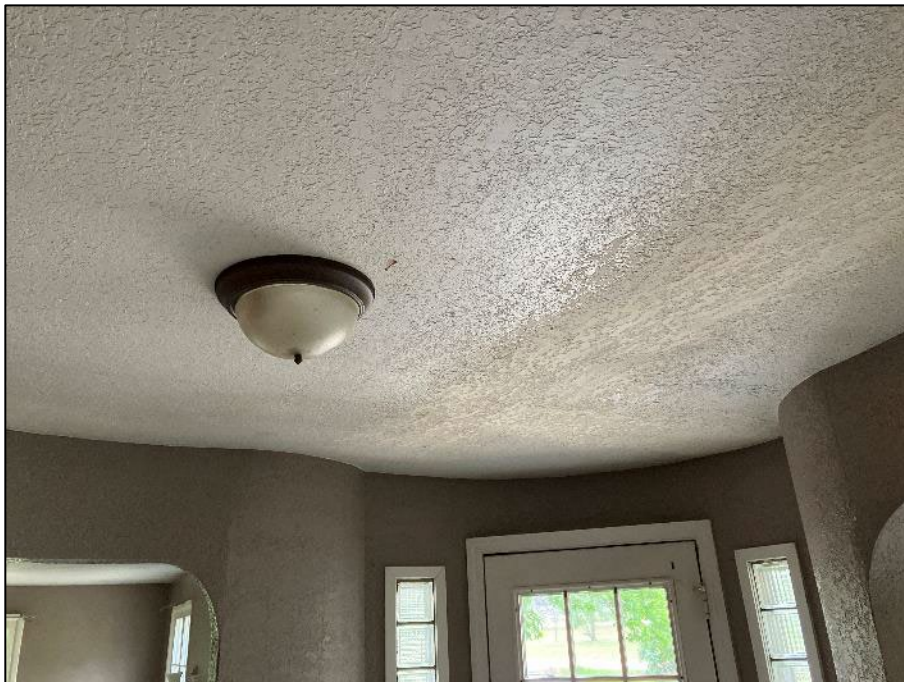
PHOTOGRAPH #10: Ceiling Texture - Floor 1 Foyer (Non-Asbestos)

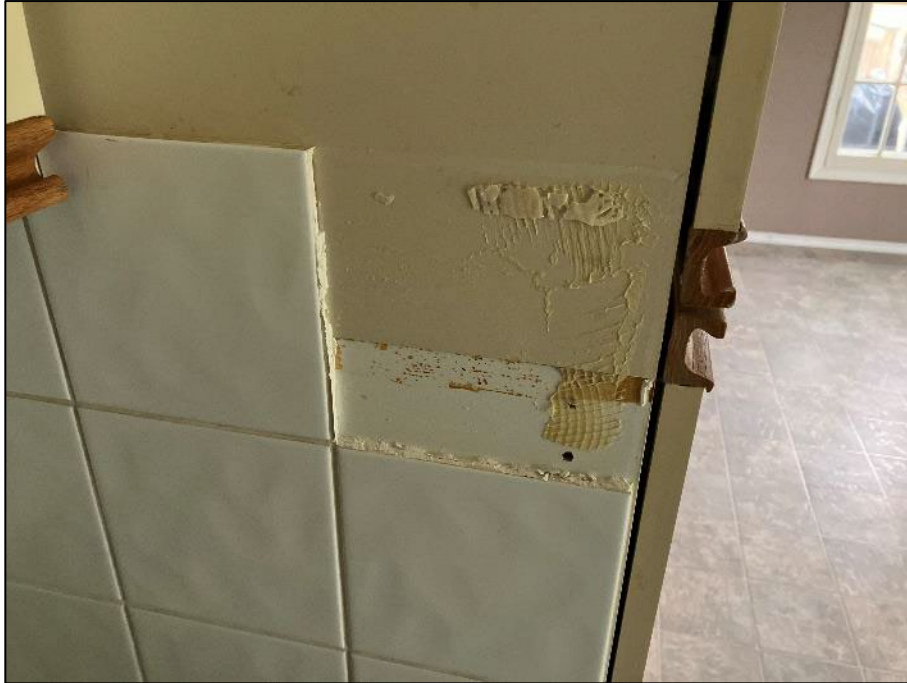
PHOTOGRAPH #13: Thinset – Kitchen (Non-Asbestos)

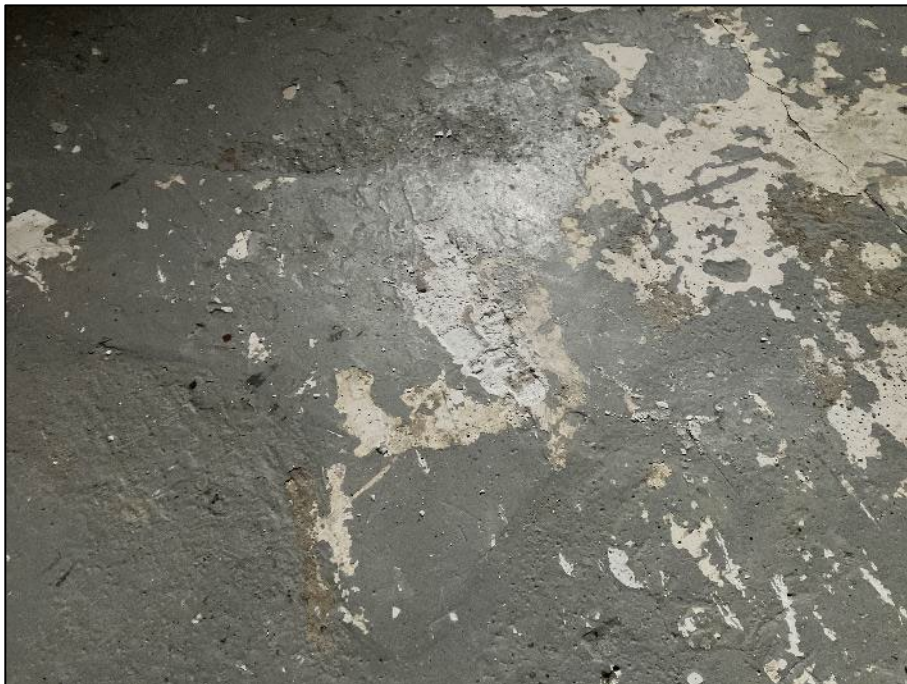
PHOTOGRAPH #14: Leveling Compound – Basement (Non-Asbestos)

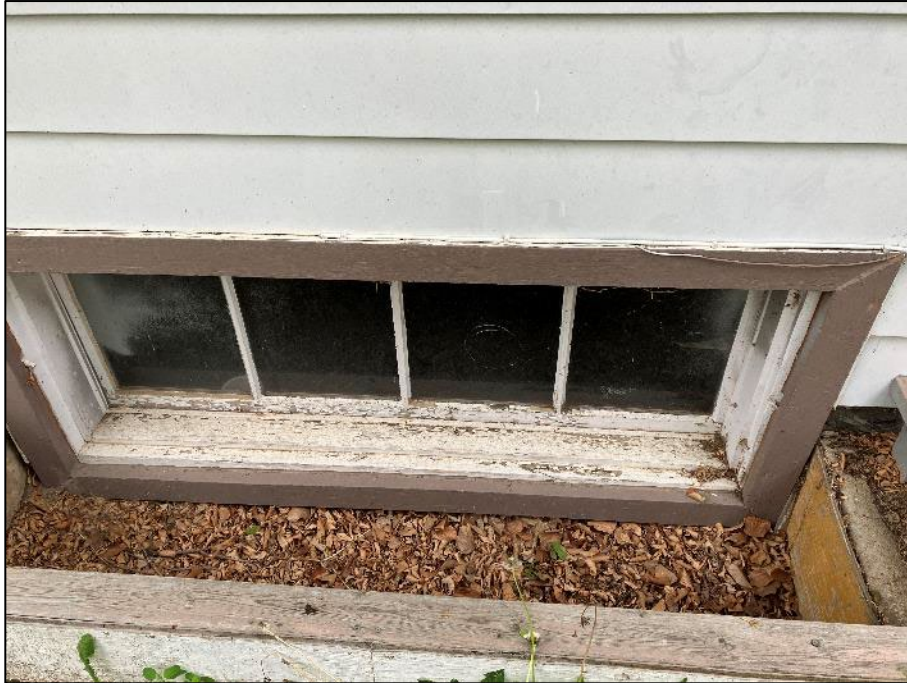
PHOTOGRAPH #15: Window Caulking – Exterior (Non-Asbestos)

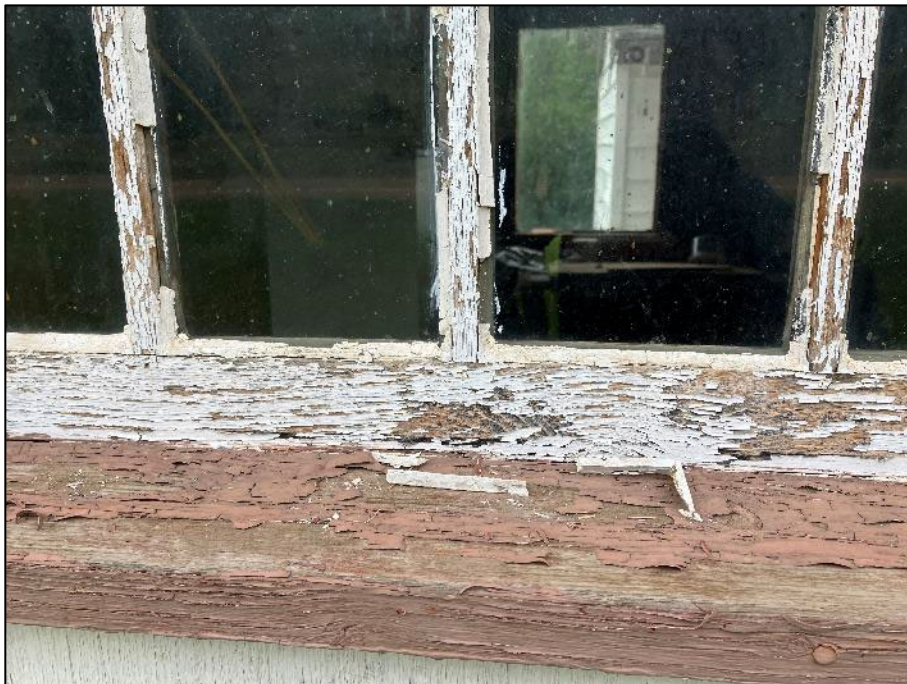
PHOTOGRAPH #16: Window Caulking – Shed (Non-Asbestos)

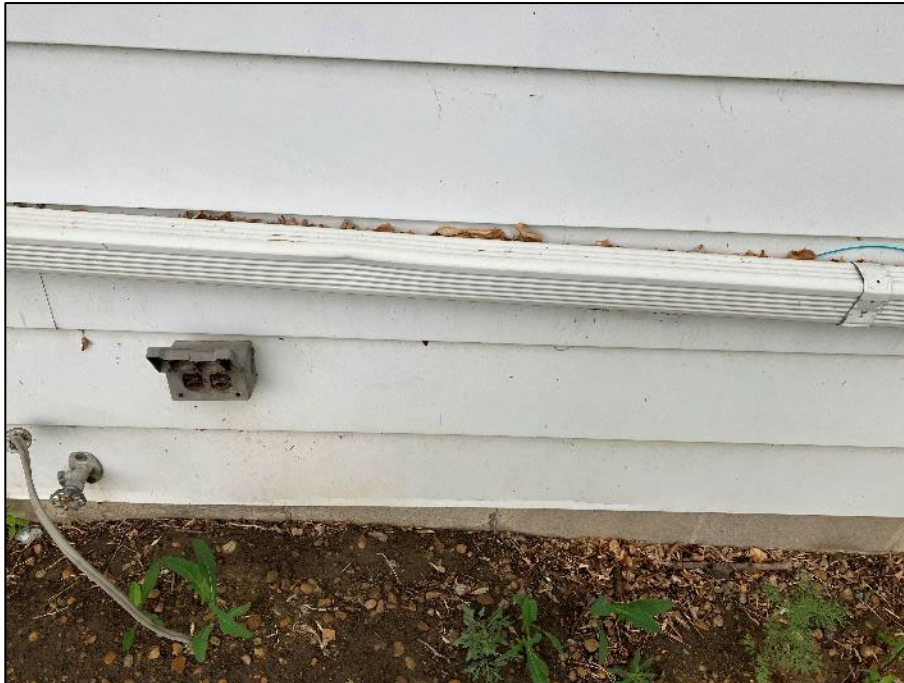
PHOTOGRAPH #17: Parging 1 – Exterior (Non-Asbestos)

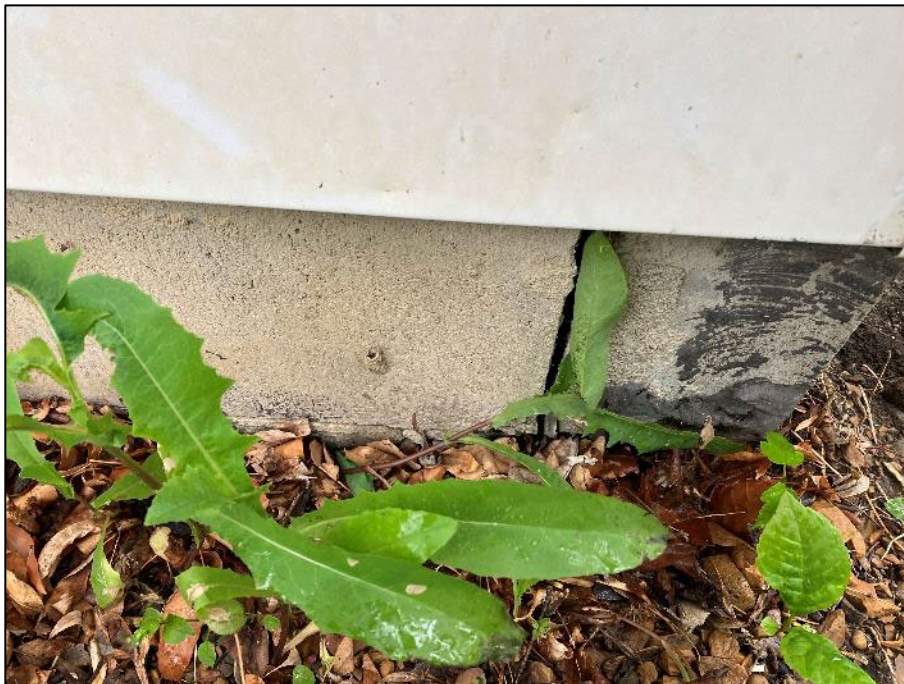
PHOTOGRAPH #18: Parging 2 – Exterior (Non-Asbestos)

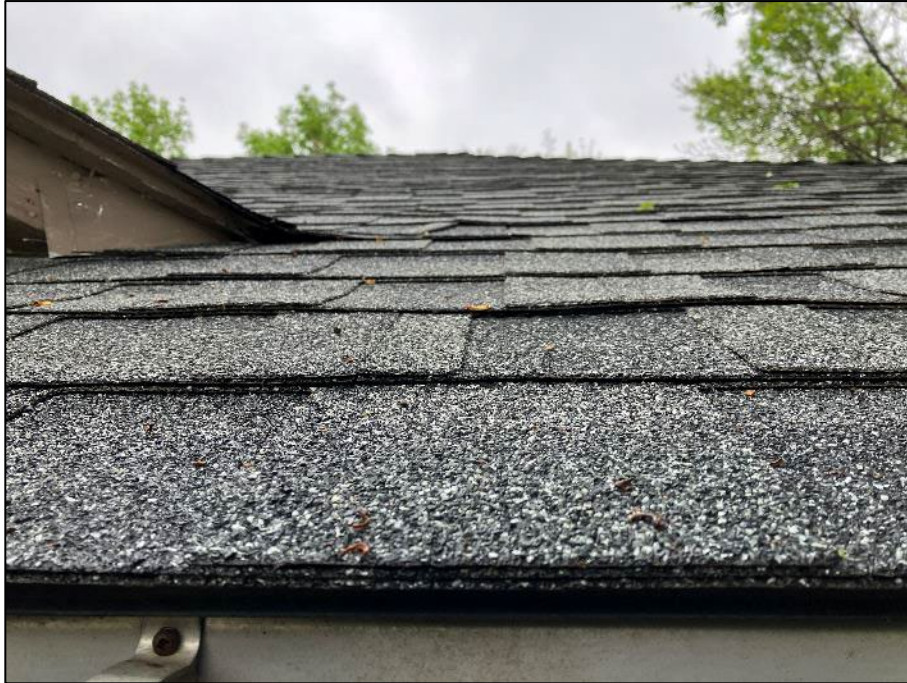
PHOTOGRAPH #19: Roof Shingle – Exterior (Non-Asbestos)

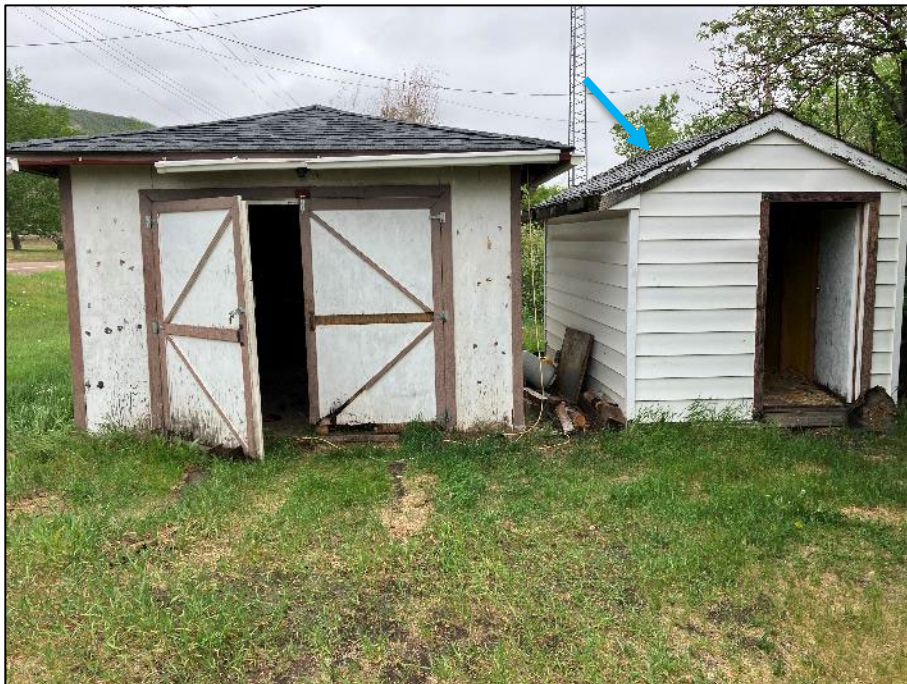
PHOTOGRAPH #20: Roof Shingle – Shed (Non-Asbestos)

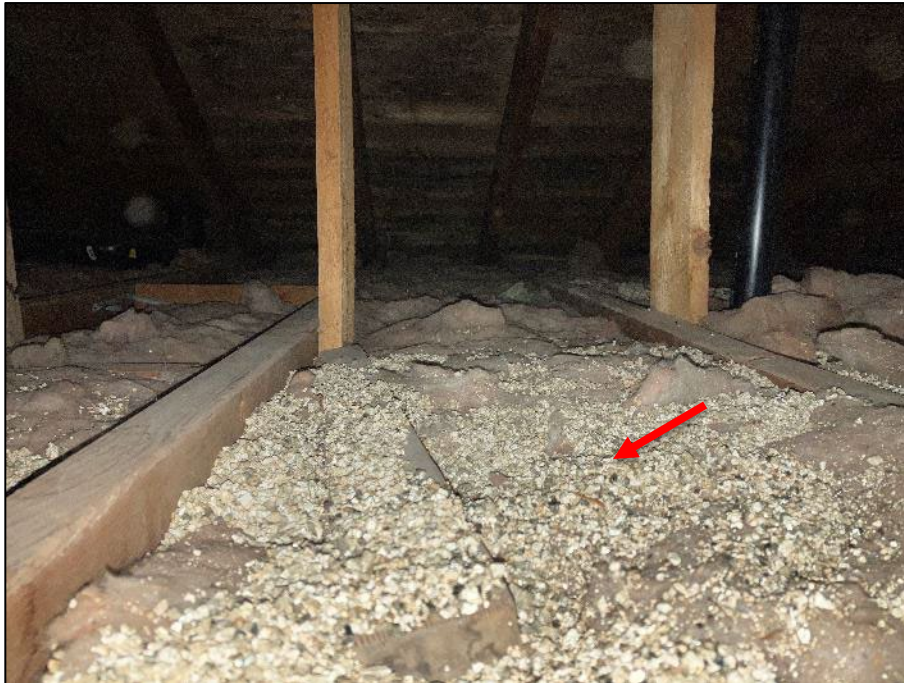
PHOTOGRAPH #21: Vermiculite in the Attic Space (<1% Tremolite)

2. Vermiculite material was confirmed in the attic space and confirmed asbestos-containing (*See Photographs #21 and 22*). Removal of the material must be performed prior to demolition by a qualified abatement contractor using high-risk asbestos abatement procedures found in Section 5.4 of the AAAM (2019).
3. Lead-containing paints (*See Appendix II*) were identified on all surfaces present on the home. Disturbance of lead-containing surface coatings should be performed following using exposure prevention controls found in WorkSafeBC's Lead Containing Paints and Coatings: Preventing Exposure in the Construction Industry (2011) document and described in the Alberta Governments Lead at the Work Site (2013) bulletin.

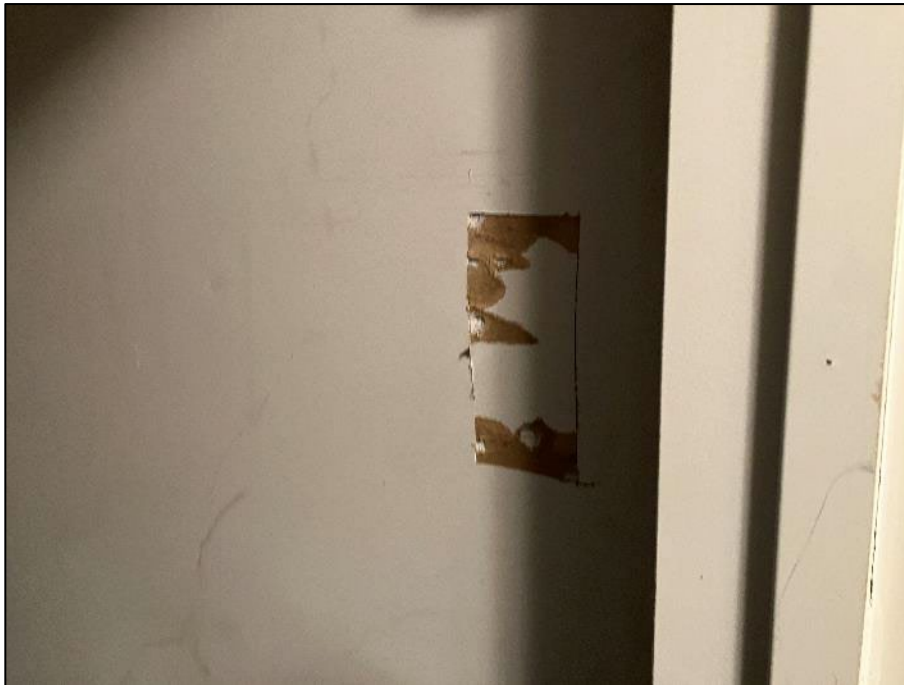
PHOTOGRAPH #23: Paint – White Stairs (Non-Lead Based)

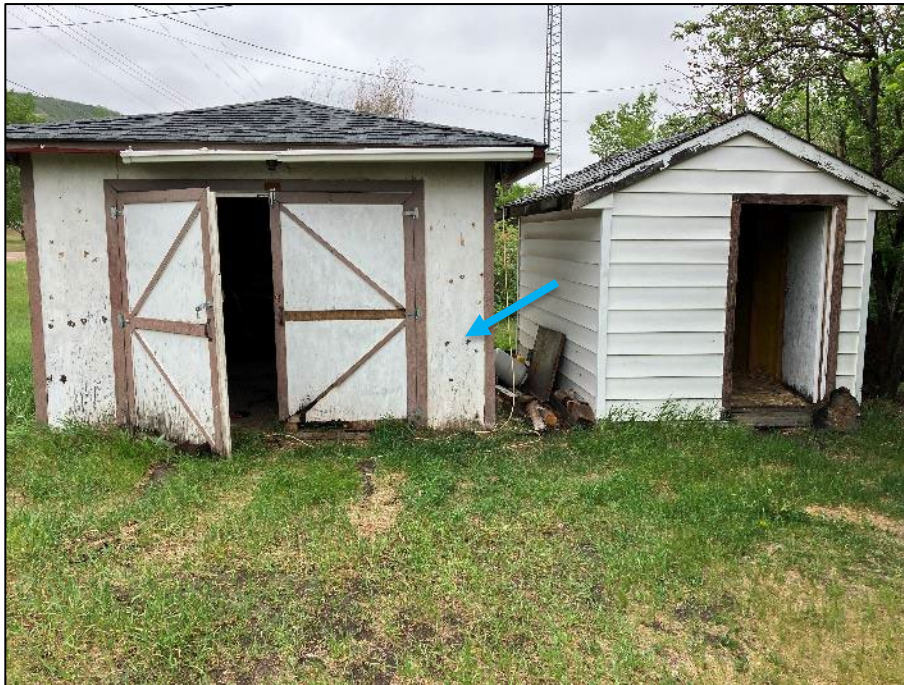
PHOTOGRAPH #27: Paint – White Shed (Non-Lead Based)

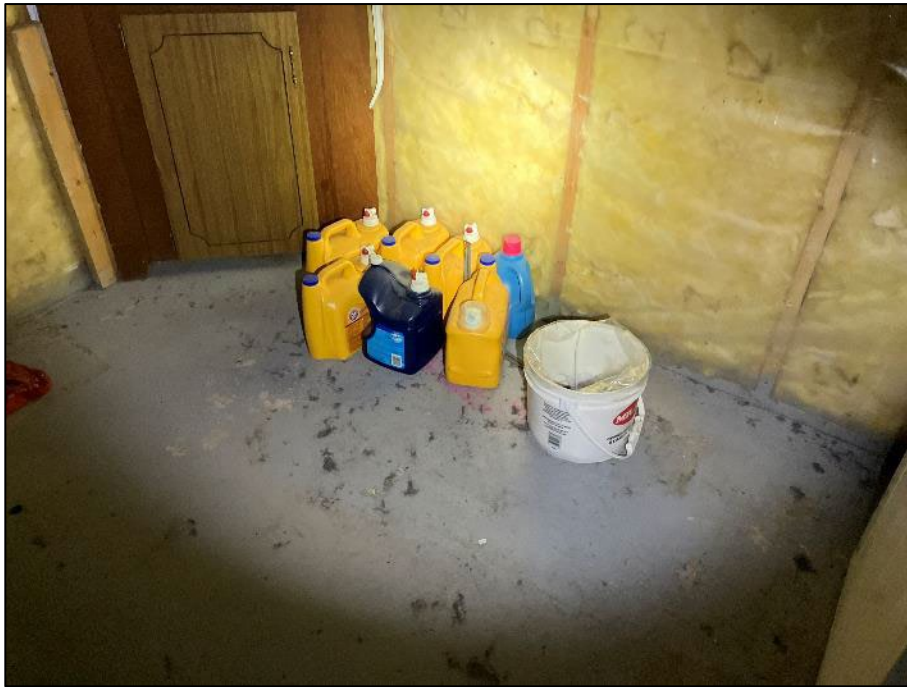
PHOTOGRAPH #29: Miscellaneous Chemicals - Basement

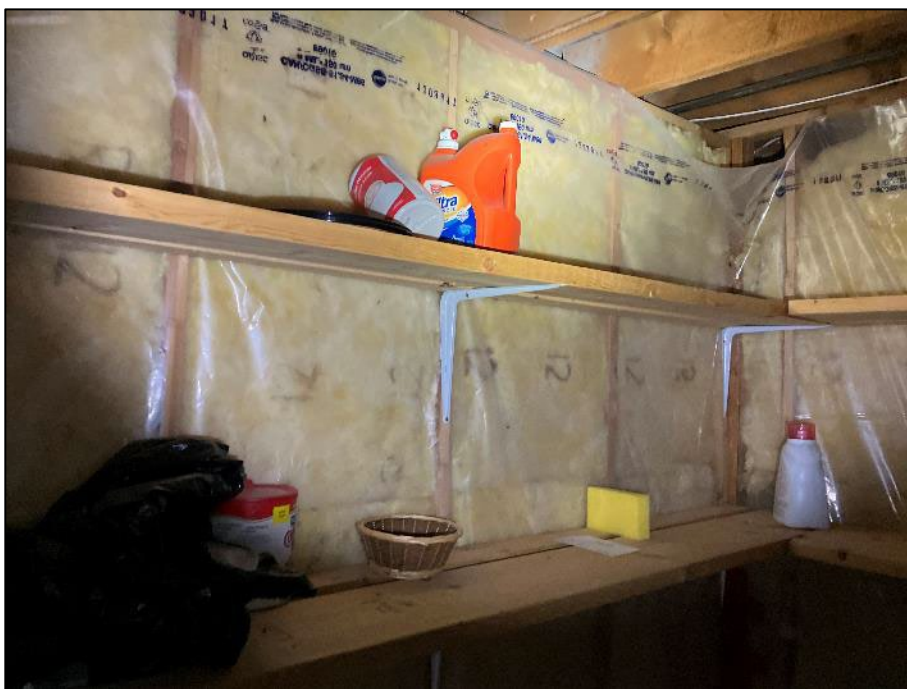
PHOTOGRAPH #30: Miscellaneous Chemicals - Basement

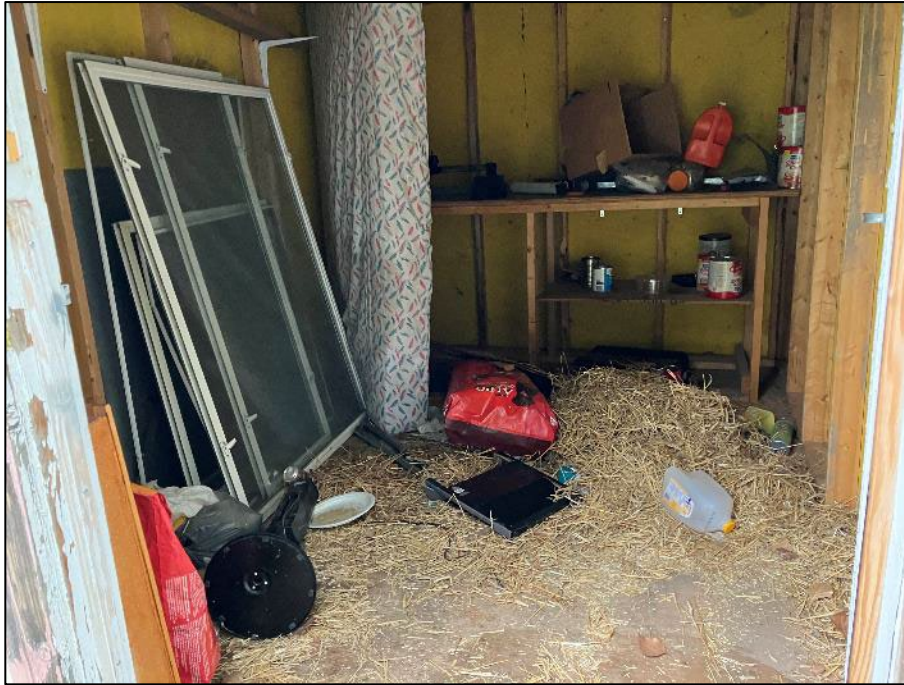
PHOTOGRAPH #31: Miscellaneous Chemicals - Shed

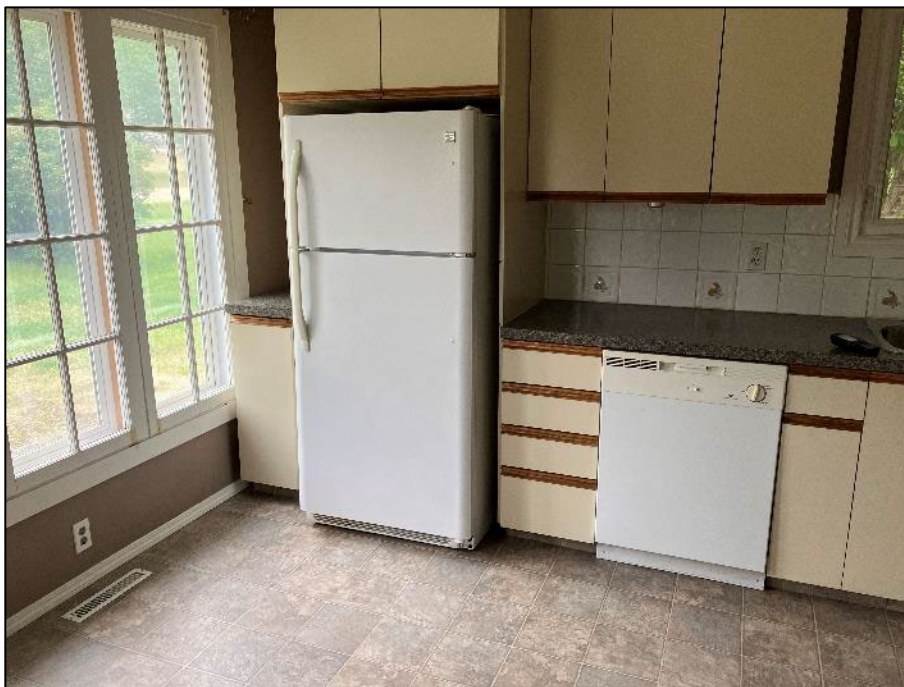
PHOTOGRAPH #32: Ozone Depleting Unit - Fridge

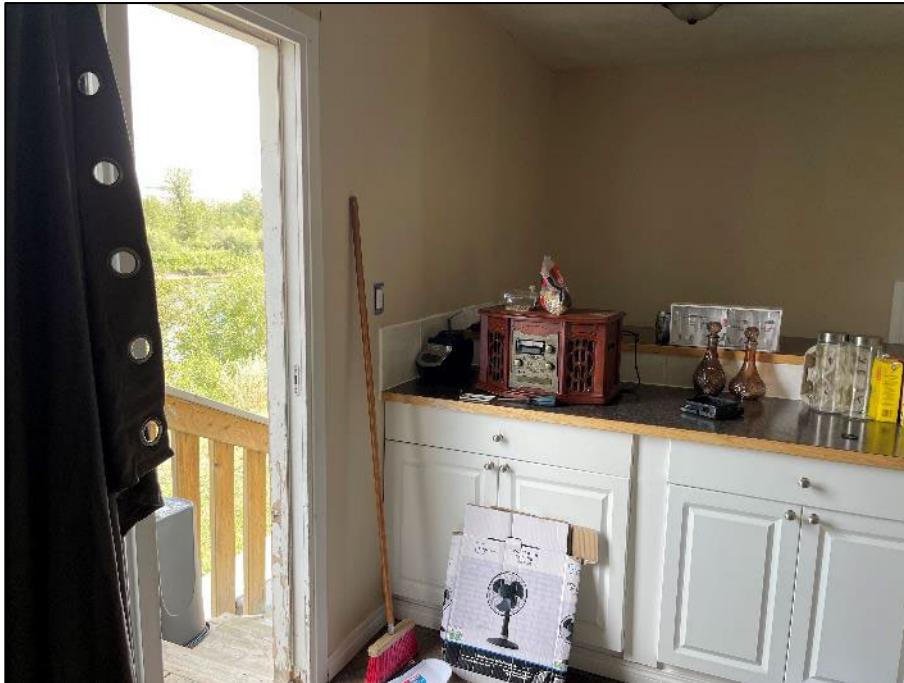
1. The following materials were identified as asbestos-containing and will require abatement prior to demolition of the structure:
 - a. Plaster on main floor walls and ceiling (*See Photographs #1 to 6*).
 - b. Stucco beneath exterior siding (*See Photographs #11 and 12*).

PHOTOGRAPH #1: Plaster - Level 1 Kitchen Exterior (<1% Actinolite)

1. Plaster was observed and confirmed asbestos-containing (*See Photographs #1 through 6*). Removal of the material must be performed prior to demolition by a qualified abatement contractor using moderate-risk asbestos abatement procedures found in Section 5.3 of the AAAM (2019).

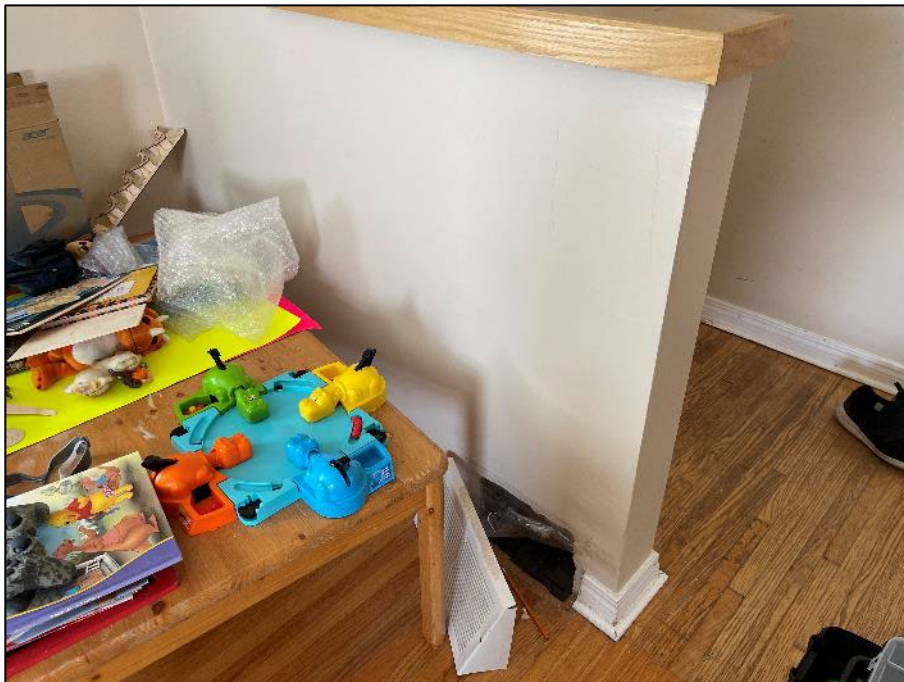
PHOTOGRAPH #4: Plaster - Level 1 Living Room Interior (<1% Actinolite)
