Demolition and Remediation Services

**Residential Demolition Project
for
The Town of Drumheller**

Tender issued September 2, 2022
Tender closing September 22, 2022 – 2:00:00 P.M.

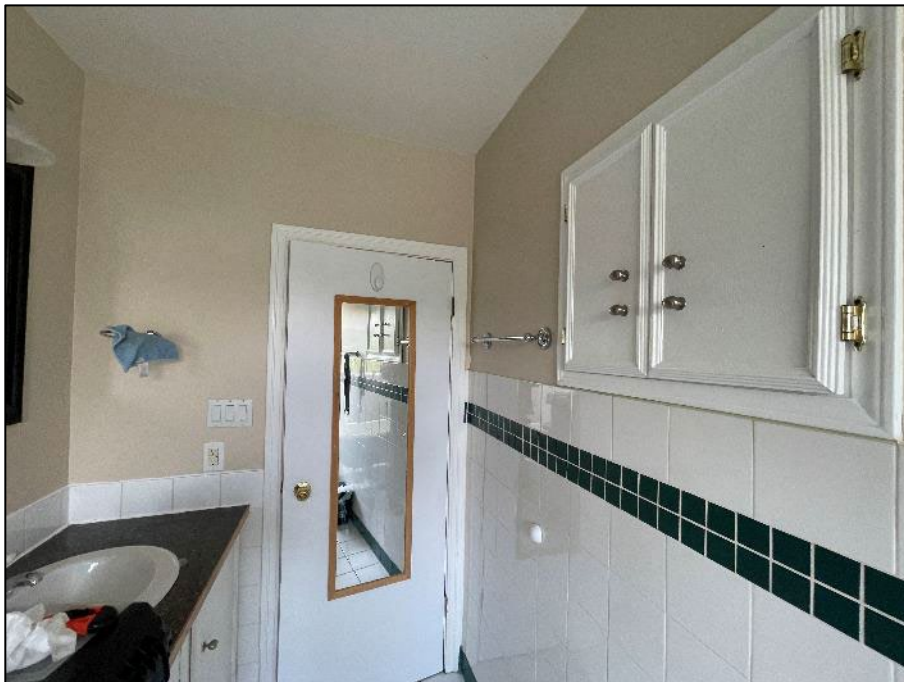
1. The following materials were identified as asbestos-containing and will require abatement prior to demolition of the structure:
 - a. Plaster on main floor walls and ceiling (*See Photographs #1 to 6*).
 - b. Stucco beneath exterior siding (*See Photographs #11 and 12*).

PHOTOGRAPH #6: Plaster - Level 1 Bathroom Interior (<1% Actinolite)

1. Plaster was observed and confirmed asbestos-containing (*See Photographs #1 through 6*). Removal of the material must be performed prior to demolition by a qualified abatement contractor using moderate-risk asbestos abatement procedures found in Section 5.3 of the AAAM (2019).

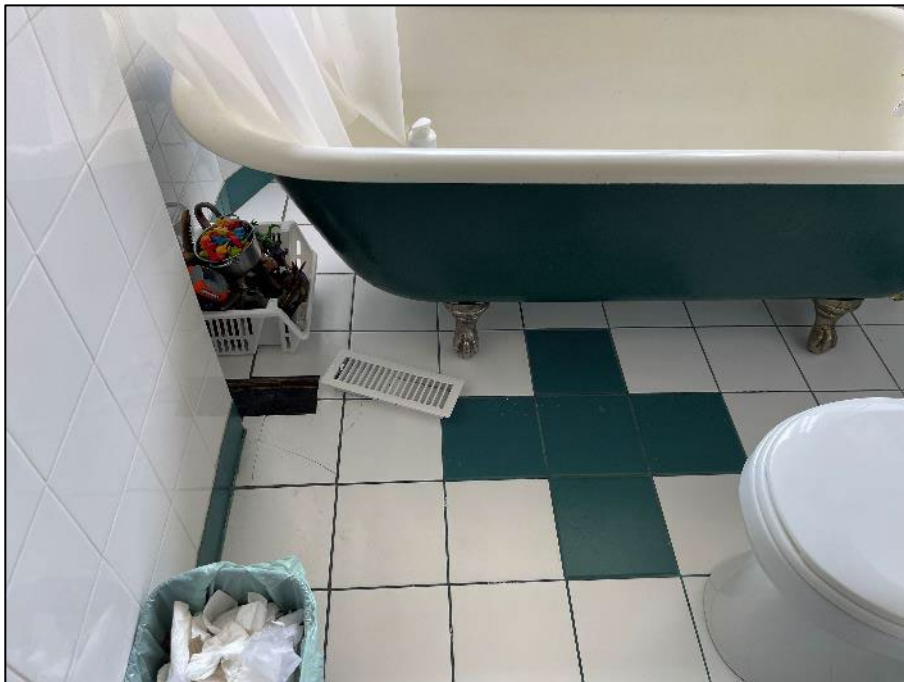
PHOTOGRAPH #8: Thinset – Bathroom (Non-Asbestos)

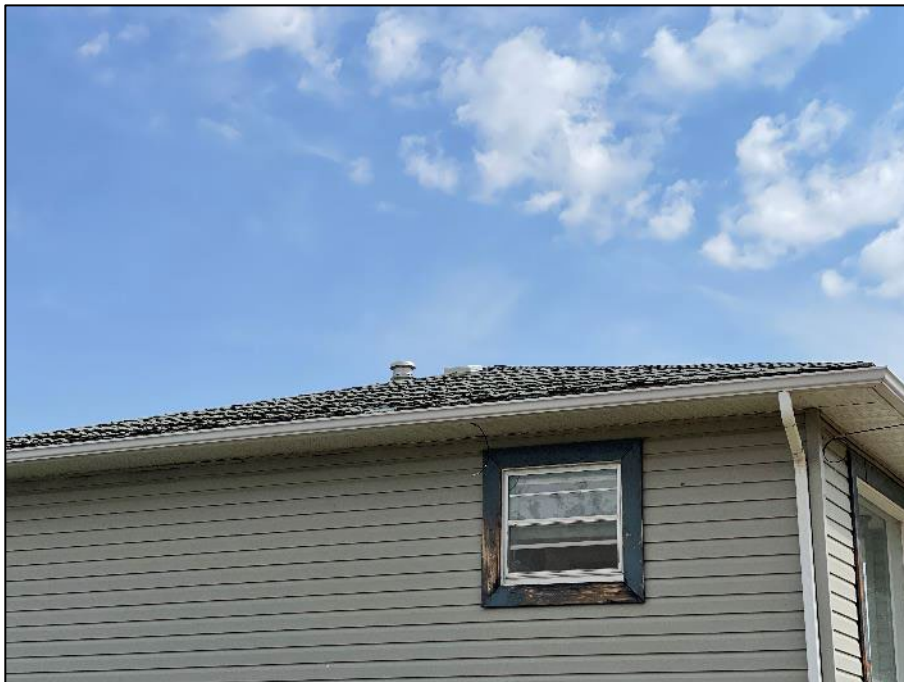
PHOTOGRAPH #10: Roofing (Non-Asbestos)

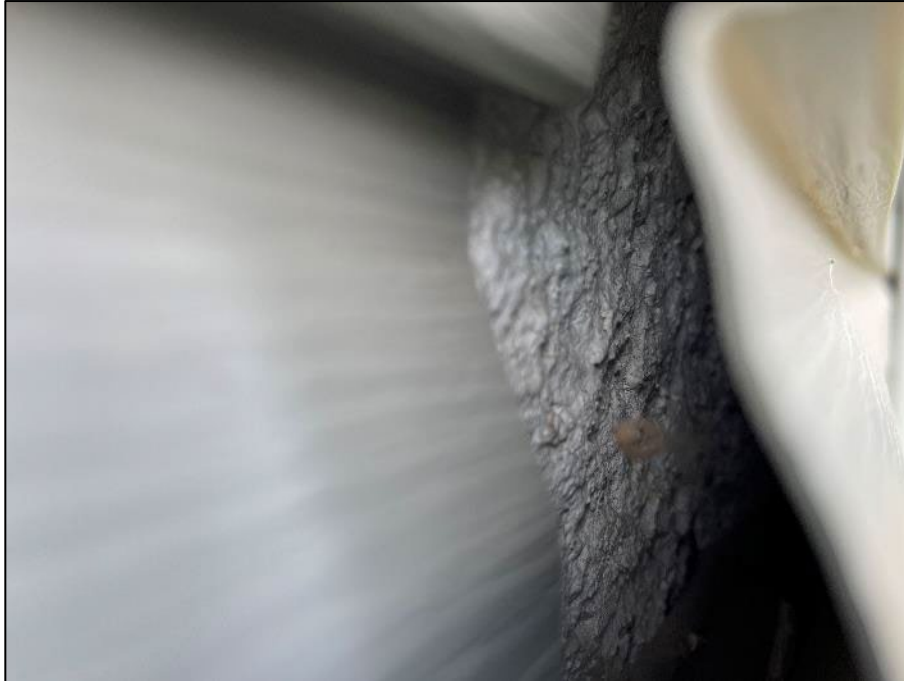
PHOTOGRAPH #11: Stucco 1 - West Face (<1% Chrysotile)

2. The stucco beneath the exterior siding was confirmed as asbestos-containing (*See Photographs #11 and 12*). Removal of the material must be performed prior to demolition by a qualified abatement contractor using moderate-risk asbestos abatement procedures found in Section 5.3 of the AAAM (2019).
3. Lead-containing paints (*See Appendix II*) were identified. Disturbance of lead-containing surface coatings must be performed following exposure prevention controls similar to those found in WorkSafeBC's Lead Containing Paints and Coatings: Preventing Exposure in the Construction Industry (2011) document and described in the Alberta Governments Lead at the Work Site (2013) bulletin.

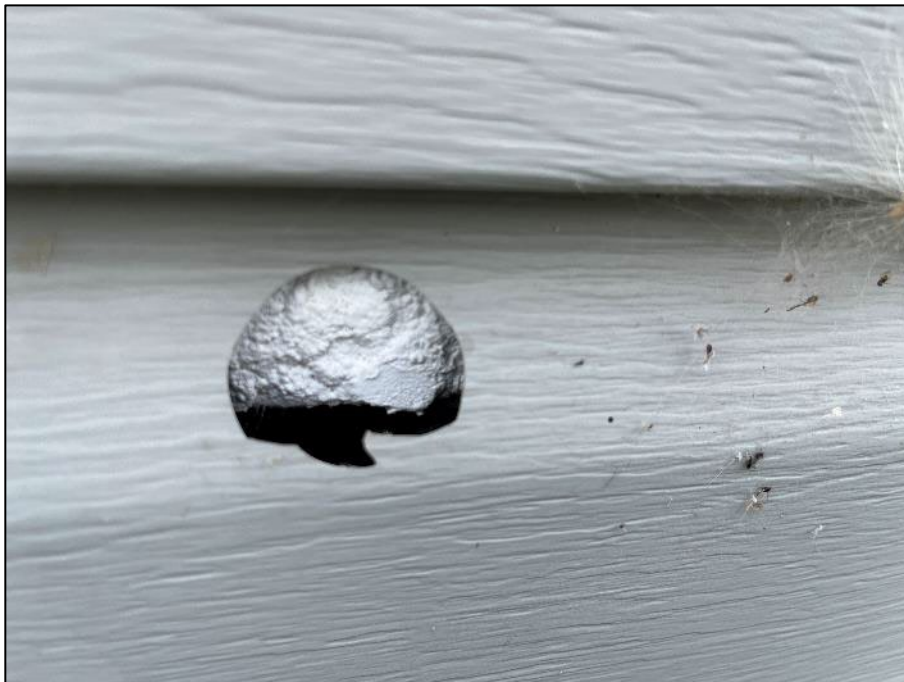
PHOTOGRAPH #12: Stucco 2 - West Face (<1% Chrysotile)

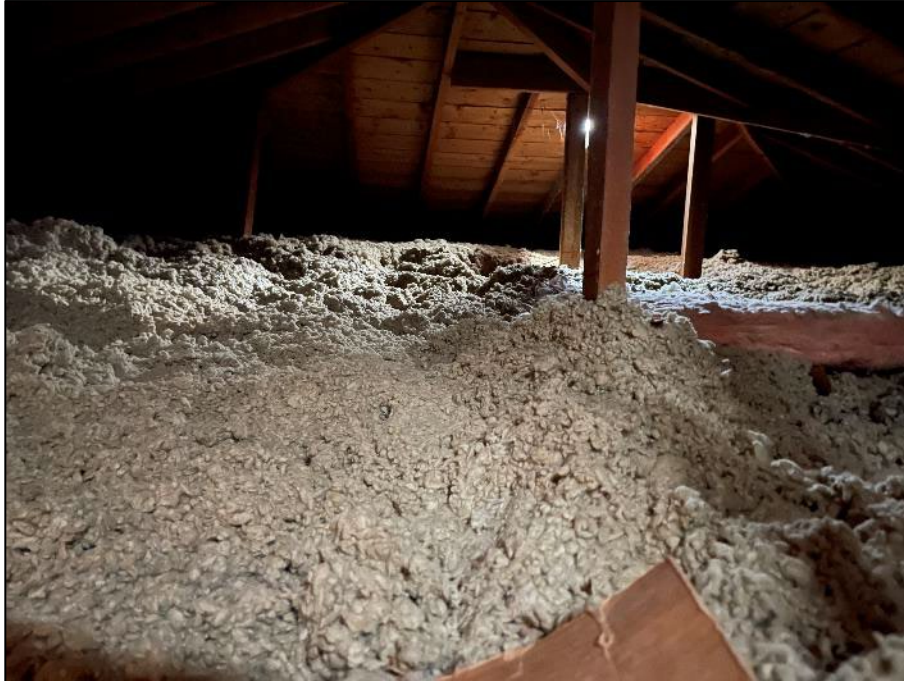
PHOTOGRAPH #13: Attic Insulation (Non-Asbestos)

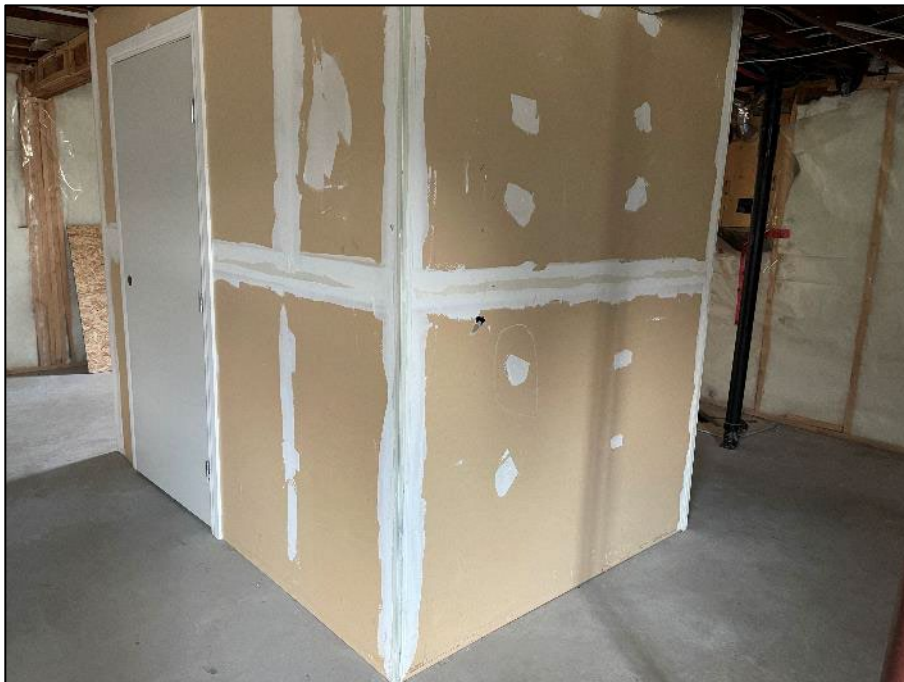
PHOTOGRAPH #14: Drywall Joint Compound - Basement Furnace Room (Non-Asbestos)

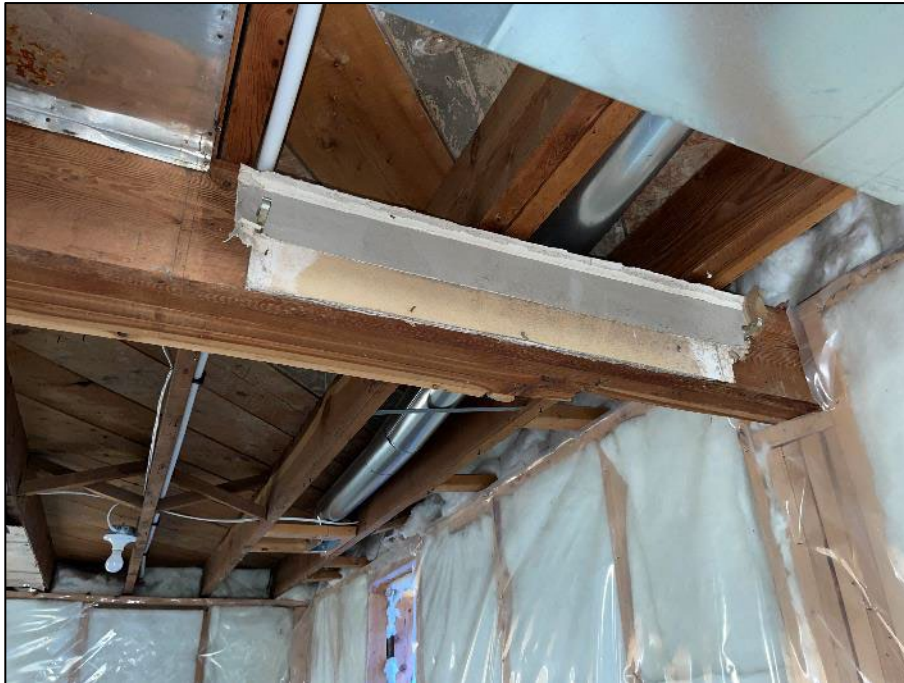
PHOTOGRAPH #15: Drywall Joint Compound - Basement Laundry Room (Non-Asbestos)

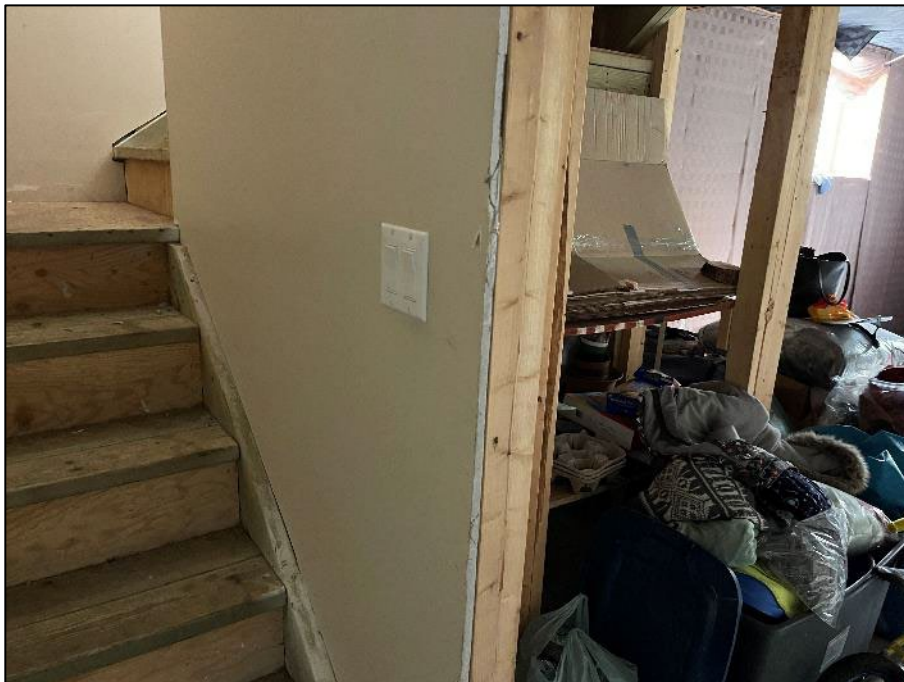
PHOTOGRAPH #16: Drywall Joint Compound - Basement Stairs (Non-Asbestos)

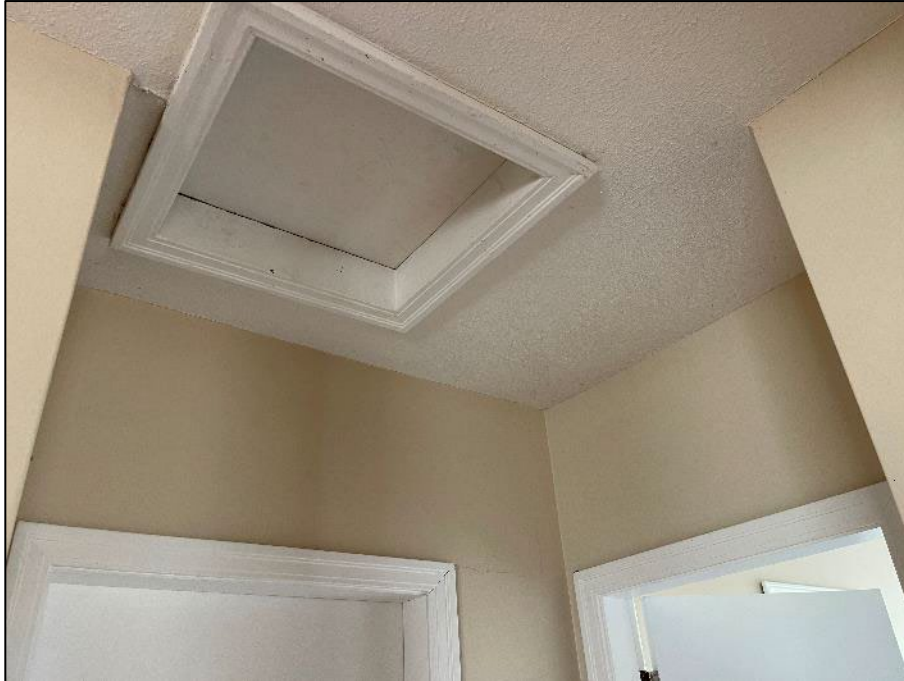
PHOTOGRAPH #17: Ceiling Texture - Level 1 Hallway (Non-Asbestos)

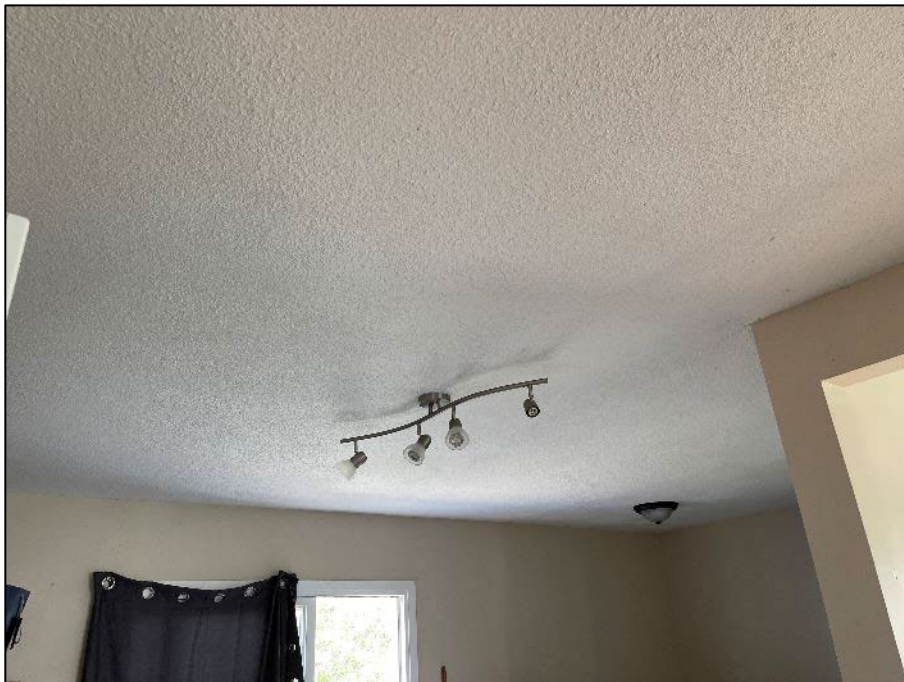
PHOTOGRAPH #18: Ceiling Texture - Level 1 Kitchen (Non-Asbestos)

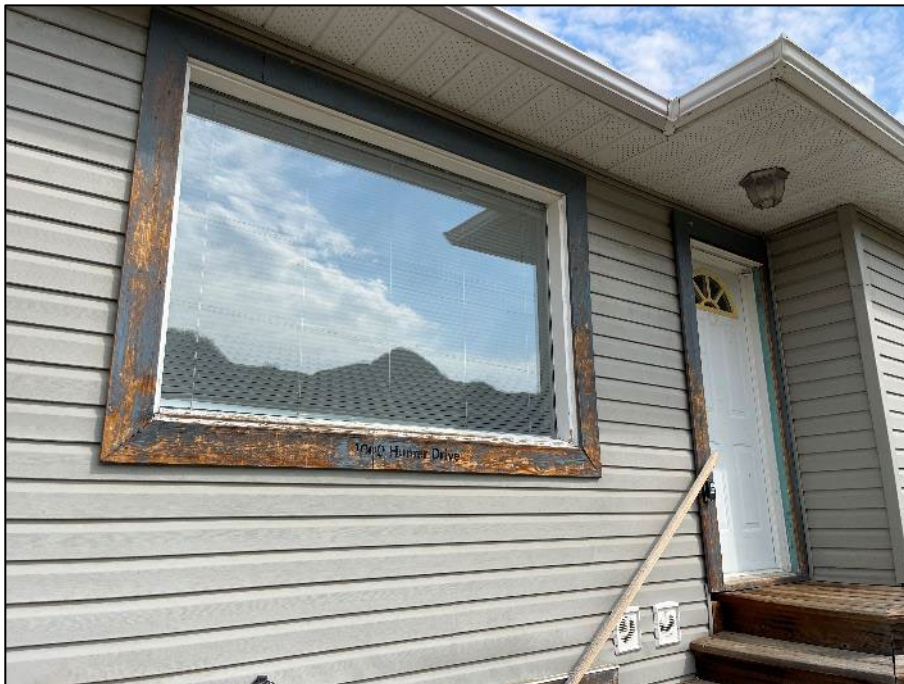
PHOTOGRAPH #22: White Paint – Exterior Trim (Lead Based)

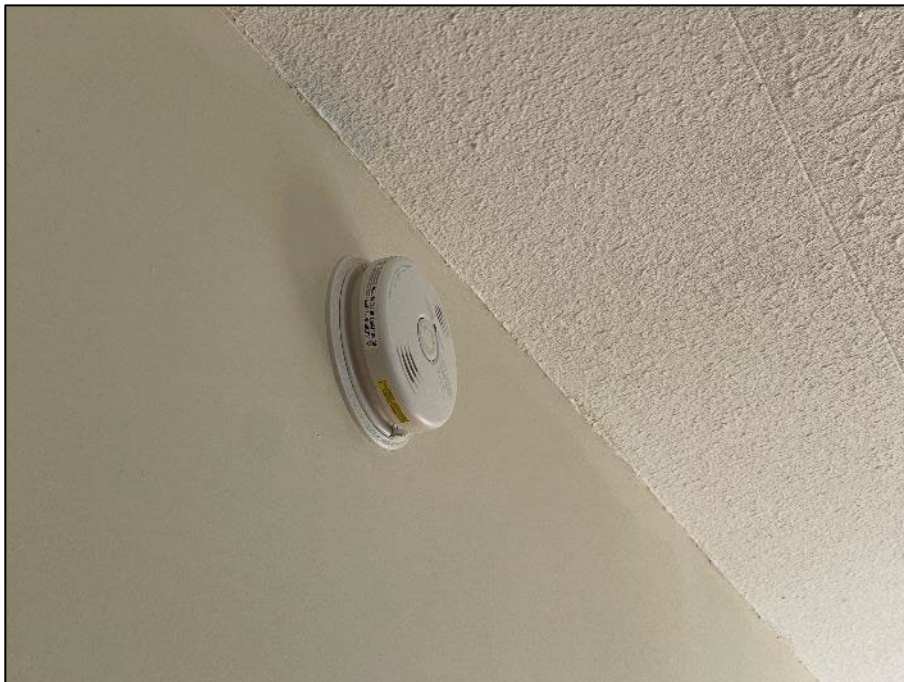
PHOTOGRAPH #24: Smoke Detector – Main Floor Living Room (Radioactive Materials)
