## EXPRESSION OF INTEREST DRFM #2023-02-16

PROPOSAL: [Flood Mitigation– House Salvage]

DATE: [February 16, 2023]

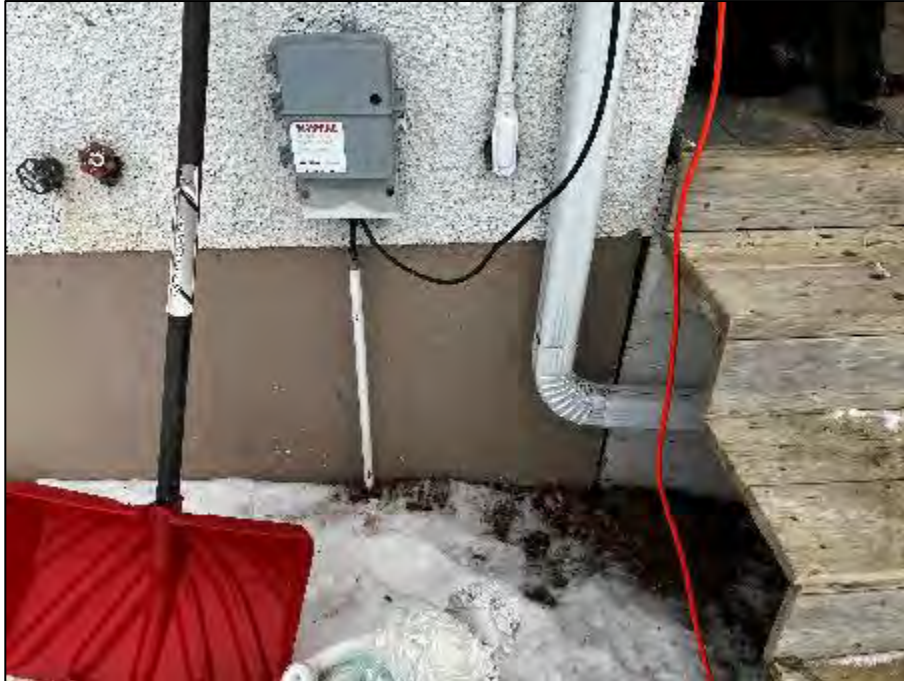
#	DESCRIPTION / LOCATION	ASB TYPE	ASB%	CONDITION	PHOTO
18	Stucco* Exterior – Back	Chrysotile	2%	Fair	18
19	Stucco* Exterior – Right Side	Chrysotile	2%	Fair	19
20	Stucco* Exterior – Left Side	Chrysotile	2%	Fair	20
22	Window Caulking Exterior	Chrysotile	3%	Fair	22
27	Vermiculite Insulation Attic	Actinolite	<1%	Fair	27

**PHOTOGRAPH #18:** Stucco - Back Exterior (2% Chrysotile)

1. The following materials were identified as asbestos-containing and will require abatement prior to demolition of the structure:
  - a. Exterior Stucco (*See Photographs #18 to 20*).
  - b. Window Caulking (*See Photograph #22*).
  - c. Vermiculite Insulation (*See Photograph #27*).

Removal of the materials must be performed by a qualified abatement contractor prior to demolition using procedures found in the Alberta Asbestos Abatement Manual (2019).

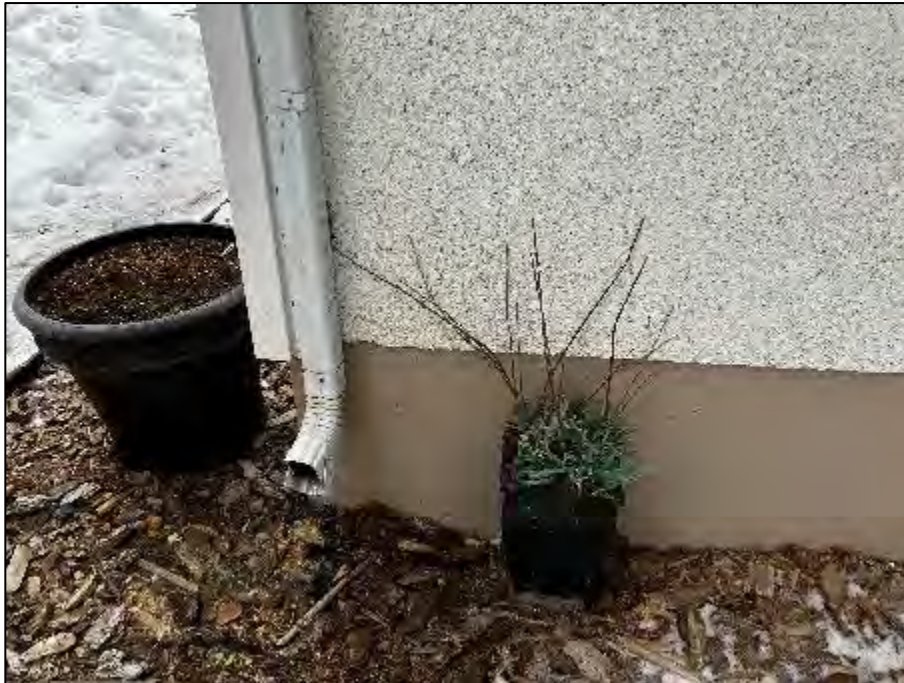
**PHOTOGRAPH #20:** Stucco - North Exterior (2% Chrysotile)

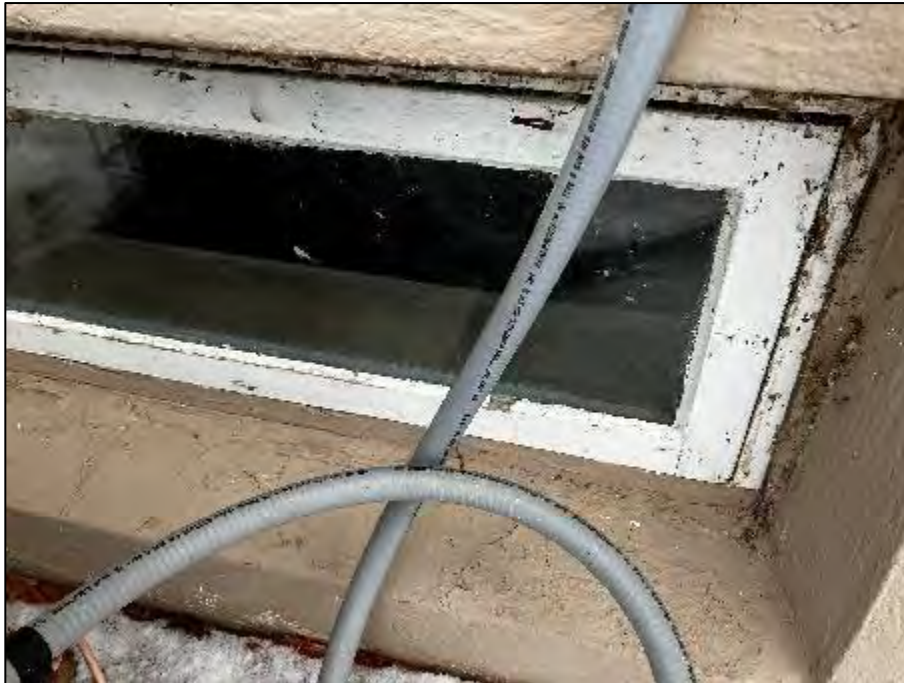
**PHOTOGRAPH #22:** Window Caulking Exterior (3% Chrysotile)

2. The window caulking on the property was identified as asbestos-containing. Any renovation, demolition, or removal of the material must be performed by a qualified abatement contractor using low asbestos abatement procedures found in Section 5.2 of the Alberta Asbestos Abatement Manual (2019) (See *Photograph #22*).

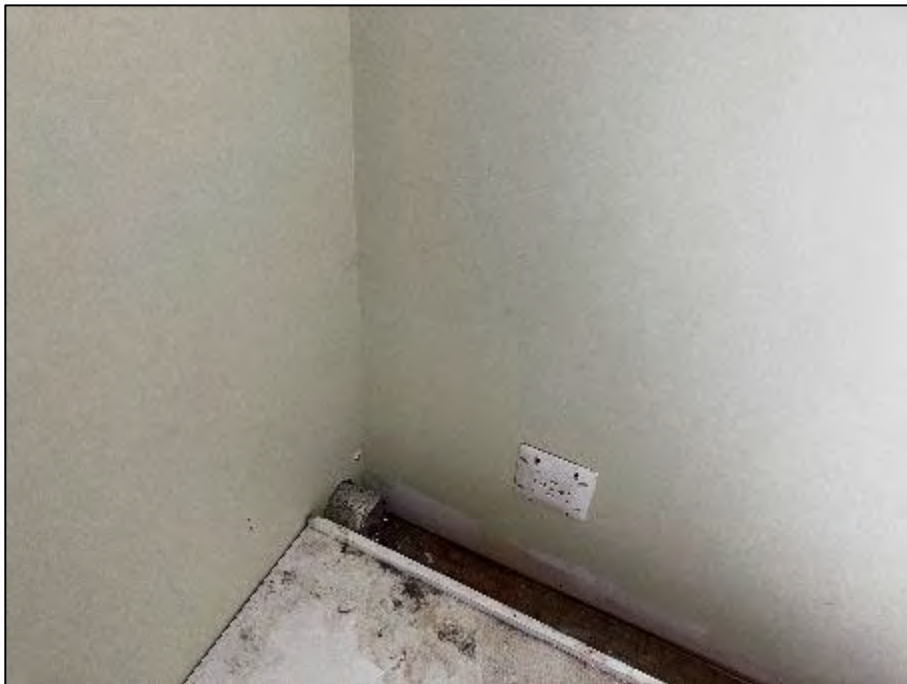
**PHOTOGRAPH #4:** Drywall Joint Compound - Level 1 Laundry Room Exterior (None Detected)

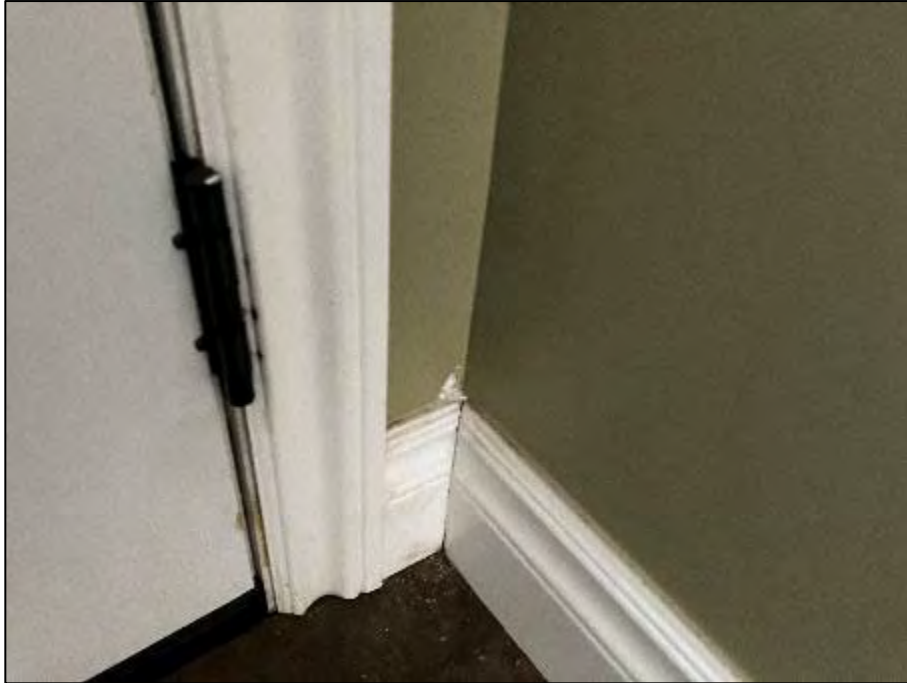
**PHOTOGRAPH #5:** Drywall Joint Compound - Level 1 Foyer Exterior (None Detected)

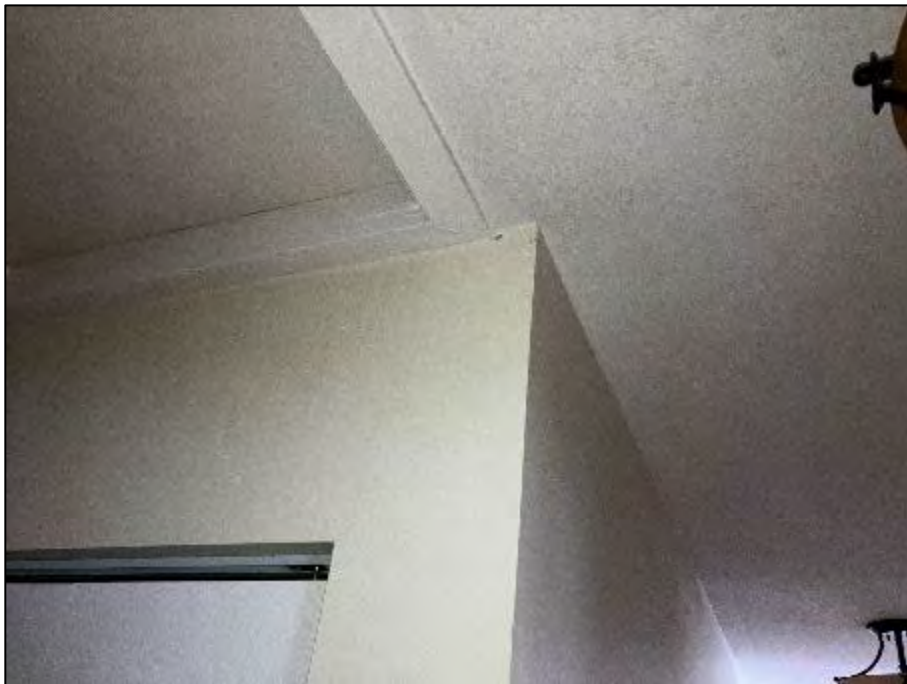
**PHOTOGRAPH #6:** Drywall Joint Compound - Level 1 Hallway Interior (None Detected)

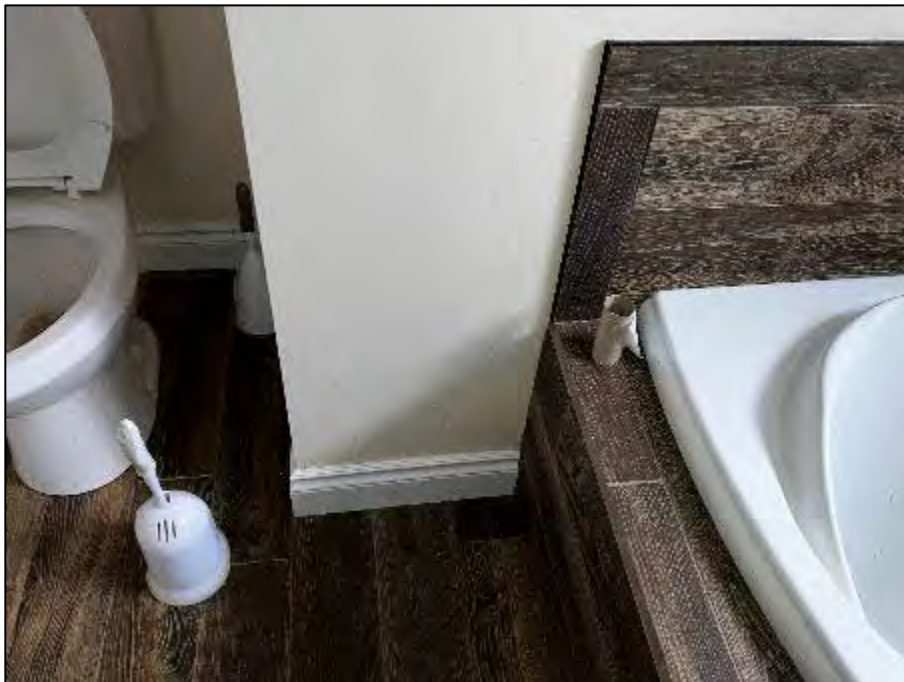
**PHOTOGRAPH #10:** Drywall Joint Compound - Level 1 Bathroom Interior (None Detected)

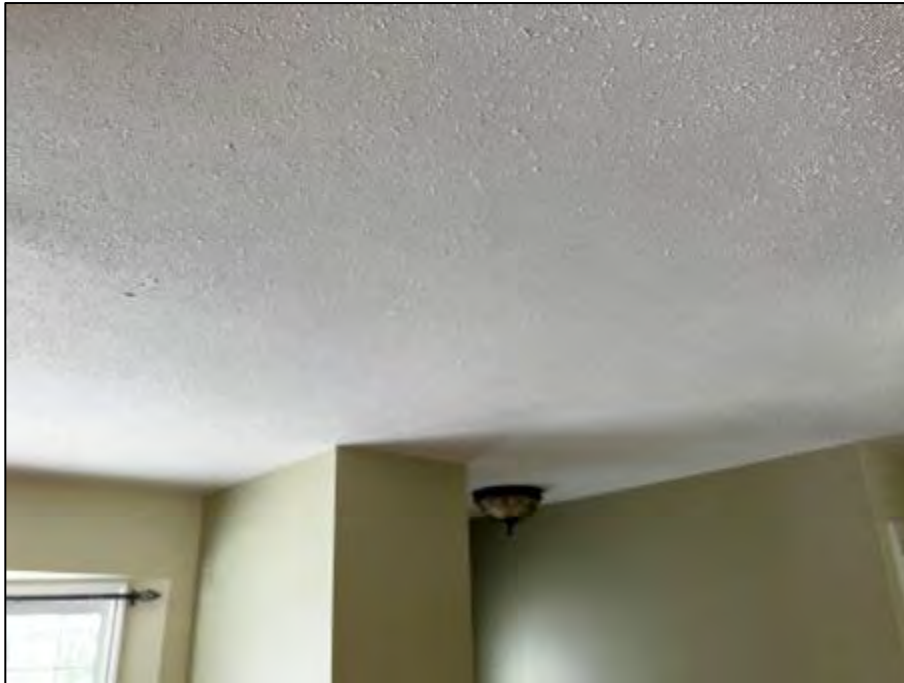
**PHOTOGRAPH #11:** Ceiling Texture - Level 1 Foyer Popcorn (None Detected)

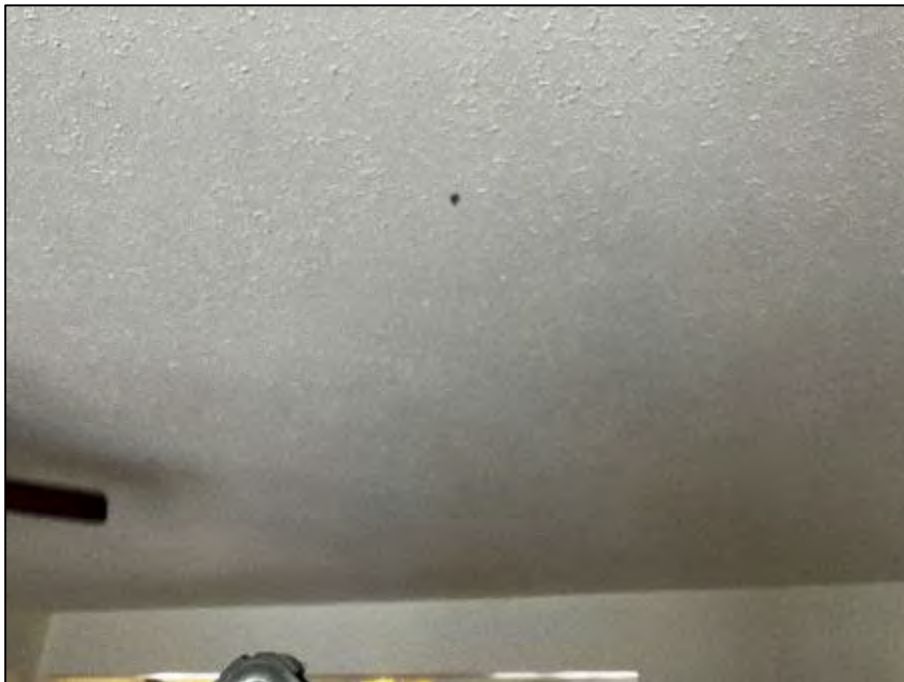
**PHOTOGRAPH #12:** Ceiling Texture - Level 1 Dining Room Popcorn (None Detected)

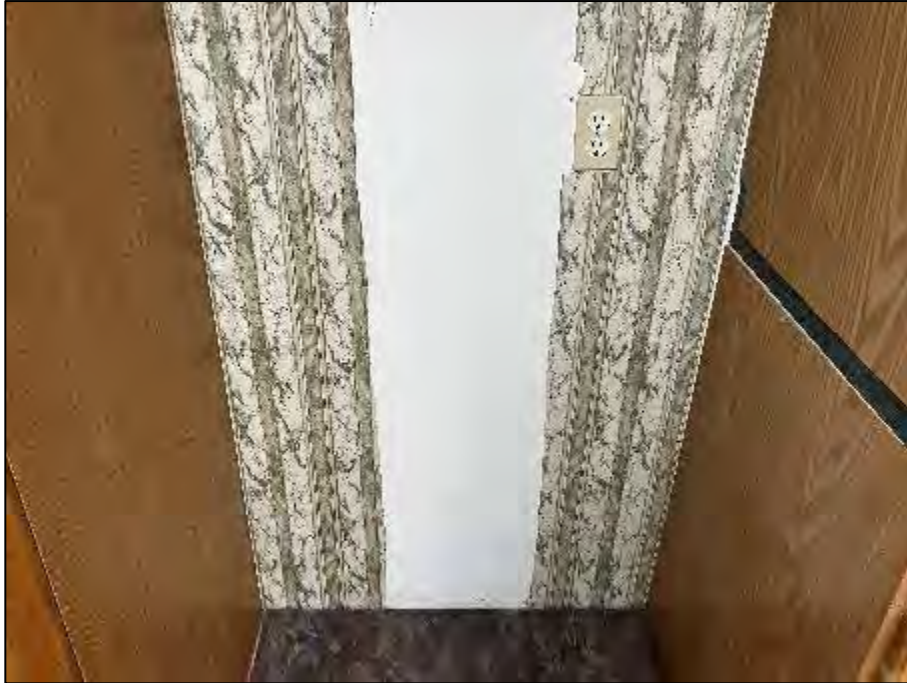
**PHOTOGRAPH #15:** Wall Paper - Level 1 Kitchen (None Detected)

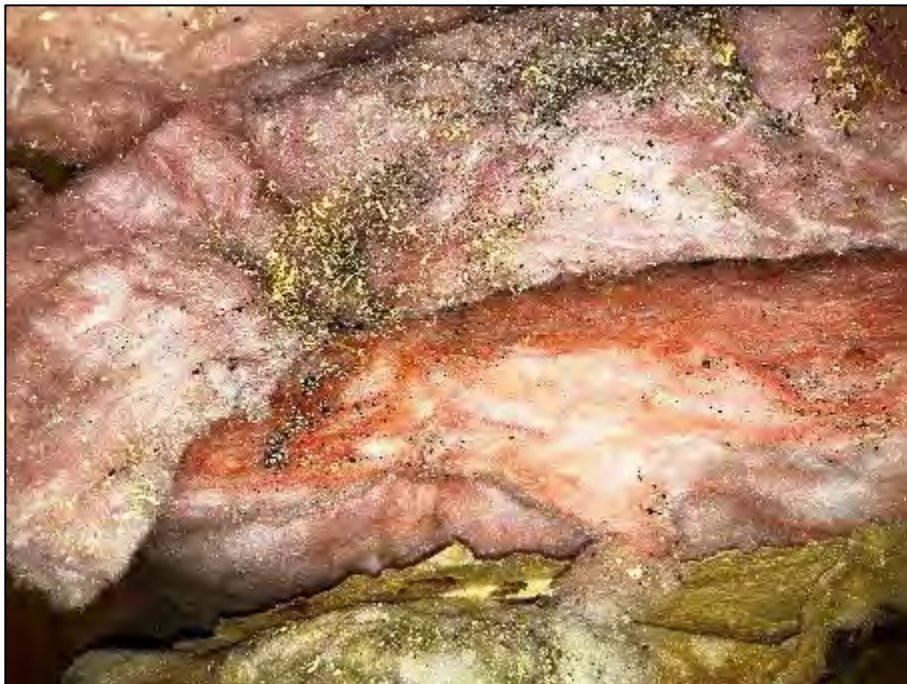
**PHOTOGRAPH #16:** Attic Insulation (None Detected)

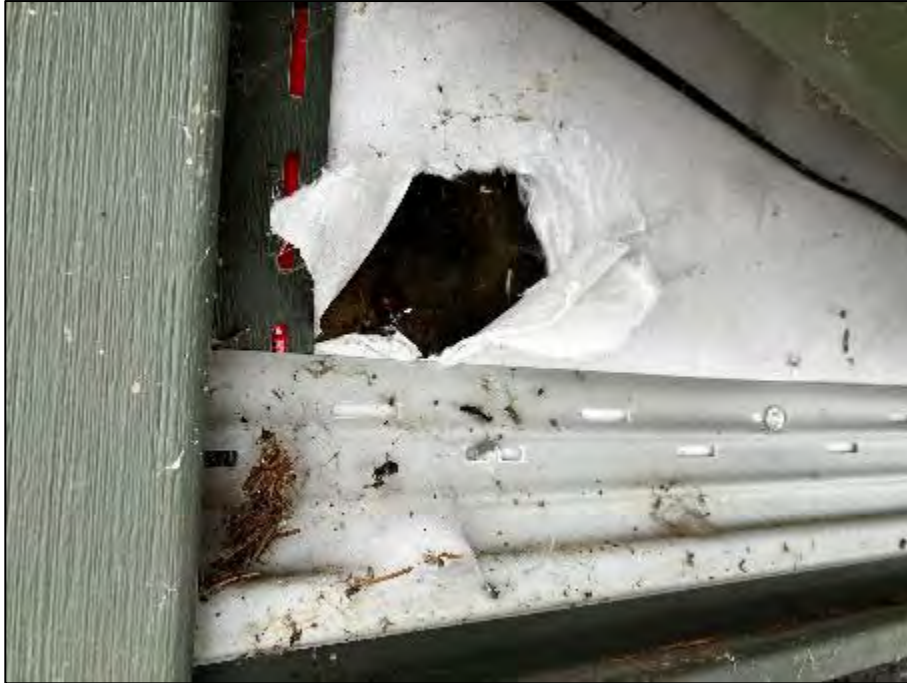
**PHOTOGRAPH #17:** Siding Paper (None Detected)

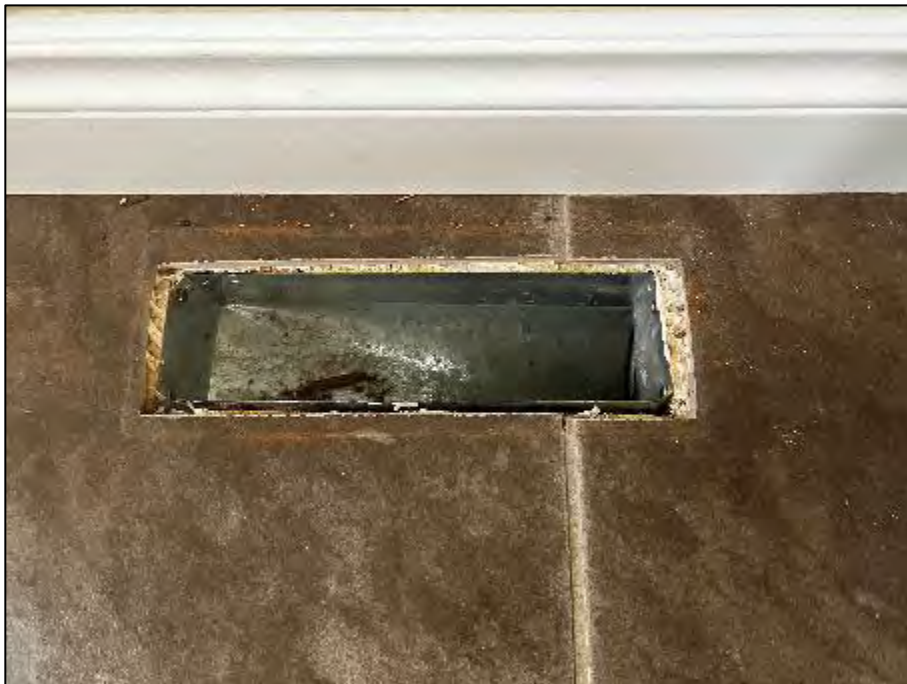
**PHOTOGRAPH #18:** Flooring - Level 1 Foyer (None Detected)

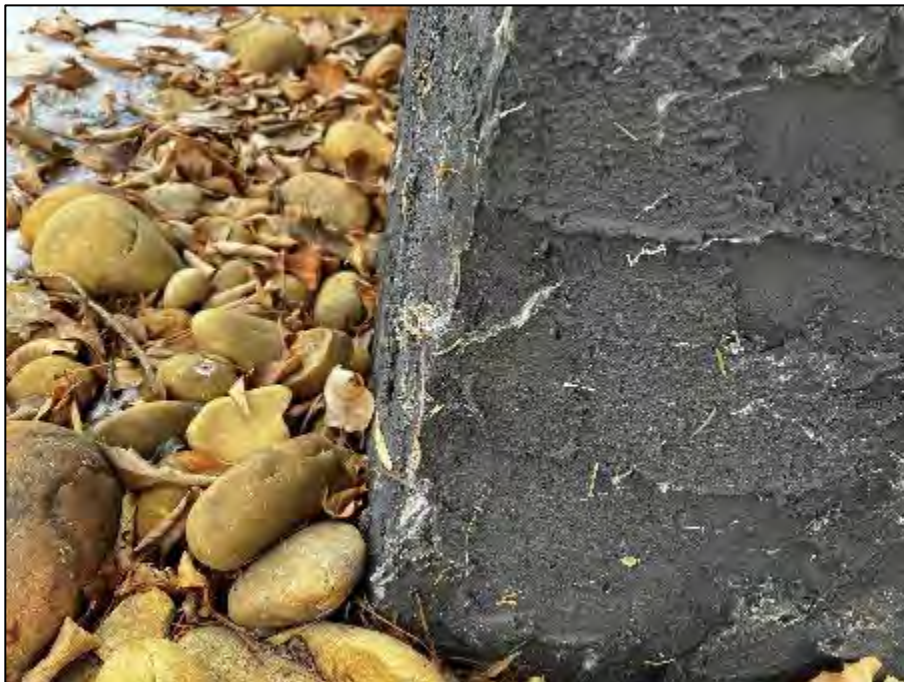
**PHOTOGRAPH #20:** Parging - Front Exterior (None Detected)

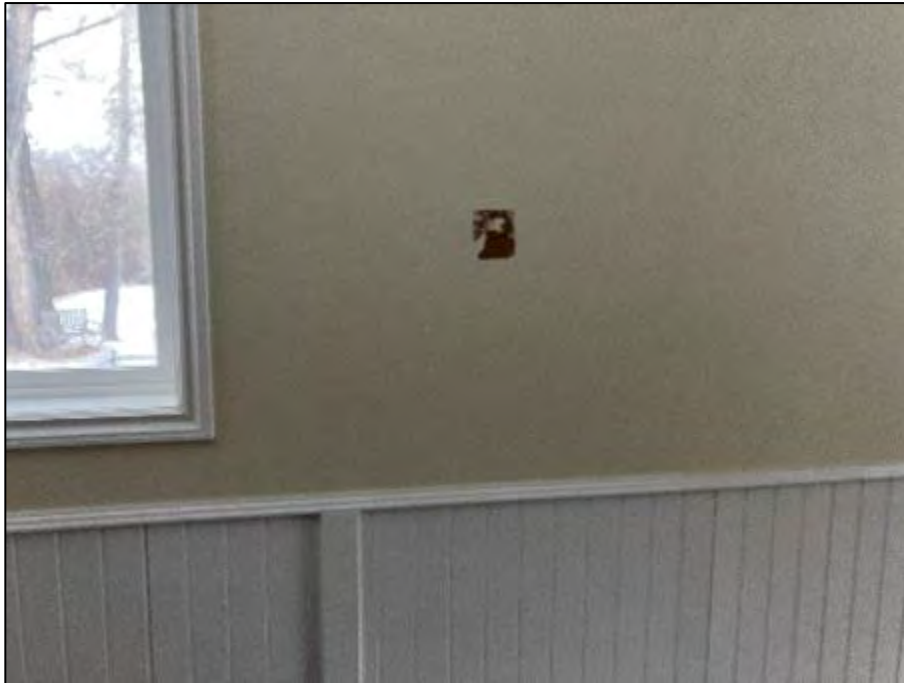
**PHOTOGRAPH #21:** Paint - Level 1 Dining Room Yellow (<80 ppm Lead)

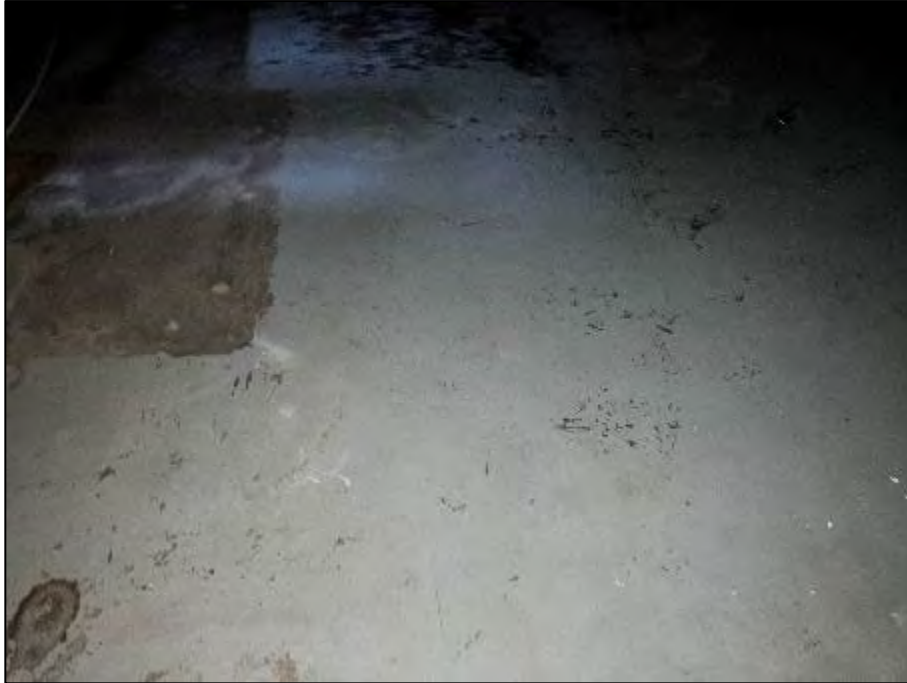
**PHOTOGRAPH #23:** Paint - Basement Floor Grey (<80 ppm Lead)

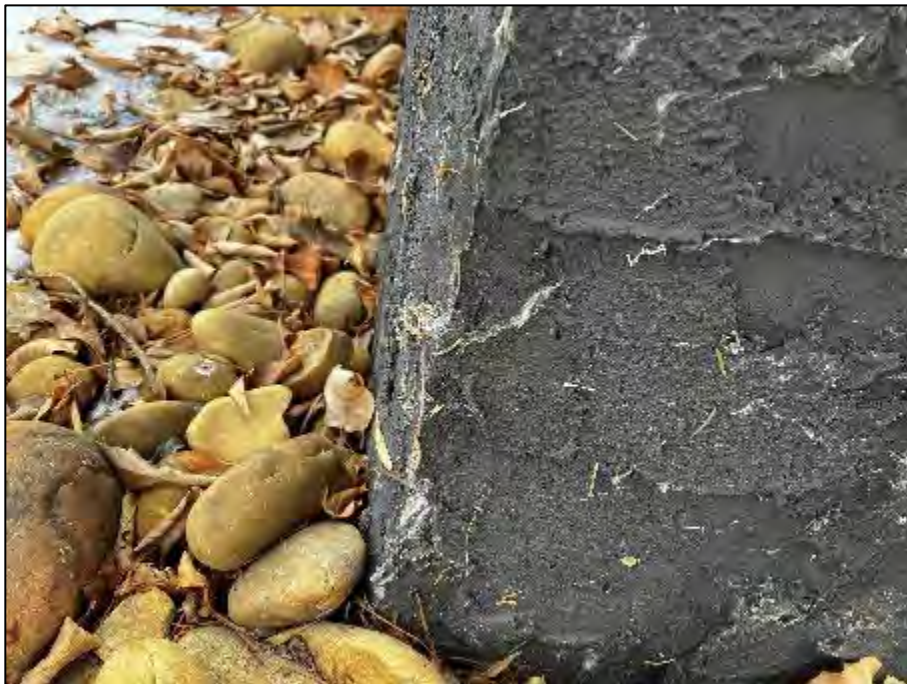
**PHOTOGRAPH #24:** Paint - Parging Exterior (<80 ppm Lead)

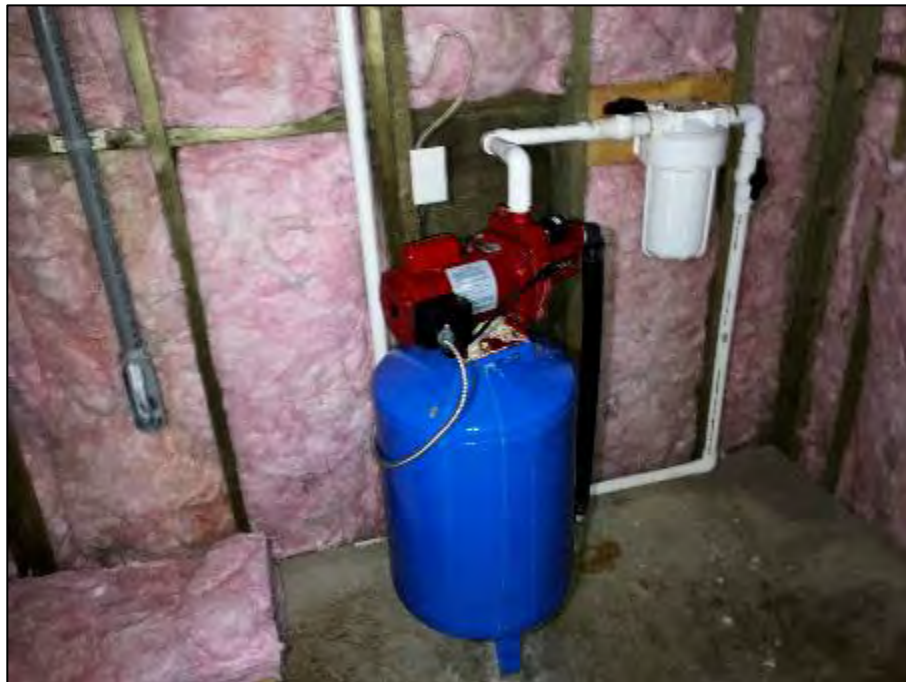
**PHOTOGRAPH #26:** Basement Sump Pump

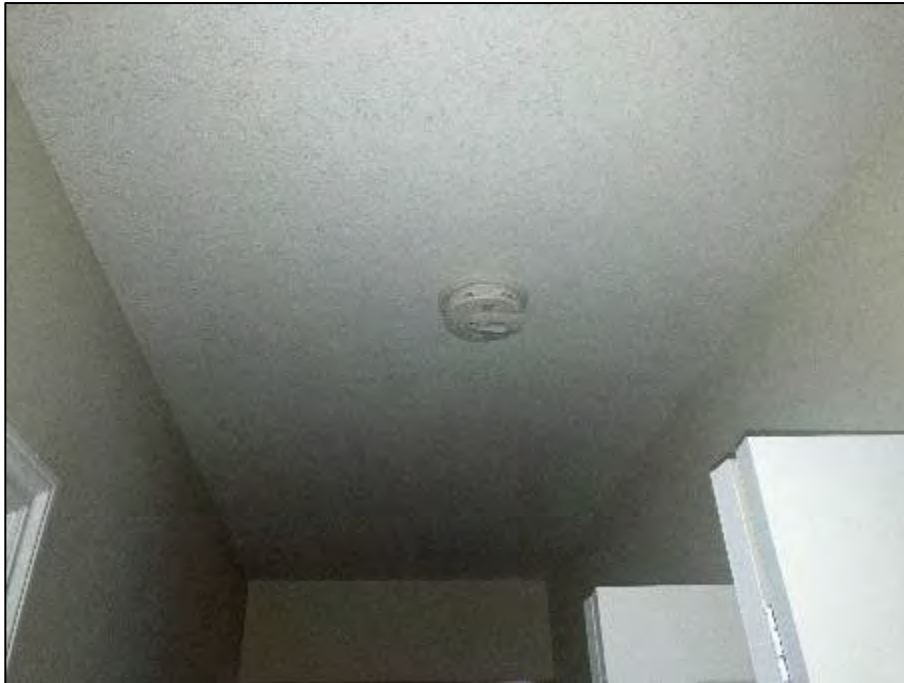
**PHOTOGRAPH #27:** Smoke Detector in Hallway

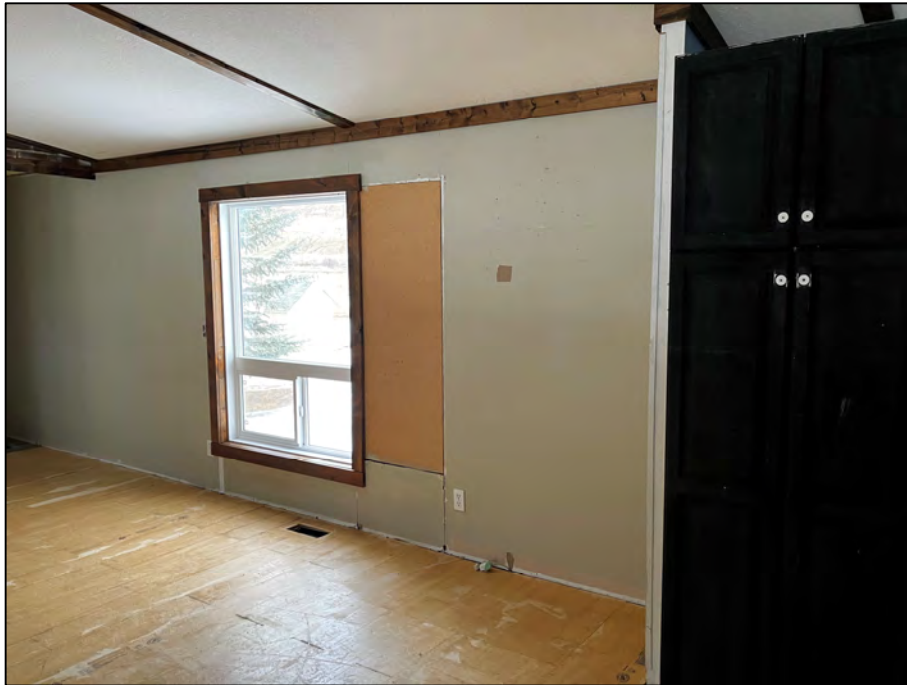
**PHOTOGRAPH #6:** Paint - N Bedroom Pale Blue (<80 ppm Lead)

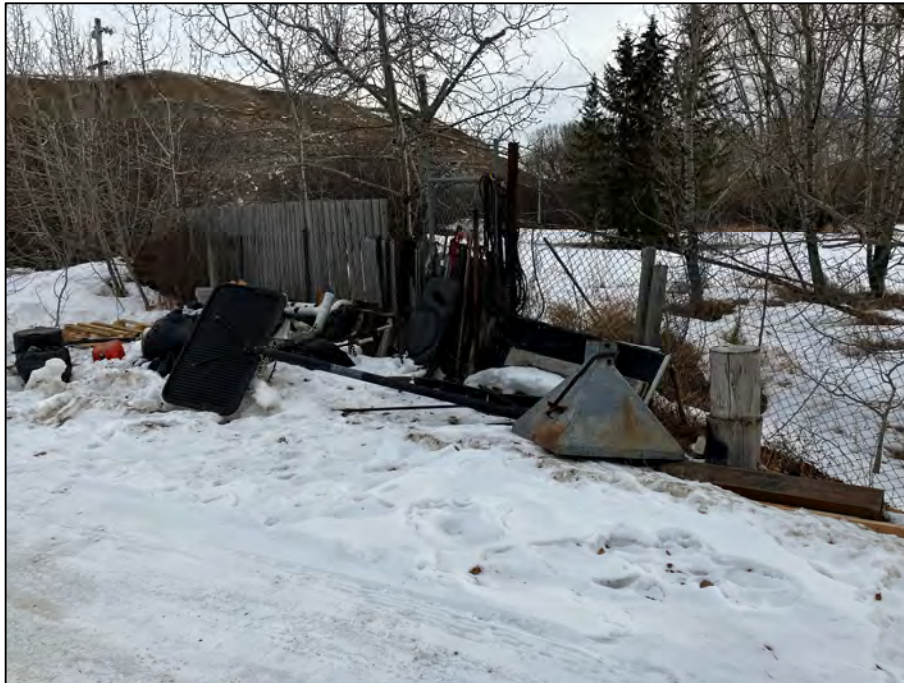
**PHOTOGRAPH #16:** Vehicles on Property

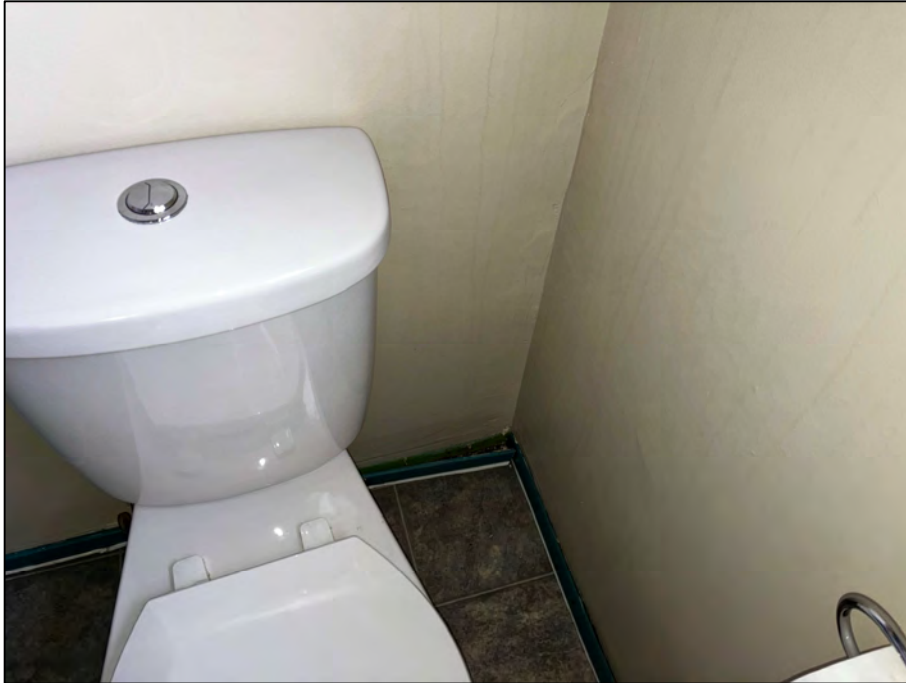
1. The following materials were identified as asbestos-containing and will require abatement prior to demolition of the structure:
  - a. Drywall Joint Compound (*See Photographs #1 to 8*).
2. **PLEASE NOTE:** Due to the homogenous appearance of drywall, all sections of the materials throughout the property must be treated as asbestos-containing as required by Section 7.1.1 of the Alberta Asbestos Abatement Manual (2019).

**PHOTOGRAPH #3:** Drywall Joint Compound - Level 1 Bathroom Exterior (2% Chrysotile)

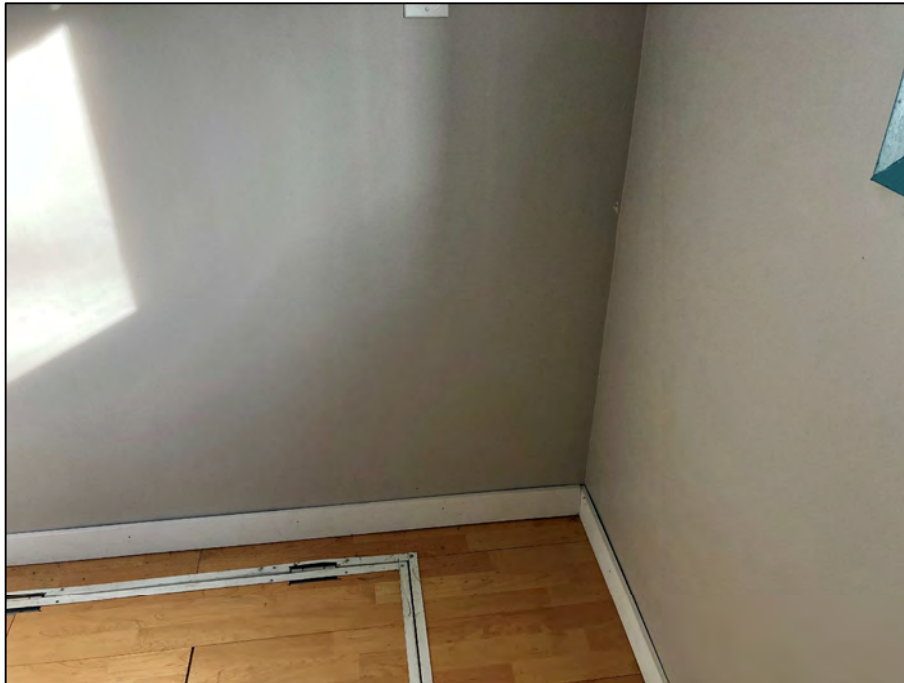
**PHOTOGRAPH #5:** Drywall Joint Compound - Level 1 Storage Room Exterior (2% Chrysotile)

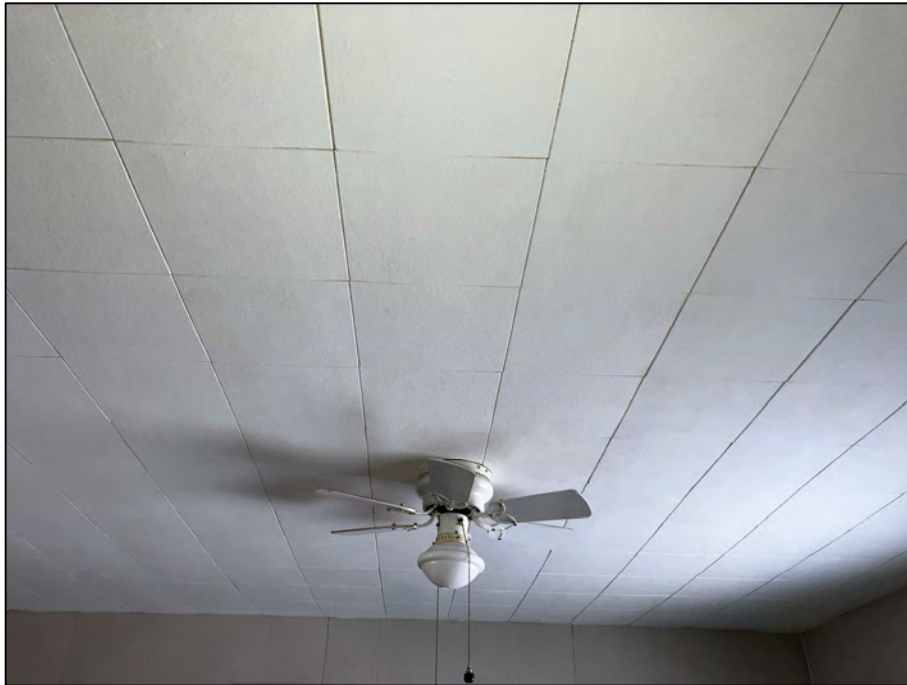
**PHOTOGRAPH #9:** Ceiling Tile - Level 1 Main Room (None Detected)

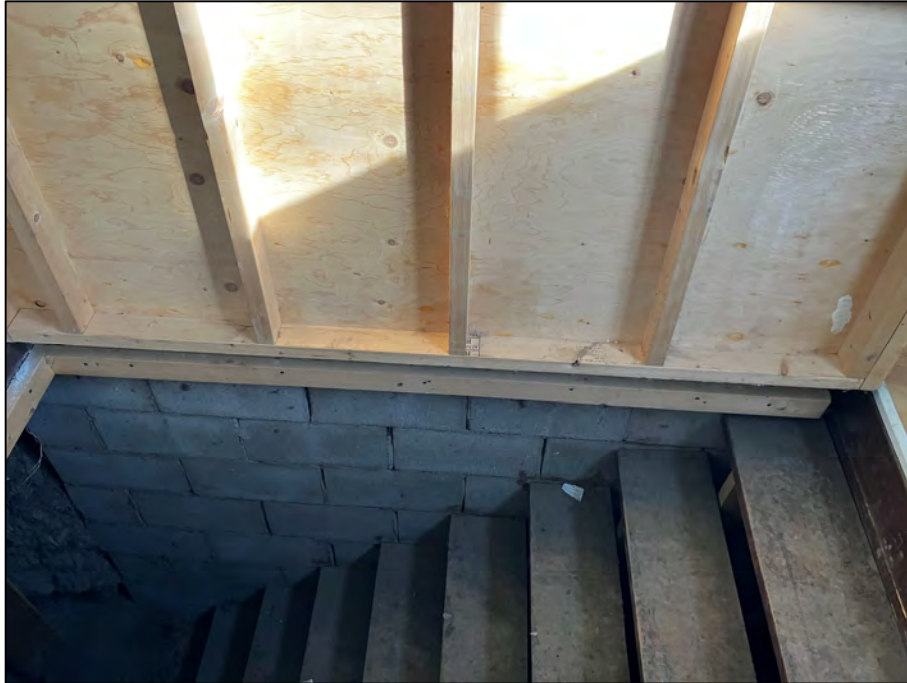
**PHOTOGRAPH #15:** Brick Mortar - Stairs (None Detected)

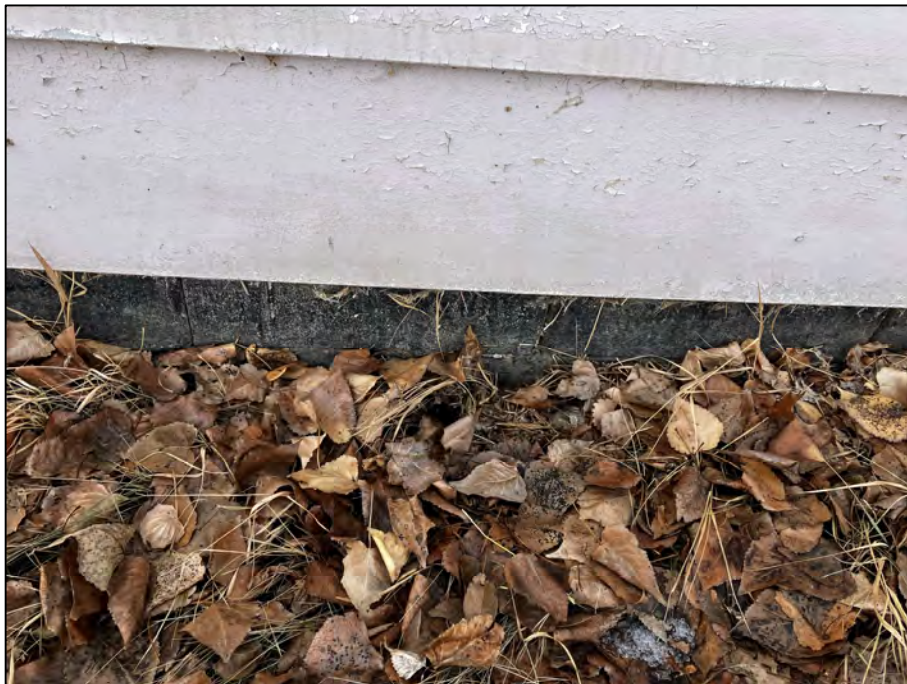
**PHOTOGRAPH #16:** Parging - Exterior (None Detected)

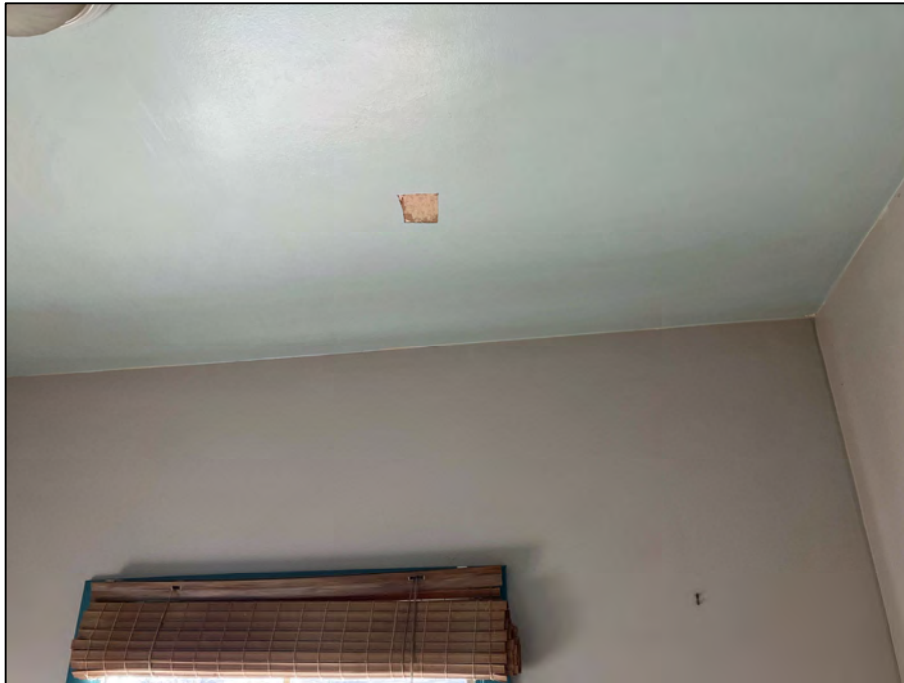
**PHOTOGRAPH #19:** Paint - Storage Room Green (640 ppm Lead)

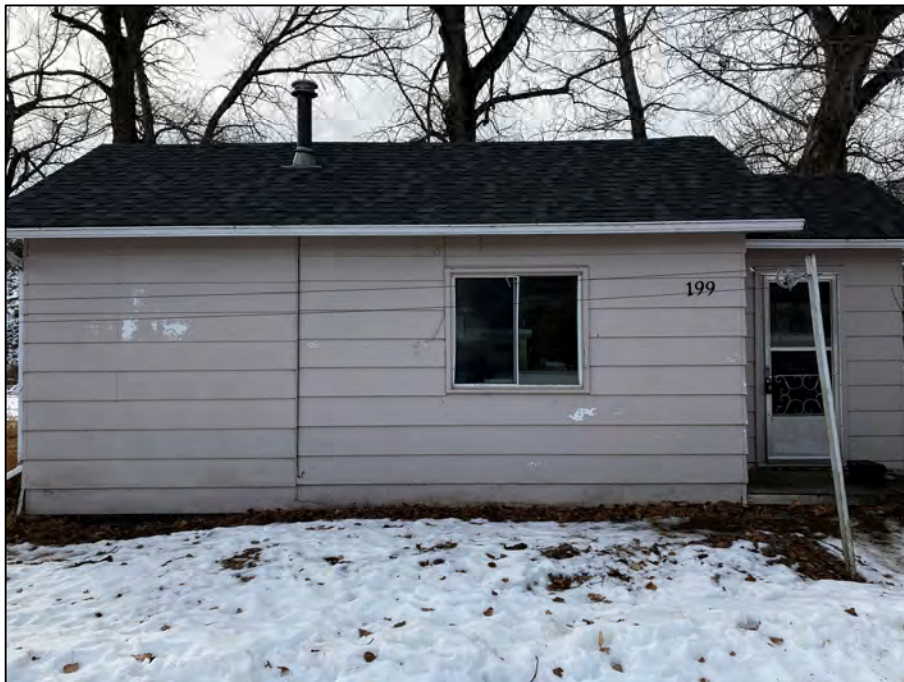
**PHOTOGRAPH #20:** Paint - Exterior Beige (<80 ppm Lead)

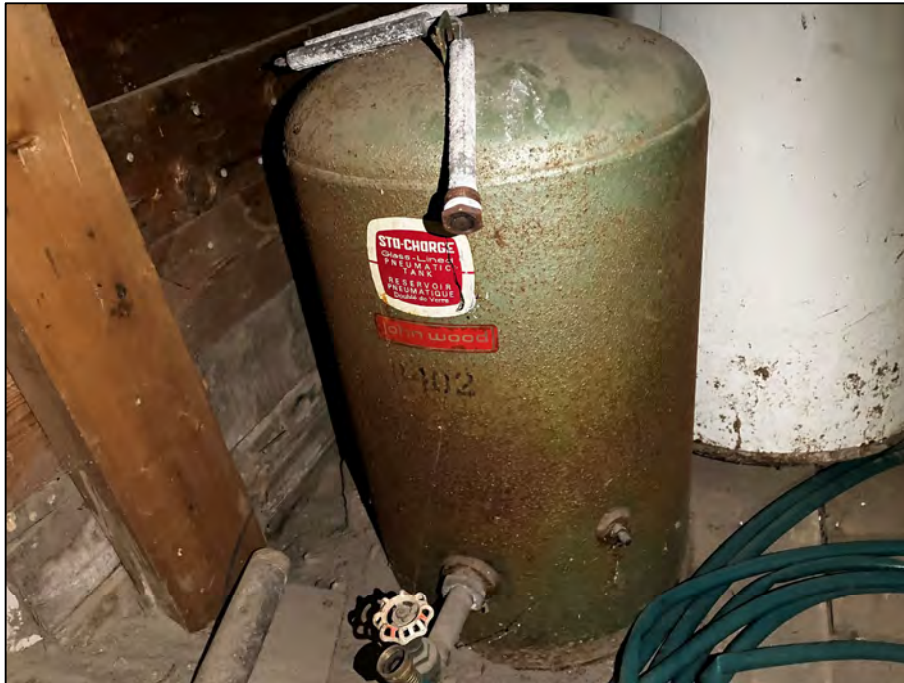
**PHOTOGRAPH #24:** Pneumatics Storage Tank in Basement

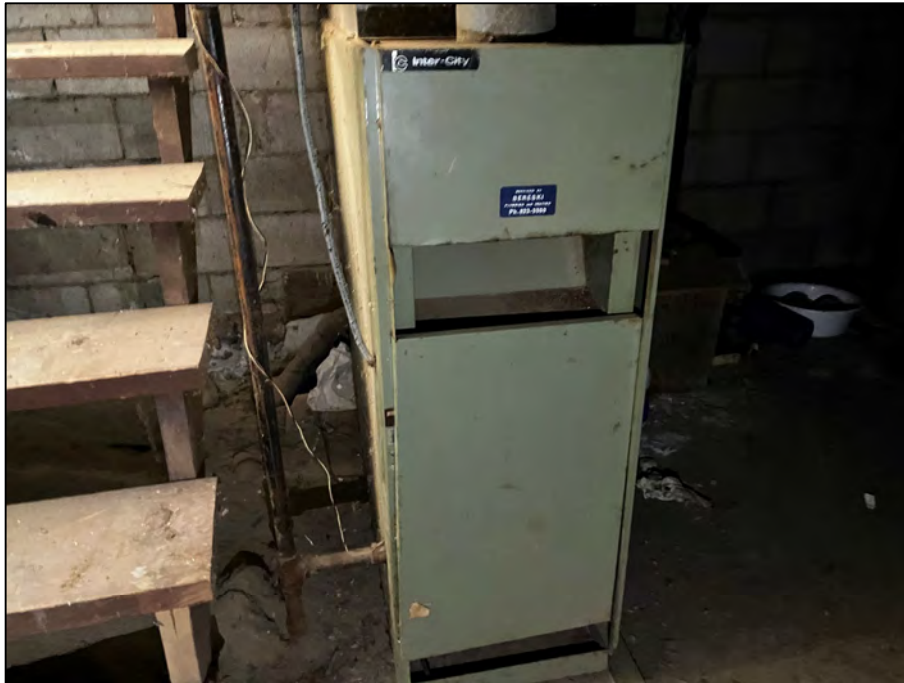
PHOTOGRAPH #26: Furnace Unit Within Basement
