# Demolition and Remediation Services

<p style="text-align: center;"><b>Institutional &amp; Residential Demolitions Project for The Town of Drumheller</b></p>
--

## **Hazardous Building Materials Assessment (Pre-construction)**

Abandoned Health Centre  
625 Riverside Drive East,  
Drumheller, Alberta

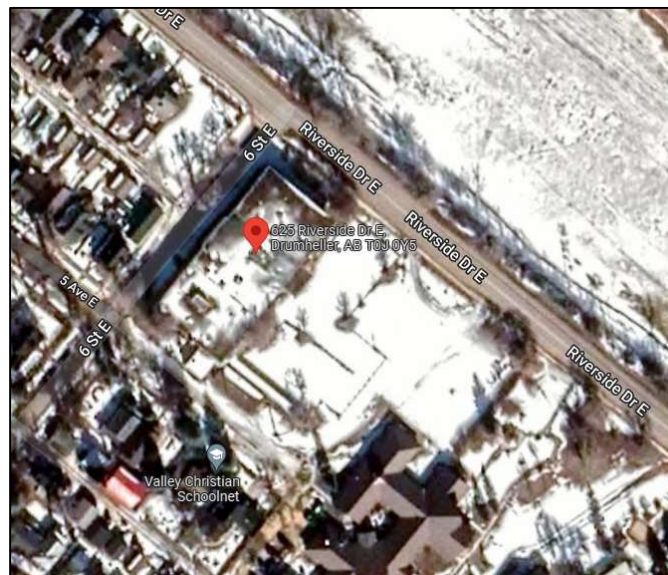
The Health Centre was built in 1970 to replace an existing and aging facility in the same location, address 625 Riverside Drive East Drumheller. It is a two-story above grade concrete building of approximately 47,000 square feet that contains operating and surgical suites, x-ray and lab areas, an incinerator, patient rooms, change rooms, an industrial kitchen, storage rooms, mechanical/electrical and utility rooms, a loading dock, and more. It also has an existing surface parking lot of approximately 22,500 square feet. The Health Centre served the Town for 32 years before being decommissioned. Most furniture and hospital equipment were removed during this decommissioning phase. Note that initial asbestos abatement was completed in 2016, with some remaining abatement still required.

*Figure 1- The Old Heath Centre*

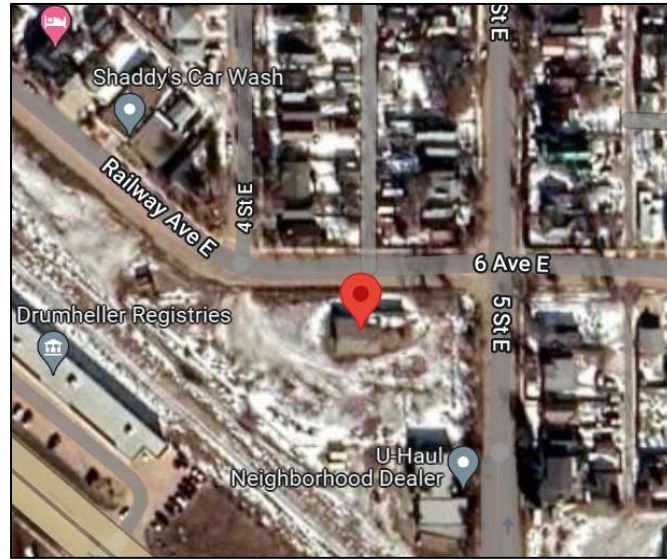
The Consortium was originally built in 1928 and in 1960 it was expanded to incorporate a library addition, address 601 5 St E Drumheller. This building has been abandoned for around 40 years and was partially burnt down 20 years ago. The remaining area after the fire is around 3,200 square feet and contains some offices and an open space where the library used to be. The building is partially furnished with a significant amount of old debris being stored in it.

Figure 2 – Consortium

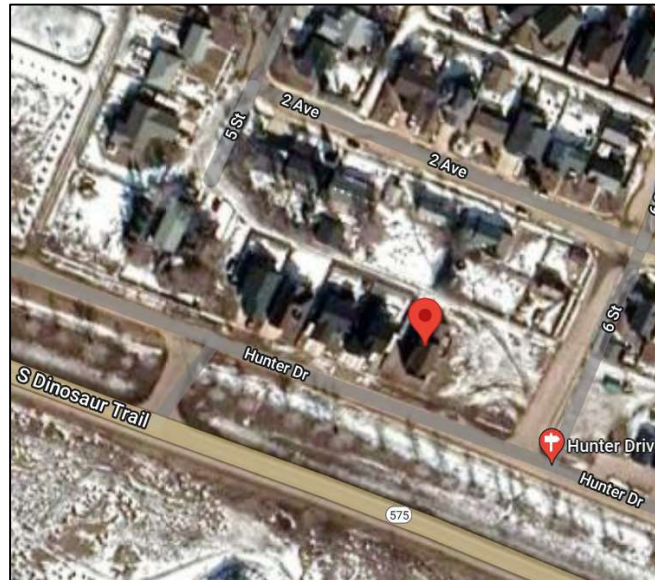
The Nacmine Hotel, address 572 Hunter Drive Drumheller is a two-story wood frame building with a partial concrete basement, constructed approximately 1949. The building was used as a hotel establishment and contains one bar with a dance floor area, a commercial kitchen, and multiple hotel rooms located upstairs. The floor area of both above grade floors is approximately 3,800 square feet. There is an approximately 340 square foot wooden deck on the east side of the building. The building is partially furnished.

Figure 3 – Nacmine Hotel

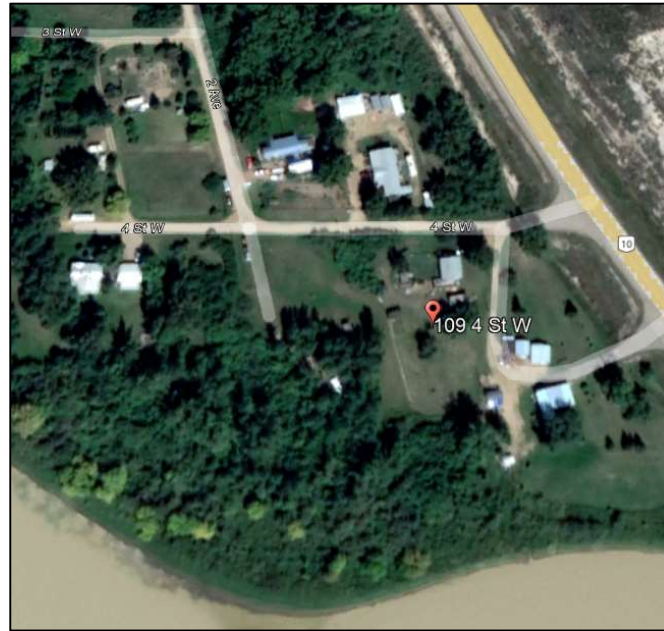
With regards to the residential properties, the first property is at 109 4 Street West Drumheller and was constructed in the 1950's. It is approximately a 1,200 square feet single-story building with a basement, detached garage, and two detached outbuildings. Refer to Appendix H for a copy of an inspection report completed for this property.

*Figure 4 – 109 4 Street West*

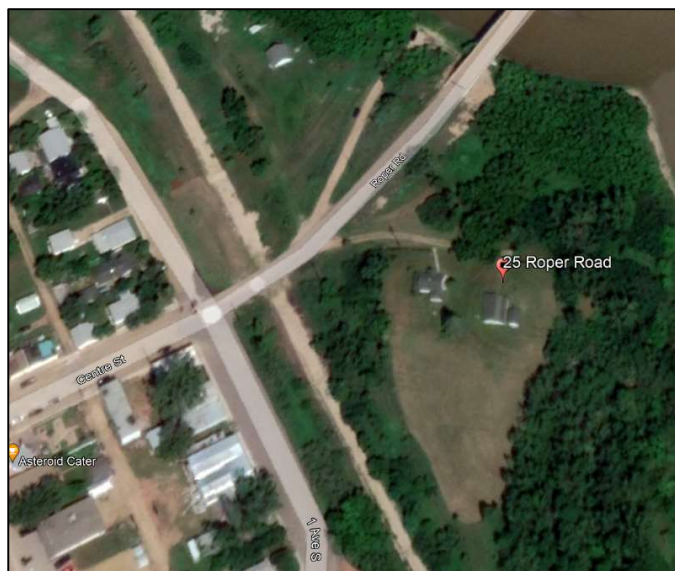
The second residential property is located at 25 Roper Road Drumheller and was also constructed in the 1950's. It is approximately a 1,200 square feet two-story building with a basement, detached garage, and shed. Refer to Appendix H for a copy of an inspection report completed for this property.

*Figure 5 – 25 Roper Road*

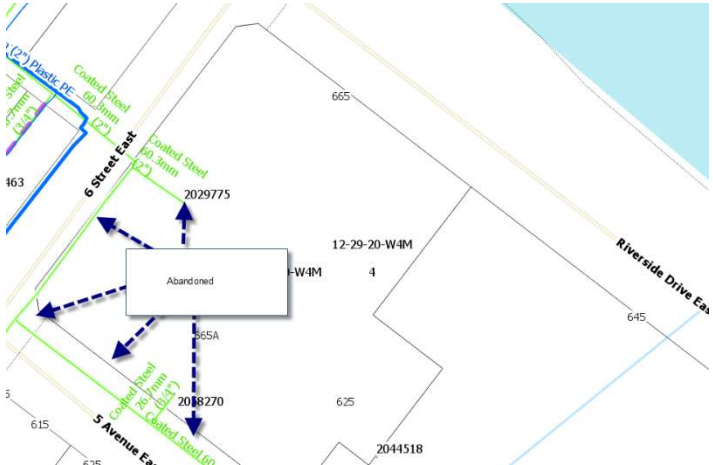
Utility Provider	Service	Comment
Health Centre		
Apex	Gas	<p>Apex confirmed that there are no active gas lines on site, only an abandoned gas line that can be removed.</p>

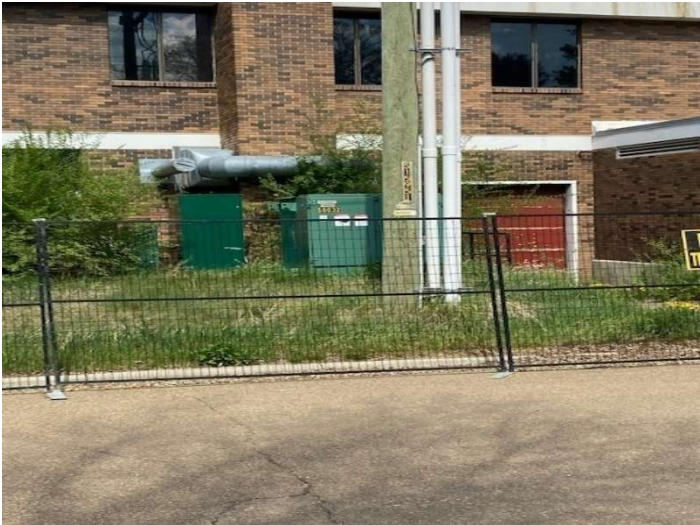
ATCO Electric	Electricity	<p>ATCO Electric confirmed that the building is de-energized/disconnected and that all wires and meters have been removed.</p> <p>The padmount transformer that is still on site is tentatively scheduled to be removed by June 30, 2022.</p>

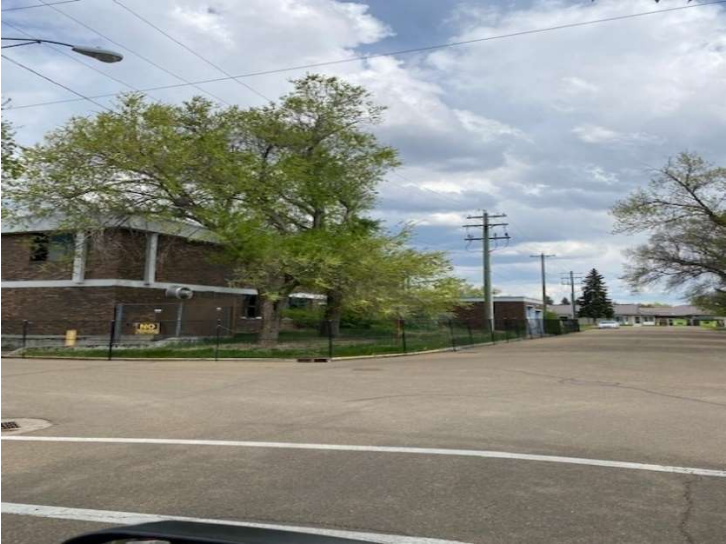
Utility Provider	Service	Comment
		<p>High voltage lines running along the south side of the building will need to be considered when planning for the demolition.</p>

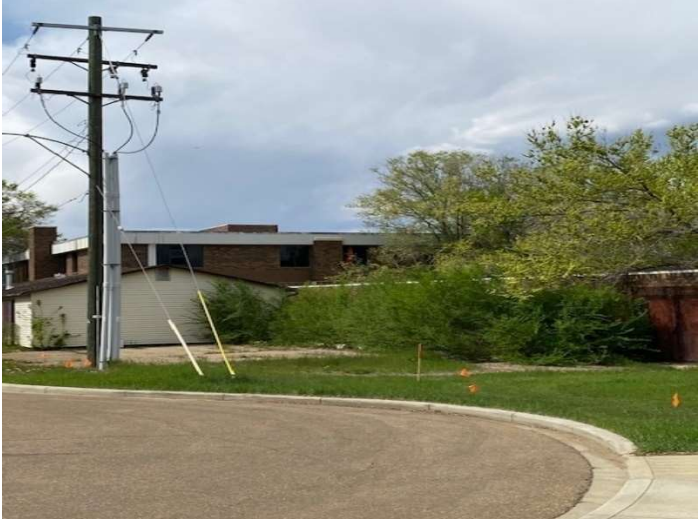
<p>There is an underground riser pole on the South corner of the old Health Centre. These are live cables going underground to the Sunshine Lodge.</p>

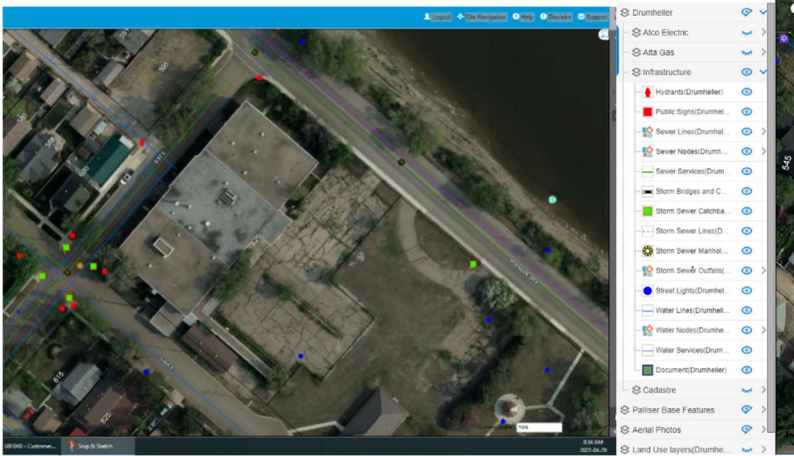
Utility Provider	Service	Comment
Town's Utility Department	Water & Sewer	<p>It was confirmed that the water CC valve is in the off position, and the Town will mark the valve location closer to the start of demolition. The waterline will need to be capped at the property line, whilst the sewer lines will need to be capped at the nearest manhole or property line, whichever is more cost-effective for the Town.</p>

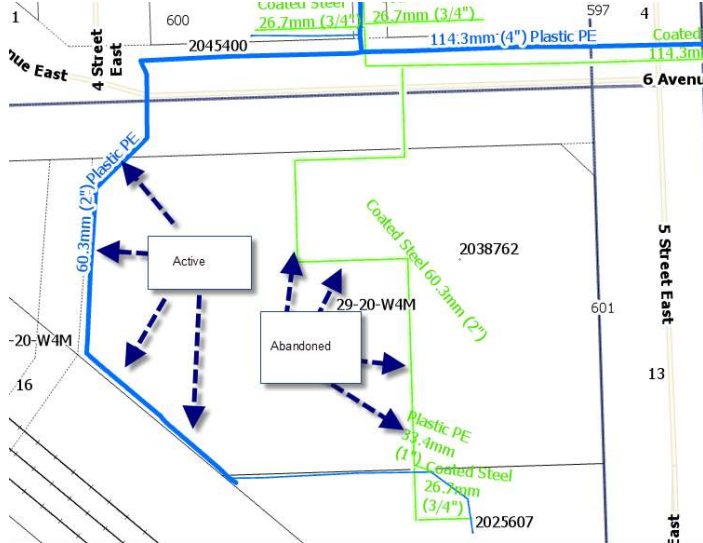
Apex	Gas	<p>Apex confirmed that there is a main gas line to the west side of the lot and an abandoned gas line running through the perimeter of the Consortium. The active line is not in conflict with the planned demolition as it is far away from the building, but special consideration should be made to avoid any potential damages to this active line. The abandoned gas line can be removed.</p>

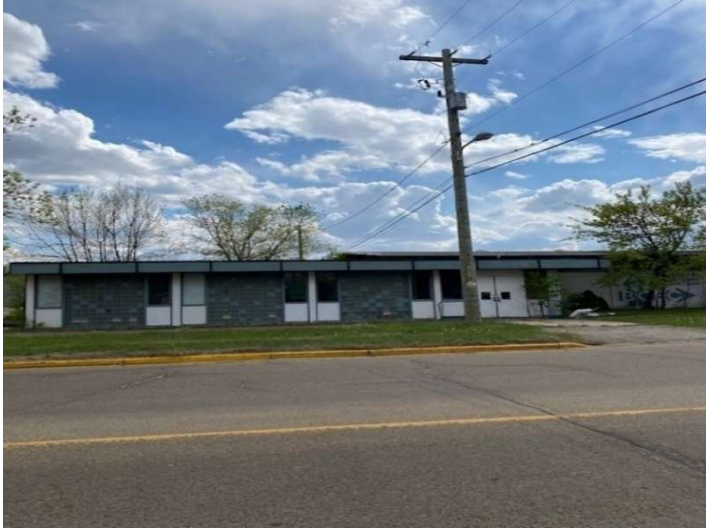
Utility Provider	Service	Comment
ATCO Electric	Electricity	<p>ATCO Electric confirmed that the building is de-energized/disconnected and that all wires and meters have been removed (meter was not recovered after the fire).</p> <p>Low voltage/ communication cables going directly over the building will need to be considered when planning for the demolition.</p>

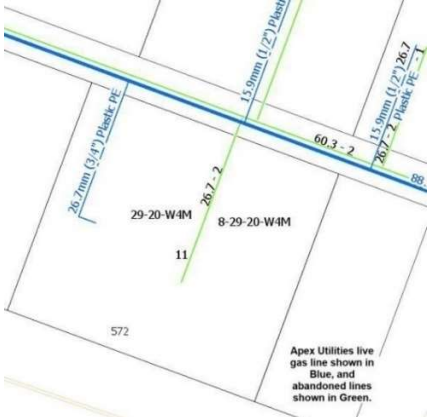
Utility Provider	Service	Comment
Nacmine Hotel		
Apex	Gas	<p>There was an active gas line running to the Nacmine Hotel, which was removed on May 24, 2022. Apex confirmed that the line was capped off at the main gas line and the riser at the building should be cut off at ground level. There will be an abandoned gas line left but at no risk for demolition.</p>

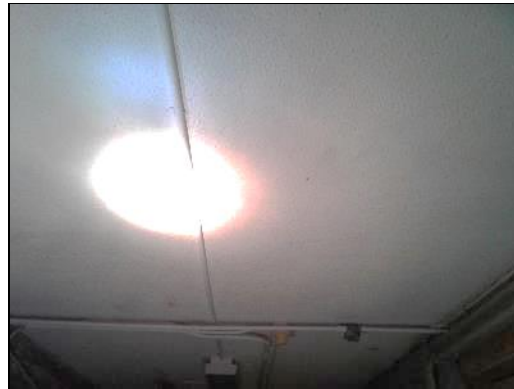
Texture finish, containing chrysotile asbestos, is present on the concrete deck in the ground floor Hallway (location 43, samples S0017A-C).

Asbestos-containing texture coat (sample S0017A) as a ceiling finish in the Hallway (location 43).

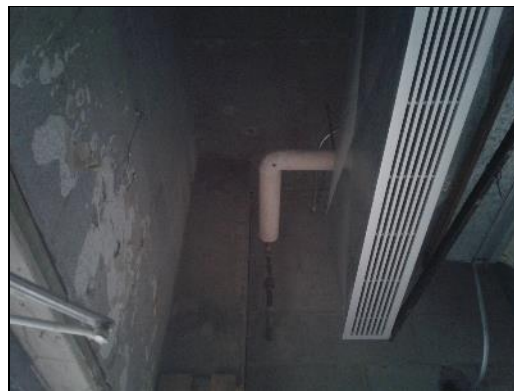
Parging cement, containing chrysotile asbestos, is present on pipe elbows jacketed with canvas (samples S0012A-C).

Asbestos-containing parging cement (sample S0012B) on pipe elbow in the Vestibule (location 17).

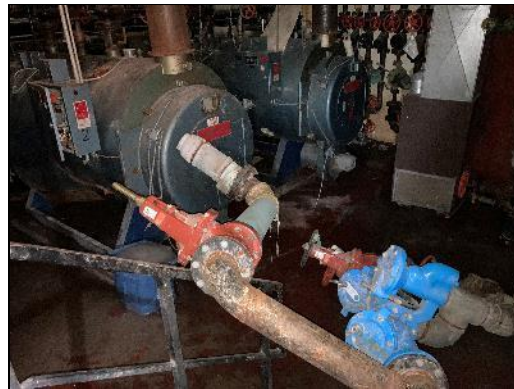
Mechanical equipment (boilers, generators) is either uninsulated or insulated with non-asbestos fibreglass.

Pipes were obstructing access to the boilers at the time of the assessment. Additional investigation for suspect materials should be conducted prior to demolition.

General view of mechanical equipment.

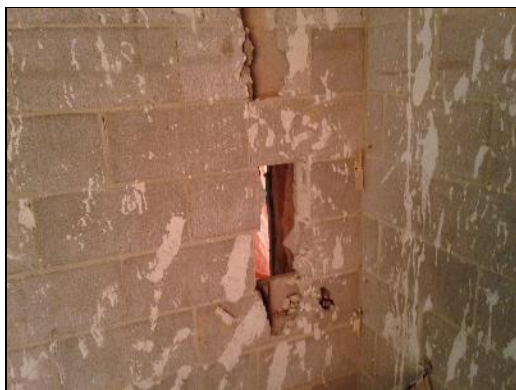
Destructive testing was conducted of a representative selection of masonry block walls, including creating penetrations at thirteen locations. The locations of destructive testing have been indicated on the drawings in Appendix I.

Intrusive inspection location in the Office (location 3).

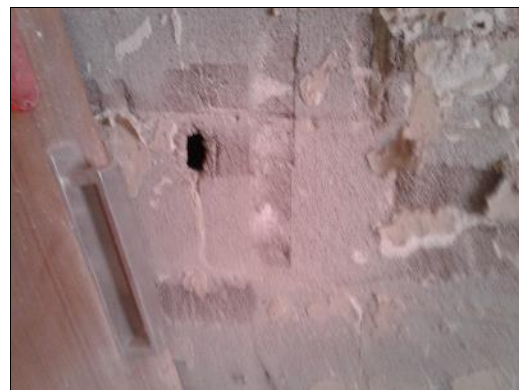
Intrusive inspection location in Room 43 (location 45).

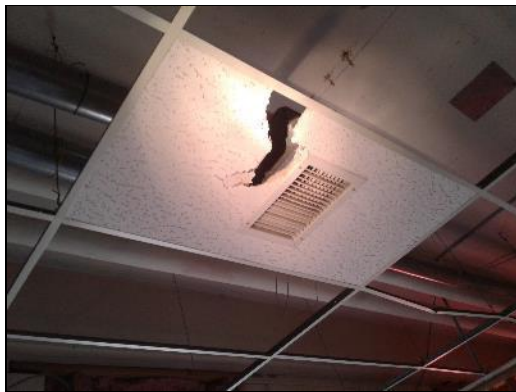
Non-asbestos 24"x48" large fissures and pinholes patterned acoustic ceiling tile (sample S0009A) in the Administration Area (location 2).

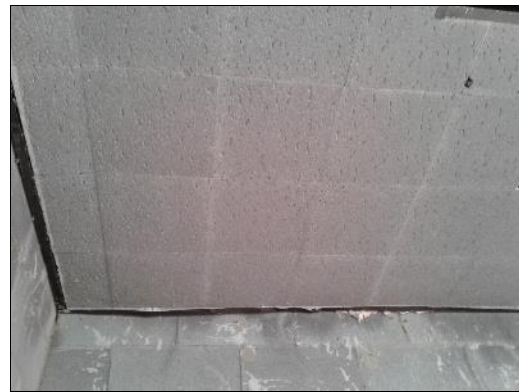
Non-asbestos 12"x12" fissures, mechanically fastened, acoustic ceiling tiles (sample S0028C) in the Conference Room (location 119).

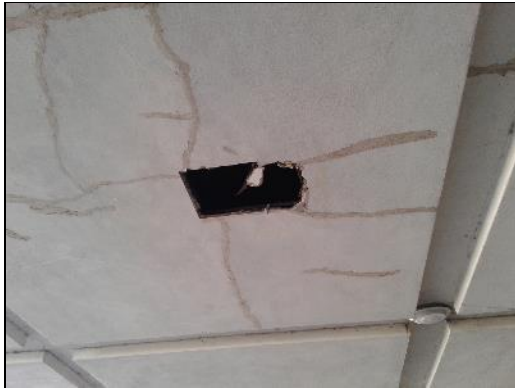
Non-asbestos plaster (sample S0004C) as a ceiling finish on the Exterior (location 1).

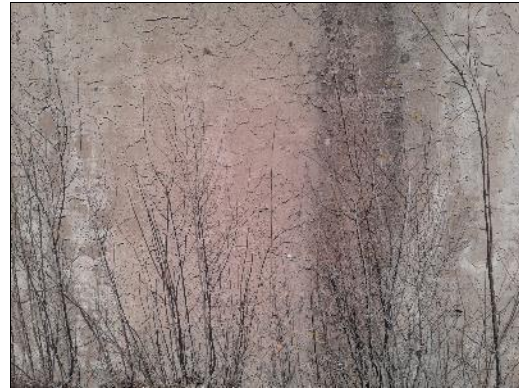
Non-asbestos stucco (sample S0005C) on the exterior (location 1).

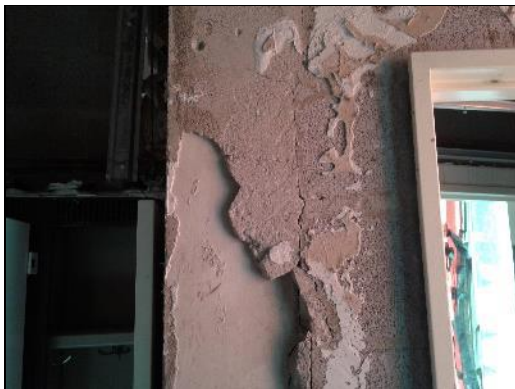
Non-asbestos plaster on the wall (sample S0014B) in Room 42 (location 47).

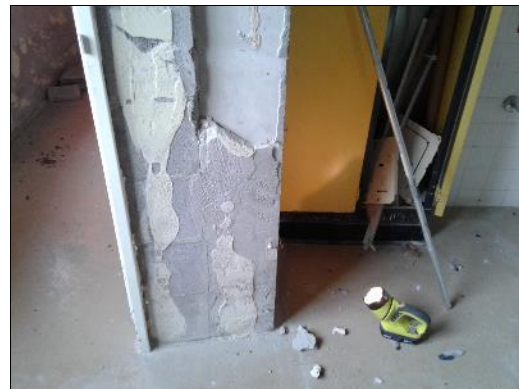
Non-asbestos plaster on the wall (sample S0014D) on the wall in Room 28 (location 72).

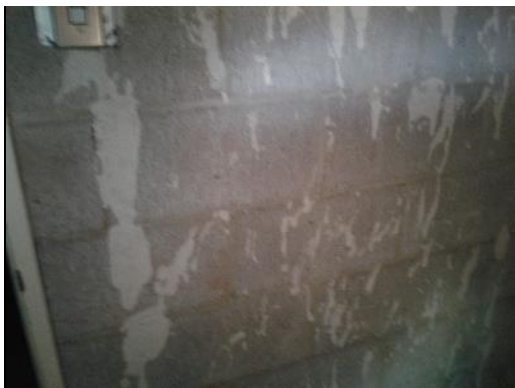
Drywall joint compound, containing chrysotile asbestos, is present on wall and ceiling finishes throughout the assessed area (samples S0010A-G, S0016A-C, and sample S0018A-E).

Asbestos-containing residual drywall joint compound pucks (sample S0010C) on the wall in Room 1013 (location 15).

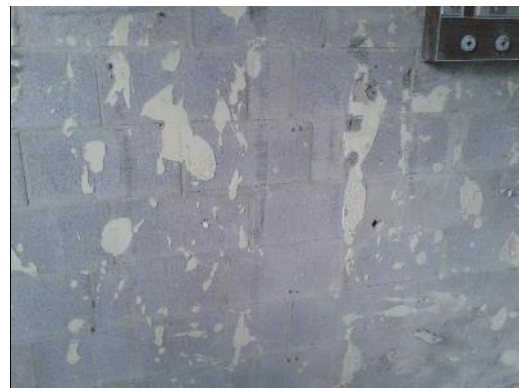
Asbestos-containing residual drywall joint compound pucks (sample S0018C) on the wall in Room 33 (location 60).

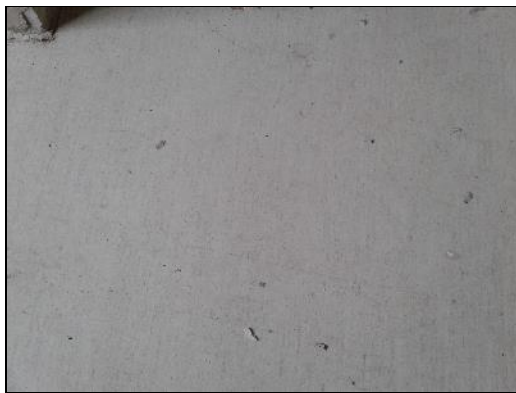
Non-asbestos grey streaks patterned vinyl sheet flooring (sample S0022) in Room 24 (location 79).

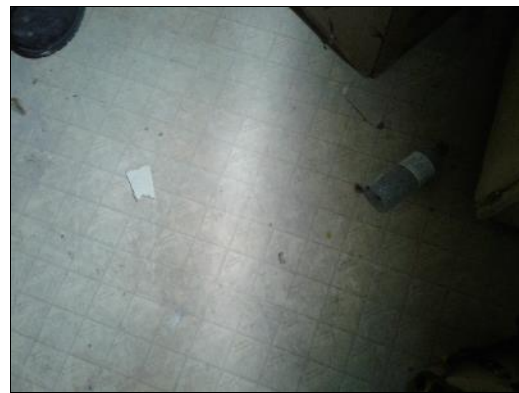
Non-asbestos cream squares patterned vinyl sheet flooring (sample S0027) in the Nurses Room (location 115).

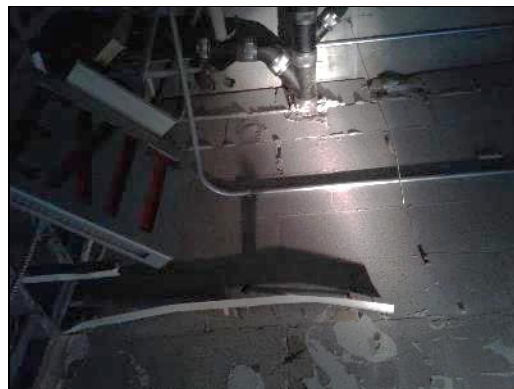
Firestopping (cementitious) present at pipe and conduit penetrations in the Hallway (location 22) does not contain asbestos (sample S0013).

Non-asbestos cementitious firestopping (sample S0013) in the Hallway (location 22).

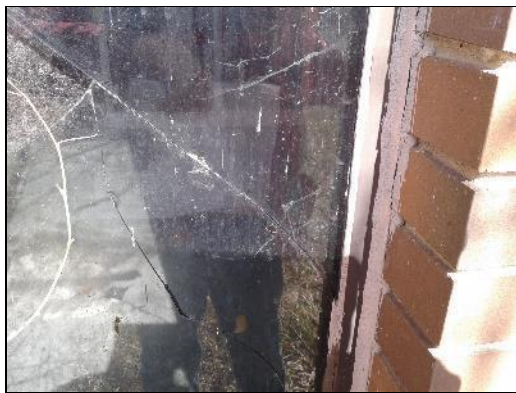
Non-asbestos grey caulking (sample S0003) on the window on the Exterior (location 1).

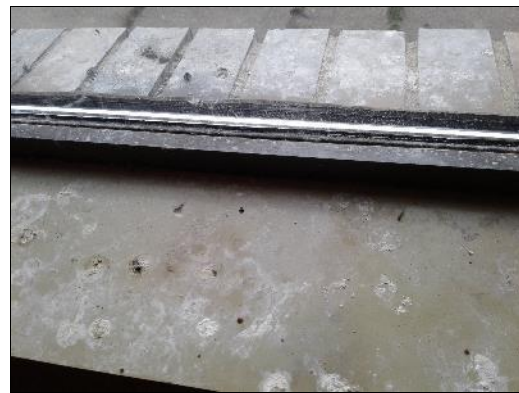
Asbestos-containing black caulking (sample S0021) on the window in Room 24 (location 47).

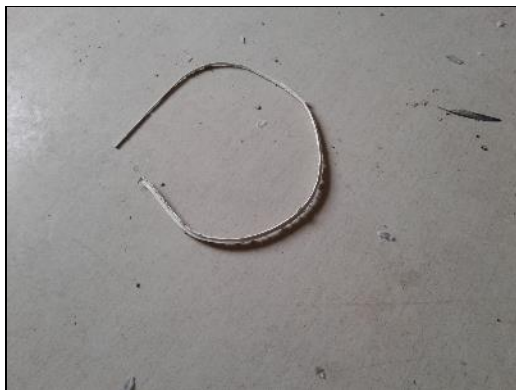
Non-asbestos white caulking debris (sample S0023) in Room 24 (location 79).

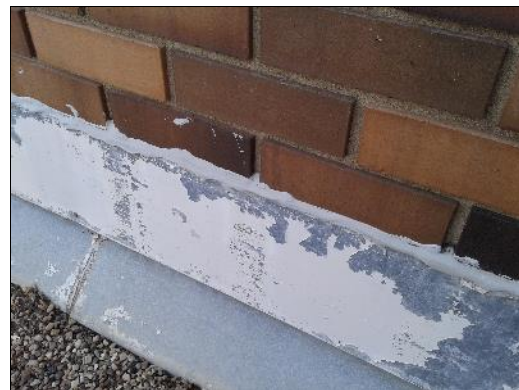
Non-asbestos grey caulking (sample S0030) on seams on the Roof (location 133).

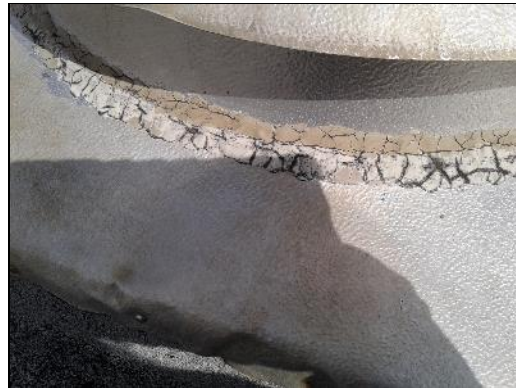
Non-asbestos white and black caulking (sample S0031) on piping on the Roof (location 133).

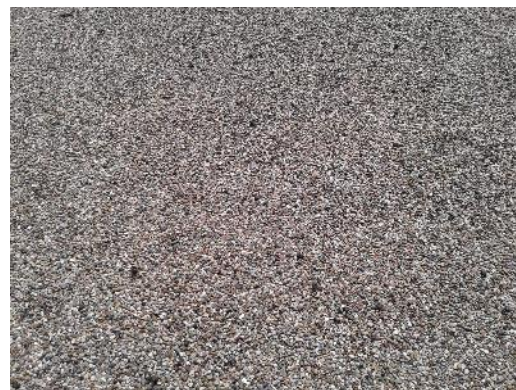
The materials associated with the built-up roofing do not contain asbestos (samples S0006A-C).

Non-asbestos built-up roofing (sample S0006A) on the Roof (location 133).

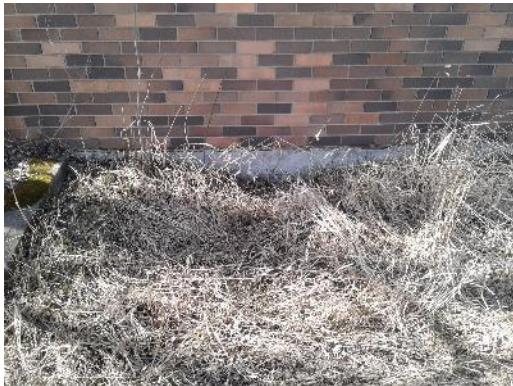
Non-asbestos brick mortar (sample S0001G) and non-asbestos paring cement over foundation (sample S0002G) on the Exterior (location 1).

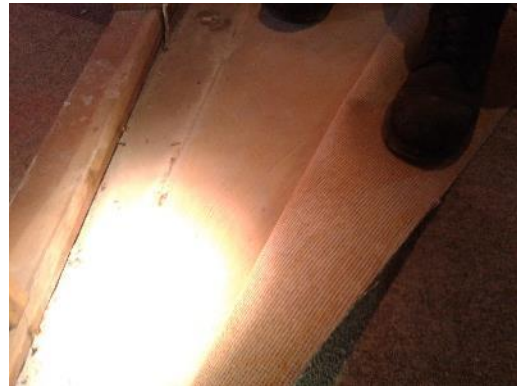
Asbestos-containing adhesive below carpet (sample S0007) in the Administration Area (location 2).

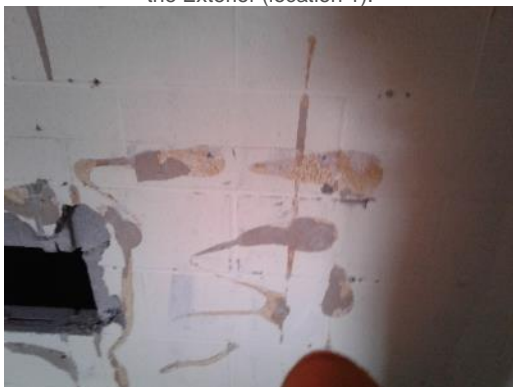
Non-asbestos adhesive (sample S0008) on the concrete block wall in the Administration Area (location 2).

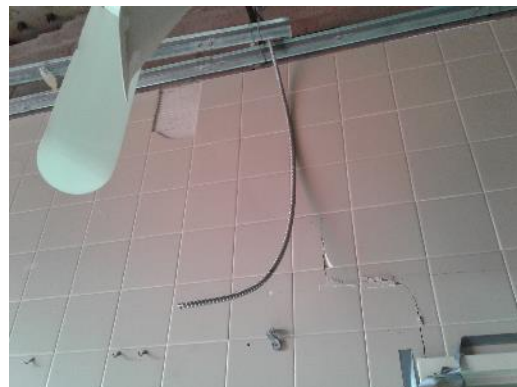
Non-asbestos thin-set (sample S0011D) on the wall in the Cafeteria (location 28).

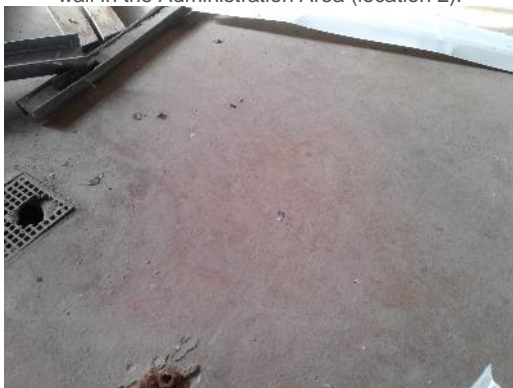
Non-asbestos non-slip flooring (sample S0015) in the Cafeteria (location 28).

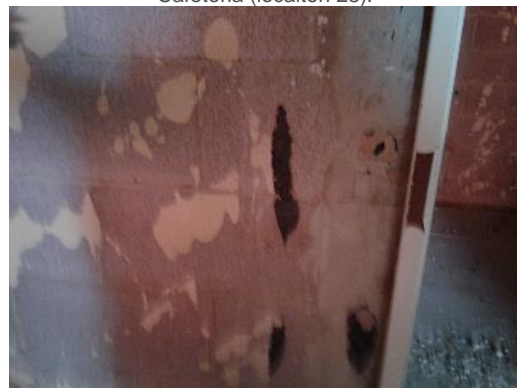
Non-asbestos black mastic (sample S0024) on the wall in Room 23 (location 81).

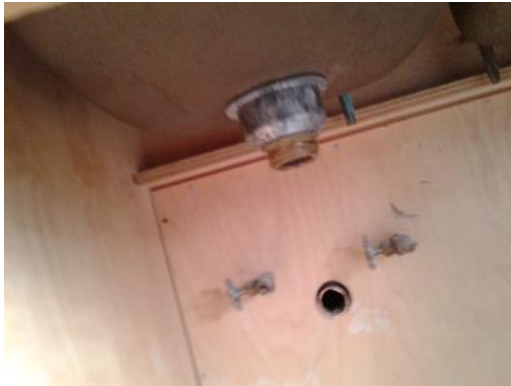
Asbestos-containing mastic below the sink (sample S0025) in the Nureses Room (location 84).

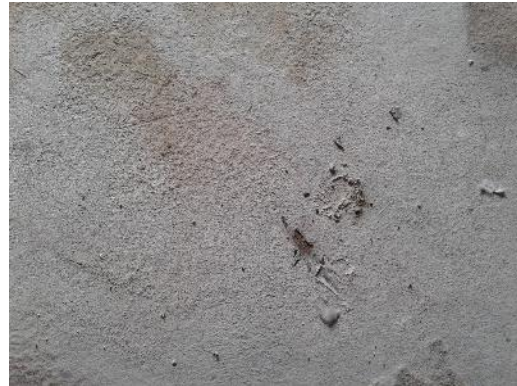
Non-asbestos unidentified cement product (sample S0026) on the floor in the Office (location 106).

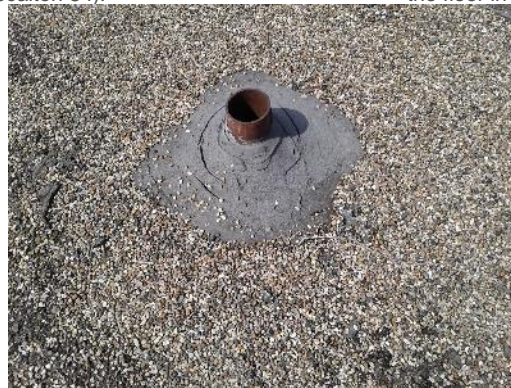
Non-asbestos black mastic (sample S0029) at a pipe penetration on the Roof (location 133).

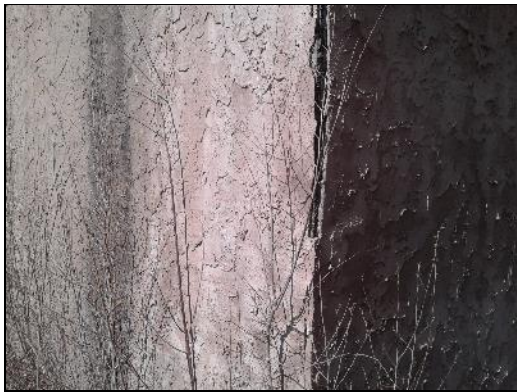
Non-lead based pink paint (sample L0001) on the stucco Exterior (location 1).

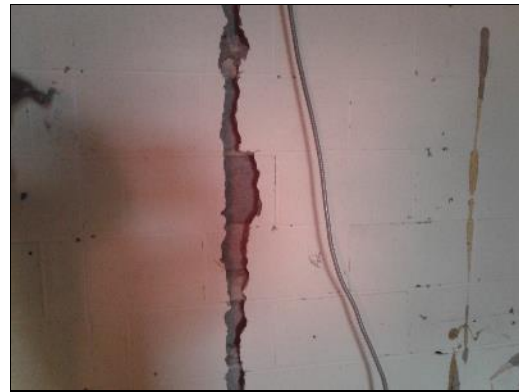
Non-lead based white paint (sample L0002) on the masonry block wall in the Administration Area (location 2).

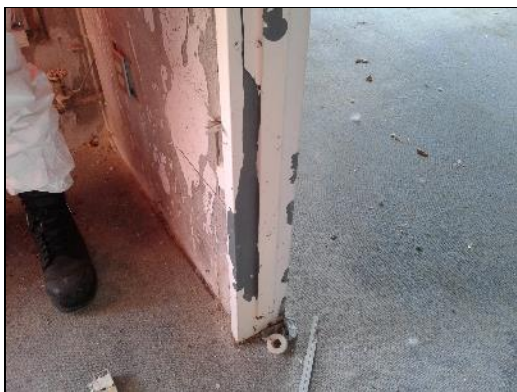
Lead-based white paint (sample L0003) on the metal door frame in the Office (location 3).

Sample Number	Colour, Substrate Description	Sample Location	Lead (%)
L0003	White paint on metal door frames	Boiler Room (Loc. 23)	0.068
L0004	Blue paint on metal door frames	Shower Room (location 16)	0.084
L0005	White paint on metal door frames	Vestibule (location 17)	2.2
L0006	Grey paint on concrete floor	Generator Room (location 25)	0.34
L0007	Red paint on concrete floor	Mechanical Room (location 27)	0.011
L0008	Green paint on masonry block wall	Laundry Area (location 36)	0.024
L0009	Orange paint on masonry block wall	Laundry Area (location 36)	2.6
L0010	White paint on metal roof trim	Room (location 133)	0.41

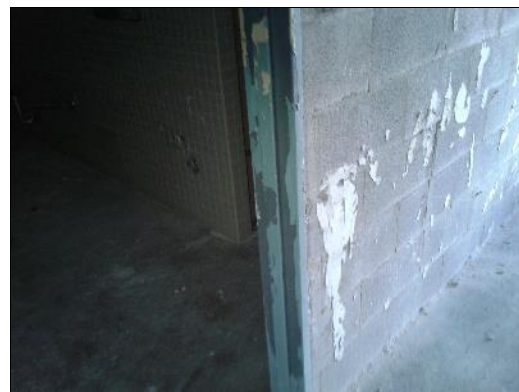
Lead-based blue paint (sample L0004) on the metal door frame in the Shower Room (location 16).

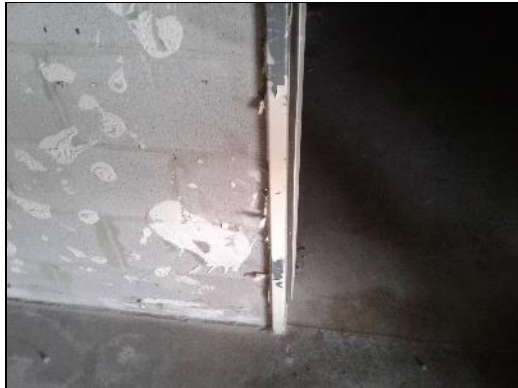
Lead-based white paint (sample L0005) on the metal door frame in the Vestibule (location 17).

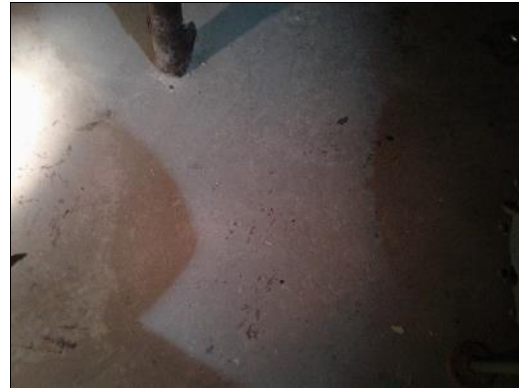
Lead-based grey paint (sample L0006) on the concrete floor in the Generator Room (location 25).

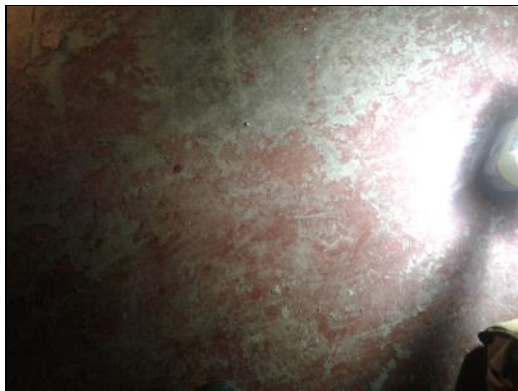
Lead-based red paint (sample L0007) on the concrete floor in the Mechanical Room (location 27).

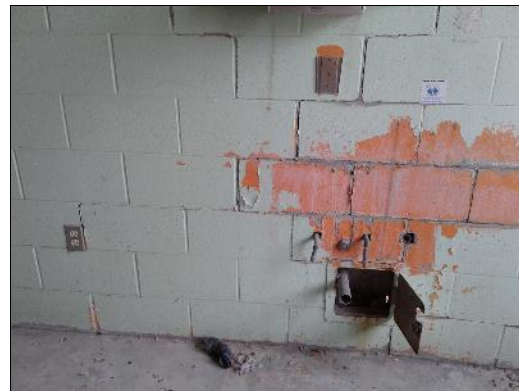
Lead-based green paint (sample L0008) and lead-based orange paint (sample L0009) on the masonry block wall in the Laundry Area (location 36).

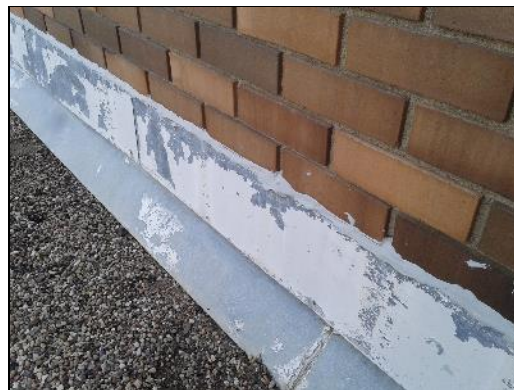
Lead-based white paint (sample L0010) on the metal trim on the Roof (location 133).

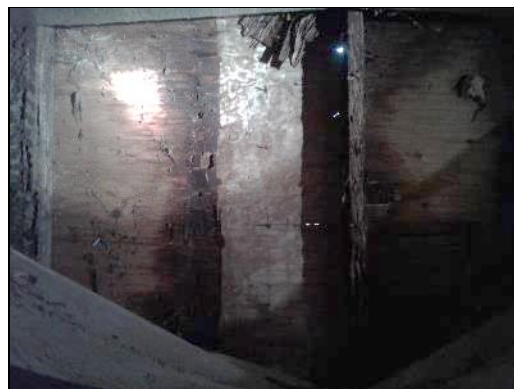
Mould growth on the wood wall in the Telephone Room (location 44).

Visible mould growth and water staining is present on the wood wall in the Telephone Room (location 44). There is approximately 500 square feet of visible mould growth.

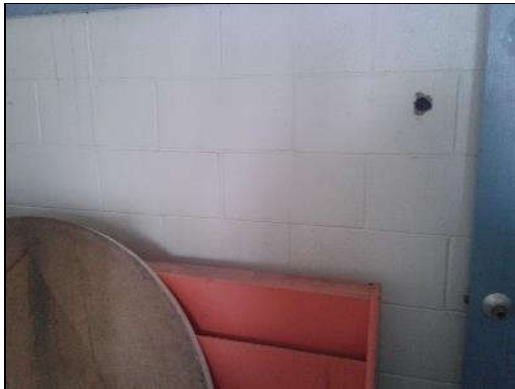
Intrusive inspection location in the Kitchen (location 5).

Destructive testing was conducted of a representative selection of masonry block walls, including creating penetrations at three locations. The locations of destructive testing have been indicated on the drawings in Appendix I.

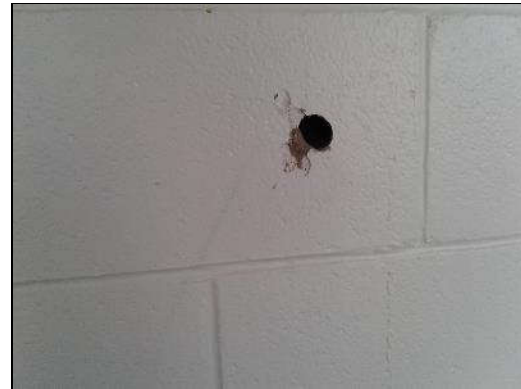
Intrusive inspection location in the Hallway (location 6).

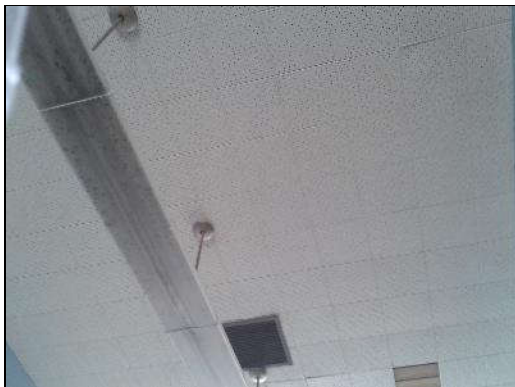
Non-asbestos 24"x24" mechanically fastened acoustic ceiling tiles (sample S0004A) in the Daycare (location 2).

Size, Type, Pattern	Sample Locations	Sample Number or Date Code	Asbestos Type
24"x24" mechanically fastened	Daycare (location 2), Classroom (location 3), and Storage Room (location 4)	S0004A-C	None Detected

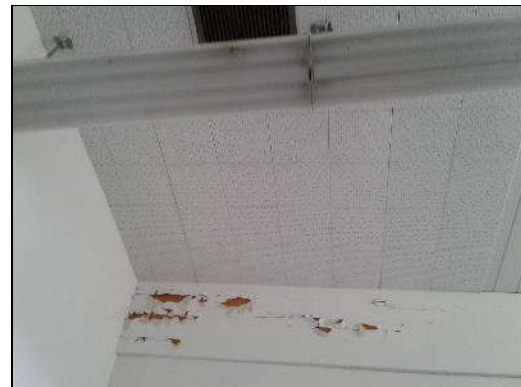
Non-asbestos 24"x24" mechanically fastened acoustic ceiling tiles (sample S0004B) in the Classroom (location 3).

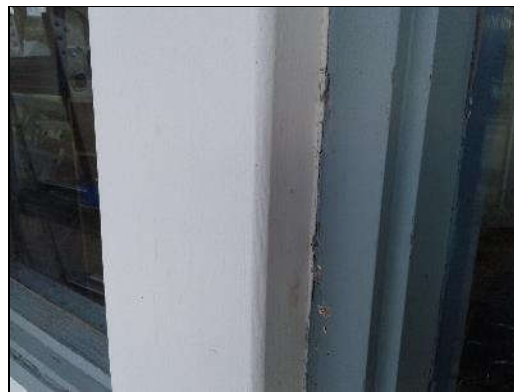
Non-asbestos grey caulking, covered in paint (sample S0001) on the window on the Exterior (location 1).

Grey caulking, covered in paint, at exterior window frames does not contain asbestos (sample S0001).

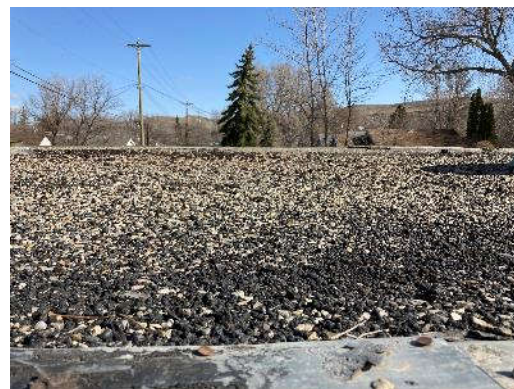
Asbestos-containing tar (sample S0007A) on the Roof (location 9).

Tar, containing chrysotile asbestos, is present in roof over the entire building (samples S0007A-C).

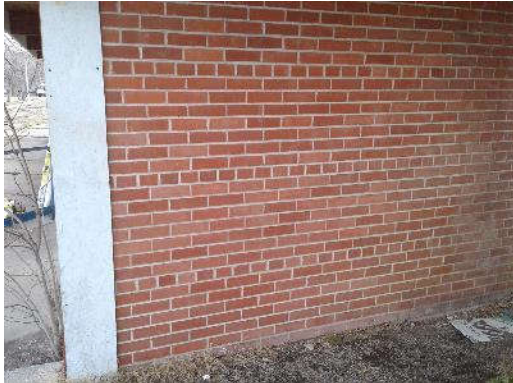
Non-asbestos brick mortar (sample S0002C) on the Exterior (location 1).

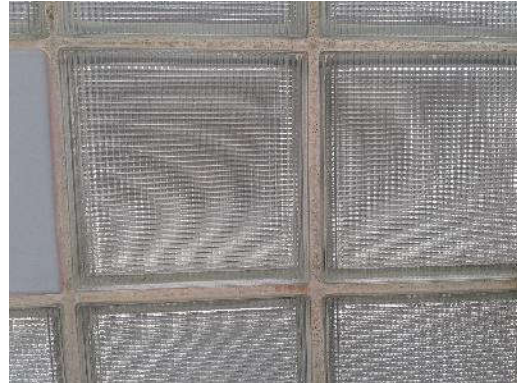
Non-asbestos mortar around glass blocks (sample S0003A) on the Exterior (location 1).

Mortar around glass blocks on the Exterior (location 1) does not contain asbestos (sample S0003A-C).

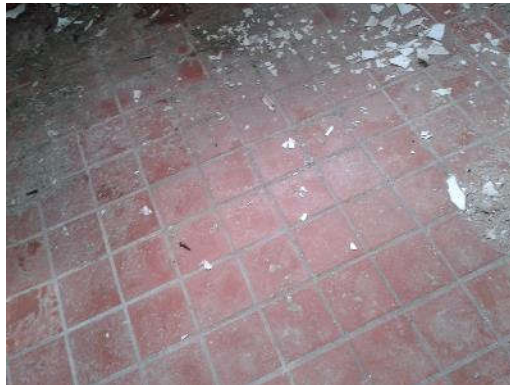
Ceramic tiles over non-asbestos thin set (sample S0006A) in the Men's Washroom (location 7).

Thin set below ceramic tiles in the Men's Washroom (location 7) and Women's Washroom (location 8) does not contain asbestos (samples S0006A-C).

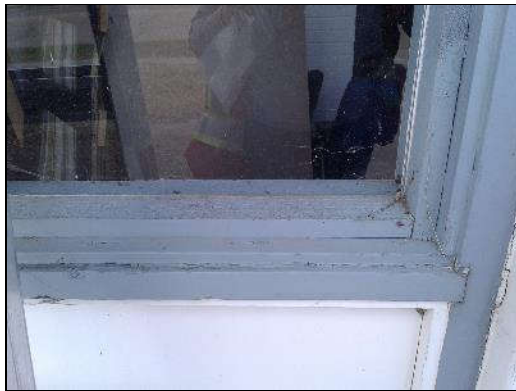
Lead-based white paint (sample L0001) on the wood wall and lead-based blue paint (sample L0002) on the wood window frame on the Exterior (location 1).

Sample Number	Colour, Substrate Description	Sample Location	Lead (%)
L0001	White paint on wood wall	Exterior (location 1)	1.3
L0002	Blue paint on wood window frame	Exterior (location 1)	0.36
L0004	White paint on wood wall	Daycare (location 2)	0.011
L0005	White paint on brick wall	Daycare (location 2)	0.021
L0006	White paint on drywall wall	Daycare (location 2)	0.011
L0007	Blue paint on wood structure	Daycare (location 2)	0.19
L0008	Blue paint on wood door	Hallway (location 6)	0.16
L0009	White paint on wood ceiling	Hallway (location 6)	0.13

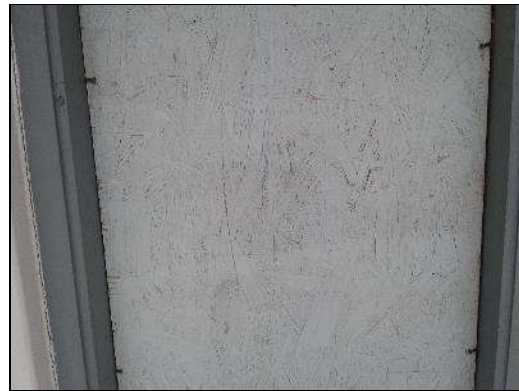
Non-lead based light blue paint (sample L0003) on the wood wall on the Exterior (location 1).

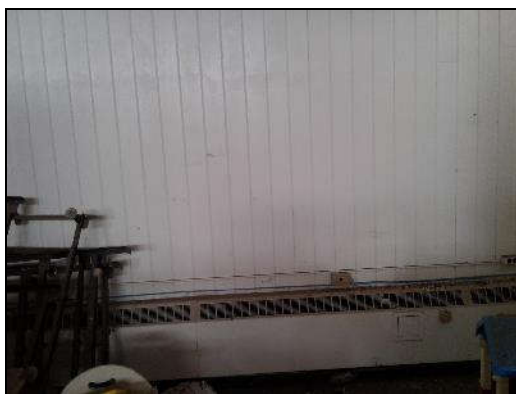
Lead-based white paint on the wood wall (sample L0004) in the Daycare (location 2).

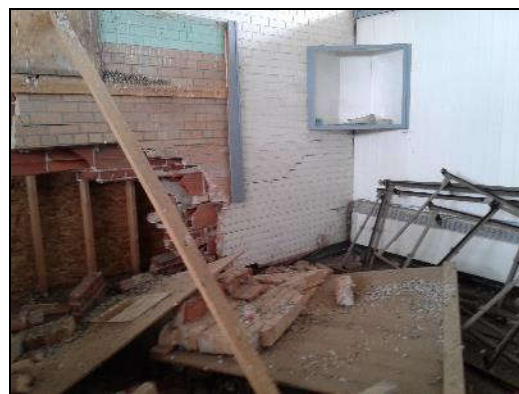
Lead-based white paint (sample L0005) and presumed lead-based light green paint on the brick wall in the Daycare (location 2).

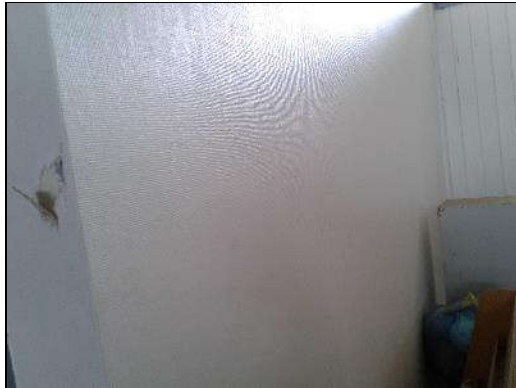
Lead-based white paint on drywall wall (sample L0006) in the Daycare (location 2).

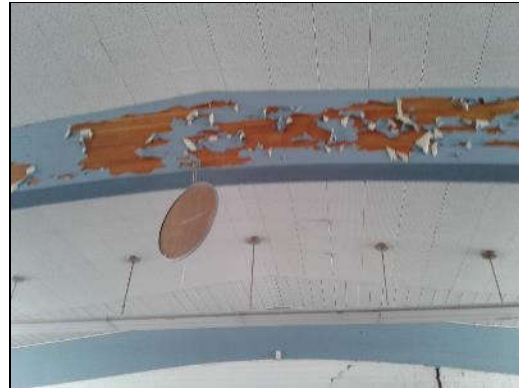
Lead-based blue paint (sample L0007) on wooden structural components in the Daycare (location 2).

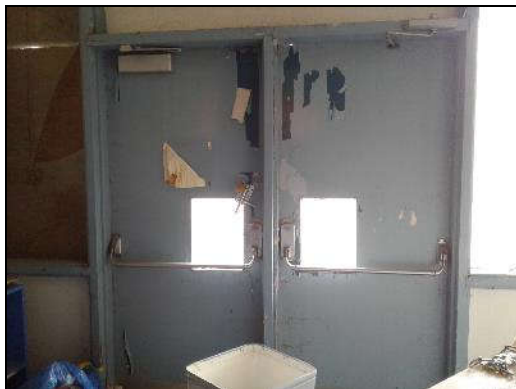
Lead-based blue paint (sample L0008) on the wood door in the Hallway (location 6).

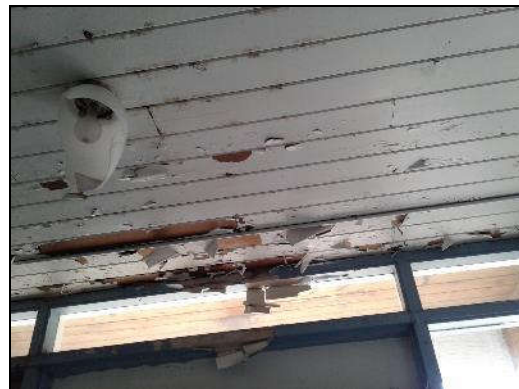
Lead-based white paint (sample L0009) on the wood ceiling in the Hallway (location 6).

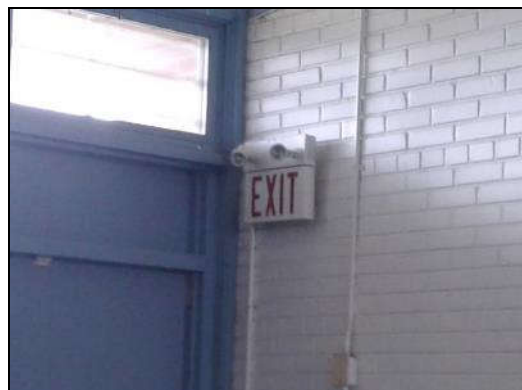
Lead-acid battery in the Daycare (location 2).

Lead-containing batteries are present in emergency lighting.

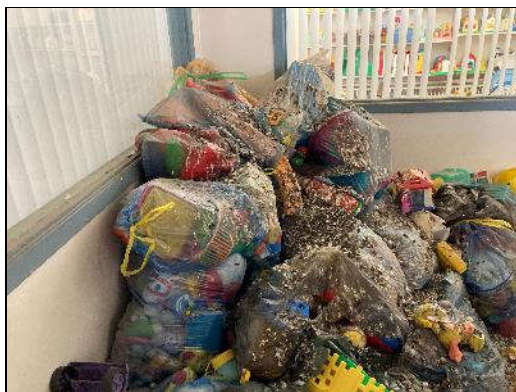
View of accumulated bird droppings in the Classroom (location 3).

Bird droppings were observed to be present throughout the building.

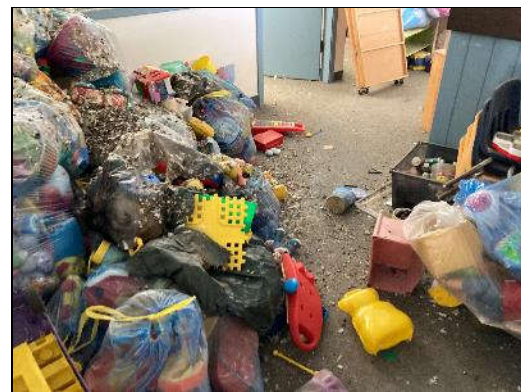
View of accumulated bird droppings in the Classroom (location 3).
