# Demolition and Remediation Services

<p style="text-align: center;"><b>Institutional &amp; Residential Demolitions Project for The Town of Drumheller</b></p>
--

## **Hazardous Building Materials Assessment (Pre-construction)**

Abandoned Health Centre  
625 Riverside Drive East,  
Drumheller, Alberta

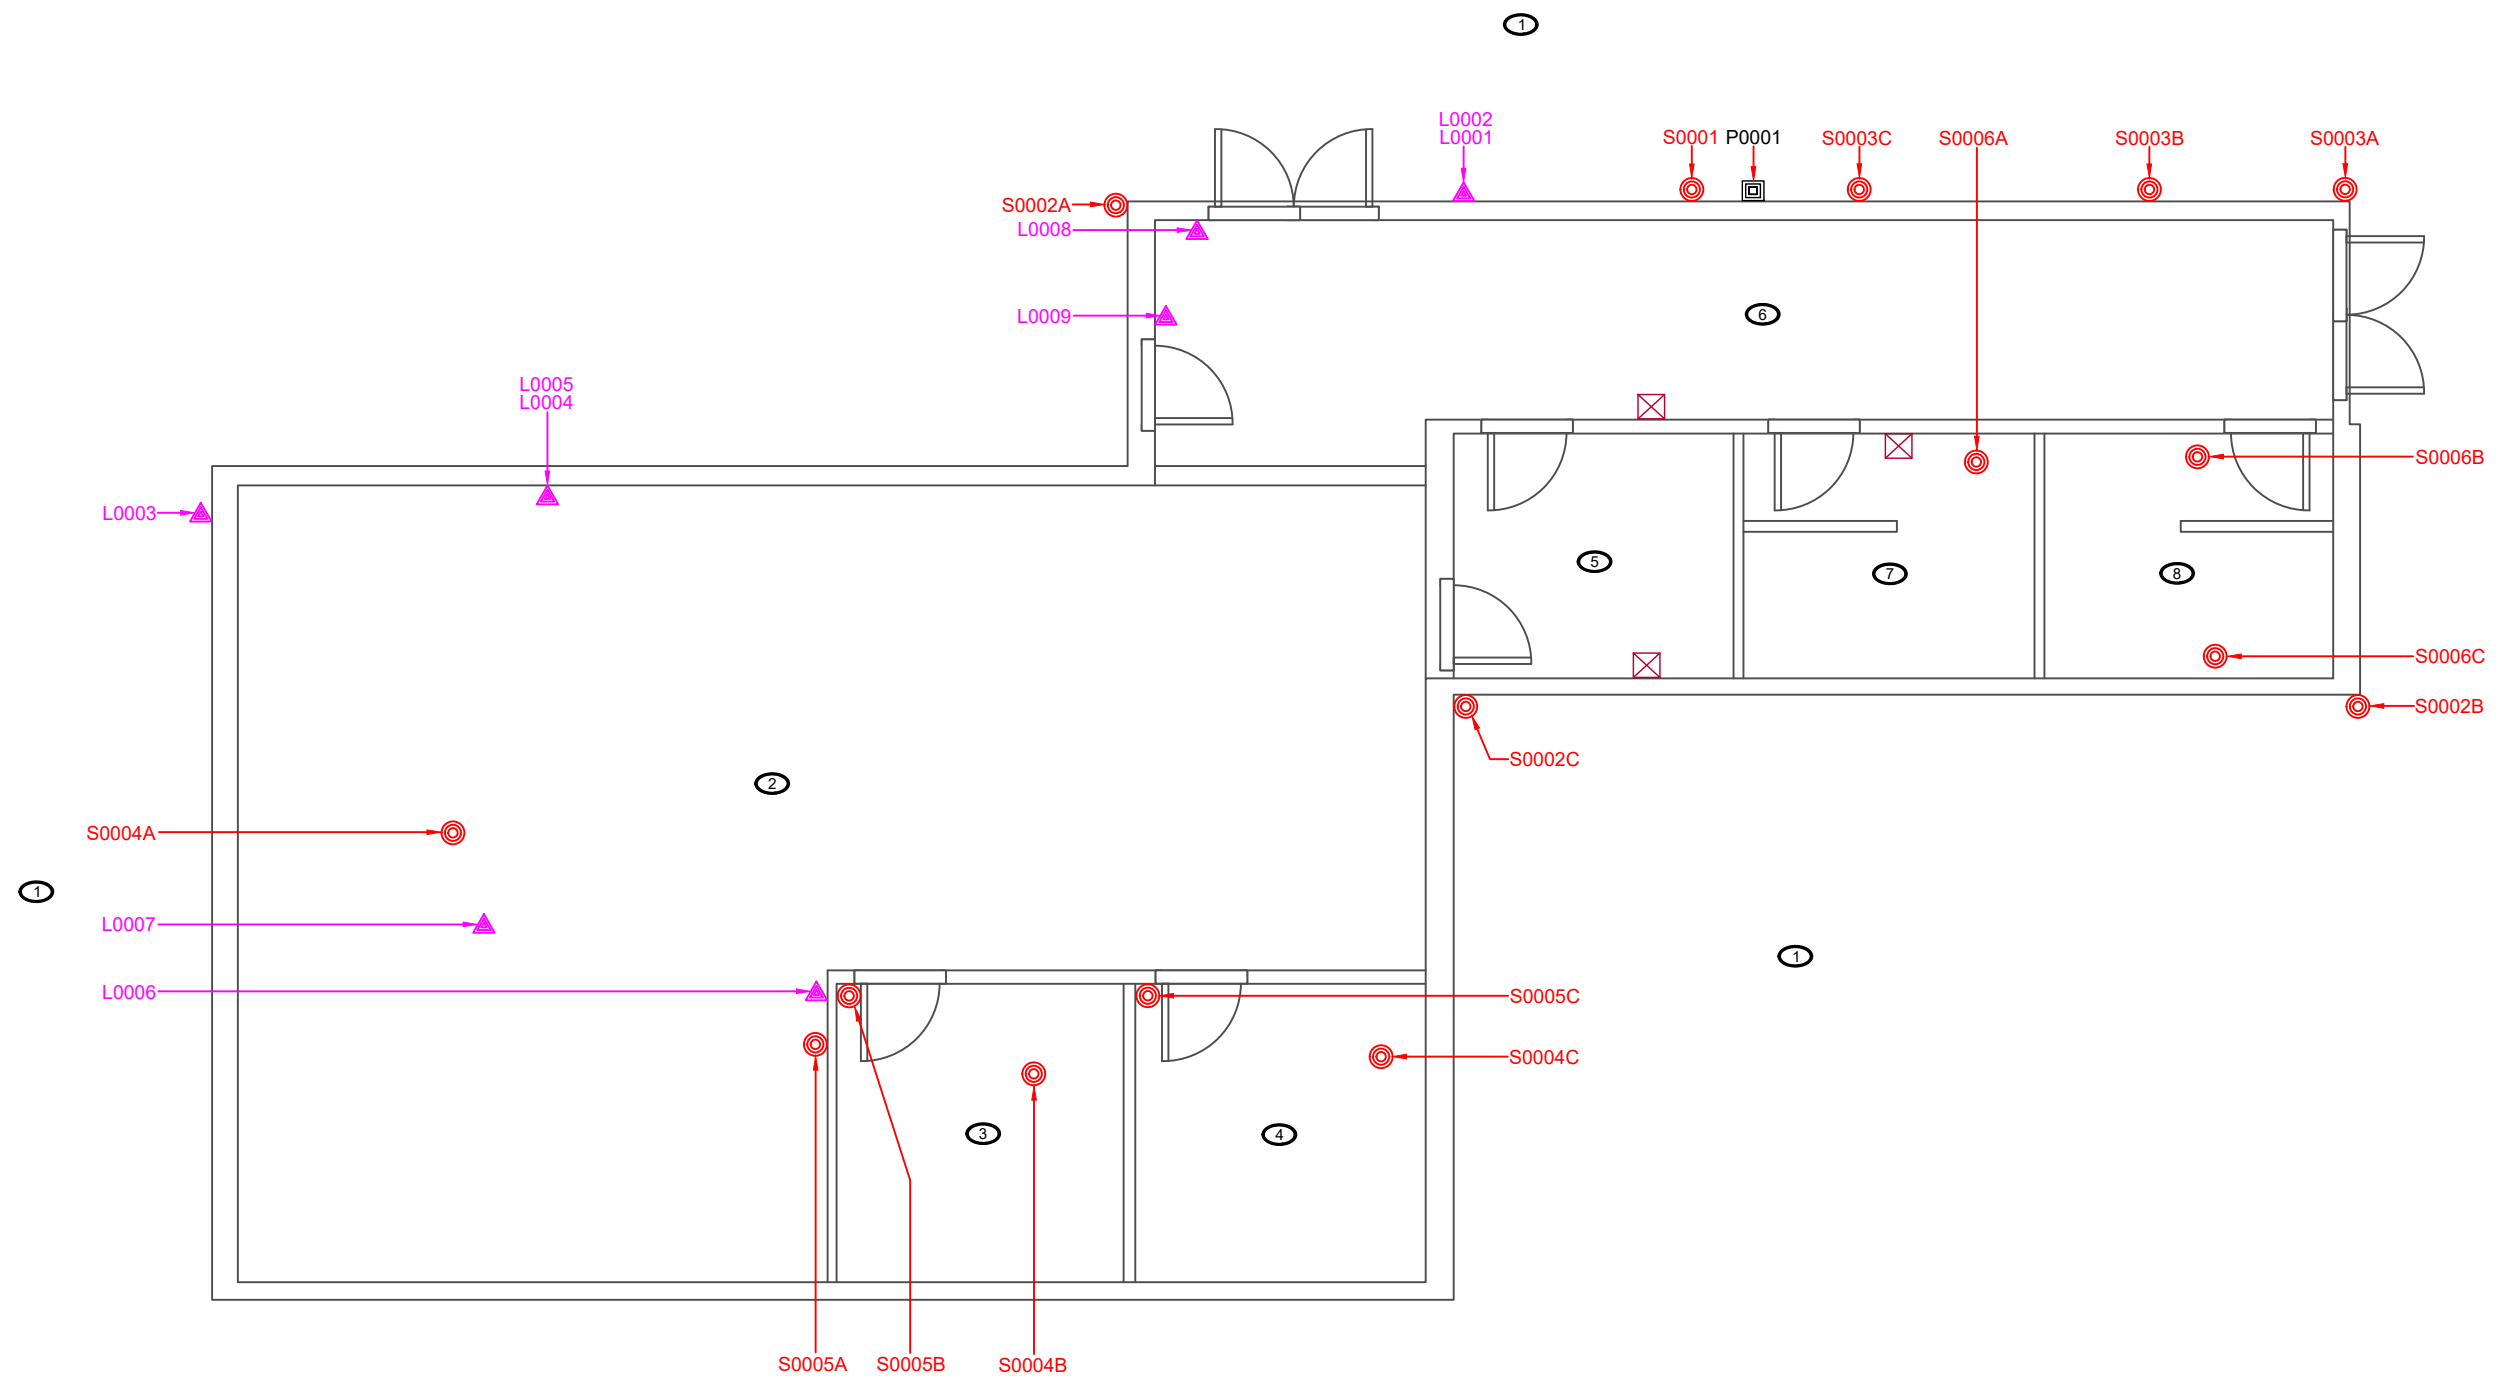
FIGURE NAME:  
**GROUND FLOOR**

PROJECT NUMBER: 309337.000	SCALE: NOT TO SCALE
DRAWN BY: BPC	REVIEWED BY: SR
DATE: MAY 12/22	FIGURE NUMBER: 1 OF 2

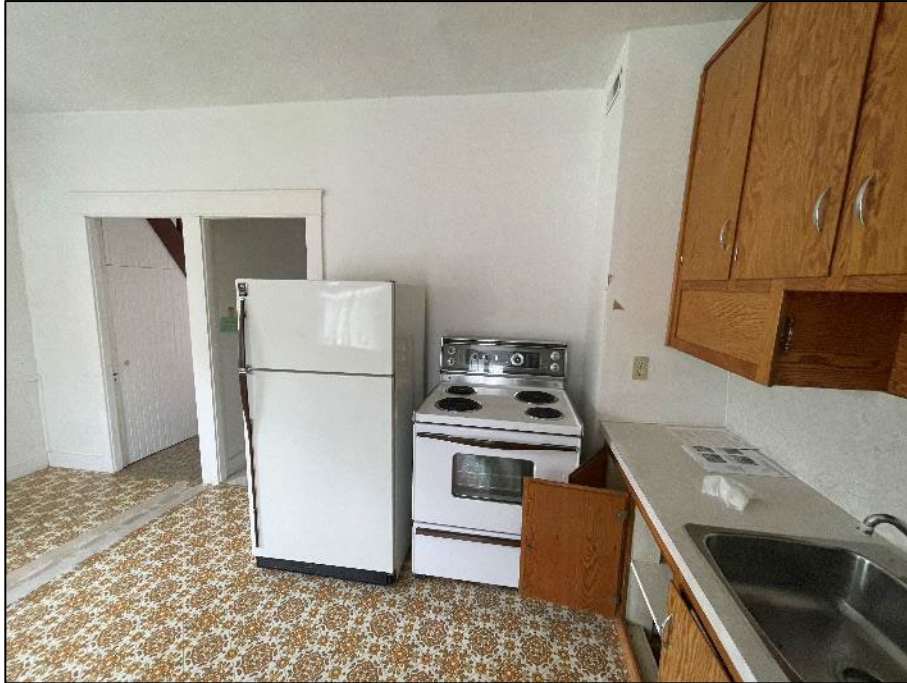
**PHOTOGRAPH #1:** Drywall Joint Compound - Floor 1 Int Kitchen (Non-Asbestos)

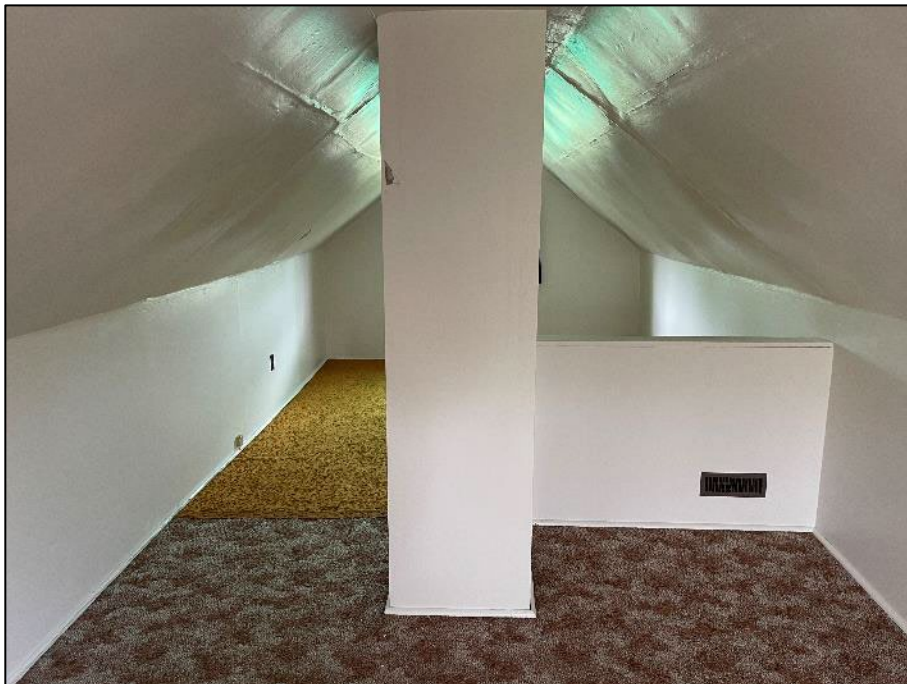
**PHOTOGRAPH #2:** Drywall Joint Compound – Floor 2 Int Chimney (Non-Asbestos)

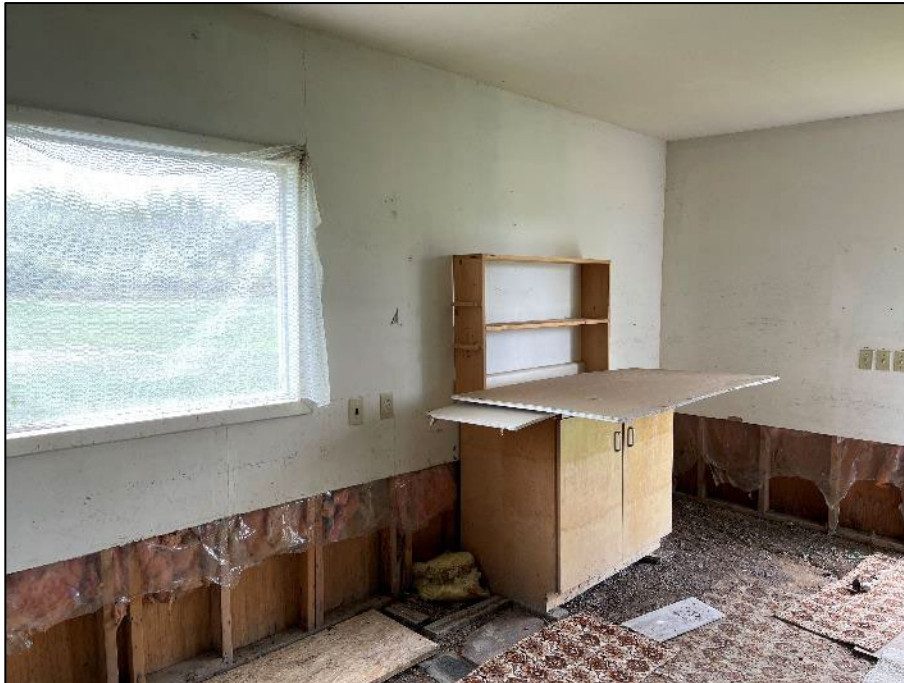
**PHOTOGRAPH #3:** Drywall Joint Compound – Ext Garage (Non-Asbestos)

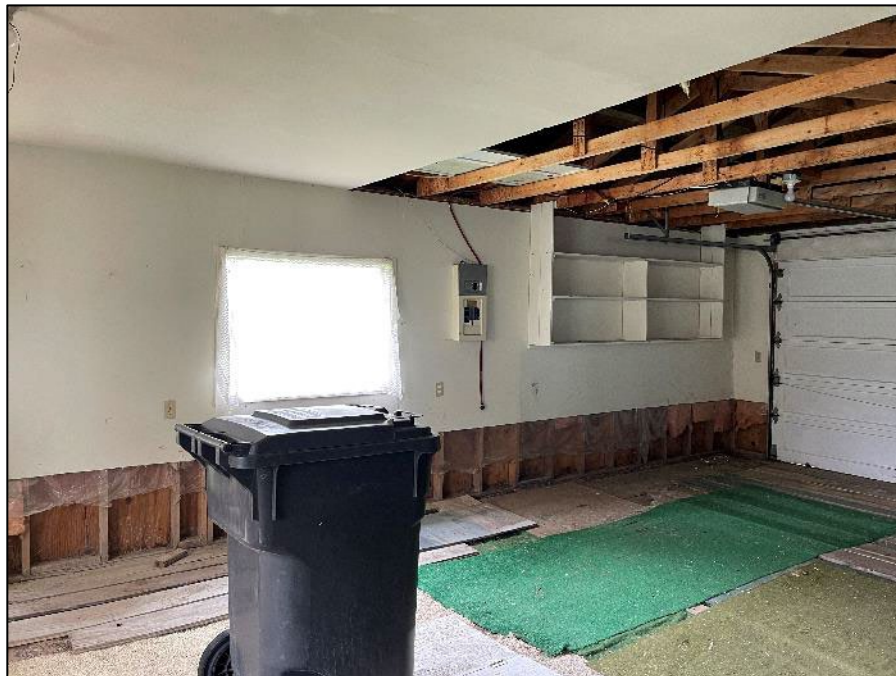
**PHOTOGRAPH #4:** Drywall Joint Compound – Ext Garage (Non-Asbestos)

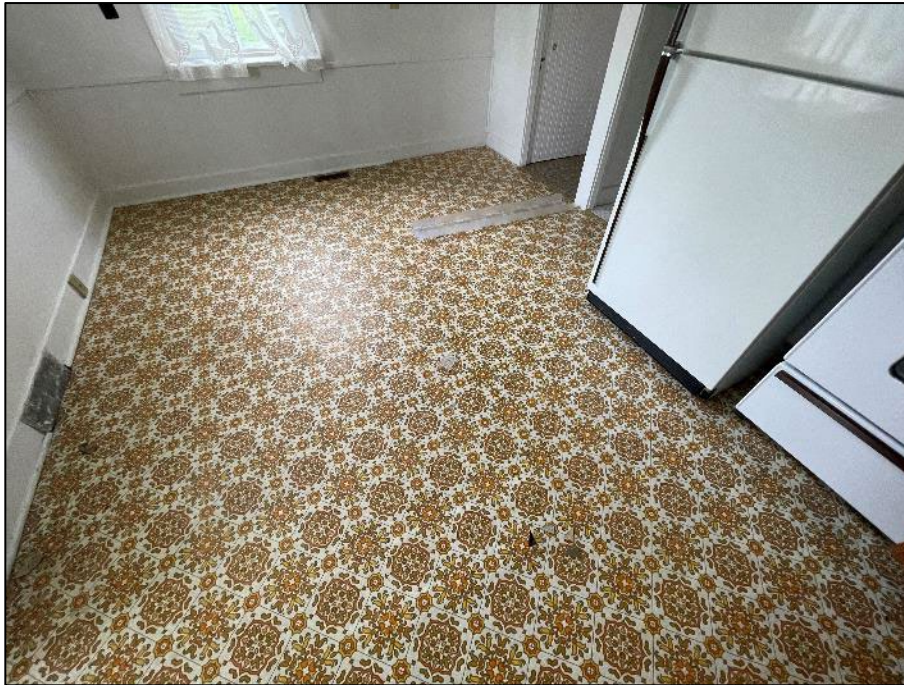
**PHOTOGRAPH #5:** Sheet Flooring (Brown) 3 Layers - Floor 1 Kitchen (20% Chrysotile)

1. The following materials were identified as asbestos-containing and will require abatement prior to demolition of the structure:
  - a. Sheet Flooring – Level 1 Kitchen (*See Photograph #5*).
  - b. Sheet Flooring – Under Kitchen Cabinets (*See Photograph #6*).
  - c. Duct Wrap – Level 1 Living Room (*See Photograph #11*).
  - d. Vermiculite – Attic and Exterior Walls (*See Photographs #13, 14 and 21*).

#	DESCRIPTION / LOCATION	ASB TYPE	ASB%	CONDITION	PHOTO
5	Sheet Flooring (Brown) Floor 1 Kitchen – 3 Layers	Chrysotile	20%	Poor	5
6	Flooring (Beige/White) Floor 1 Under Cabinets	Chrysotile	25%	Fair	6
11	Duct Wrap Floor 1 Living Room	Chrysotile	80%	Fair	11
13	Vermiculite West Wall	Actinolite	<1%	Fair	13
14	Vermiculite East Wall	Actinolite	<1%	Fair	14
-	Vermiculite Attic	<i>Assume Positive</i>		Fair	21

1. Sheet flooring in the level 1 kitchen consisting of 3 layers, and beneath the kitchen cabinets, was identified as asbestos-containing (See *Photographs #5 and 6*). Removal of the material must be performed prior to demolition by a qualified abatement contractor using appropriate asbestos abatement procedures found in Section 5 of the AAAM (2019).

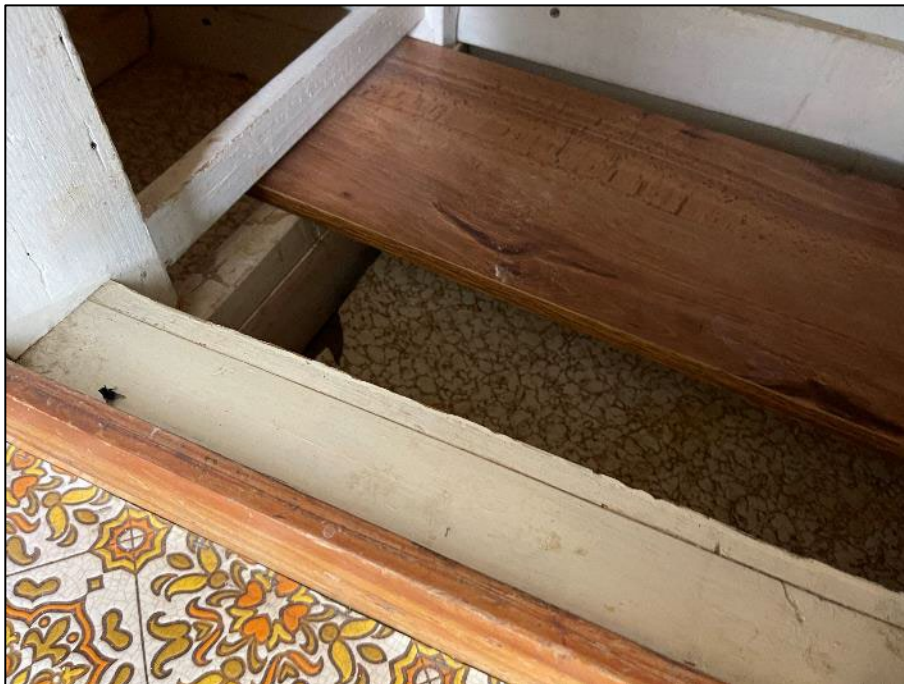
**PHOTOGRAPH #6:** Flooring (Beige/White) – Floor 1 Under Cabinets (25% Chrysotile)

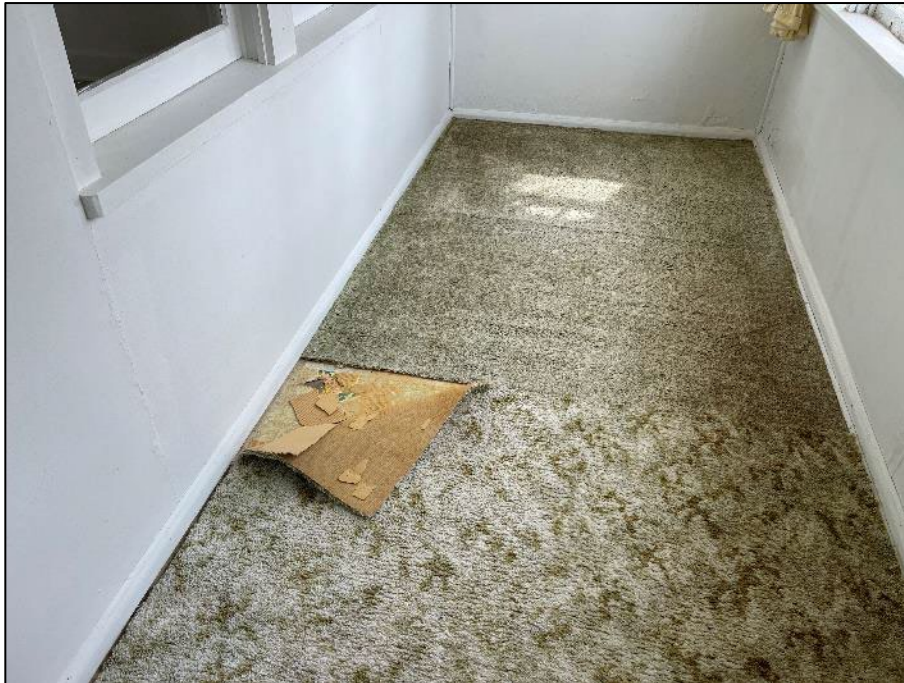
**PHOTOGRAPH #7:** Flooring – Floor 1 Sun Room (Non-Asbestos)

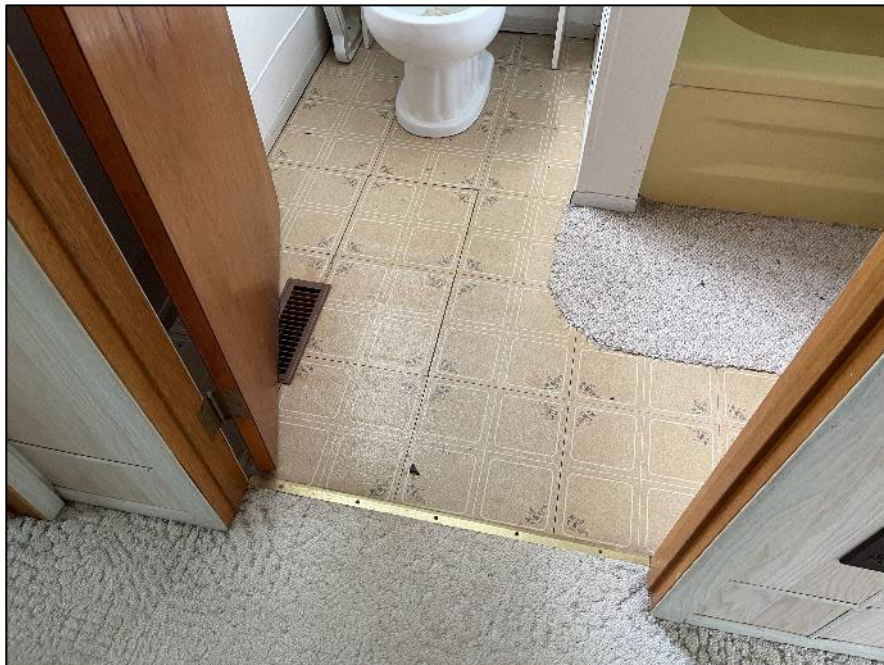
**PHOTOGRAPH #8:** Flooring – Floor 1 Bathroom (Non-Asbestos)

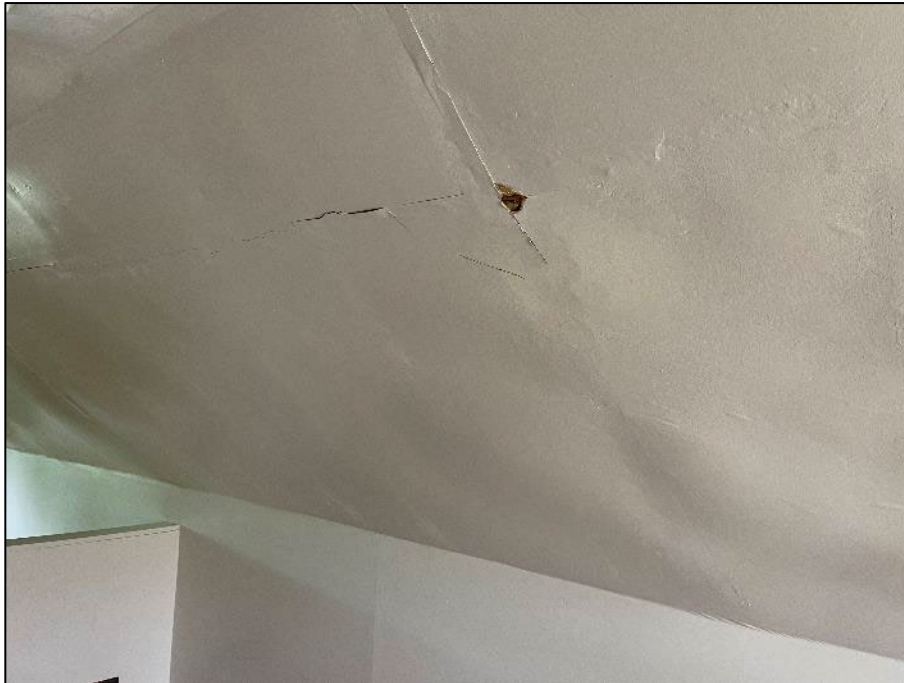
**PHOTOGRAPH #9:** Skim Coat (White) - Floor 2 West Wall (Non-Asbestos)

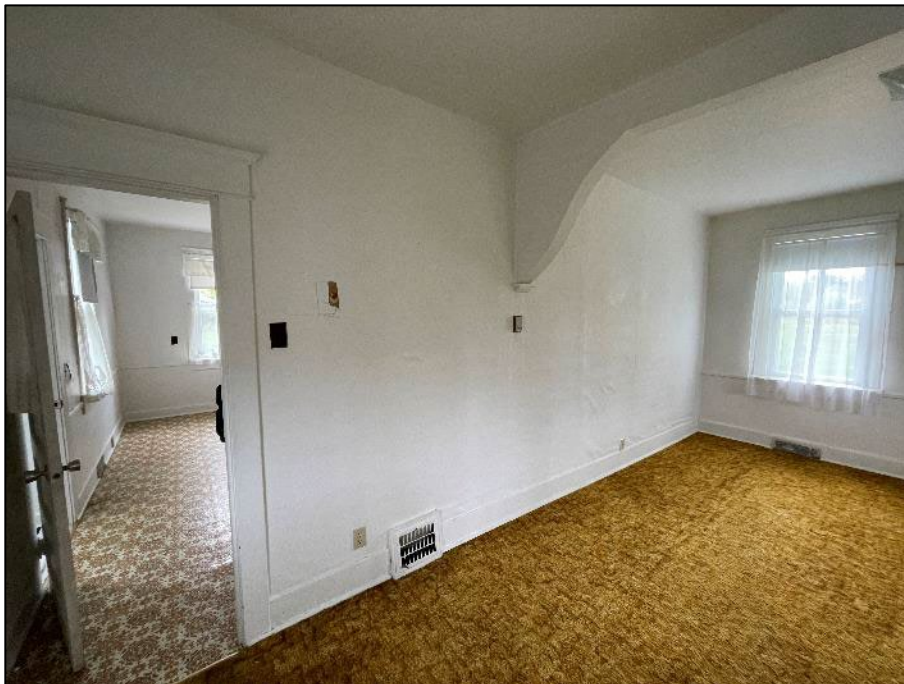
**PHOTOGRAPH #10:** Wall Board - Floor 1 Living Room (Non-Asbestos)

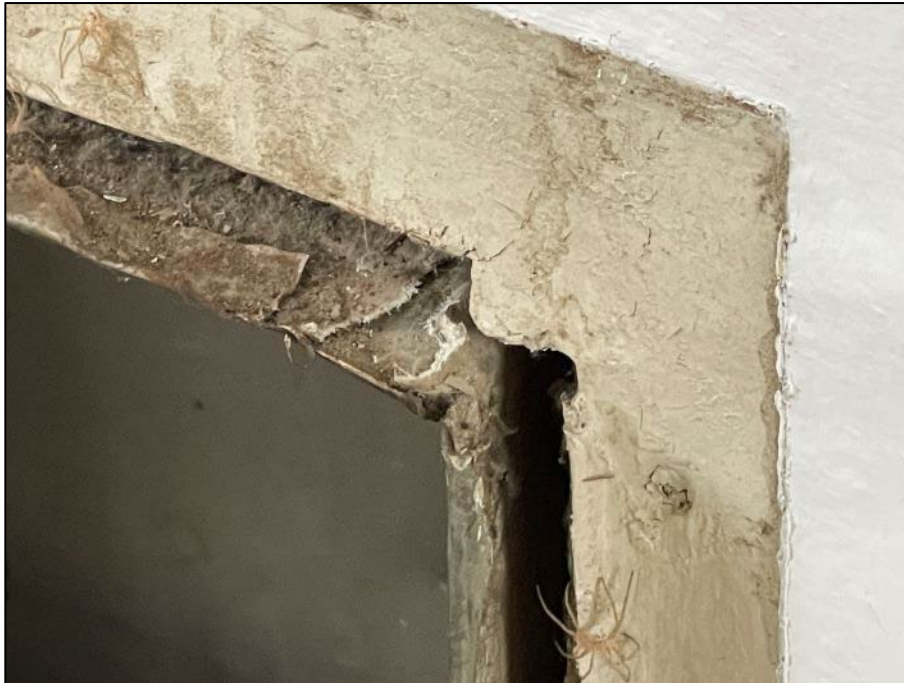
**PHOTOGRAPH #11:** Duct Wrap – Floor 1 Living Room (80% Chrysotile)

2. Duct wrap in the level 1 living room was identified as asbestos-containing (See Photograph #11). Removal of the materials throughout the home must be performed prior to demolition by a qualified abatement contractor using high-risk asbestos abatement procedures found in Section 5.4 of the AAAM (2019).

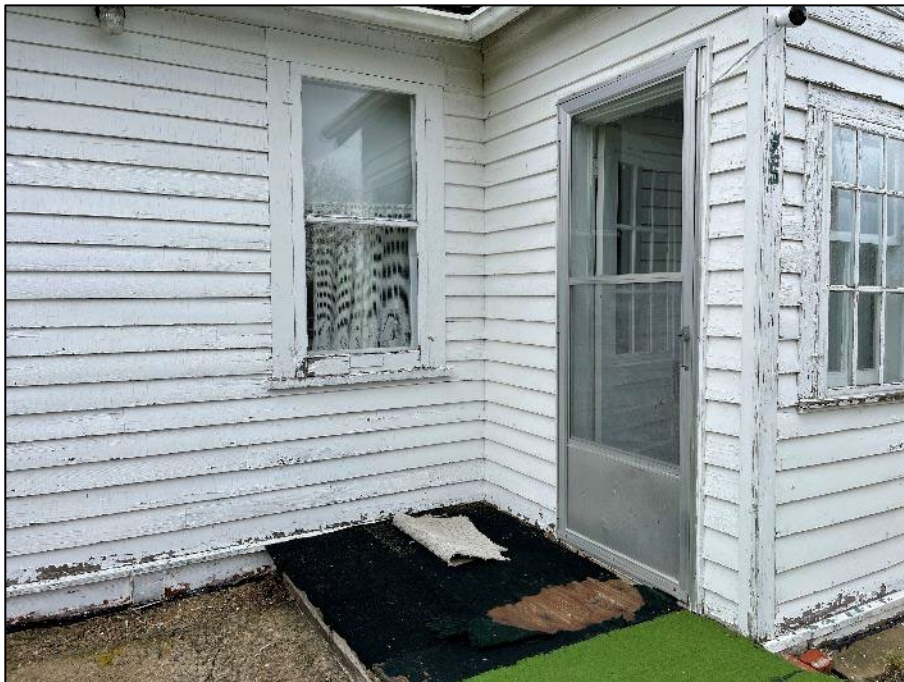
**PHOTOGRAPH #12:** Window Caulking - Exterior (Non-Asbestos)

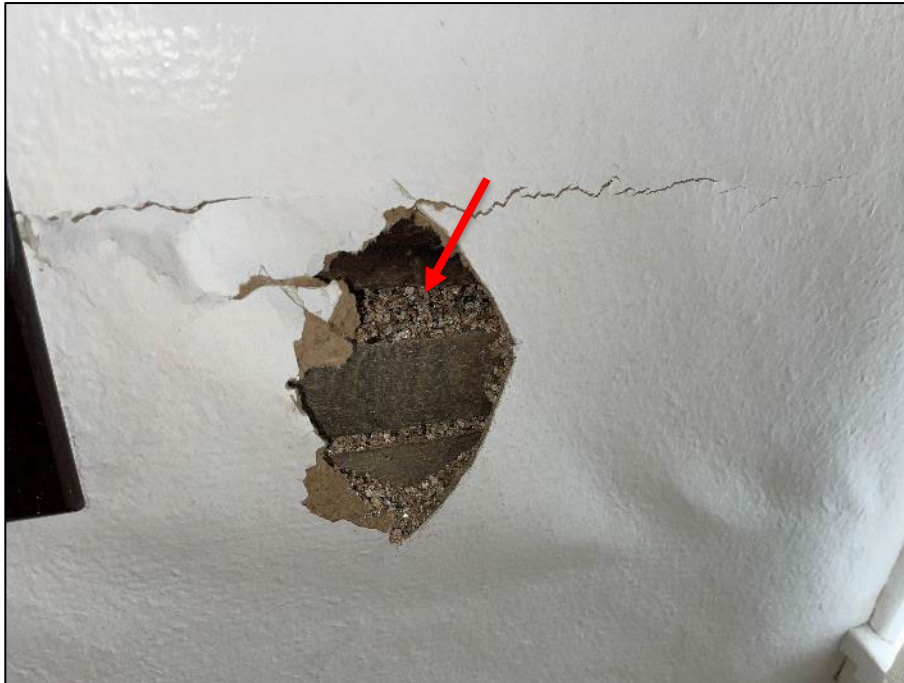
**PHOTOGRAPH #13:** Vermiculite – West Wall (<1% Actinolite)

3. Vermiculite material was confirmed in the attic spaces and exterior walls and confirmed asbestos-containing (See *Photographs #13 and 14*). Removal of the material must be performed prior to demolition by a qualified abatement contractor using high-risk asbestos abatement procedures found in Section 5.4 of the AAAM (2019).

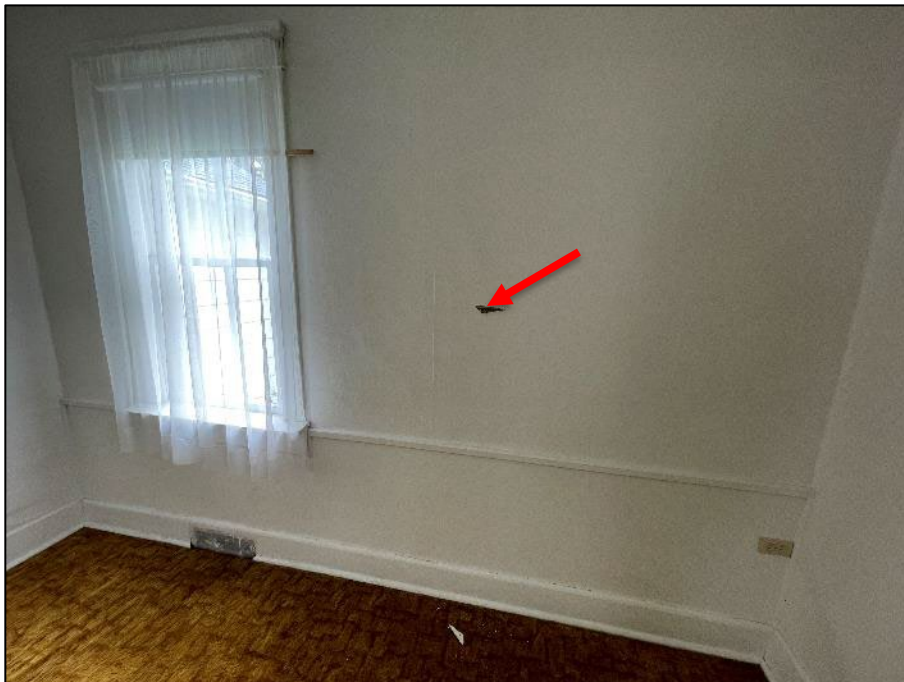
**PHOTOGRAPH #14:** Vermiculite – East Wall (<1% Actinolite)

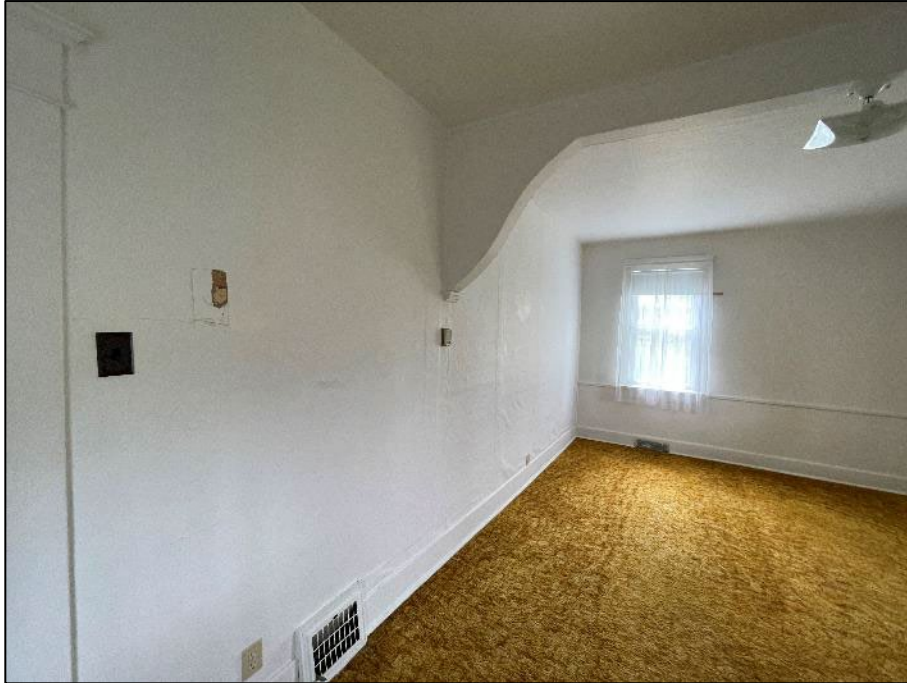
**PHOTOGRAPH #15:** Paint- White Floor 1 Int. Living Room Wall (Lead Based)

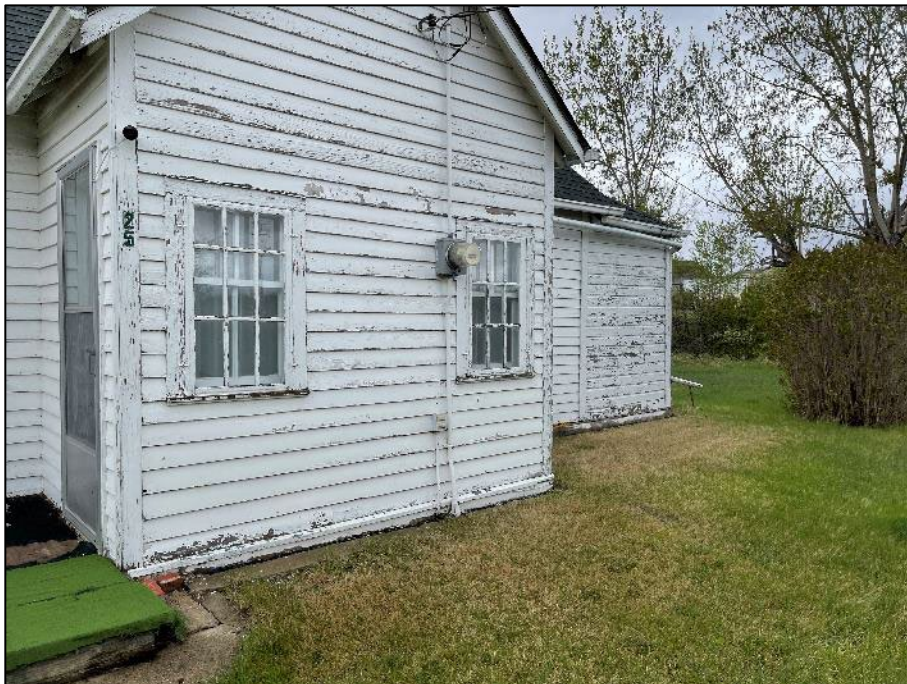
**PHOTOGRAPH #16:** Paint – White Exterior of Home (Lead Based)

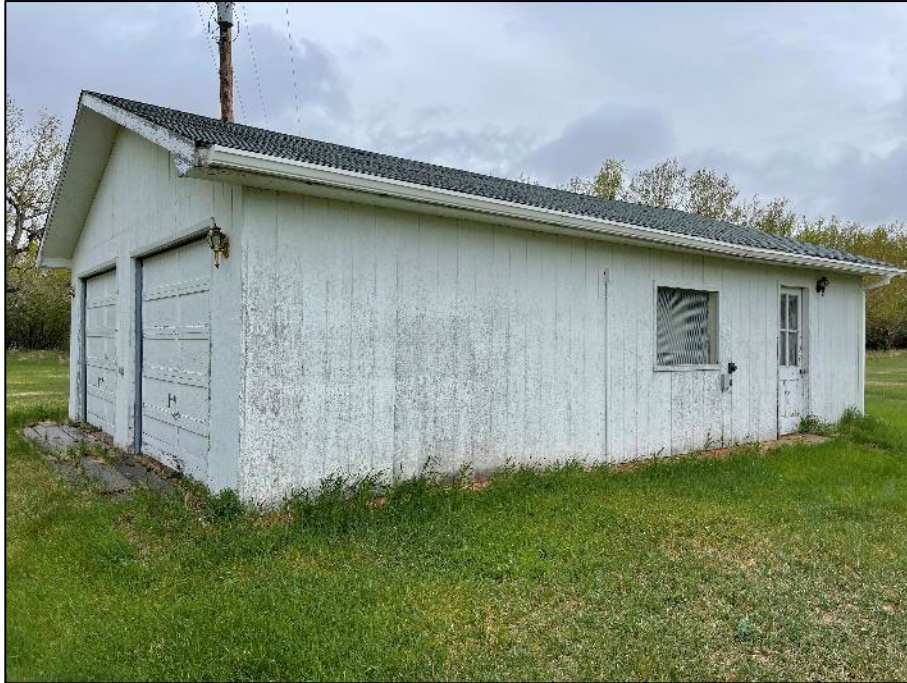
**PHOTOGRAPH #17:** Paint- White Exterior of Large Garage (Lead Based)

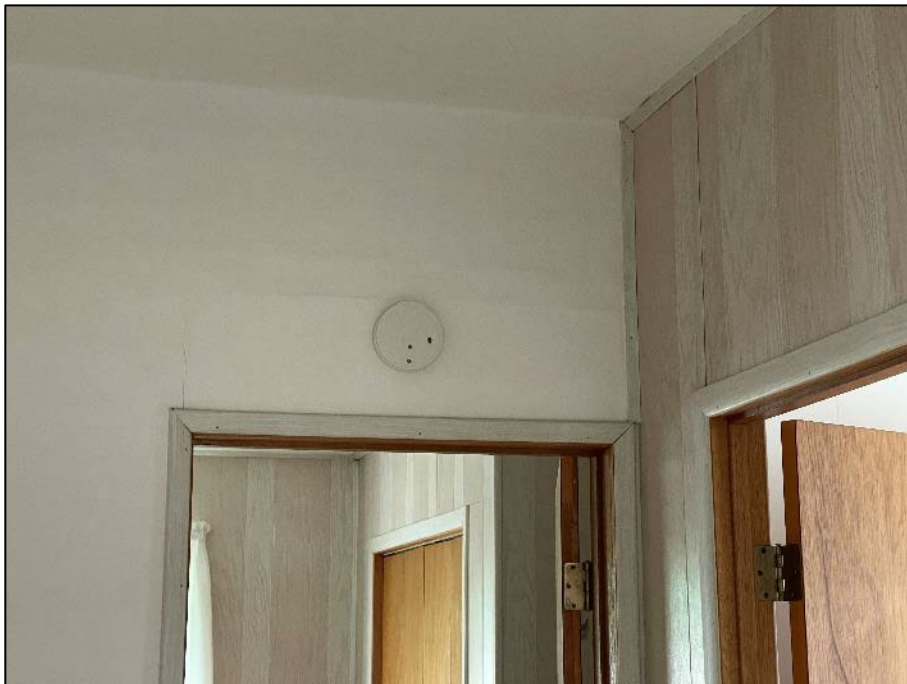
**PHOTOGRAPH #18:** Smoke Detector

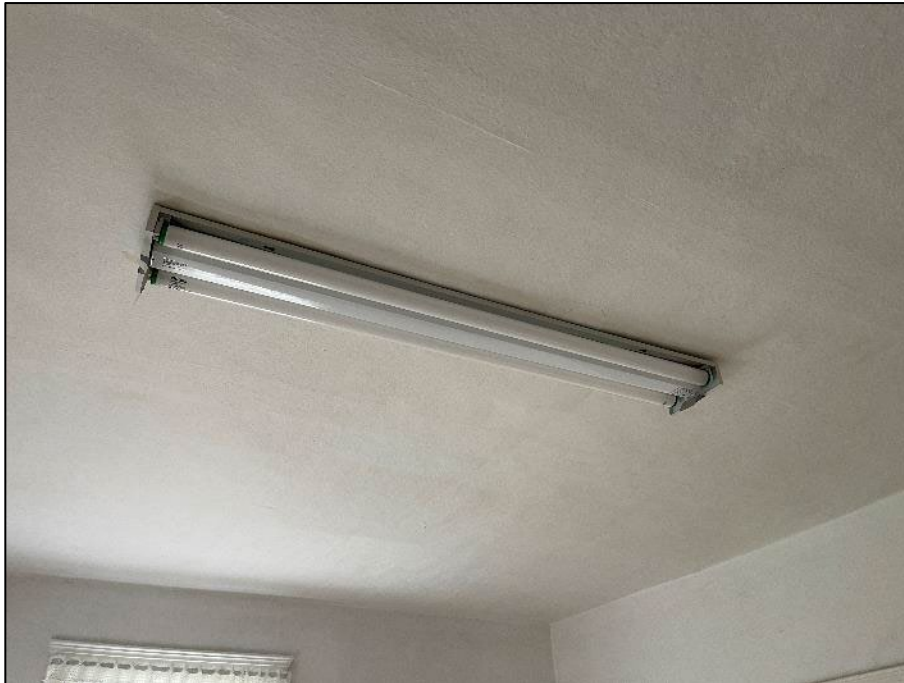
**PHOTOGRAPH #19:** Fluorescent Light Tubes (Mercury)

Do not break lamps. Recycle and reclaim mercury from fluorescent lamps when taken out of service. Mercury is classified as a hazardous waste and must be disposed of in accordance with applicable regulations.

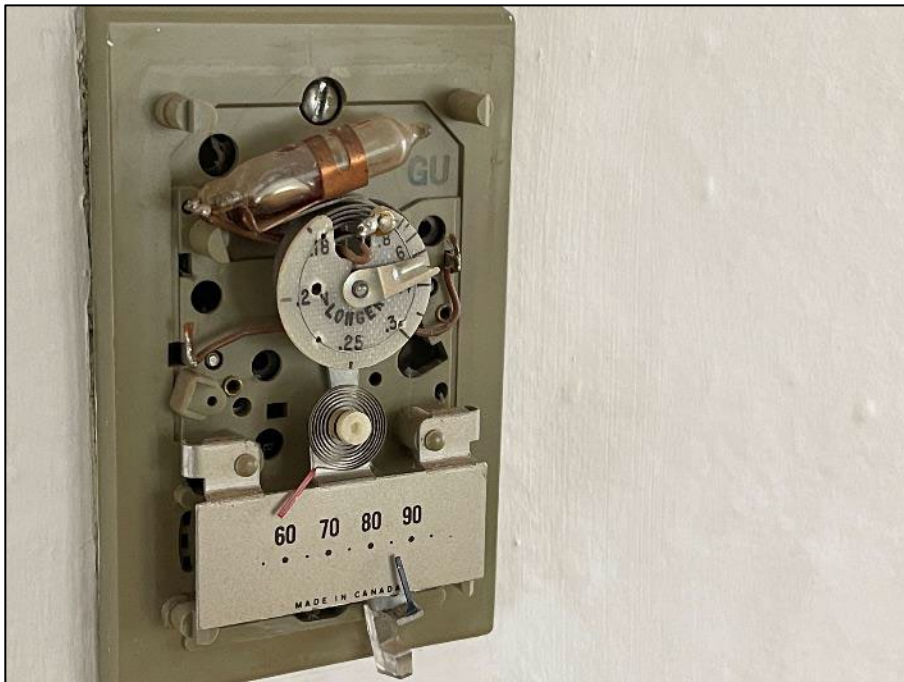
**PHOTOGRAPH #20:** Thermostat (Mercury)

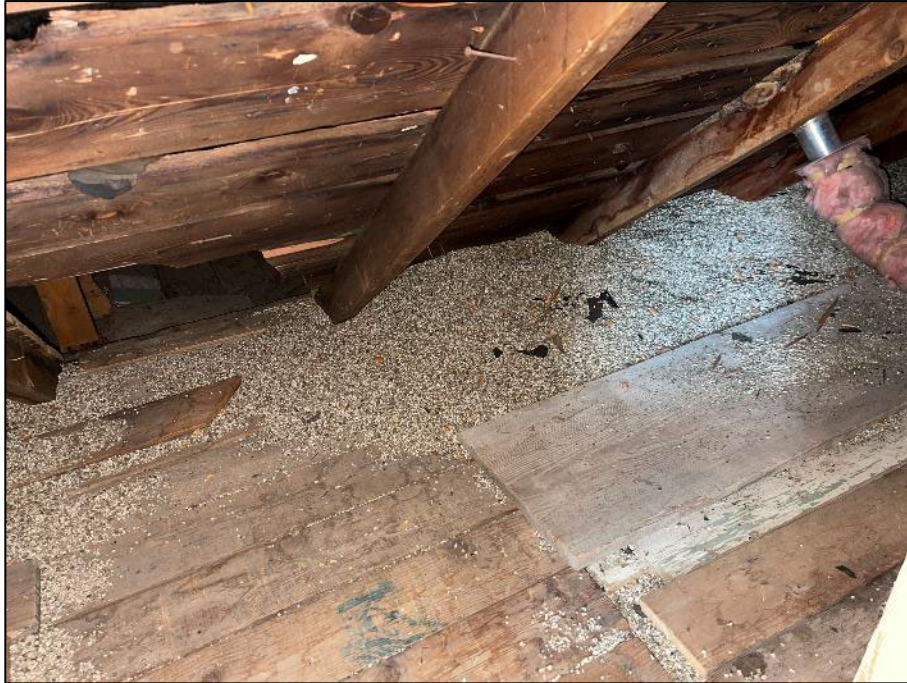
**PHOTOGRAPH #21:** Vermiculite in the Attic Space (<1% Actinolite)

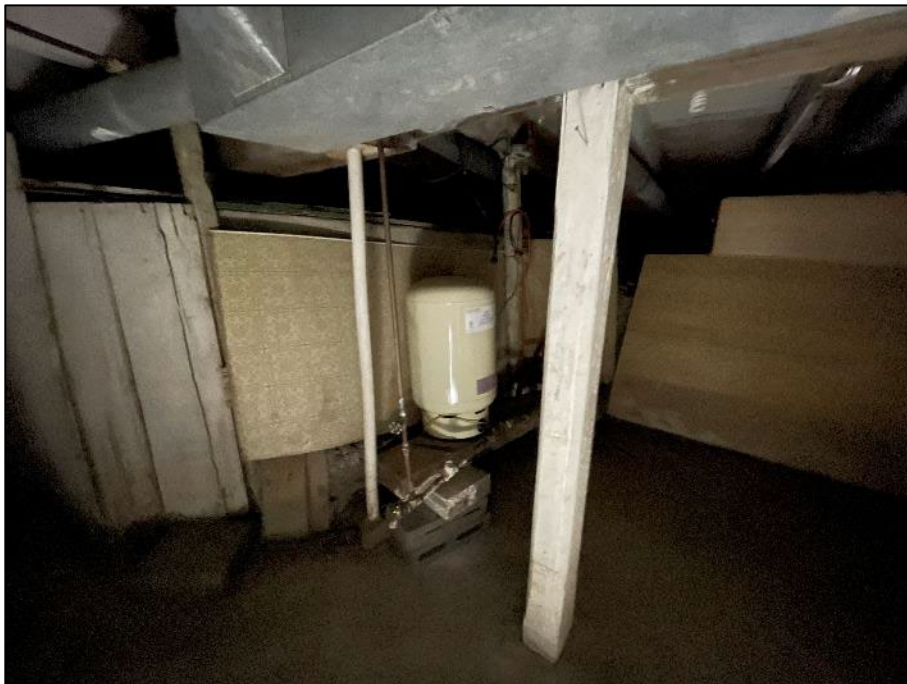
**PHOTOGRAPH #22:** Captive Air Tank in Basement

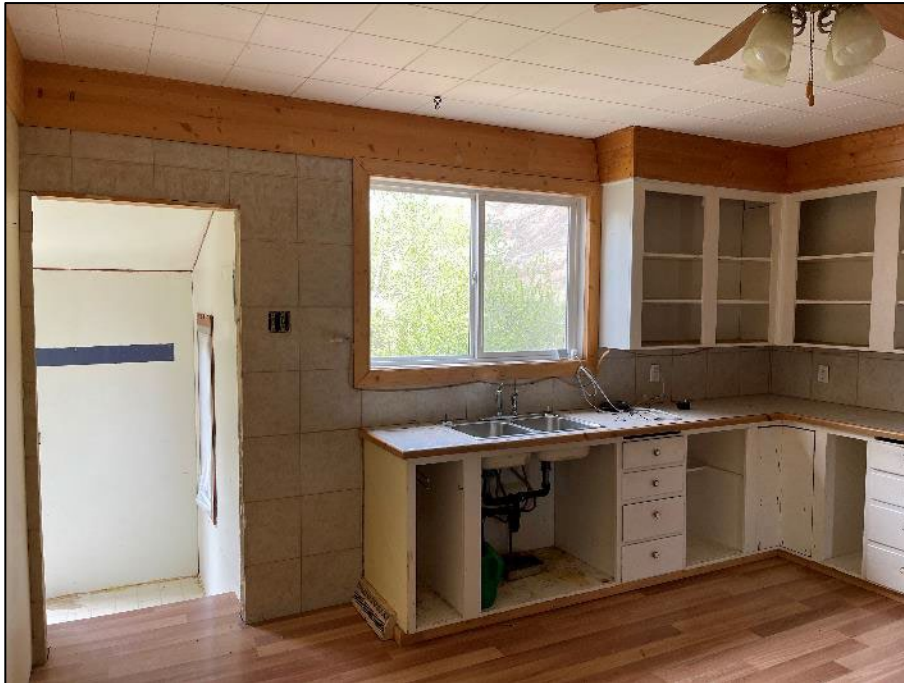
**PHOTOGRAPH #1:** Drywall Joint Compound - Floor 1 Exterior Kitchen (2% Chrysotile)

1. The following materials were identified as asbestos-containing and will require abatement prior to demolition of the structure:
  - a. Drywall Joint Compound (*See Photographs #1 to 7*).
  - b. Floor Tiles (*See Photograph #14*).
  - c. Transite Soffits on Small Shed (*See Photograph #20*).
  - d. Cement Shingle on Small Shed (*See Photograph #21*).
  - e. Window Caulking on Large Shed (*See Photograph #23*).

1. The drywall on the property was identified as asbestos-containing. Any renovation, demolition, or removal of the material must be performed by a qualified abatement contractor using moderate-risk asbestos abatement procedures found in Section 5.3 of the Alberta Asbestos Abatement Manual (2019) (See *Photographs #1 to 7*)

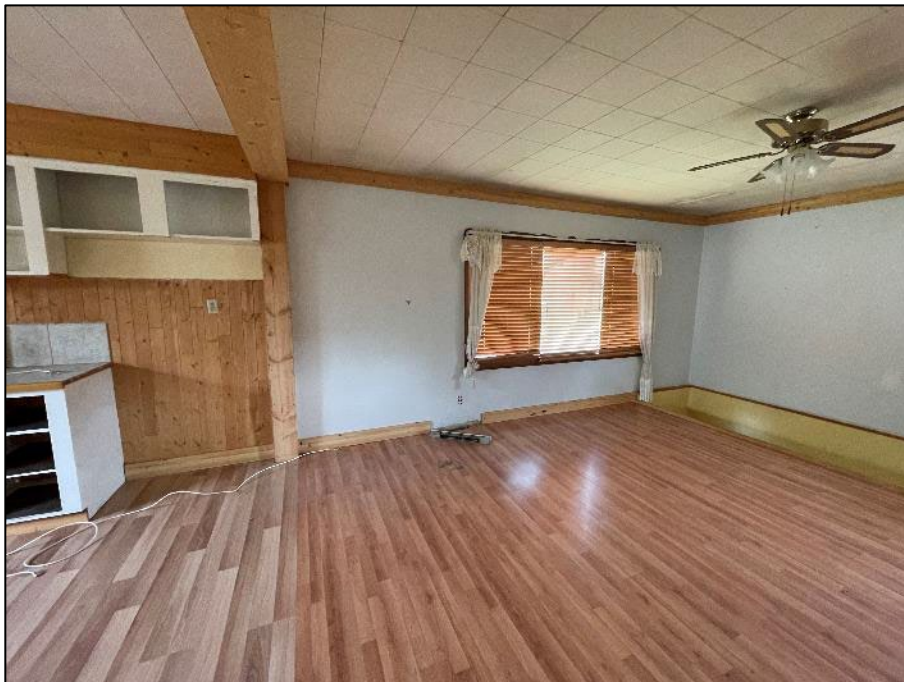
**PHOTOGRAPH #2:** Drywall Joint Compound - Level 1 Dining Area Exterior (2% Chrysotile)

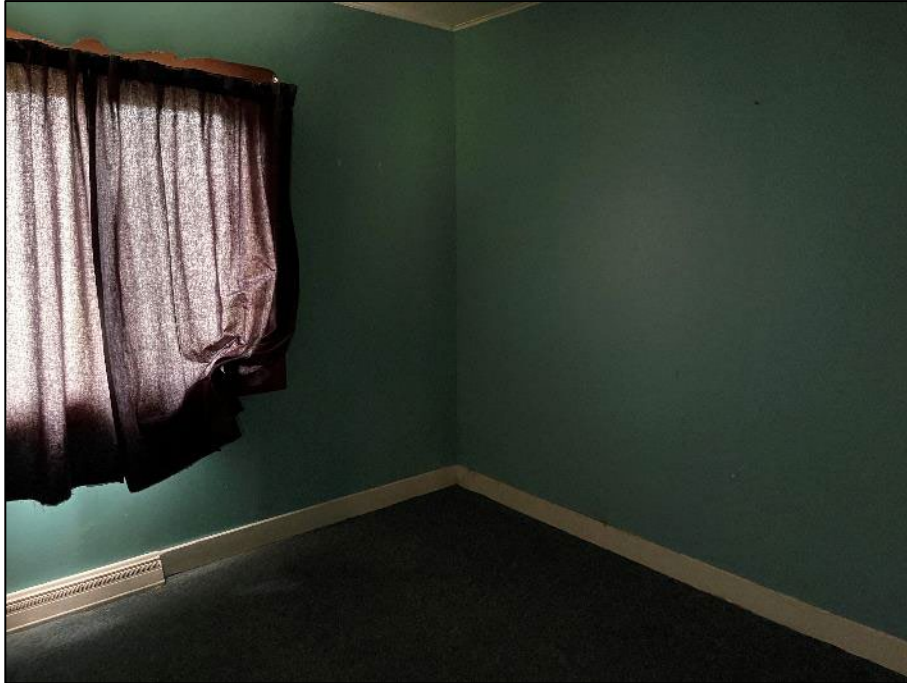
**PHOTOGRAPH #3:** Drywall Joint Compound - Level 1 North Bedroom Exterior (Assume Positive)

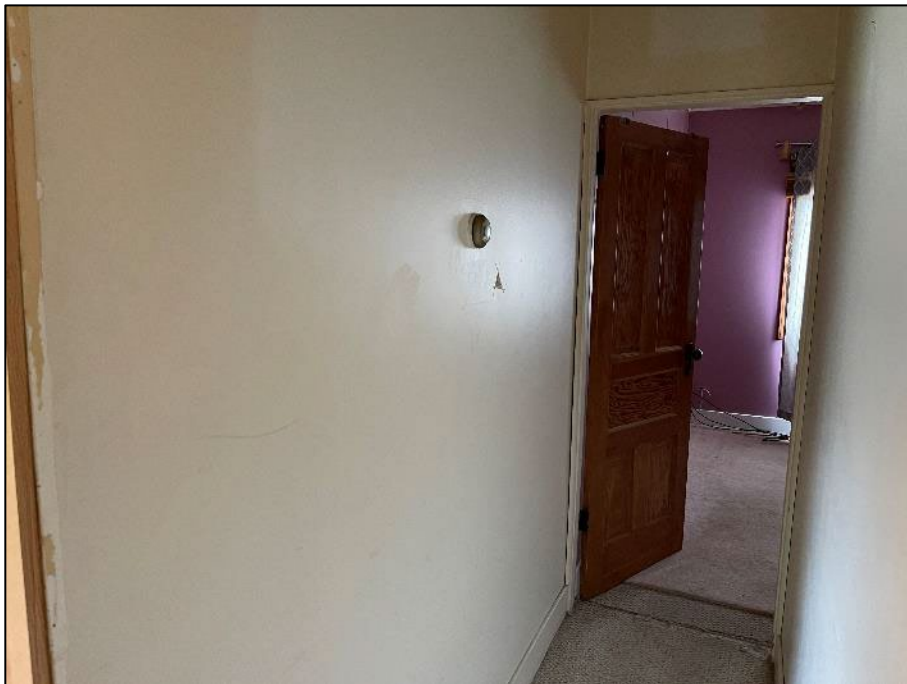
**PHOTOGRAPH #4:** Drywall Joint Compound - Level 1 Hallway Interior (2% Chrysotile)

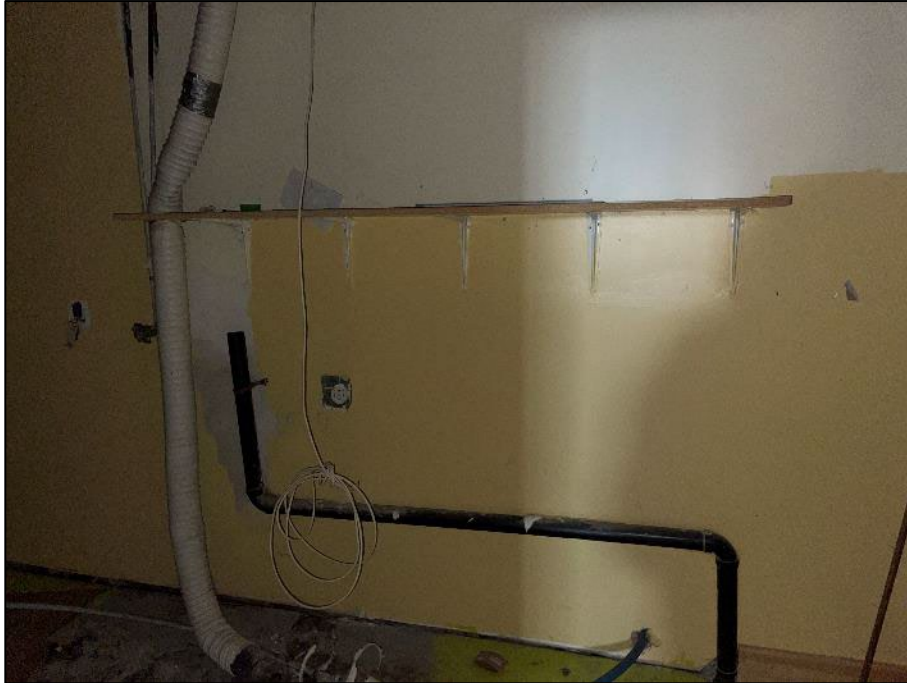
**PHOTOGRAPH #5:** Drywall Joint Compound - Basement Furnace Room Exterior (Assume Positive)

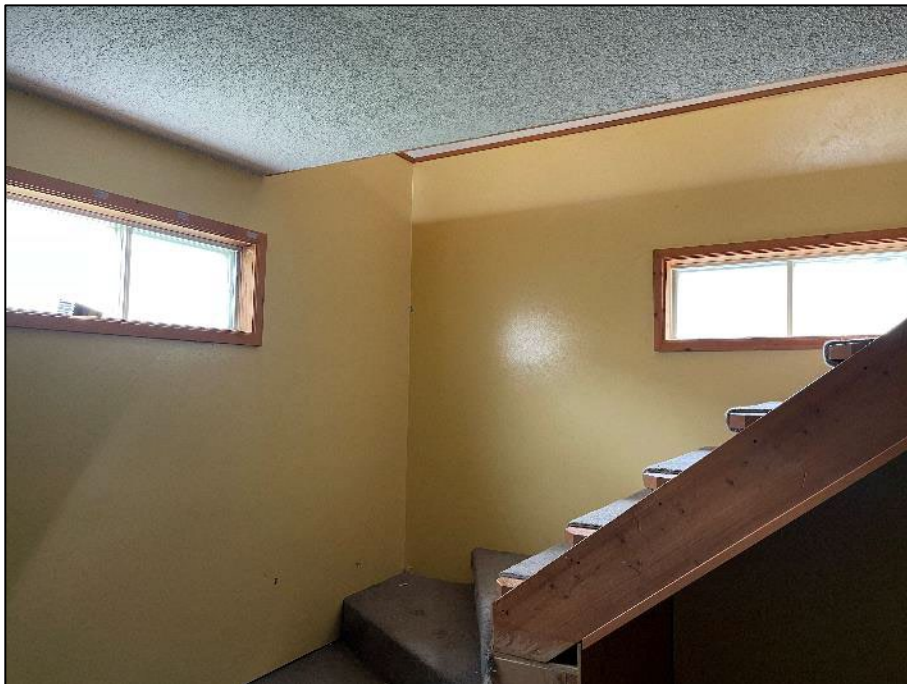
**PHOTOGRAPH #6:** Drywall Joint Compound - Basement Stairs Exterior (Assume Positive)

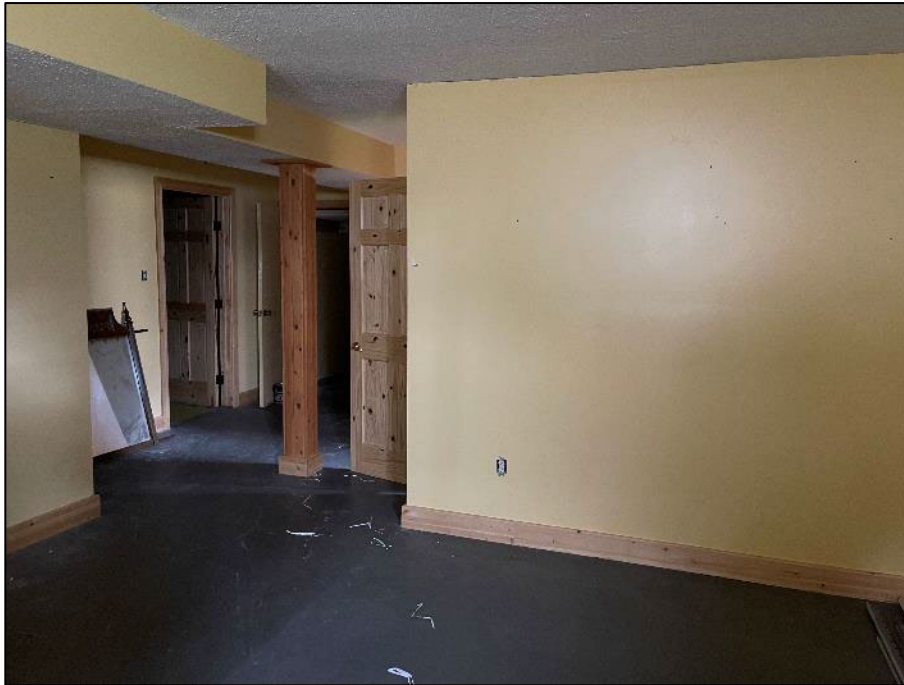
**PHOTOGRAPH #7:** Drywall Joint Compound - Basement Living Room Interior (Assume Positive)
