# Demolition and Remediation Services

<p style="text-align: center;"><b>Institutional &amp; Residential Demolitions Project for The Town of Drumheller</b></p>
--

## **Hazardous Building Materials Assessment (Pre-construction)**

Abandoned Health Centre  
625 Riverside Drive East,  
Drumheller, Alberta

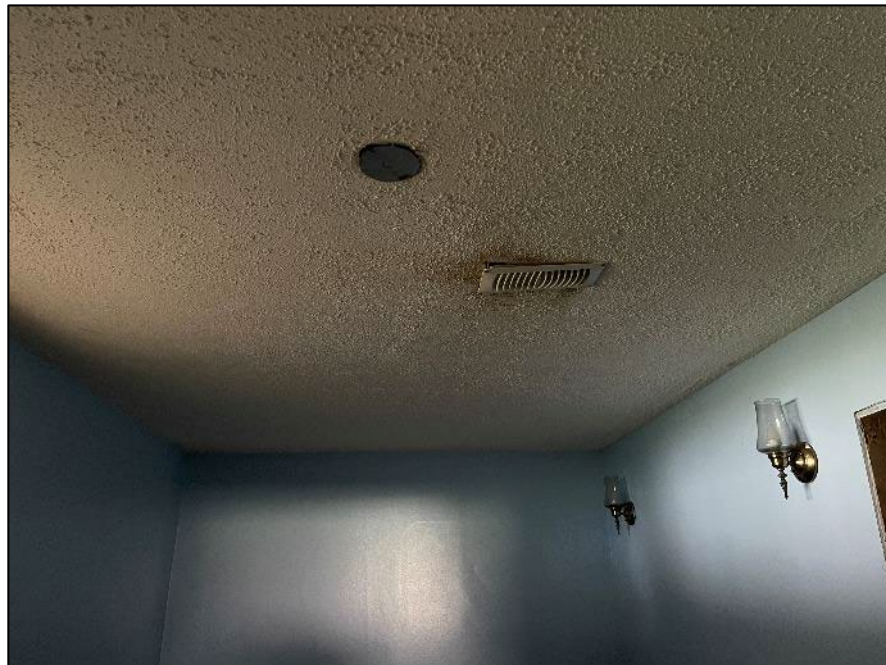
**PHOTOGRAPH #8:** Ceiling Texture - Basement Bedroom (Non-Asbestos)

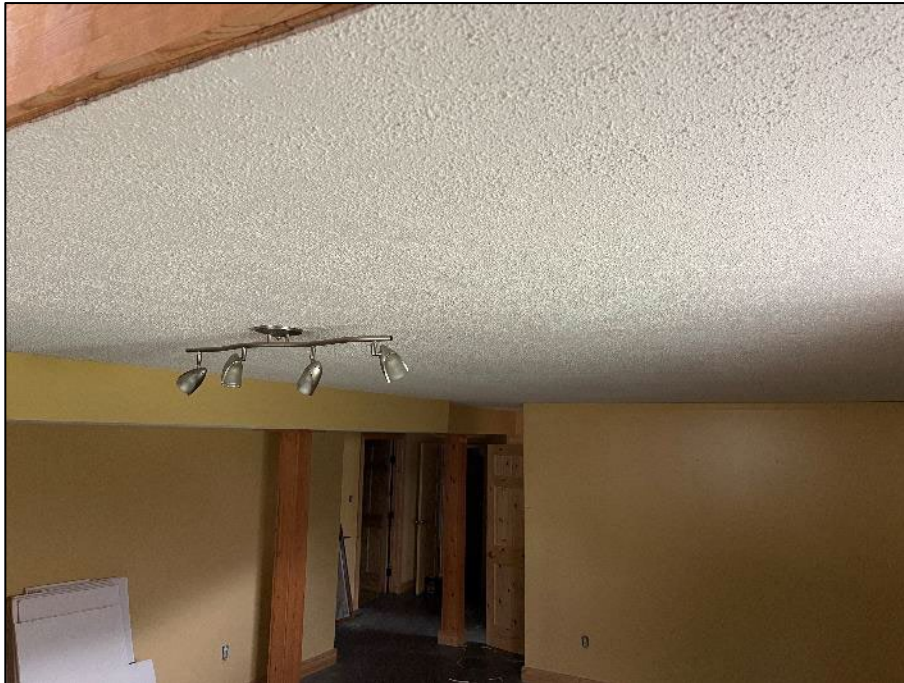
**PHOTOGRAPH #9:** Ceiling Texture - Basement Living Room (Non-Asbestos)

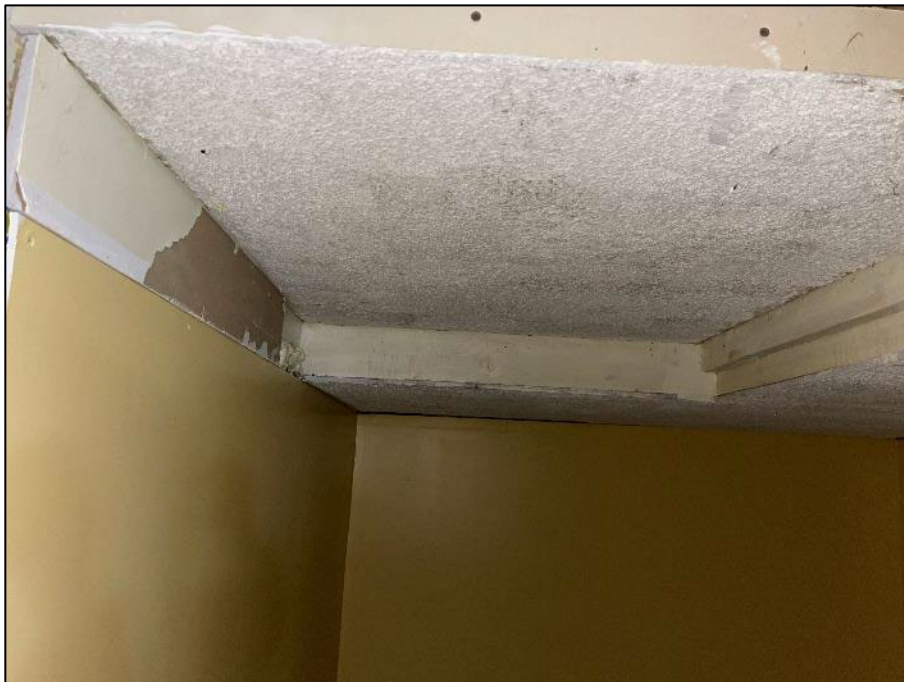
**PHOTOGRAPH #10:** Ceiling Texture - Basement Closet (Non-Asbestos)

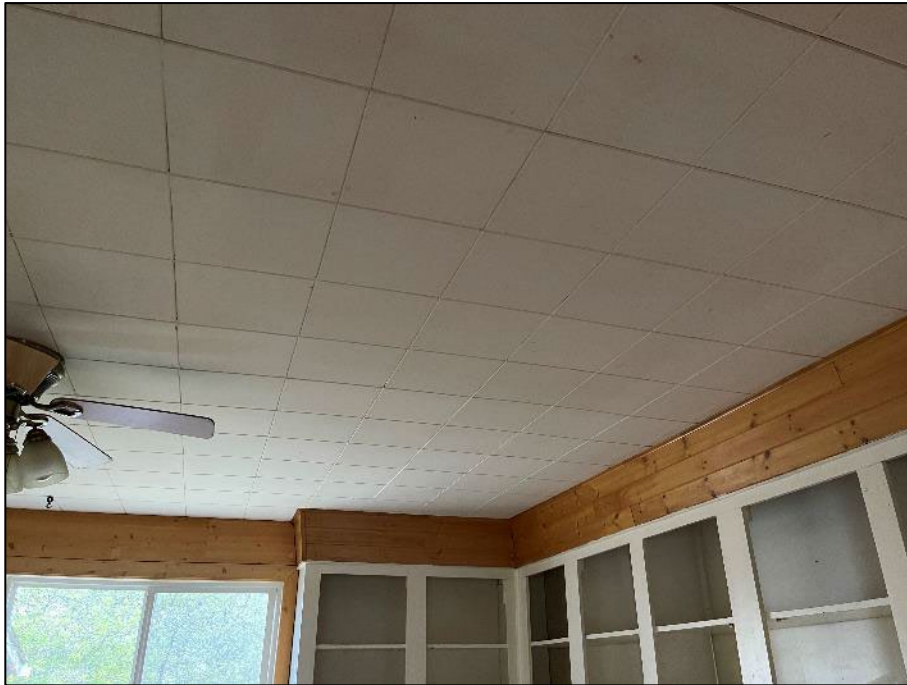
**PHOTOGRAPH #11:** Ceiling Tile - Level 1 Kitchen (1x1) (Non-Asbestos)

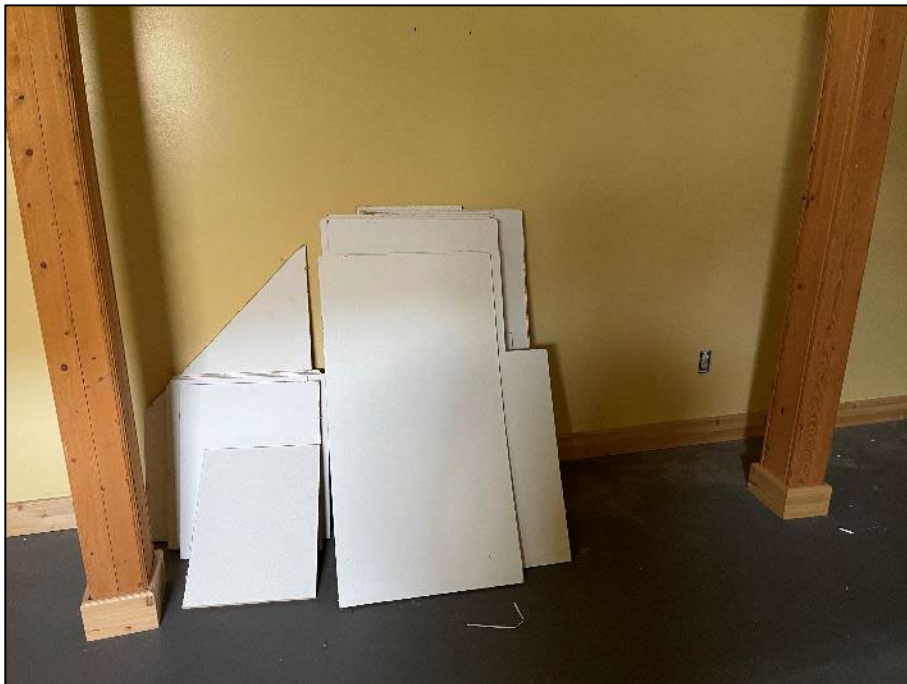
**PHOTOGRAPH #12:** Ceiling Tile - Basement Living Room (2x4) (Non-Asbestos)

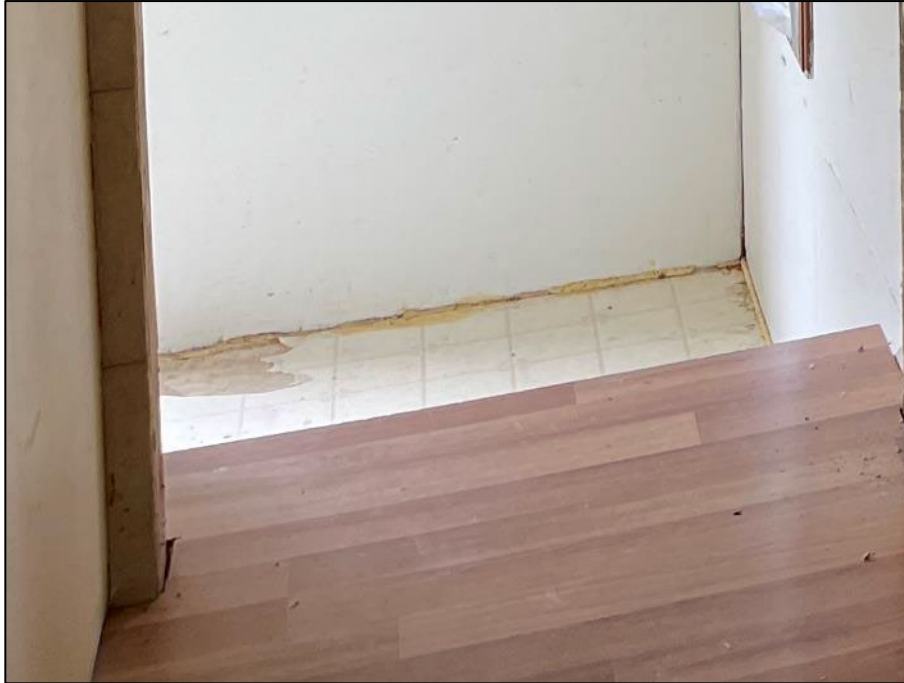
**PHOTOGRAPH #13:** Sheet Flooring - Level 1 Foyer (Non-Asbestos)

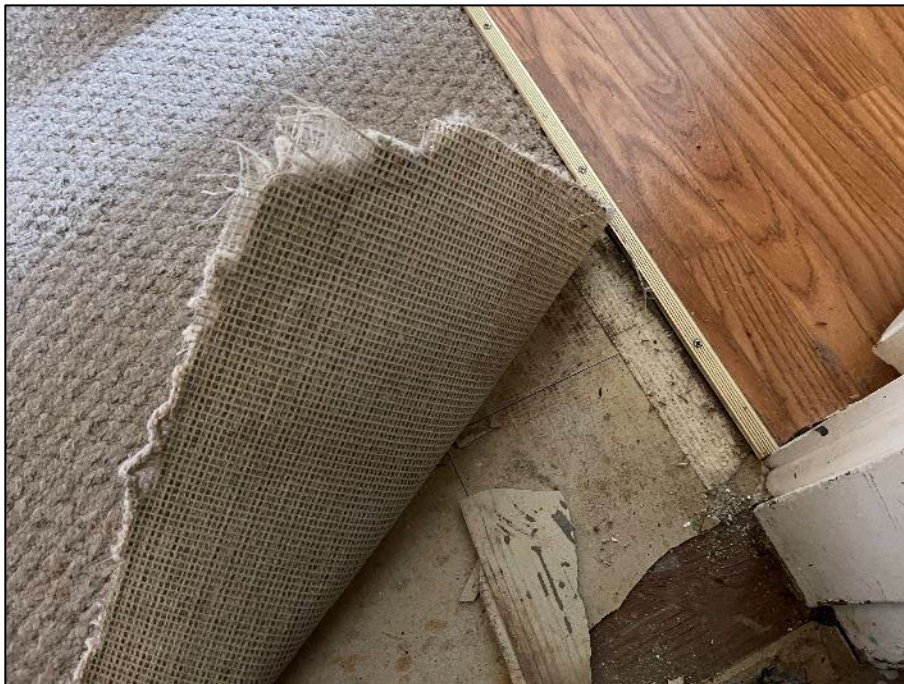
**PHOTOGRAPH #14:** Floor Tile - Level 1 Hallway (4% Chrysotile)

1. The following materials were identified as asbestos-containing and will require abatement prior to demolition of the structure:
  - a. Drywall Joint Compound (*See Photographs #1 to 7*).
  - b. Floor Tiles (*See Photograph #14*).
  - c. Transite Soffits on Small Shed (*See Photograph #20*).
  - d. Cement Shingle on Small Shed (*See Photograph #21*).
  - e. Window Caulking on Large Shed (*See Photograph #23*).

2. The floor tile on the property was identified as asbestos-containing. Any renovation, demolition, or removal of the material must be performed by a qualified abatement contractor using low asbestos abatement procedures found in Section 5.2 of the Alberta Asbestos Abatement Manual (2019) (See *Photograph #14*)

ID	Sample Description / Location	Results
1	Drywall Joint Compound - Level 1 Kitchen (EXT)	2% Chrysotile
2	Drywall Joint Compound - Level 1 Dining Area (EXT)	2% Chrysotile
3	Drywall Joint Compound - Level 1 North Bedroom (EXT)	None Detected
4	Drywall Joint Compound - Level 1 Hallway (INT)	2% Chrysotile
5	Drywall Joint Compound - Basement Furnace Room (EXT)	None Detected
6	Drywall Joint Compound - Basement Stairs (EXT)	None Detected
7	Drywall Joint Compound - Basement Living Room (INT)	None Detected
8	Ceiling Texture - Basement Bedroom	None Detected
9	Ceiling Texture - Basement Living Room	None Detected
10	Ceiling Texture - Basement Closet	None Detected
11	Ceiling Tile - Level 1 Kitchen (1x1)	None Detected
12	Ceiling Tile - Basement Living Room (2x4)	None Detected
13	Sheet Flooring - Level 1 Foyer	None Detected
14	Floor Tile - Level 1 Hallway	4% Chrysotile
15	Floor Tile - Level 1 North Bedroom	None Detected

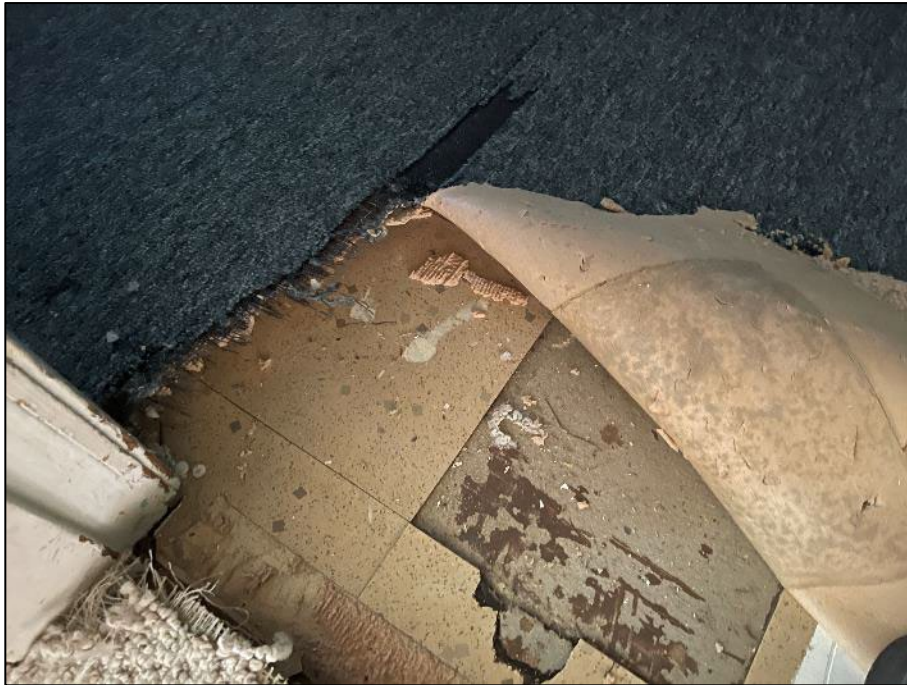
**PHOTOGRAPH #15:** Floor Tile - Level 1 North Bedroom (Non-Asbestos)

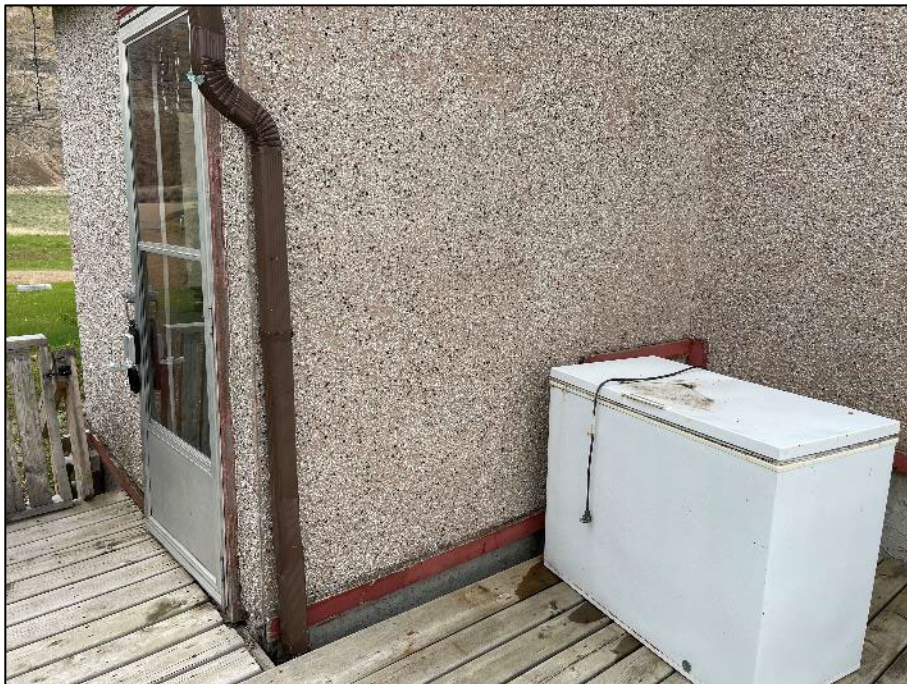
**PHOTOGRAPH #16:** Stucco - Exterior North Face (Non-Asbestos)

16	Stucco - Exterior North Face	None Detected
17	Stucco - Exterior East Face	None Detected
18	Stucco - Exterior West Face	None Detected
19	Parging - Exterior NW Corner	None Detected
20	Transite Soffit - Small Shed	15% Chrysotile
21	Cement Shingle - Small Shed	10% Chrysotile
22	Window Caulking - Large Shed Interior	None Detected
23	Window Caulking - Large Shed Exterior	8% Chrysotile
24	Ceiling Tile - Small House	None Detected
25	Ceiling Board - Small House	None Detected

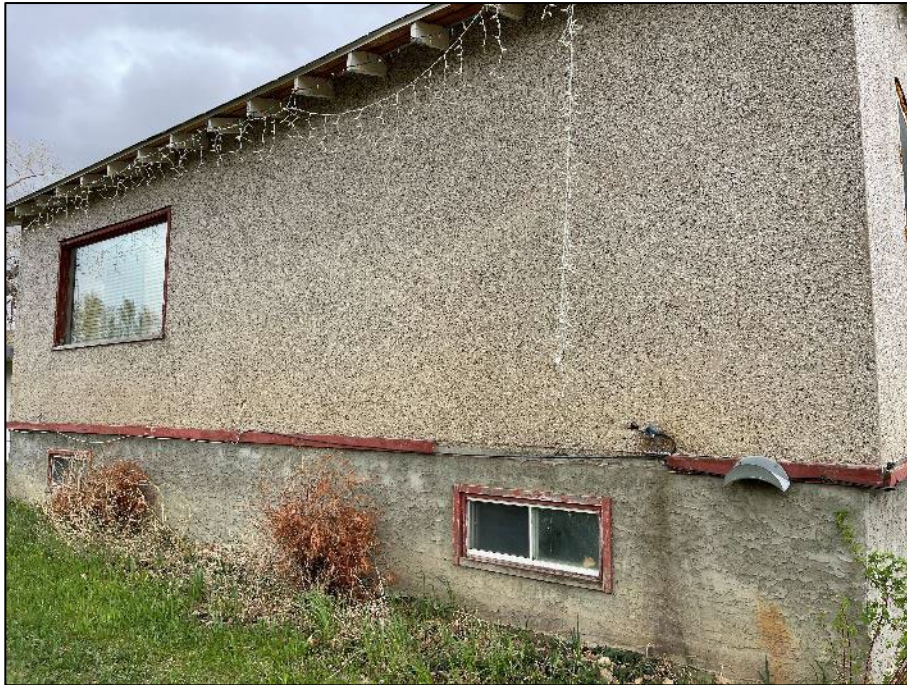
**PHOTOGRAPH #17:** Stucco - Exterior East Face (Non-Asbestos)

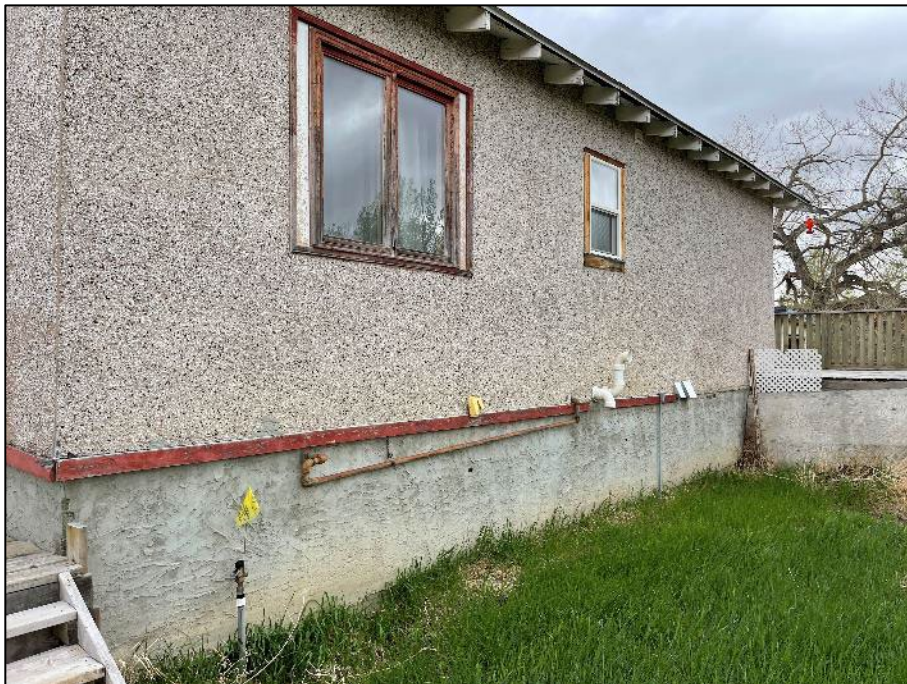
**PHOTOGRAPH #18:** Stucco - Exterior West Face (Non-Asbestos)

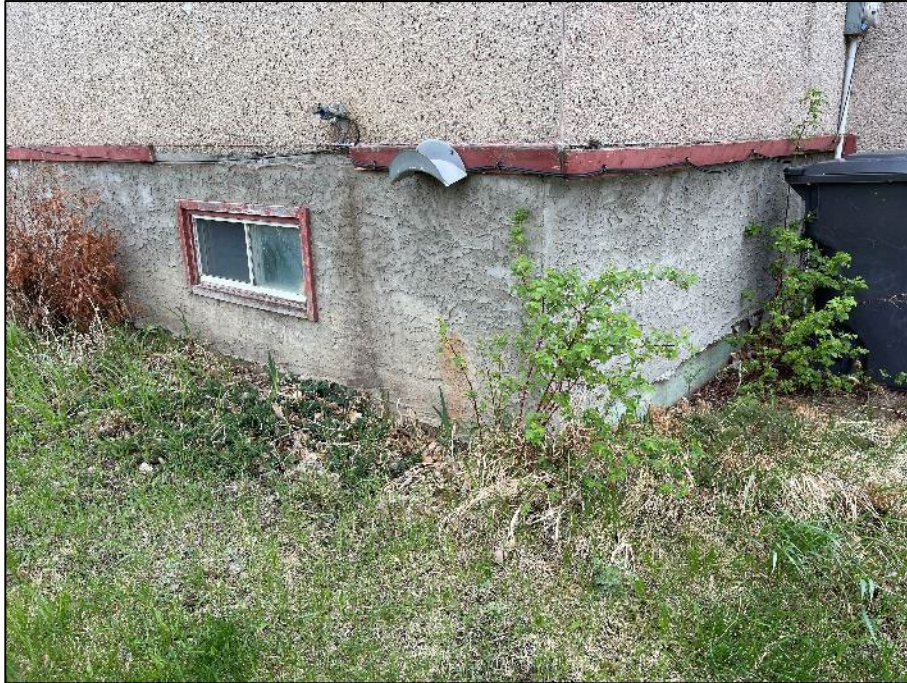
**PHOTOGRAPH #19:** Parging - Exterior NW Corner (Non-Asbestos)

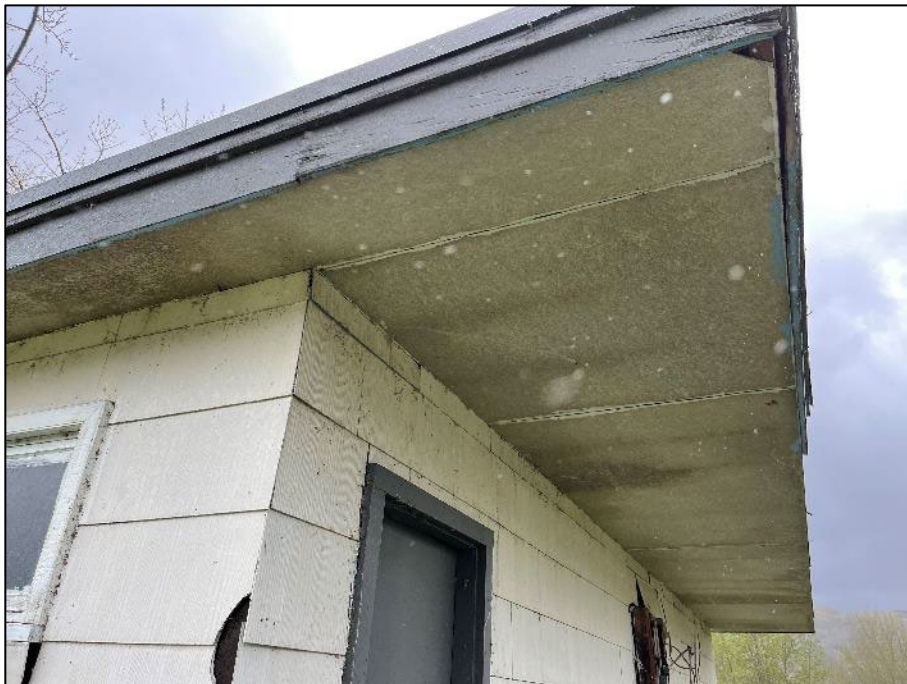
**PHOTOGRAPH #20:** Transite Soffit - Small Shed (15% Chrysotile)

3. The transite soffit on the property was identified as asbestos-containing. Any renovation, demolition, or removal of the material must be performed by a qualified abatement contractor using low-risk asbestos abatement procedures found in Section 5.2 of the Alberta Asbestos Abatement Manual (2019) (See *Photograph #20*)

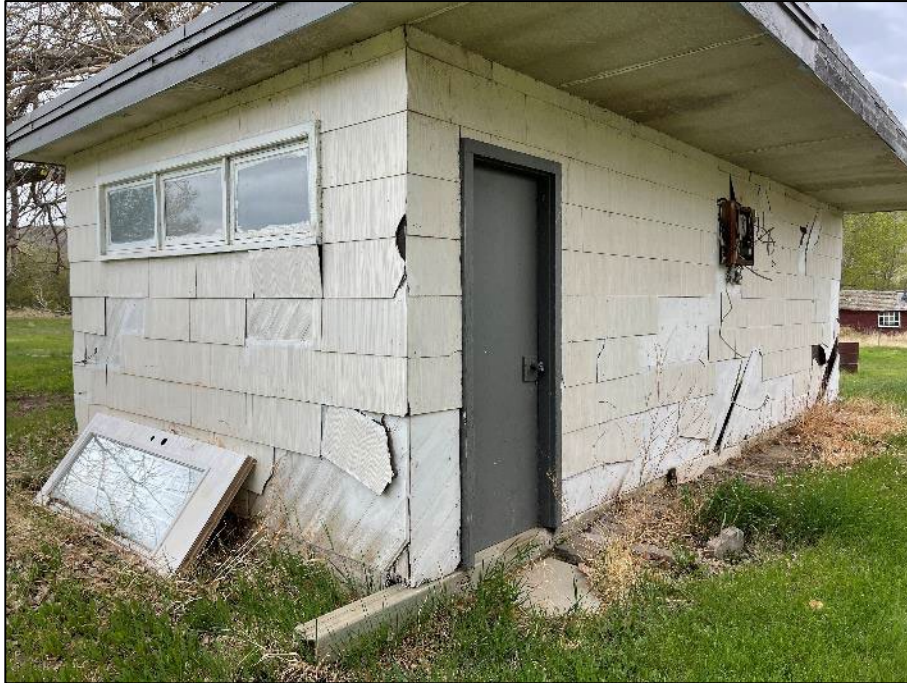
**PHOTOGRAPH #21:** Cement Shingle - Small Shed (10% Chrysotile)

4. The cement shingle on the property was identified as asbestos-containing. Any renovation, demolition, or removal of the material must be performed by a qualified abatement contractor using low-risk asbestos abatement procedures found in Section 5.2 of the Alberta Asbestos Abatement Manual (2019) (See *Photograph #21*)

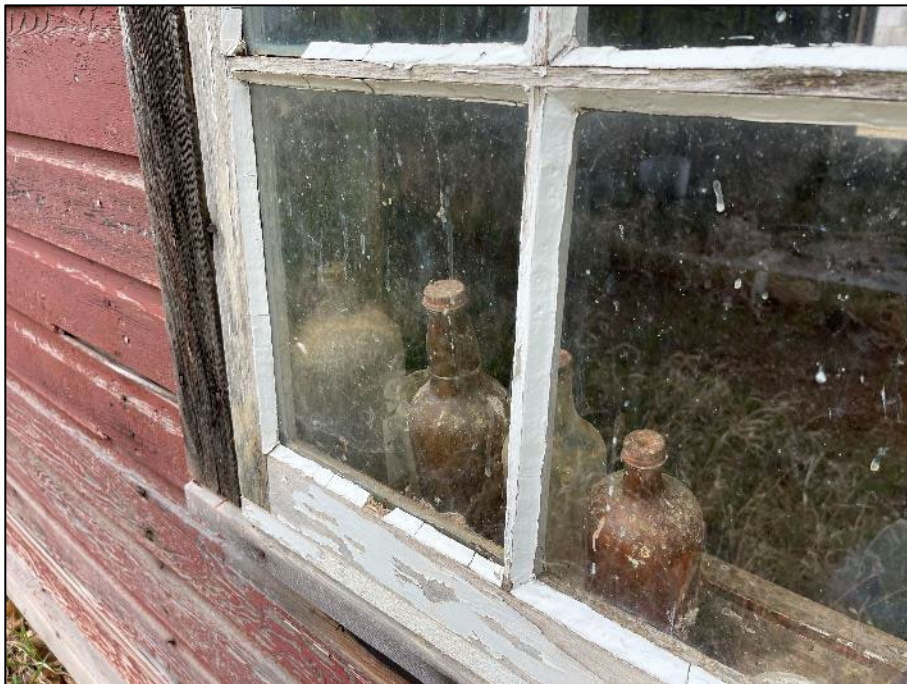
**PHOTOGRAPH #22:** Window Caulking - Large Shed Interior (Non-Asbestos)

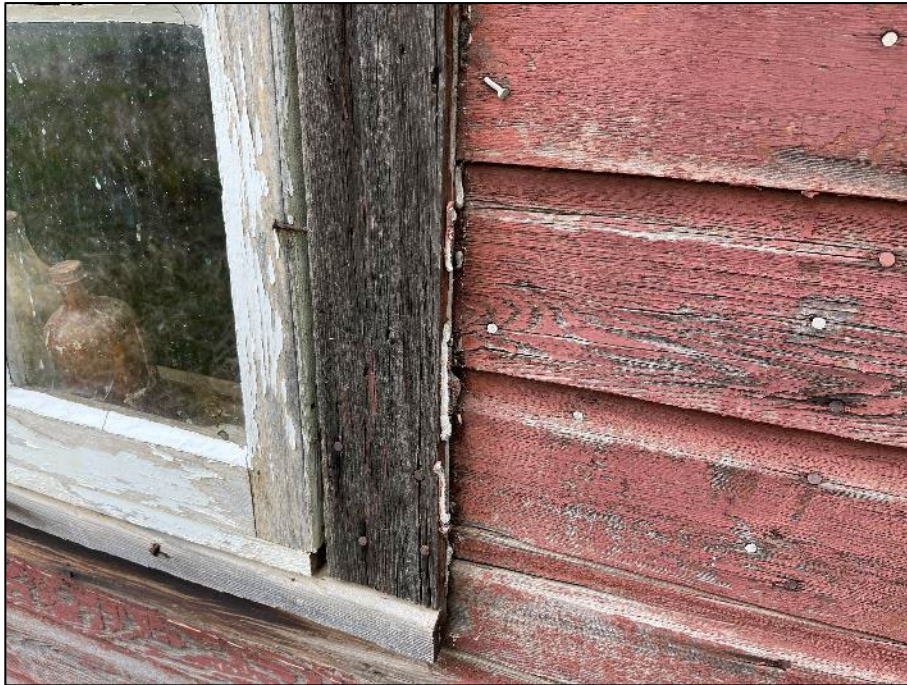
**PHOTOGRAPH #23:** Window Caulking - Large Shed Exterior (8% Chrysotile)

5. The window caulking on the property was identified as asbestos-containing. Any renovation, demolition, or removal of the material must be performed by a qualified abatement contractor using low-risk asbestos abatement procedures found in Section 5.2 of the Alberta Asbestos Abatement Manual (2019) (See *Photograph #23*).

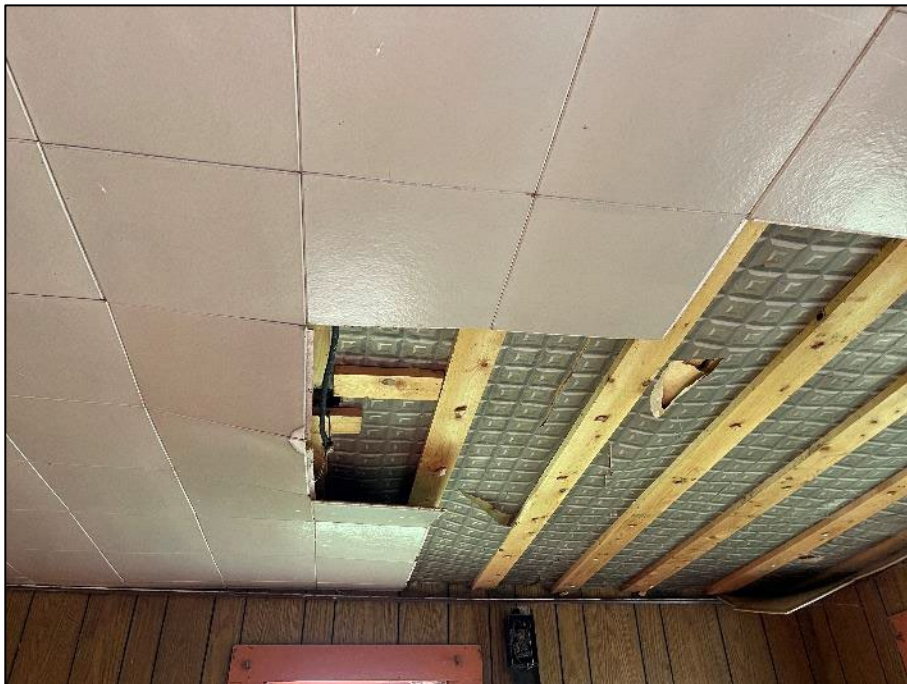
**PHOTOGRAPH #24:** Ceiling Tile - Small House (Non-Asbestos)

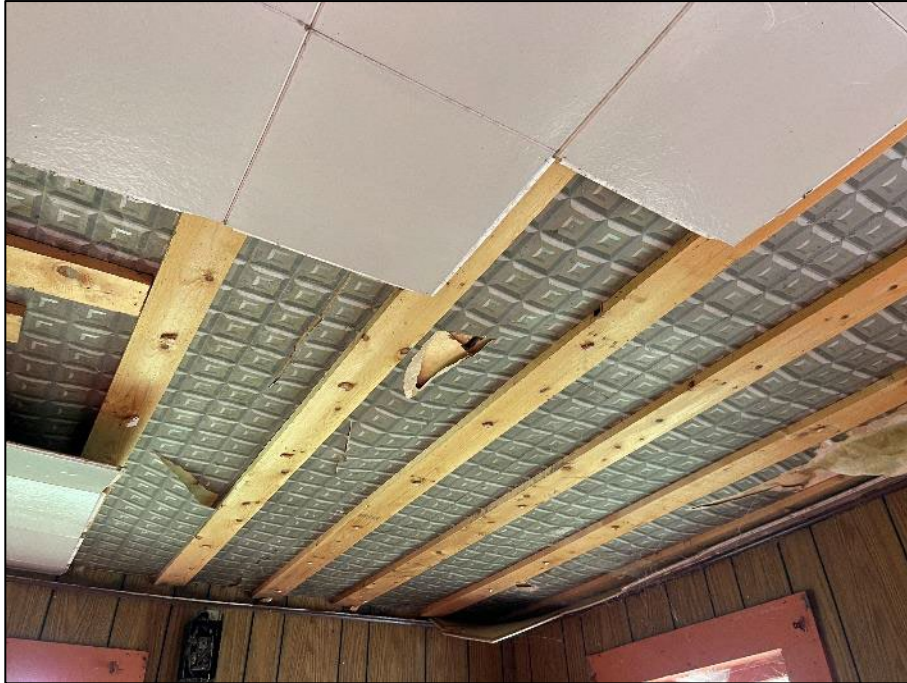
**PHOTOGRAPH #25:** Ceiling Board - Small House (Non-Asbestos)

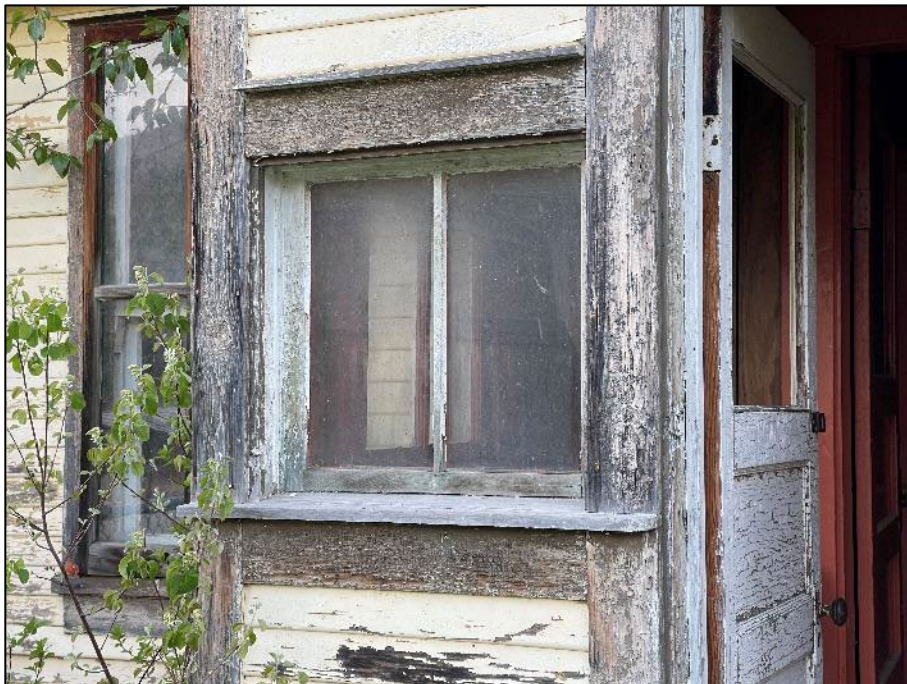
**PHOTOGRAPH #26:** Window Caulking - Small House (Non-Asbestos)

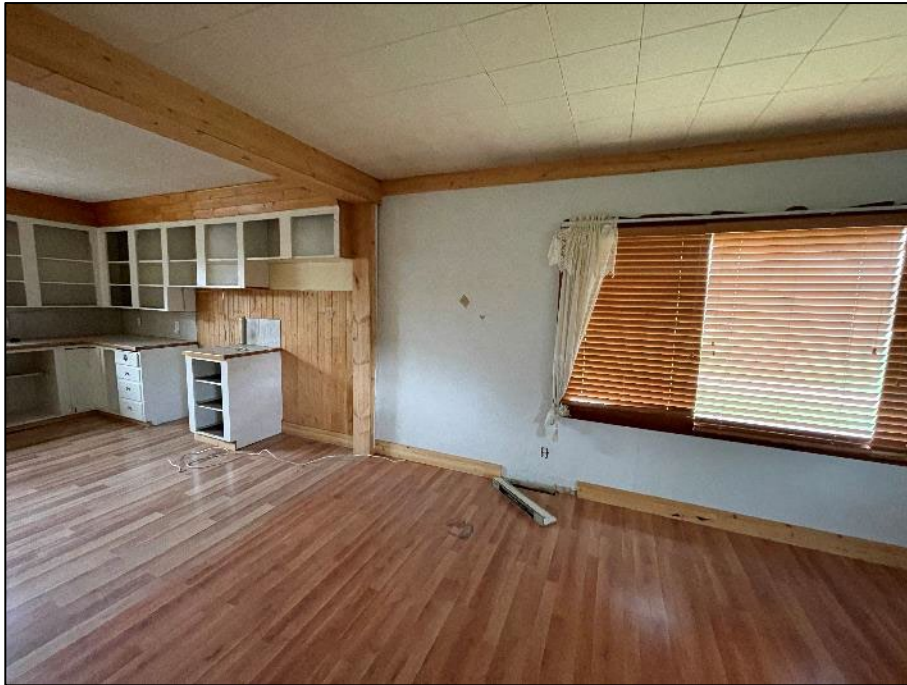
**PHOTOGRAPH #27:** Paint- White Interior Dining Room (Lead Based)

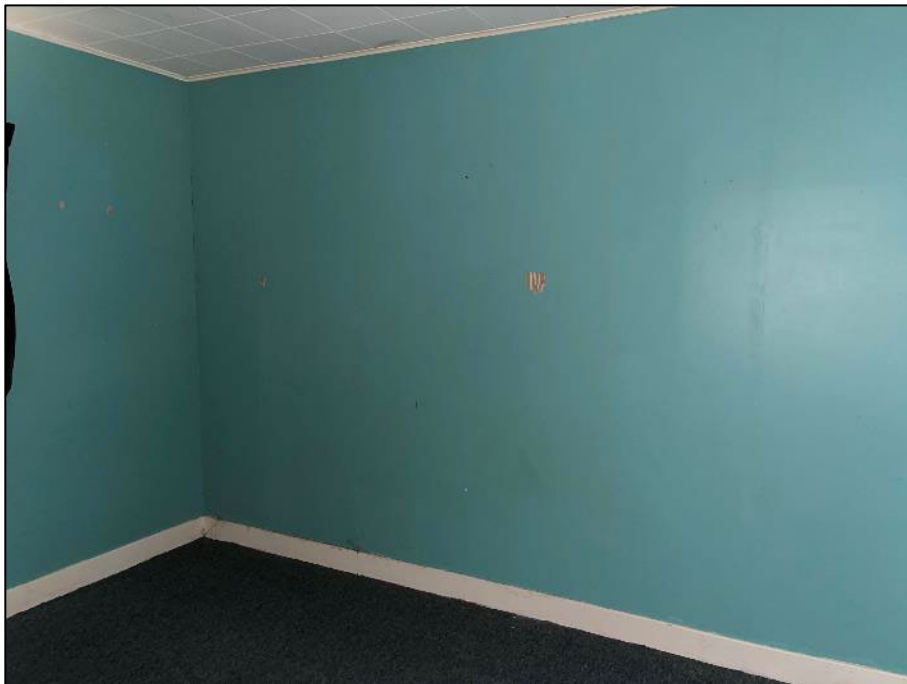
**PHOTOGRAPH #28:** Paint- Blue Interior Bedroom (Non-Lead)

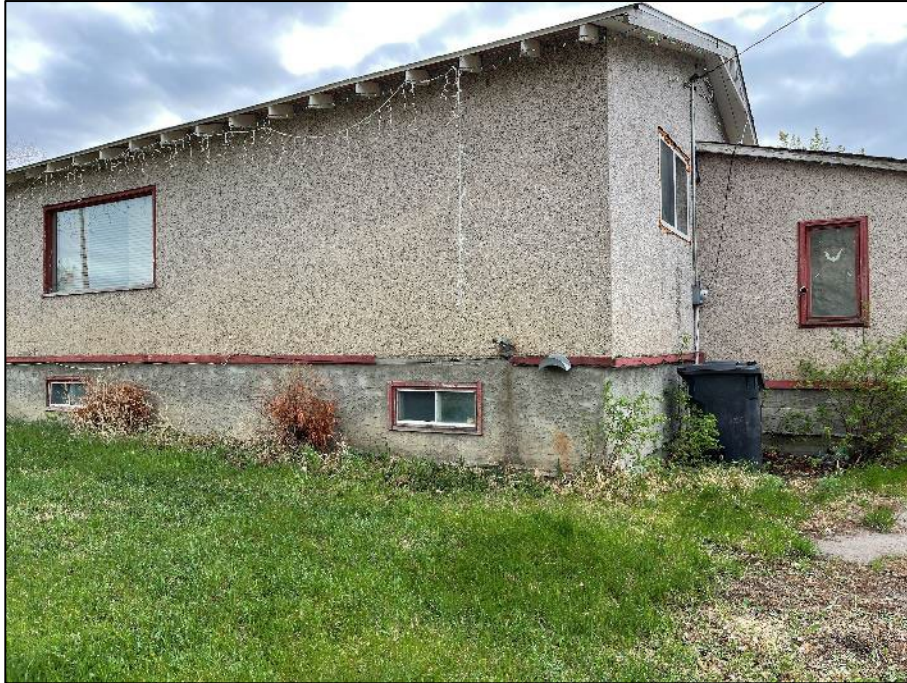
**PHOTOGRAPH #29:** Paint- Red on Main Home (Lead Based)

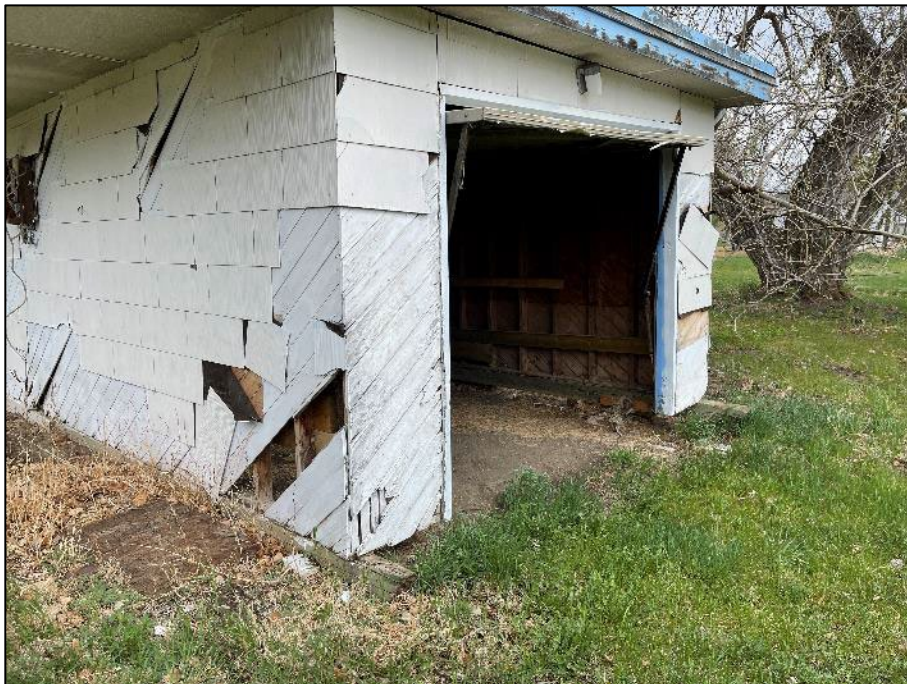
**PHOTOGRAPH #30:** Paint- Small White Shed (Lead Based)

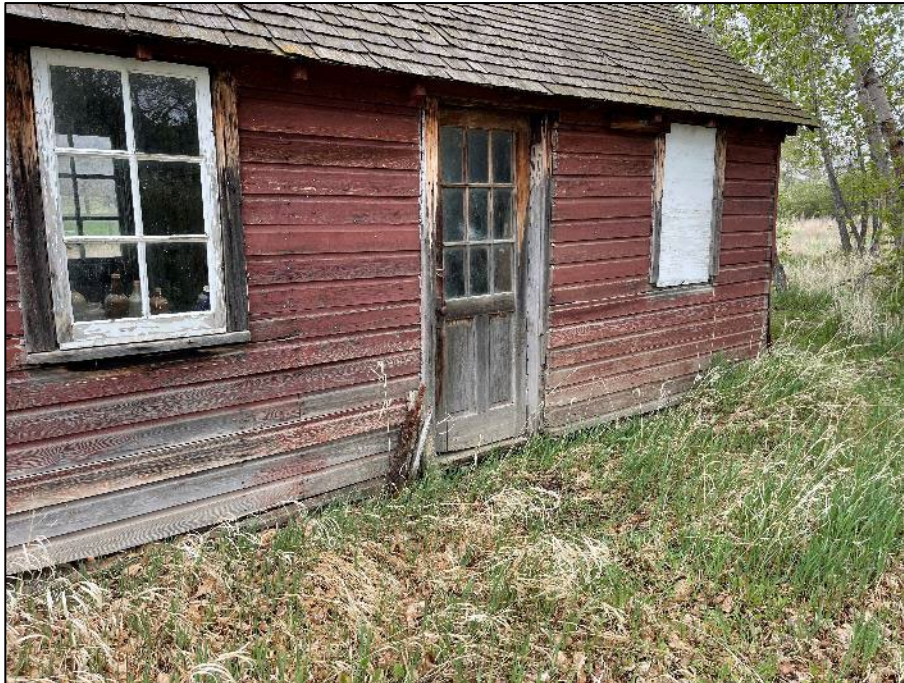
**PHOTOGRAPH #31:** Paint- Large Red Shed (Lead Based)

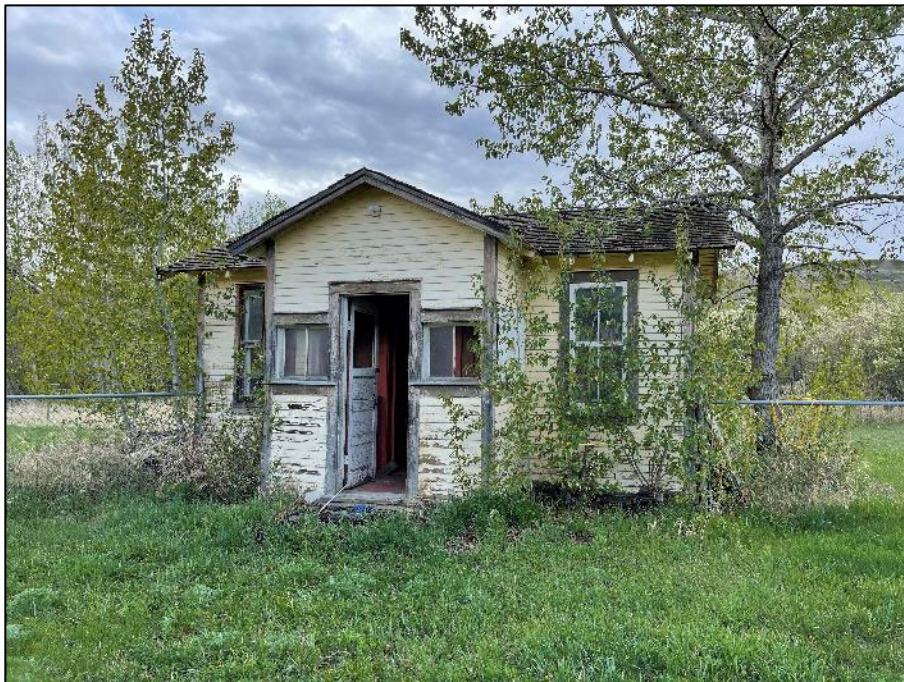
**PHOTOGRAPH #32:** Paint- Small Beige House (Lead Based)

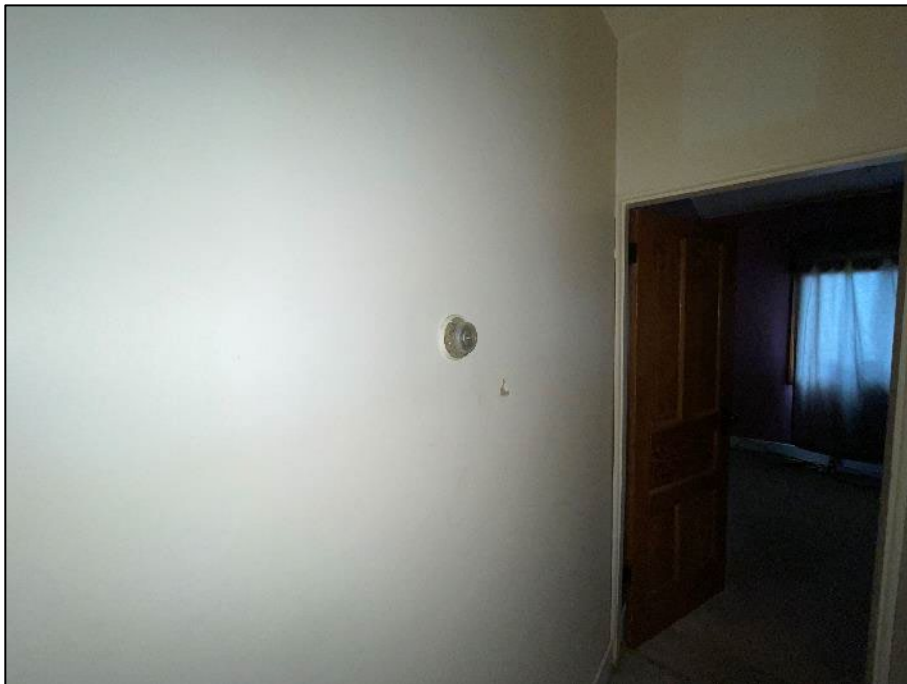
**PHOTOGRAPH #36:** Thermostat (Mercury)

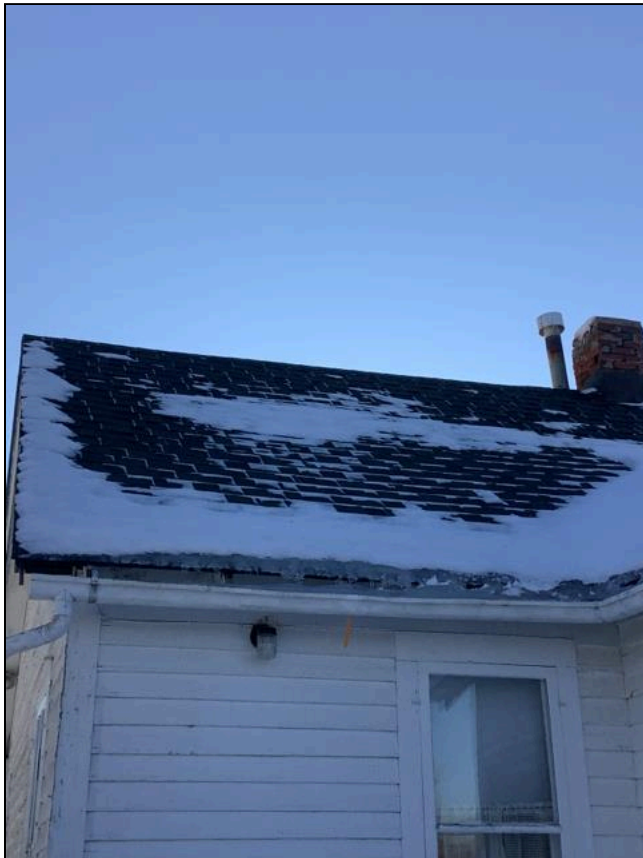
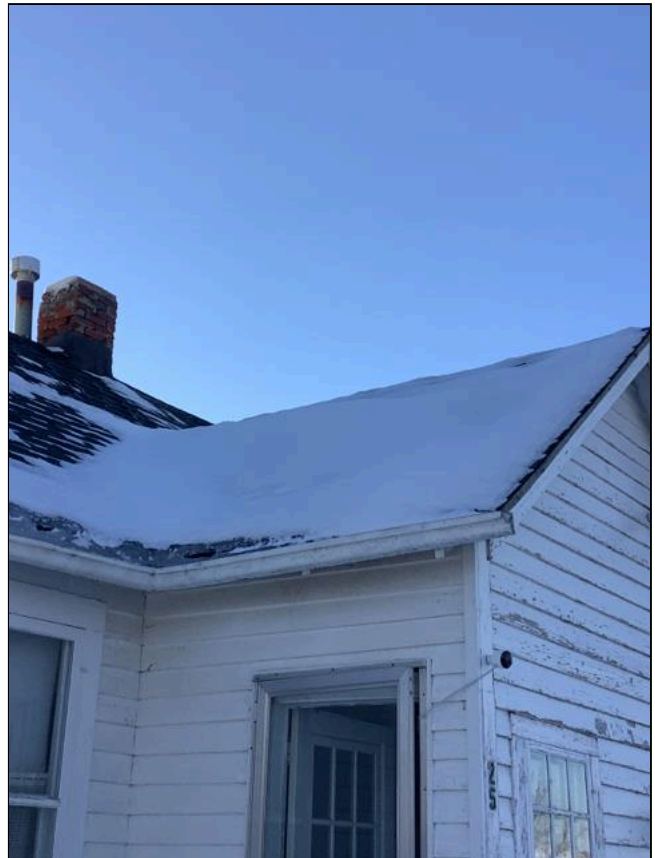
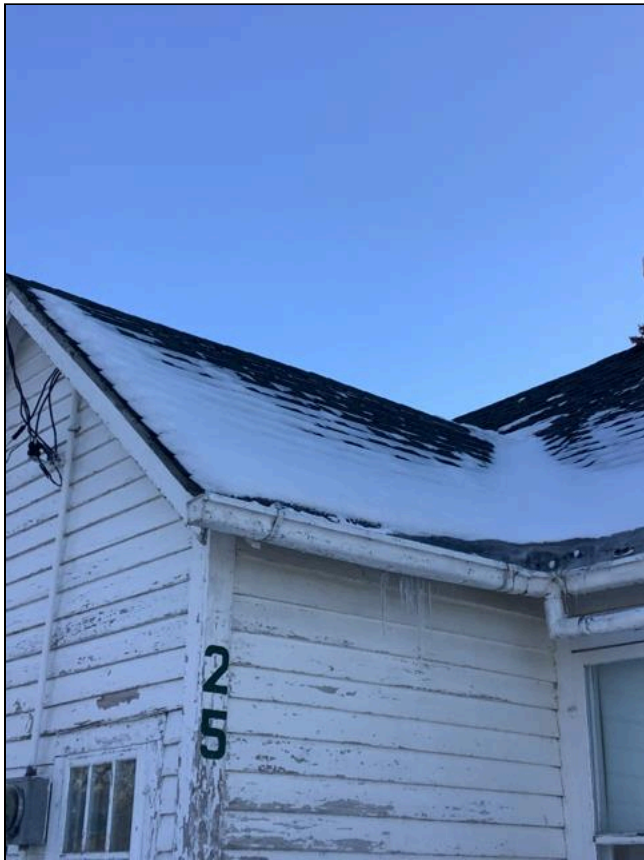
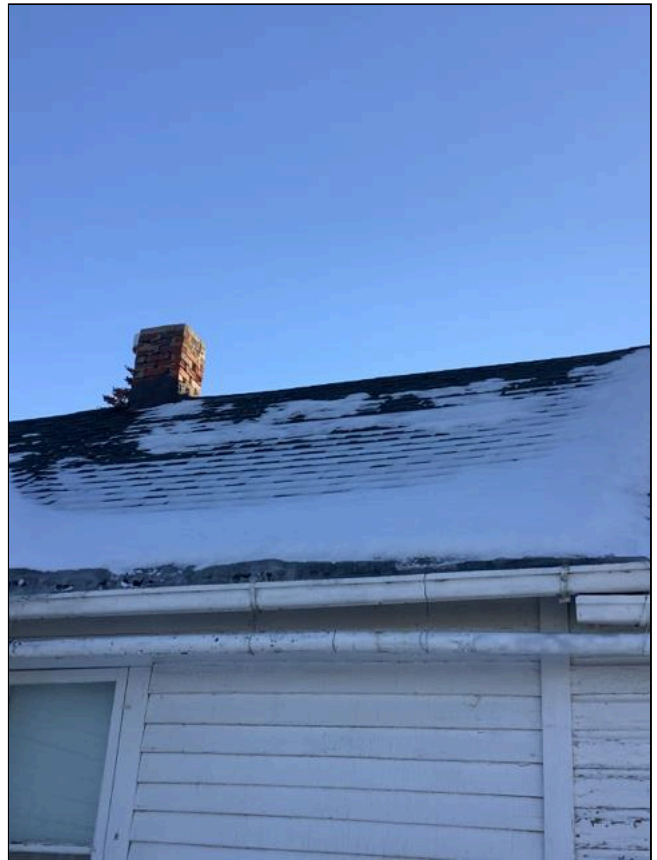
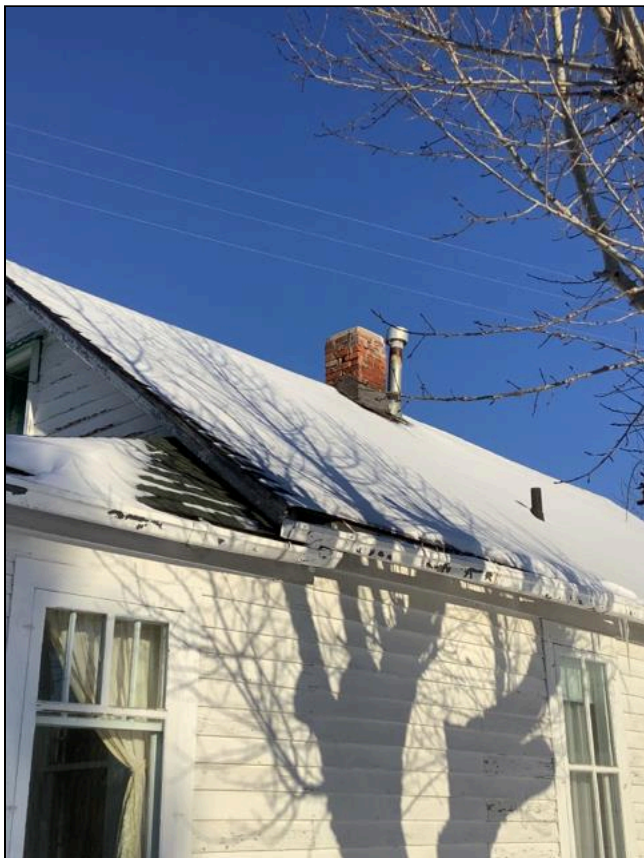
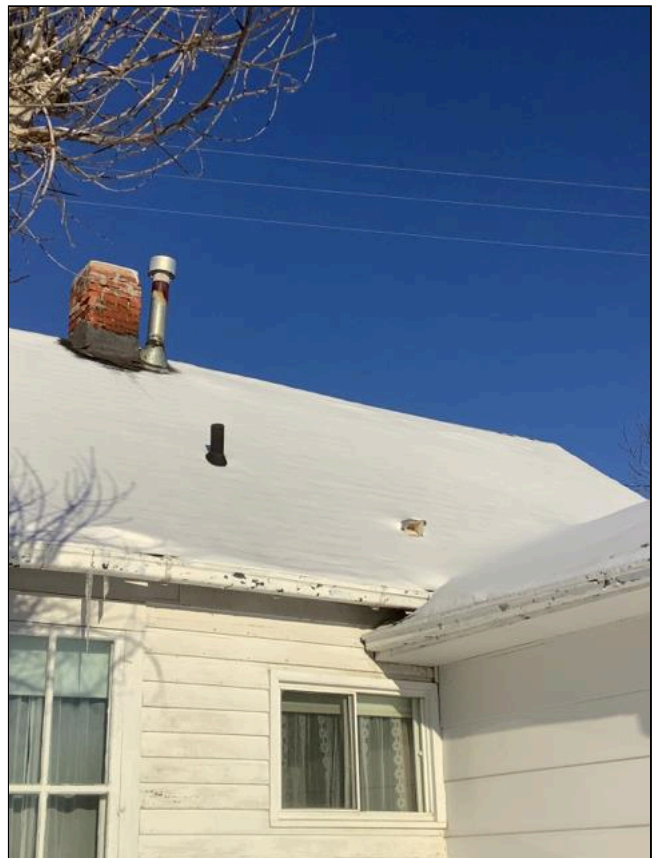
Roof was limited to a visual inspection with the use of binoculars as it was covered in snow, no issues to report from what was seen.

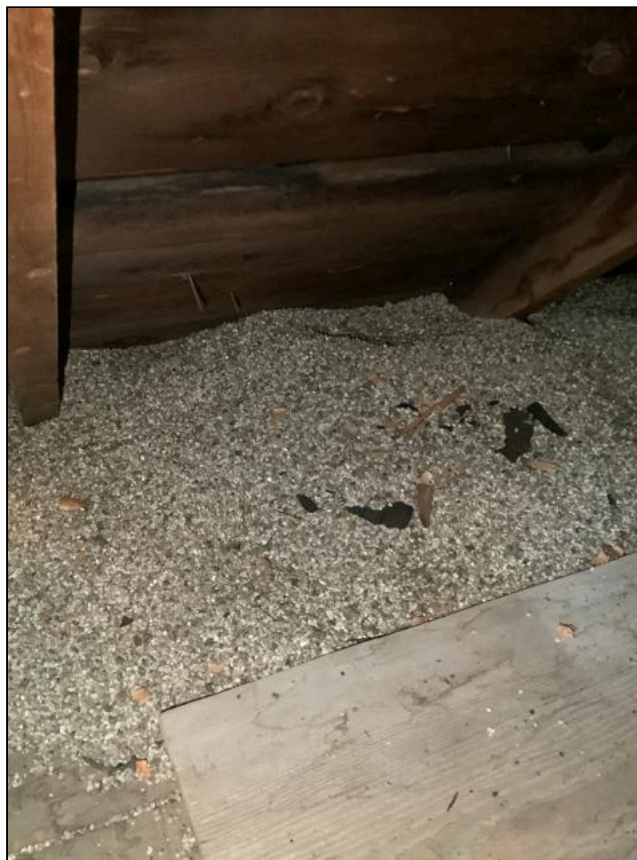
Good amount of insulation in the attic during the inspection but vermiculite was found in the attic space, samples can be taken to the lab for further analysis to confirm if it contains asbestos or not.

2.4 Item 1(Picture) Attic Insulation - vermiculite

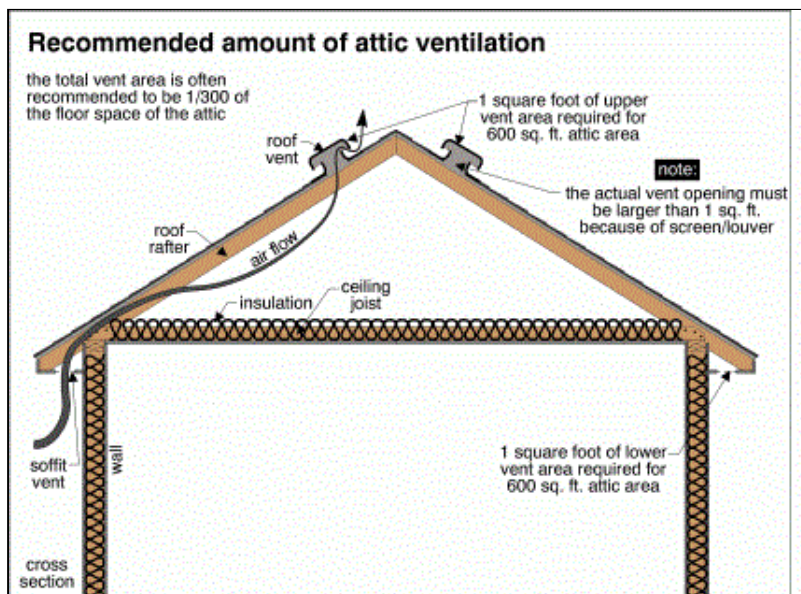
2.5 Item 1(Picture) Attic Ventilation
