# Demolition and Remediation Services

<p style="text-align: center;"><b>Institutional &amp; Residential Demolitions Project for The Town of Drumheller</b></p>
--

## **Hazardous Building Materials Assessment (Pre-construction)**

Abandoned Health Centre  
625 Riverside Drive East,  
Drumheller, Alberta

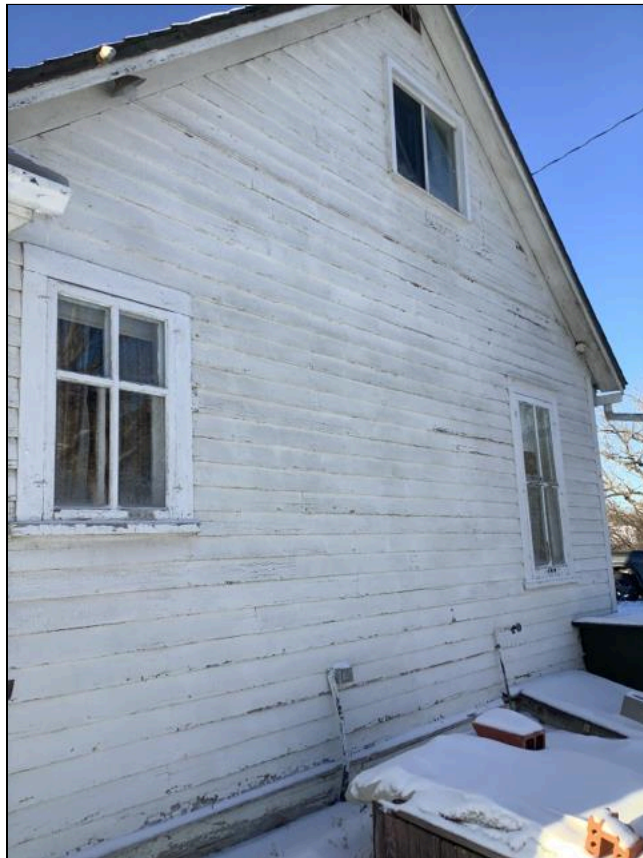
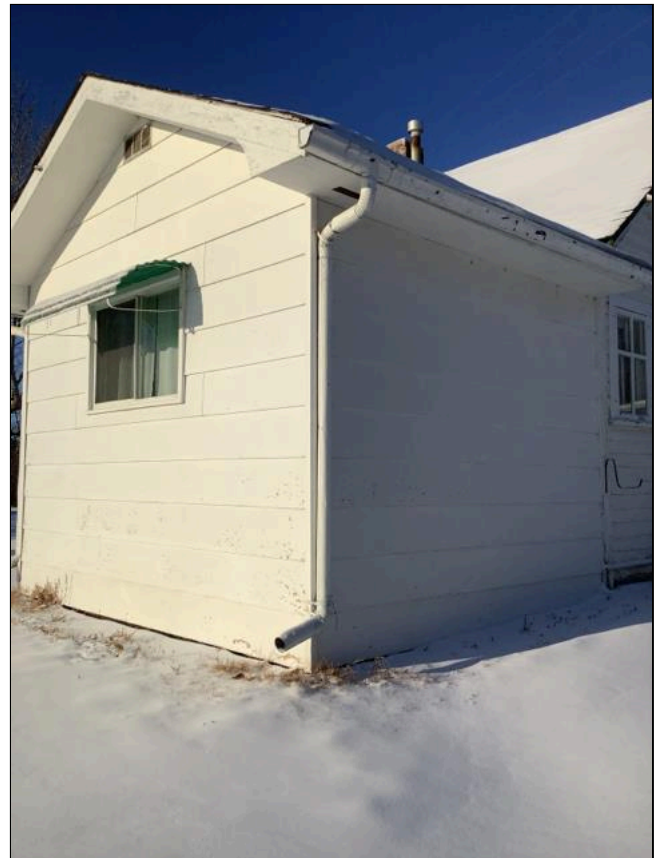
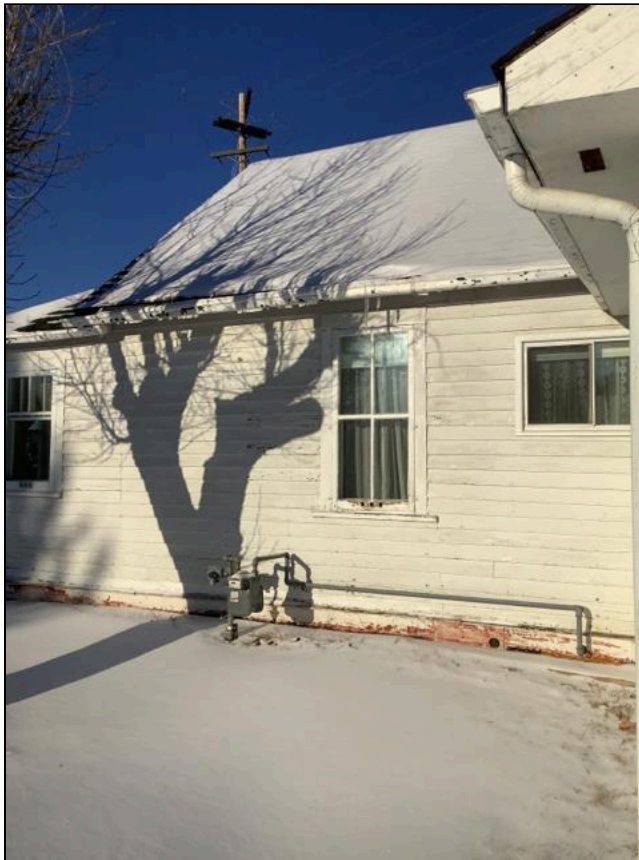
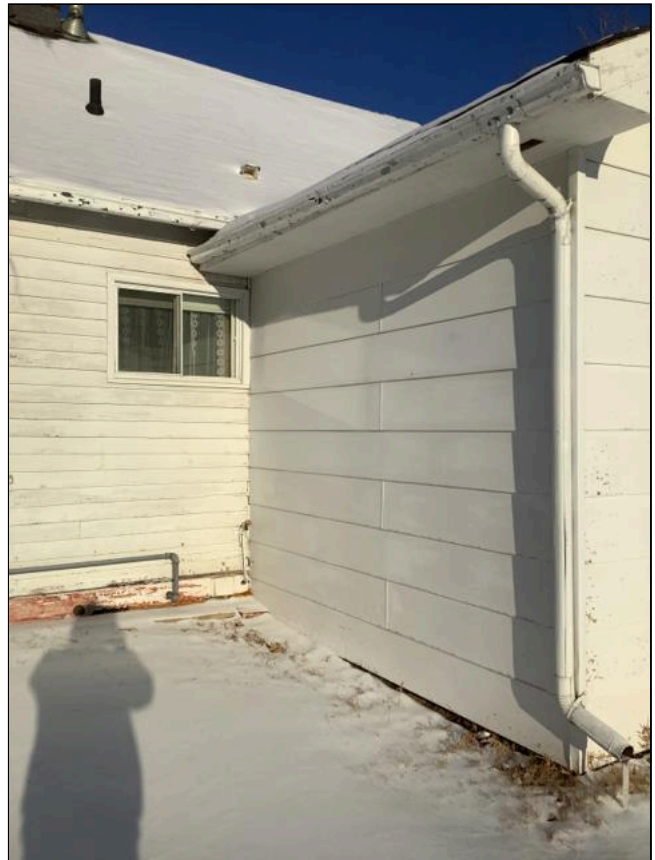
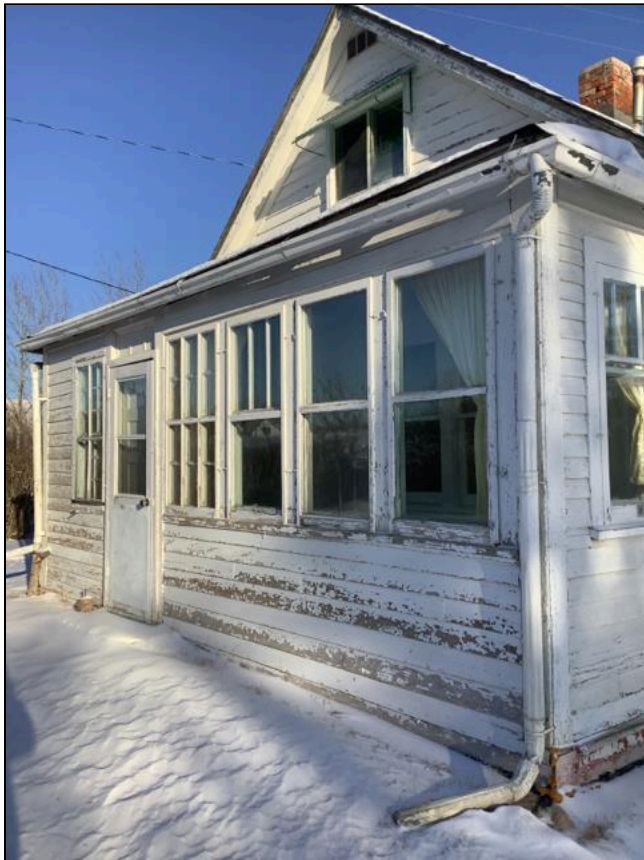
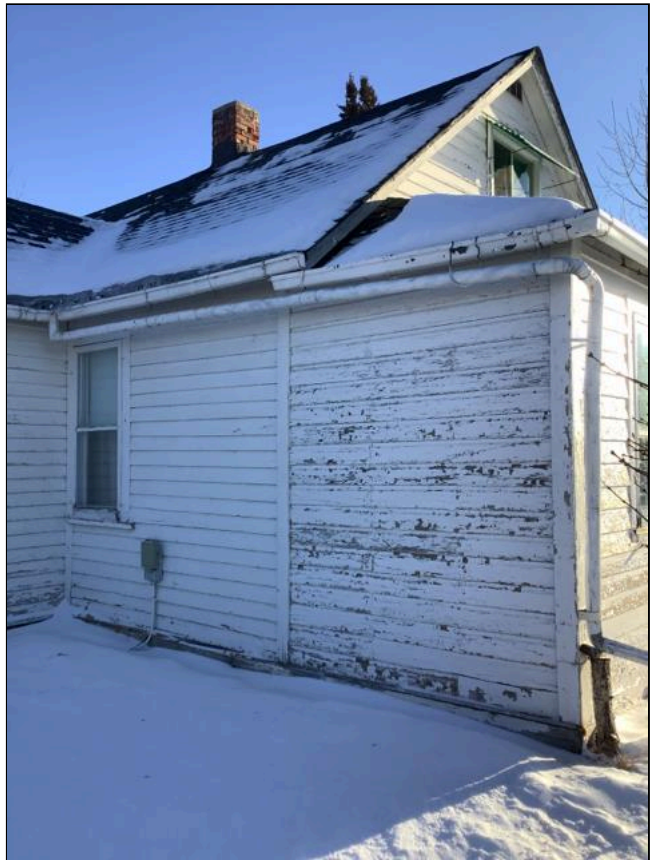
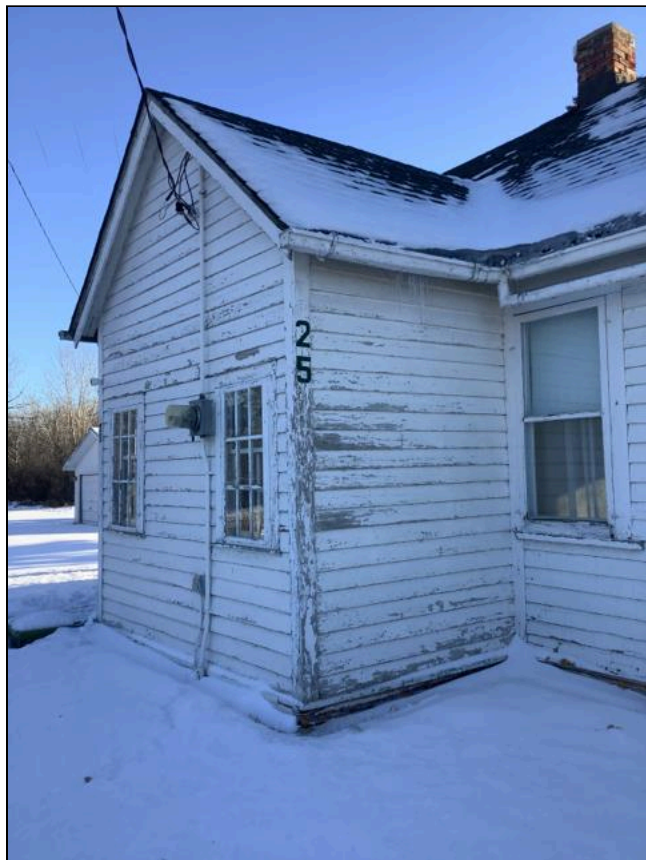
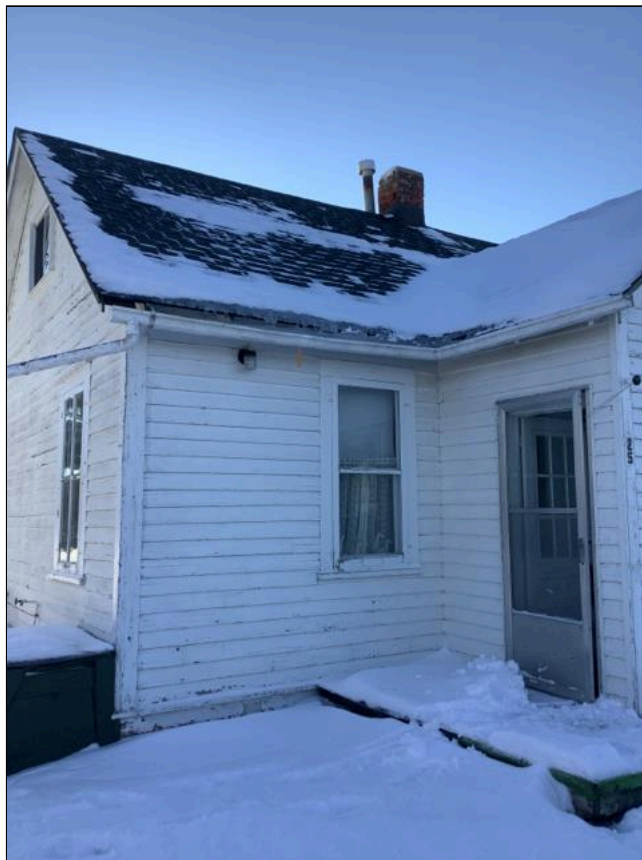
Higher levels of wall clad around the home are only visually inspected from the ground level. Exterior siding requires prep and paint to protect from the elements of nature.

3.1 Item 1(Picture) Exterior - siding requires prep and paint

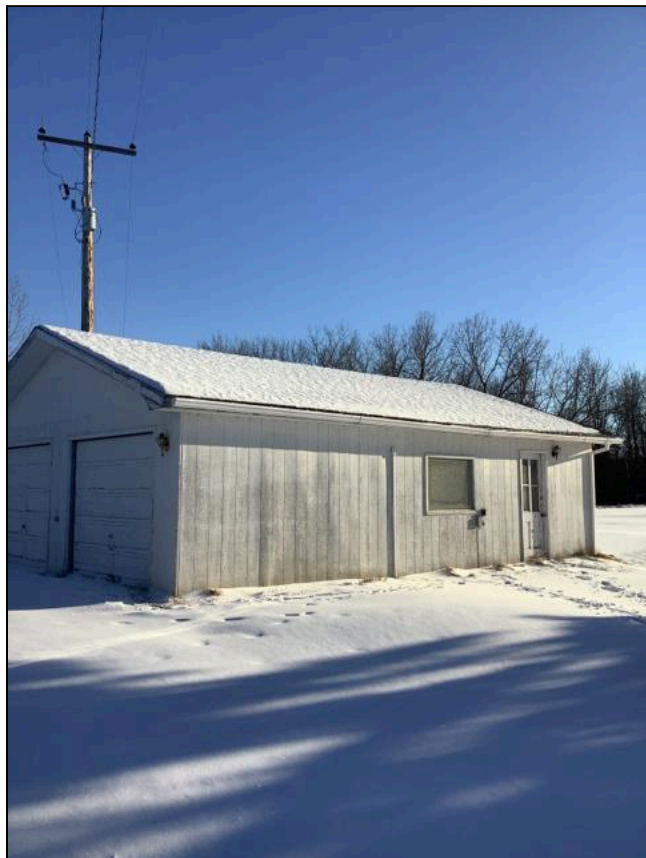
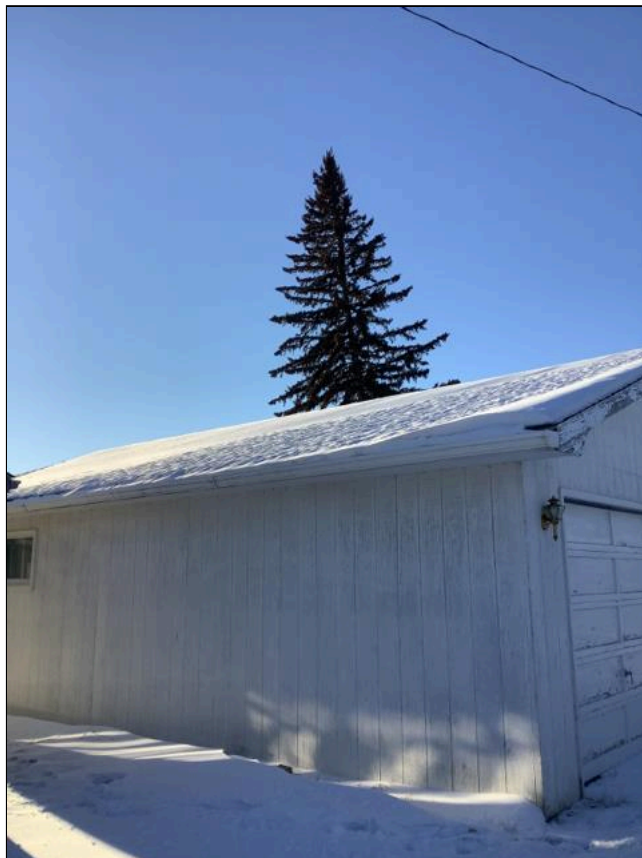
Roof was limited to a visual inspection with the use of binoculars as it was covered in snow, no issues to report from what was seen.

4.0 Item 1(Picture) Garage Roof

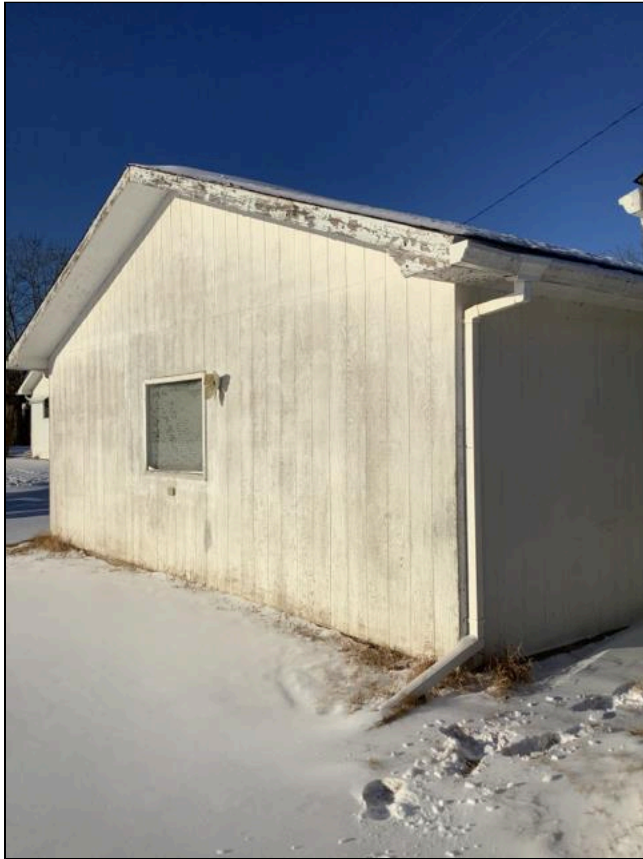
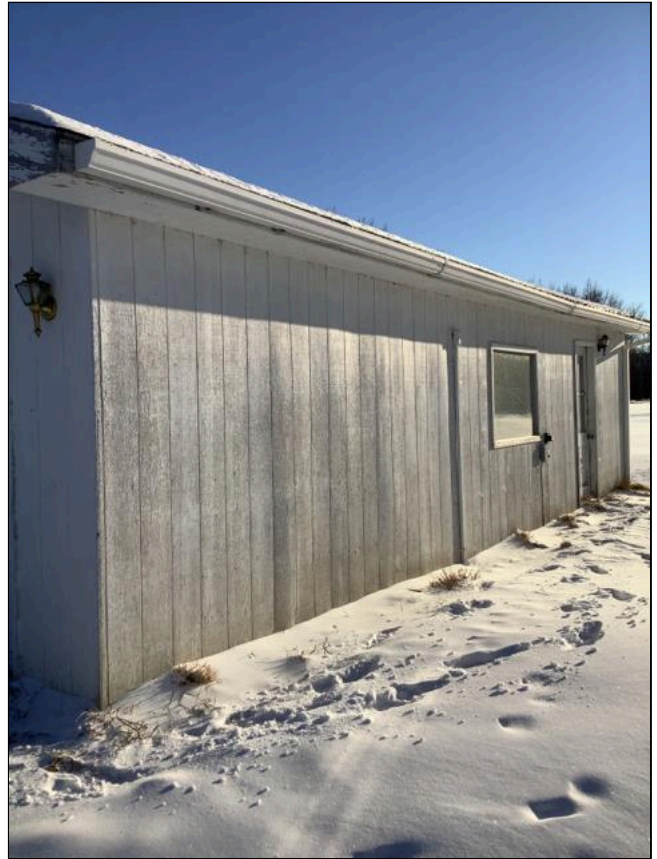
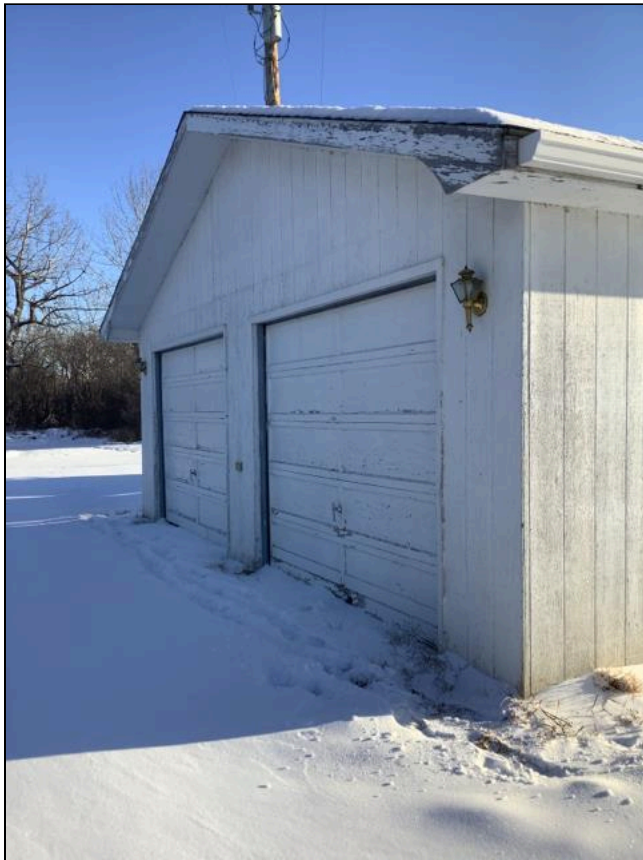
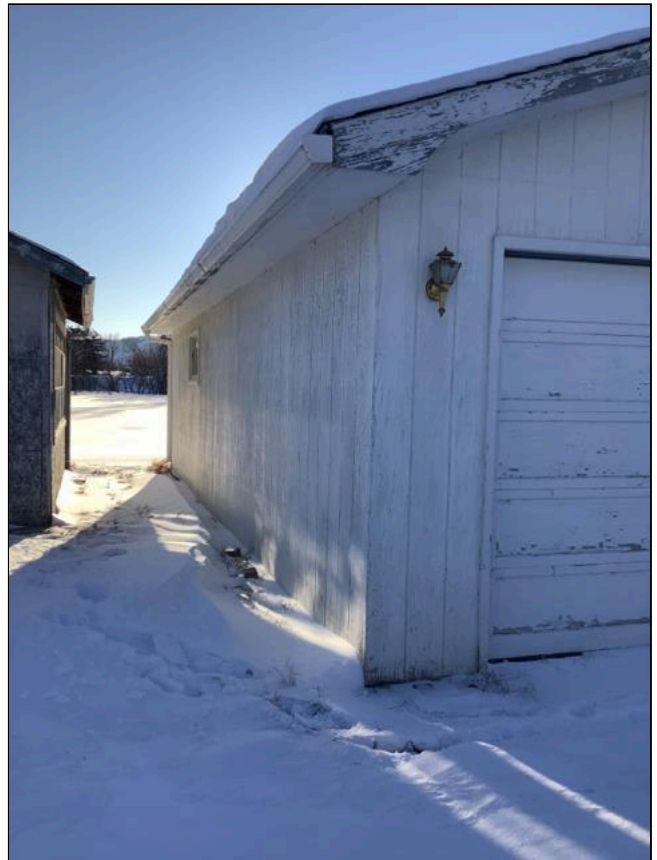
Higher levels of wall clad around the home are only visually inspected from the ground level. Exterior siding requires prep and paint to protect from the elements of nature.

4.4 Item 1(Picture) Garage Exterior - siding requires prep and paint

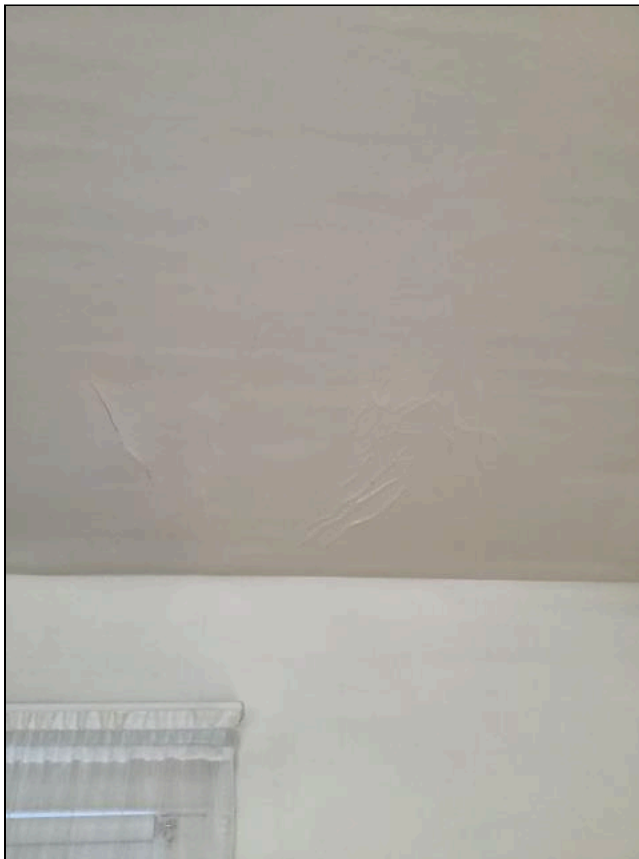
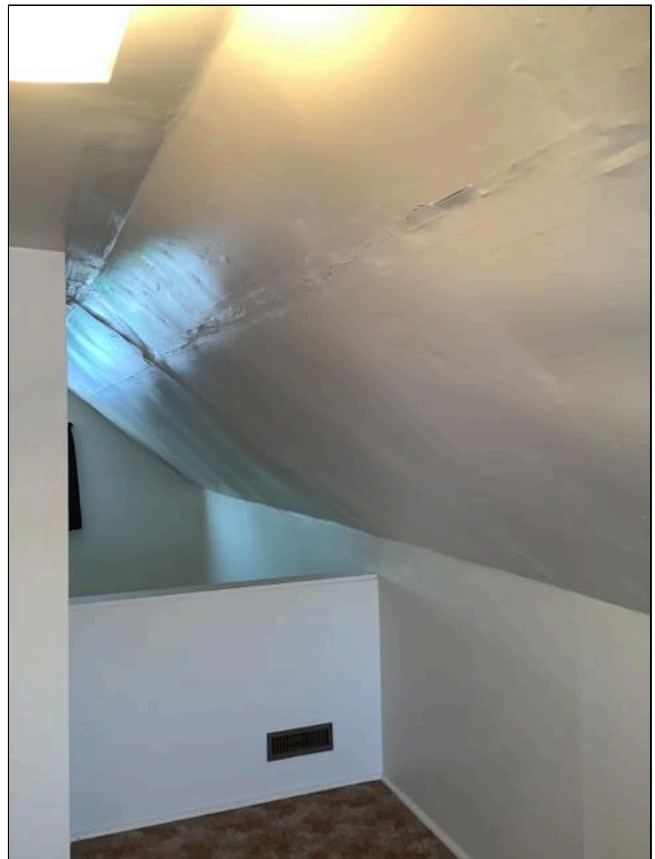
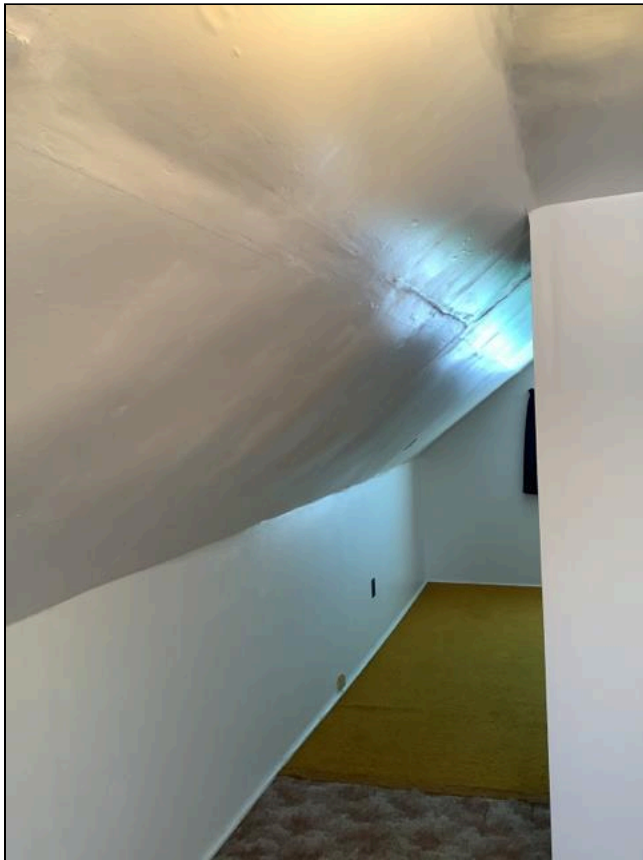
The plaster is all wrinkling and cracking and will require repair, plaster also may contain asbestos and should be tested for further verification by a lab.

5.0 Item 1(Picture) Ceiling - plaster wrinkled and cracking, may contain asbestos

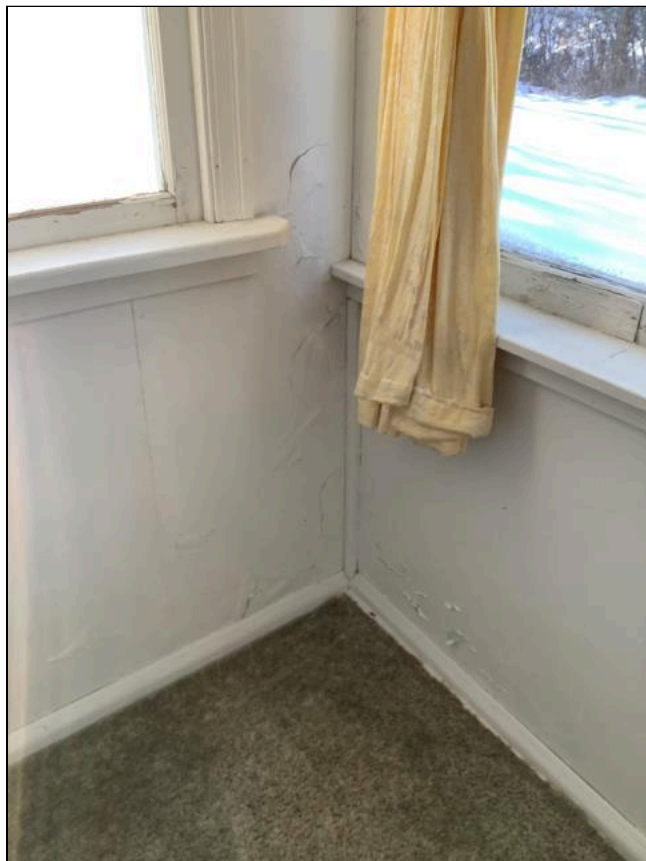
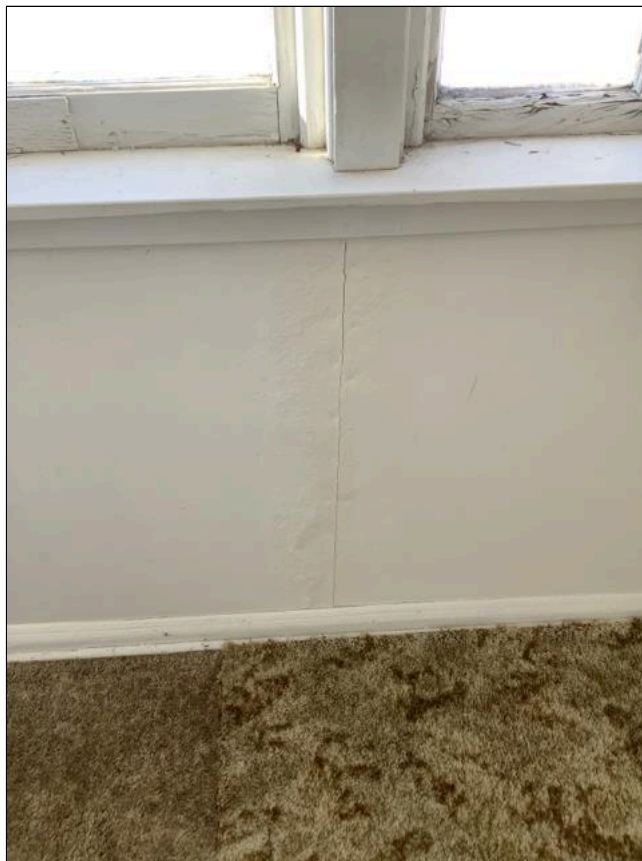
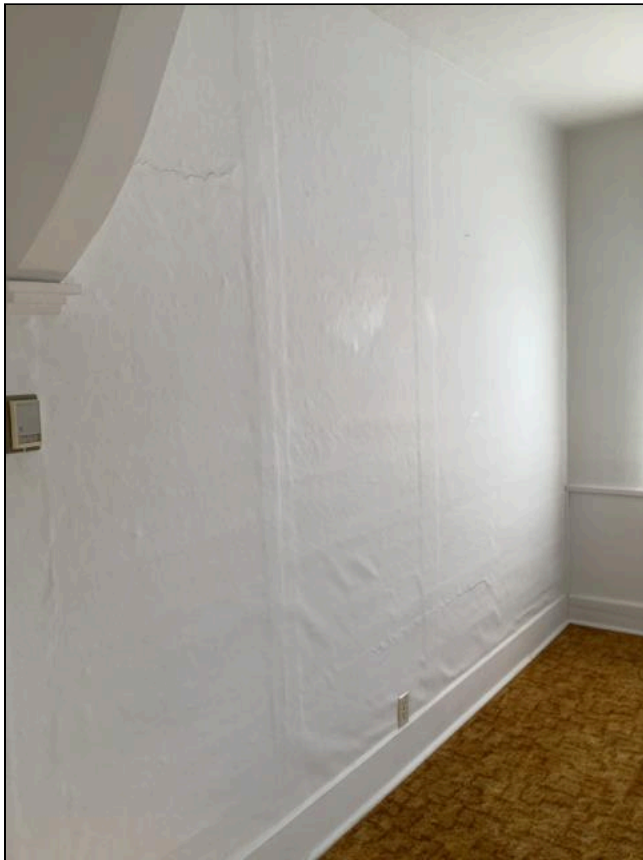
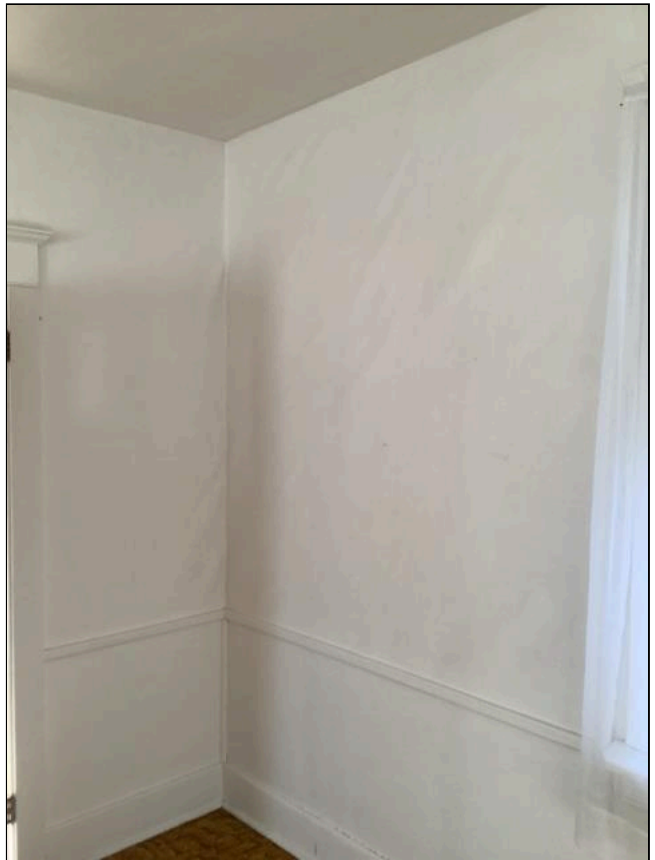
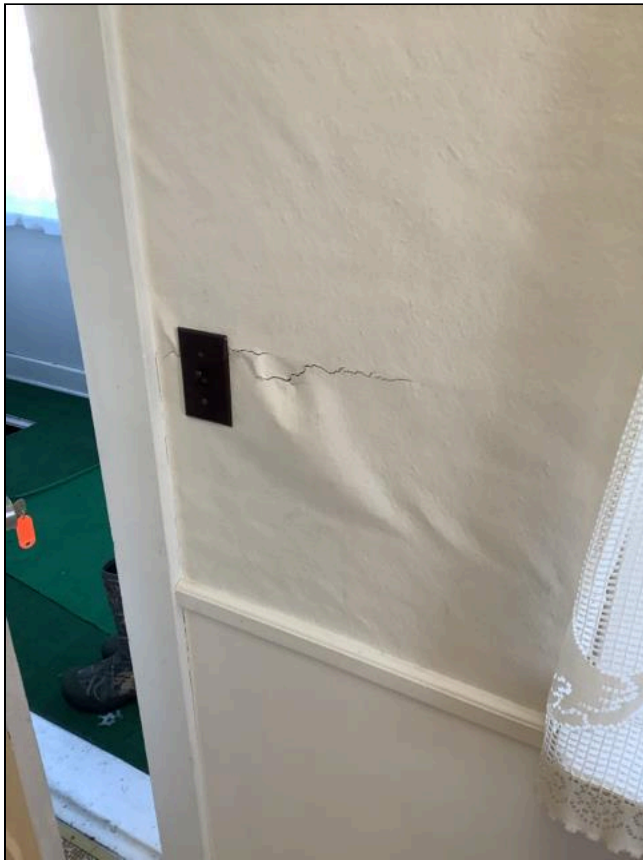
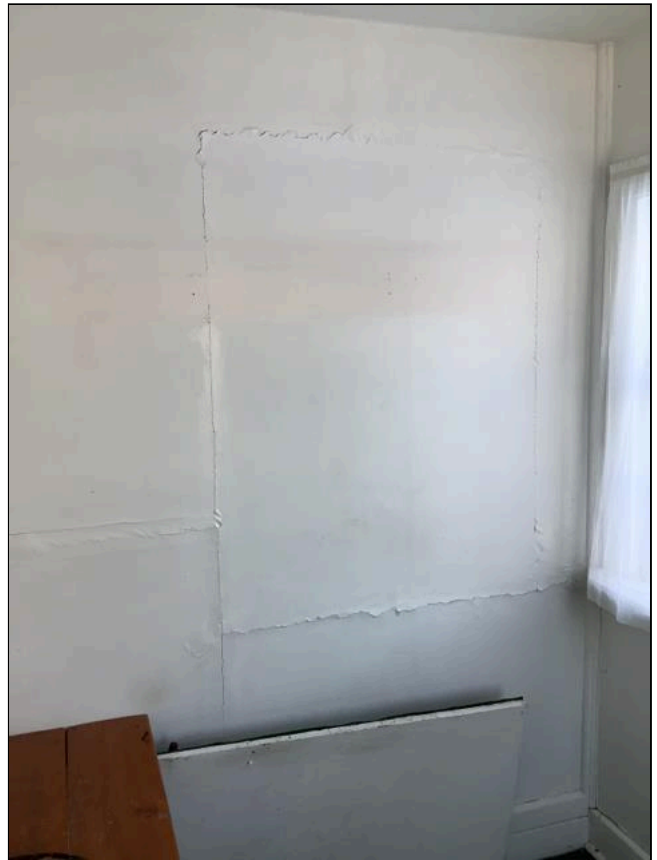
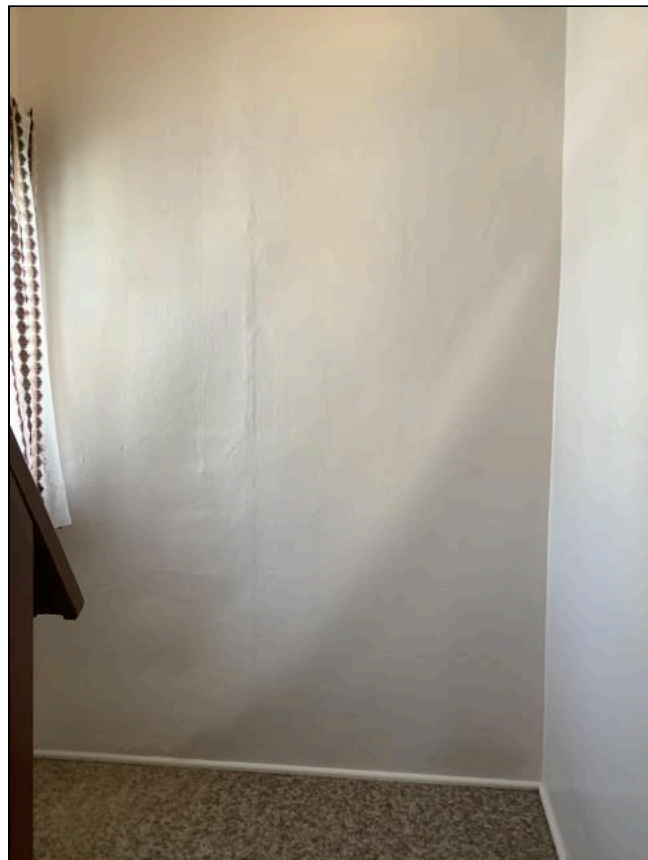
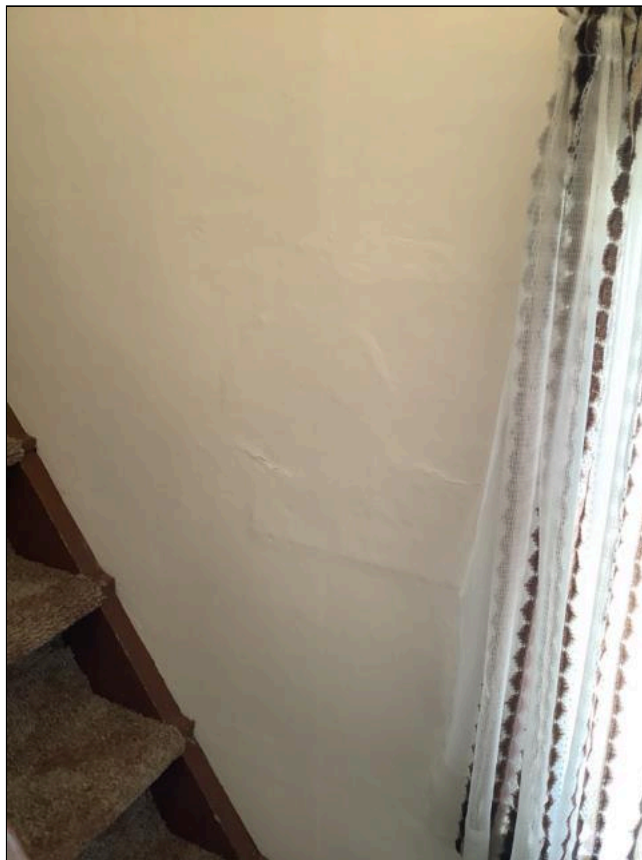
The plaster is all wrinkling and cracking and will require repair, plaster also may contain asbestos and should be tested for further verification by a lab.

5.1 Item 1(Picture) Interior Walls - plaster wrinkling and cracked, may contain asbestos

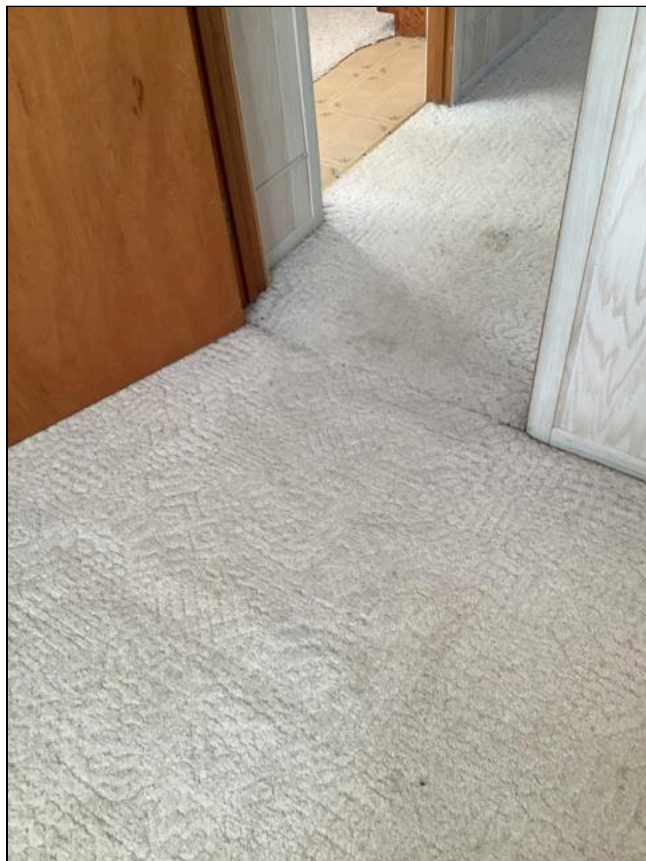
In between the bedroom and bathroom there is a soft spot in the flooring, there is also two heaved areas, one in the kitchen and the other in the living room.

5.2 Item 1(Picture) Bedroom/Bathroom Floor - soft spot

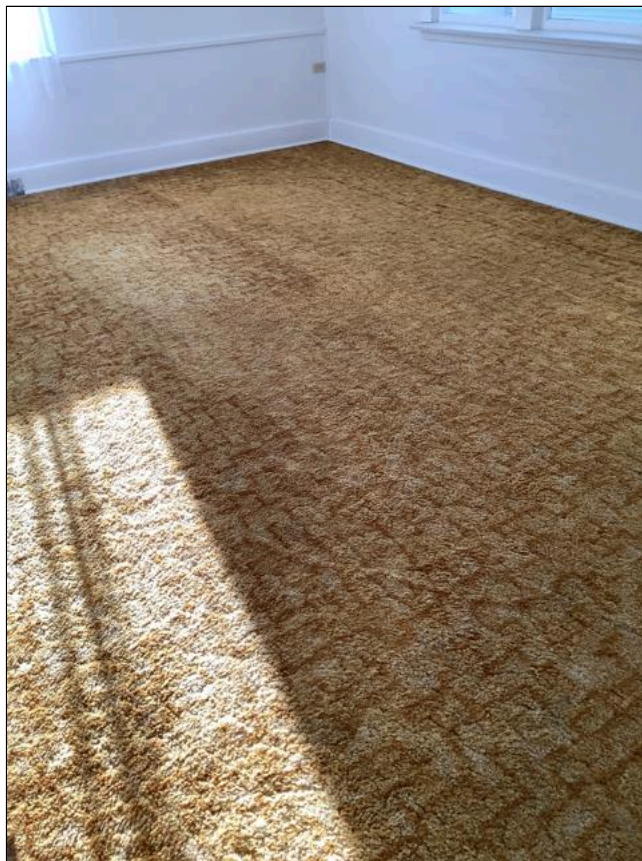
5.2 Item 2(Picture) Floor - heaved

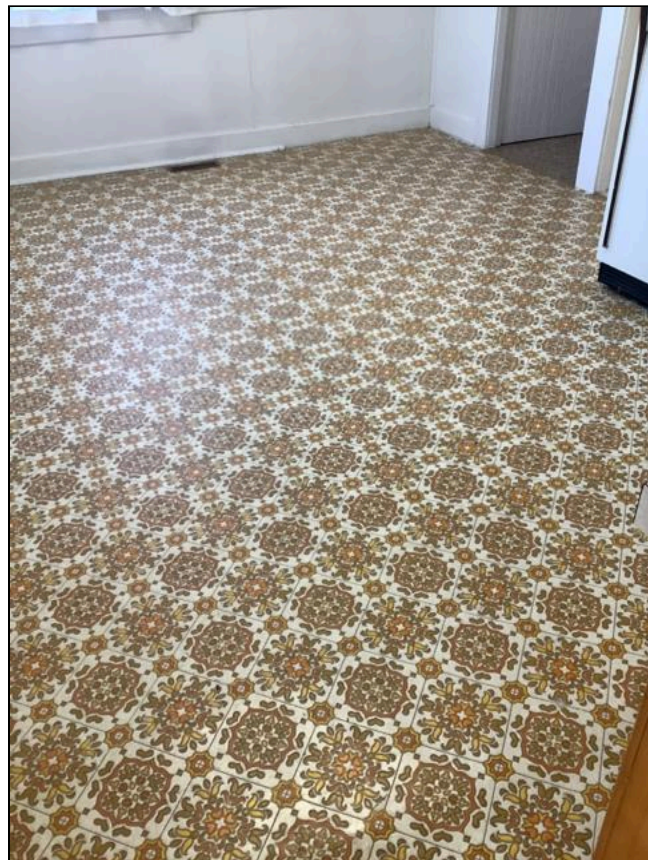
5.2 Item 3(Picture) Floor - heaved

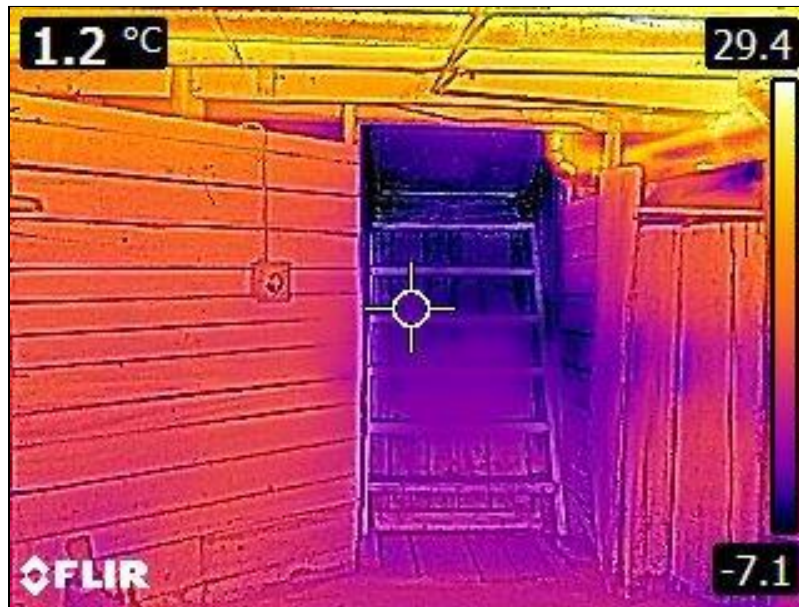
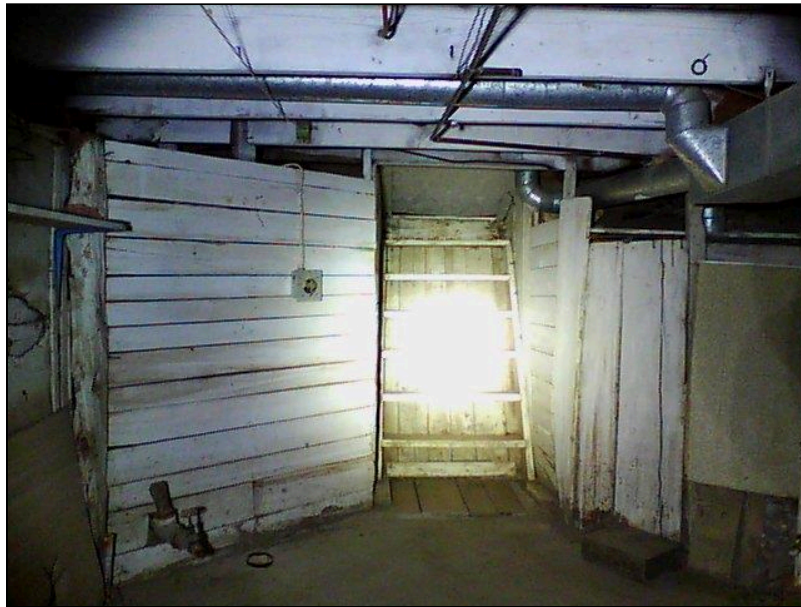
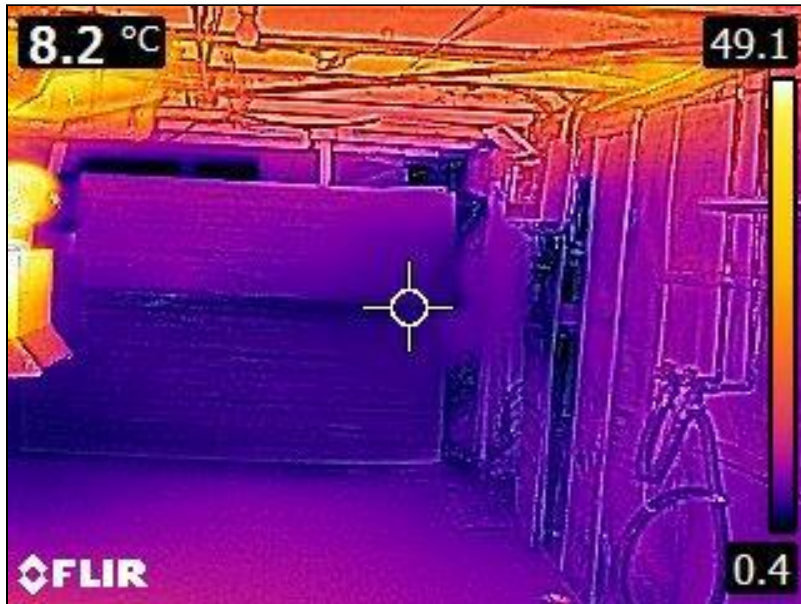
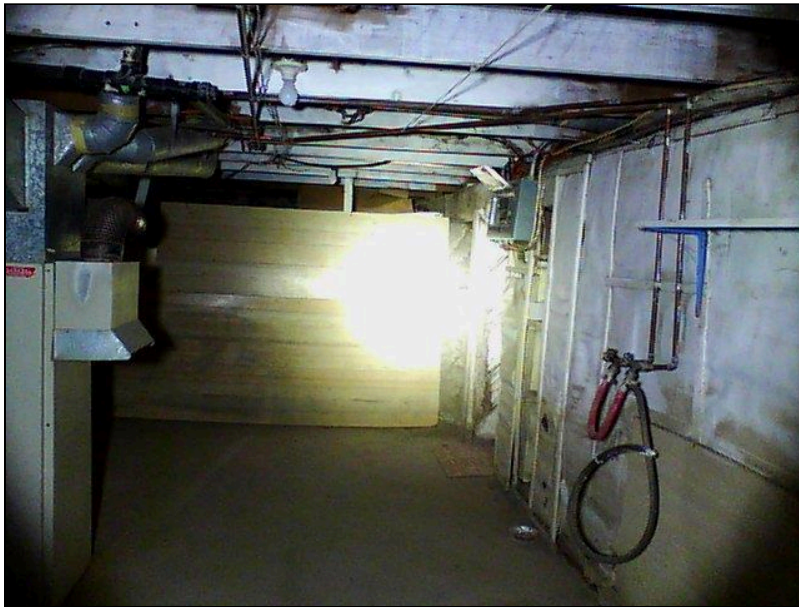
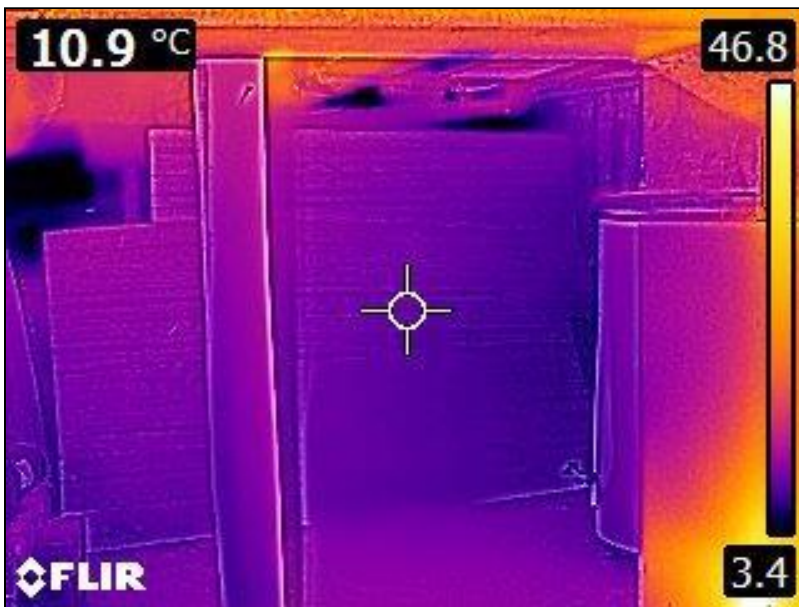
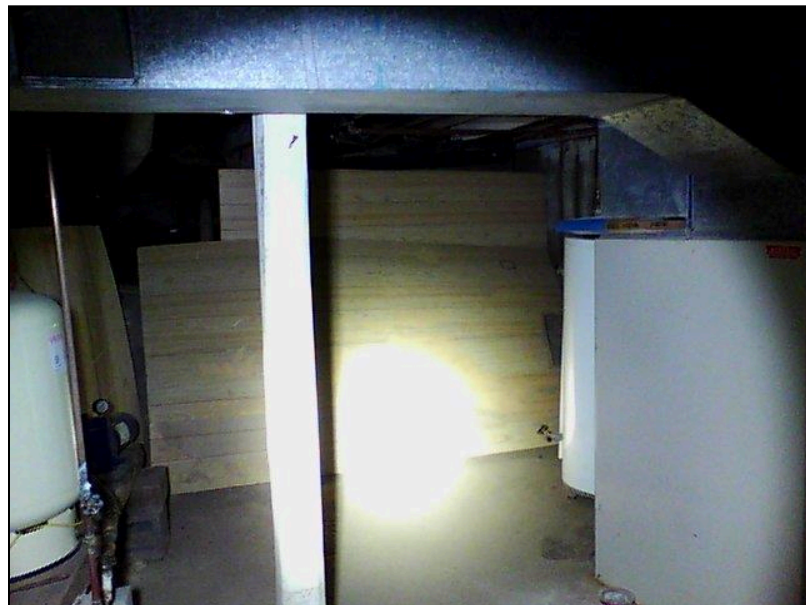
The basement area was dry on day of the inspection. Future conditions cannot be determined as these are changeable with the weather conditions. Recommend obtaining information from seller on any past water/moisture penetration.

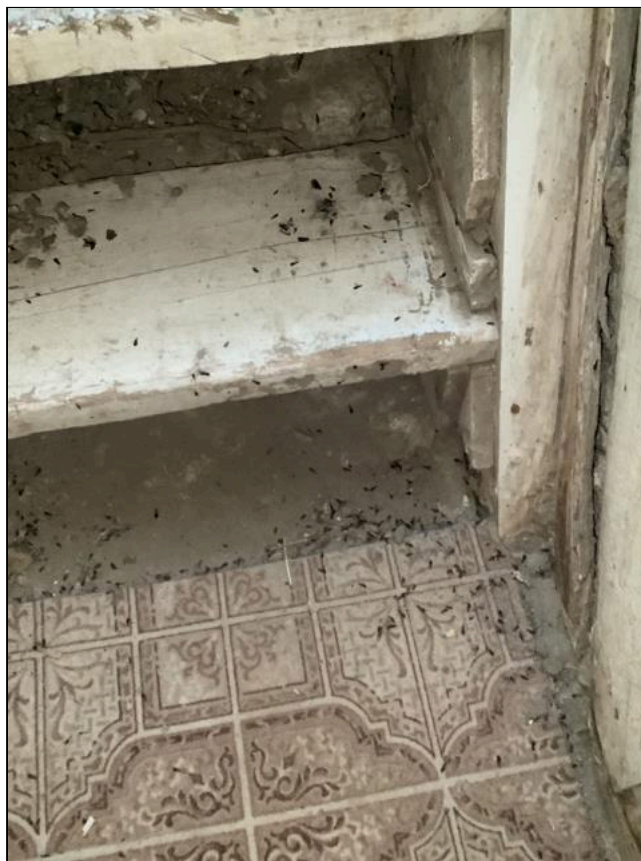
The basement has lots of signs of rodent droppings, recommend that a pest specialist further review and remove as required.

7.3 Item 1(Picture) Basement - signs of rodent droppings

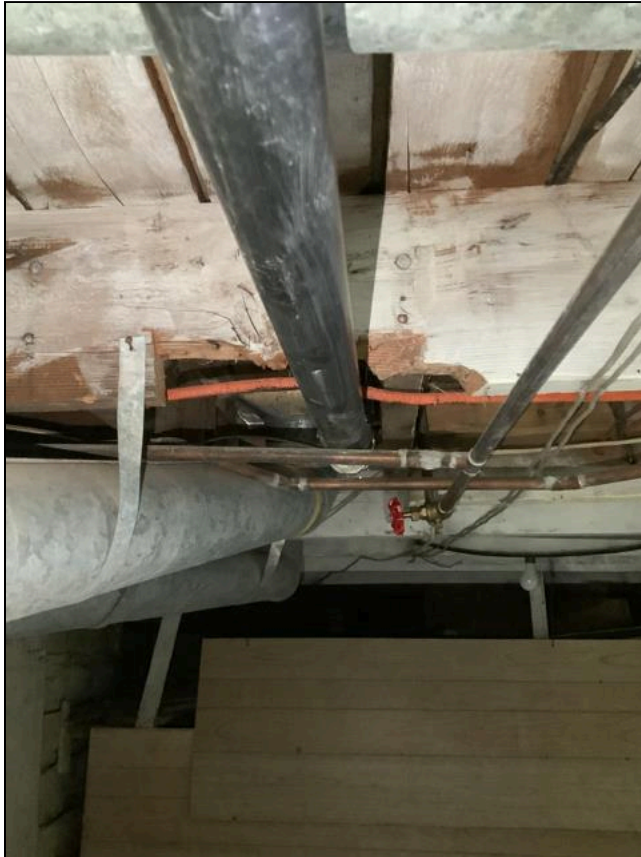
Floor joists are an important part of the supportive structure of a floor. They hold up the weight of a building, absorb impacts on the floor, and create structural support so that the floor will be stable secure. Suggest consulting professional prior to modification.

7.9 Item 1(Picture) Joists and Beams - notched out and split

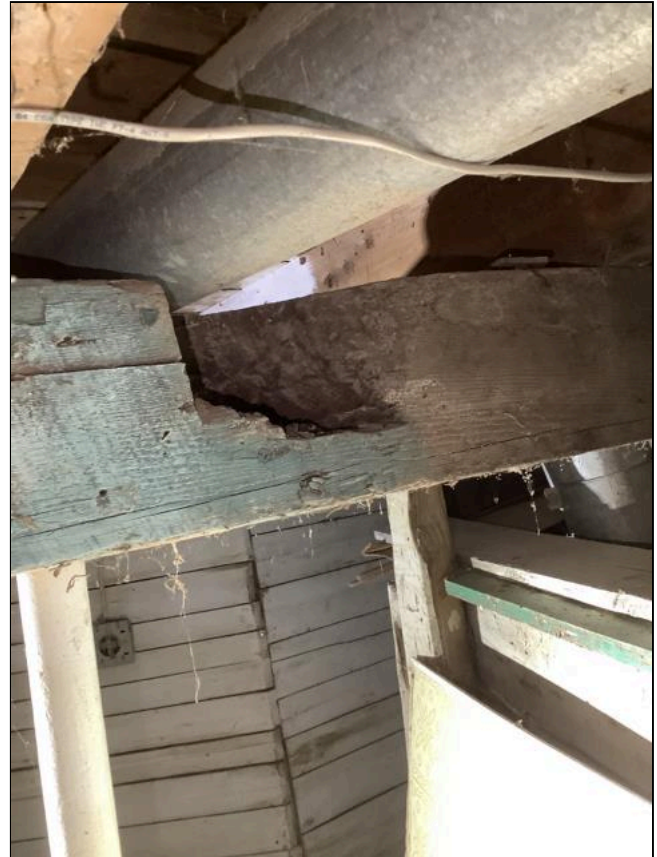
7.9 Item 2(Picture) Joists and Beams - notched out and split

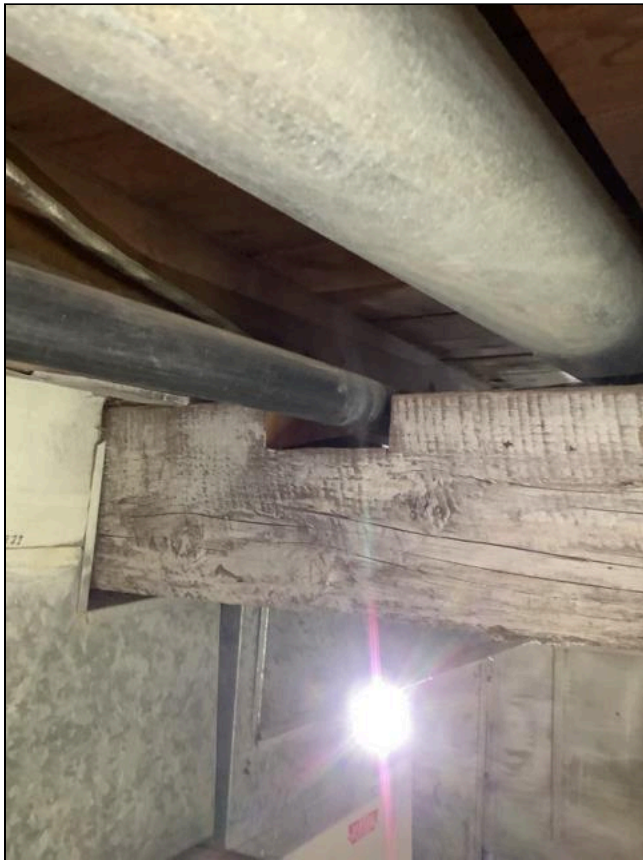
7.9 Item 3(Picture) Joists and Beams - notched out and split

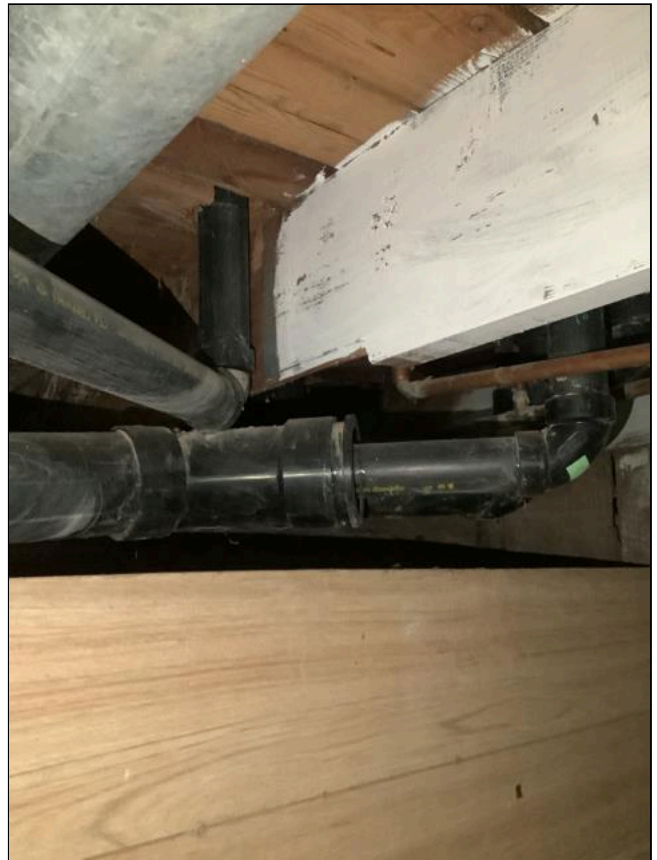
7.9 Item 4(Picture) Joists and Beams - notched out and split

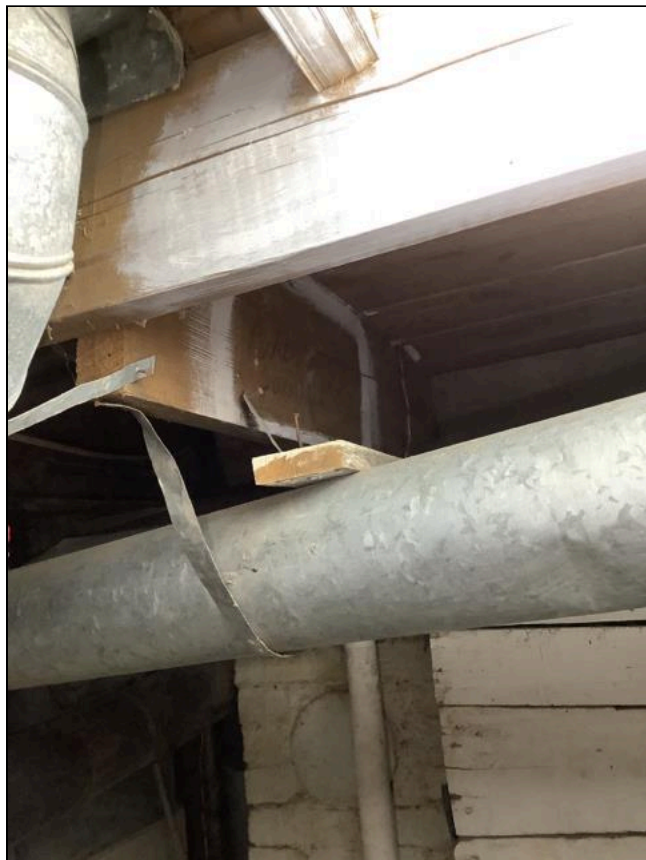
7.9 Item 5(Picture) Joists and Beams - notched out and split

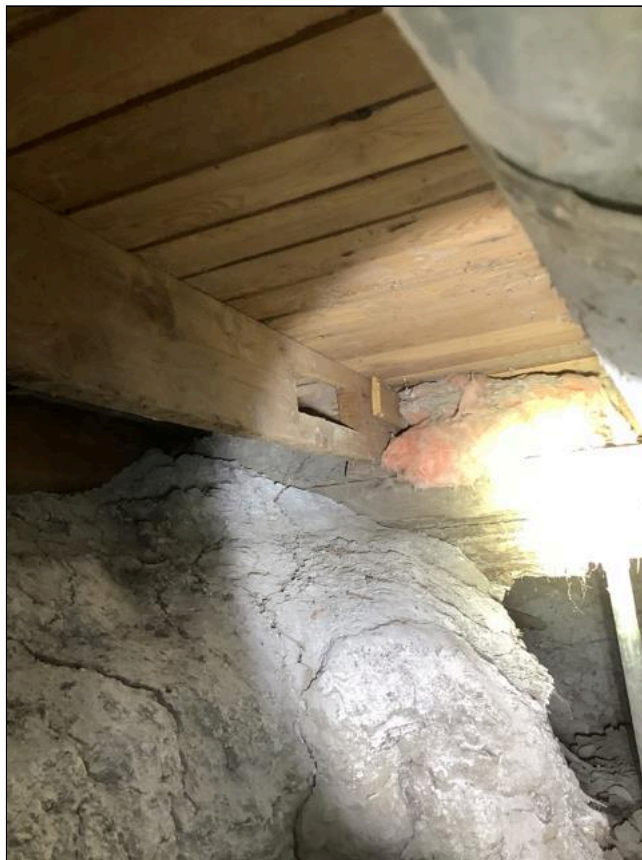
7.9 Item 6(Picture) Joists and Beams - notched out and split
