# Demolition and Remediation Services

<p style="text-align: center;"><b>Institutional &amp; Residential Demolitions Project for The Town of Drumheller</b></p>
--

## **Hazardous Building Materials Assessment (Pre-construction)**

Abandoned Health Centre  
625 Riverside Drive East,  
Drumheller, Alberta

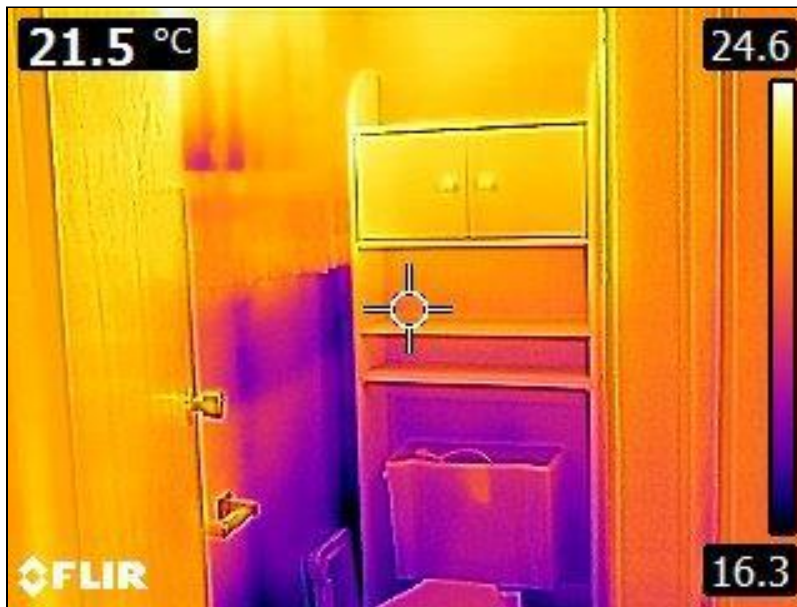
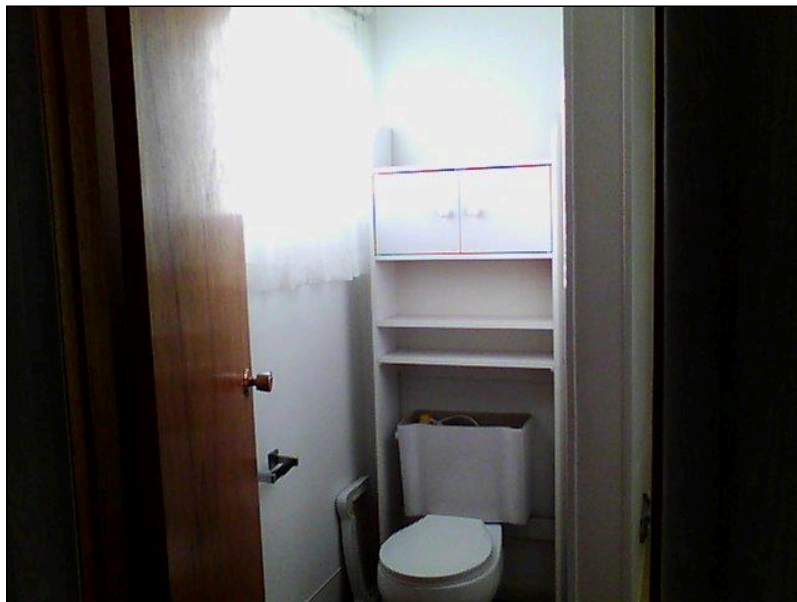
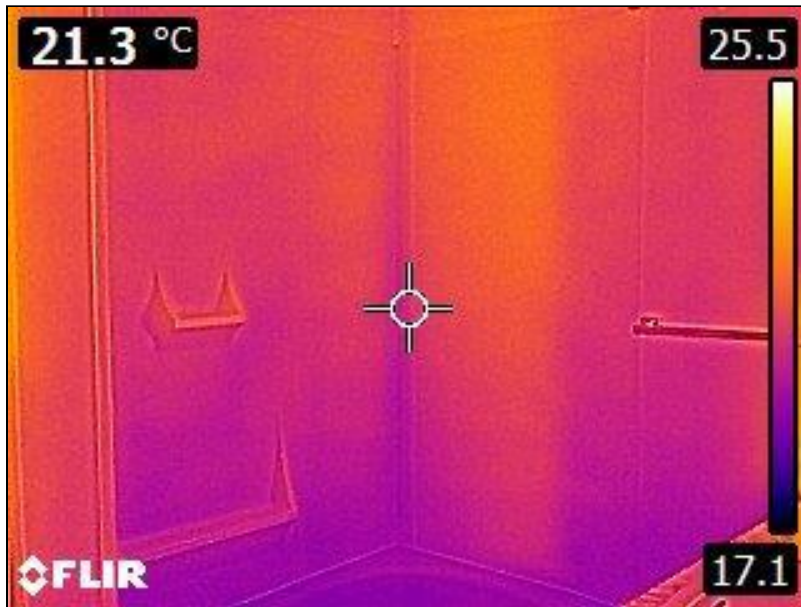
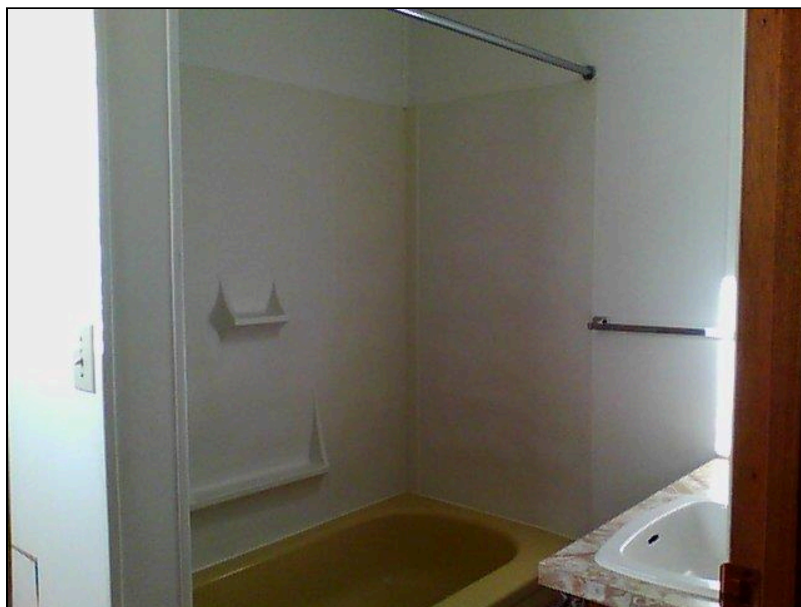
All bathroom walls and ceiling were in good condition and dry at time of inspection. (Cosmetic issues are not part of the inspection.)

9.0 Item 1(Picture) Bathroom Walls

9.0 Item 2(Picture) Bathroom Walls

9.0 Item 3(Picture) Bathroom Walls

9.0 Item 4(Picture) Bathroom Walls

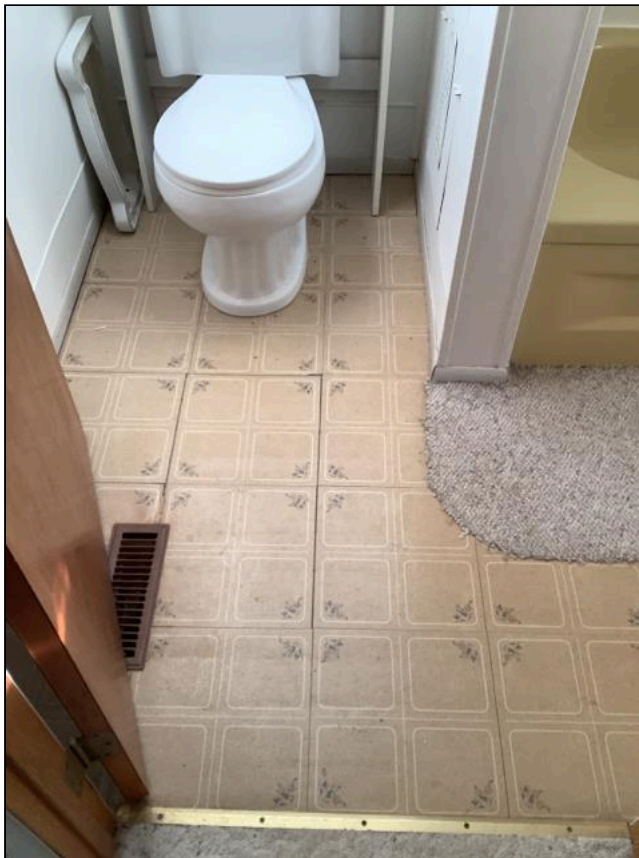
The main floor bathroom has the old 9" tiles that may contain asbestos and should be further reviewed by a lab to see if they contain asbestos or not.

9.1 Item 1(Picture) Main Floor Bathroom - tiles may contain asbestos

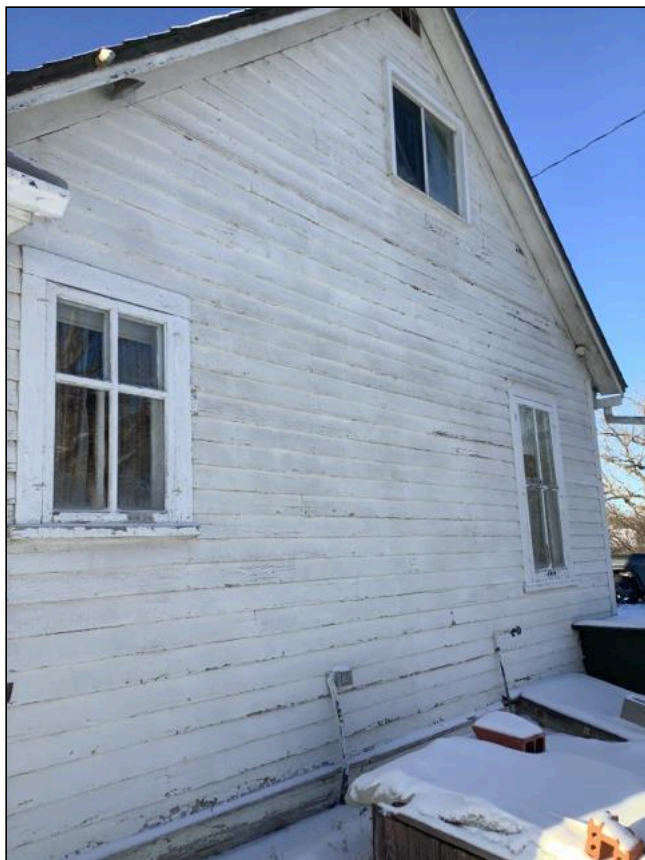
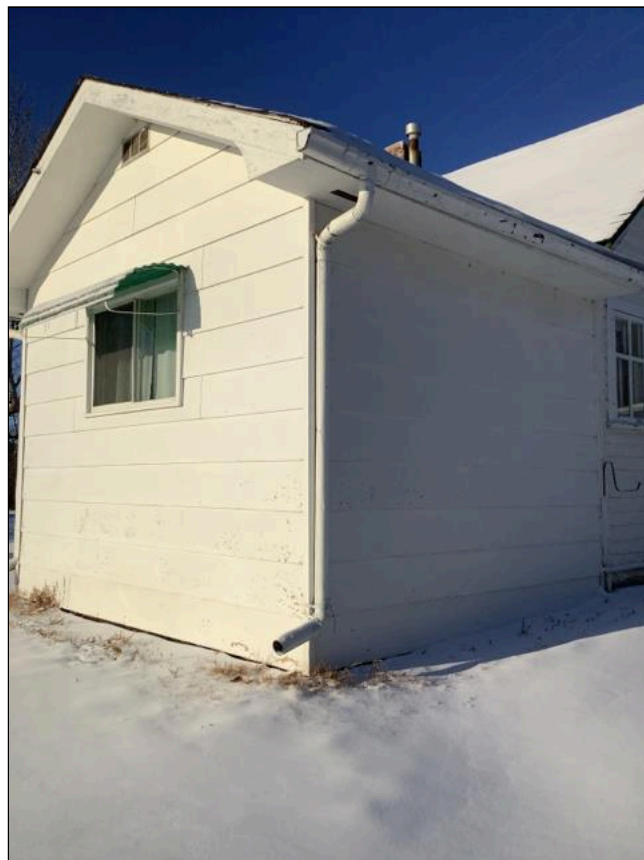
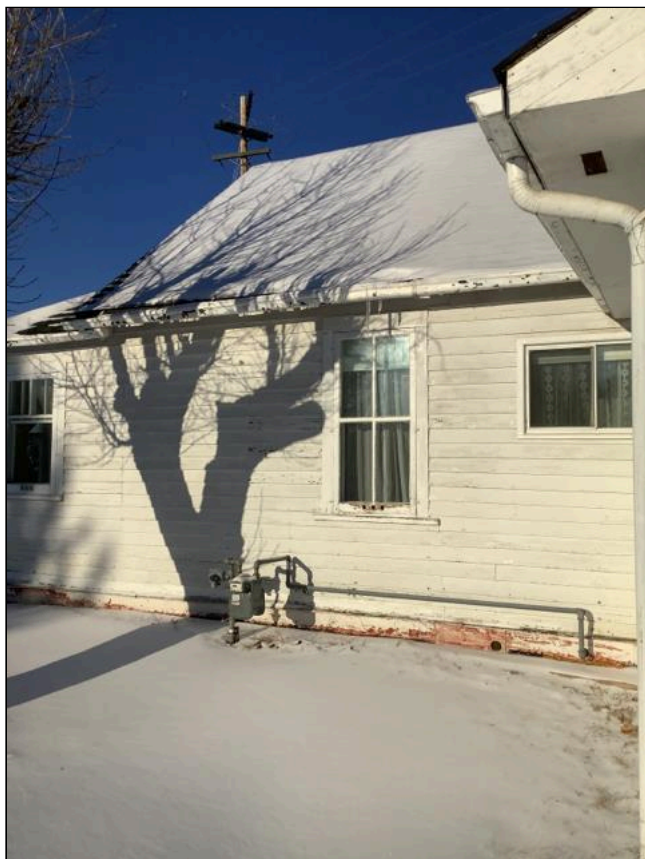
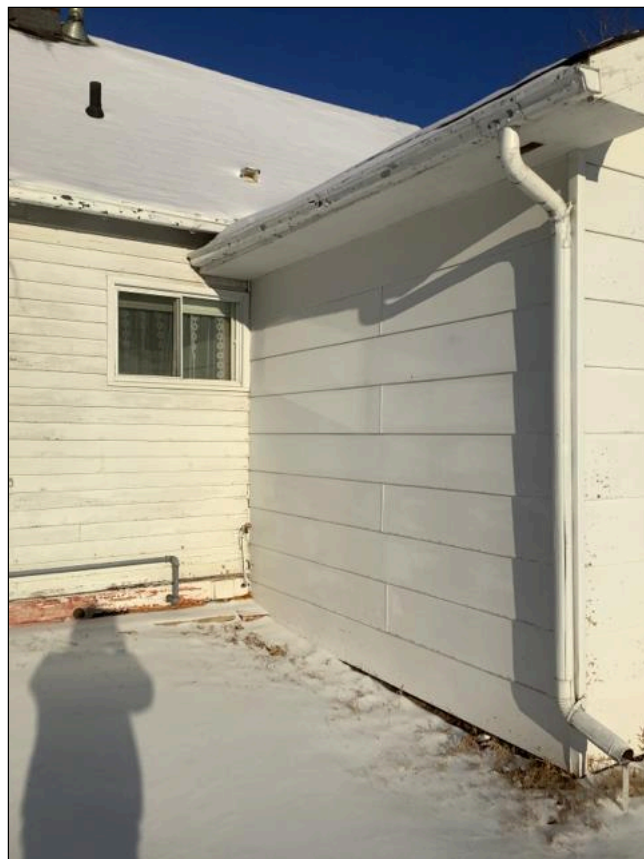
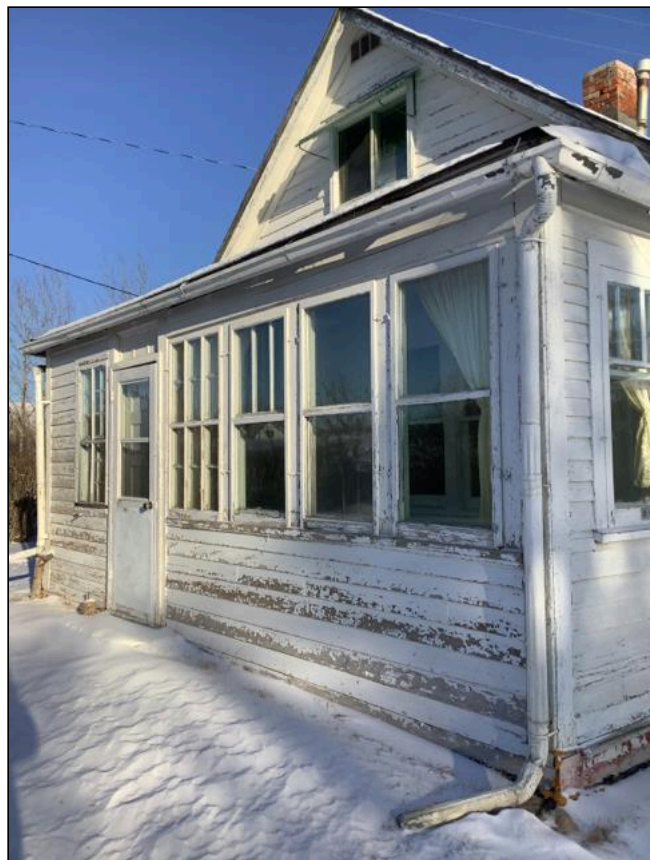
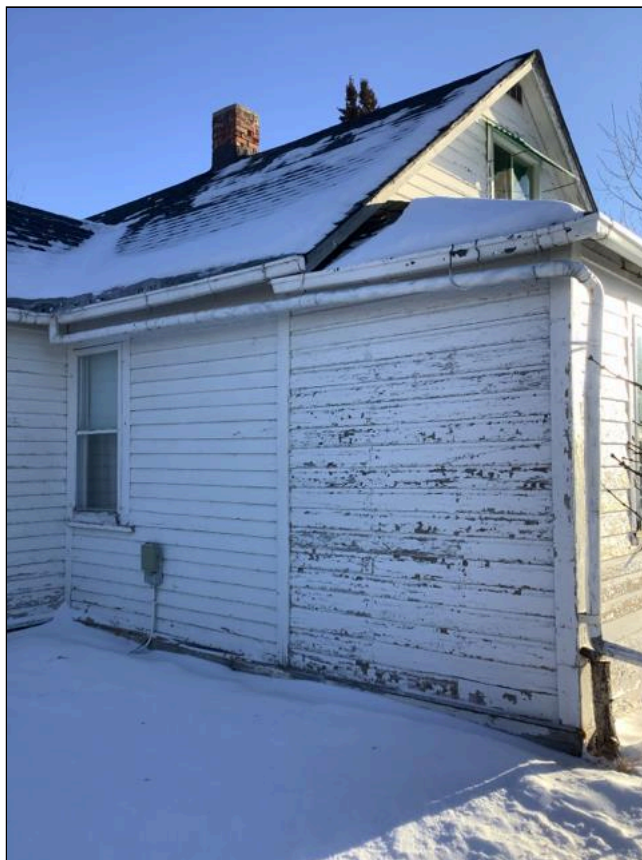
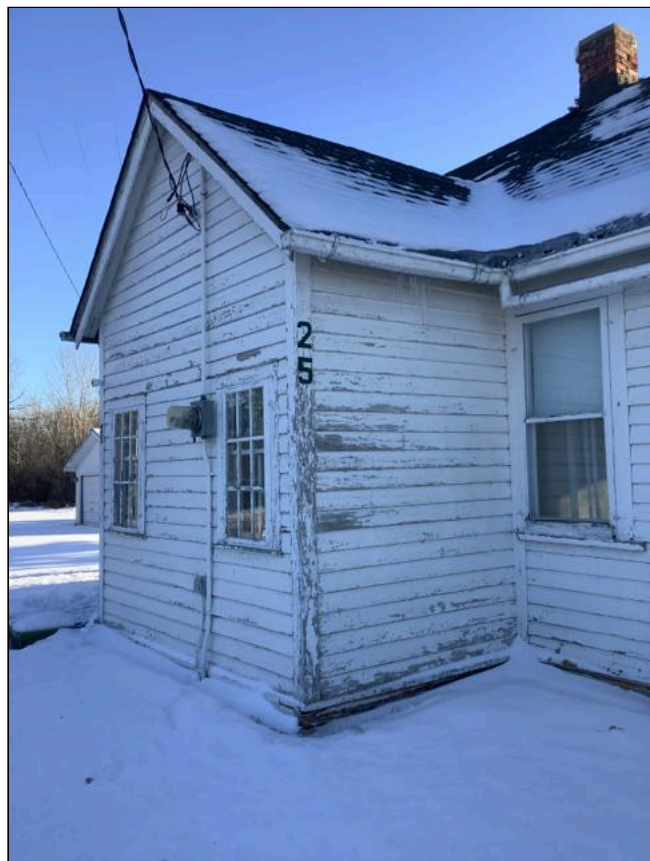
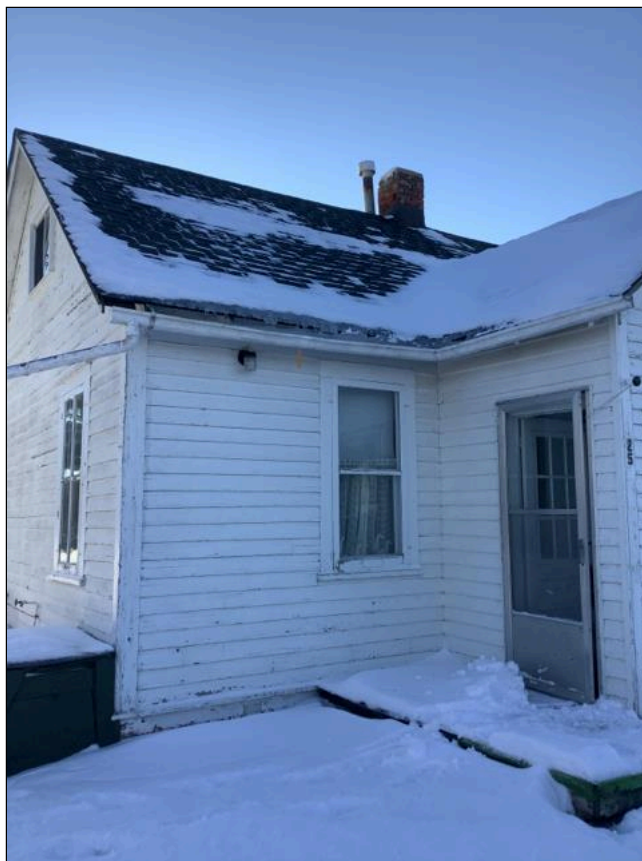
Higher levels of wall clad around the home are only visually inspected from the ground level. Exterior siding requires prep and paint to protect from the elements of nature.

3.1 Item 1(Picture) Exterior - siding requires prep and paint

3.1 Item 2(Picture) Exterior - siding requires prep and paint

3.1 Item 3(Picture) Exterior - siding requires prep and paint

3.1 Item 4(Picture) Exterior - siding requires prep and paint

3.1 Item 5(Picture) Exterior - siding requires prep and paint

3.1 Item 6(Picture) Exterior - siding requires prep and paint

3.1 Item 7(Picture) Exterior - siding requires prep and paint

3.1 Item 8(Picture) Exterior - siding requires prep and paint

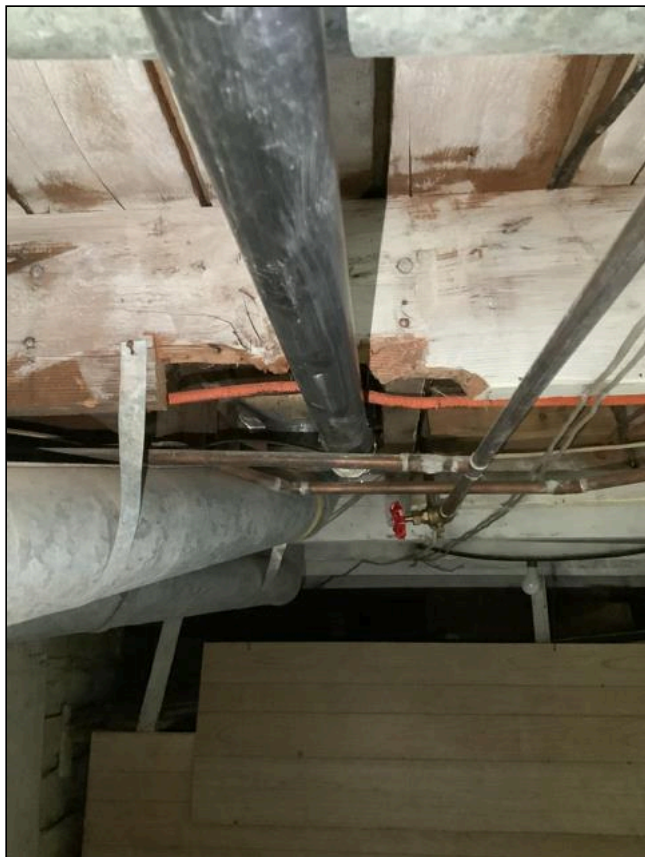
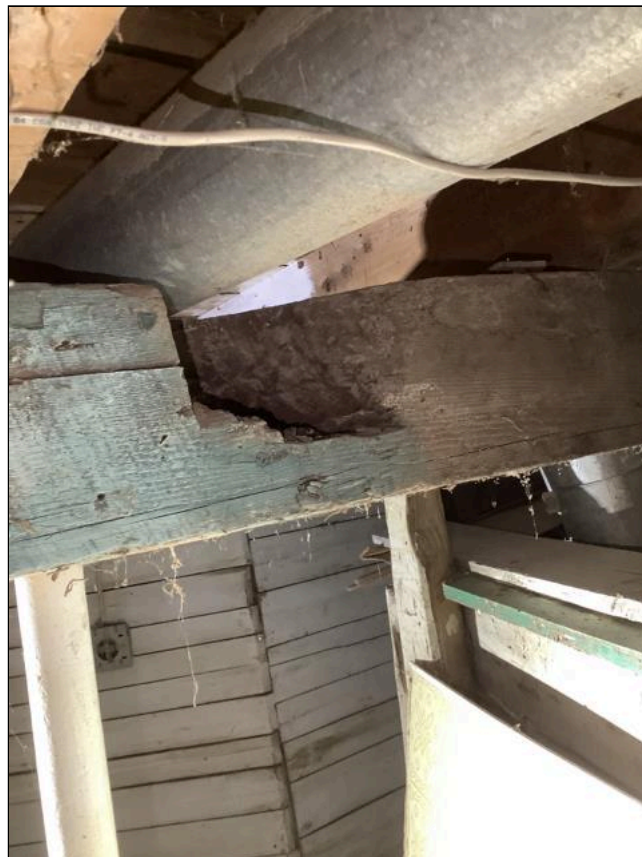
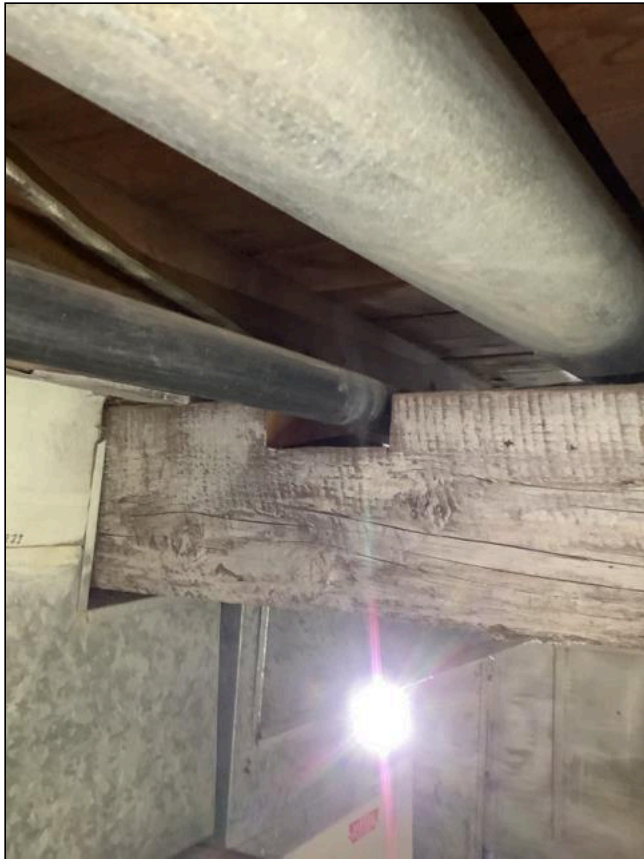
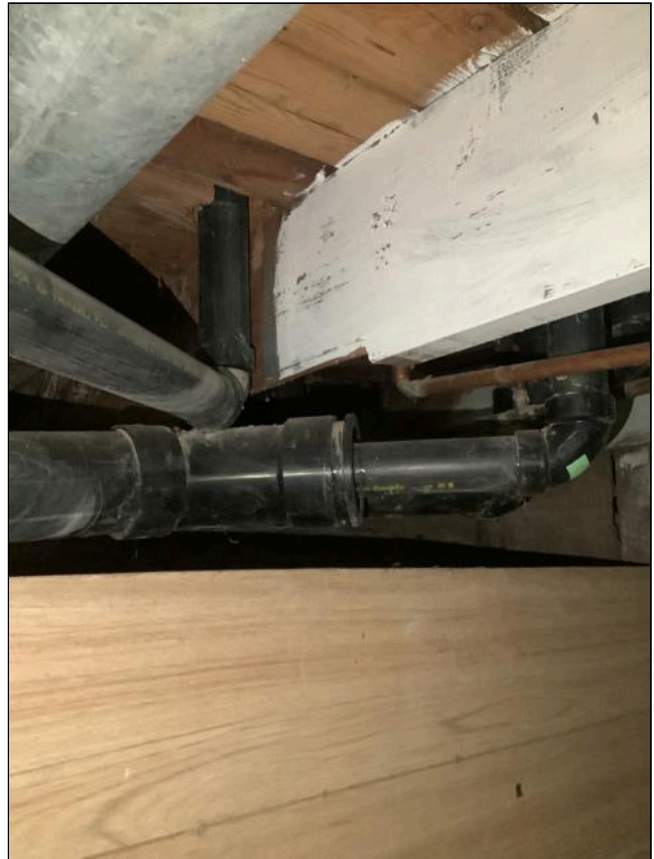
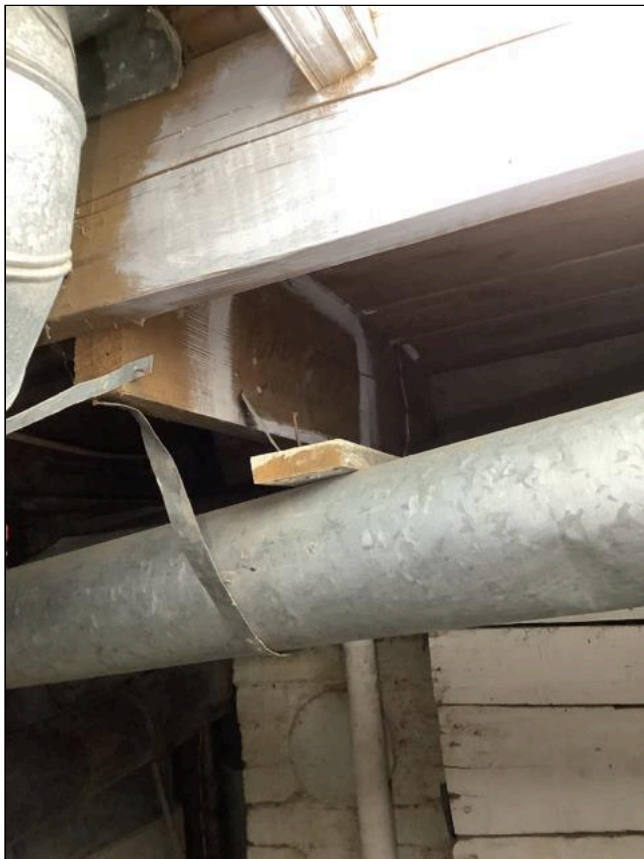
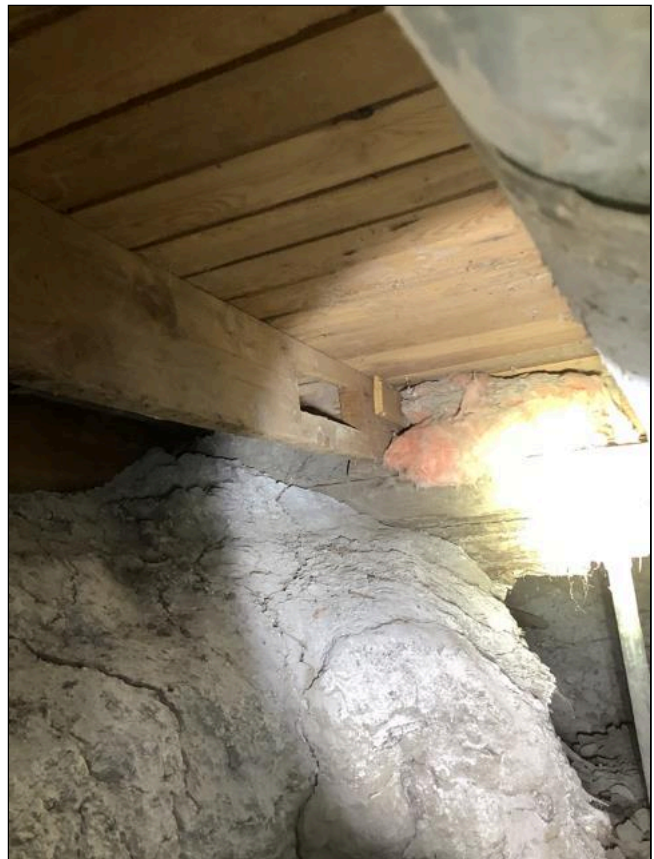
Floor joists are an important part of the supportive structure of a floor. They hold up the weight of a building, absorb impacts on the floor, and create structural support so that the floor will be stable secure. Suggest consulting professional prior to modification.

7.9 Item 1(Picture) Joists and Beams - notched out and split

7.9 Item 2(Picture) Joists and Beams - notched out and split

7.9 Item 3(Picture) Joists and Beams - notched out and split

7.9 Item 4(Picture) Joists and Beams - notched out and split

7.9 Item 5(Picture) Joists and Beams - notched out and split

7.9 Item 6(Picture) Joists and Beams - notched out and split

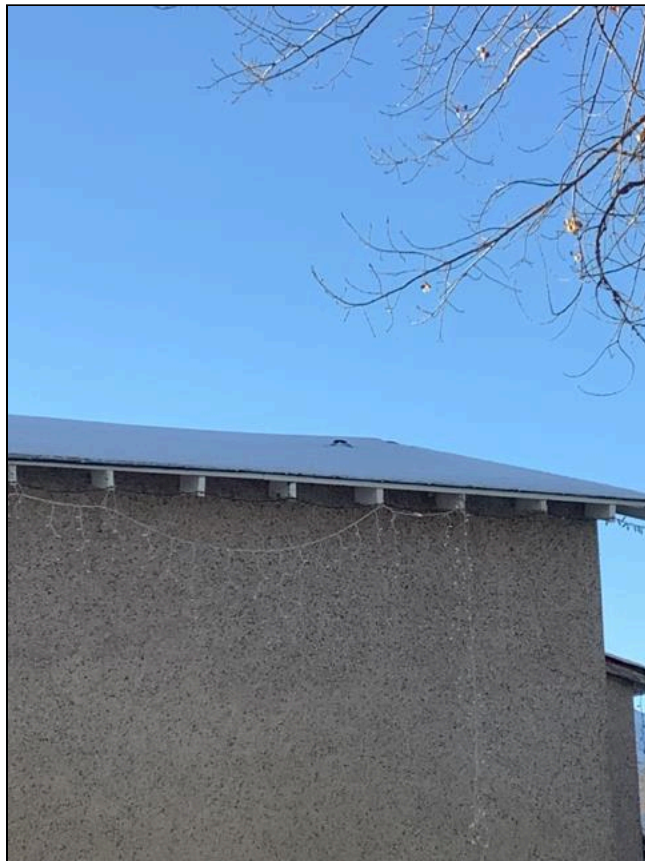
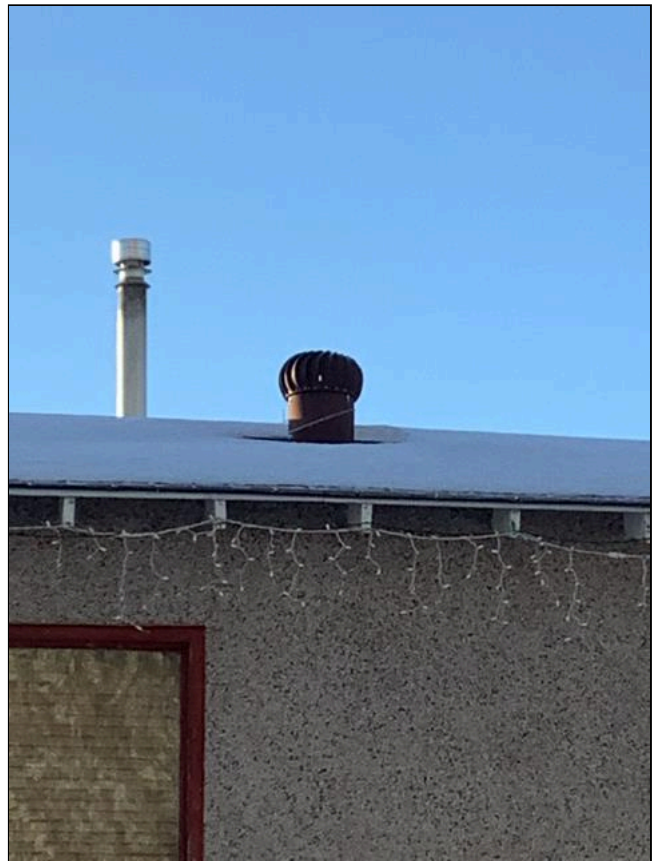
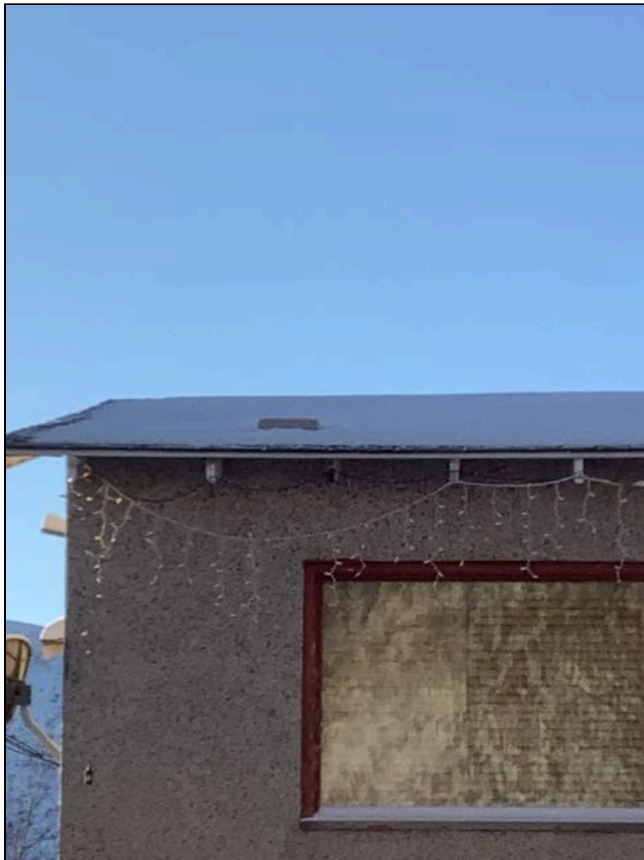
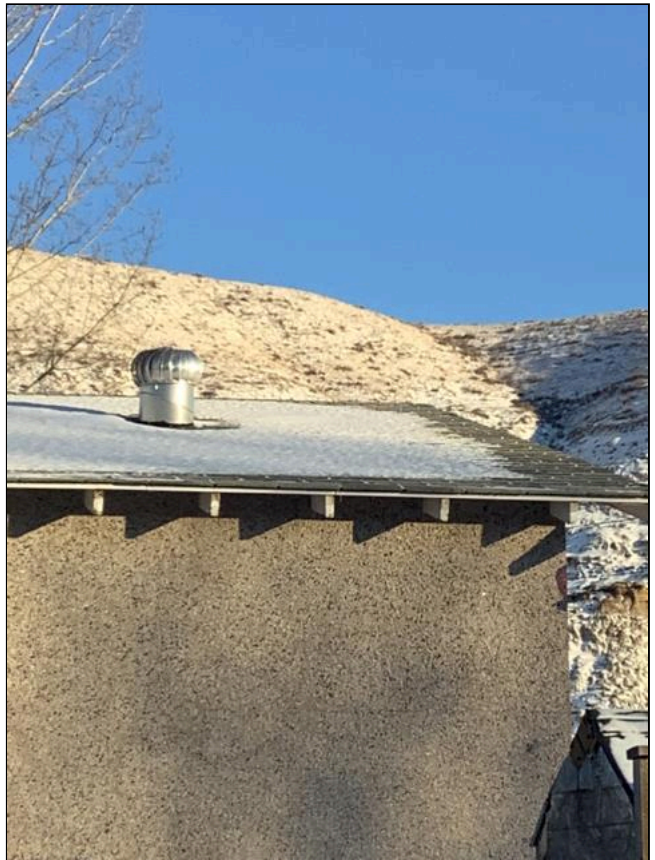
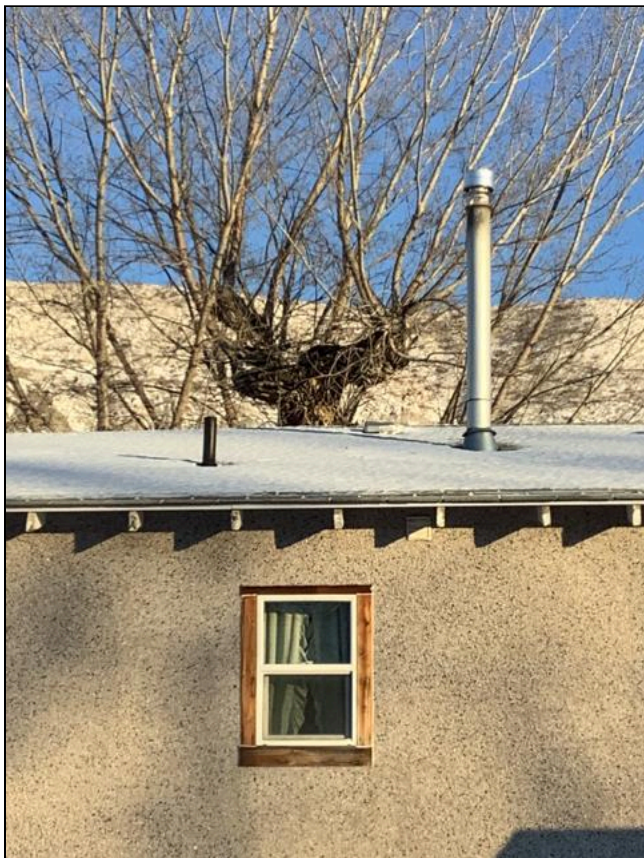
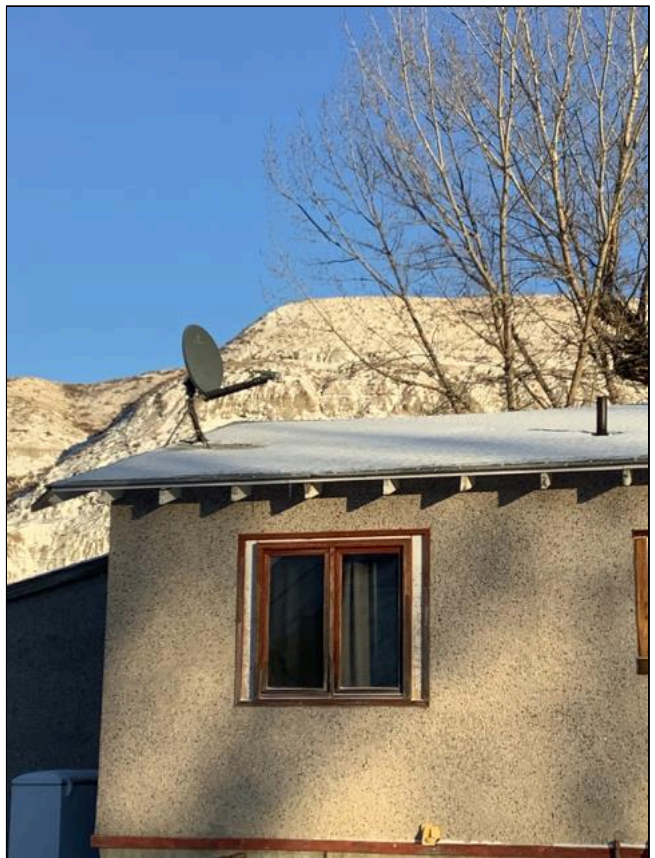
Roof was limited to a visual inspection with the use of binoculars as it was covered in snow, no issues to report from what was seen.

1.0 Item 1(Picture) Roof

1.0 Item 2(Picture) Roof

1.0 Item 3(Picture) Roof

1.0 Item 4(Picture) Roof

1.0 Item 5(Picture) Roof

1.0 Item 6(Picture) Roof

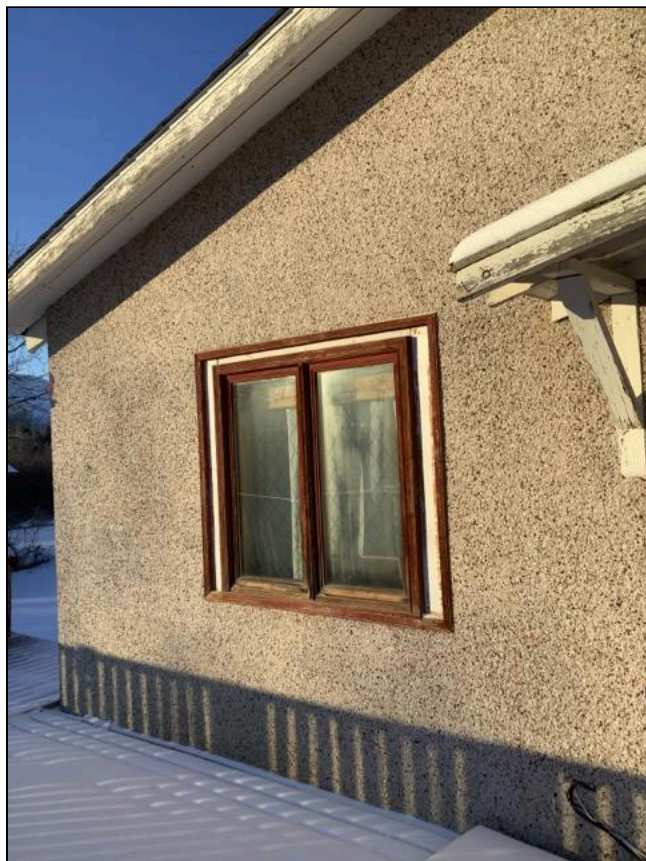
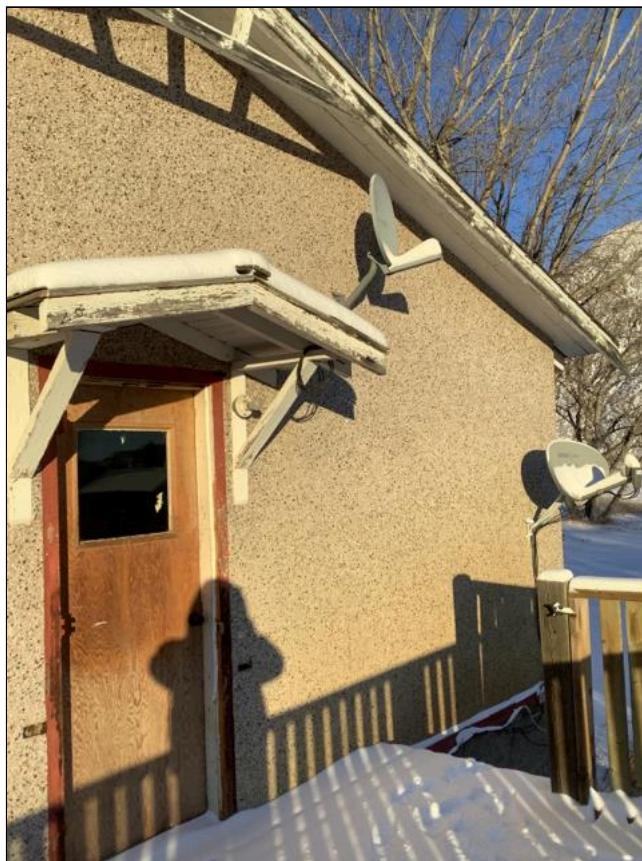
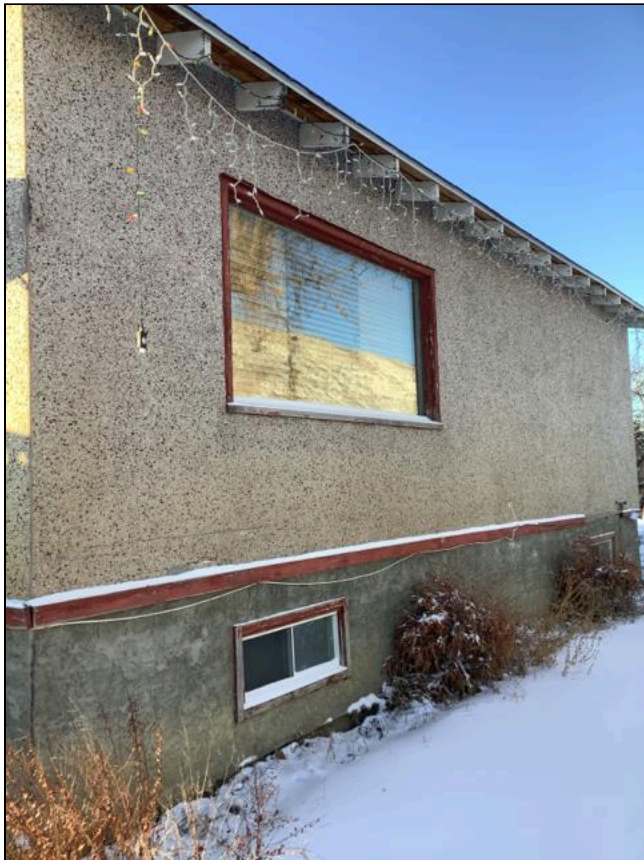
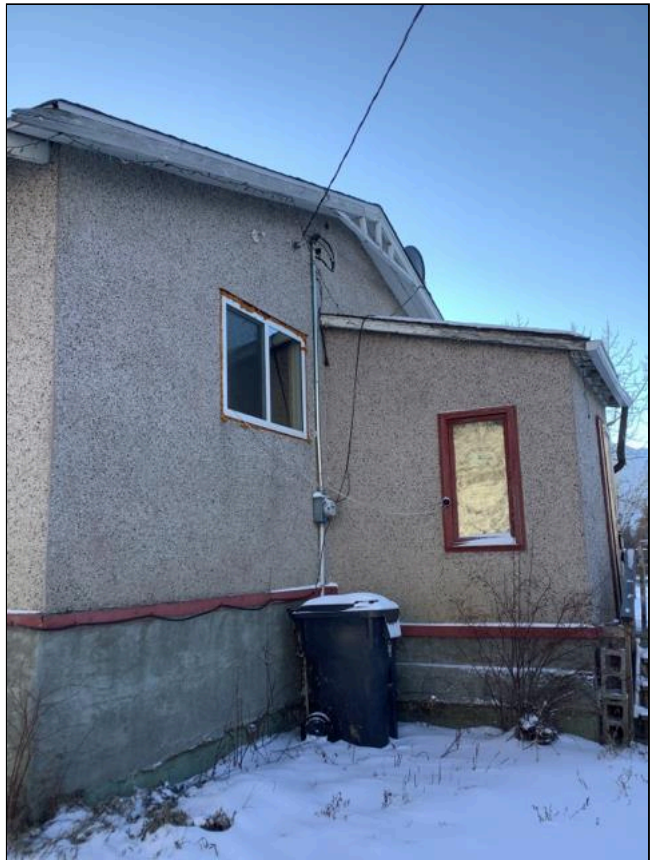
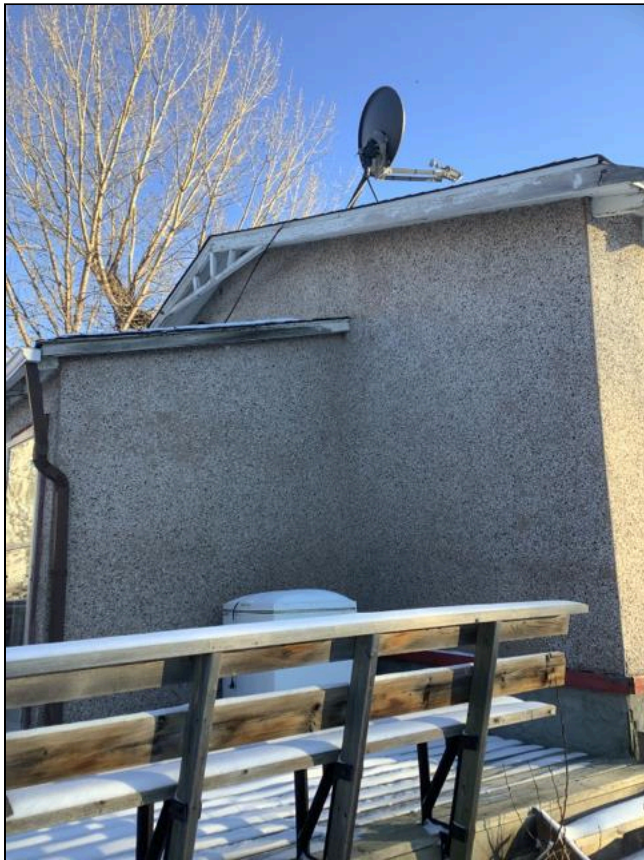
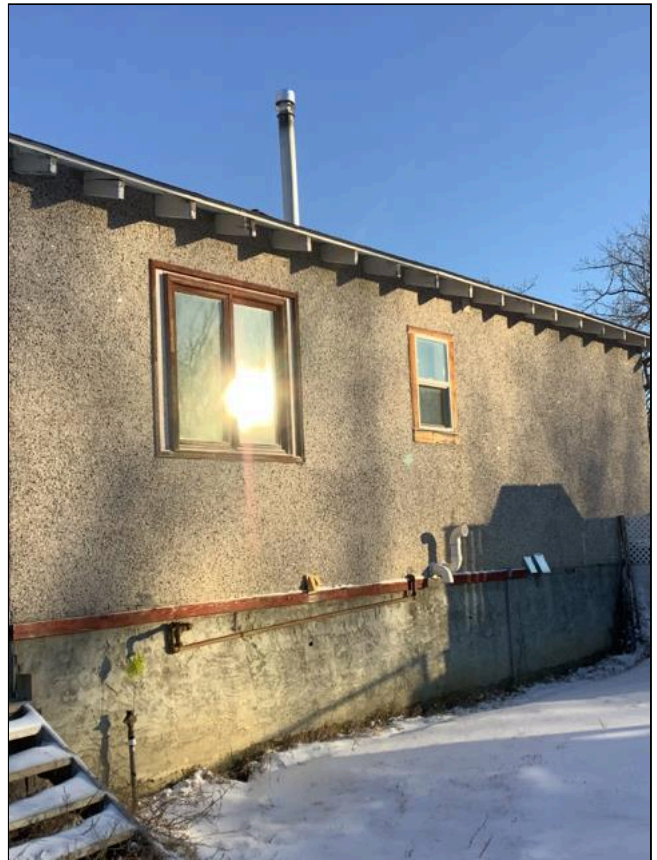
Higher levels of wall clad around the home are only visually inspected from the ground level. The exterior of the main house was only inspected as the property was inaccessible at the time of the inspection, the pebble dash exterior may contain asbestos so I recommend testing for further verification. The two outbuildings are aged as well and the structure demo is recommended.

3.1 Item 1(Picture) Exterior - pebble dash may contain asbestos

3.1 Item 2(Picture) Exterior - pebble dash may contain asbestos

3.1 Item 3(Picture) Exterior - pebble dash may contain asbestos

3.1 Item 4(Picture) Exterior - pebble dash may contain asbestos

3.1 Item 5(Picture) Exterior - pebble dash may contain asbestos

3.1 Item 6(Picture) Exterior - pebble dash may contain asbestos

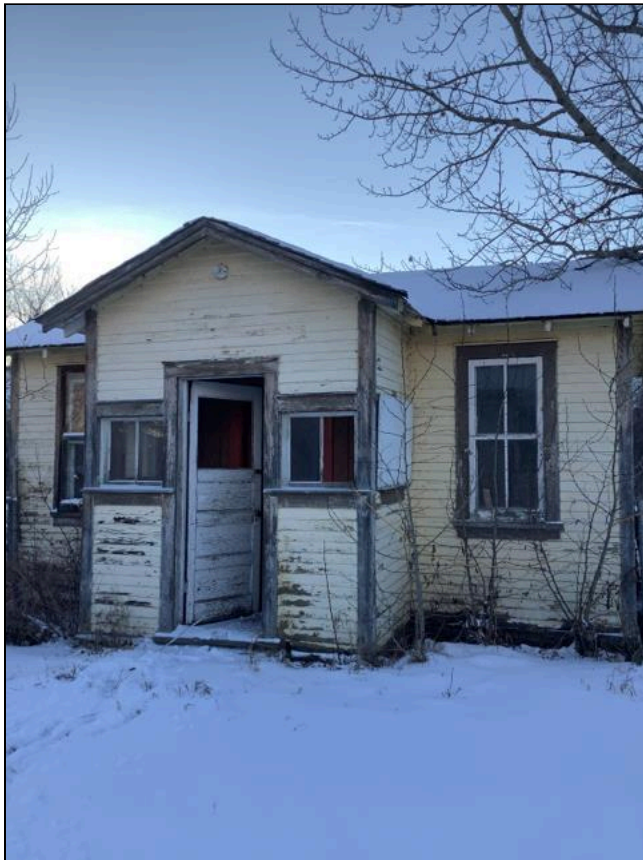
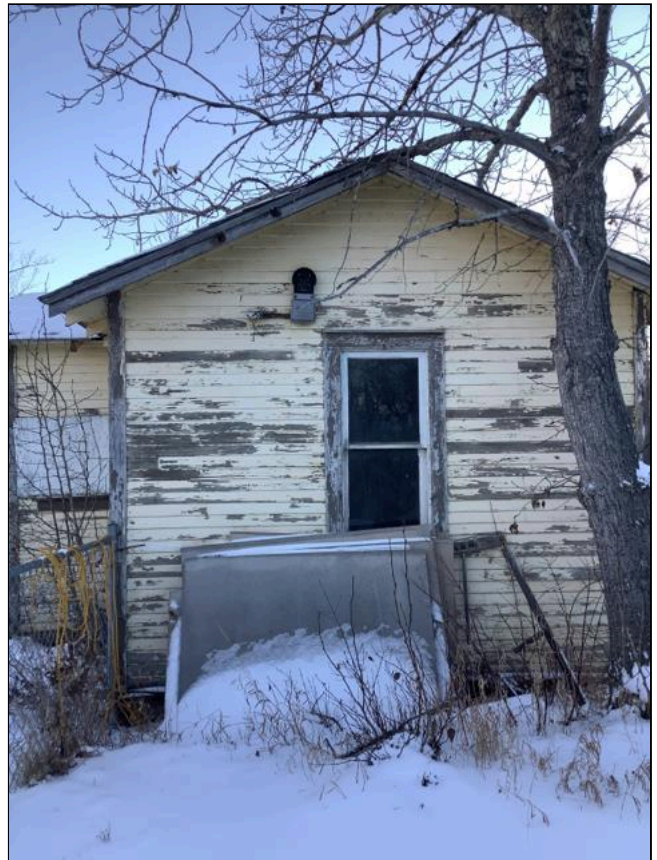
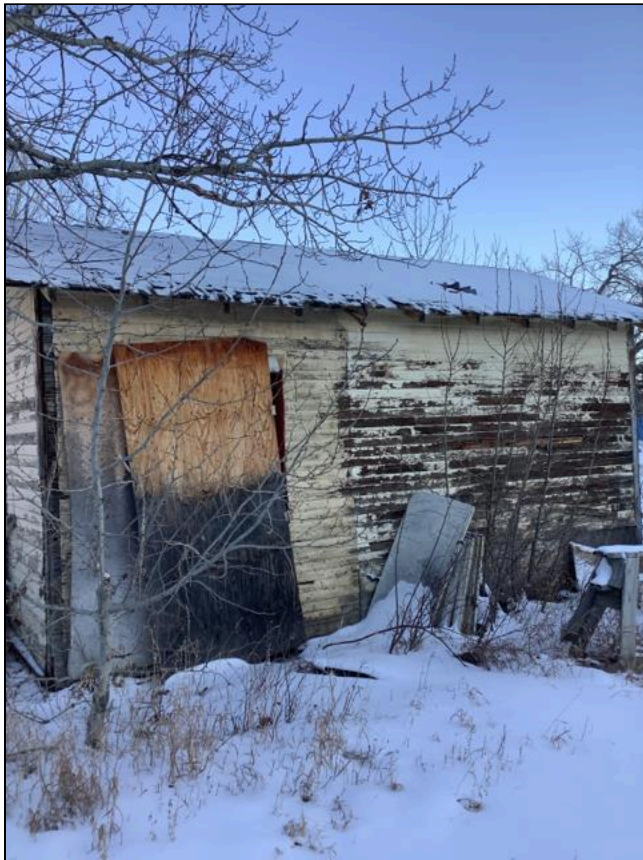
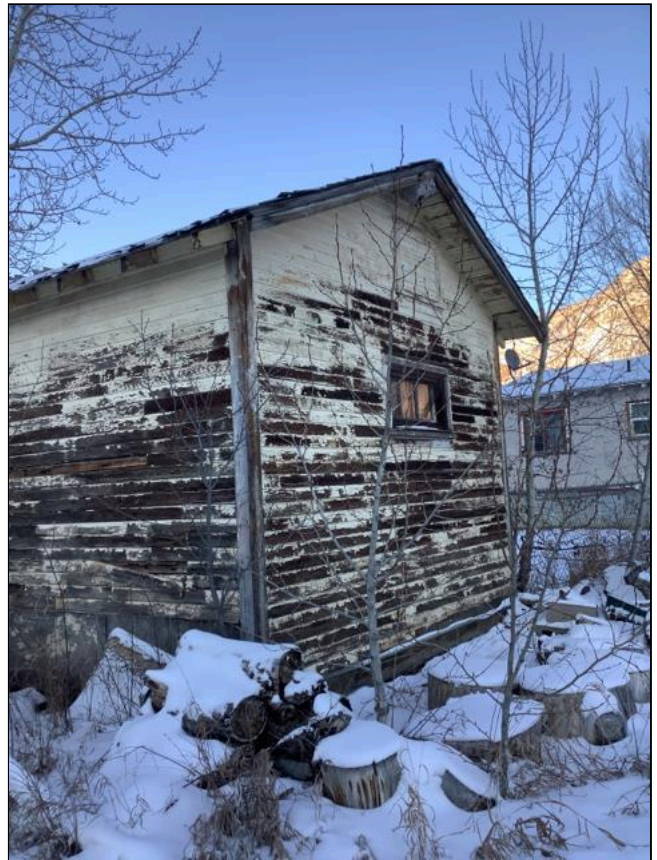
3.1 Item 7(Picture) Outbuilding - aged, structure demo recommended

3.1 Item 8(Picture) Outbuilding - aged, structure demo recommended

3.1 Item 9(Picture) Outbuilding - aged, structure demo recommended

3.1 Item 10(Picture) Outbuilding - aged, structure demo recommended

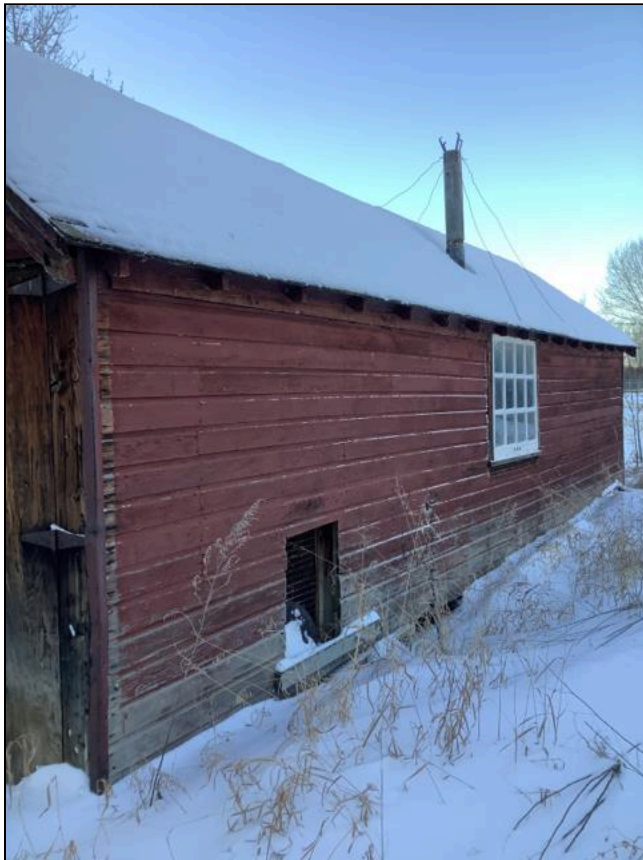
3.1 Item 11(Picture) Outbuilding - aged, structure demo recommended

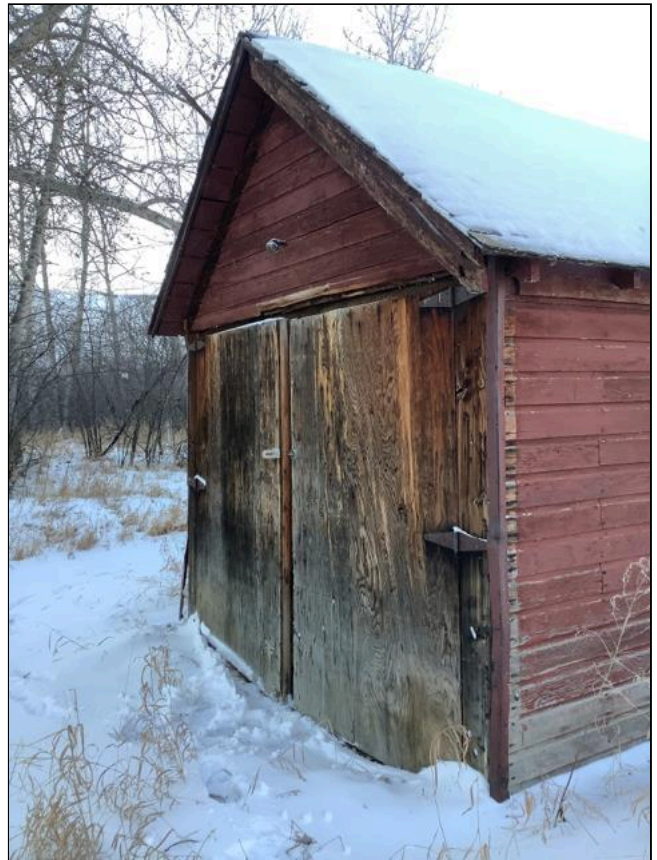
3.1 Item 12(Picture) Outbuilding - aged, structure demo recommended

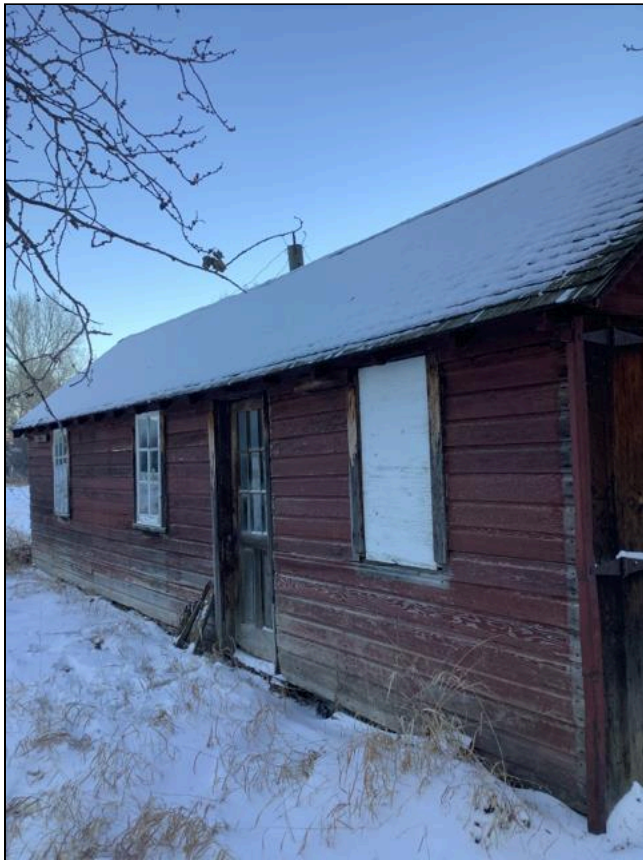
3.1 Item 13(Picture) Outbuilding - aged, structure demo recommended

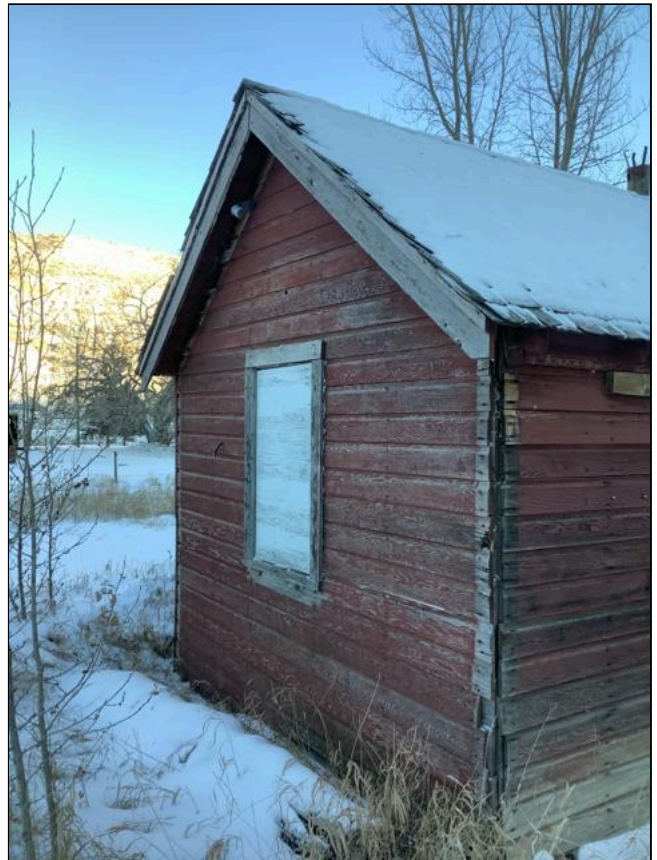
3.1 Item 14(Picture) Outbuilding - aged, structure demo recommended

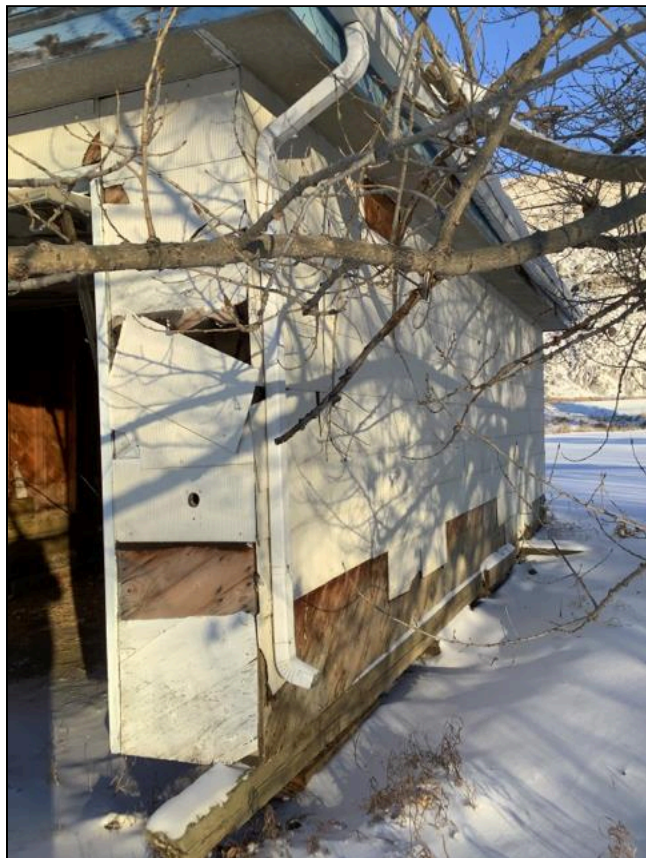
4.4 Item 1(Picture) Garage Exterior - damaged from flood, demo recommended

The exterior of the garage is damaged from the flood and the integrity could be compromised, demo is recommended.
