# Demolition and Remediation Services

<p style="text-align: center;"><b>Institutional &amp; Residential Demolitions Project for The Town of Drumheller</b></p>
--

## **Hazardous Building Materials Assessment (Pre-construction)**

Abandoned Health Centre  
625 Riverside Drive East,  
Drumheller, Alberta

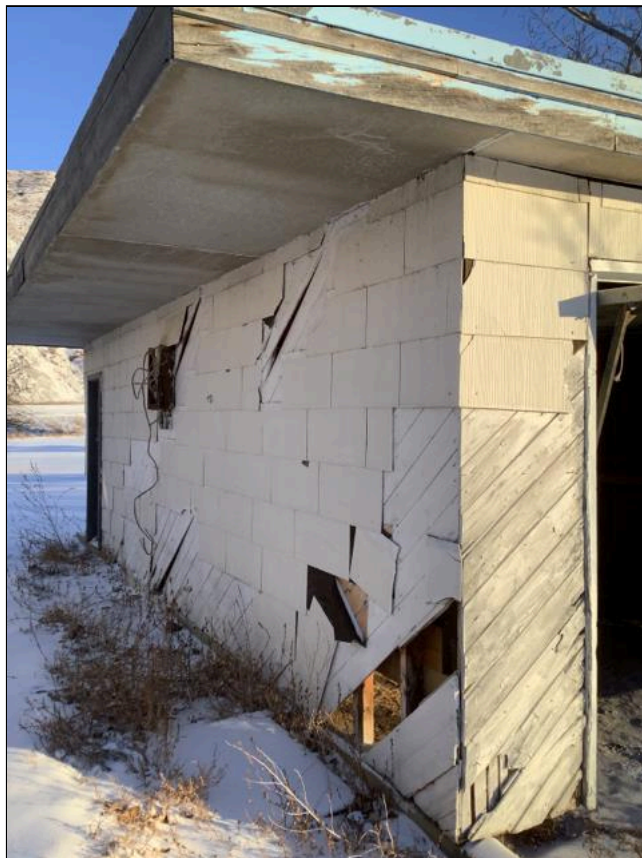
4.4 Item 2(Picture) Garage Exterior - damaged from flood, demo recommended

The exterior of the garage is damaged from the flood and the integrity could be compromised, demo is recommended.

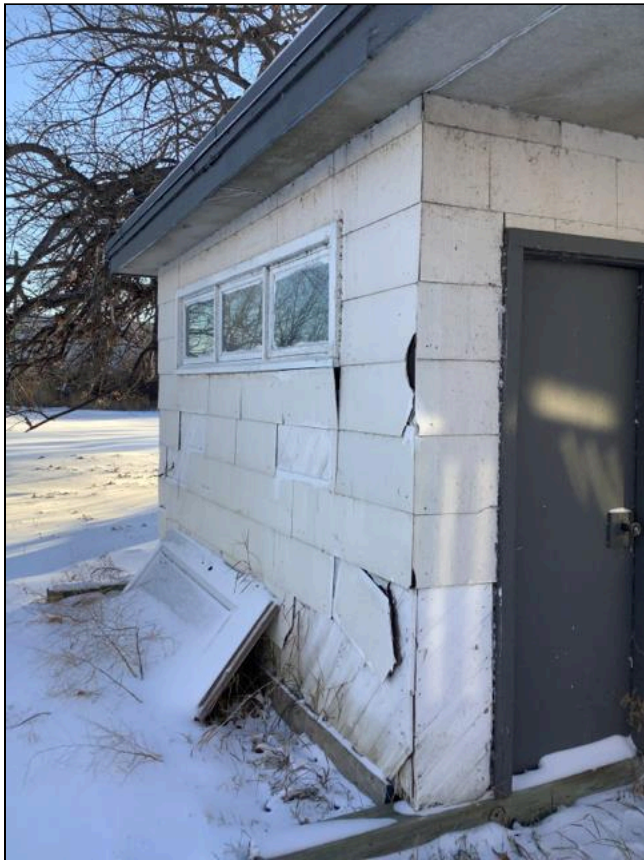
4.4 Item 3(Picture) Garage Exterior - damaged from flood, demo recommended

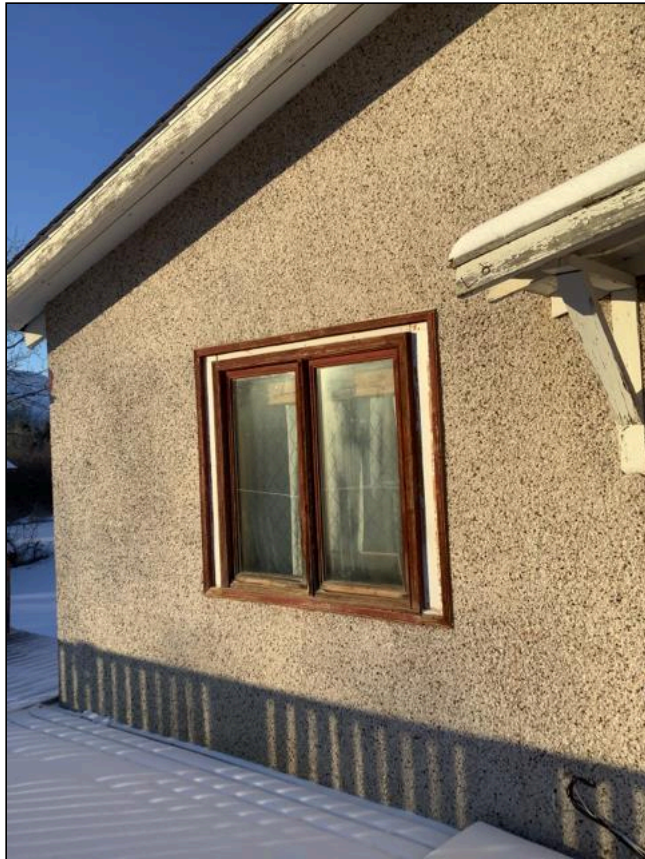
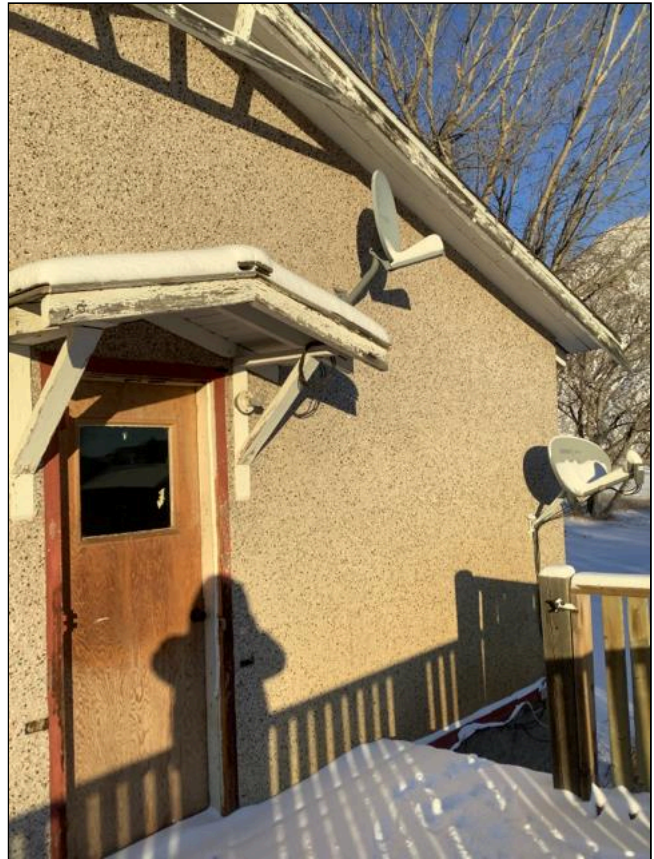
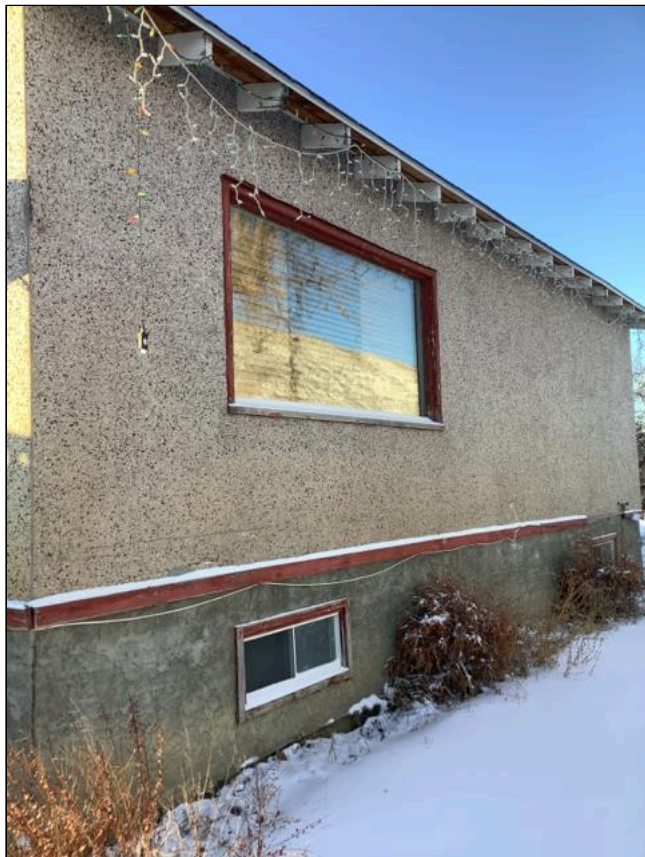
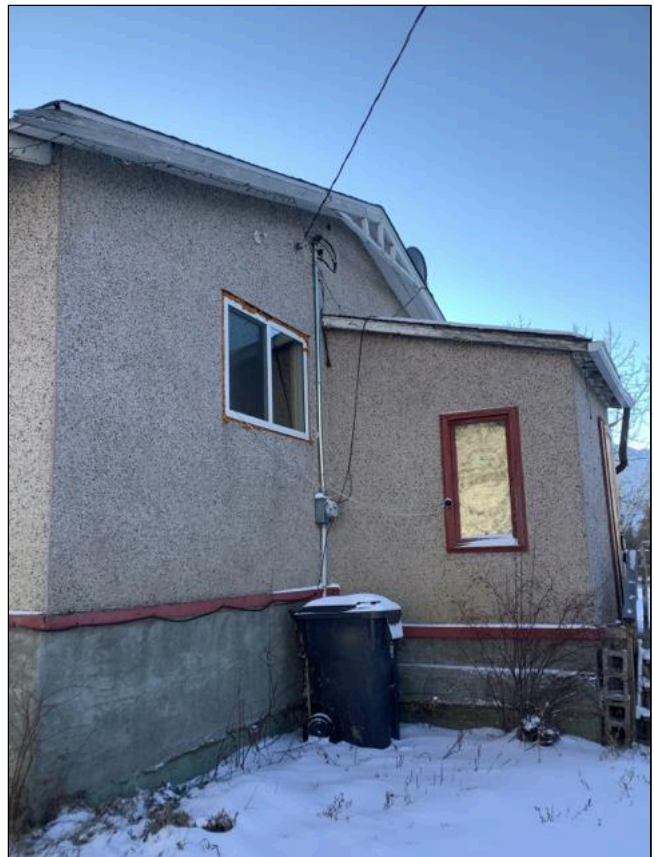
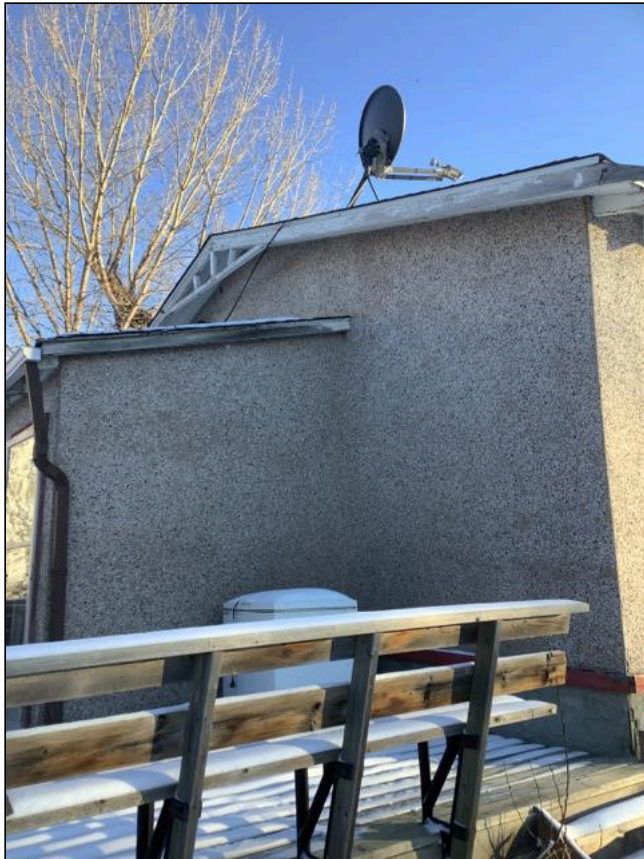
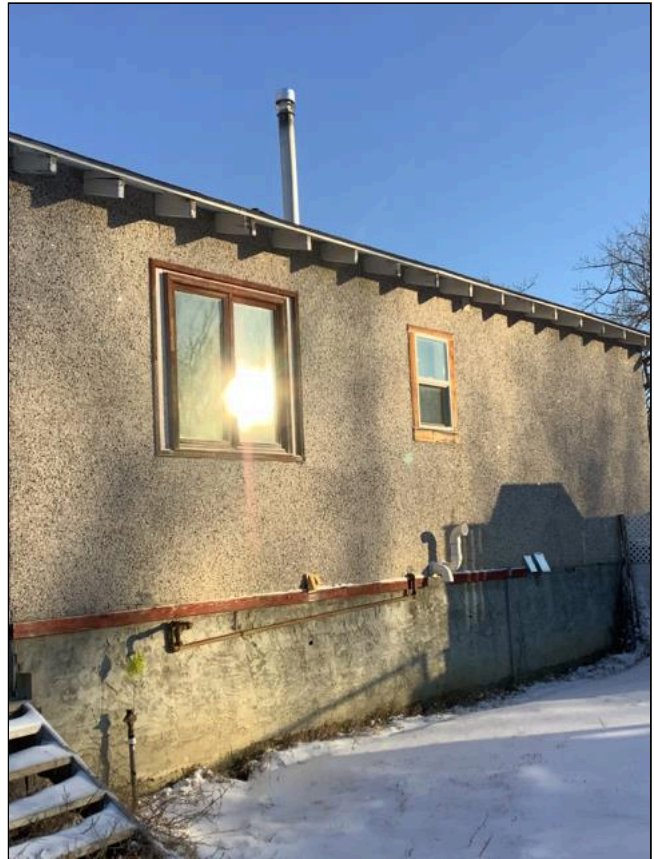
3.1 Item 1(Picture) Exterior - pebble dash may contain asbestos

3.1 Item 2(Picture) Exterior - pebble dash may contain asbestos

3.1 Item 3(Picture) Exterior - pebble dash may contain asbestos

3.1 Item 4(Picture) Exterior - pebble dash may contain asbestos

3.1 Item 5(Picture) Exterior - pebble dash may contain asbestos

3.1 Item 6(Picture) Exterior - pebble dash may contain asbestos

Higher levels of wall clad around the home are only visually inspected from the ground level. The exterior of the main house was only inspected as the property was inaccessible at the time of the inspection, the pebble dash exterior may contain asbestos so I recommend testing for further verification. The two outbuildings are aged as well and the structure demo is recommended.

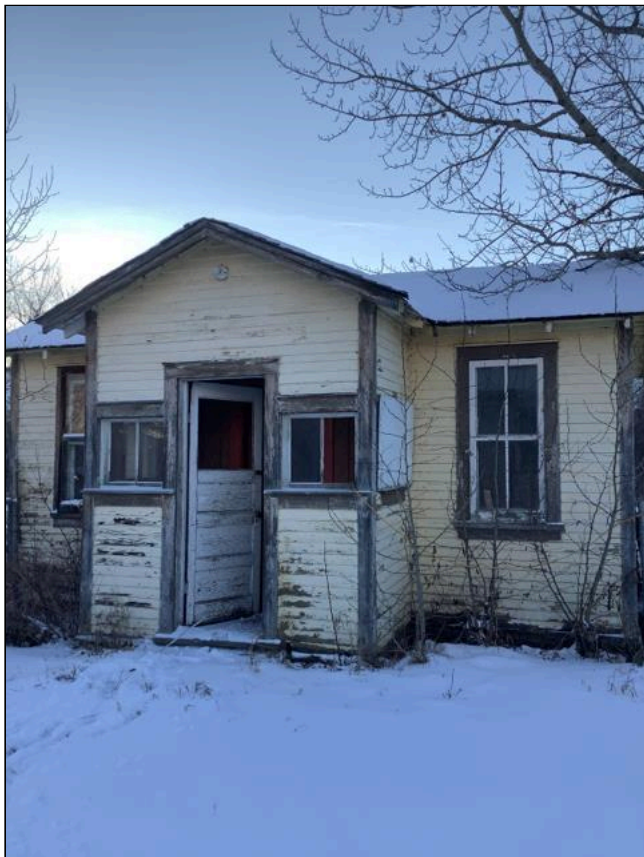
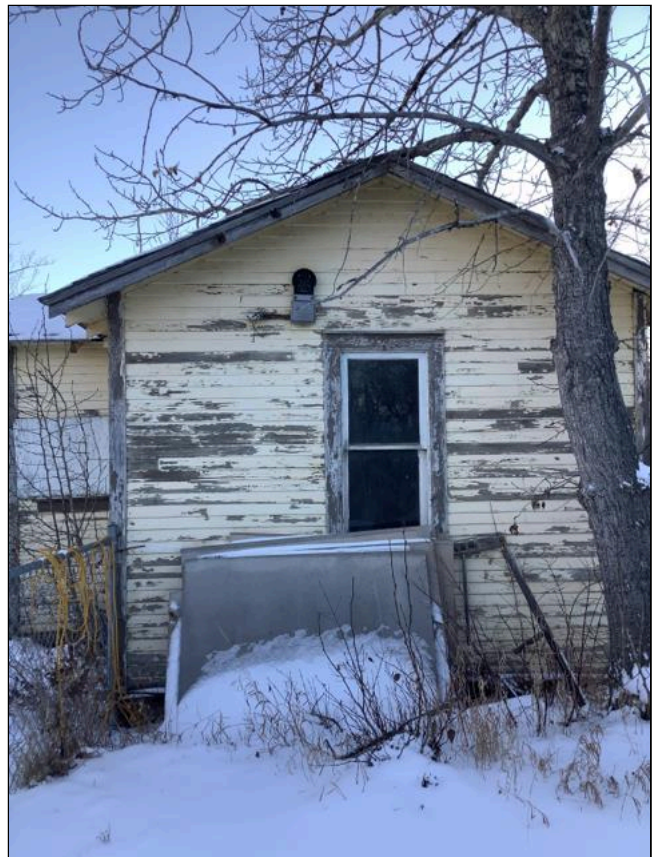
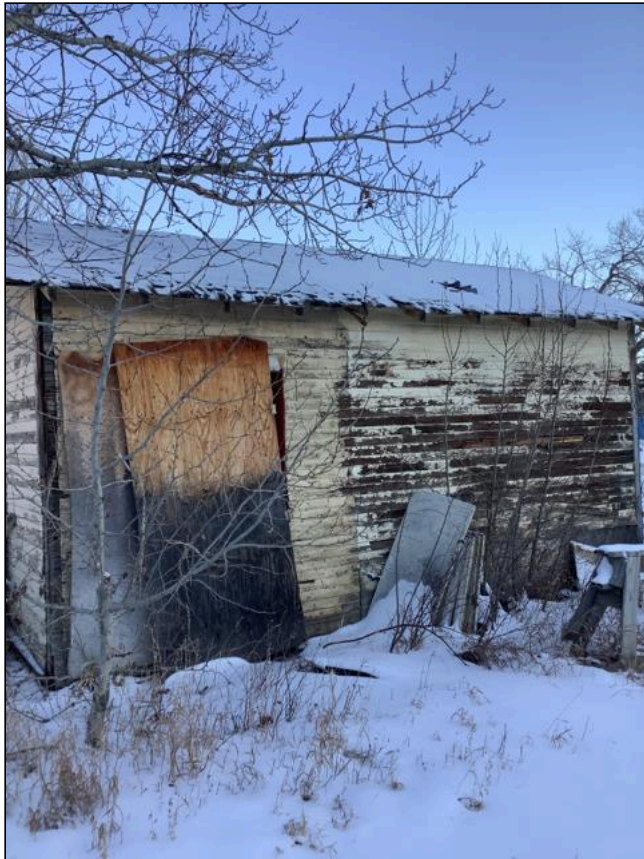
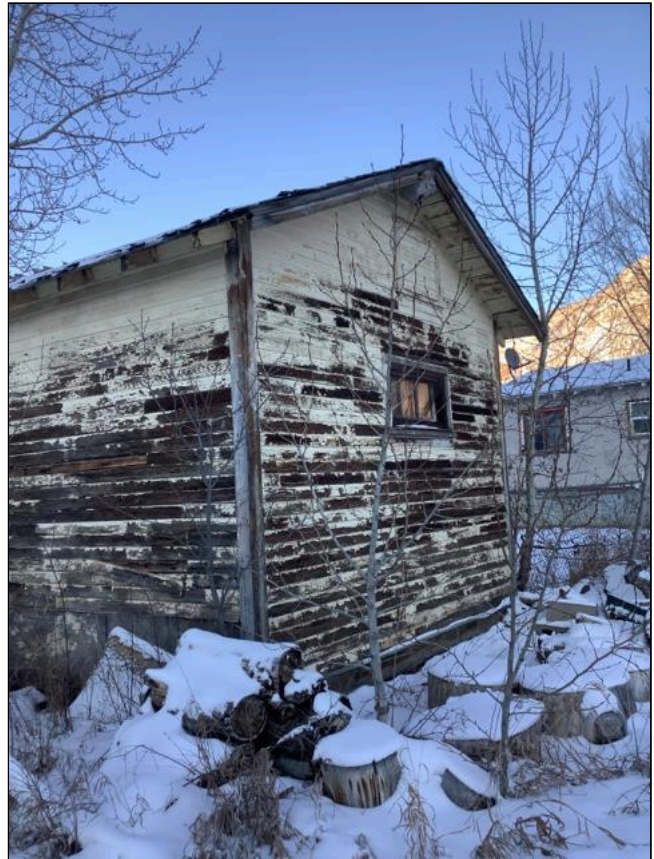
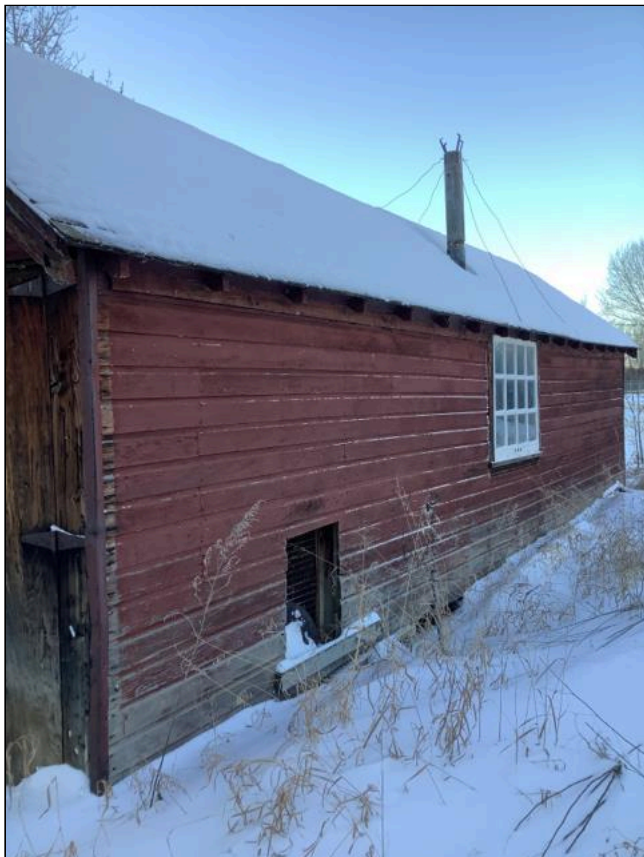
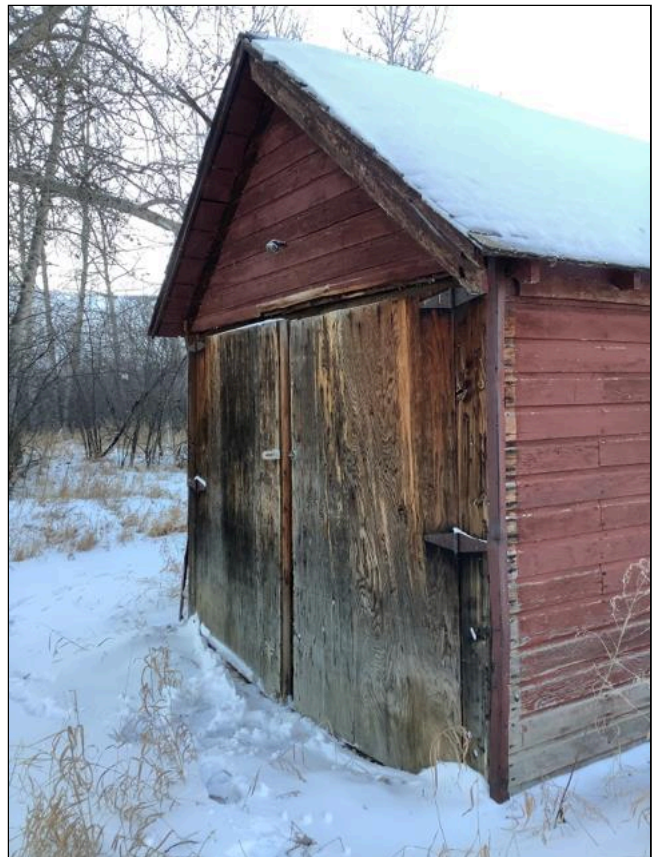
3.1 Item 7(Picture) Outbuilding - aged, structure demo recommended

3.1 Item 8(Picture) Outbuilding - aged, structure demo recommended

3.1 Item 9(Picture) Outbuilding - aged, structure demo recommended

3.1 Item 10(Picture) Outbuilding - aged, structure demo recommended

3.1 Item 11(Picture) Outbuilding - aged, structure demo recommended

3.1 Item 12(Picture) Outbuilding - aged, structure demo recommended

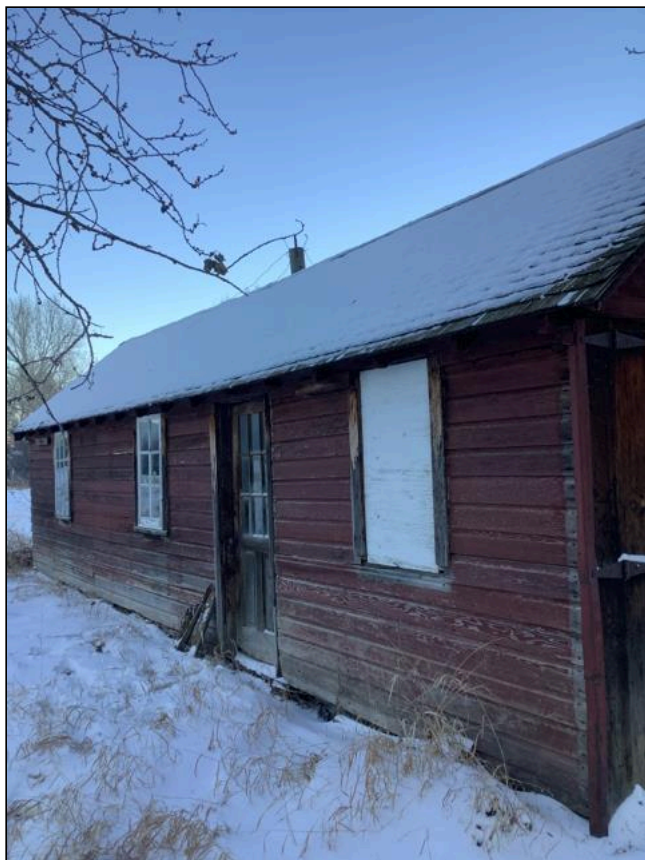
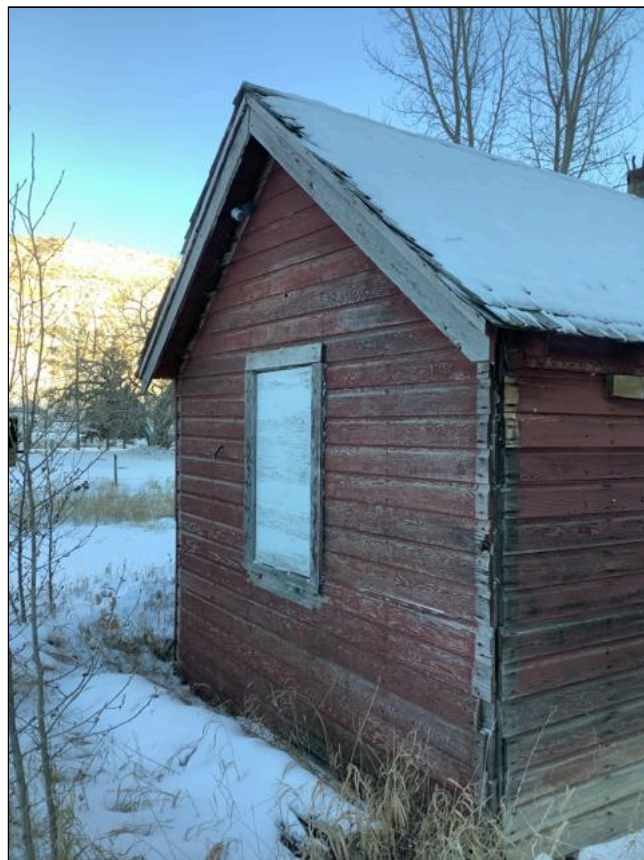
3.1 Item 13(Picture) Outbuilding - aged, structure demo recommended

3.1 Item 14(Picture) Outbuilding - aged, structure demo recommended

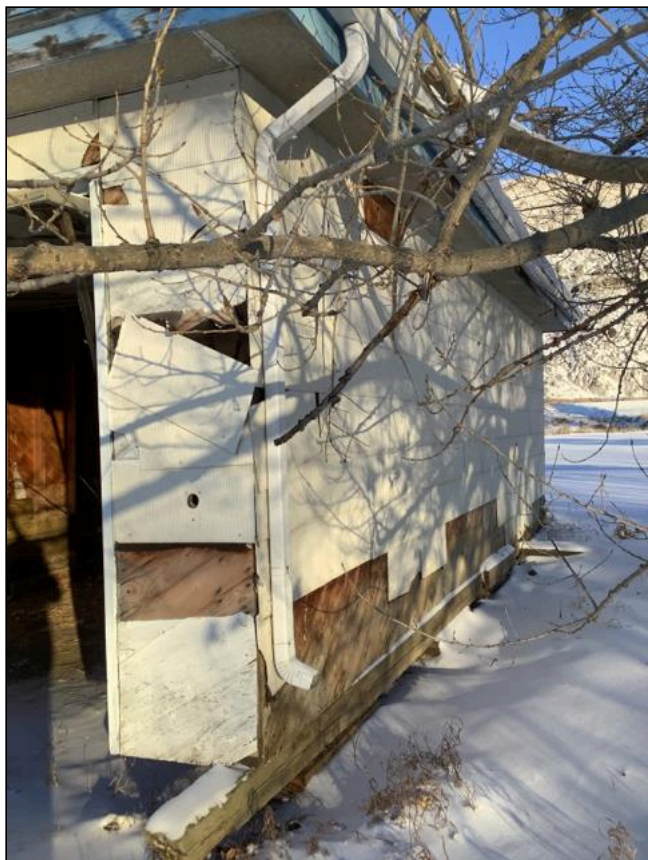
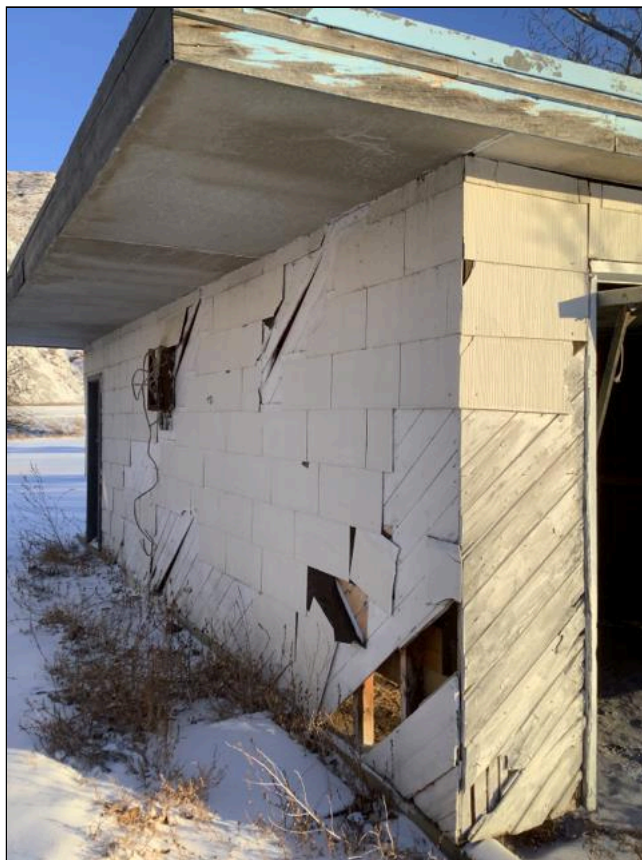
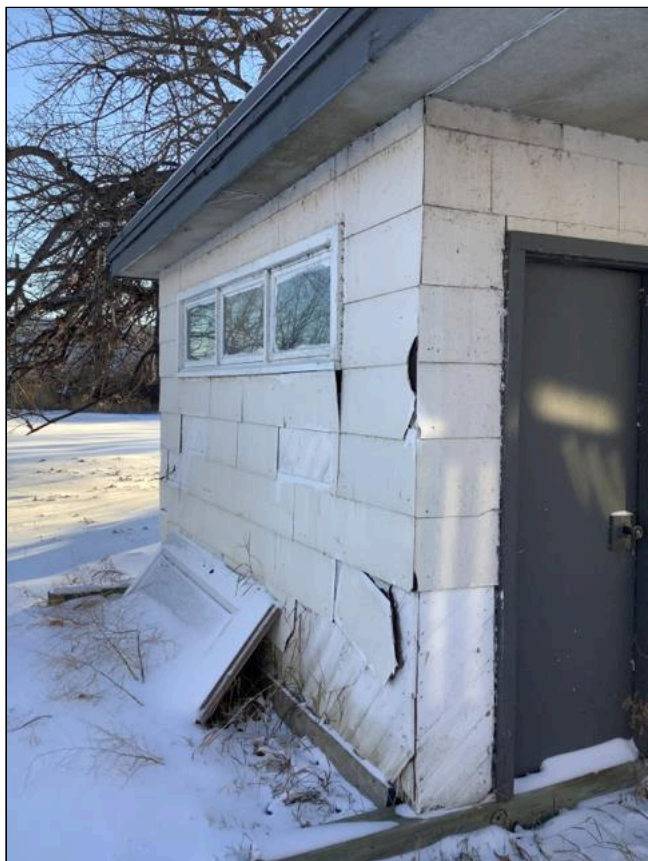
4.4 Item 1(Picture) Garage Exterior - damaged from flood, demo recommended

4.4 Item 2(Picture) Garage Exterior - damaged from flood, demo recommended

4.4 Item 3(Picture) Garage Exterior - damaged from flood, demo recommended

The exterior of the garage is damaged from the flood and the integrity could be compromised, demo is recommended.
