HOME
INSPECTION

Inspection Report

Property Address:
964 Hunter Drive - Nacmine
Drumheller Alberta T0J 0Y0

| Date: 16/12/2021 | Time: 11:00 AM | Report ID: 964 Hunter Drive - Nacmine |

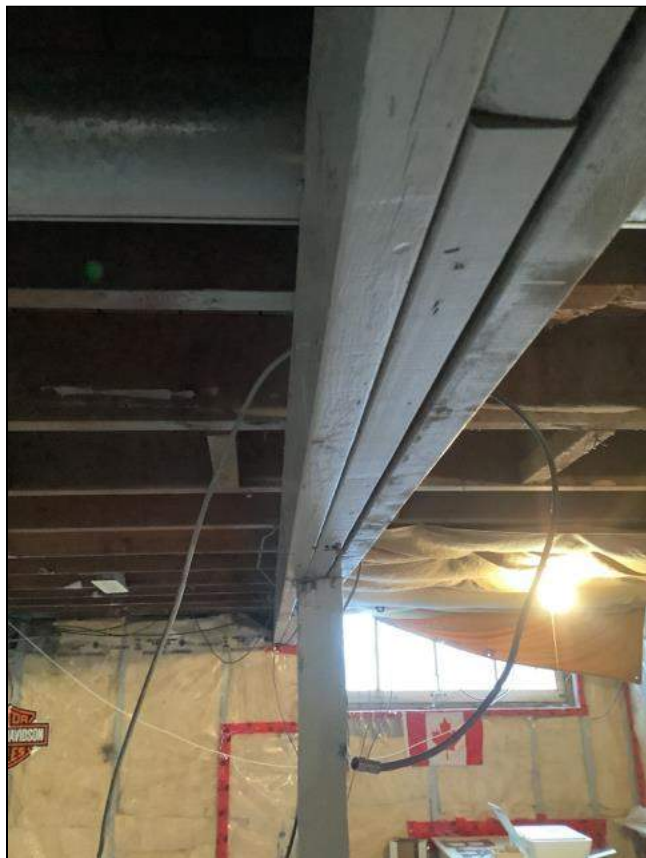
7.9 Item 1(Picture) Joists and Beams - slanted, crooked, notched out, bowed, split

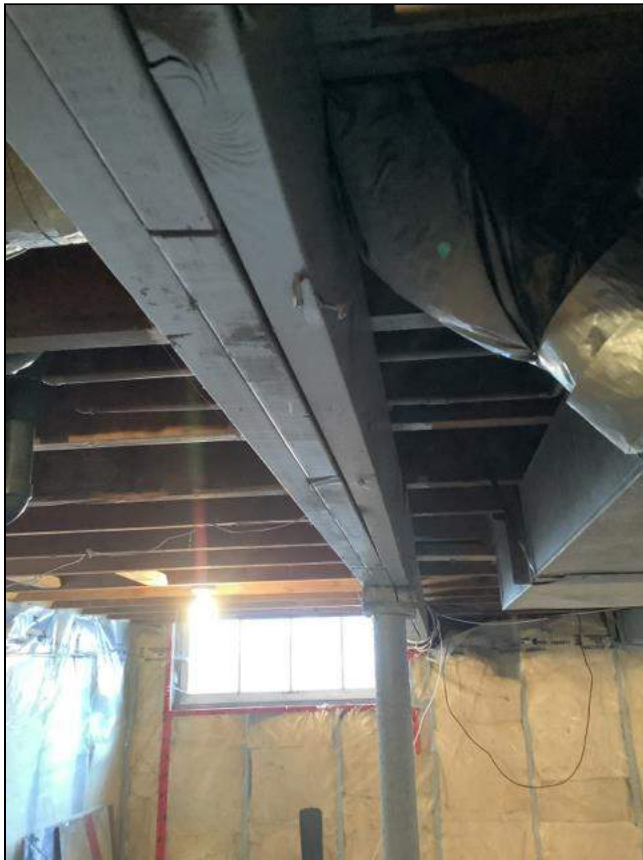
7.9 Item 3(Picture) Joists and Beams - slanted, crooked, notched out, bowed, split

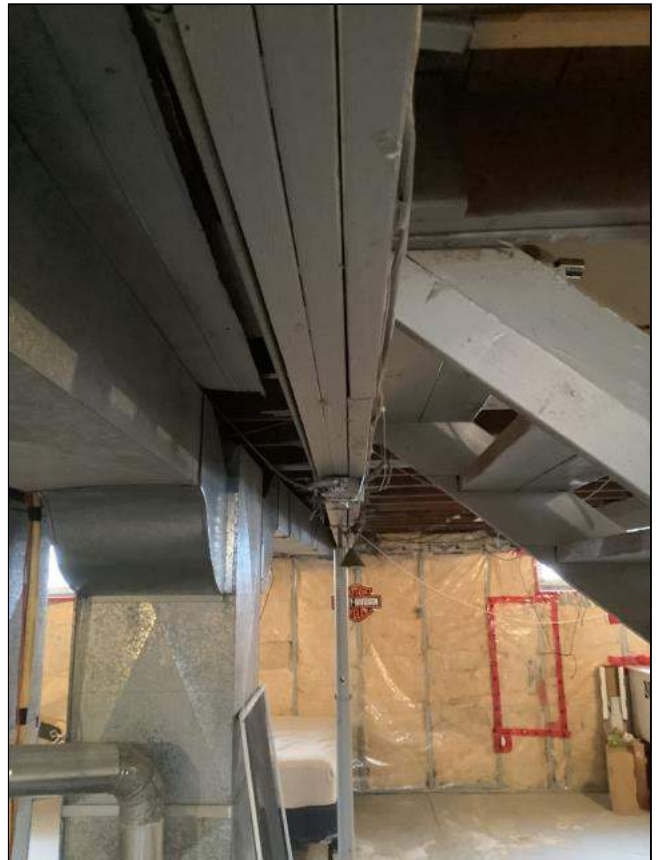
7.9 Item 4(Picture) Joists and Beams - slanted, crooked, notched out, bowed, split

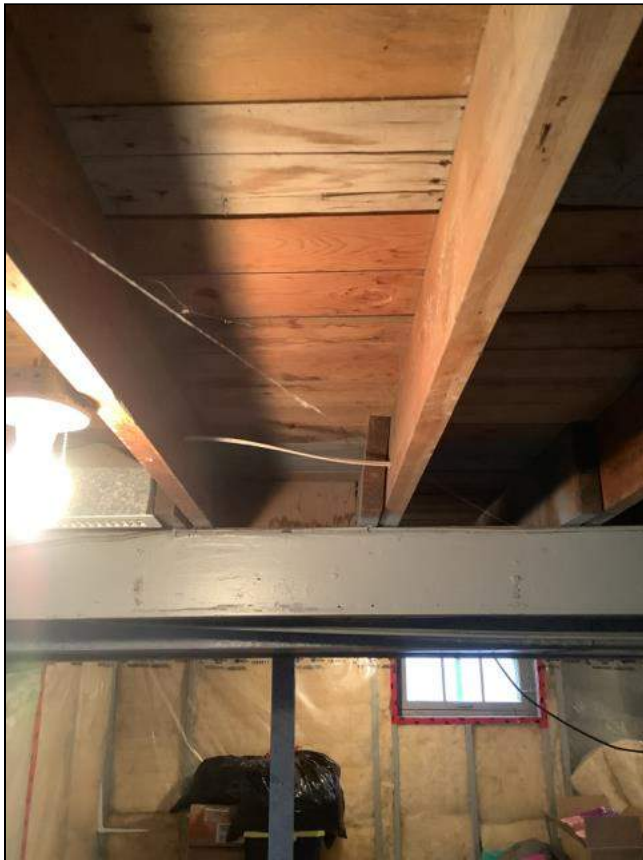
7.9 Item 5(Picture) Joists and Beams - slanted, crooked, notched out, bowed, split

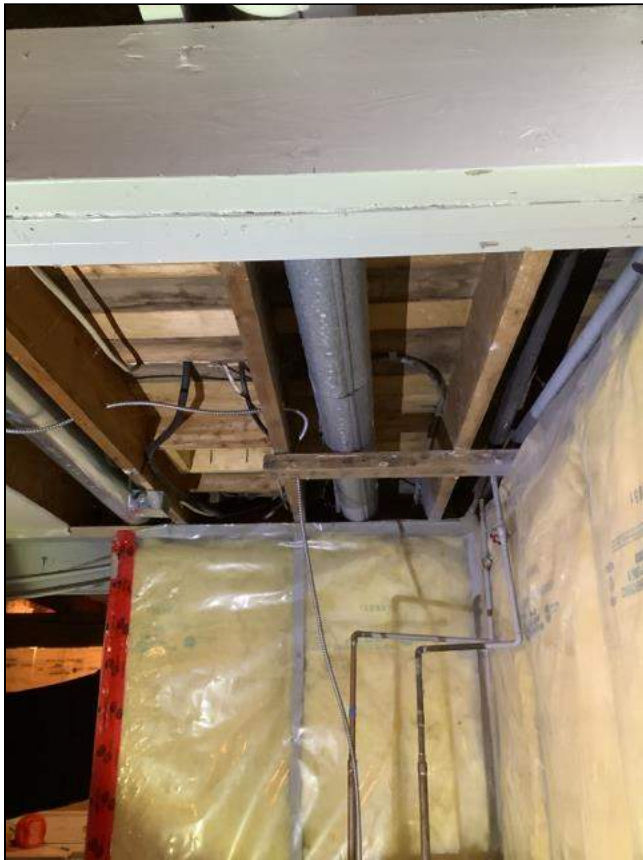
7.9 Item 7(Picture) Joists and Beams - slanted, crooked, notched out, bowed, split

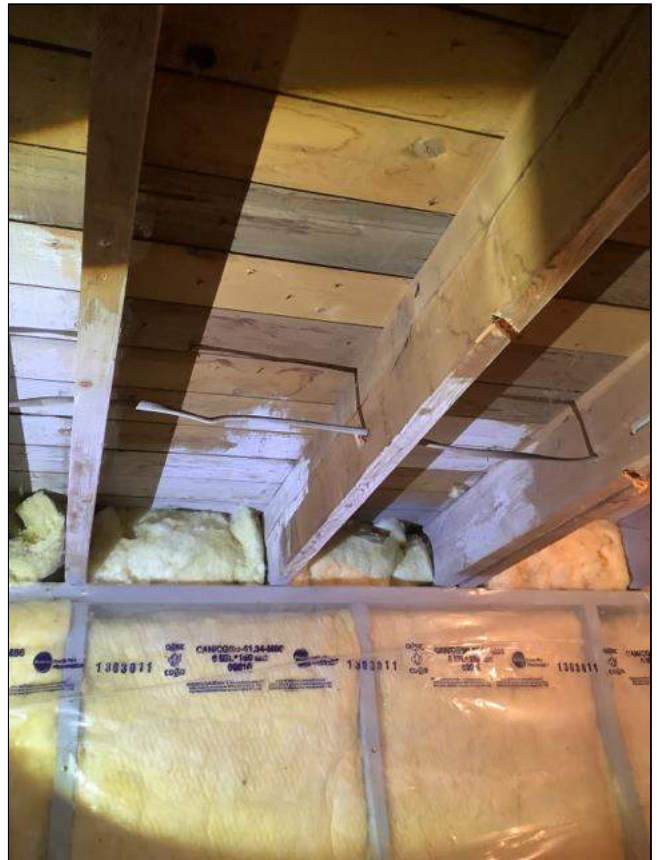
7.9 Item 8(Picture) Joists and Beams - slanted, crooked, notched out, bowed, split

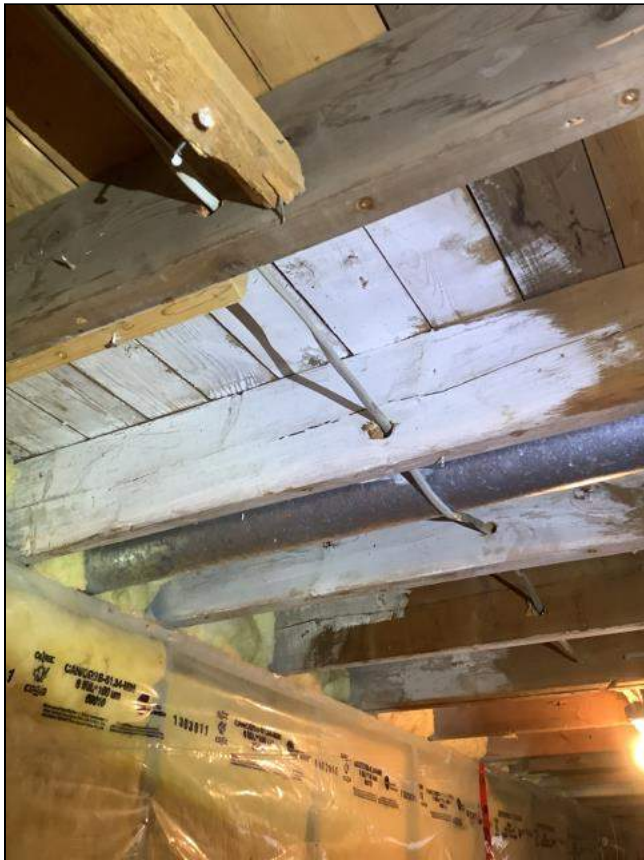
7.9 Item 9(Picture) Joists and Beams - slanted, crooked, notched out, bowed, split

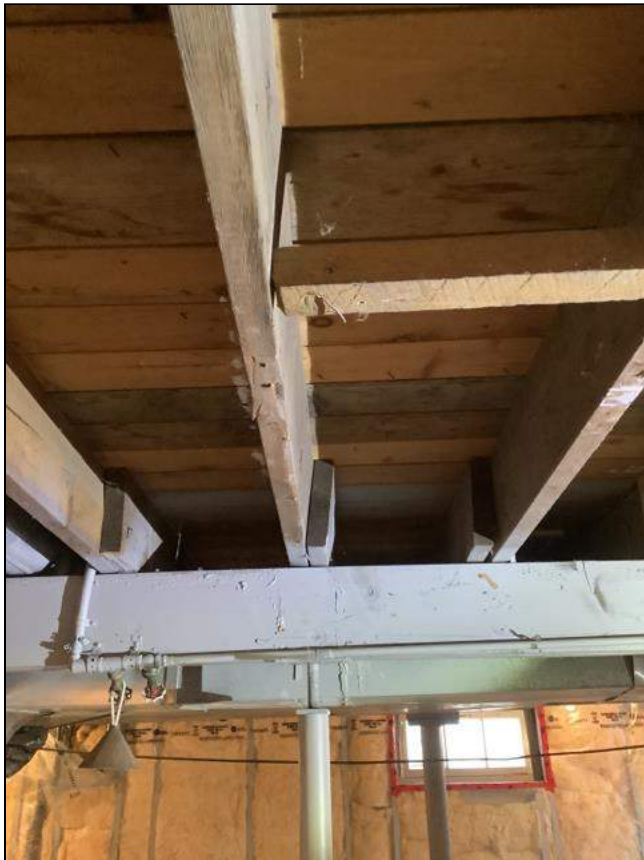
7.9 Item 11(Picture) Joists and Beams - slanted, crooked, notched out, bowed, split

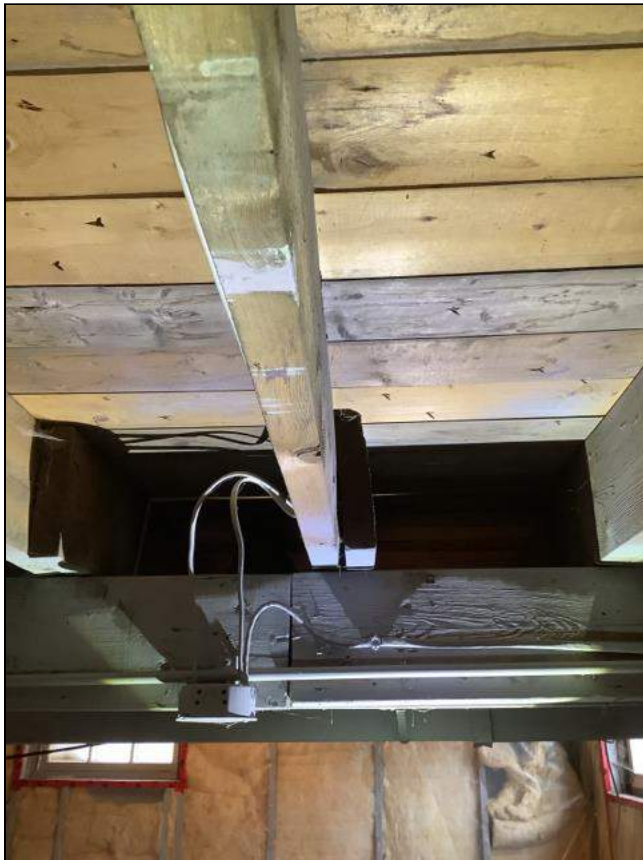
7.9 Item 13(Picture) Joists and Beams - slanted, crooked, notched out, bowed, split

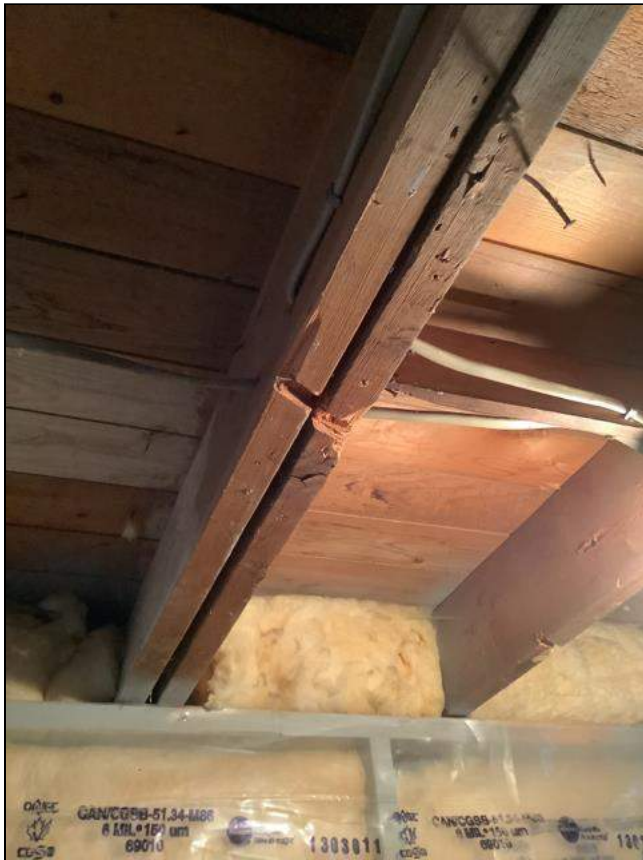
7.9 Item 15(Picture) Joists and Beams - slanted, crooked, notched out, bowed, split

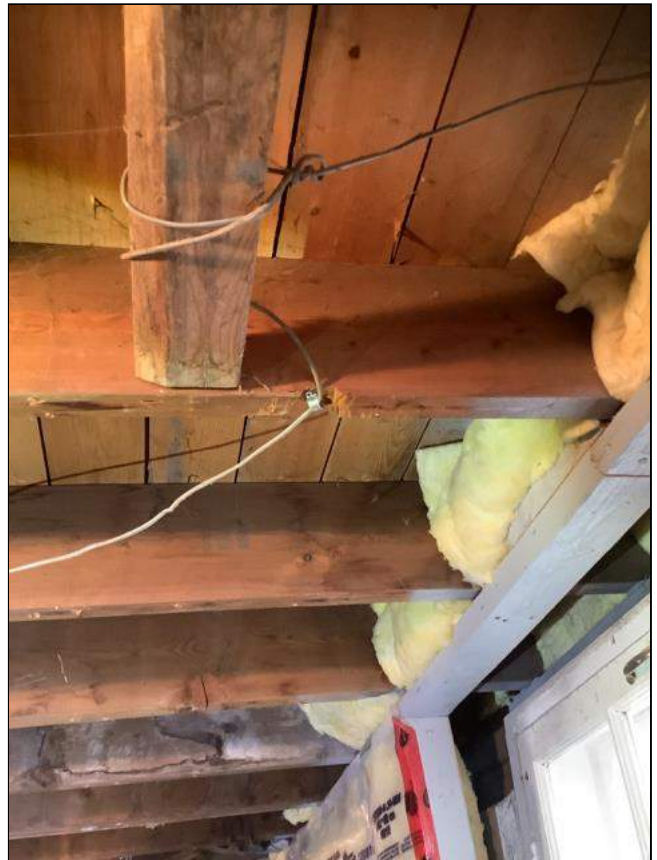
7.9 Item 18(Picture) Joists and Beams - slanted, crooked, notched out, bowed, split

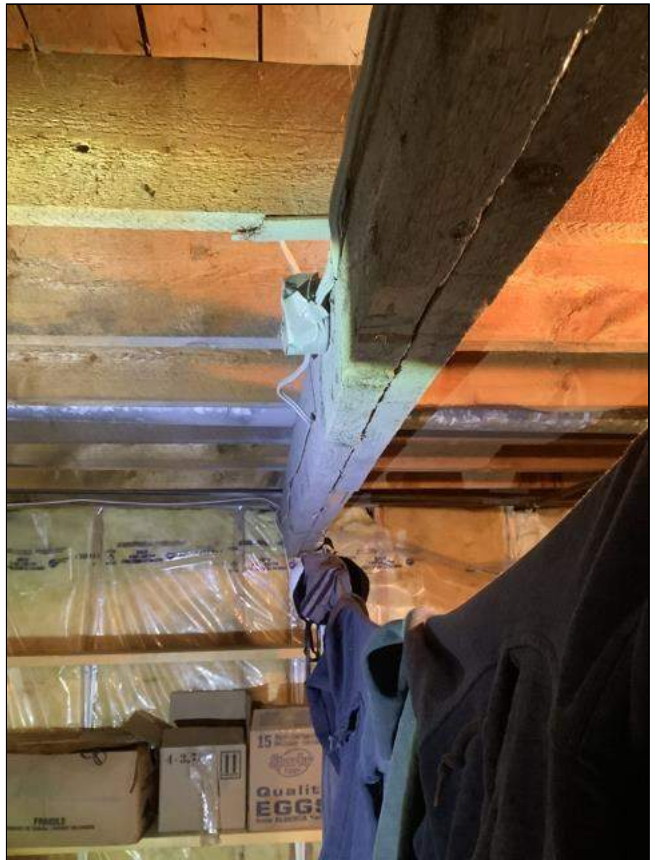
7.9 Item 20(Picture) Joists and Beams - slanted, crooked, notched out, bowed, split

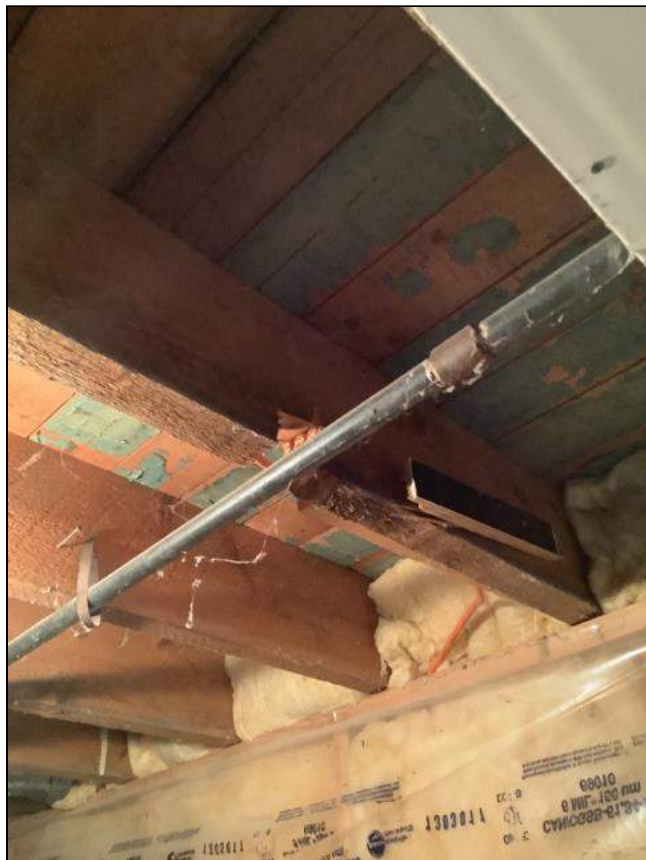
7.9 Item 23(Picture) Joists and Beams - slanted, crooked, notched out, bowed, split

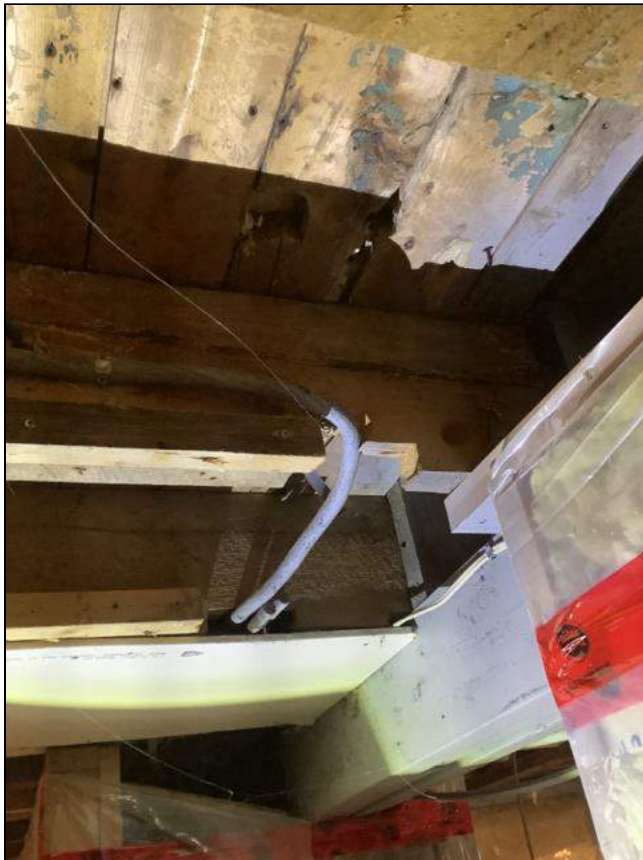
7.9 Item 25(Picture) Joists and Beams - slanted, crooked, notched out, bowed, split

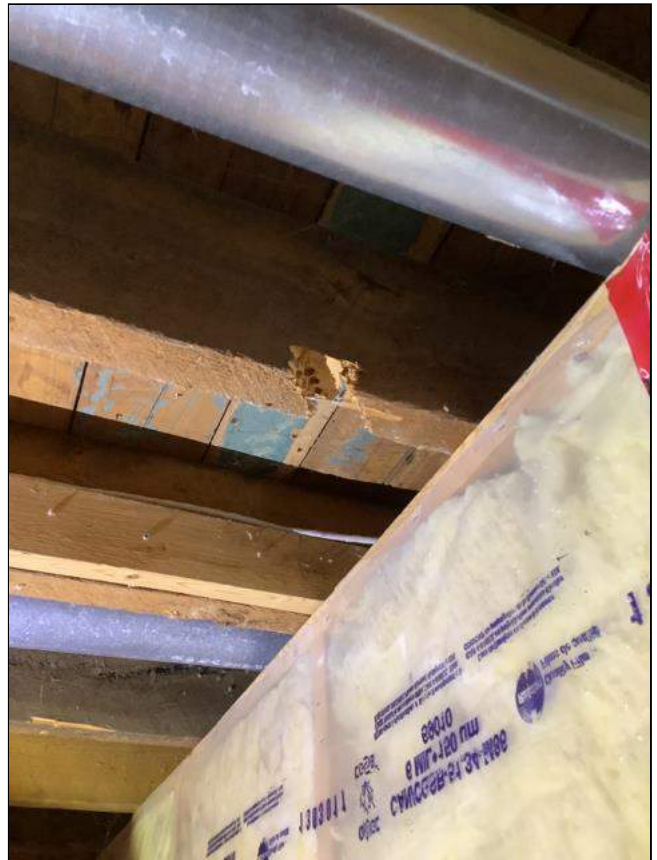
7.9 Item 26(Picture) Joists and Beams - slanted, crooked, notched out, bowed, split

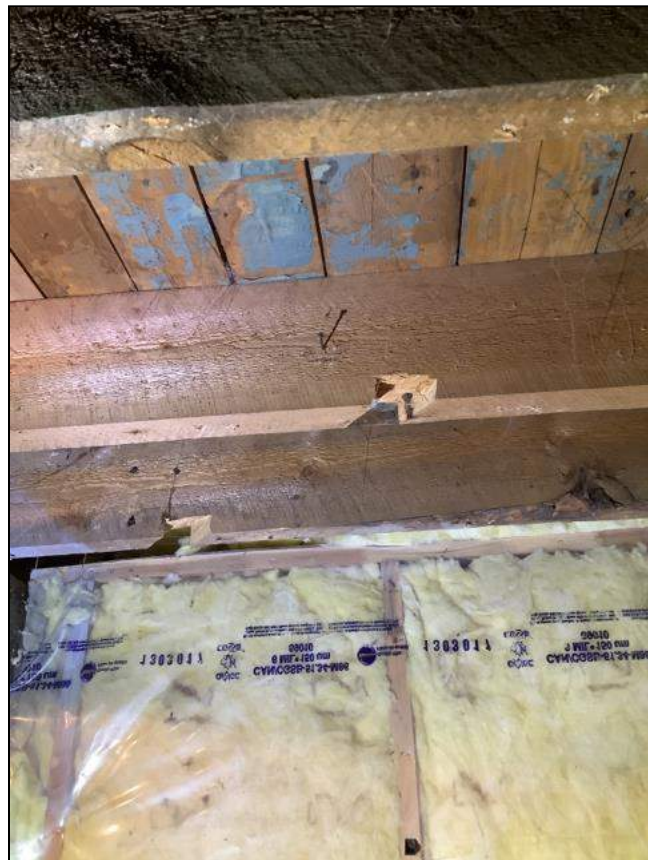
7.9 Item 27(Picture) Joists and Beams - slanted, crooked, notched out, bowed, split

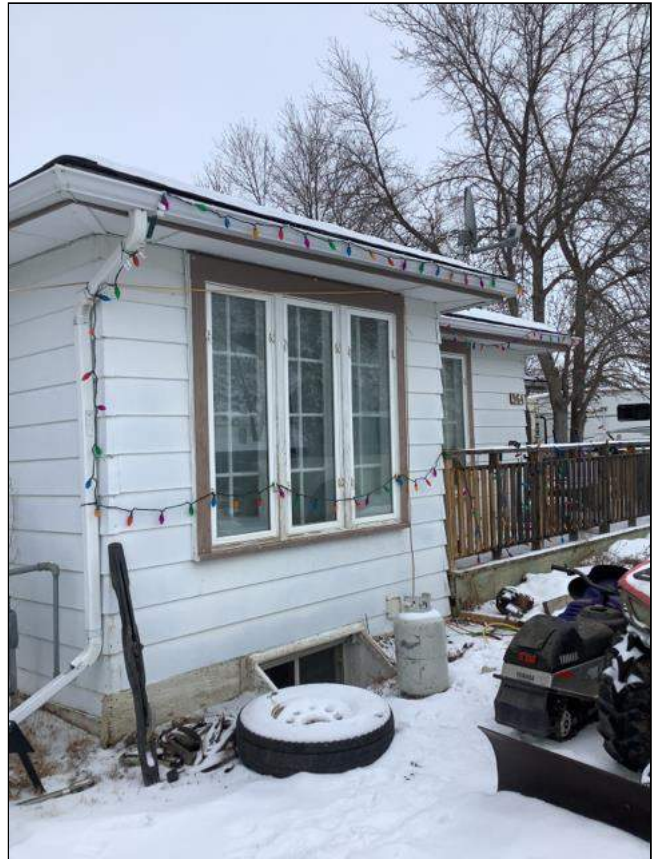
Higher levels of wall clad around the home are only visually inspected from the ground level. There was an area on the back of the house that has signs of moisture damage, recommend further review and repair as required.

3.1 Item 1(Picture) Exterior - signs of moisture damage

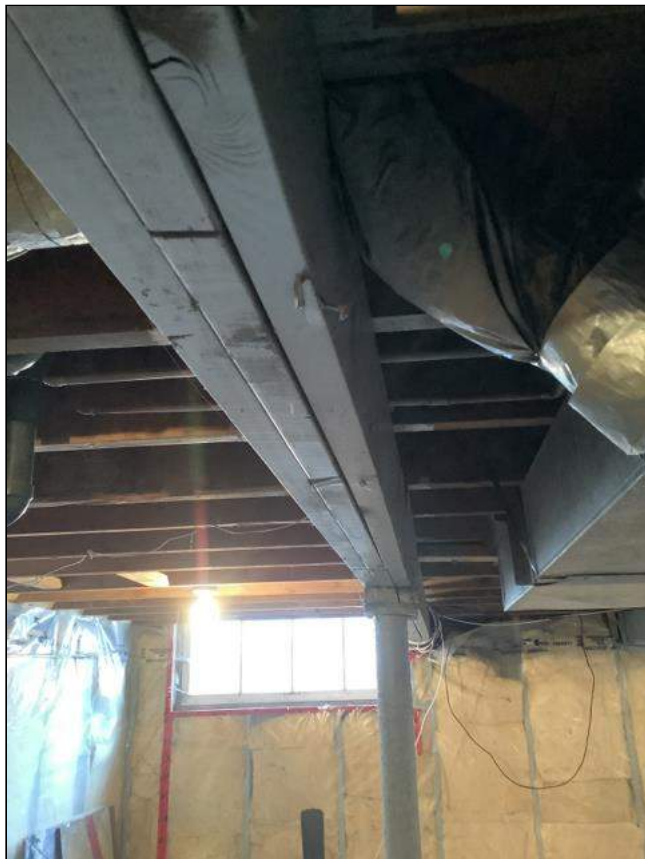
7.9 Item 3(Picture) Joists and Beams - slanted, crooked, notched out, bowed, split

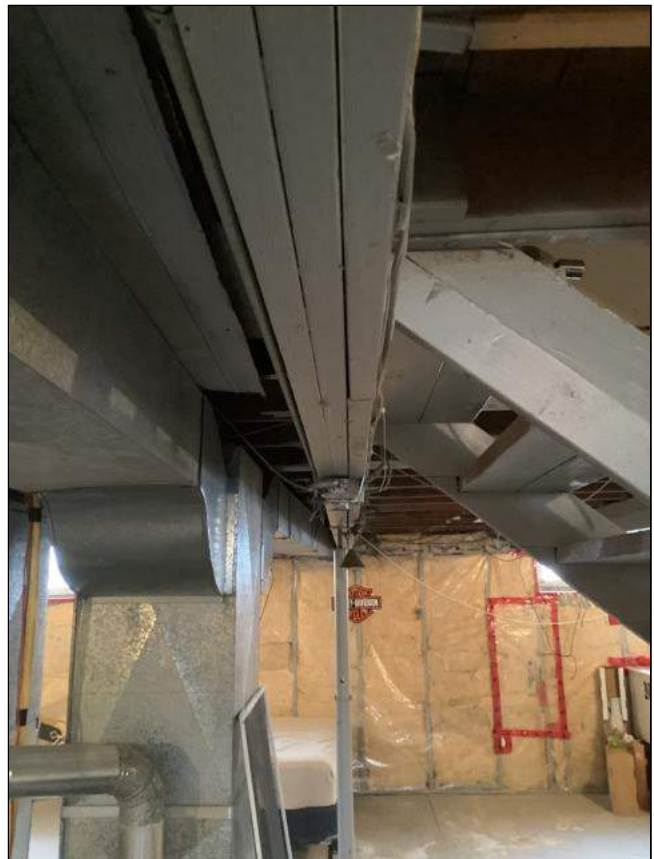
7.9 Item 4(Picture) Joists and Beams - slanted, crooked, notched out, bowed, split

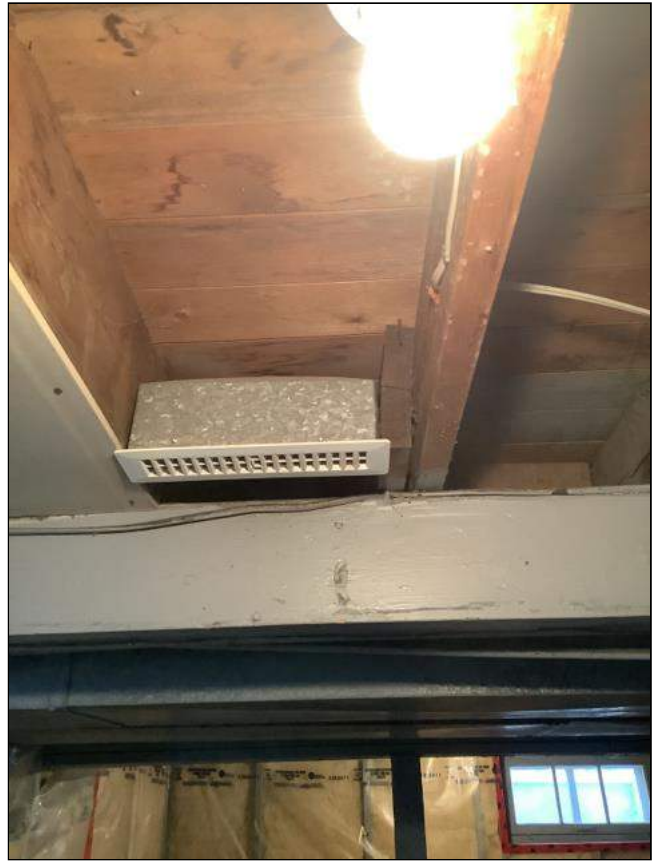
7.9 Item 5(Picture) Joists and Beams - slanted, crooked, notched out, bowed, split

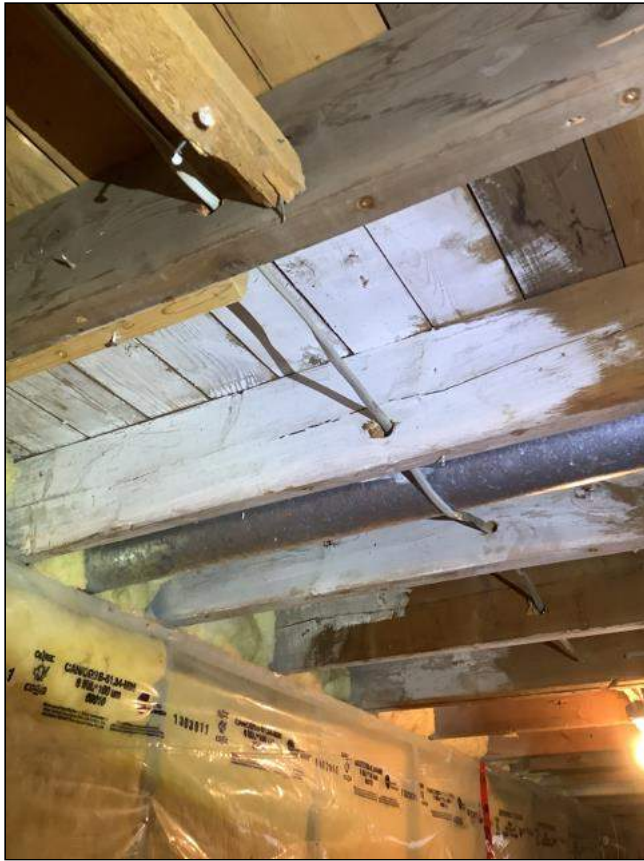
7.9 Item 8(Picture) Joists and Beams - slanted, crooked, notched out, bowed, split

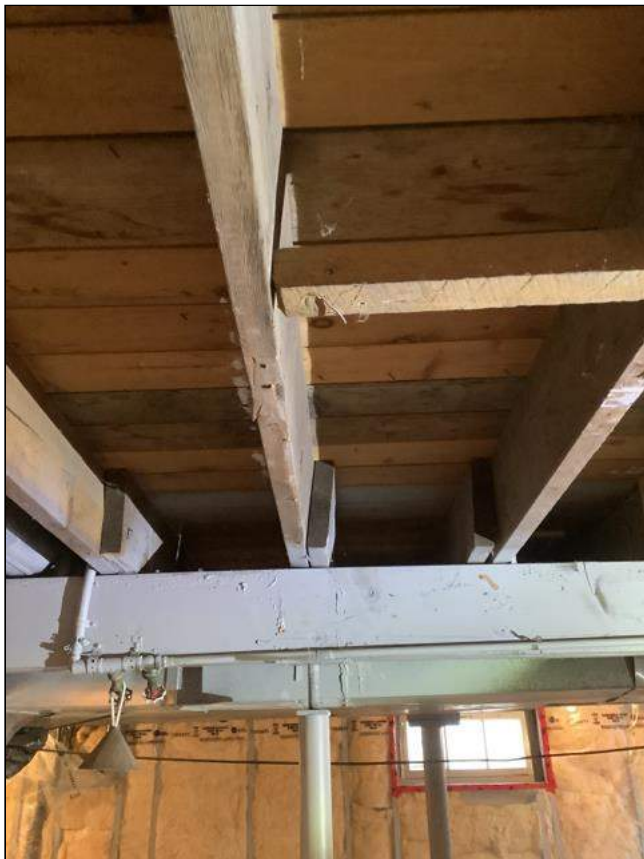
7.9 Item 10(Picture) Joists and Beams - slanted, crooked, notched out, bowed, split

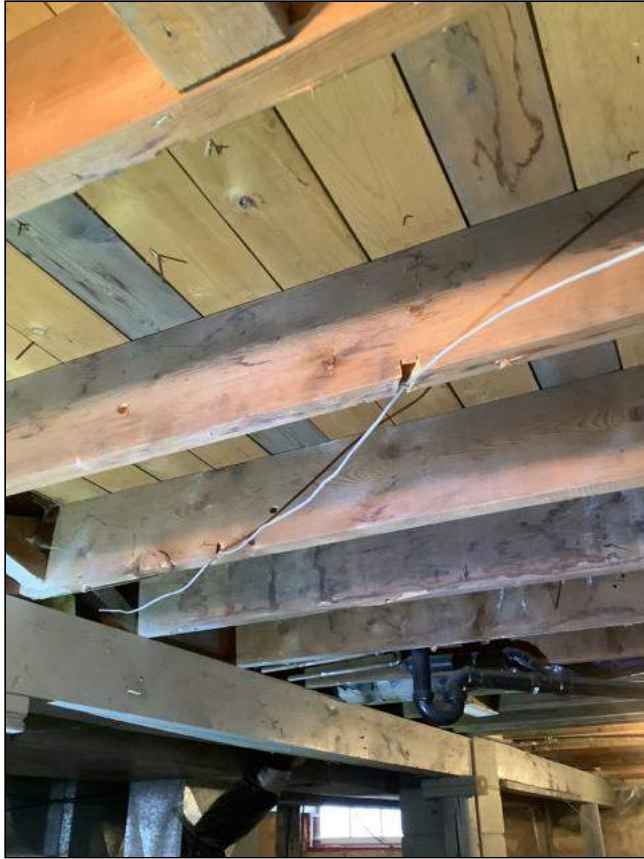
7.9 Item 16(Picture) Joists and Beams - slanted, crooked, notched out, bowed, split

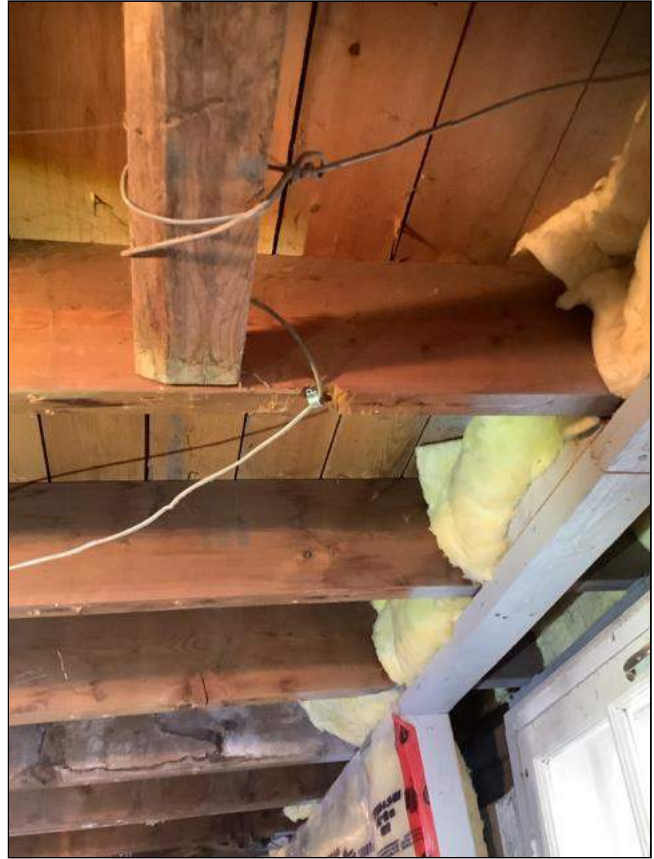
7.9 Item 17(Picture) Joists and Beams - slanted, crooked, notched out, bowed, split

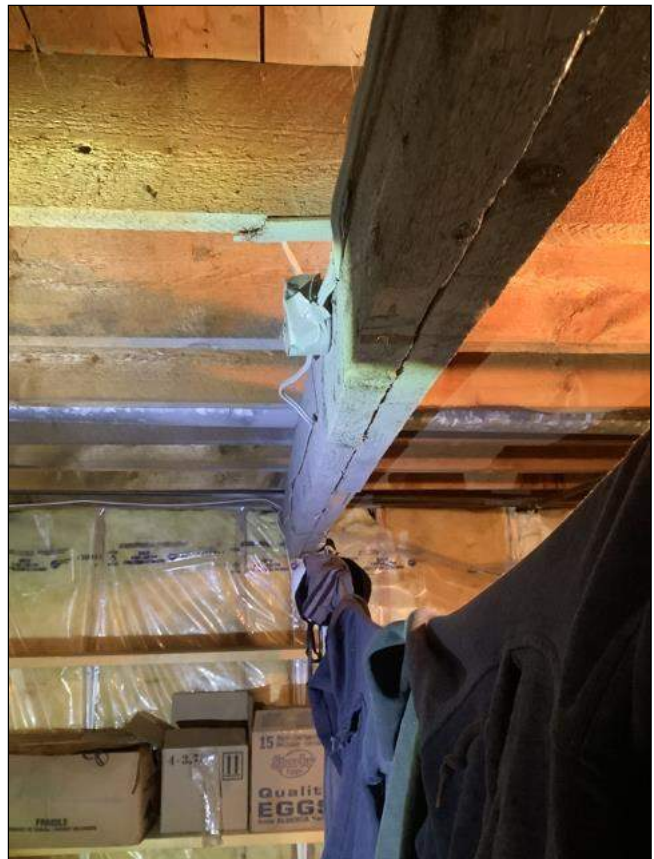
7.9 Item 19(Picture) Joists and Beams - slanted, crooked, notched out, bowed, split

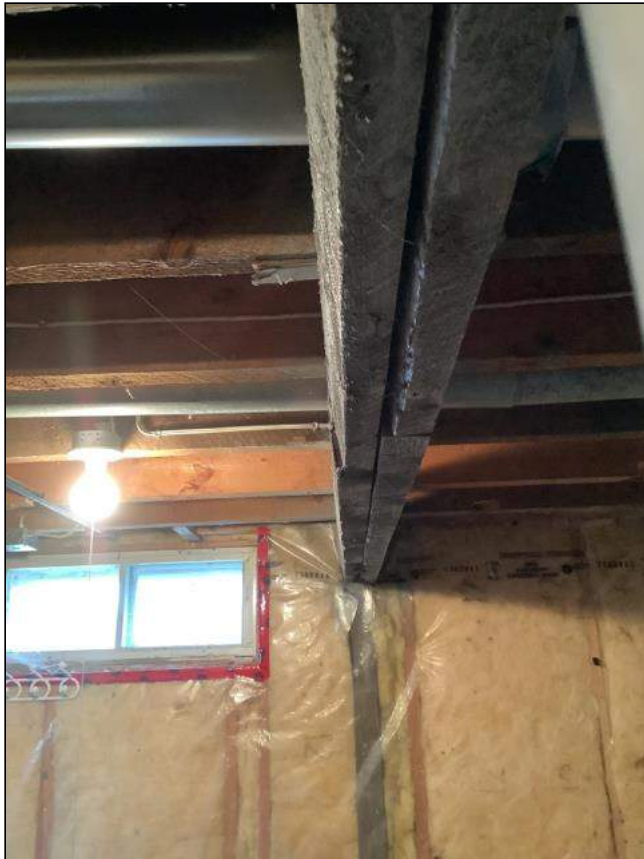
7.9 Item 20(Picture) Joists and Beams - slanted, crooked, notched out, bowed, split

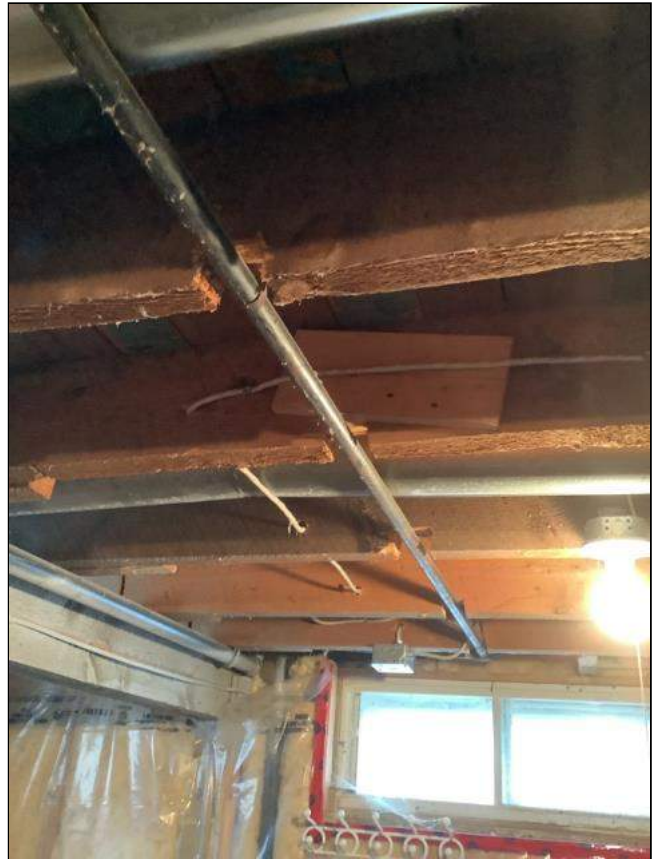
7.9 Item 21(Picture) Joists and Beams - slanted, crooked, notched out, bowed, split

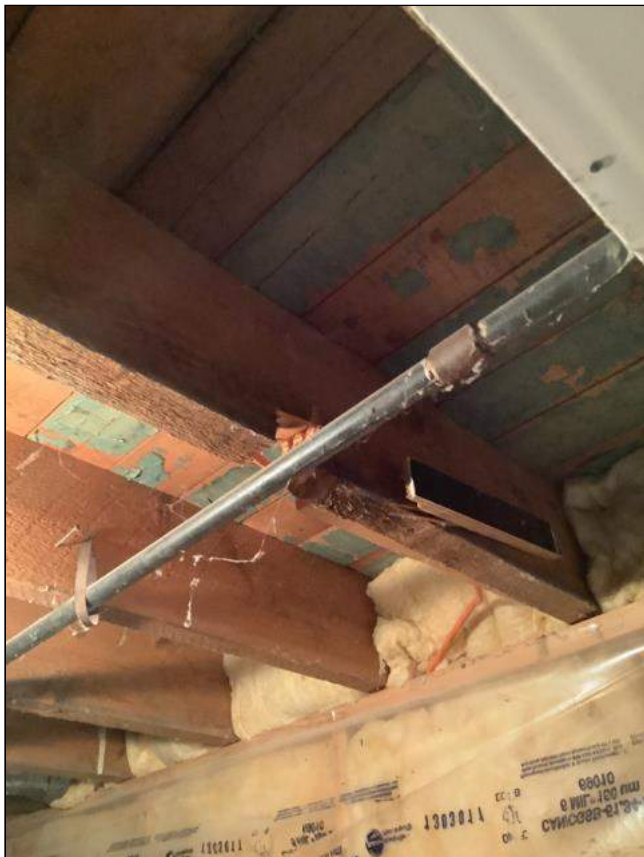
7.9 Item 22(Picture) Joists and Beams - slanted, crooked, notched out, bowed, split

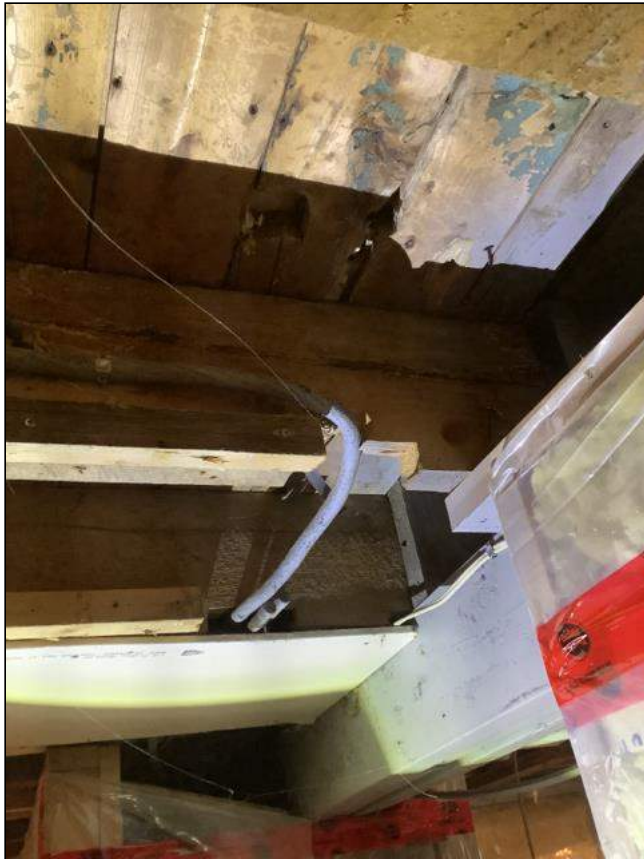
7.9 Item 24(Picture) Joists and Beams - slanted, crooked, notched out, bowed, split

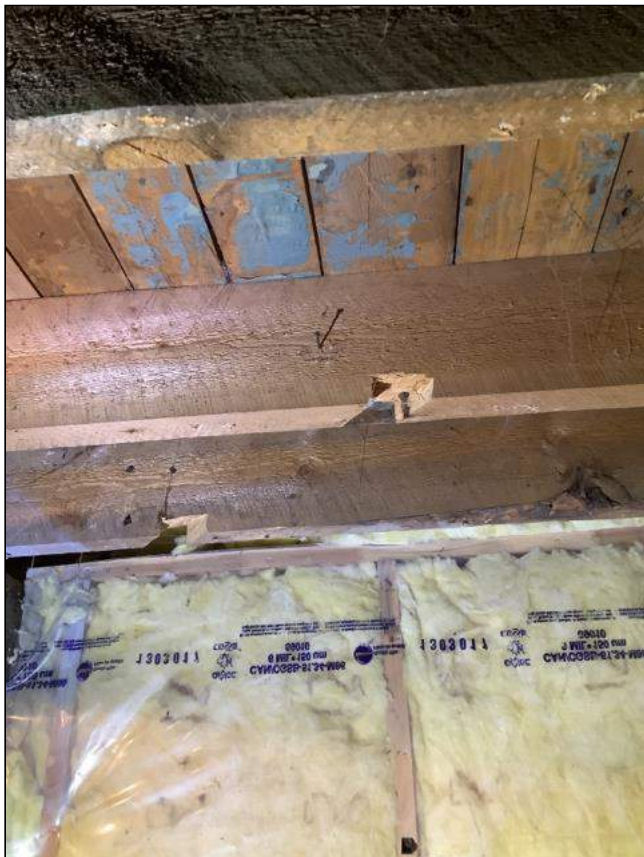
7.9 Item 26(Picture) Joists and Beams - slanted, crooked, notched out, bowed, split

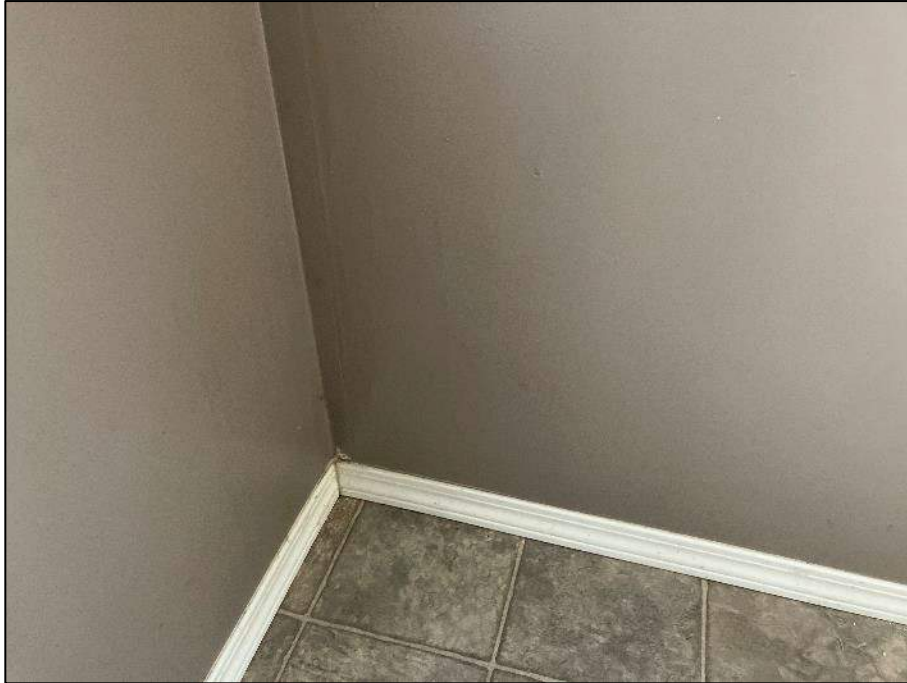
1. The following materials were identified as asbestos-containing and will require abatement prior to demolition of the structure:
 - a. Drywall Joint Compound (*See Photographs #1 to 8*).
 - b. Vermiculite – Attic (*See Photographs #21 and 22*).

1. Drywall joint compound was identified as asbestos-containing (*See Photographs #1 to 8*). Removal of the material must be performed prior to demolition by a qualified abatement contractor using moderate risk asbestos abatement procedures found in Section 5.3 of the AAAM (2019).

PHOTOGRAPH #1: Drywall Joint Compound - Floor 1 Ext Dining Room (2% Chrysotile)

Removal of the materials must be performed by a qualified abatement contractor prior to demolition using procedures found in the Alberta Asbestos Abatement Manual (2019).

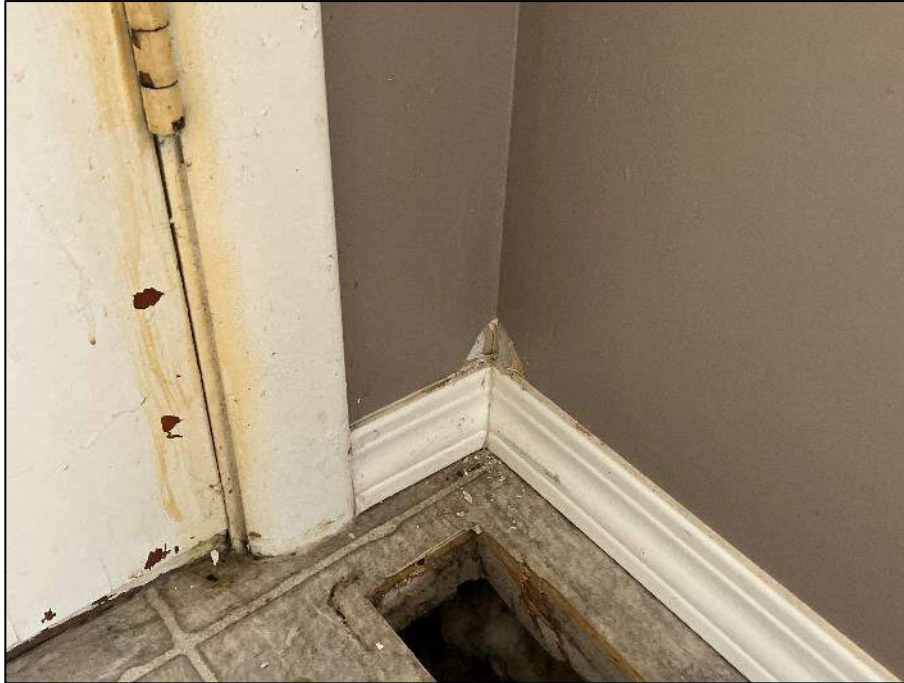
PHOTOGRAPH #3: Drywall Joint Compound – Floor 1 Ext Kitchen (2% Chrysotile)

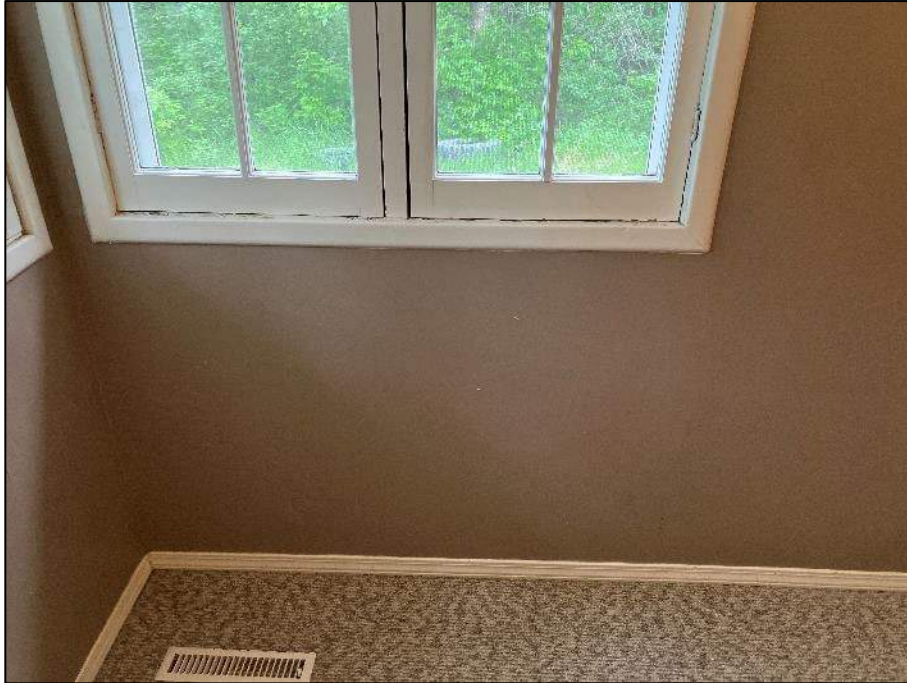
PHOTOGRAPH #5: Drywall Joint Compound – Floor 1 Ext NW Bedroom (Assume Positive)

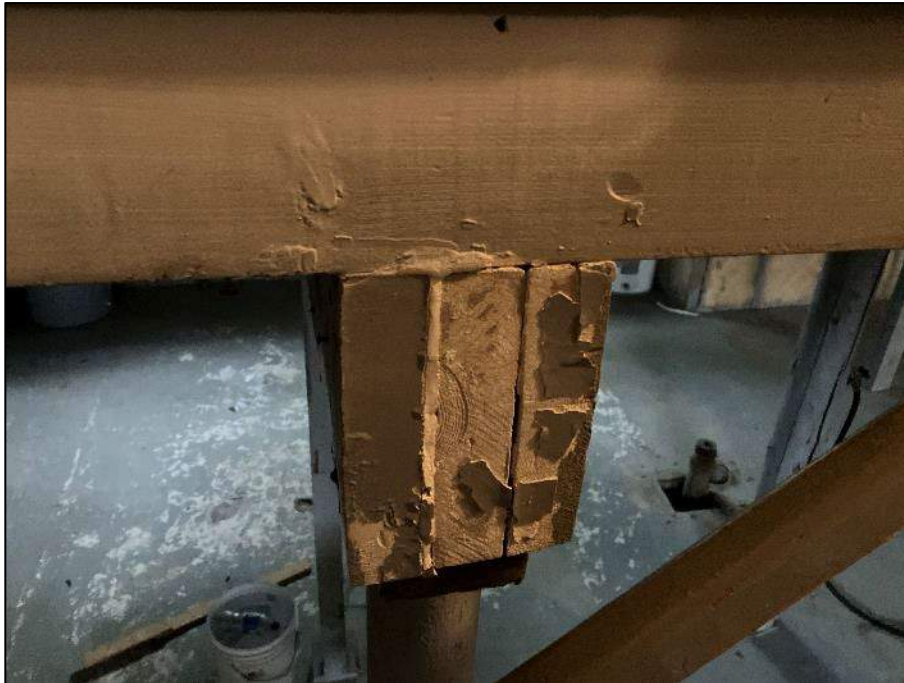
PHOTOGRAPH #7: Drywall Joint Compound – Basement Int Stairs (Assume Positive)

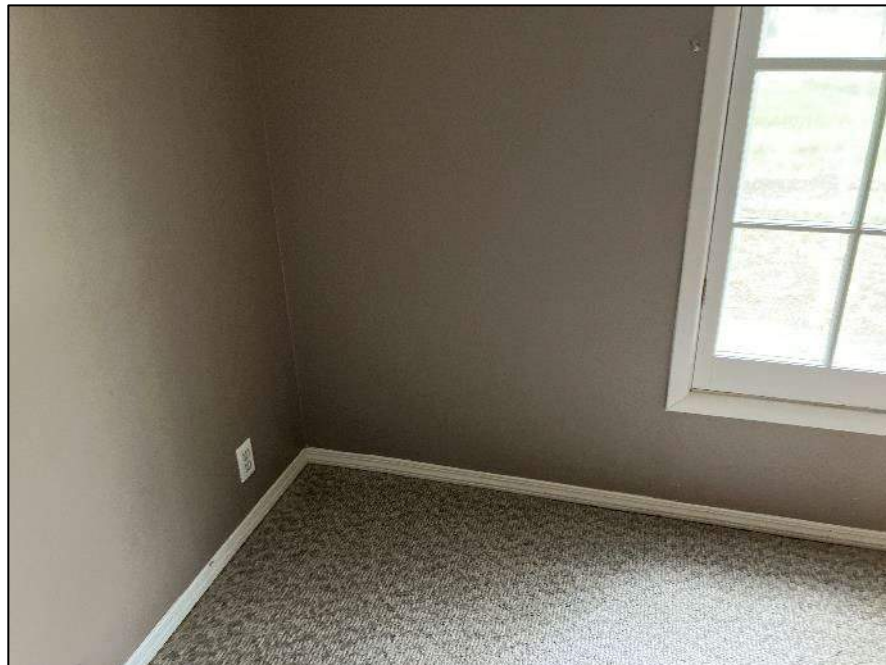
PHOTOGRAPH #8: Drywall Joint Compound – Floor 1 Ext NE Bedroom (2% Chrysotile)

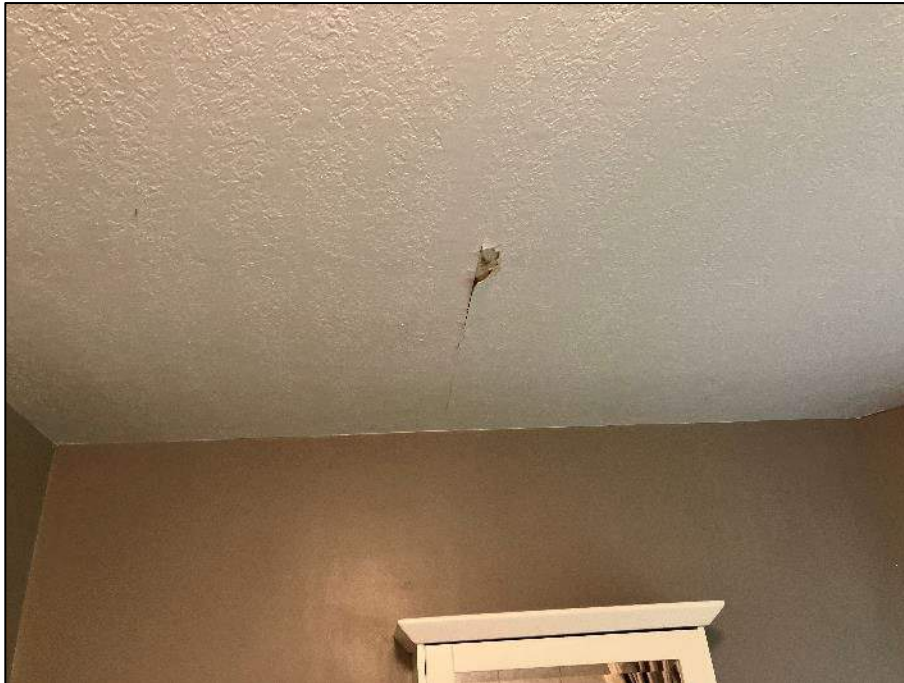
PHOTOGRAPH #9: Ceiling Texture - Floor 1 Bathroom (Non-Asbestos)

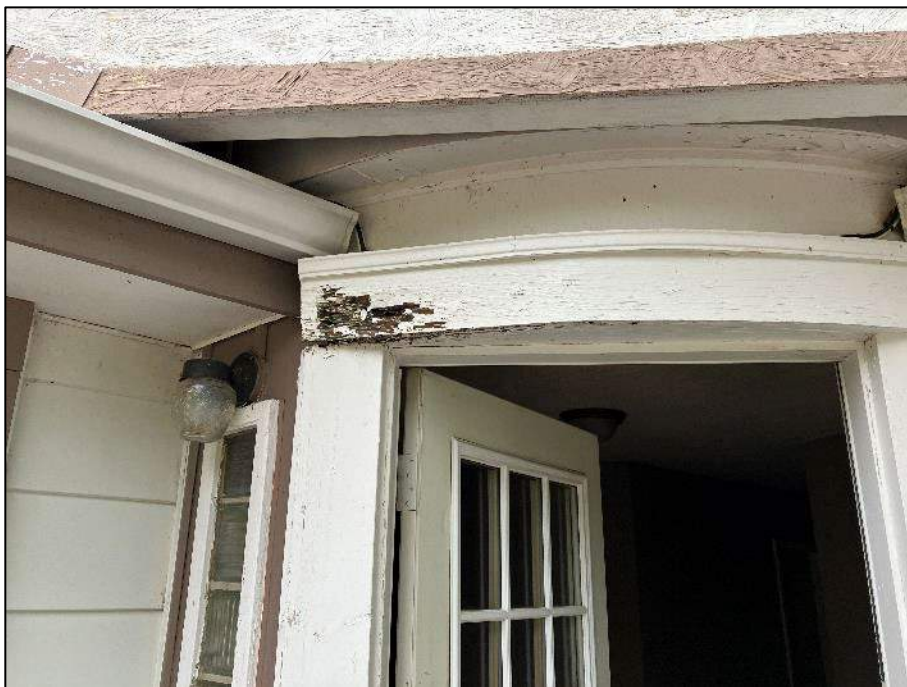
PHOTOGRAPH #26: Paint- White Exterior (Non-Lead Based)

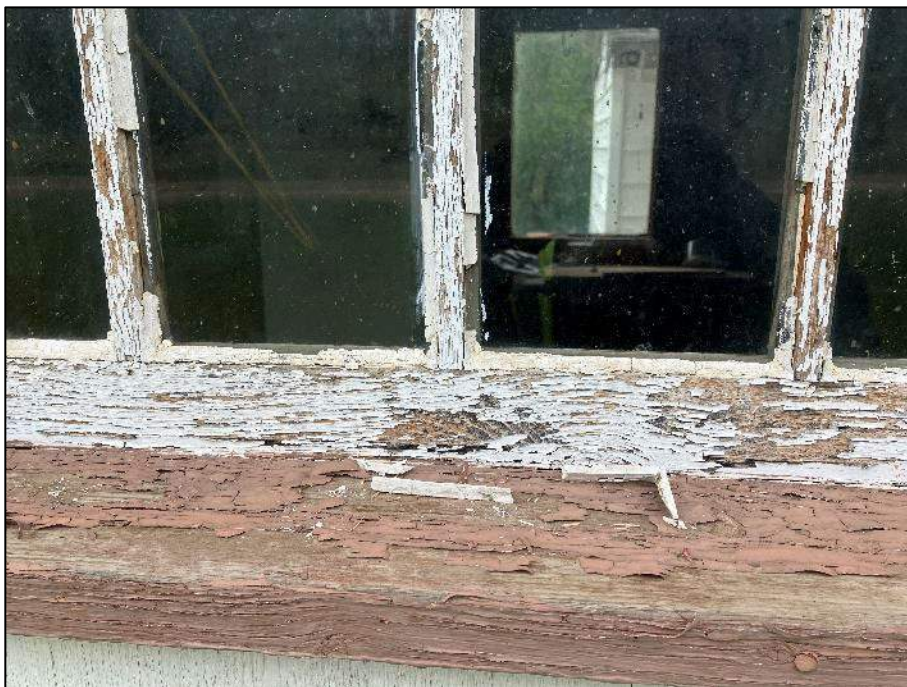
PHOTOGRAPH #28: Paint – Burgundy Shed (Non-Lead Based)
