HOME
INSPECTION

Inspection Report

Property Address:
964 Hunter Drive - Nacmine
Drumheller Alberta T0J 0Y0

| Date: 16/12/2021 | Time: 11:00 AM | Report ID: 964 Hunter Drive - Nacmine |

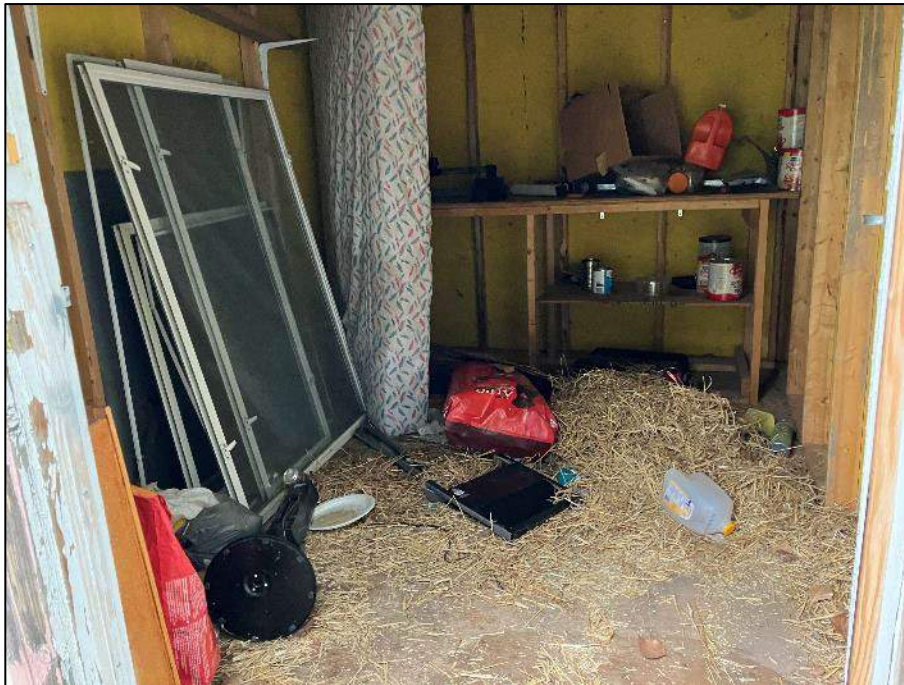
PHOTOGRAPH #31: Miscellaneous Chemicals - Shed

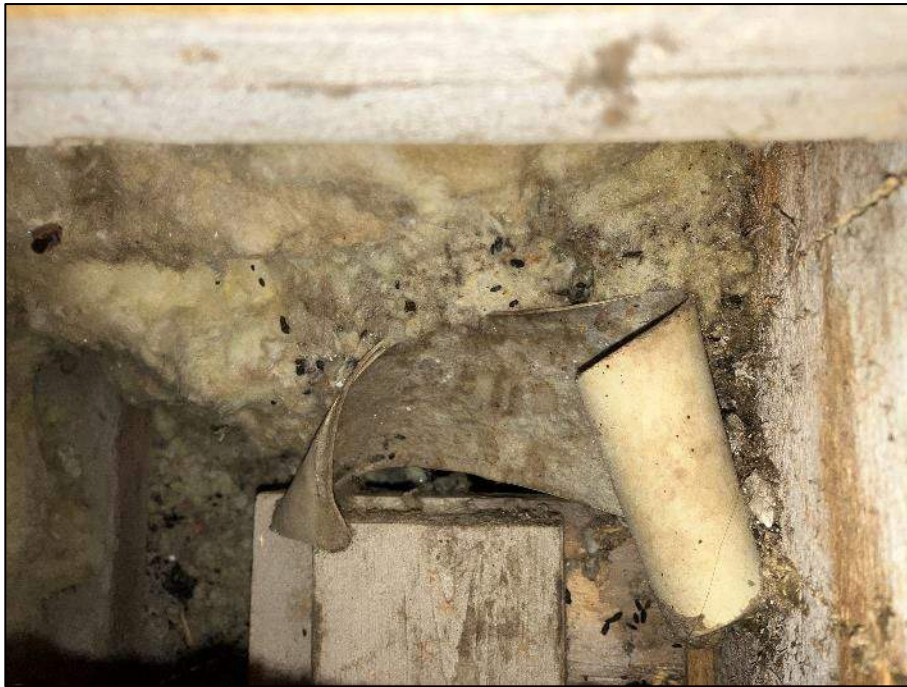
PHOTOGRAPH #33: Mouse Dropping – Kitchen Venting

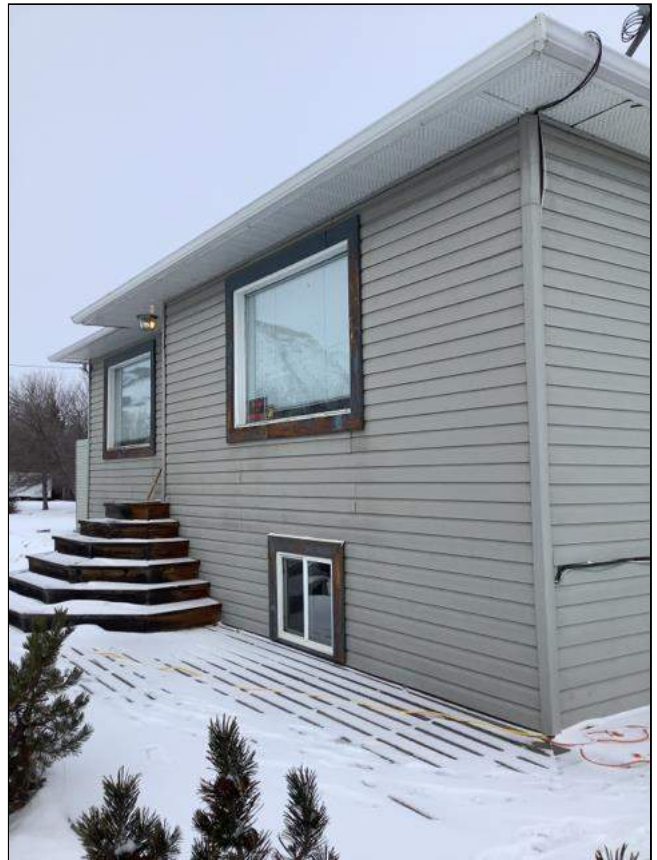
3.1 Item 8(Picture) Exterior

Higher levels of wall clad around the home are only visually inspected from the ground level. At the back of the house the top row of siding is bowed over the sliding patio door, recommend that it be further reviewed and repaired as required.

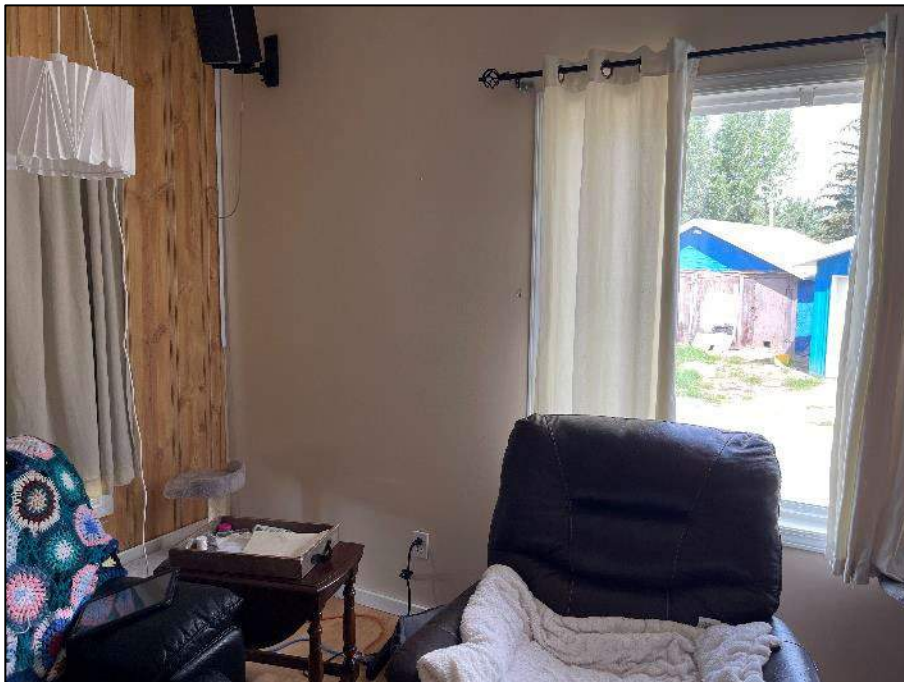
PHOTOGRAPH #2: Drywall Joint Compound - Level 1 NW Living Room (Non-Asbestos)

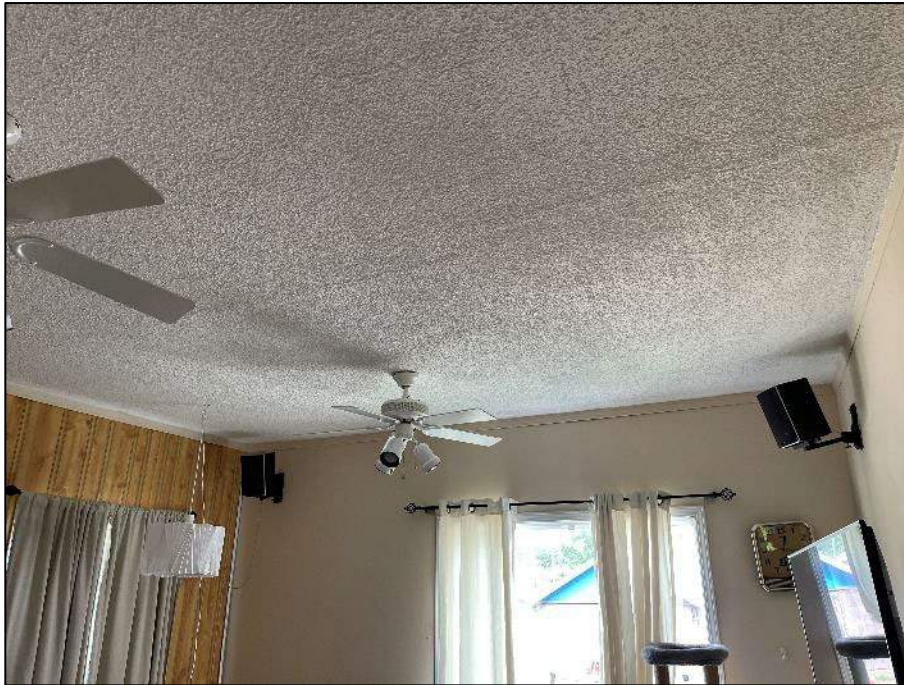
PHOTOGRAPH #7: Ceiling Texture - Level 1 Living Room (Non-Asbestos)

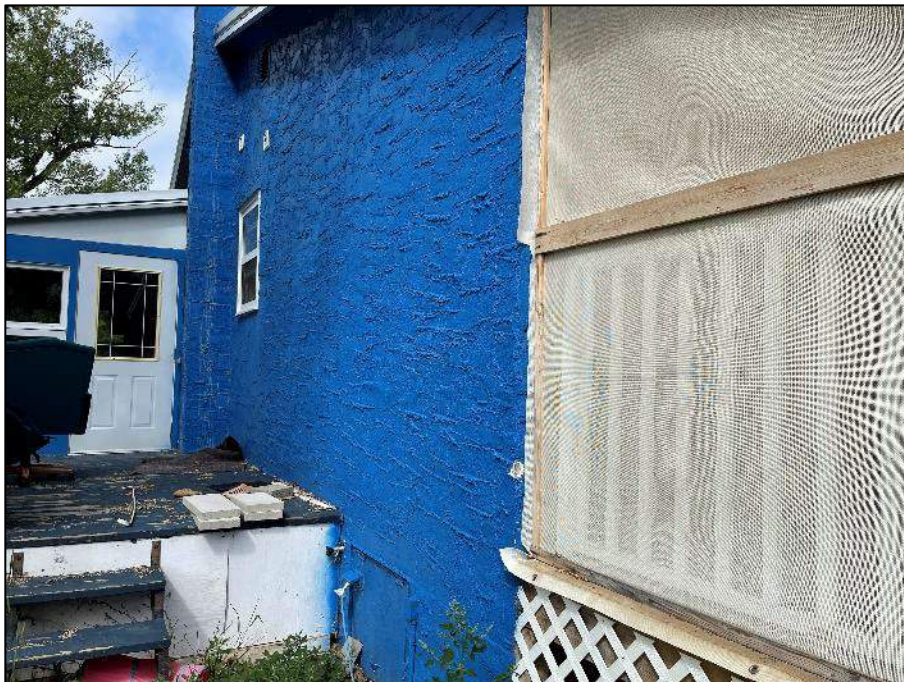
PHOTOGRAPH #14: Stucco - Exterior SE Corner (Assume Positive)

1. The stucco on the property was identified as asbestos-containing (*See Photographs #13 to 17*). Removal of the material must be performed prior to demolition by a qualified abatement contractor using moderate-risk asbestos abatement procedures found in Section 5.3 of the AAAM (2019).

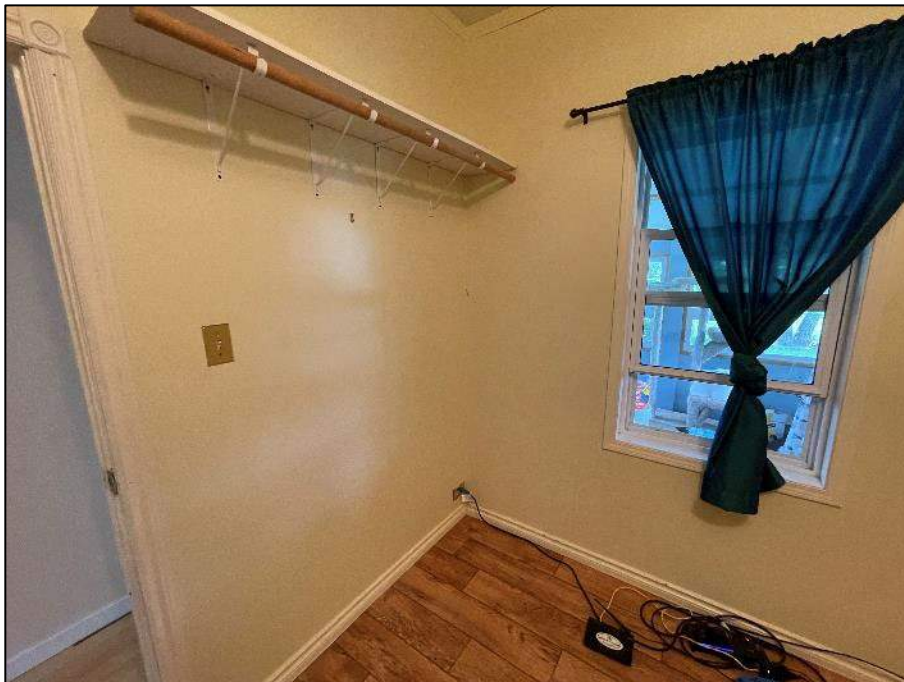
PHOTOGRAPH #18: Beige Interior Paint (Non-Lead)
