Demolition and Remediation Services

**Residential Demolition Project
for
The Town of Drumheller**

Tender issued September 2, 2022
Tender closing September 22, 2022 – 2:00:00 P.M.

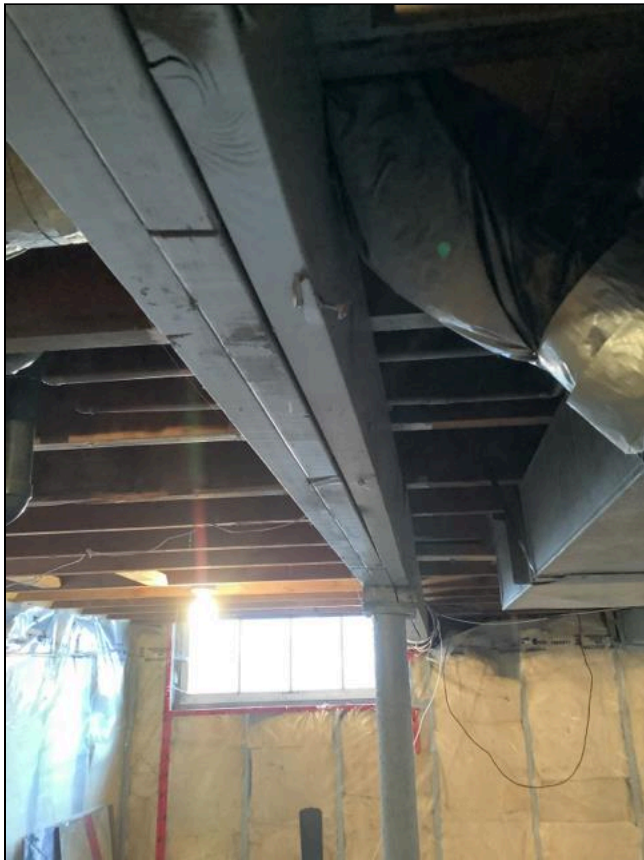
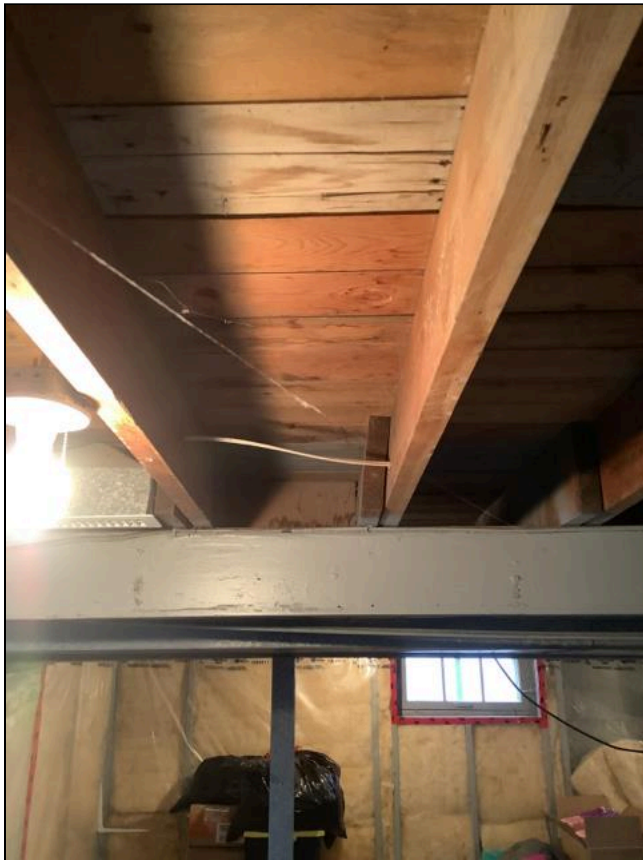
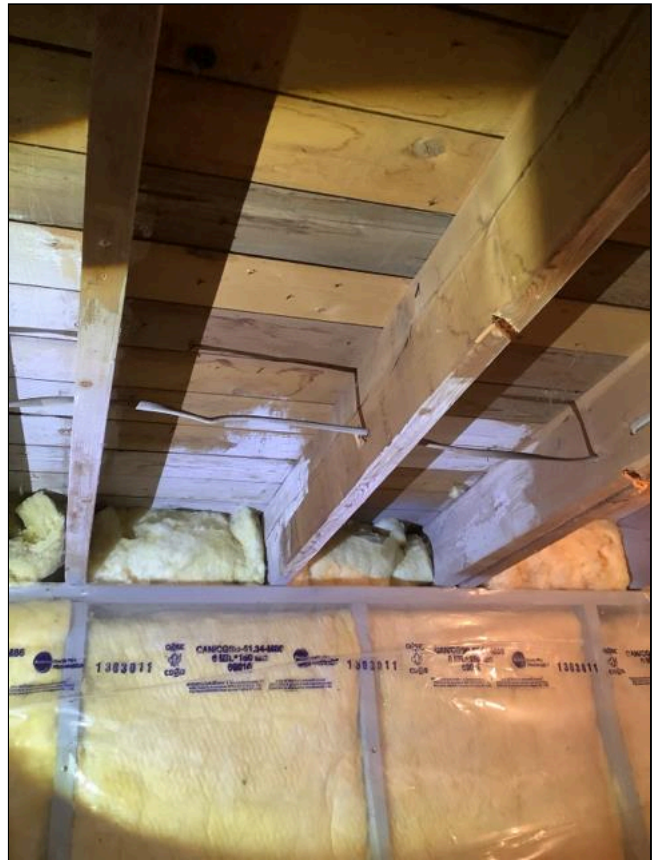
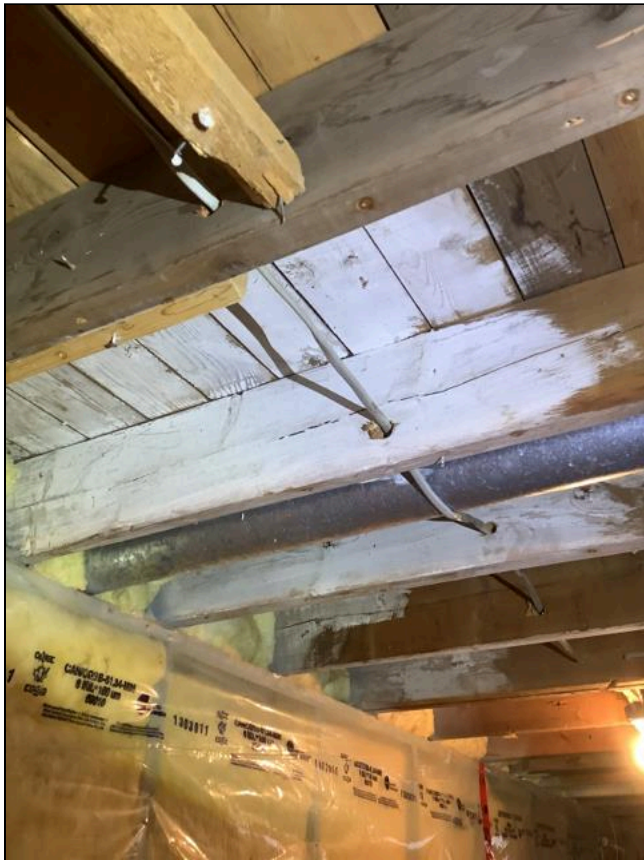
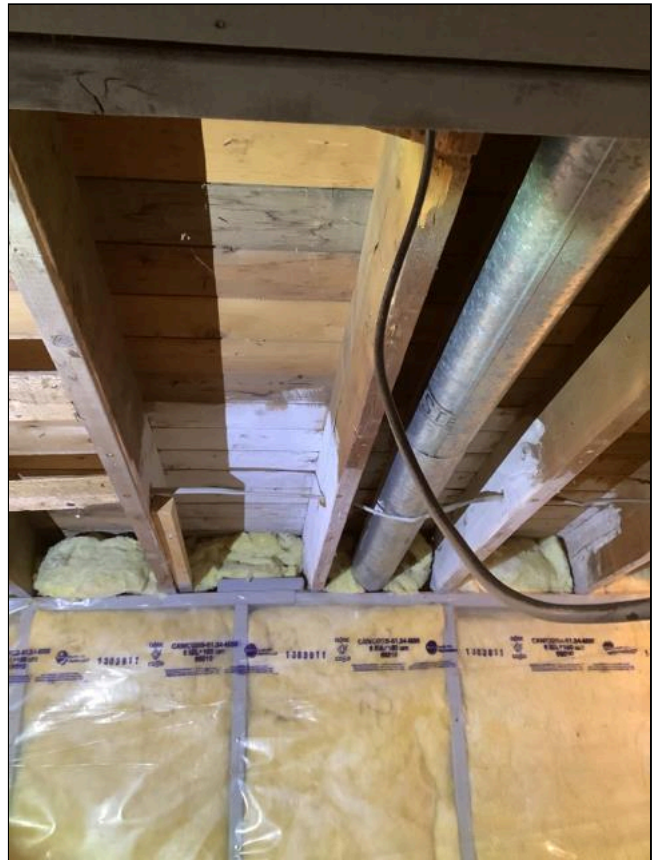
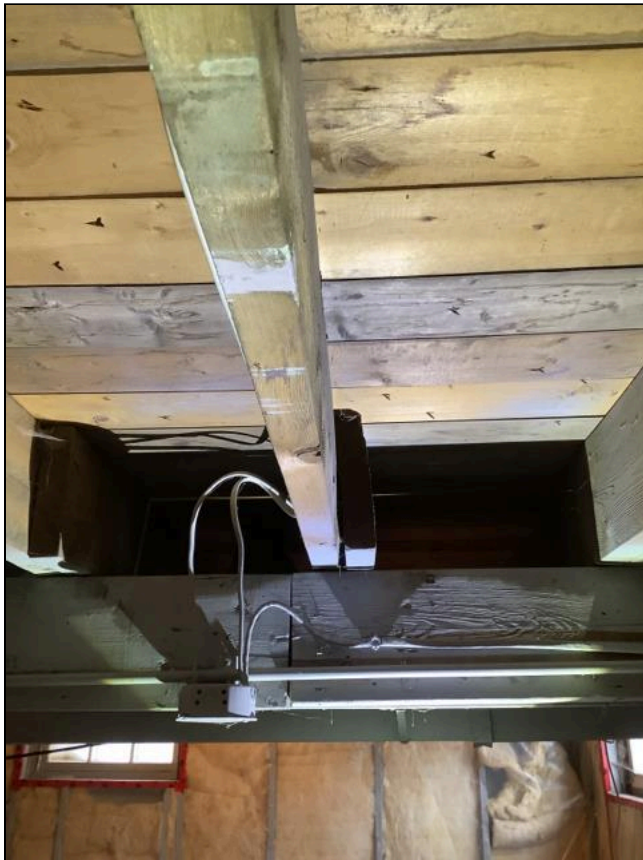
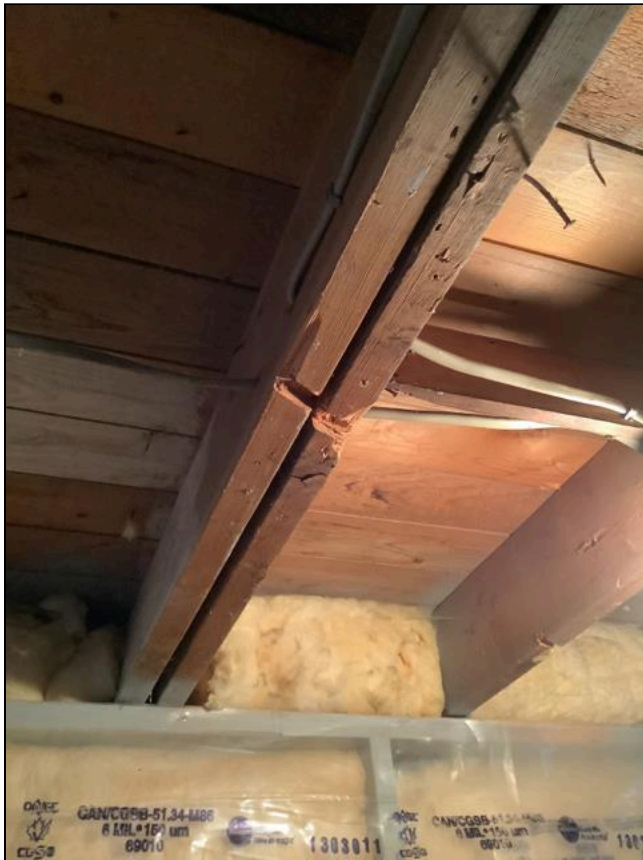
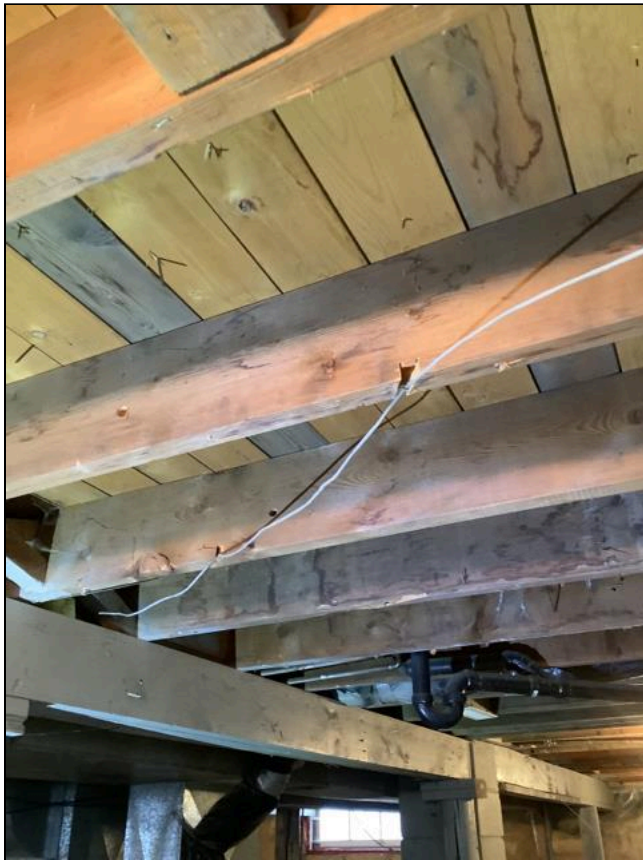
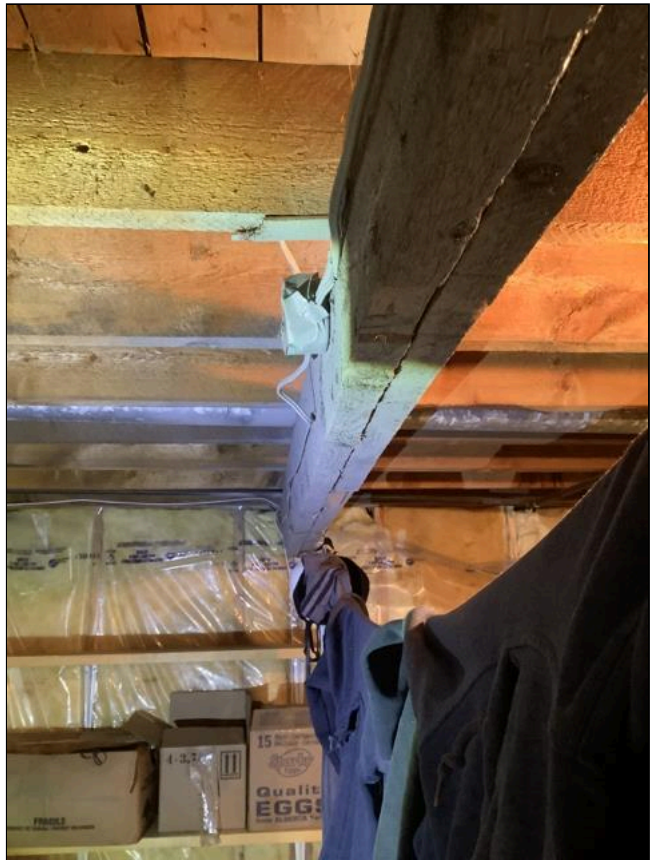
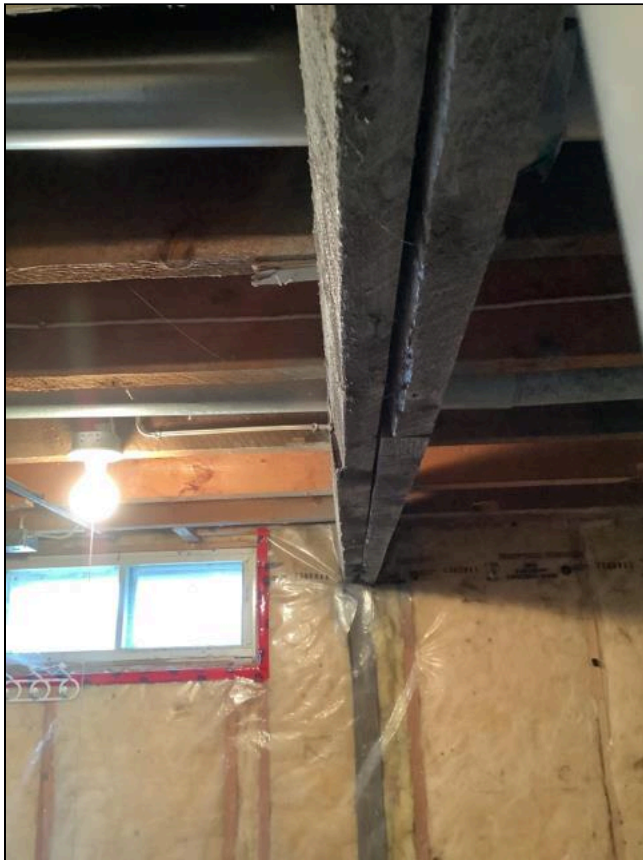
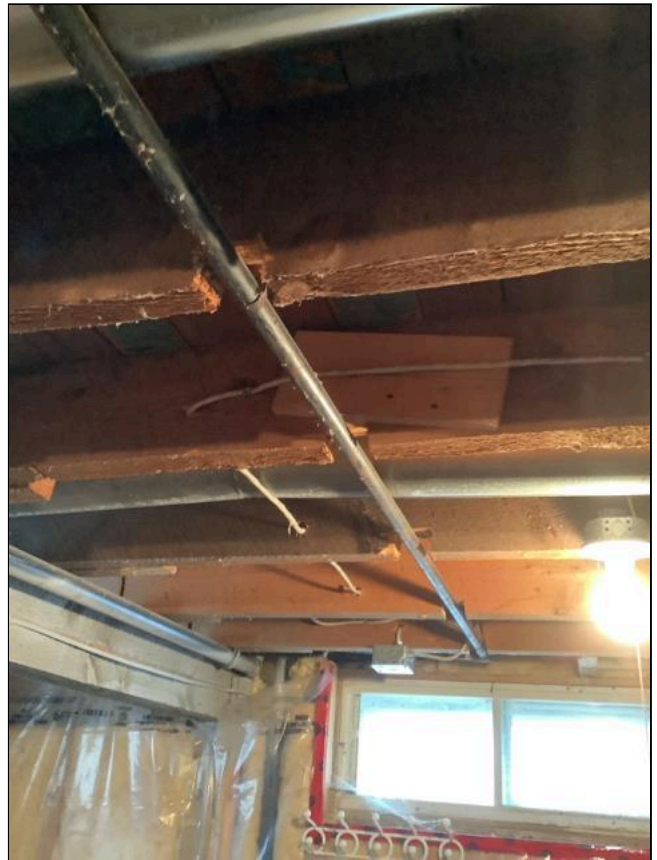
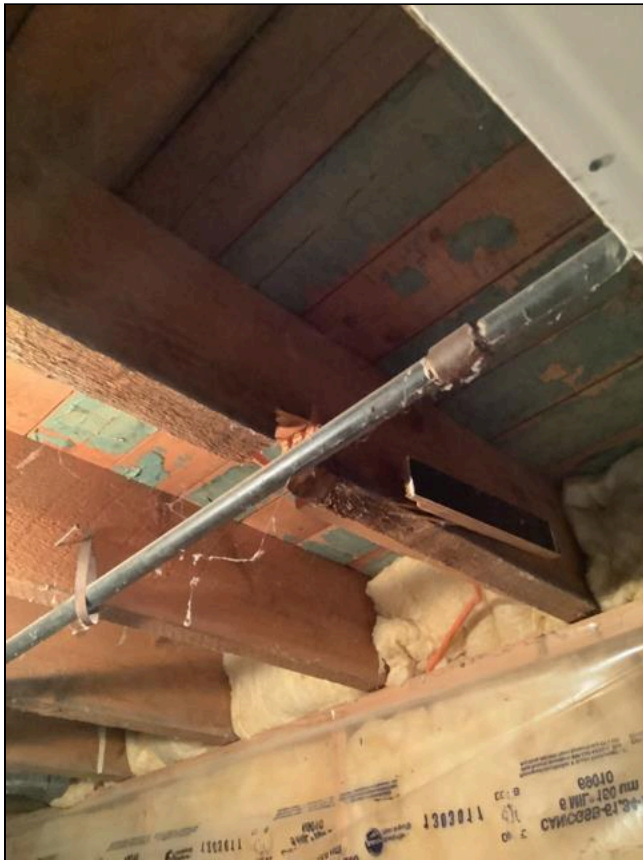
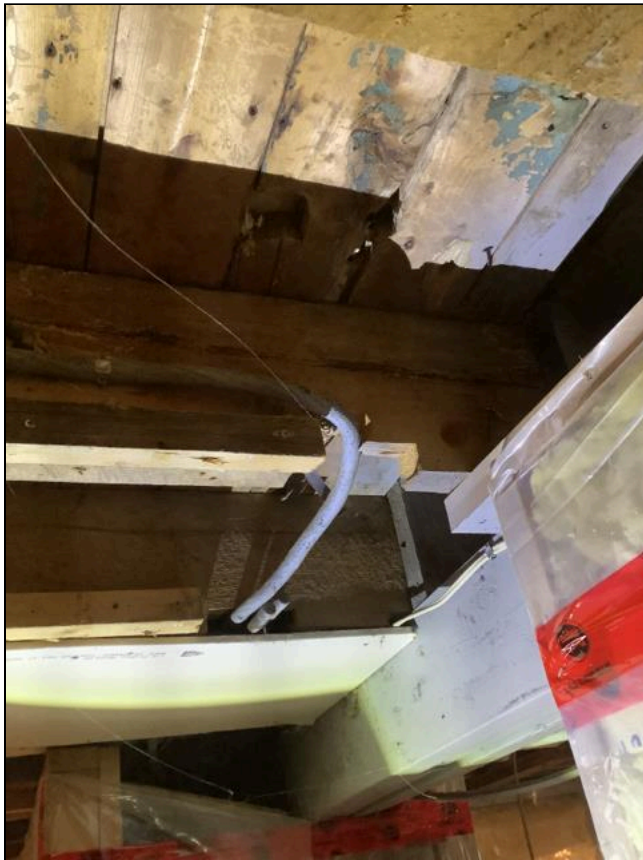
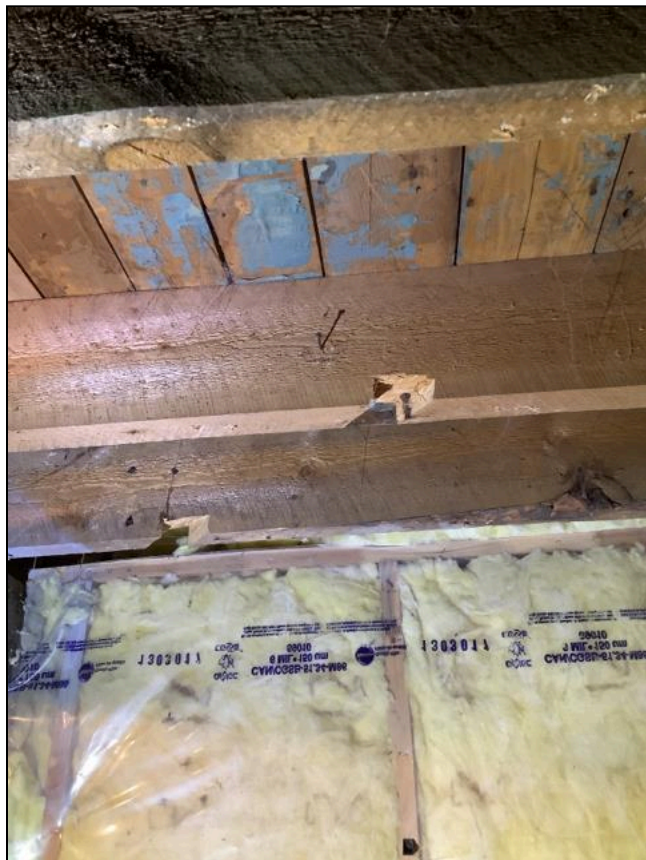
Comments: Inspected, Repair or Replace

7.9 Item 1(Picture) Joists and Beams - slanted, crooked, notched out, bowed, split

7.9 Item 2(Picture) Joists and Beams - slanted, crooked, notched out, bowed, split

7.9 Item 3(Picture) Joists and Beams - slanted, crooked, notched out, bowed, split

7.9 Item 4(Picture) Joists and Beams - slanted, crooked, notched out, bowed, split

7.9 Item 5(Picture) Joists and Beams - slanted, crooked, notched out, bowed, split

7.9 Item 6(Picture) Joists and Beams - slanted, crooked, notched out, bowed, split

7.9 Item 7(Picture) Joists and Beams - slanted, crooked, notched out, bowed, split

7.9 Item 8(Picture) Joists and Beams - slanted, crooked, notched out, bowed, split

7.9 Item 9(Picture) Joists and Beams - slanted, crooked, notched out, bowed, split

7.9 Item 10(Picture) Joists and Beams - slanted, crooked, notched out, bowed, split

7.9 Item 11(Picture) Joists and Beams - slanted, crooked, notched out, bowed, split

7.9 Item 12(Picture) Joists and Beams - slanted, crooked, notched out, bowed, split

7.9 Item 13(Picture) Joists and Beams - slanted, crooked, notched out, bowed, split

7.9 Item 14(Picture) Joists and Beams - slanted, crooked, notched out, bowed, split

7.9 Item 15(Picture) Joists and Beams - slanted, crooked, notched out, bowed, split

7.9 Item 16(Picture) Joists and Beams - slanted, crooked, notched out, bowed, split

7.9 Item 17(Picture) Joists and Beams - slanted, crooked, notched out, bowed, split

7.9 Item 18(Picture) Joists and Beams - slanted, crooked, notched out, bowed, split

7.9 Item 19(Picture) Joists and Beams - slanted, crooked, notched out, bowed, split

7.9 Item 20(Picture) Joists and Beams - slanted, crooked, notched out, bowed, split

7.9 Item 21(Picture) Joists and Beams - slanted, crooked, notched out, bowed, split

7.9 Item 22(Picture) Joists and Beams - slanted, crooked, notched out, bowed, split

7.9 Item 23(Picture) Joists and Beams - slanted, crooked, notched out, bowed, split

7.9 Item 24(Picture) Joists and Beams - slanted, crooked, notched out, bowed, split

7.9 Item 25(Picture) Joists and Beams - slanted, crooked, notched out, bowed, split

7.9 Item 26(Picture) Joists and Beams - slanted, crooked, notched out, bowed, split

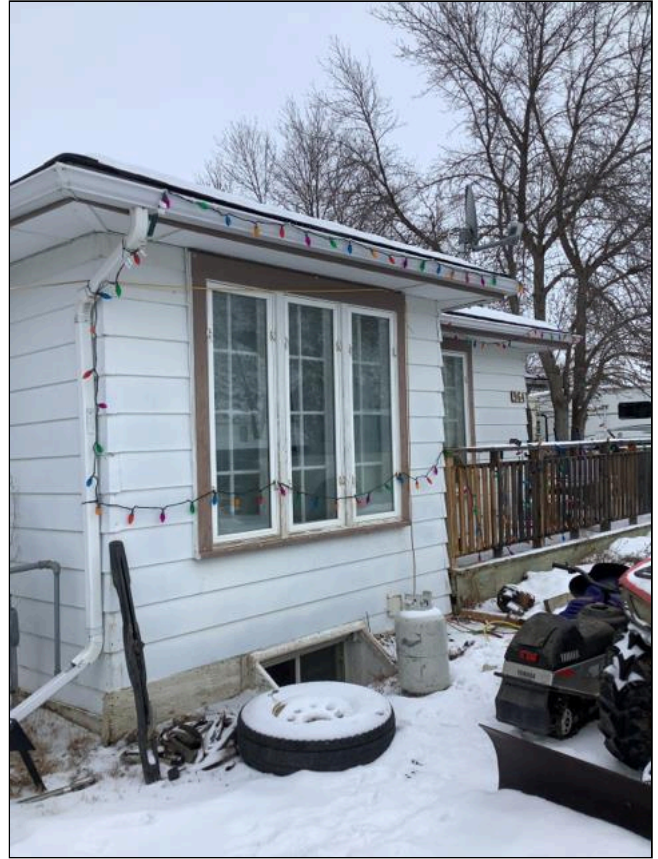
Higher levels of wall clad around the home are only visually inspected from the ground level. There was an area on the back of the house that has signs of moisture damage, recommend further review and repair as required.

3.1 Item 1(Picture) Exterior - signs of moisture damage

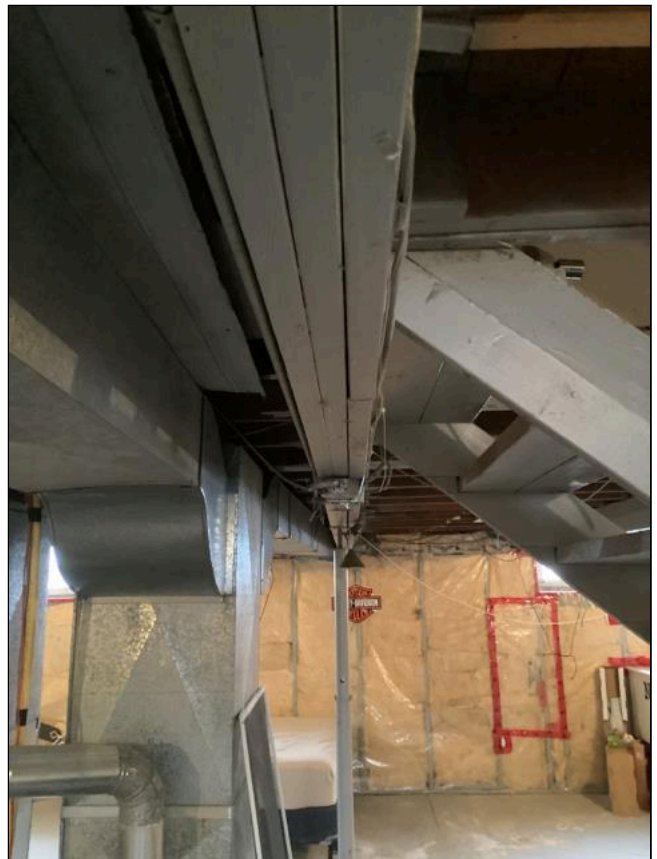
7.9 Item 3(Picture) Joists and Beams - slanted, crooked, notched out, bowed, split

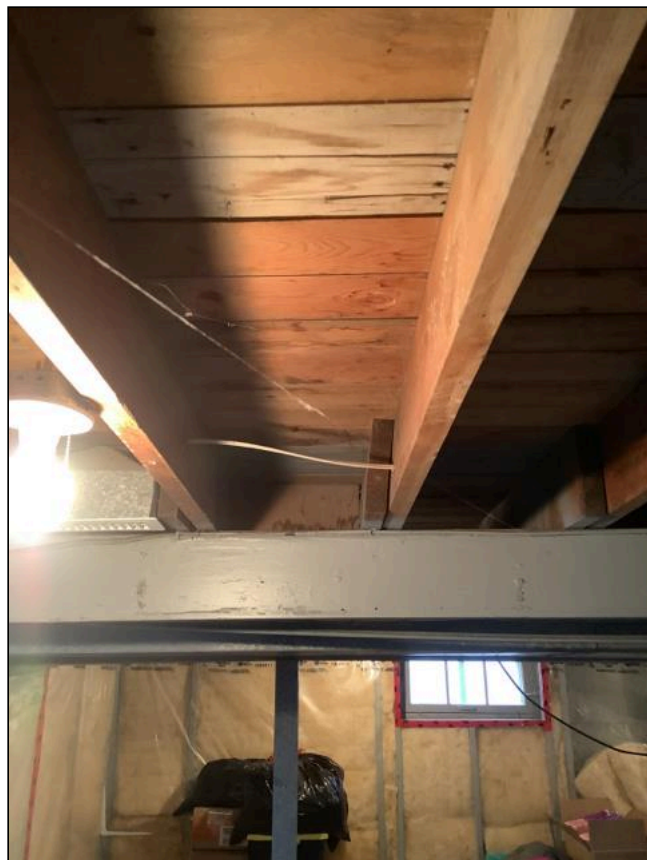
7.9 Item 4(Picture) Joists and Beams - slanted, crooked, notched out, bowed, split

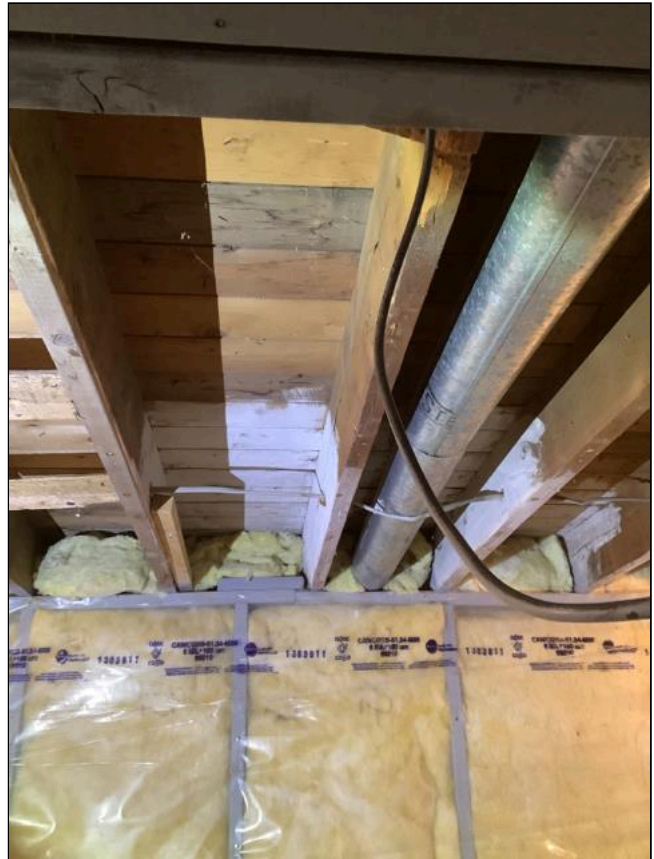
7.9 Item 9(Picture) Joists and Beams - slanted, crooked, notched out, bowed, split

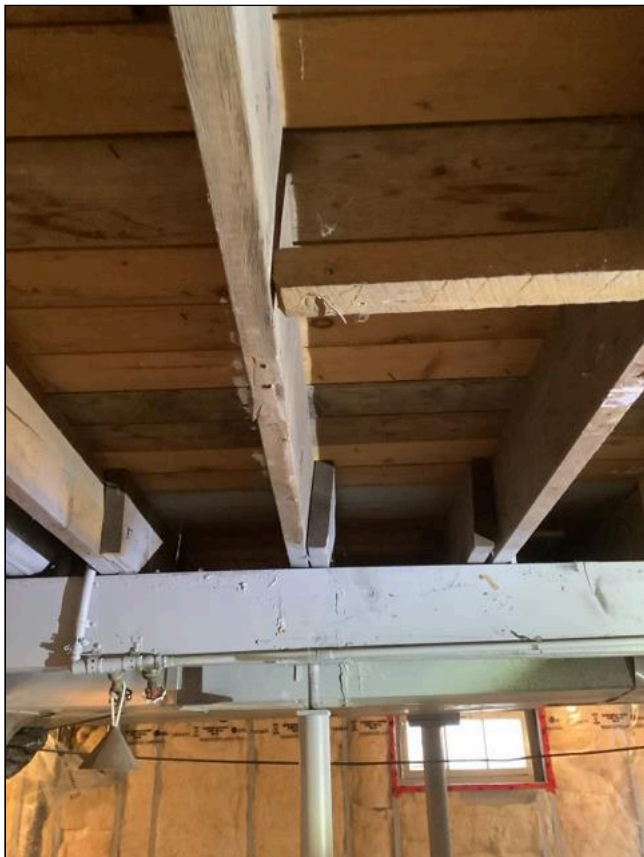
7.9 Item 10(Picture) Joists and Beams - slanted, crooked, notched out, bowed, split

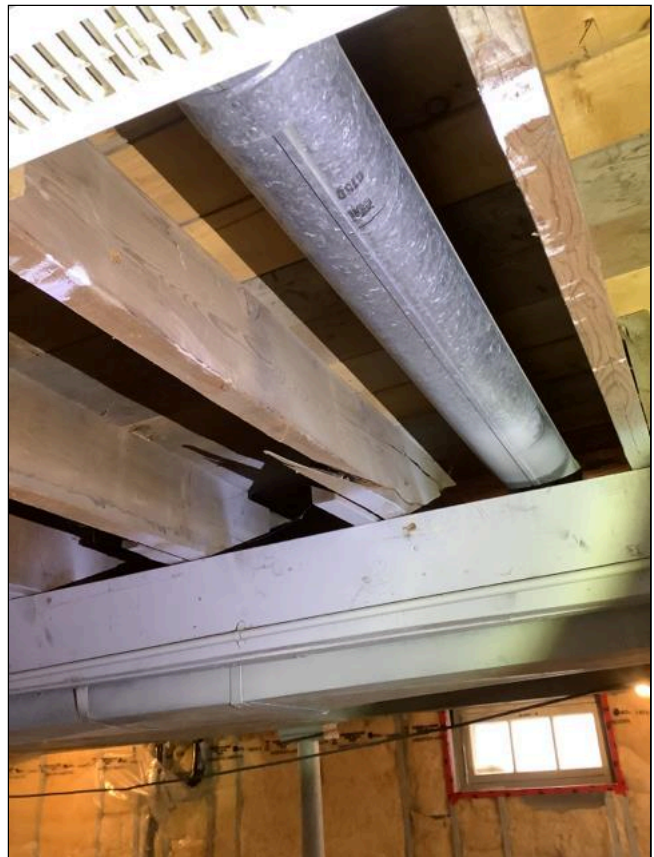
7.9 Item 11(Picture) Joists and Beams - slanted, crooked, notched out, bowed, split

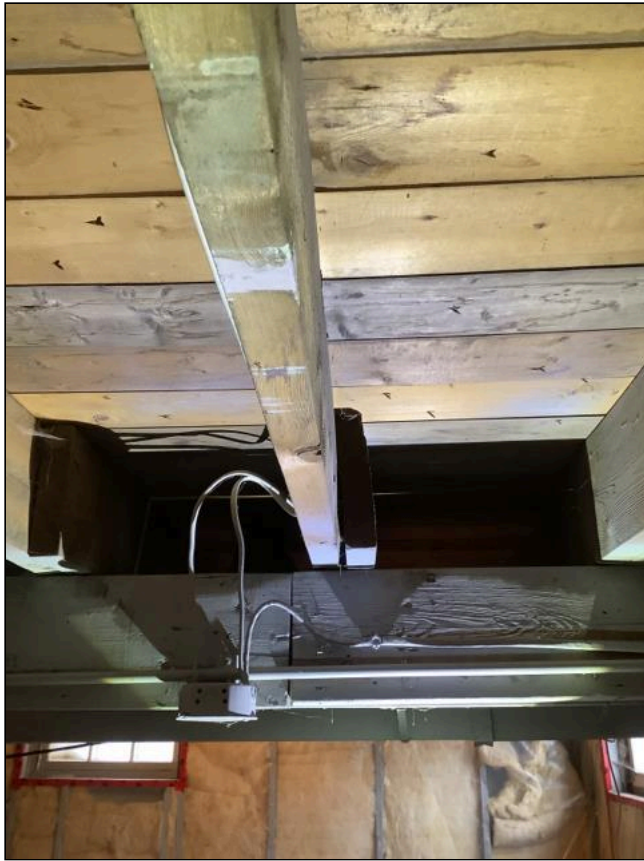
7.9 Item 12(Picture) Joists and Beams - slanted, crooked, notched out, bowed, split

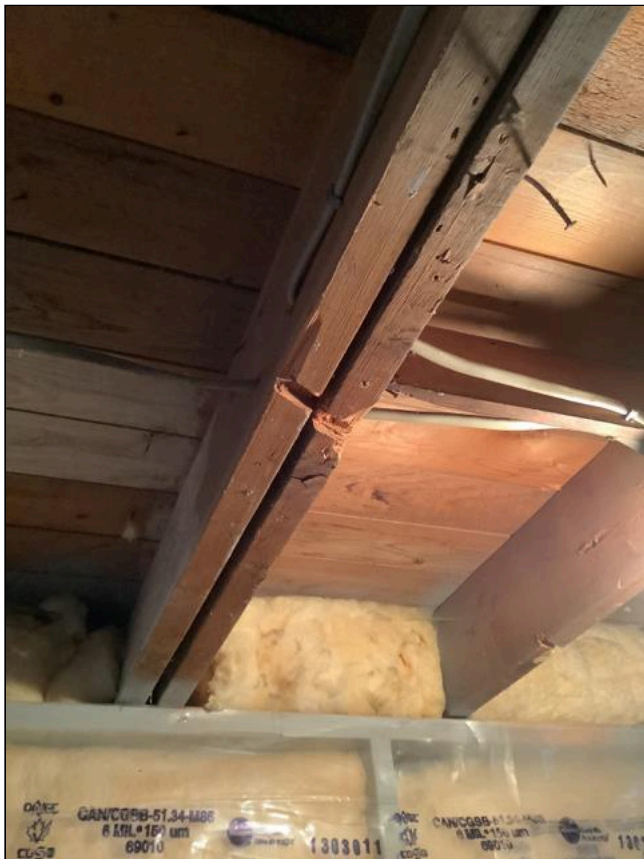
7.9 Item 14(Picture) Joists and Beams - slanted, crooked, notched out, bowed, split

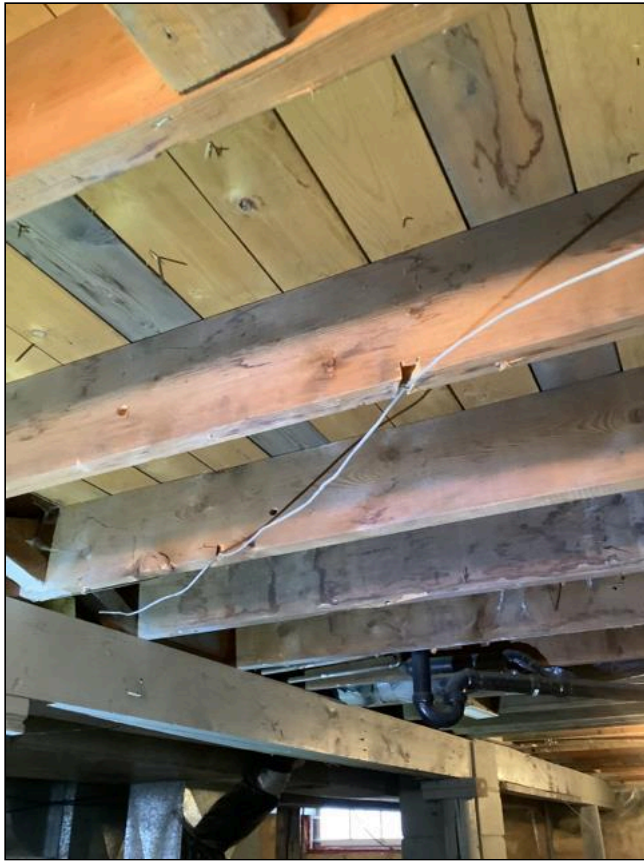
7.9 Item 16(Picture) Joists and Beams - slanted, crooked, notched out, bowed, split

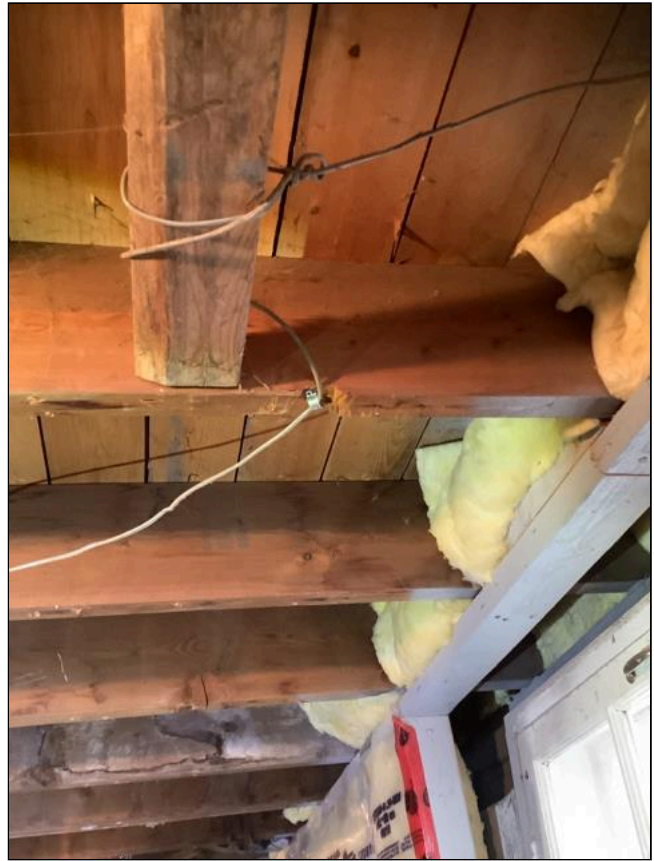
7.9 Item 17(Picture) Joists and Beams - slanted, crooked, notched out, bowed, split

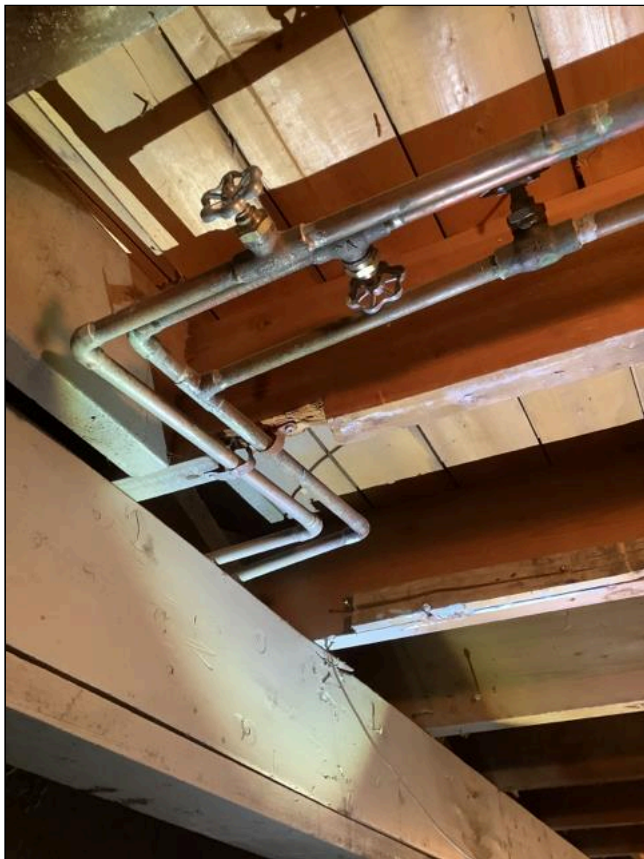
7.9 Item 18(Picture) Joists and Beams - slanted, crooked, notched out, bowed, split

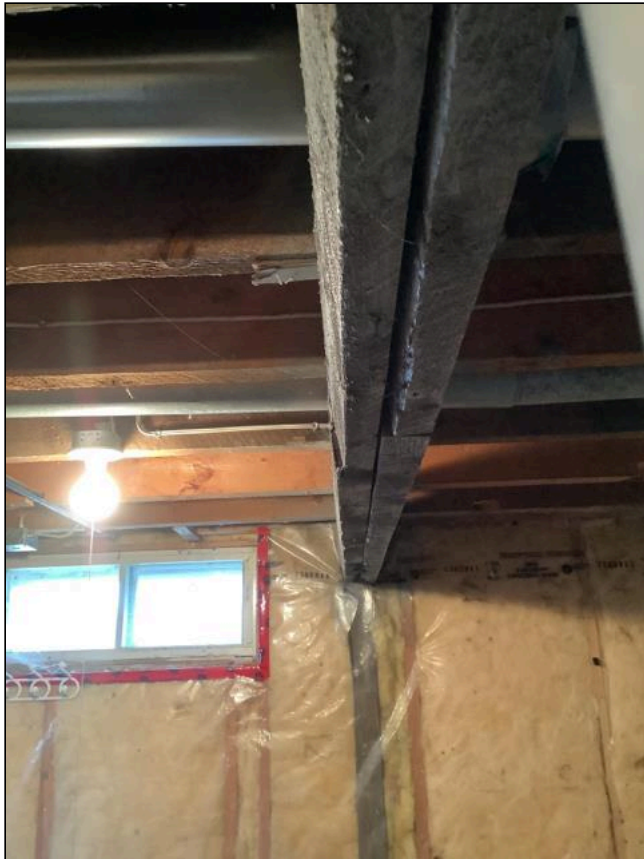
7.9 Item 20(Picture) Joists and Beams - slanted, crooked, notched out, bowed, split

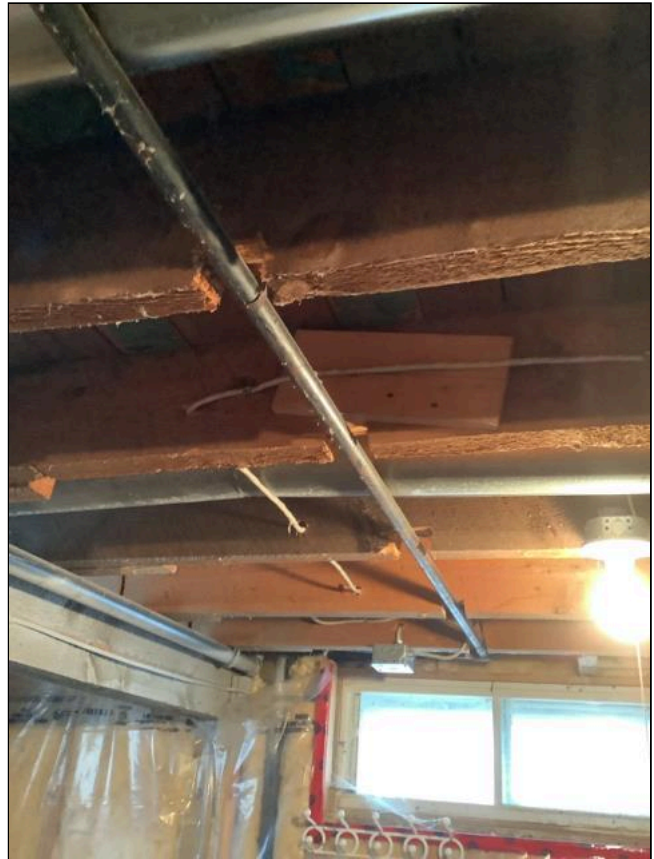
7.9 Item 21(Picture) Joists and Beams - slanted, crooked, notched out, bowed, split

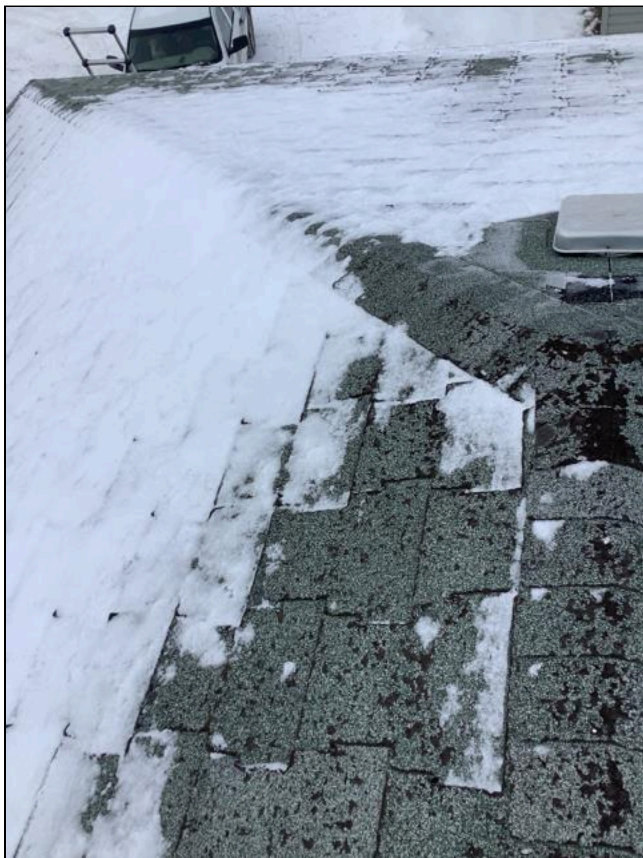
The roof was walked for assessment, could only inspect some of the roof as it was covered in snow. No visual sign of structural concern but shingles are aged and will require replacement.

1.0 Item 1(Picture) Roof - shingles are aged and will require replacement

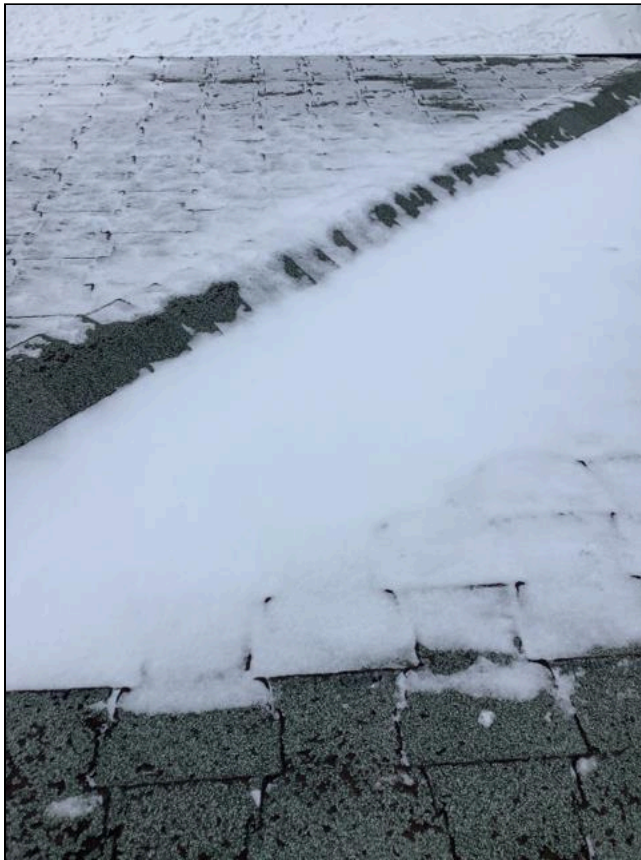
1.0 Item 9(Picture) Roof - shingles are aged and will require replacement

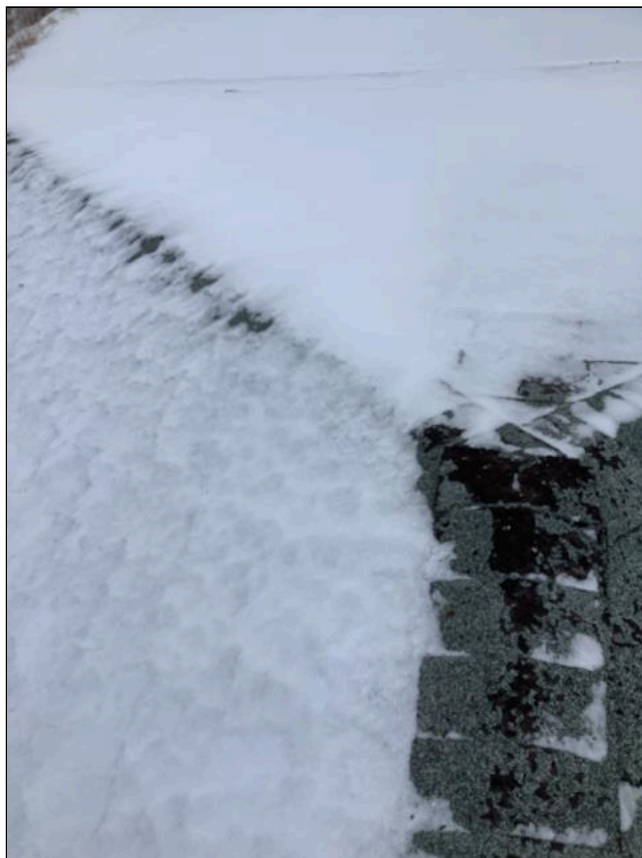
The roof was walked for assessment, could only inspect some of the roof as it was covered in snow. No visual sign of structural concern but shingles are aged and will require replacement.

1.0 Item 6(Picture) Roof - shingles are aged and will require replacement

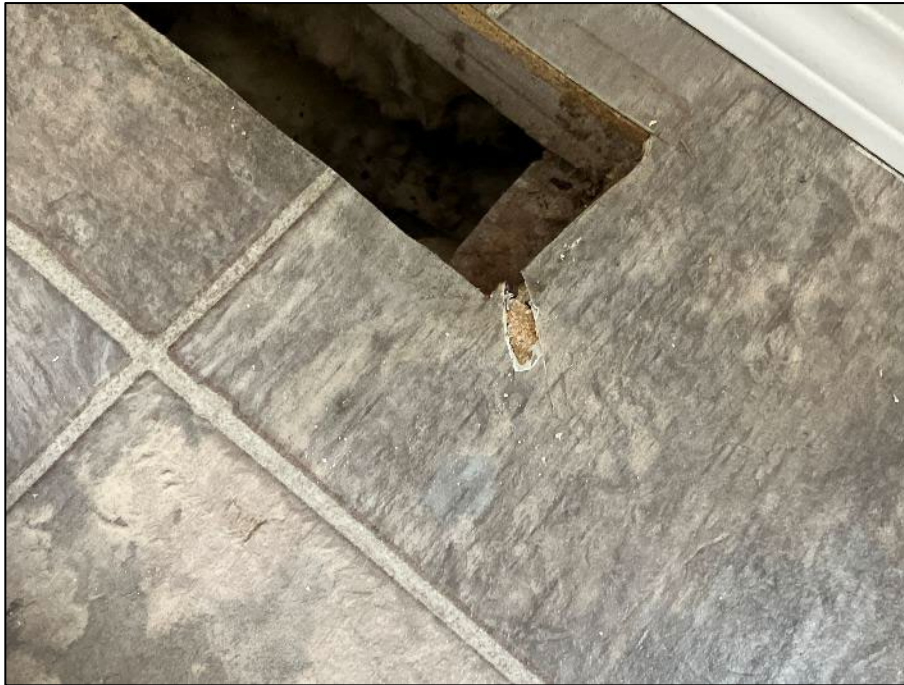
PHOTOGRAPH #11: Sheet Flooring – Floor 1 Kitchen (Non-Asbestos)

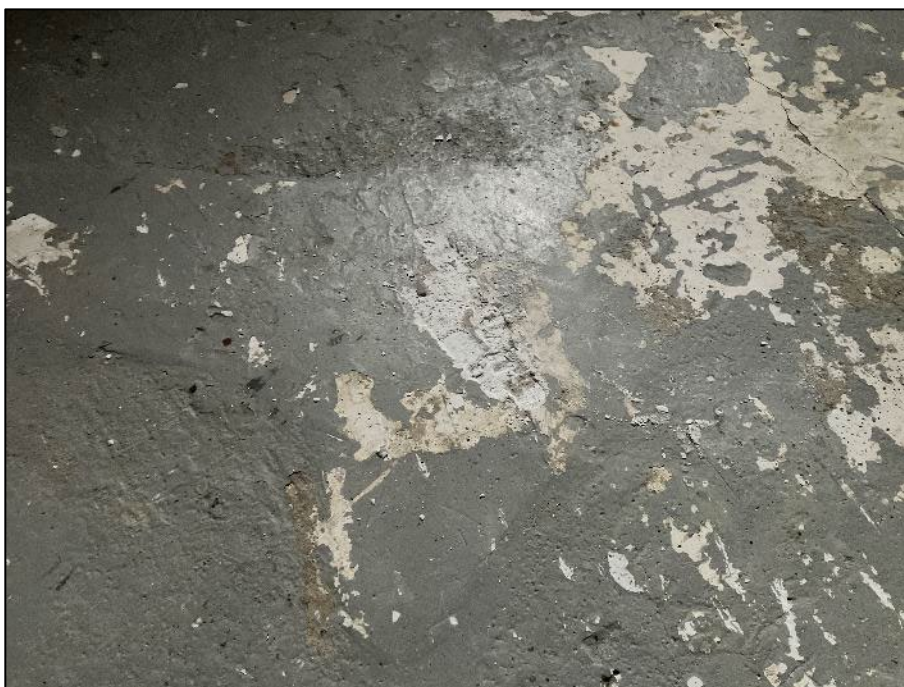
PHOTOGRAPH #24: Paint – Grey Basement (Non-Lead Based)

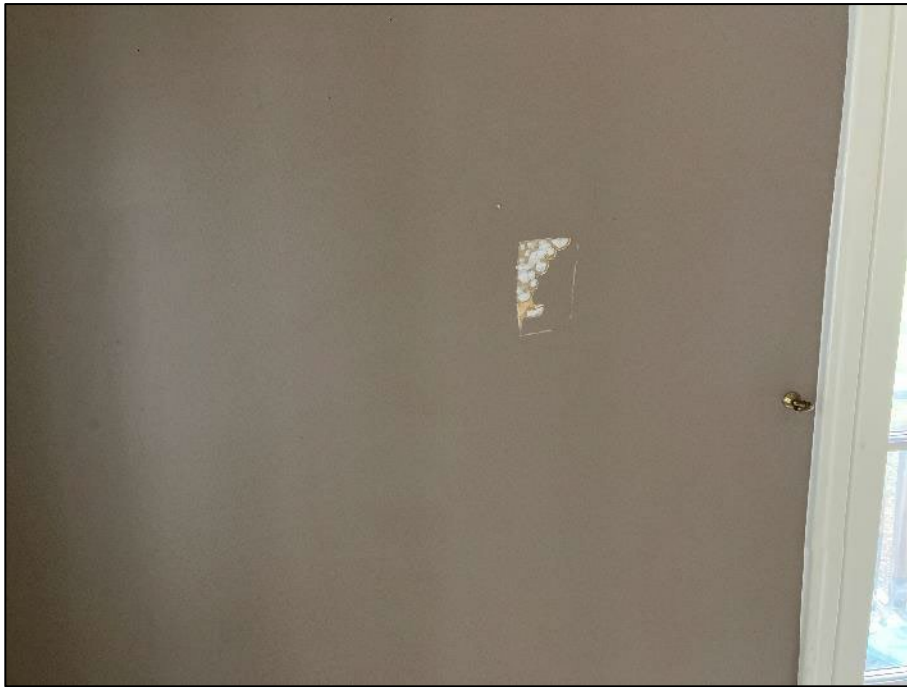
PHOTOGRAPH #25: Paint – Beige Dining Room (450 ppm)

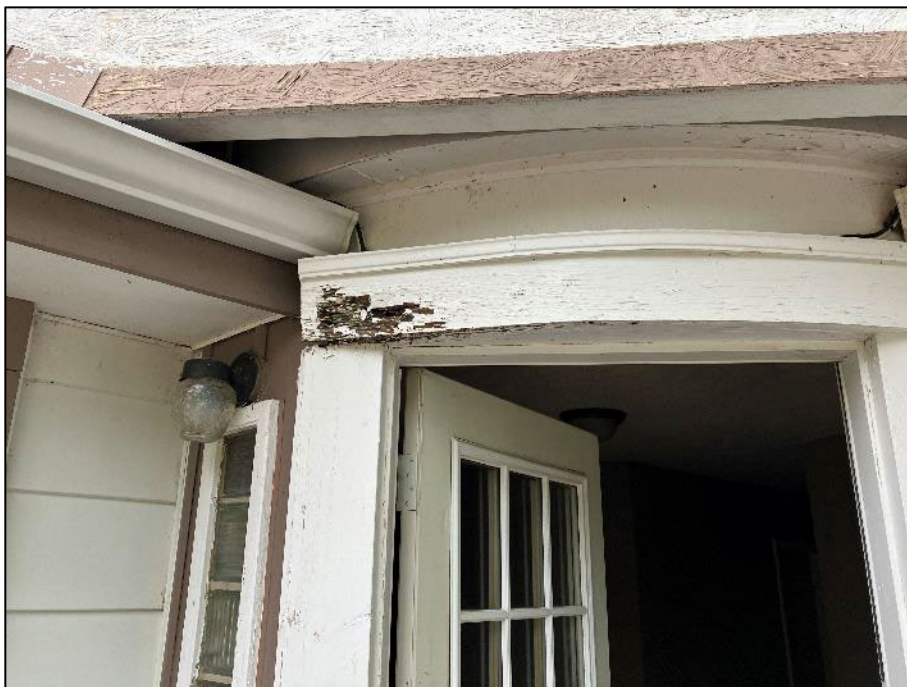
PHOTOGRAPH #26: Paint- White Exterior (Non-Lead Based)

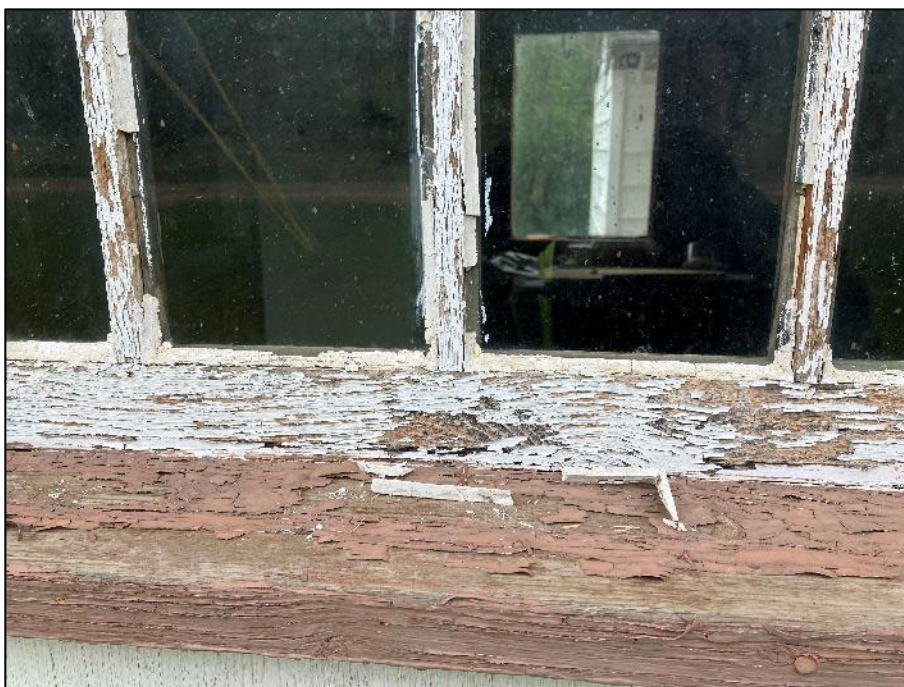
PHOTOGRAPH #28: Paint – Burgundy Shed (Non-Lead Based)

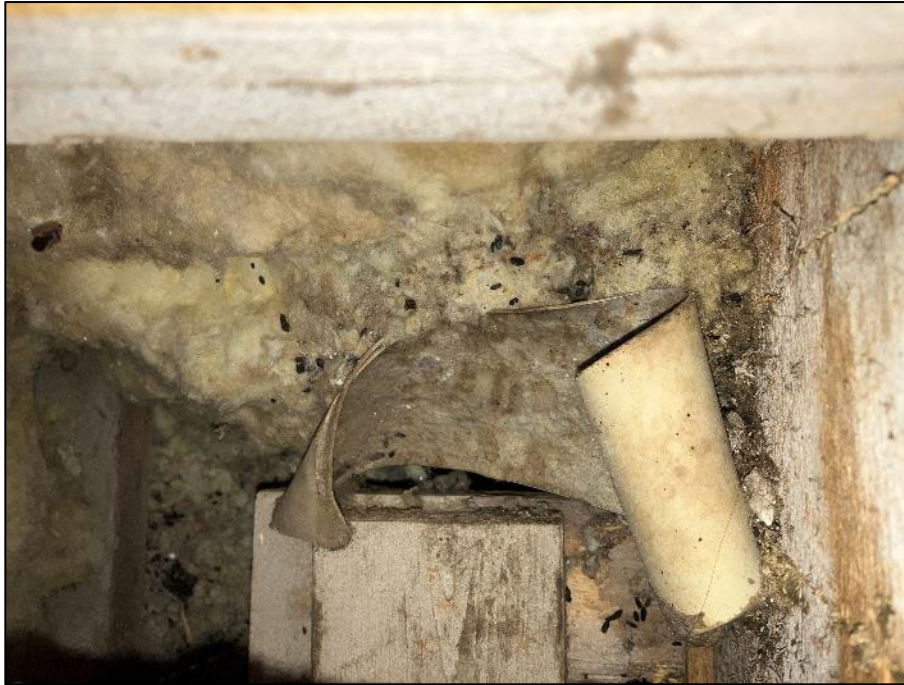
PHOTOGRAPH #33: Mouse Dropping – Kitchen Venting

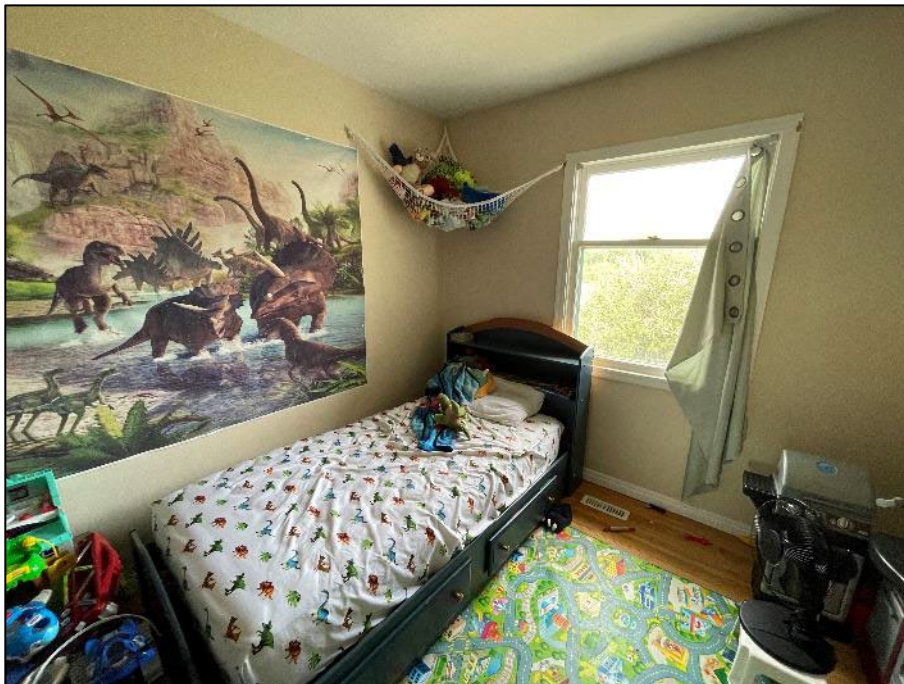
1. The following materials were identified as asbestos-containing and will require abatement prior to demolition of the structure:
 - a. Plaster on main floor walls and ceiling (*See Photographs #1 to 6*).
 - b. Stucco beneath exterior siding (*See Photographs #11 and 12*).

PHOTOGRAPH #2: Plaster - Level 1 Bedroom North Exterior (<1% Actinolite)

1. Plaster was observed and confirmed asbestos-containing (*See Photographs #1 through 6*). Removal of the material must be performed prior to demolition by a qualified abatement contractor using moderate-risk asbestos abatement procedures found in Section 5.3 of the AAAM (2019).
