Demolition and Remediation Services

**Residential Demolition Project
for
The Town of Drumheller**

Tender issued September 2, 2022
Tender closing September 22, 2022 – 2:00:00 P.M.

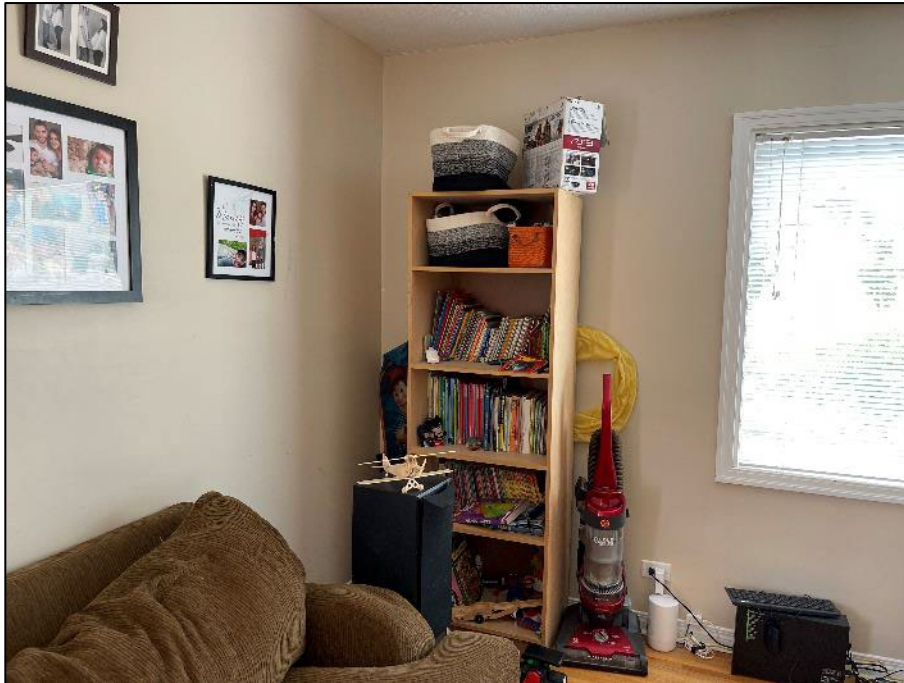
1. The following materials were identified as asbestos-containing and will require abatement prior to demolition of the structure:
 - a. Plaster on main floor walls and ceiling (*See Photographs #1 to 6*).
 - b. Stucco beneath exterior siding (*See Photographs #11 and 12*).

PHOTOGRAPH #3: Plaster - Level 1 Living Room Exterior (<1% Actinolite)

1. Plaster was observed and confirmed asbestos-containing (*See Photographs #1 through 6*). Removal of the material must be performed prior to demolition by a qualified abatement contractor using moderate-risk asbestos abatement procedures found in Section 5.3 of the AAAM (2019).

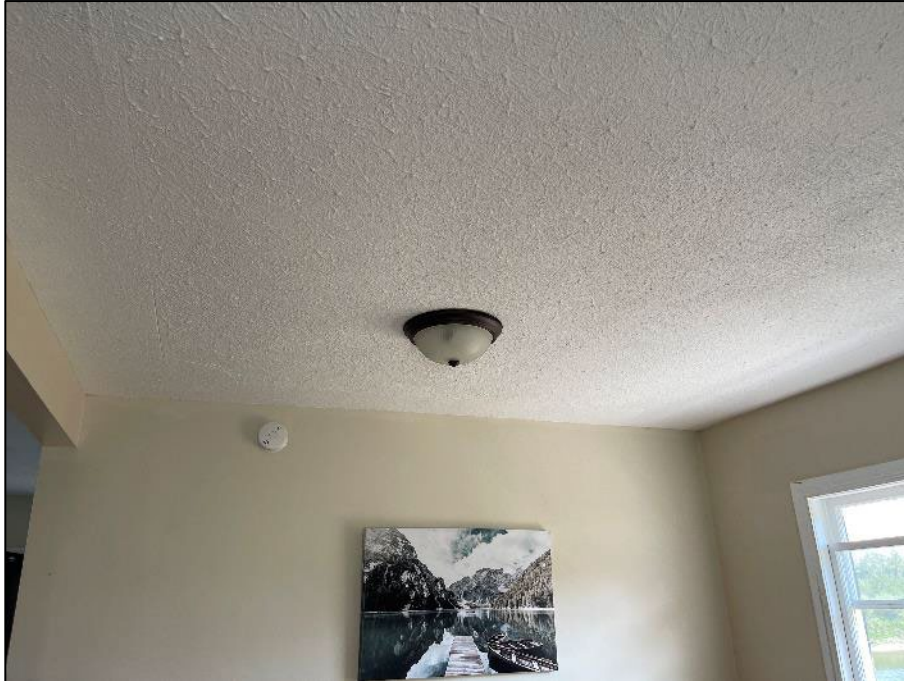
PHOTOGRAPH #19: Ceiling Texture - Level 1 Living Room (Non-Asbestos)

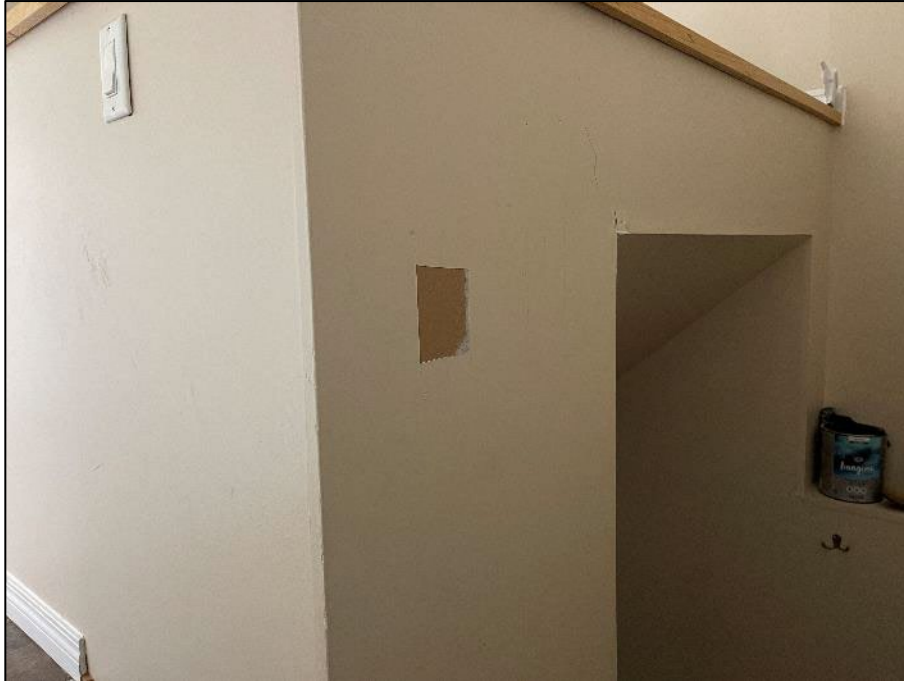
PHOTOGRAPH #21: Beige Paint - Interior (Non-Lead)
