## EXPRESSION OF INTEREST DRFM #2023-02-16

PROPOSAL: [Flood Mitigation– House Salvage]

DATE: [February 16, 2023]

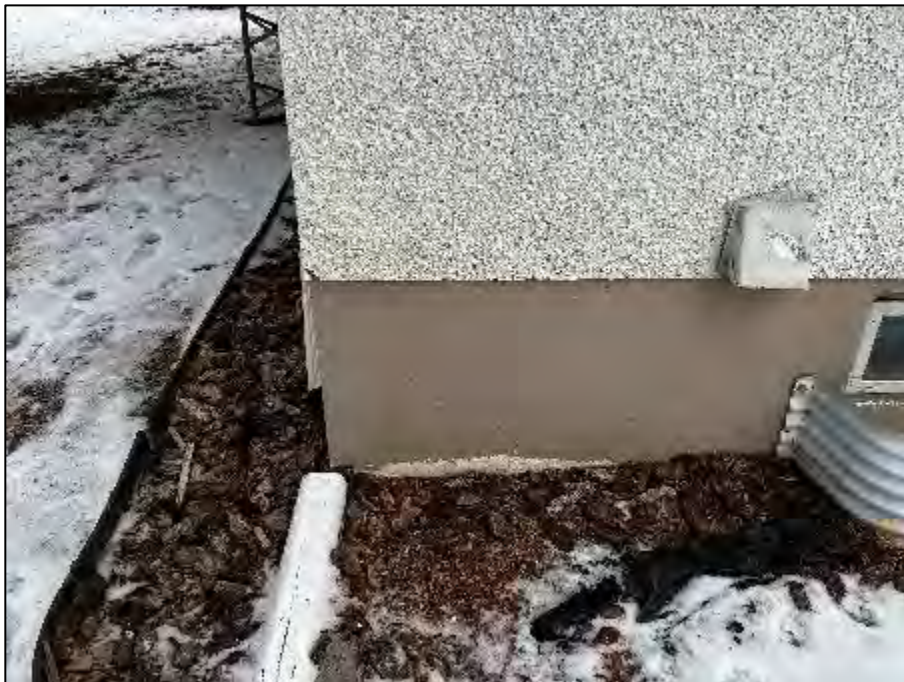
#	DESCRIPTION / LOCATION	ASB TYPE	ASB%	CONDITION	PHOTO
18	Stucco* Exterior – Back	Chrysotile	2%	Fair	18
19	Stucco* Exterior – Right Side	Chrysotile	2%	Fair	19
20	Stucco* Exterior – Left Side	Chrysotile	2%	Fair	20
22	Window Caulking Exterior	Chrysotile	3%	Fair	22
27	Vermiculite Insulation Attic	Actinolite	<1%	Fair	27

**PHOTOGRAPH #19:** Stucco - South Exterior (2% Chrysotile)

1. The following materials were identified as asbestos-containing and will require abatement prior to demolition of the structure:
  - a. Exterior Stucco (*See Photographs #18 to 20*).
  - b. Window Caulking (*See Photograph #22*).
  - c. Vermiculite Insulation (*See Photograph #27*).

Removal of the materials must be performed by a qualified abatement contractor prior to demolition using procedures found in the Alberta Asbestos Abatement Manual (2019).

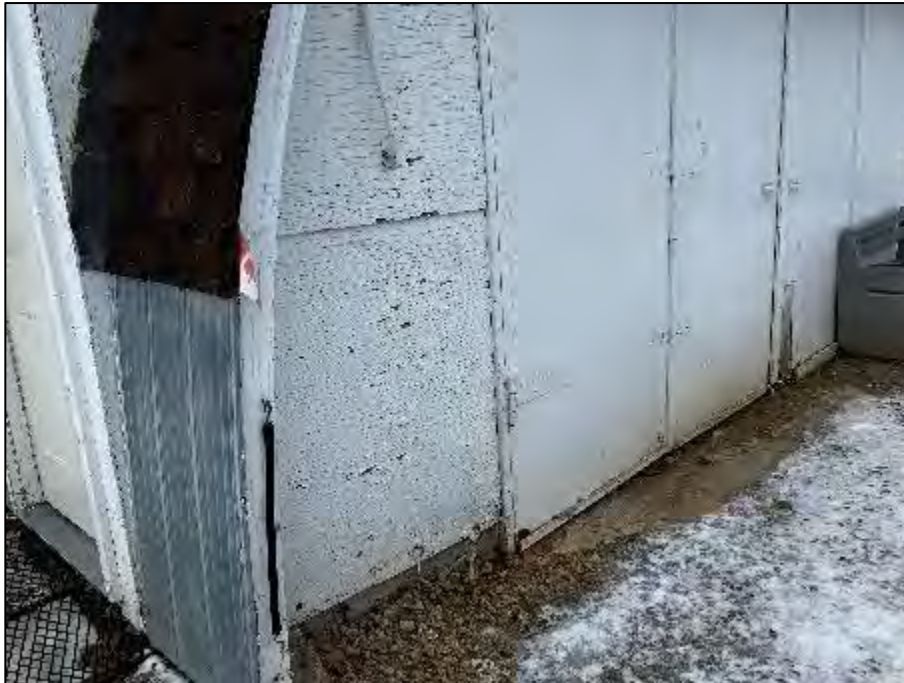
**PHOTOGRAPH #30:** Paint - Shed White (<80 ppm Lead)

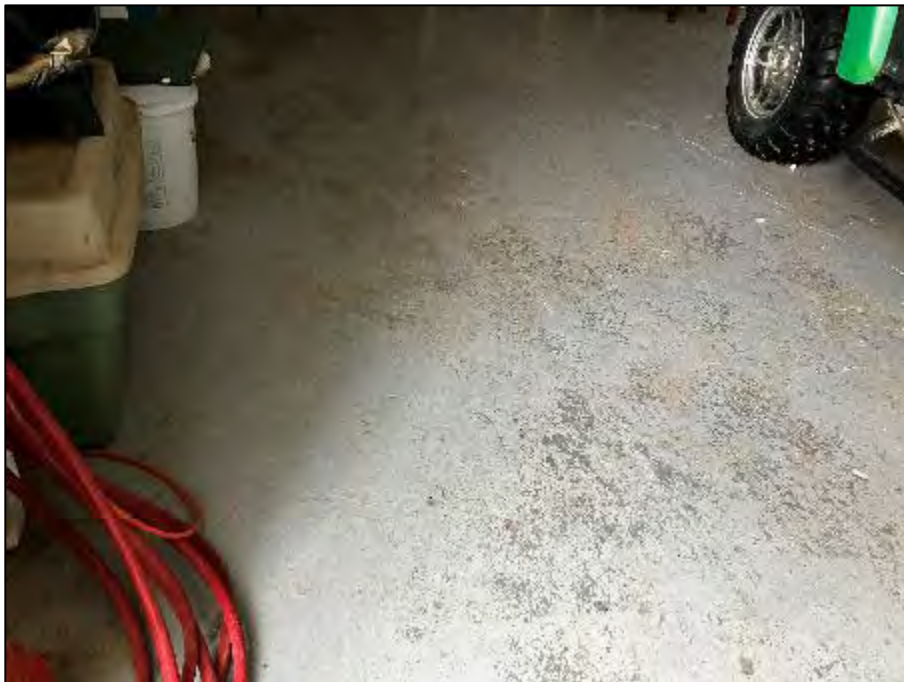
**PHOTOGRAPH #31:** Paint - Shed Floor Grey (<80 ppm Lead)

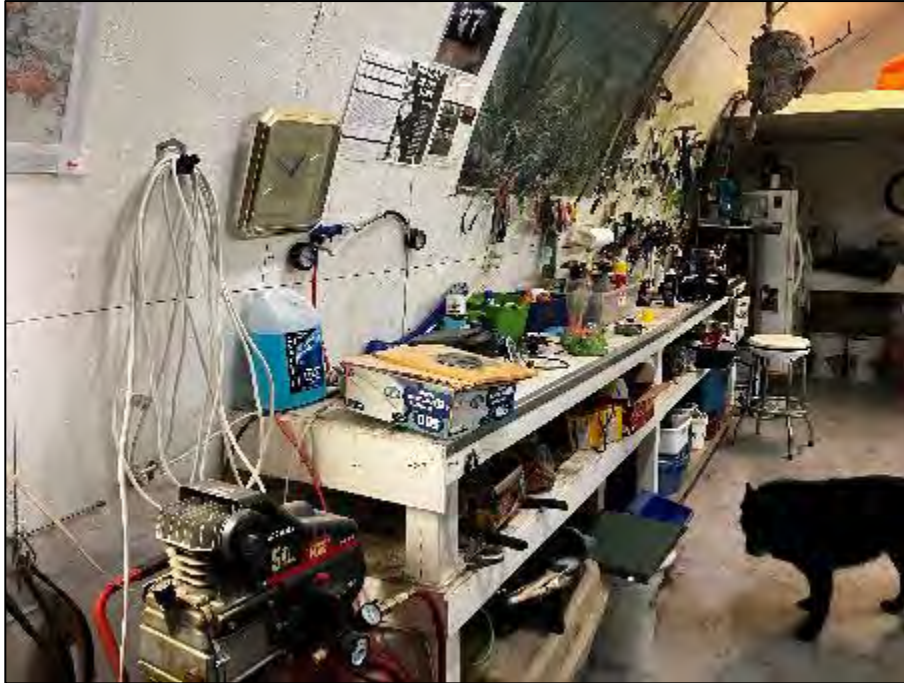
PHOTOGRAPH #32: Miscellaneous Chemicals

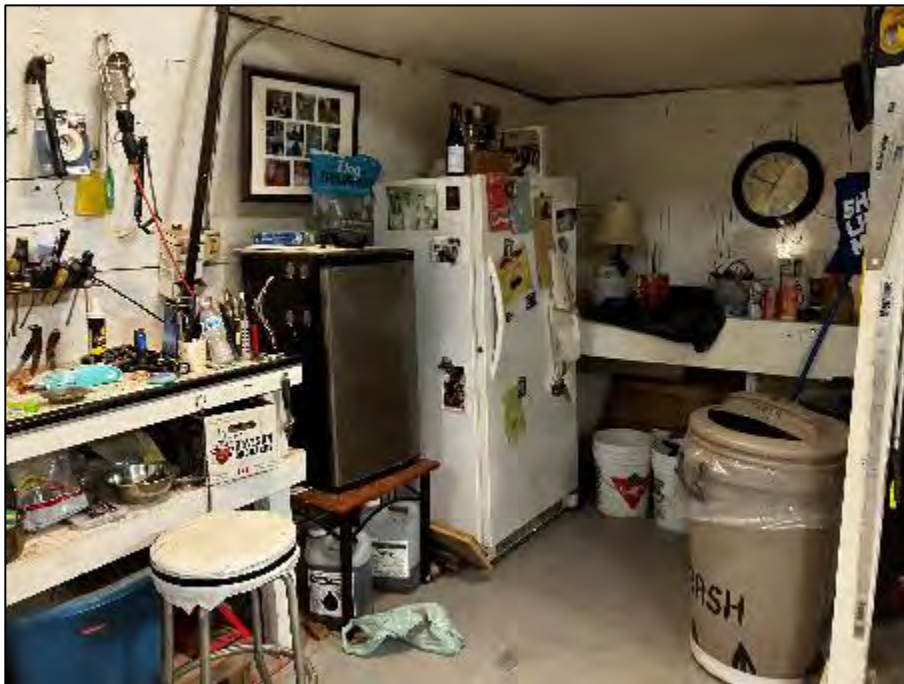
PHOTOGRAPH #33: Fridges

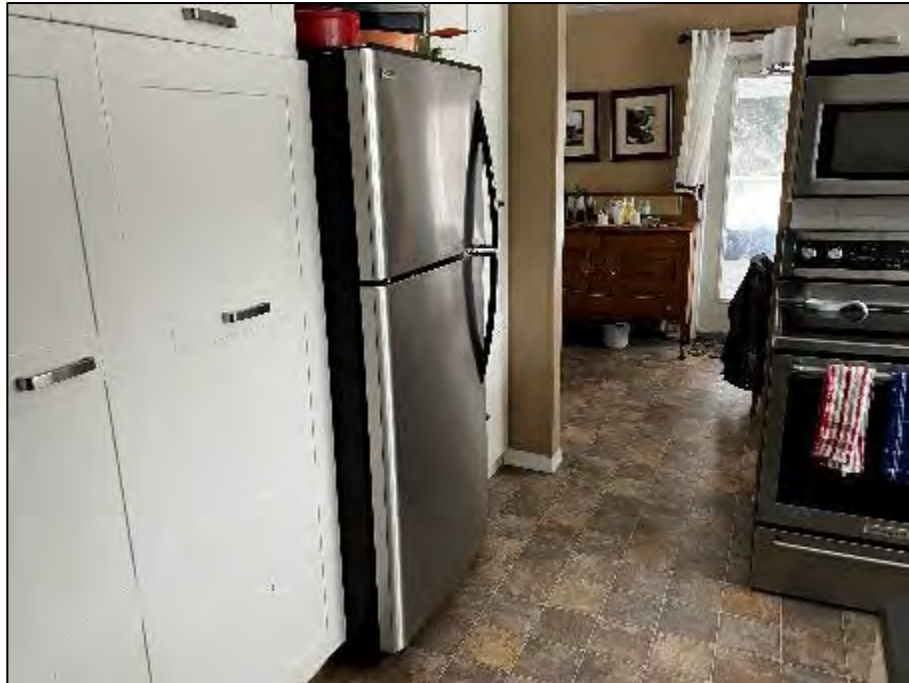
**PHOTOGRAPH #34:** Fridge in Kitchen

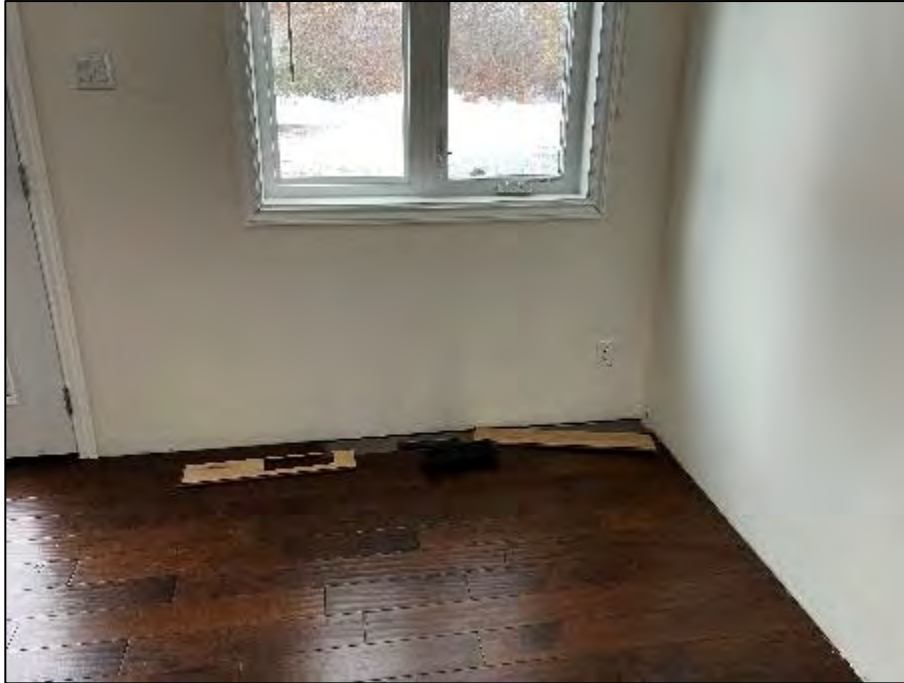
**PHOTOGRAPH #1:** Drywall Joint Compound - Level 1 Dining Room Exterior (None Detected)

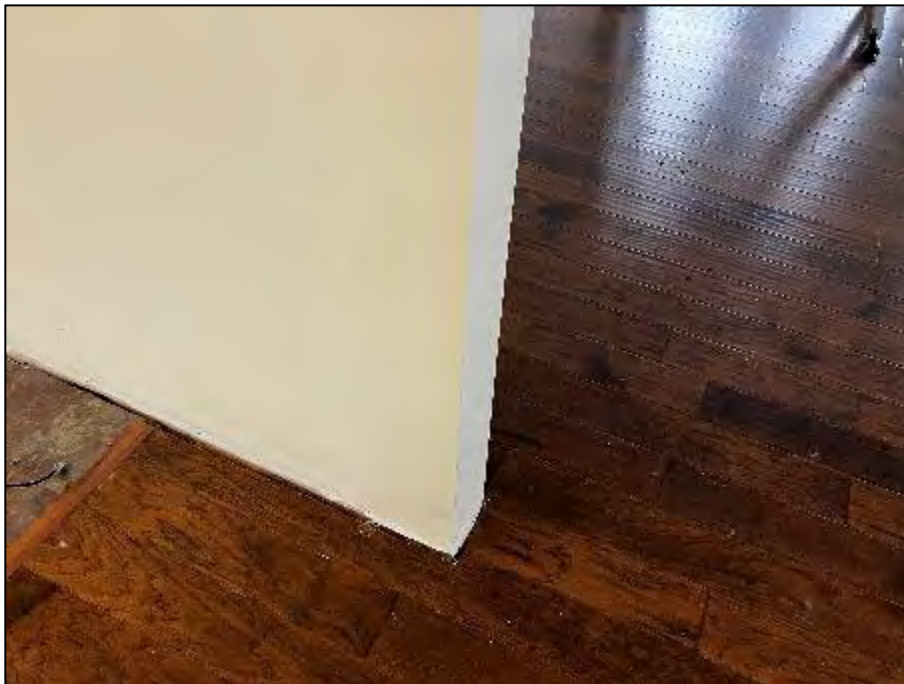
**PHOTOGRAPH #2:** Drywall Joint Compound - Level 1 Dining Room Interior (None Detected)

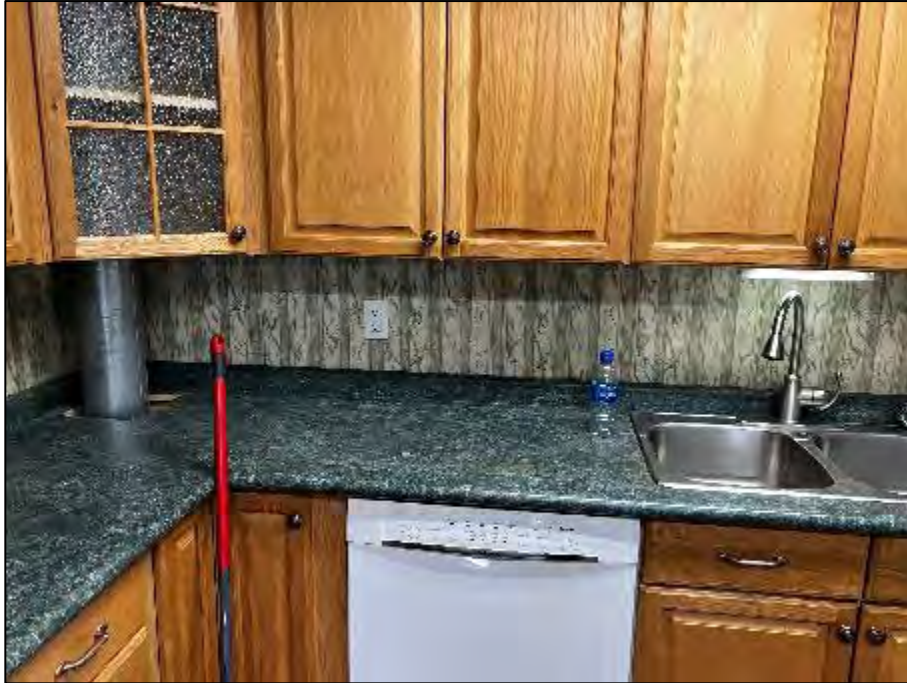
**PHOTOGRAPH #3:** Drywall Joint Compound - Level 1 Kitchen Interior (None Detected)

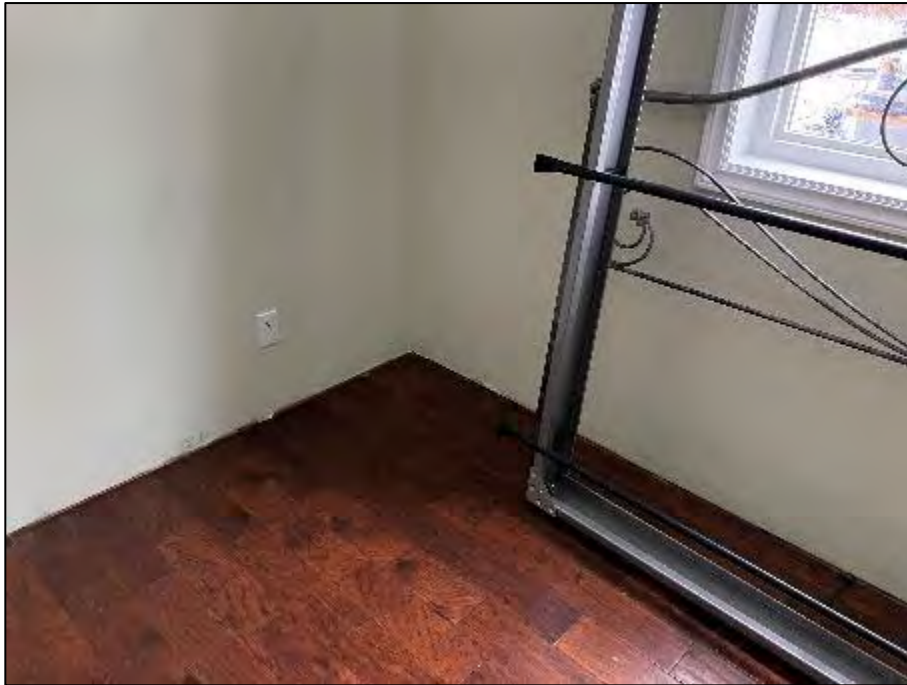
**PHOTOGRAPH #7:** Drywall Joint Compound - Level 1 SE Bedroom Exterior (None Detected)

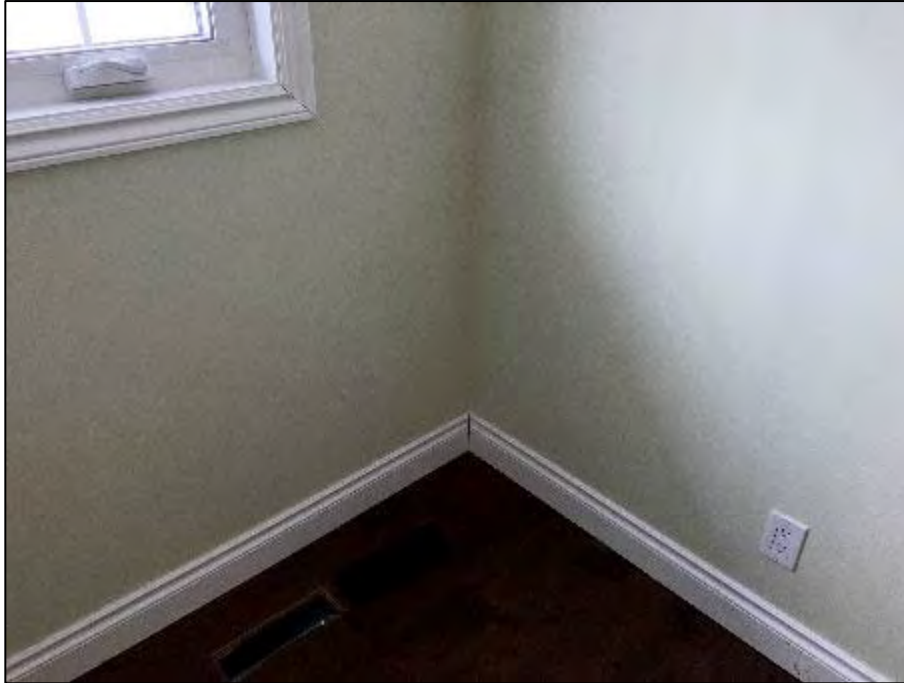
**PHOTOGRAPH #9:** Drywall Joint Compound - Level 1 N Bedroom Exterior (None Detected)

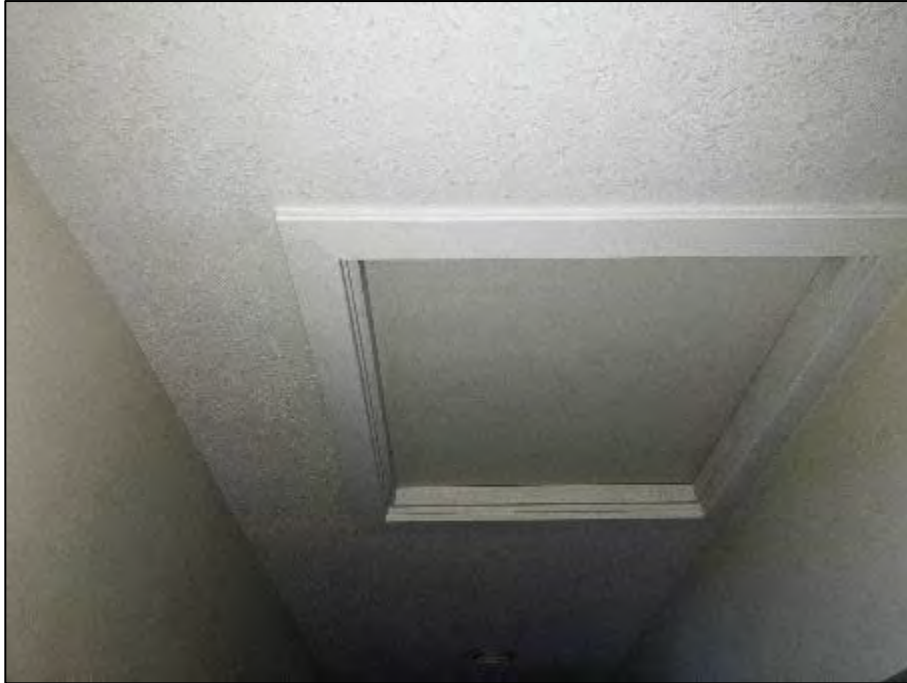
**PHOTOGRAPH #13:** Ceiling Texture - Level 1 Hallway Popcorn (None Detected)

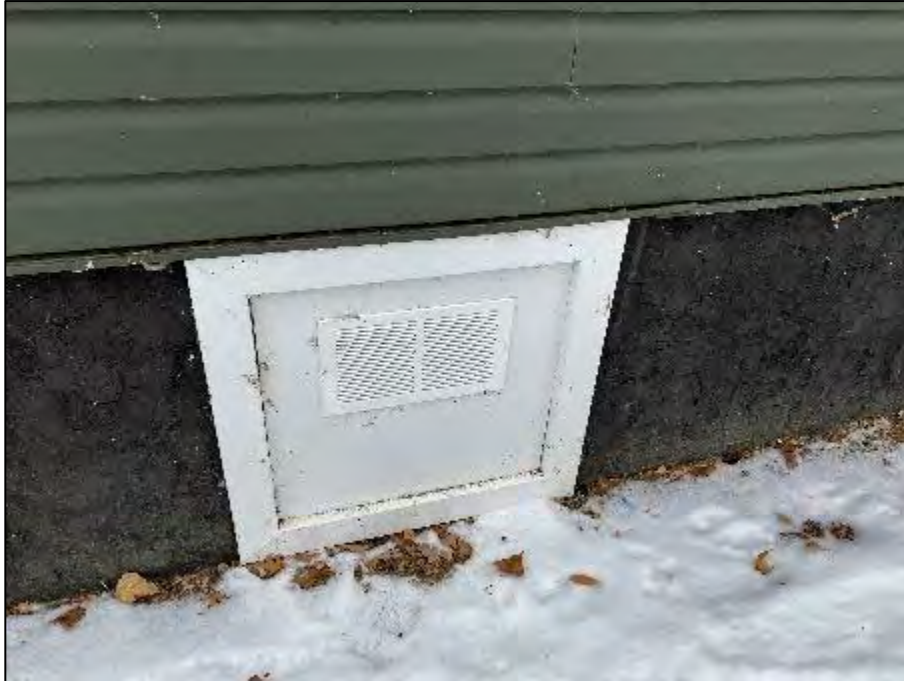
**PHOTOGRAPH #19:** Parging - Back Exterior (None Detected)

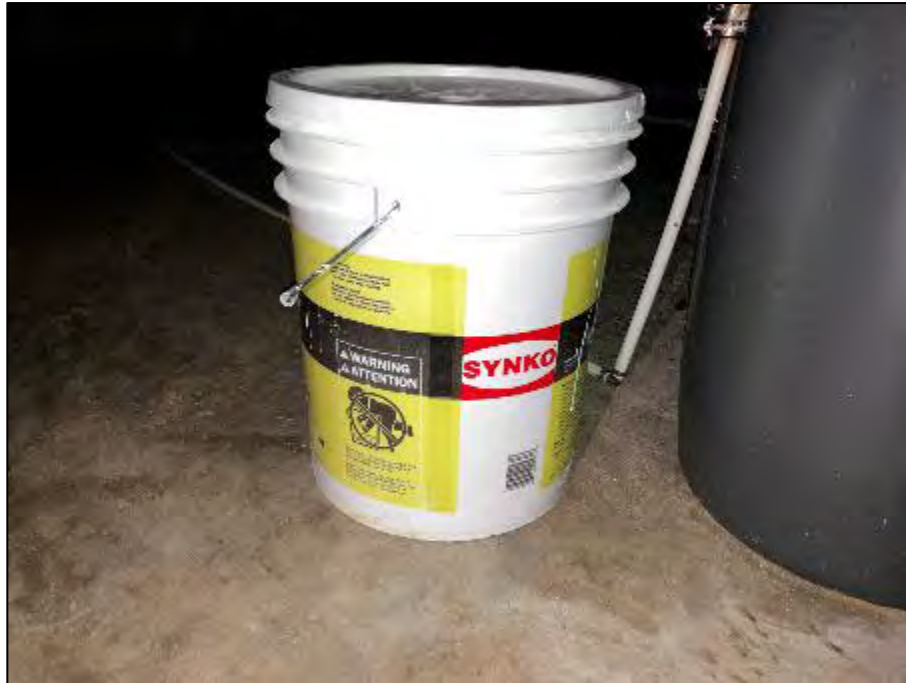
**PHOTOGRAPH #25:** Drywall Surface Equalizer

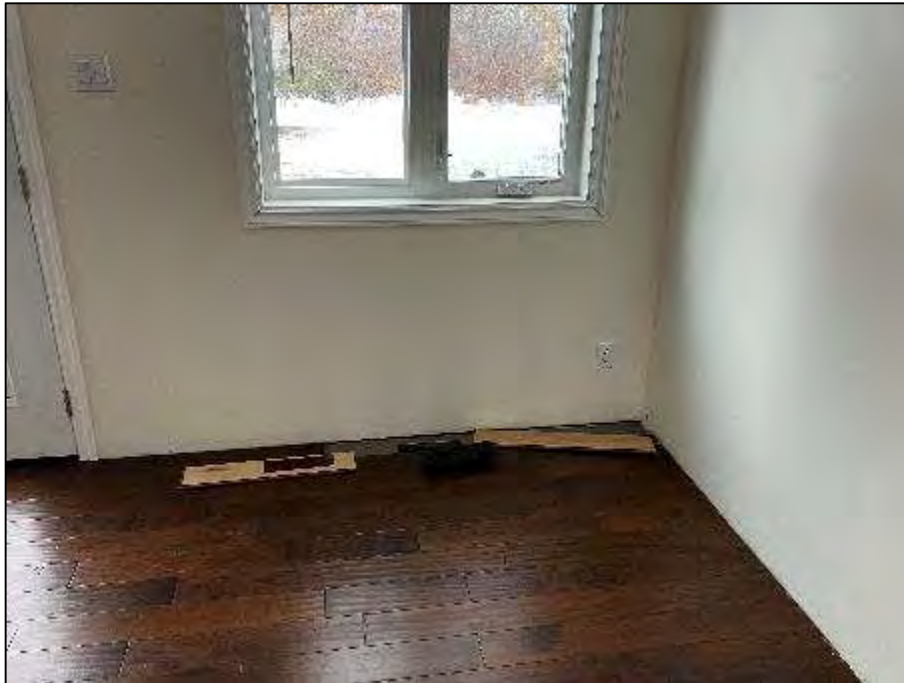
**PHOTOGRAPH #1:** Drywall Joint Compound - Level 1 SW Bedroom Exterior (None Detected)

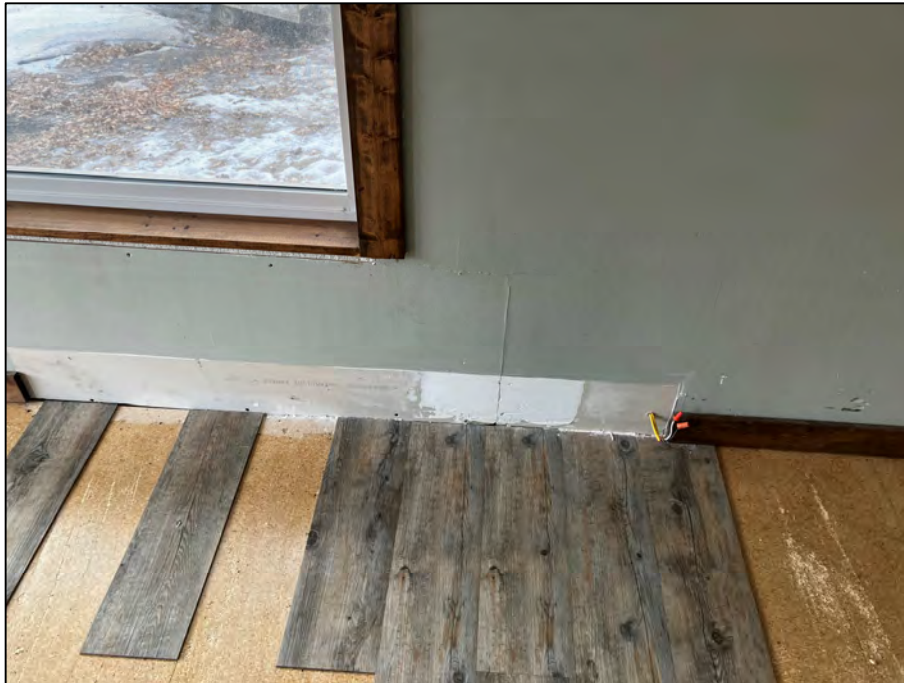
**PHOTOGRAPH #2:** Drywall Joint Compound - Level 1 S Bedroom Exterior (None Detected)

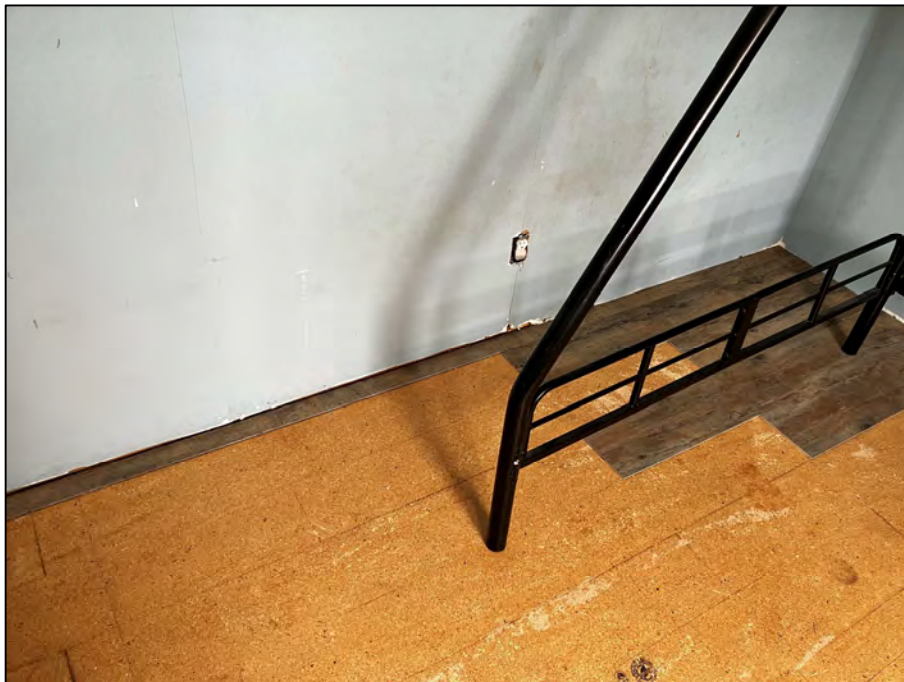
**PHOTOGRAPH #3:** Drywall Joint Compound - Level 1 Kitchen Exterior (None Detected)

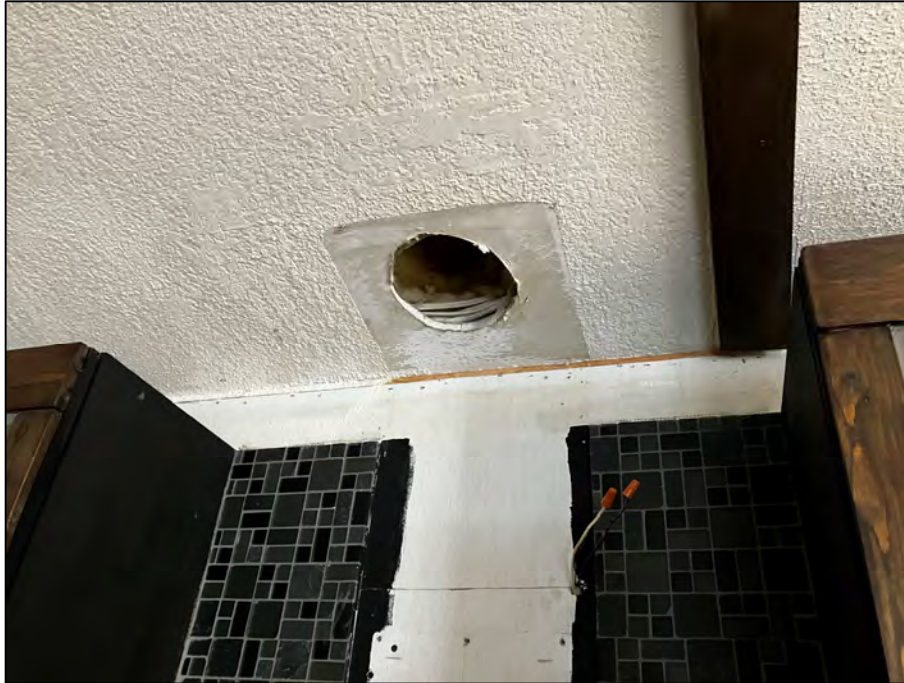
**PHOTOGRAPH #4:** Drywall Joint Compound - Level 1 N Bedroom Interior (None Detected)

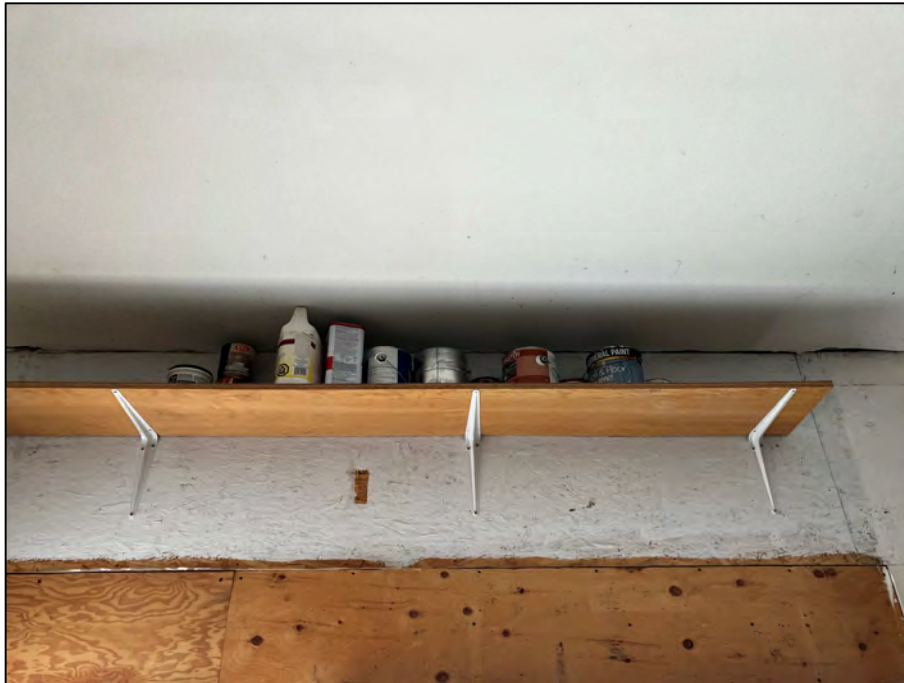
PHOTOGRAPH #12: Miscellaneous Chemicals in Garage

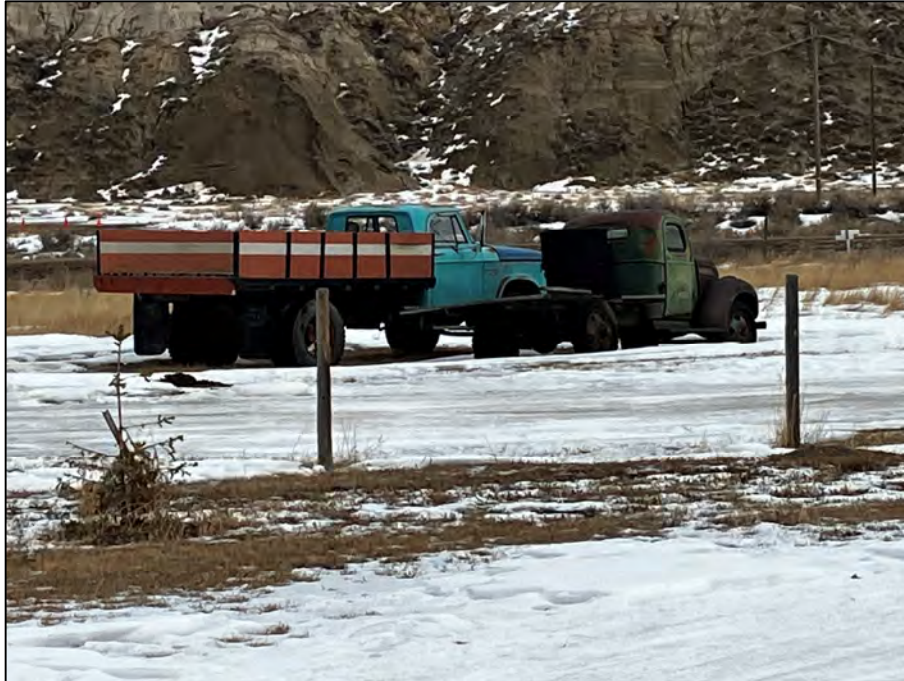
**PHOTOGRAPH #14:** Cargo Contained and Vehicle on Property

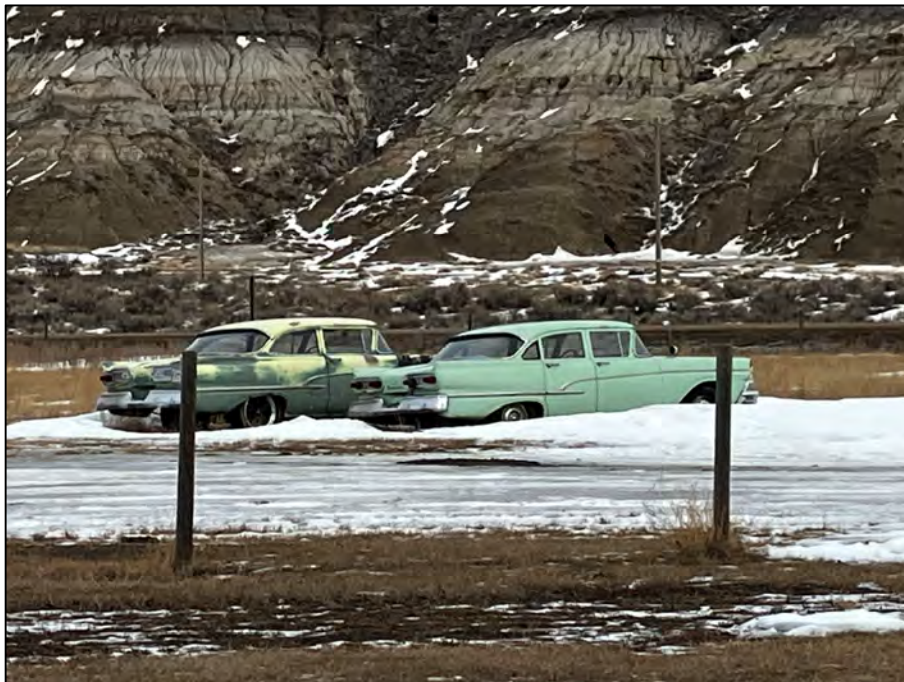
**PHOTOGRAPH #15:** Vehicles on Property

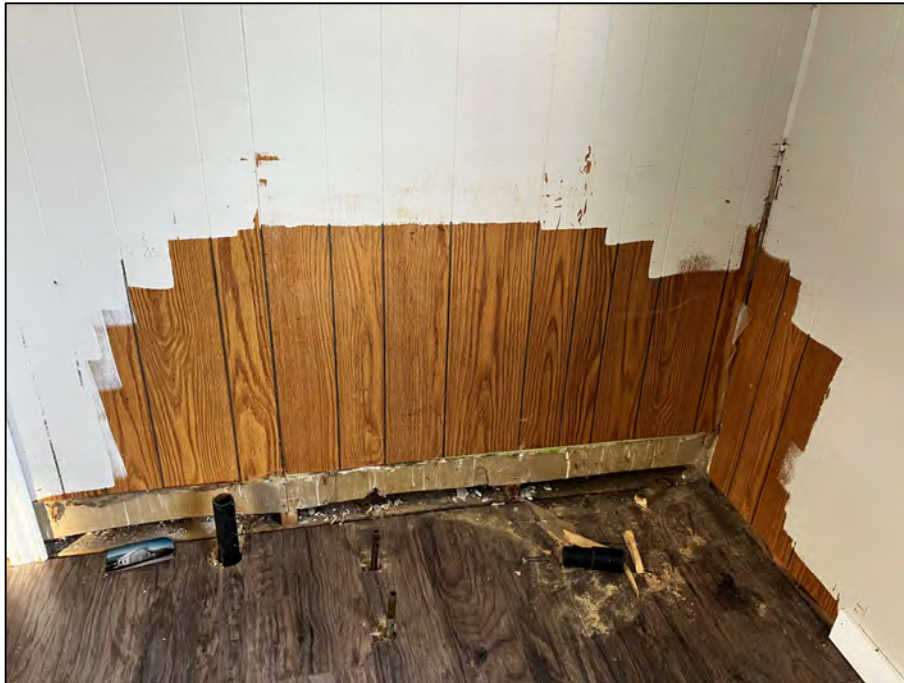
1. The following materials were identified as asbestos-containing and will require abatement prior to demolition of the structure:
  - a. Drywall Joint Compound (*See Photographs #1 to 8*).
2. **PLEASE NOTE:** Due to the homogenous appearance of drywall, all sections of the materials throughout the property must be treated as asbestos-containing as required by Section 7.1.1 of the Alberta Asbestos Abatement Manual (2019).

**PHOTOGRAPH #1:** Drywall Joint Compound - Level 1 Main Room Interior (Assume Positive)

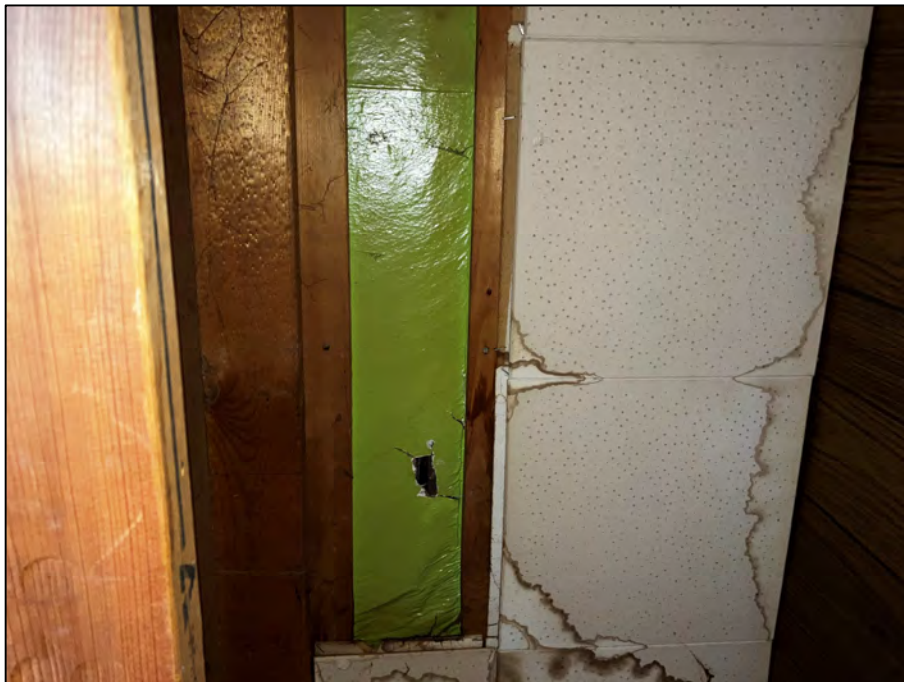
**PHOTOGRAPH #6:** Drywall Joint Compound - Level 1 Foyer Ceiling (Assume Positive)

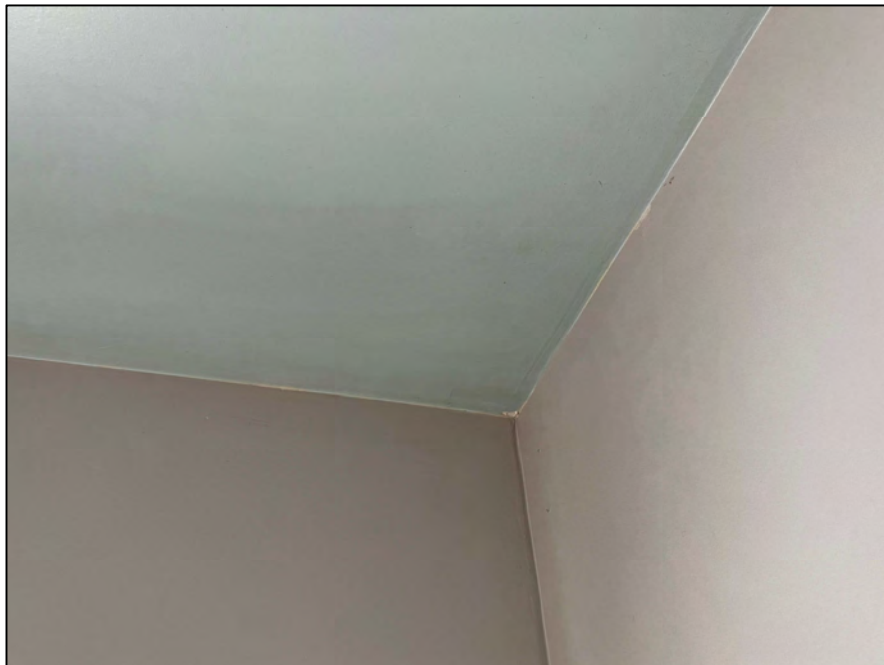
**PHOTOGRAPH #8:** Drywall Joint Compound - Level 1 Storage Room Ceiling (2% Chrysotile)

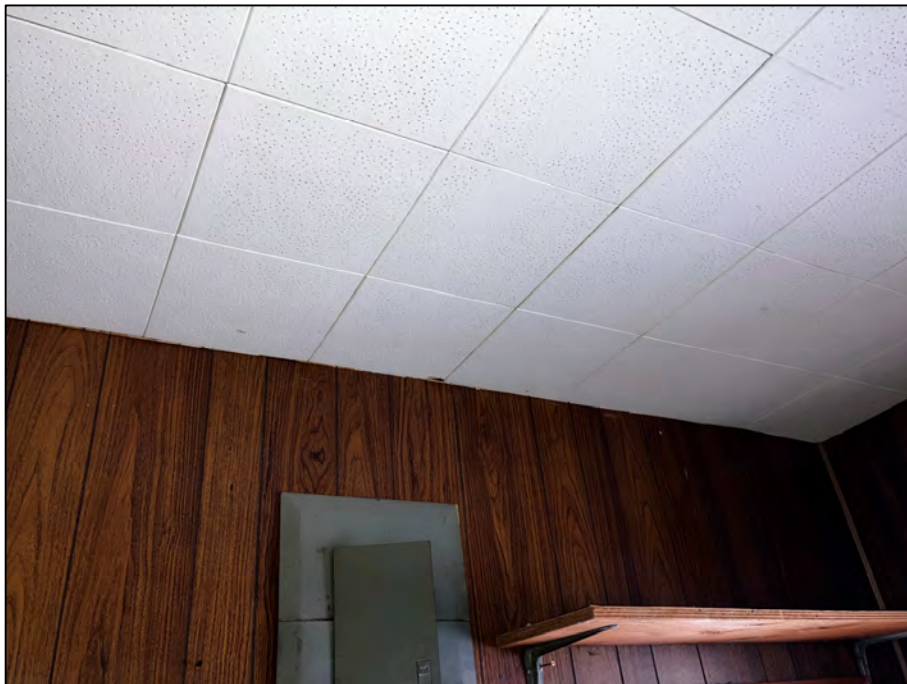
**PHOTOGRAPH #10:** Ceiling Tile - Level 1 Foyer (None Detected)

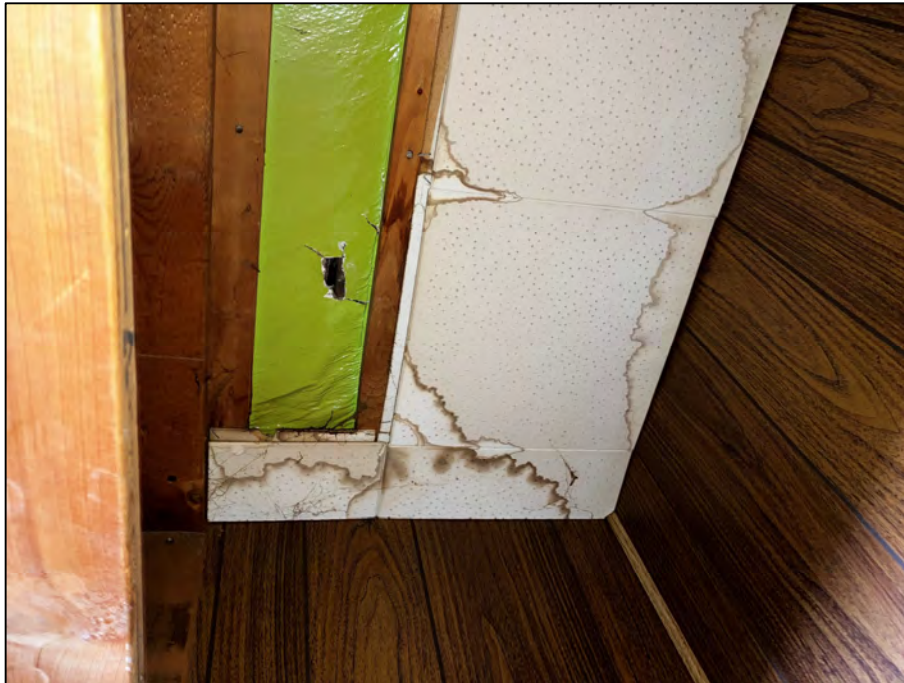
**PHOTOGRAPH #11:** Ceiling Tile - Level 1 Foyer (None Detected)

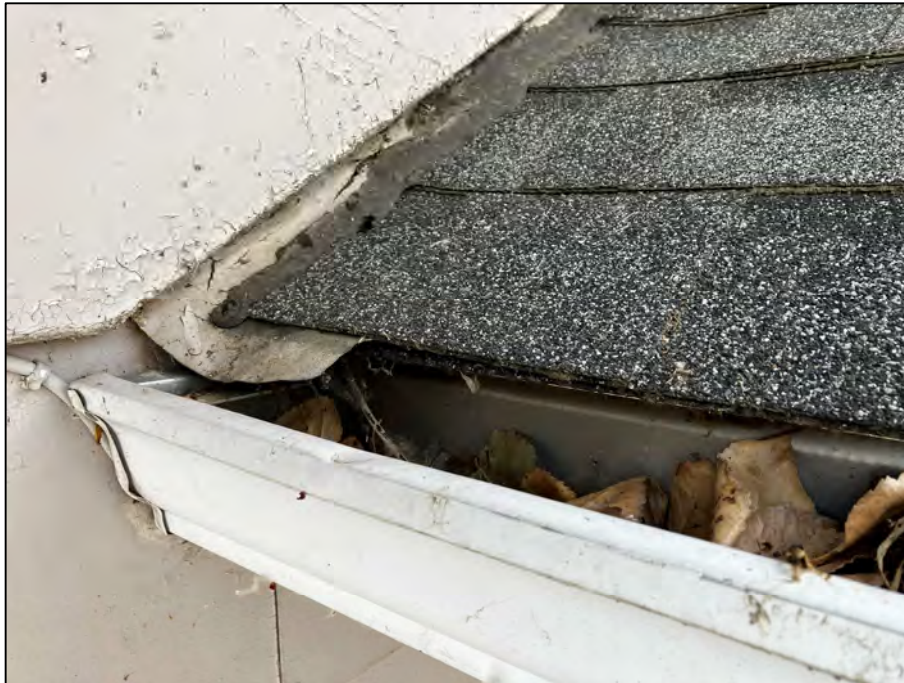
**PHOTOGRAPH #13:** Roof Shingle - Exterior Home (None Detected)

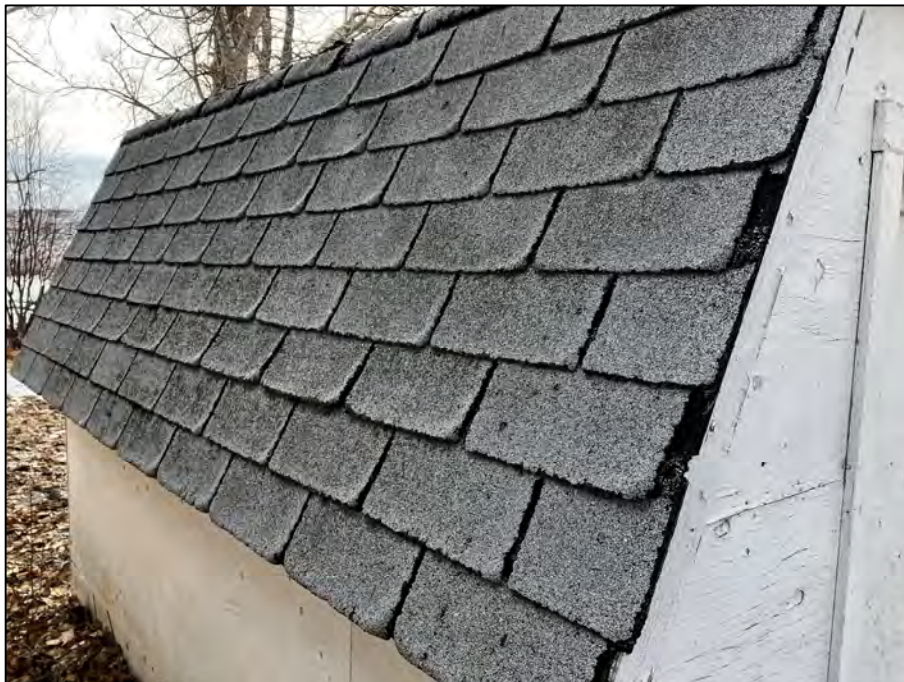
**PHOTOGRAPH #14:** Roof Shingle - Exterior Shed (None Detected)

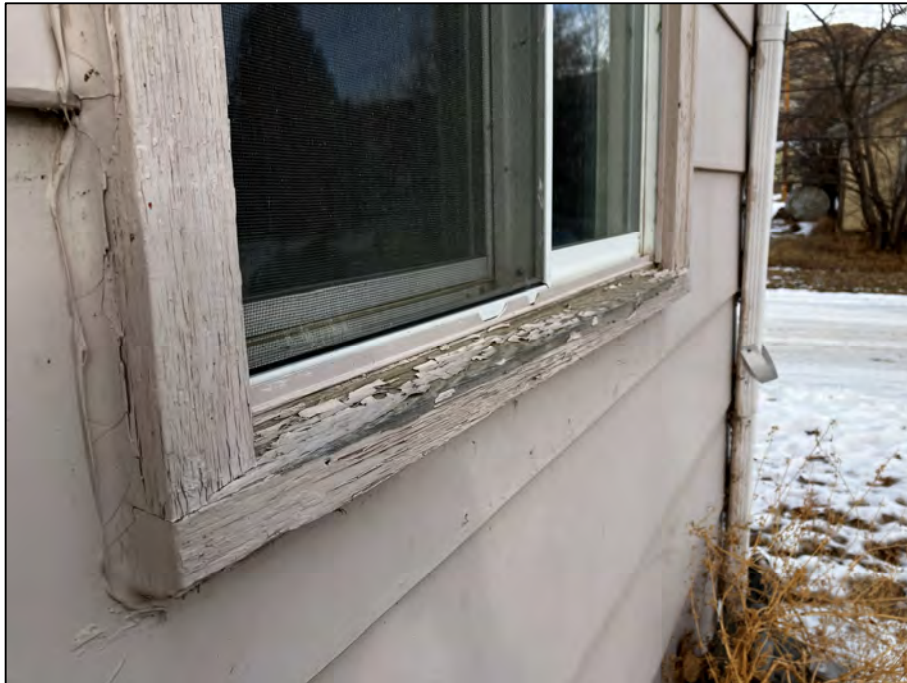
**PHOTOGRAPH #17:** Window Caulking - Exterior (None Detected)

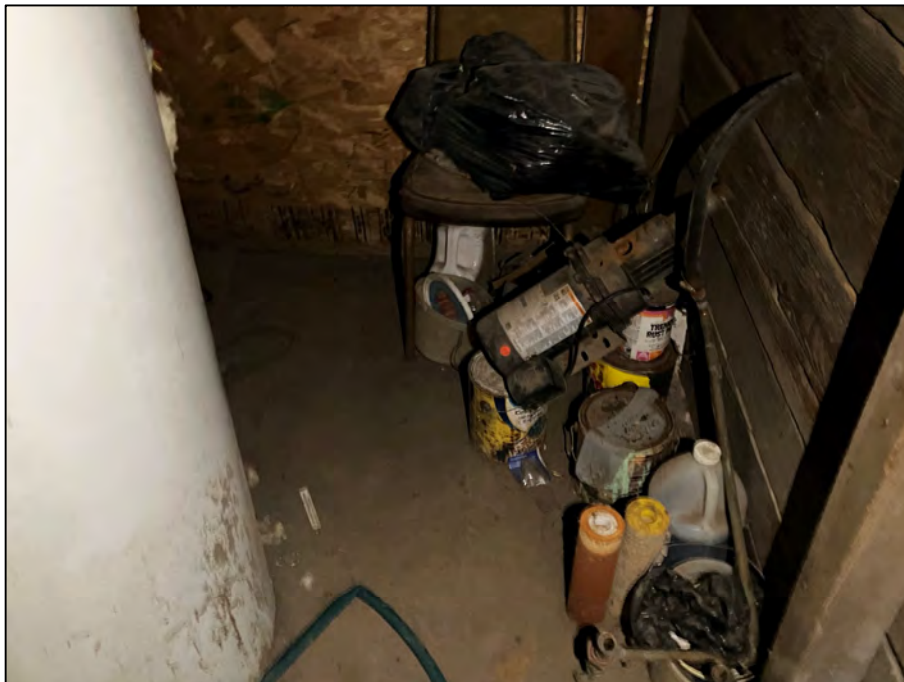
**PHOTOGRAPH #25:** Miscellaneous Chemicals in Basement
